Sydney Metro City & Southwest – Technical Services

Tree Impact Assessment Report Chatswood to Sydenham

Author:	Georgina Luck – Environmental Coordinator
Date:	March 2021
Version:	15
Reference:	SMCSWTSE-SMD-TPW-EM-REP-000541
Division:	Environmental Management
Review Date:	n/a

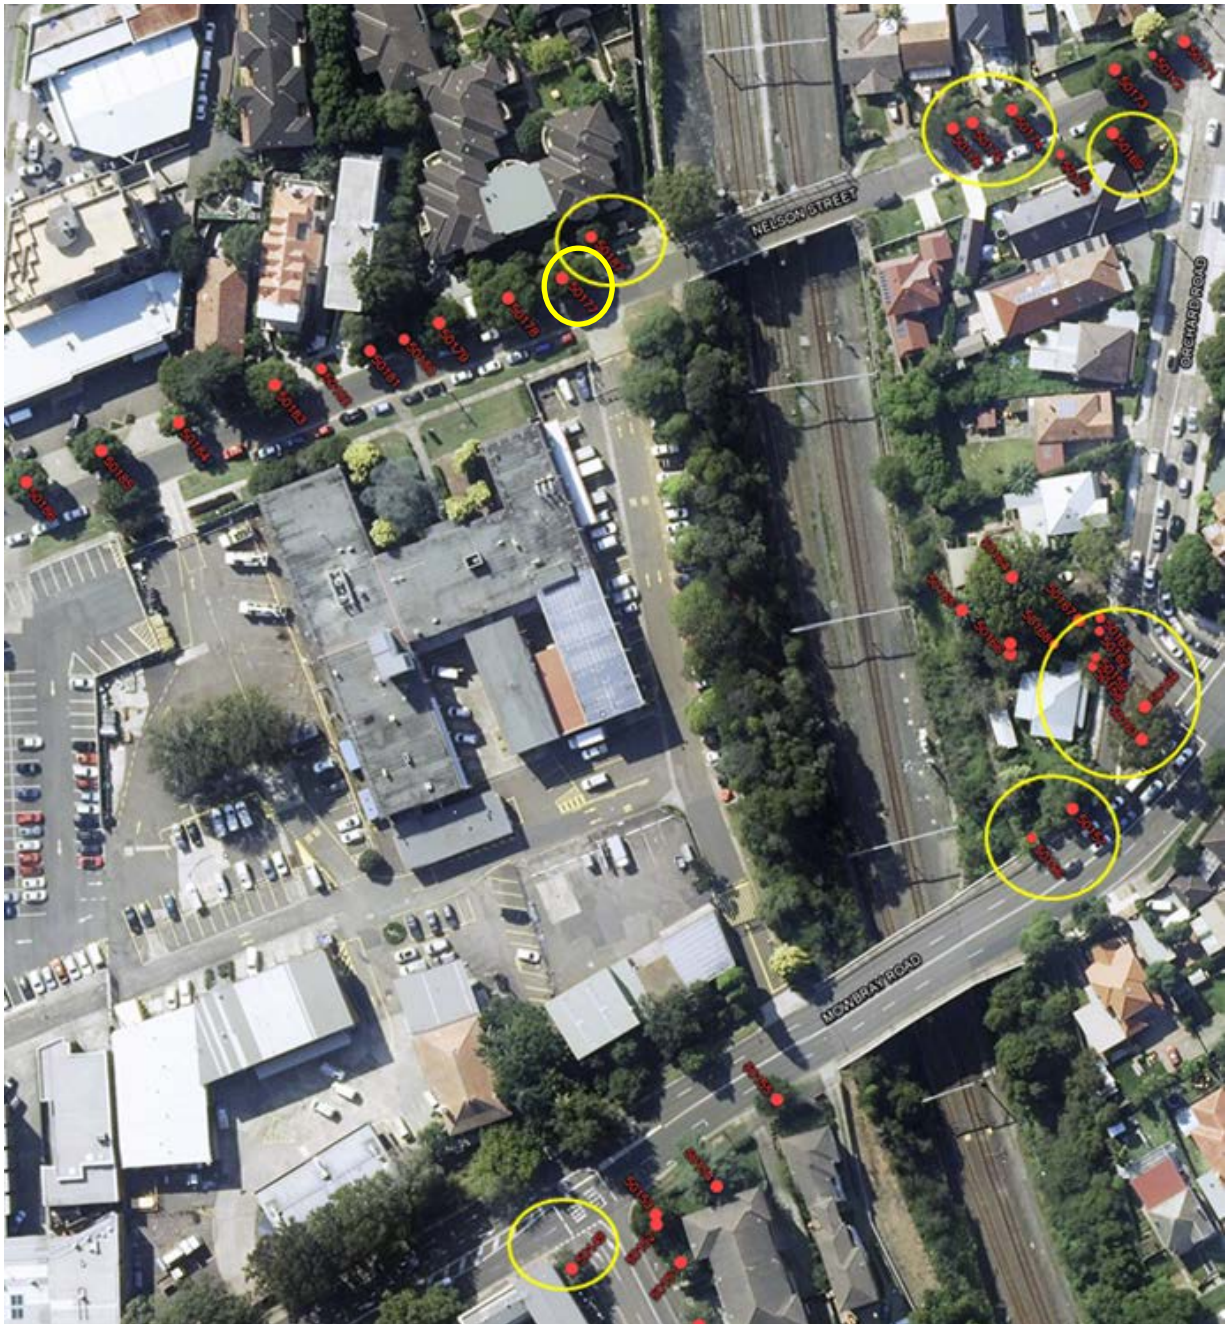
Figure 2: Plan showing tree locations along the utilities route and at the cul-de-sac

These trees are highlighted in Figure 2. Justification for impacts is provided in the table below.

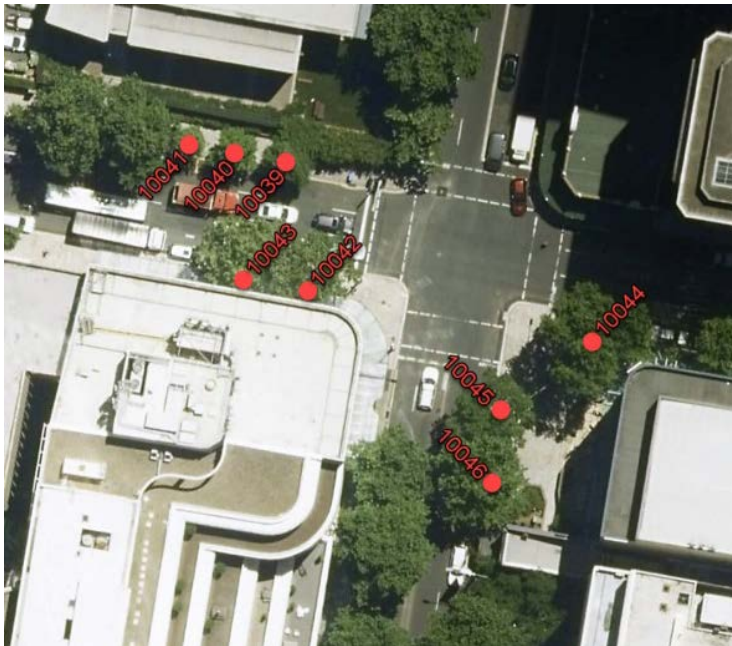
Figure 7. Victoria Cross South Utilities

Surveys were undertaken on trees located adjacent to, or across the road from utility works required to support construction activities. These trees were numbered 10039 to 10046 (Figure 7). No impacts to these trees occurred during the works.

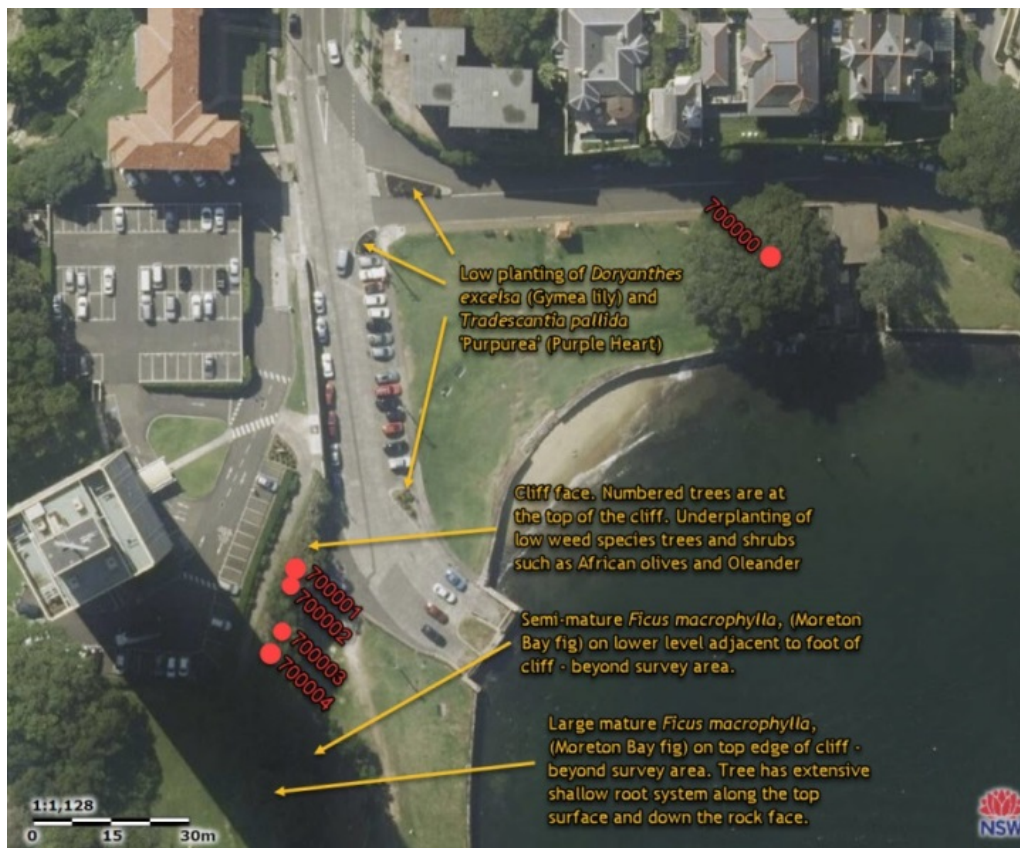
Figure 8: Blues Point Tree Survey for Utility Works

Additionally, approval was sought from the Secretary for minor pruning of the roots of the fig tree in accordance with Condition E7 of the Planning Approval. Although there was no intention to prune the fig tree roots, there was potential that they may be impacted by elevated sheds and amenities located outside the TPZ.

Approval under E7 was granted by the Department of Planning and Environment on 25 September 2018.

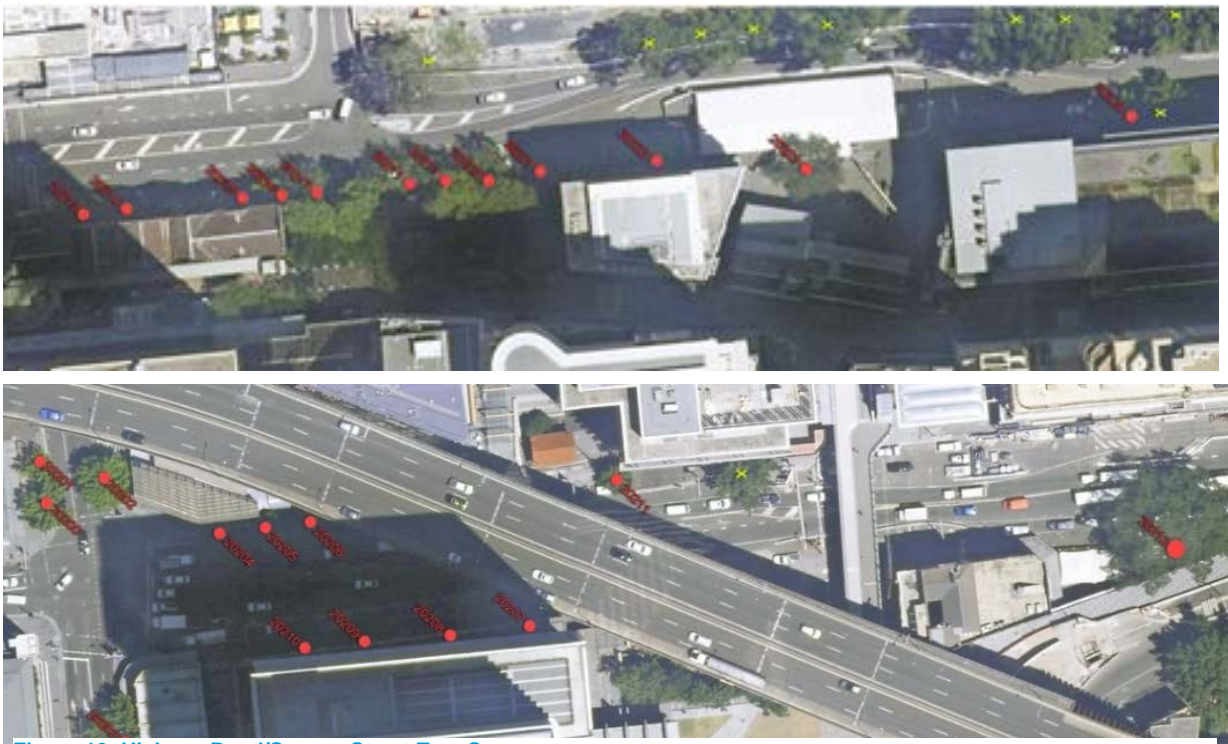
Figure 10: Hickson Road/Sussex Street Tree Survey

Trees have been surveyed which are located adjacent to, or across the road from associated utility works (Figure 10) which are required to be undertaken to support the construction activities. These trees are numbered from 20200 to 20224. No impacts have occurred to these trees during works.

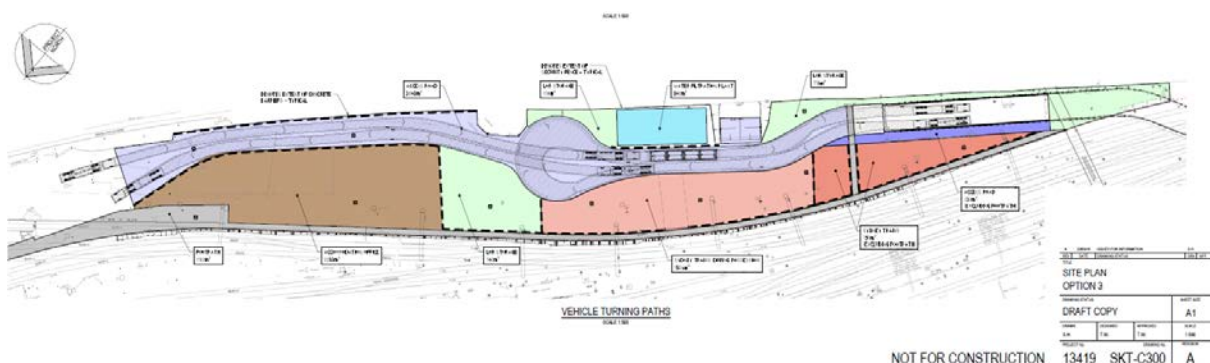
Figure 14: Site Plan Central Rail Corridor Works

Eleven (11) trees were removed to allow for the truck access route and construction of the station box as indicated in Figure 14 below. Due to the highly constrained nature of the site there was no opportunity to retain these trees.

Vegetation within the subject site was found to consist of Urban Native/ Exotic Vegetation which had previously been planted. No remnant native vegetation was identified during the survey. No trees were retained within this site.

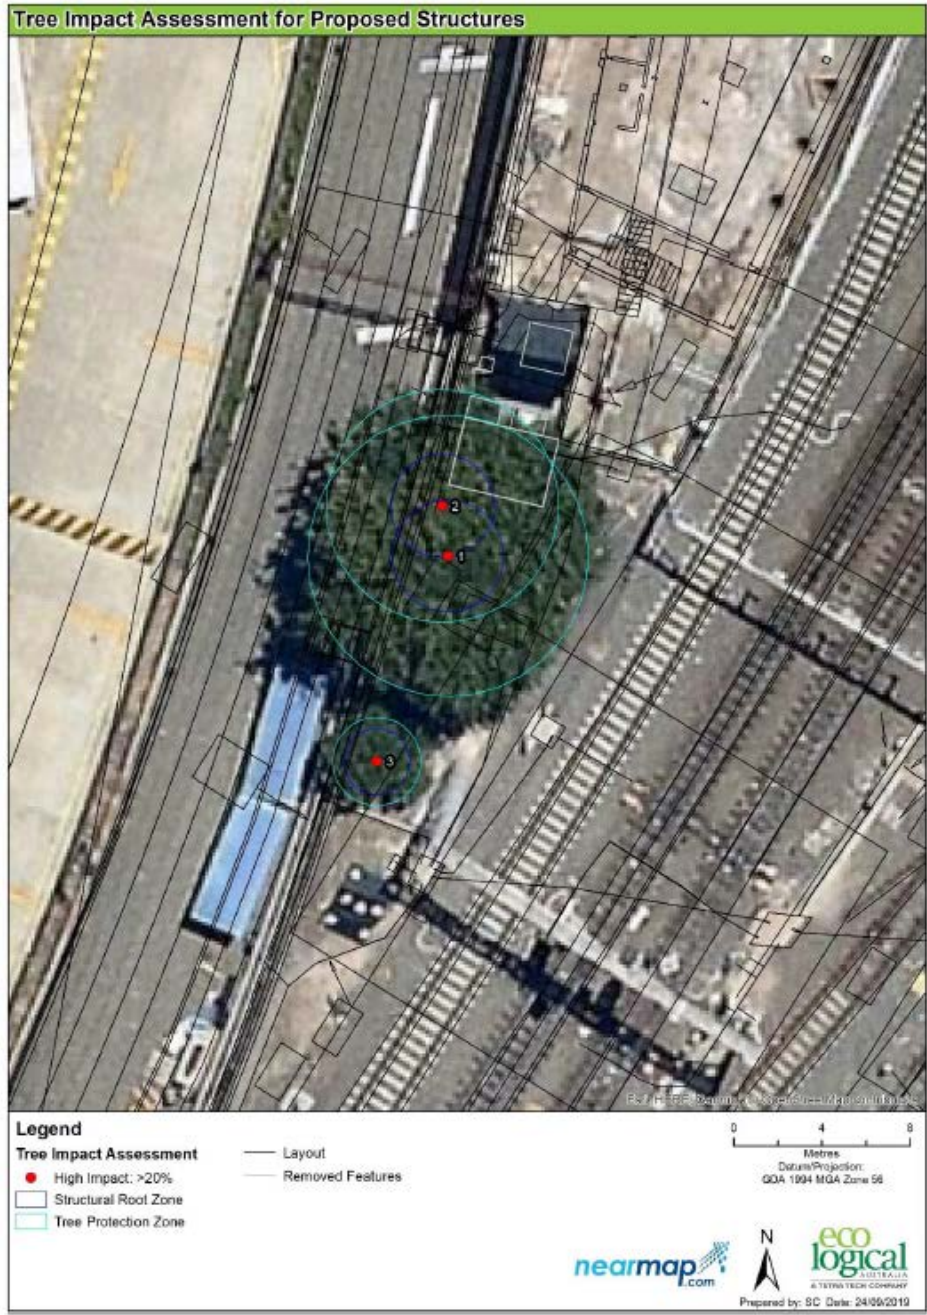
Figure 14.1: Tree impact for CSR and pad mount substation

To the south of Lee St substation, a service route is to be installed to carry High Voltage (HV) cables and a pad mount substation is to be built. Three (3) trees are located at the southern end of the substation and will need to be removed. See Figure 14.1 below. The 3 trees have low retention value. Due to the highly constrained nature of the site there was no opportunity to retain these trees.

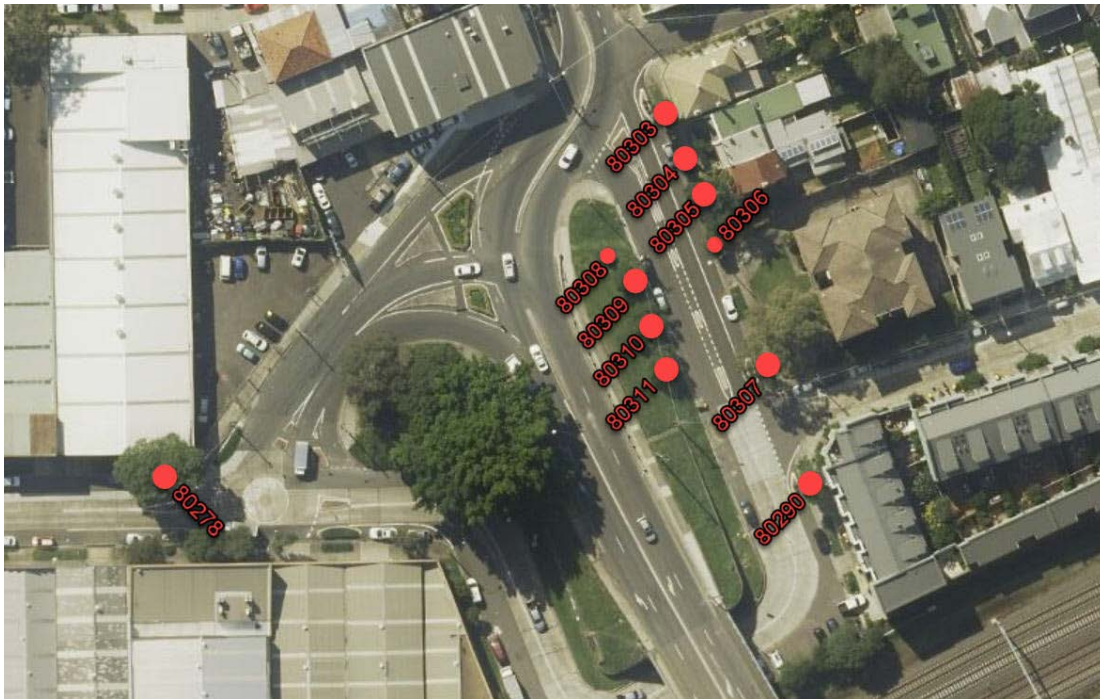
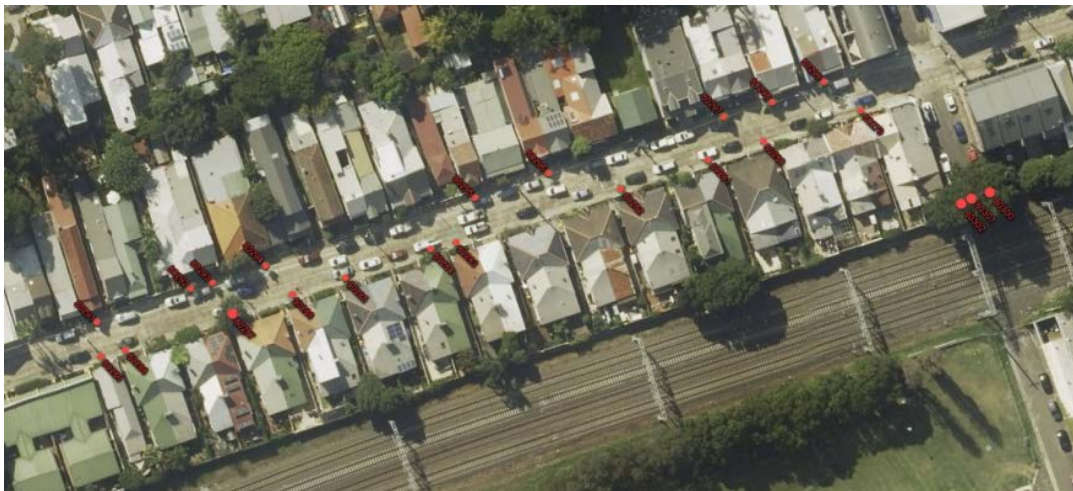
Arborist surveys have been undertaken on all trees located adjacent to, or across the road from utility works required to support construction activities (Figure 17 and Figure 18). These trees were numbered from 80278 to 80342. Impacts to these trees were able to be mitigated during the works.
