14 January 2022  
Ref: 170108-ER\_DPIE-December 2021

**RE: Sydney Metro City & South West – ER Monthly Reports for December 2021**

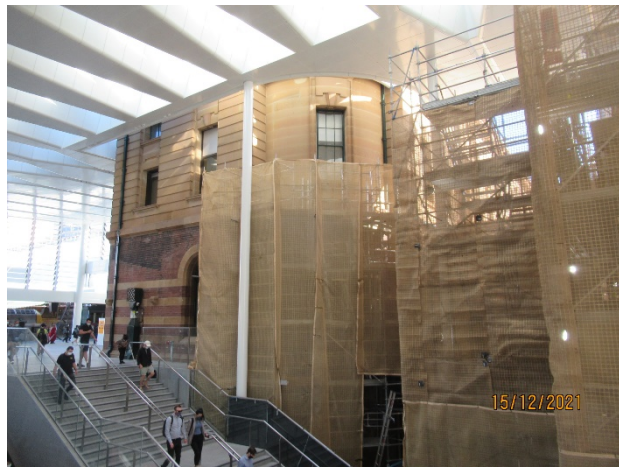
**Ongoing works in the Northern Concourse**

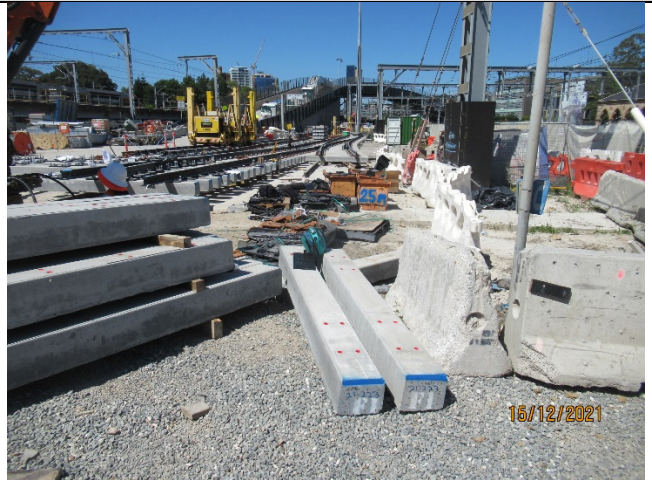
**Assembly of turnout for tracks on new platforms**

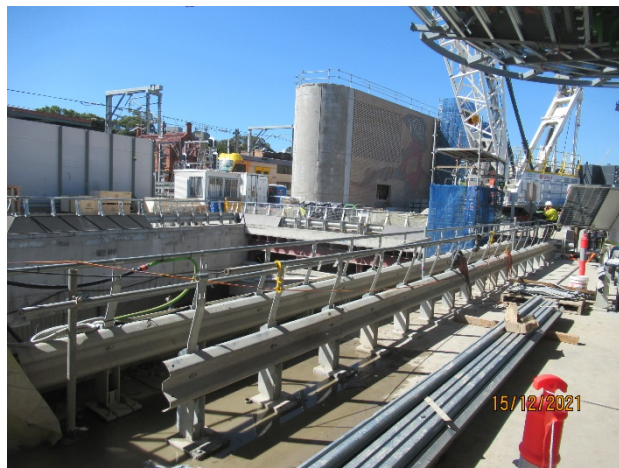
**General works in the Metro Box area**

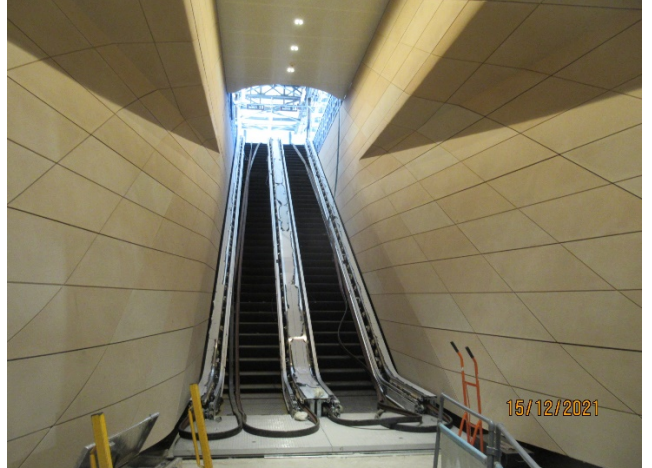
**Fit out and façade placement for escalators to Platforms 16 and 17**

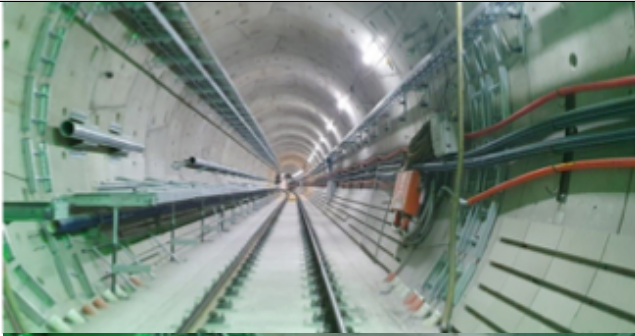
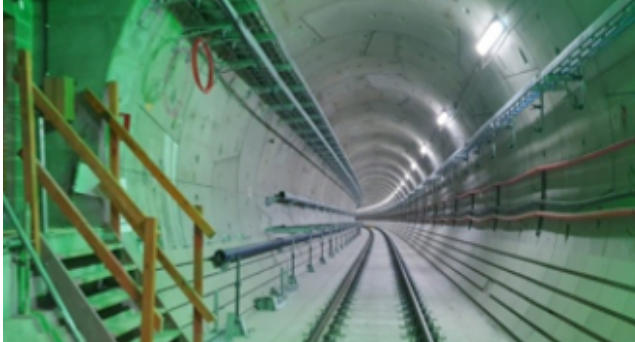
**Tunnels - installation of mesh on walkway frame and installation of noise panels (for operational phase) on both walls continuing.**

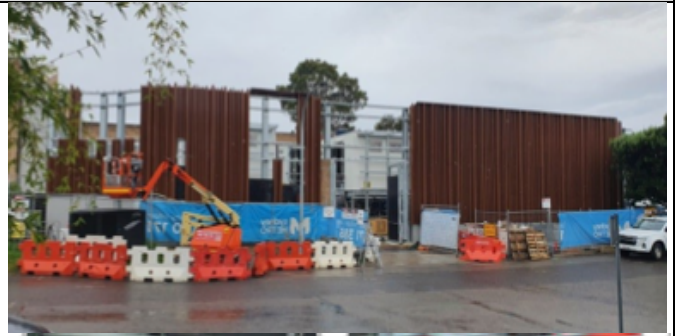
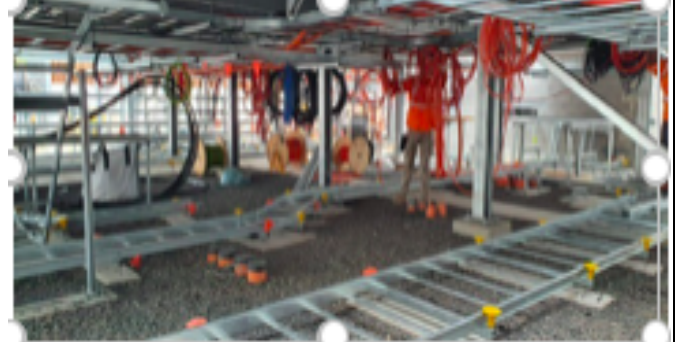
- TSS site entrance and section of Whiting St near site was observed to be tidy during the inspection.
- Minor tagging observed on shade cloth on boundary fence, shade cloth noted to be frayed and missing in a couple sections of the boundary fence. Action raised within the Inspection Report.

**Artarmon TSS - Whiting St - Installation of façade panels and cabling on TSS continuing (Whiting St). TSS site entrance and section of Whiting St near site was observed to be tidy during the inspection.**

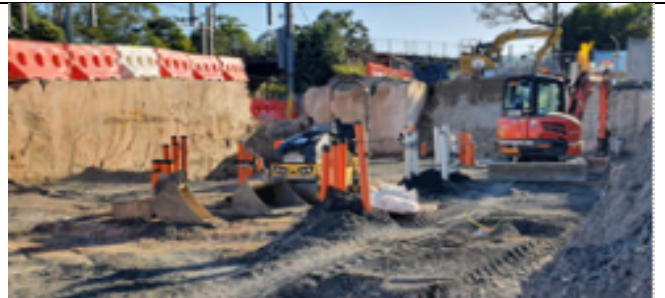
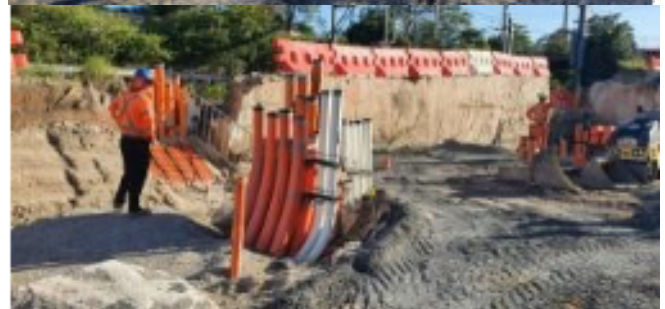
**Canterbury TSS – Combined service route (CSR) works – excavation, conduit installation and backfilling continuing.**

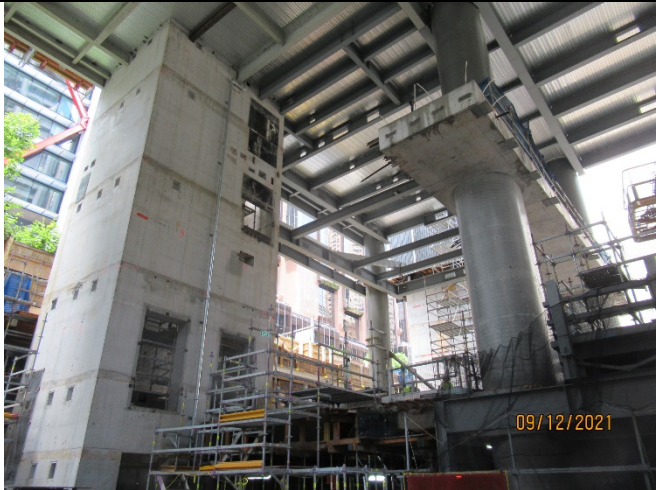
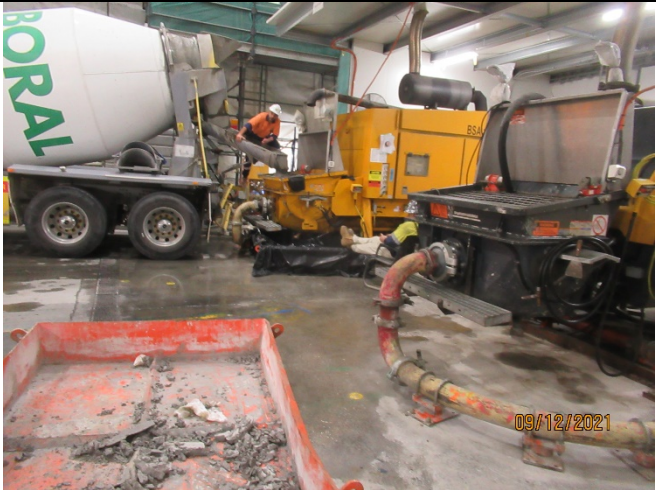
<b>Martin Place North – ongoing building works</b>	<b>Concrete trucks and pumps operating in the acoustic shed.</b>

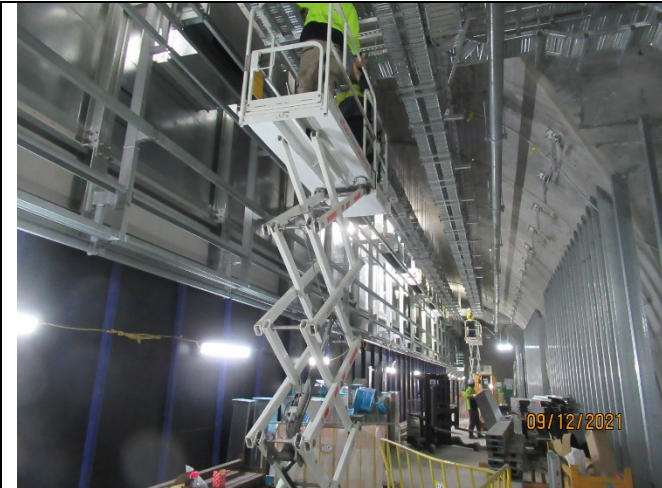
Platform Caverns – Fit out

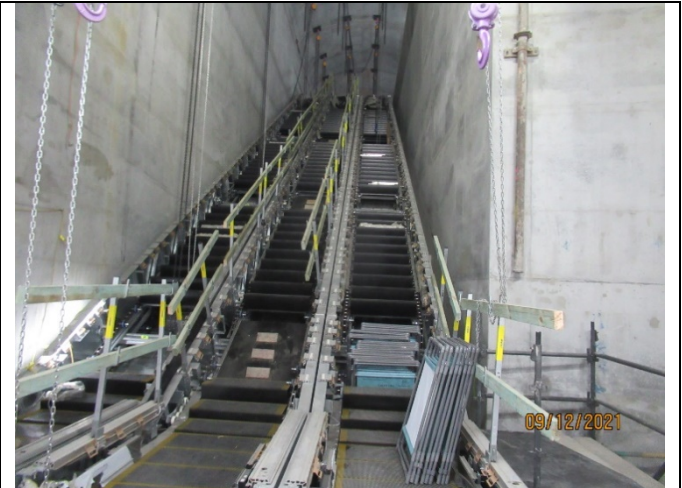
Escalators installed for access between ESR and Metro Station.

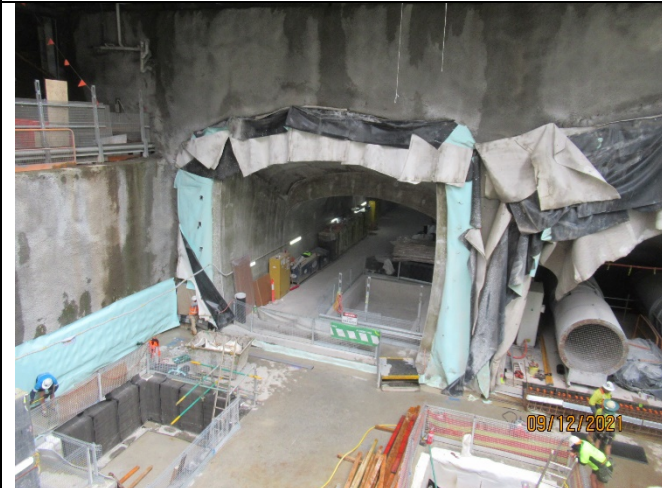
Martin Place South – Pedestrian Tunnel

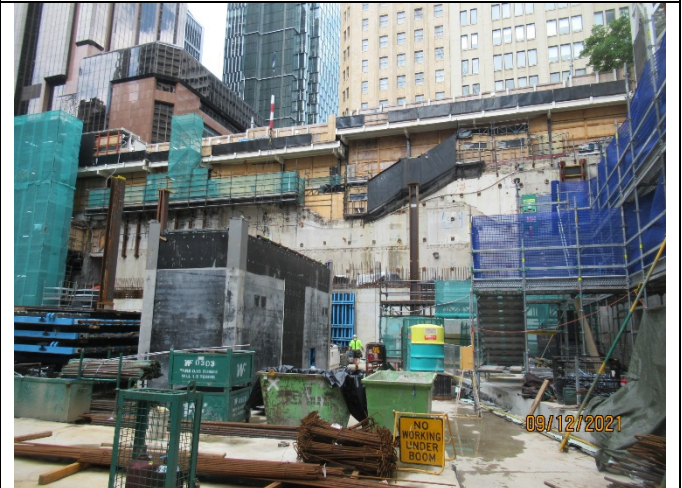
Martin Place South – ongoing FRP works

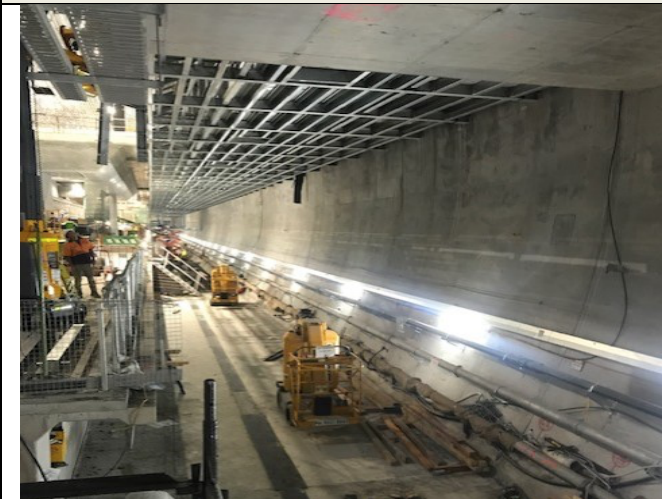
Cavern: trackway steel fixing underway on eastern side, with concrete pour scheduled to follow.

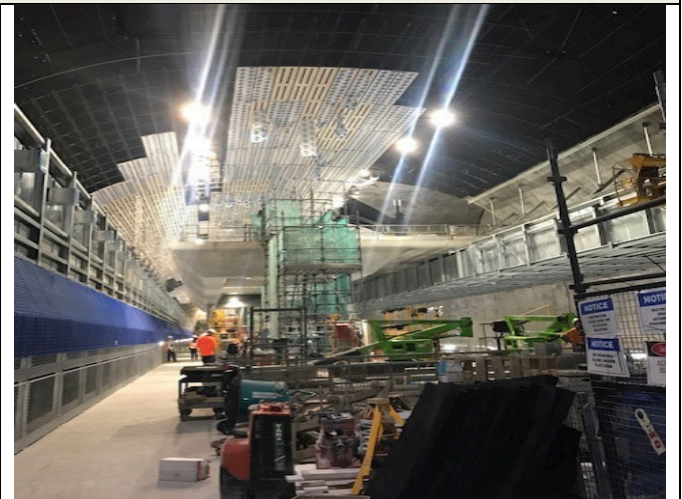
Cavern: GRC panel installation continuing on roof of cavern

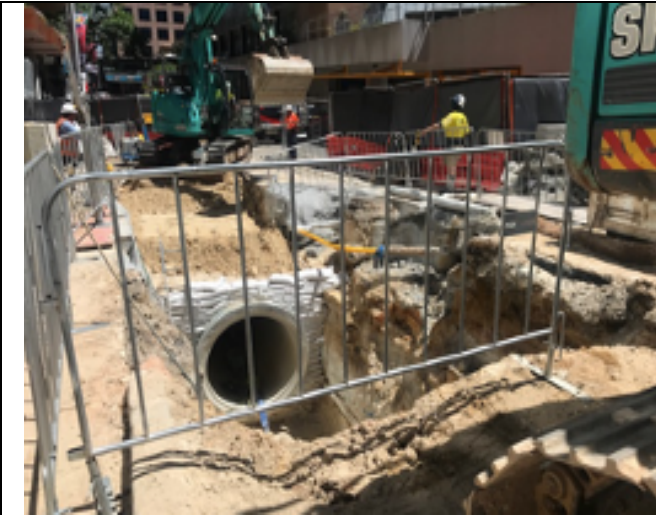
**Denison Street Stormwater works – Stage 3 area: Drainage excavation works underway. Noise blankets observed in place.**

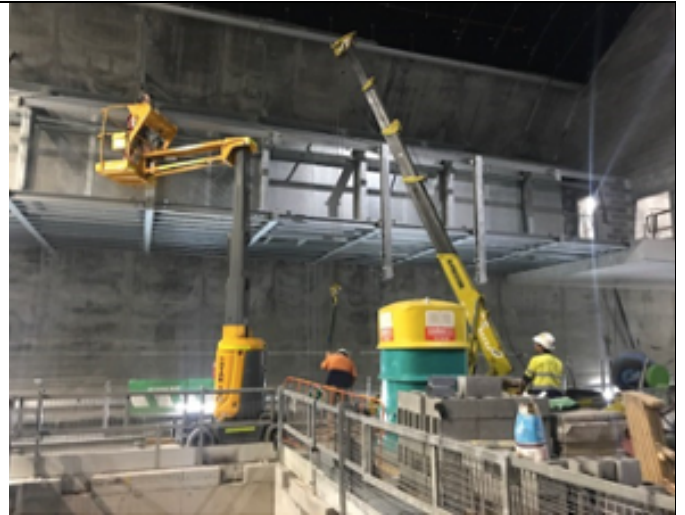
**Eastern Cavern: Structural support installation work on OTE ventilation modules underway.**

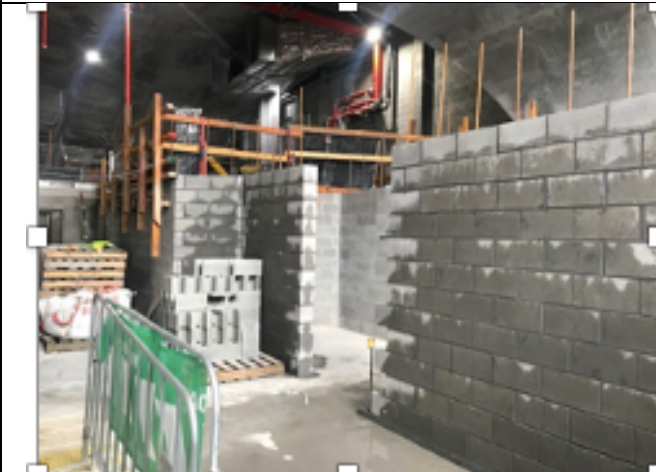
**VCS South Back of House Area: Blockwork continuing.**

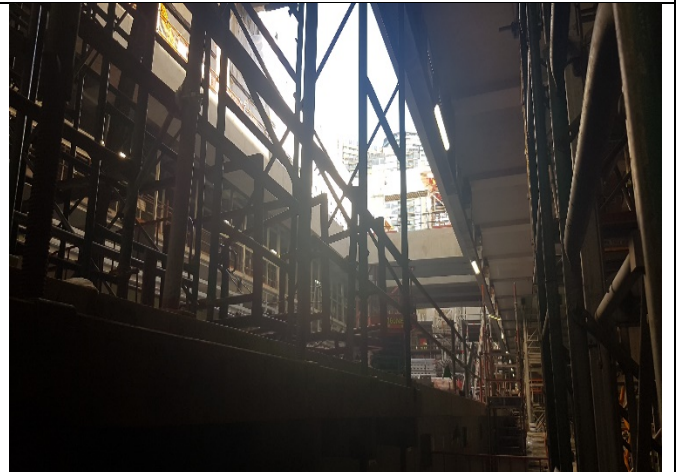
**VCN - North Yard Area: No concrete pours in yard at time of inspection.**

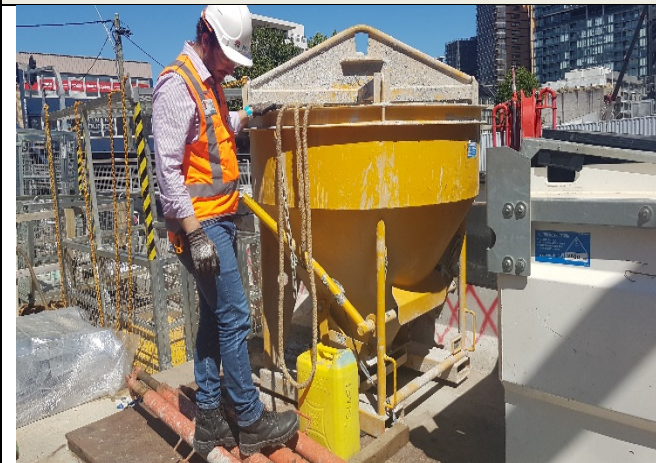
**Concrete hopper that was washed out, resulting in run-off to Clarke Lane stormwater system - incident reported**

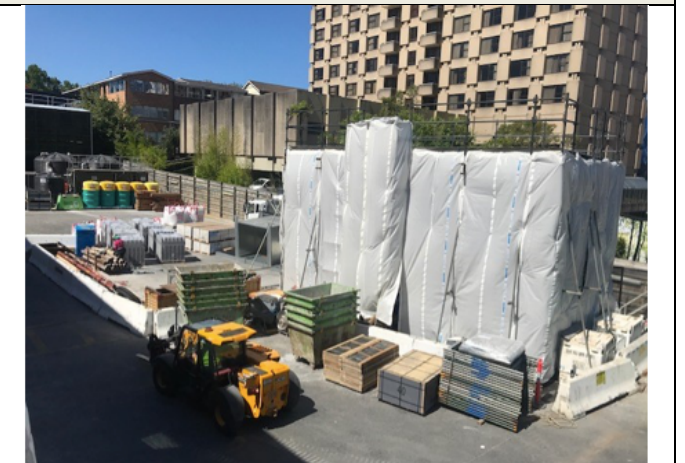
**Over-Track Exhaust structure completed**

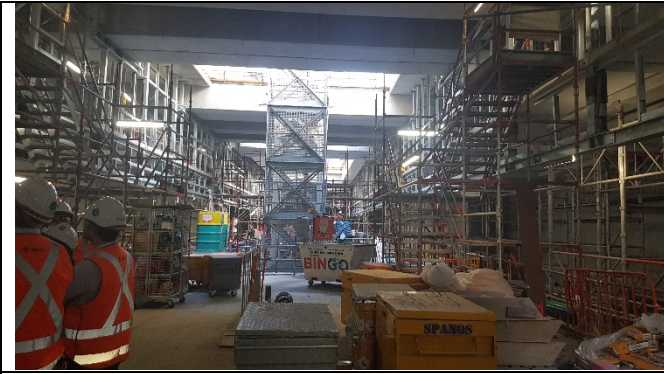
General view of station to north, from top of platform

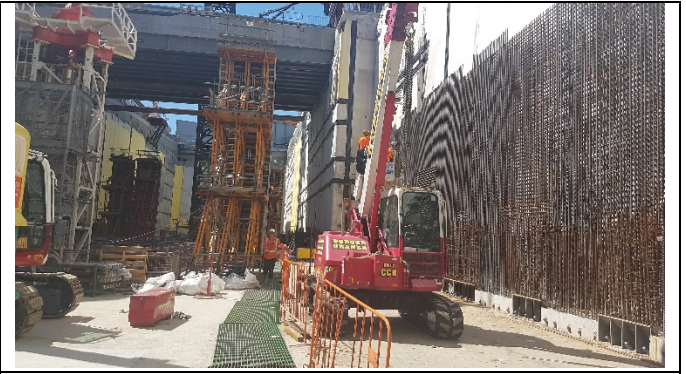
Perimeter wall steel fixing

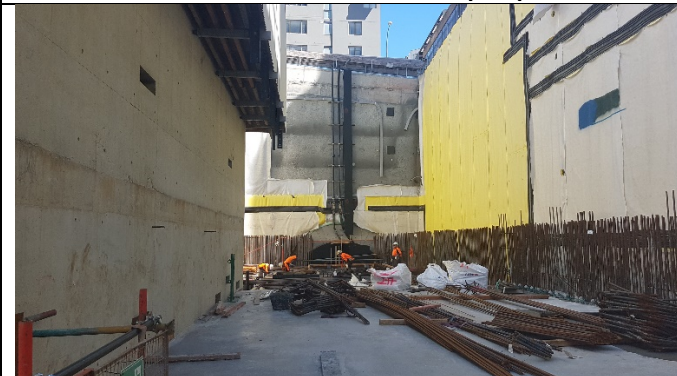
Level B3 (above girders) view North with steel fixing

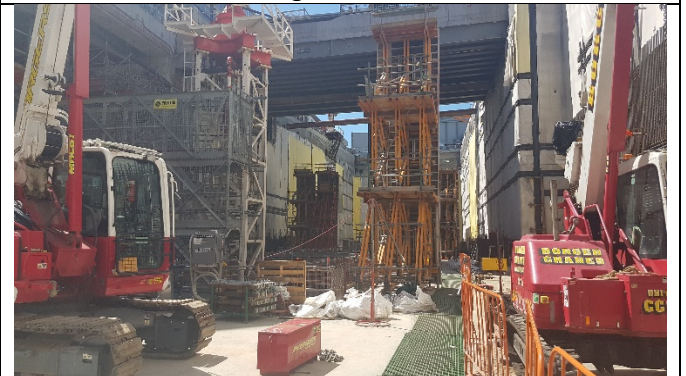
Level B3 view South

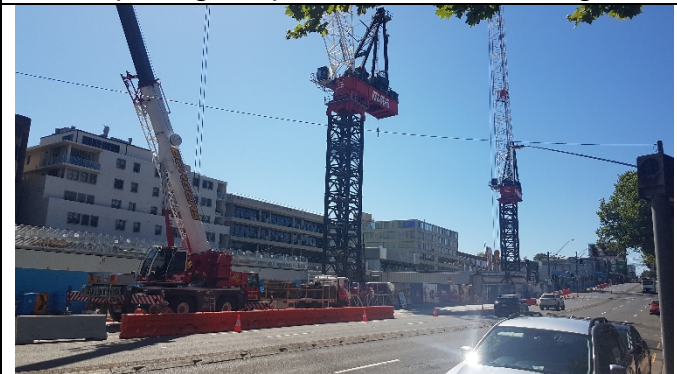
Pacific highway logistics lane in operation -view east

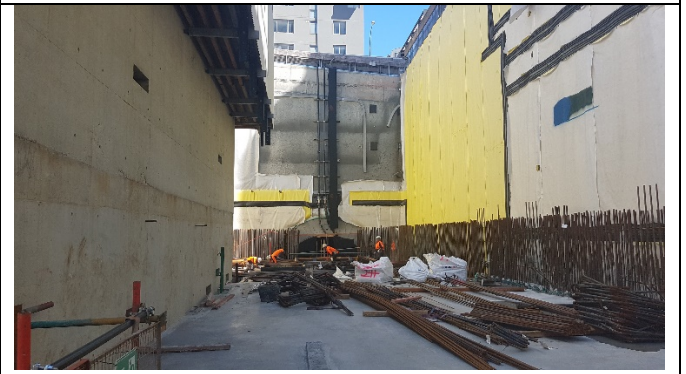
North tunnel portal ongoing waterproofing

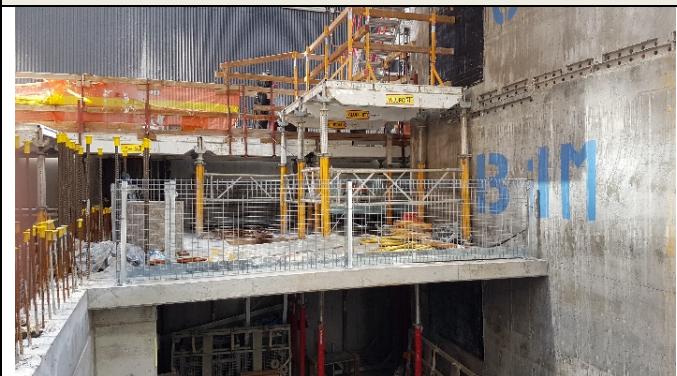
Pitt St South (PSS) B1 Mezzanine level.

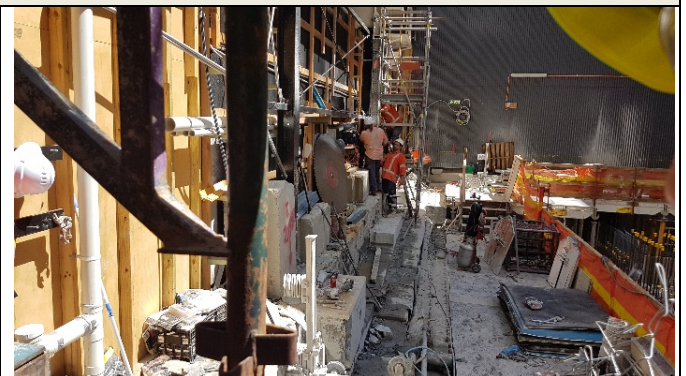
PSS Ground level, capping beam mostly removed.

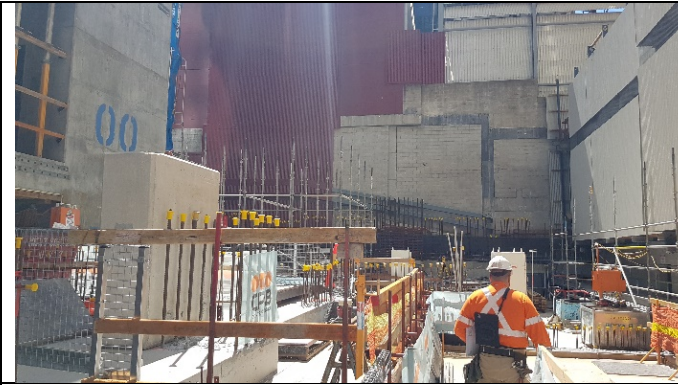
**PSS -Various steel fixing and formwork at B01M level**

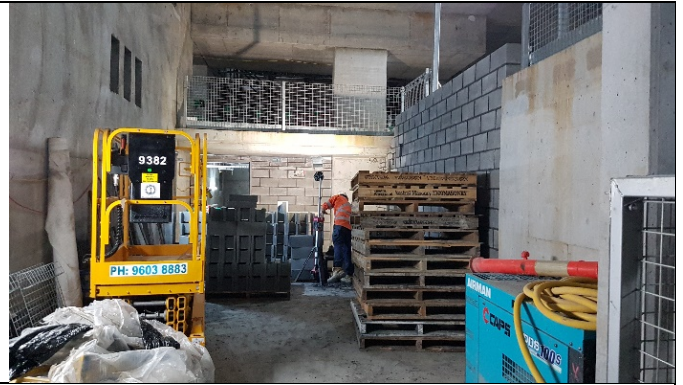
**PSS B1 interior construction, including blockwork**

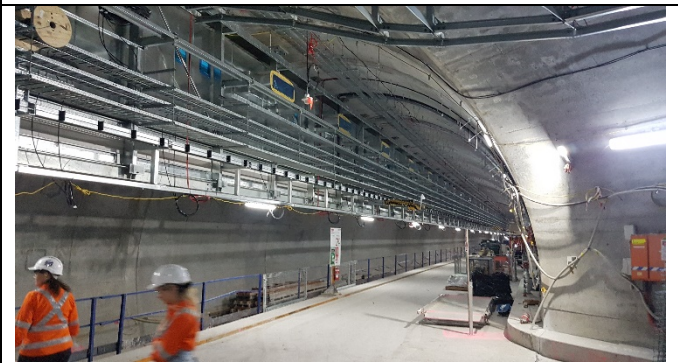
**Eastern cavern track slab and platform**

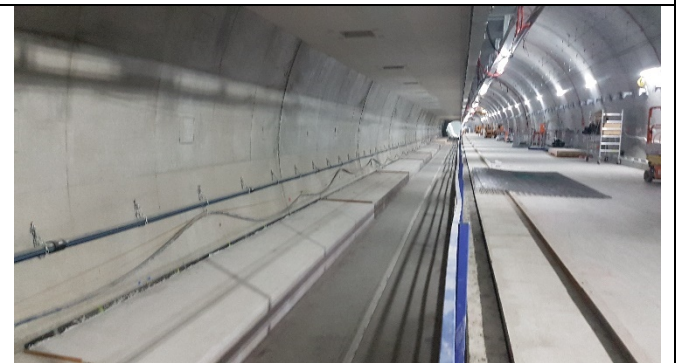
**Western cavern track slab and platform with OTE above**

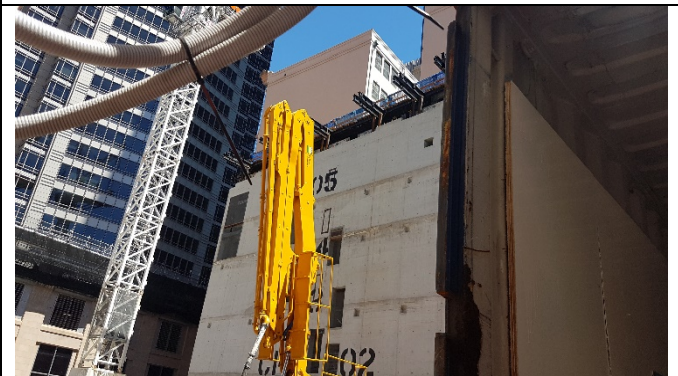
**Pitt St North (PSN) Western core structure to Level 5**

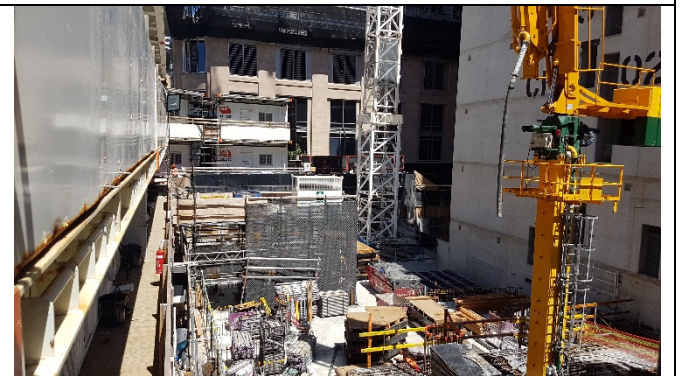
**PSN western side: FRP at levels B01M and Ground**

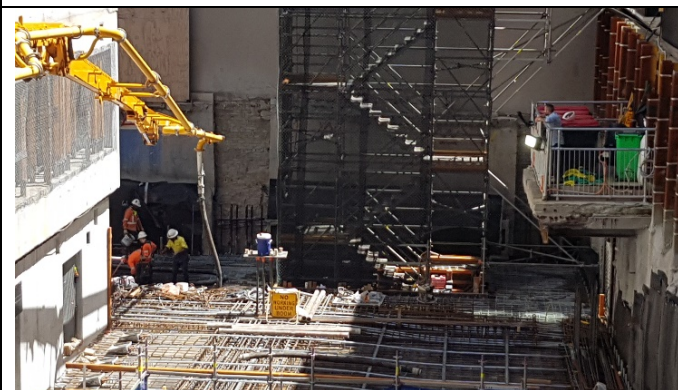
**PSN south eastern side: concrete pour level at B01M**

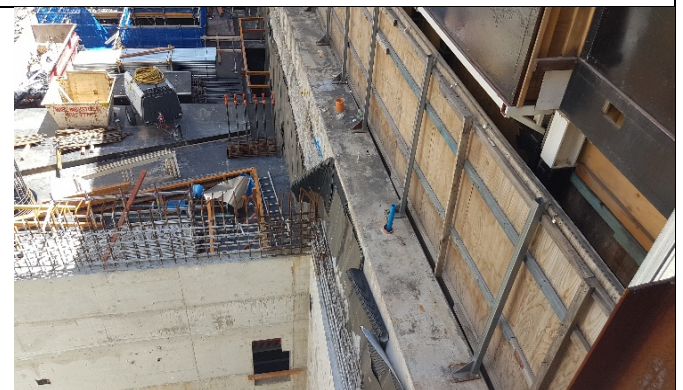
**PSN Pitt St capping beam along Castlereagh St.**

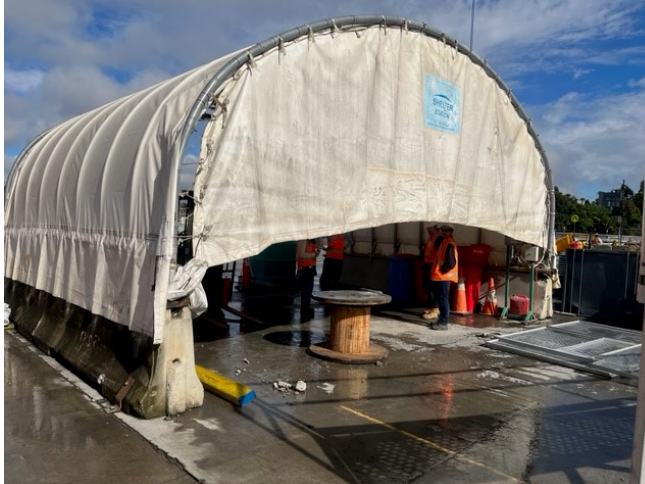
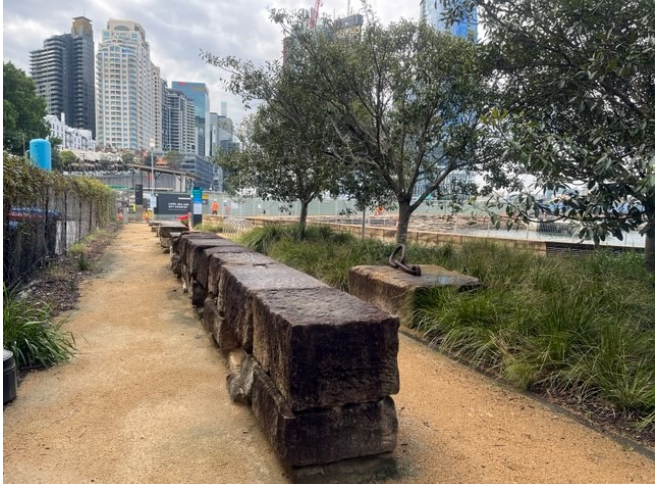
<p><b>Fuels without secondary containment and no spill kit were observed in the refuelling area</b></p>	<p><b>Proposed trenching within this landscaped area was discussed, requiring removal of Port Jackson fig trees on INSW land</b></p>

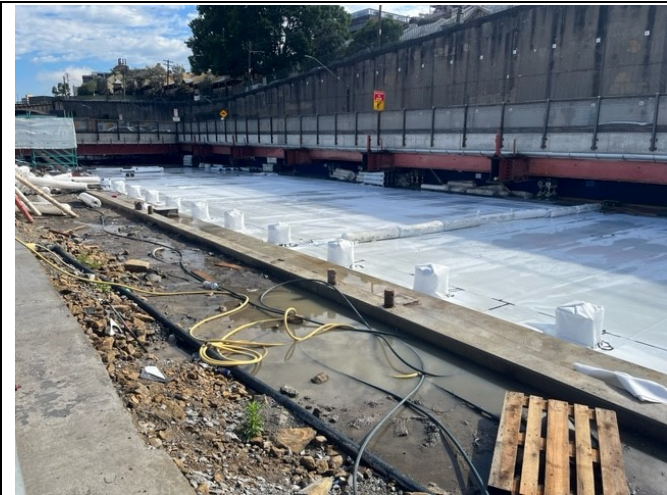
**Waterproofing of the station box roof**

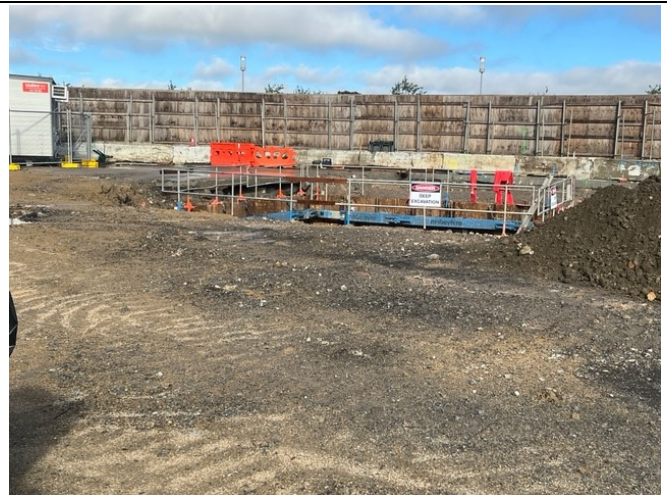
**The management of infiltration of water into deep excavations associated with stormwater trunk relocation works is under discussion**

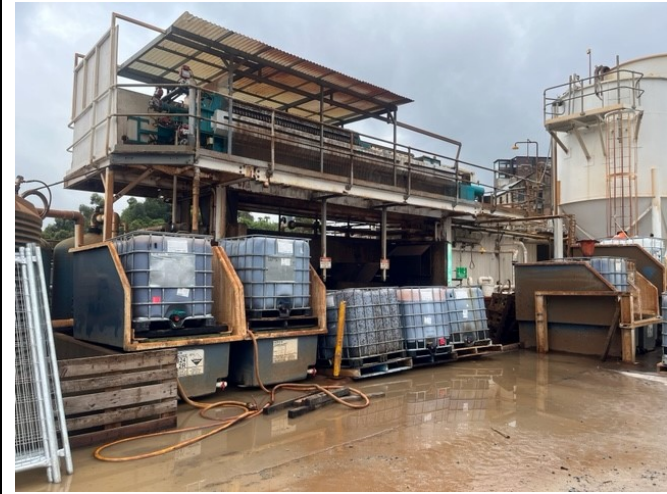
**Chemical IBCs were observed without adequate secondary containment prior to the Christmas Shutdown**

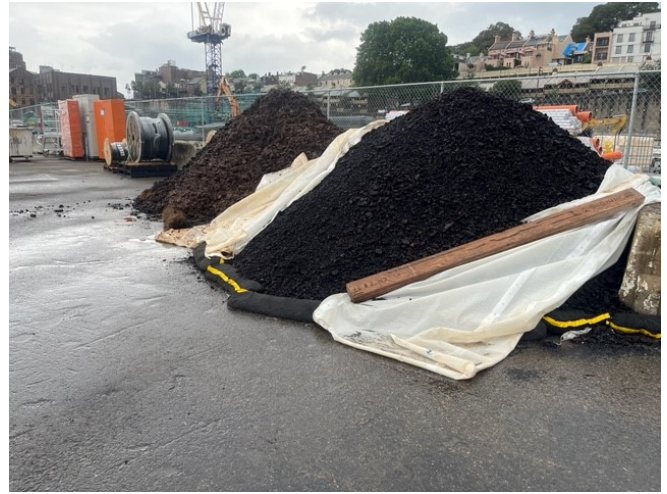
**Stockpiles of filter cake were not covered prior to the Christmas Shutdown**

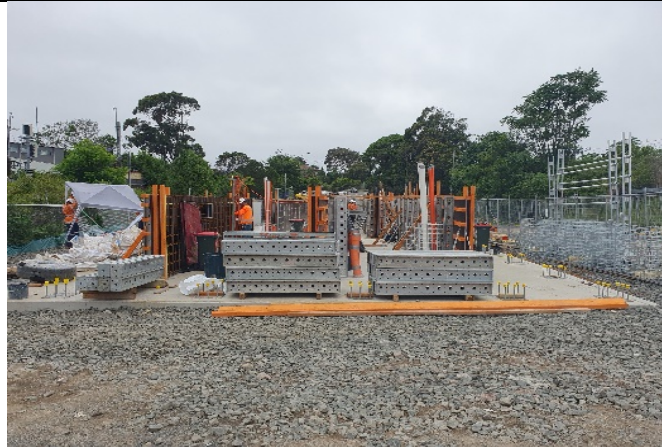
**Marrickville MSB – Concrete form works 08/12/21**

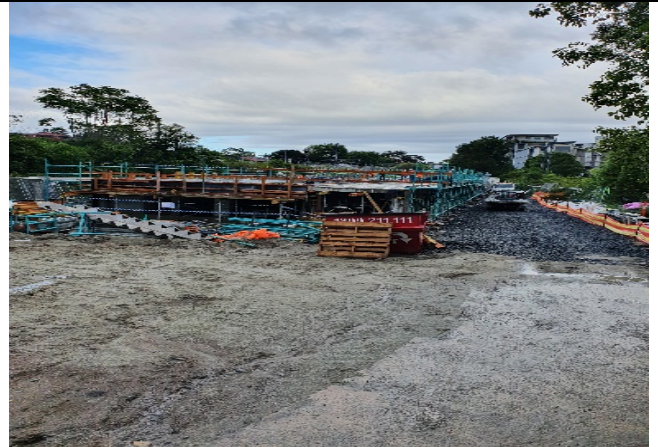
**Marrickville MSB – Concrete form works 29/12/21**

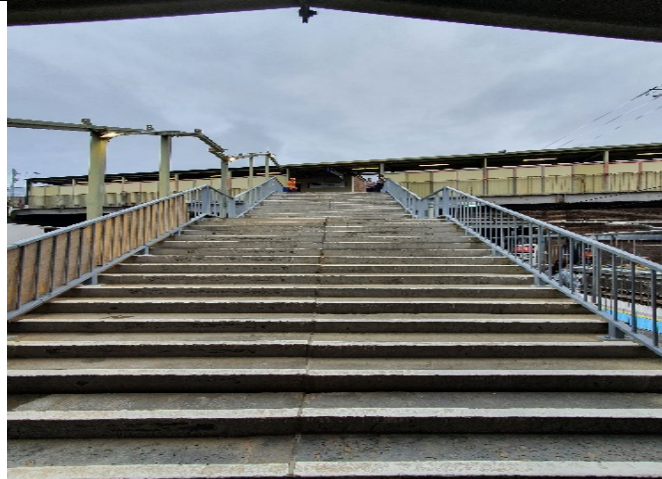
**Canterbury Platform 0/1 Canopy removed**

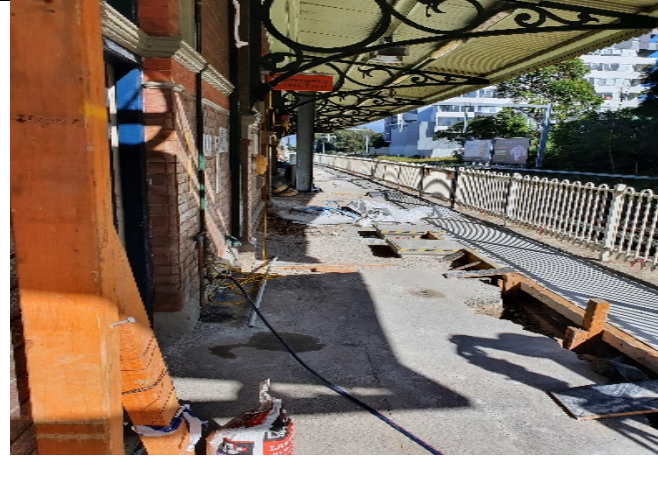
**Canterbury Platform 0 Platform reconstruction**

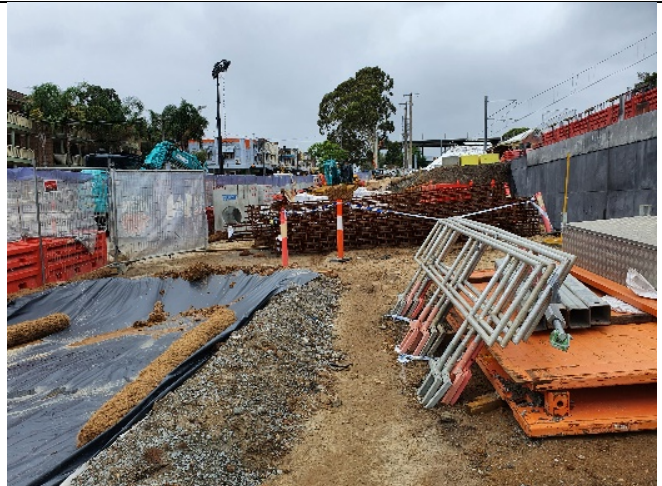
**Lakemba – MSB retaining wall**

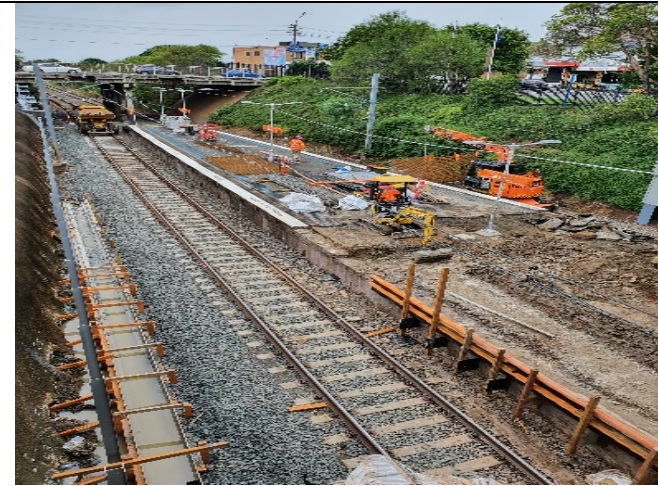
**Lakemba – Demolition of platforms commenced**

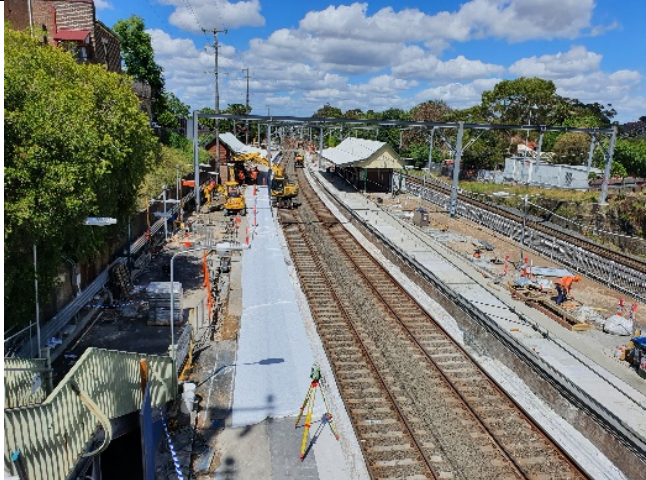
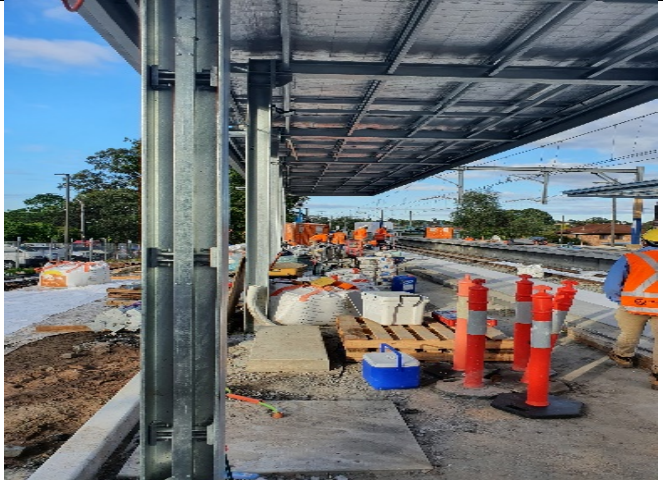
<b>Hurlstone Park platform works</b>	<b>Wiley Park construction of MSB and station shelter</b>

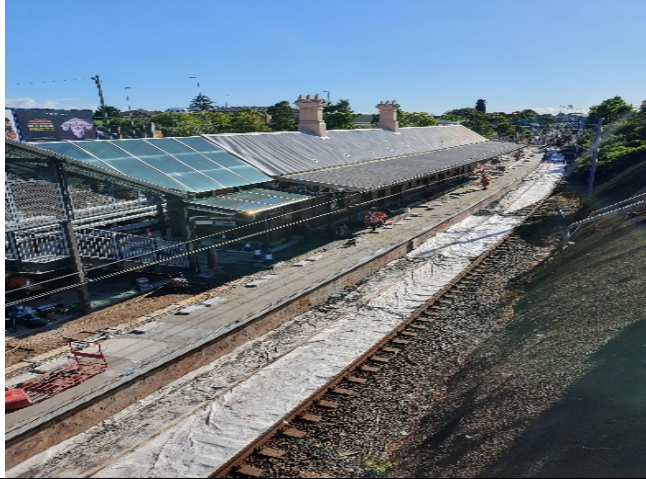
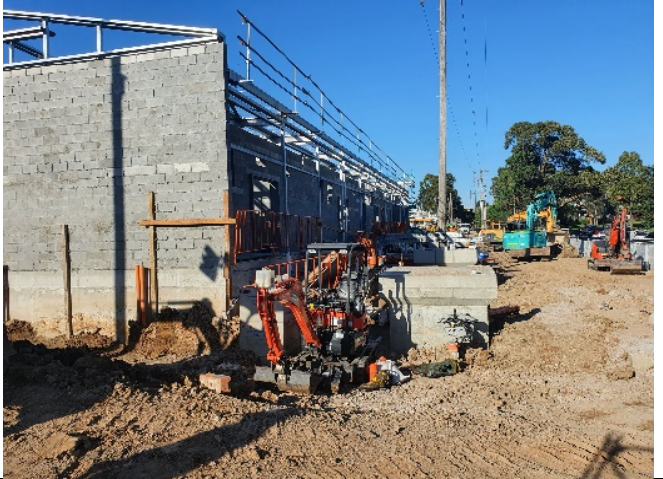
<b>Belmore platform works</b>	<b>Punchbowl MSB construction</b>

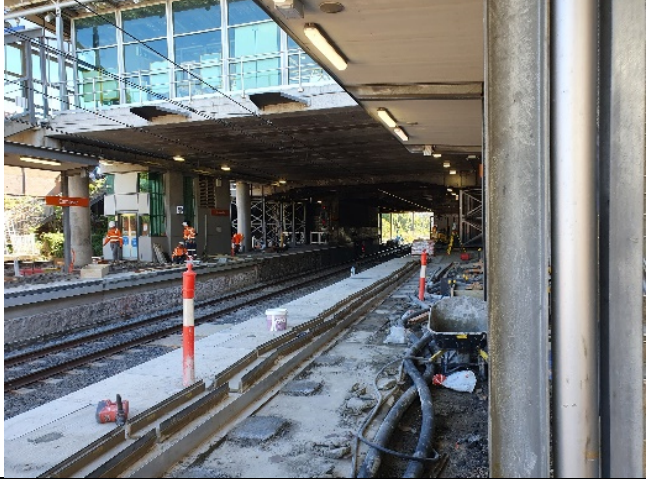
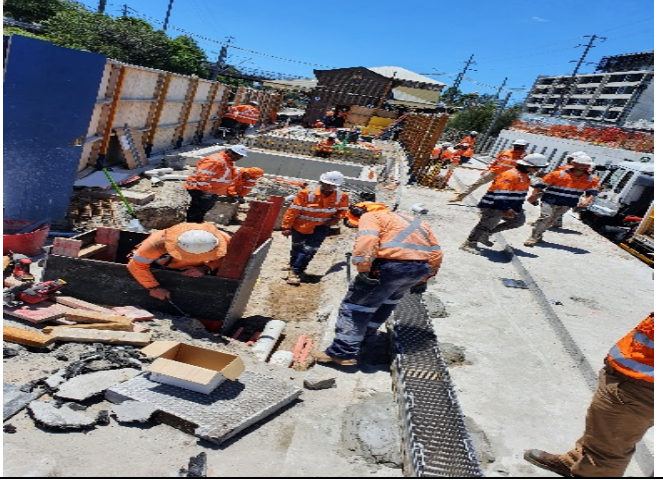
<b>Campsie platform drainage and ACO drainage installation</b>	<b>Dulwich Hill lift shaft and ACO drainage installation</b>
<b>Endorsed Document/s</b>	
<ul style="list-style-type: none"> <li>▪ Noise and Vibration Management Plan for DCP and HBW (Endorsed 16/12/21)</li> <li>▪ OOH WE25 shutdown, WE31 WE32</li> <li>▪ OOH High impact with noise mitigation to 9pm during shutdown</li> </ul>
