7 March 2022

Ref: 170108-ER DPIE-February 2022

RE: Sydney Metro City & South West - ER Monthly Reports for February 2022

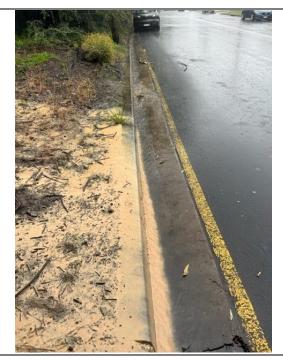
Boundary controls were at risk of overtopping during intense rainfall event at the BEW MSB Site

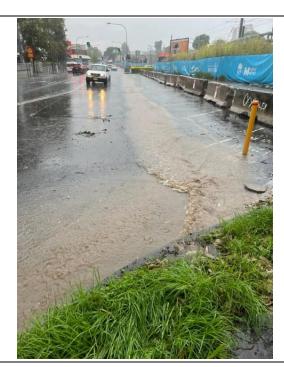
Sediment laden runoff identified under the Stacey Street Bridge after a large rainfall event (an incident was raised)

• SMC-INC-014: During an ER Inspection at Stacey Street BEW, it was identified that the ERSED controls had been breached in a heavy rain event. A coir log was missing, however was replaced immediately. The issue is related to a pre-existing site condition that was improved by the JHLOR applied ERSED controls. The rain at Bankstown reached the 20% average exceedance probability (AEP) for a 3hr period. ERSED controls are not generally designed to withstand this high AEP. No material harm to the environment.
