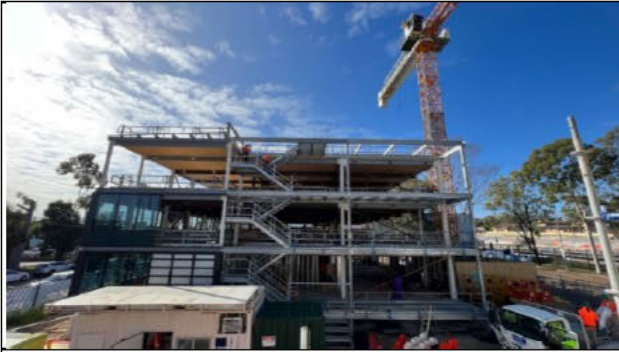
The superstructure is complete and façade elements are being installed

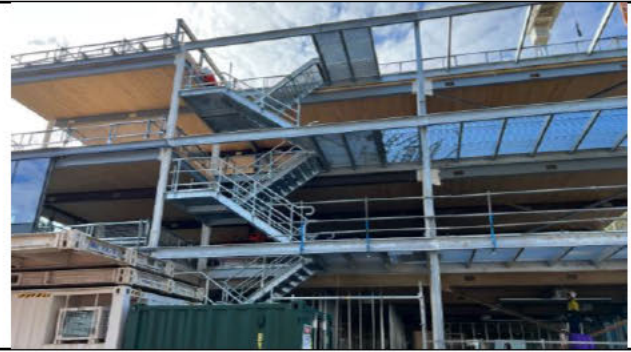
The external fire stairs are complete and fire certification works are ongoing

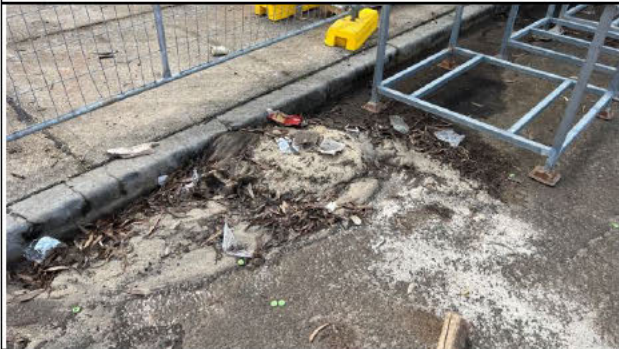
Minor amounts of rubbish at the back of the site were observed and need to be cleaned up

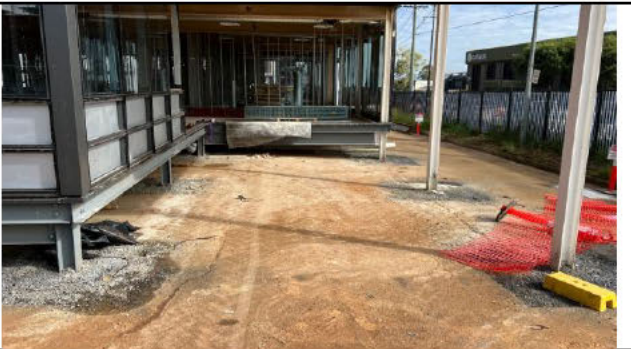
The main entrance point of the SPO is progressing

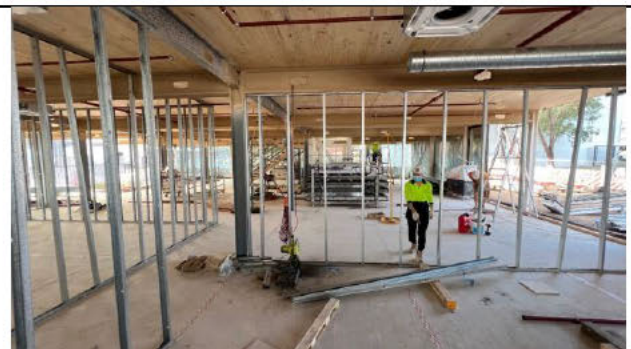
Internal fit out is progressing

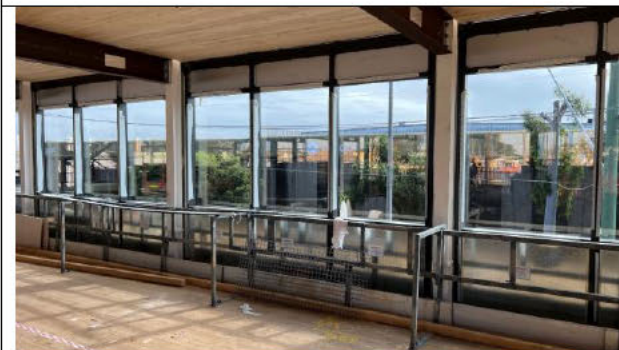
The façade is placed internally and provides a sound barrier

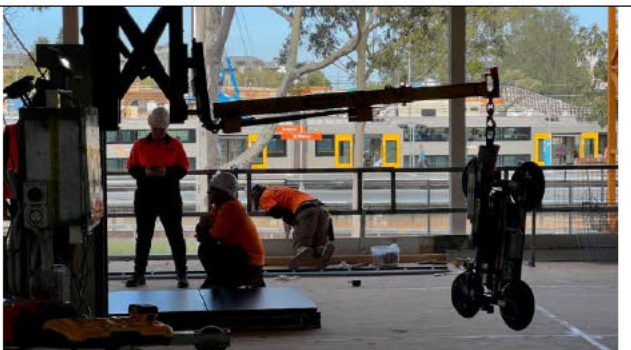
The façade is lifted using suction cups and manually placed in position

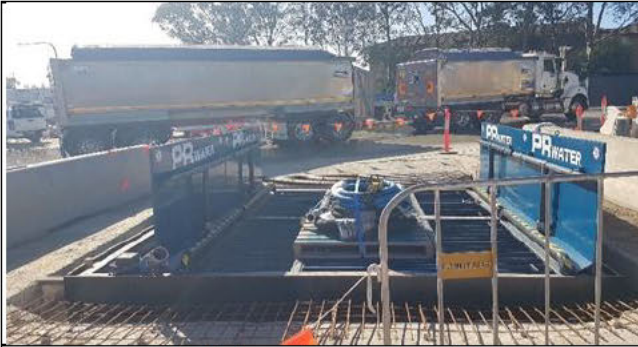
- St Marys - Truck wash/rumble grid, out of action while being replaced by automated truck wash. Wheels being hosed down individually, with water draining towards controls at Station St. Reducing tracking per the action raised above will also alleviate tracking by vehicles exiting the site and, therefore, the need for hosing down wheels. Truck wash should be commissioned and operational as a matter of priority.

St Marys- Wheels hosed as truck wash at exit out of action - being replaced by new automatic wash.

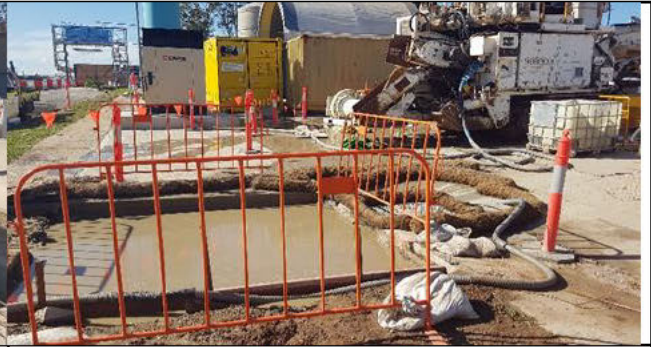
- St Marys - Observed Sediment laden water, from wheels being hosed down, discharging to stormwater pits just south of the WTP. Given that erosion and sediment controls in the area are end of line controls, not designed to cope with high sediment loads, the practice should be stopped, and the water collected and treated/disposed adequately. Alternatively, CPBG to provide procedure describing how stormwater on station St is blocked and first-flush arrangement. Also, a current up to date ESCP for the St Marys site reflecting controls including references to new procedures agreed with SEEC and/or the EPA is to be provided to the ER.

St Marys - Observed Sediment laden water, from wheels being hosed down, discharging to pits

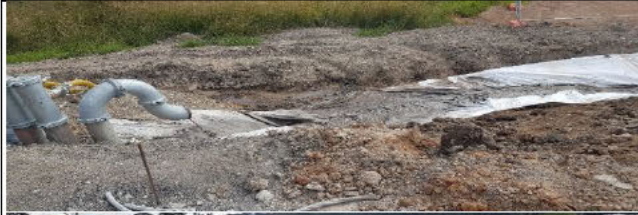
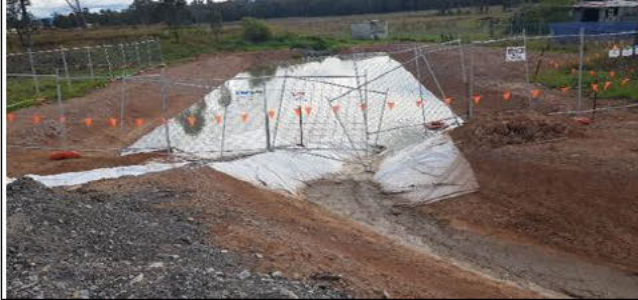
- Bringelly – It was noted that untreated shaft water (as noted by CPBG personnel) was being discharged to the sediment basin from a pipe adjacent to the WTP. Discharge of waters other than site stormwater into sediment basins is not consistent with the implementation requirements of the Blue Book. CPBG to investigate discharge and provide information, including justification, for discharge to the basin and evidence of any procedure in place to mitigate impact on the ability of the basin to operate as intended by the Blue Book. CPBG subsequently relayed that water from the shaft works discharged to the basin until the discharge permit is obtained is disposed offsite within less than 5 days and prior to rain events, and survey indicates

Bringelly Services Facility – shaft water was being discharged to the sediment basin

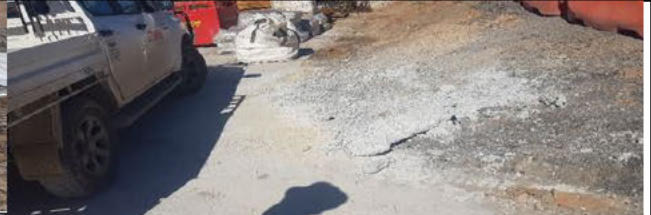
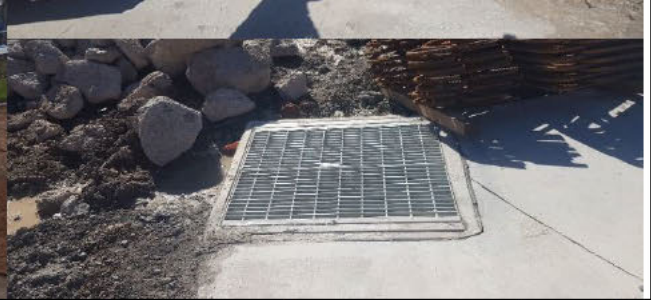
- Bringelly -- Concrete washout and waste noted throughout the central laydown area slab, adjacent a stormwater pit that discharges to a dirty water swale and ultimately to the sediment basin. CPBG to stop practice and provide additional training on the correct practices through toolbox briefing, with evidence to be provided to the ER.

Bringelly Services Facility - Concrete washout and waste near pit connected to swale, and sed. basin

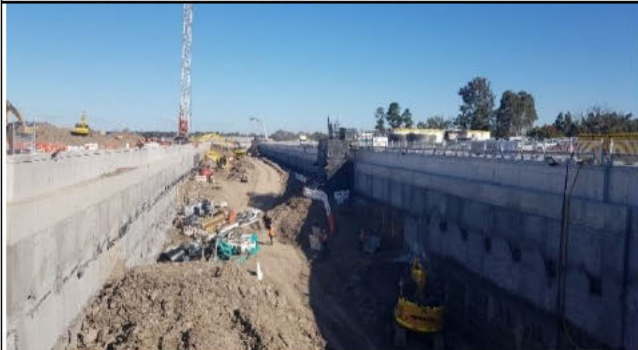
Aerotropolis station box: View south

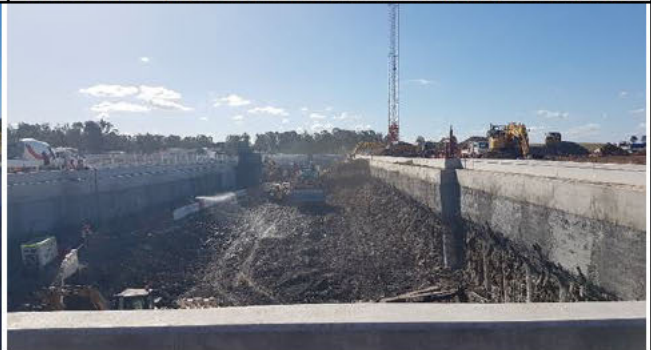
Aerotropolis station box: View north

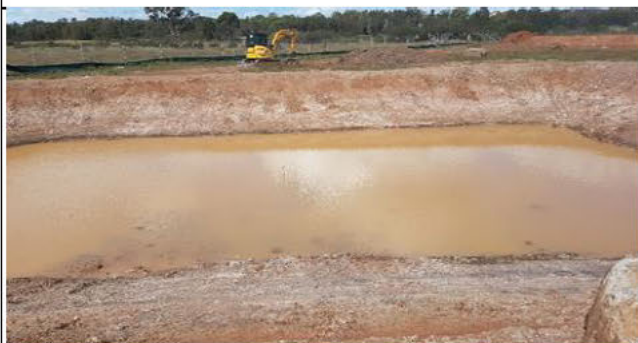
- Aerotropolis – Sediment basin has been constructed but is not operating as intended as drainage inlet pathways and spillway are yet to be constructed and appear significantly delayed due materials for reuse stockpiled in it's vicinity. CPBG to prioritise installation, within two weeks, of Ersed controls and mitigation in accordance with the progressive ESCP. I was subsequently relayed that due to the areas of the swales and the reuse of the stockpiled materials being intended for an area found to be contaminated with PFAS, disturbance of materials and reuse of materials in that area is awaiting CLM Auditor concurrence with the RAP. Consequently alternative ERSED controls are in place in the area.

Aerotropolis view to southwest: Sed basin installed awaiting inlet pathways and spillway

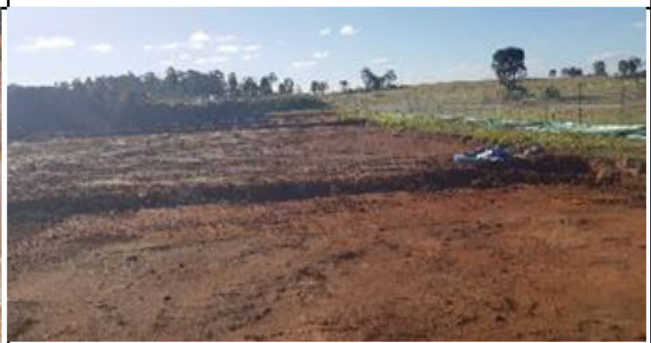
Aerotropolis : PFAs contaminated area has been broken up with earth berms to limit erosion

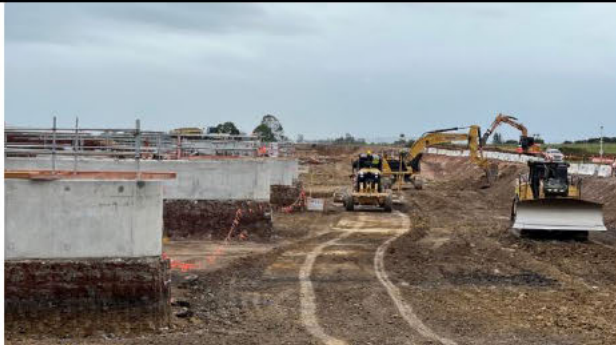
Piling pad - Excavation continues around the headstocks to allow the set up of the 500t crane and super-T delivery

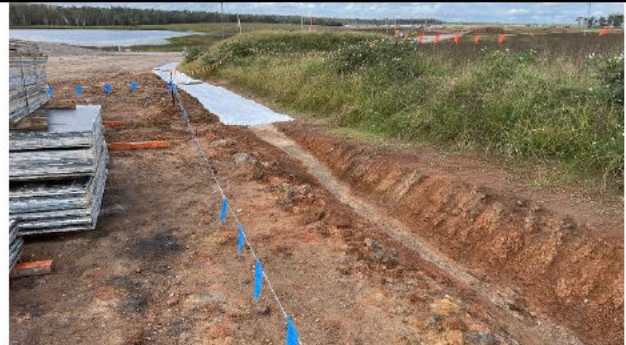
Piling pad - Geofabric and check dams have been placed in the drainage line from the piling pad

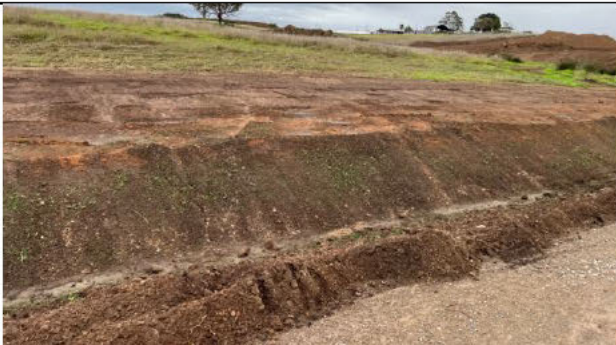
Piling pad - Green pick has started to shoot from the drainage lines and previously spread topsoil

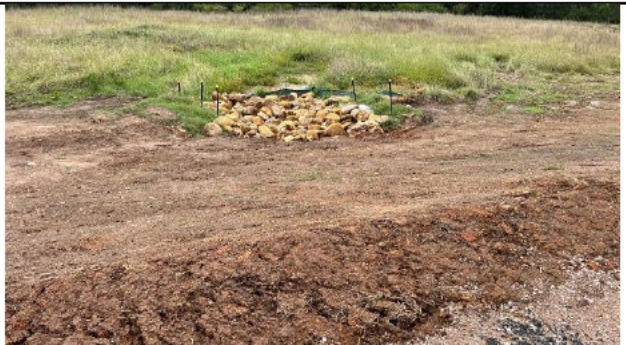
Compound access road - Site won rock is being used in erosion and sediment controls on site instead of being disposed off site

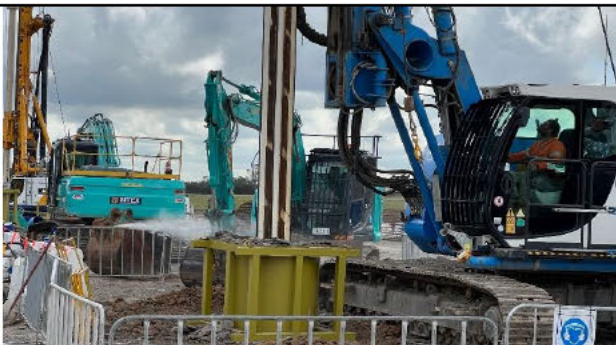
Luddenham station - this is the first pile to be constructed

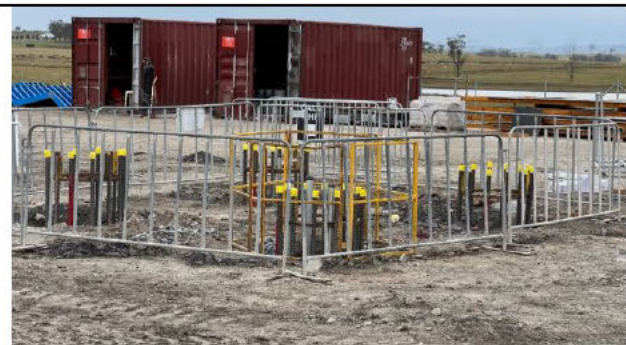
Luddenham station - Piling has commenced at the Luddenham station site

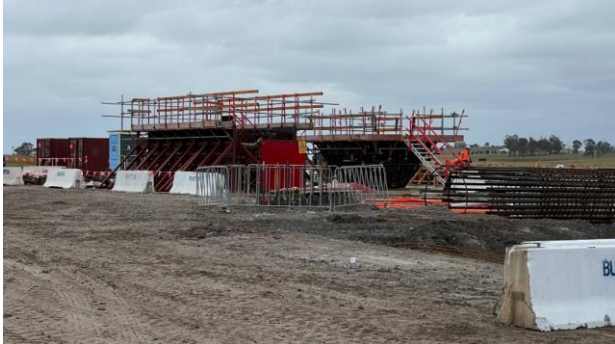
Luddenham station - Forms and reinforcement for the parapets are being constructed on site

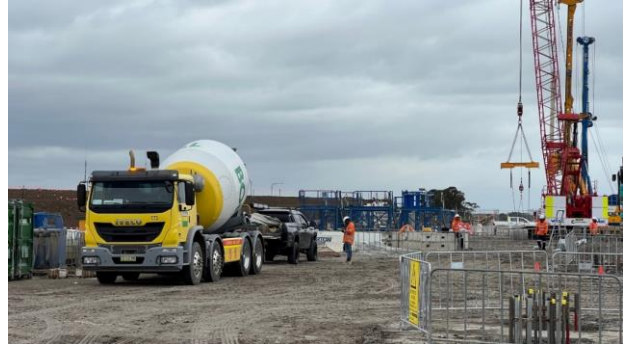
Luddenham station - All loads of concrete are being tested prior to being poured. It is noted that the trucks washout back at their depot

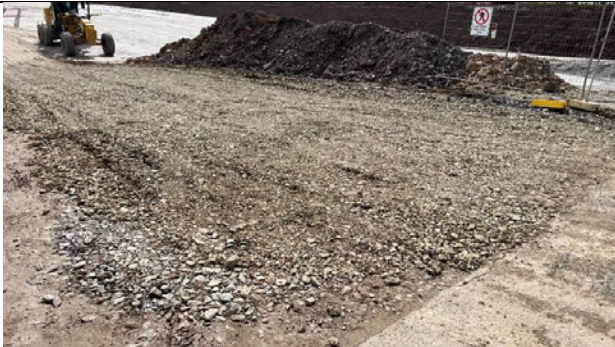
- Mud tracking was an issue at the Luddenham station site, the project should look at alternate and complimentary strategies for managing this
 - The inlet to the new basin at the Patons Lane compound required additional geofabric to prevent scour

Luddenham Station - The ballast at the exit point had become full of sediment which could be tracked onto public roads

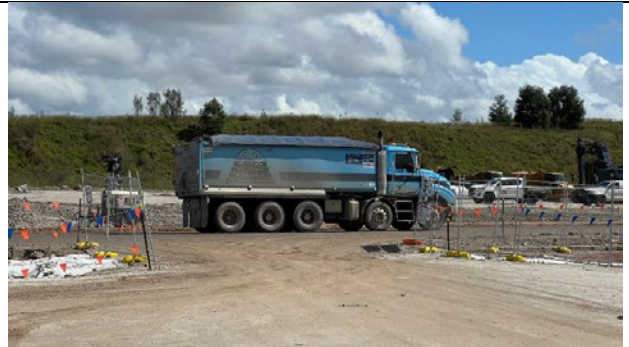
Patons Lane - Trucks from SBT are bringing material to be stockpiled at the SMF

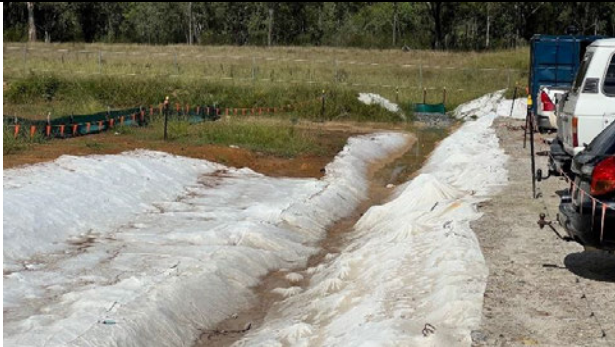
Patons Lane - ERSED controls around the perimeter of the compound have been effective in dealing with the recent rain

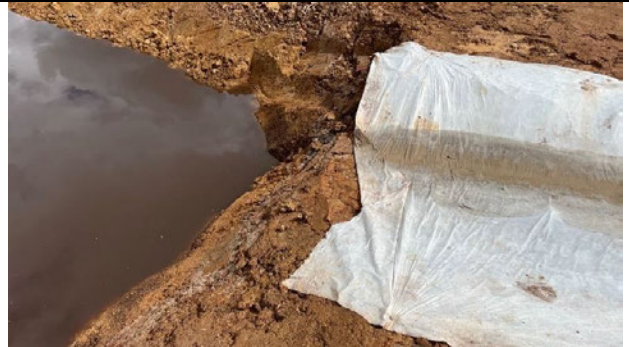
Patons Lane - The inlet to the recently dug sediment basin requires geofabric to extend down to prevent scour of the inlet

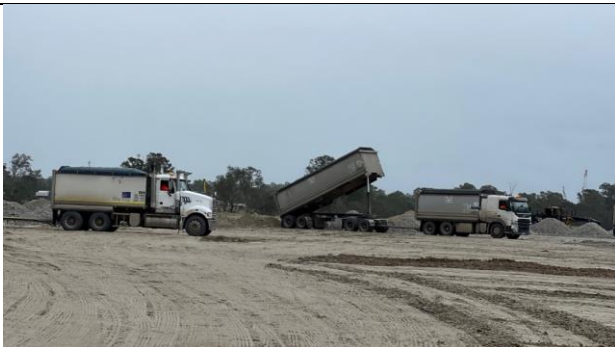
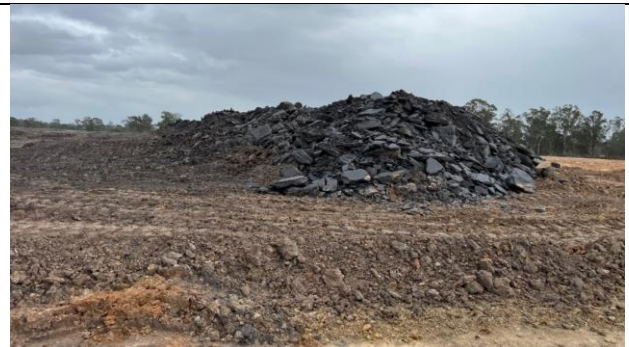
<p>SMF - Sandstone deliveries continue at the SMF</p>	<p>SMF - Shale from SBT has been delivered and stockpiled at the SMF, it was noted that this material may have hydrocarbon leachate</p>

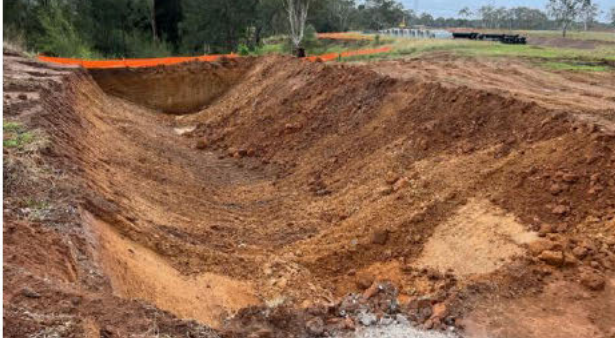
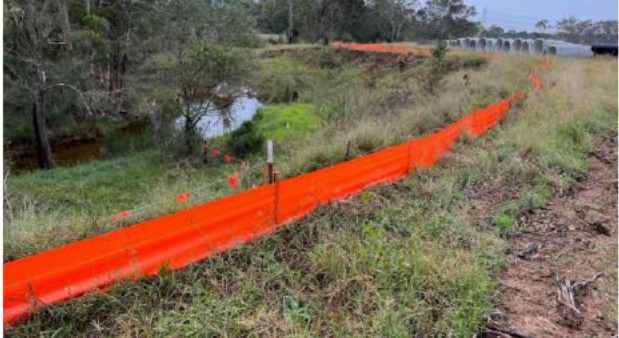
<p>SMF - Additional water retaining sumps have been created adjacent to Blaxlands Creek</p>	<p>SMF - Sediment fence has been installed ahead of any works commencing in Blaxlands Creek</p>
