## 1. Advanced and Enabling Works (AEW)

## 2. Station Boxes and Tunnelling (SBT)

### 3. Surface and Civil Alignment Works (SCAW)

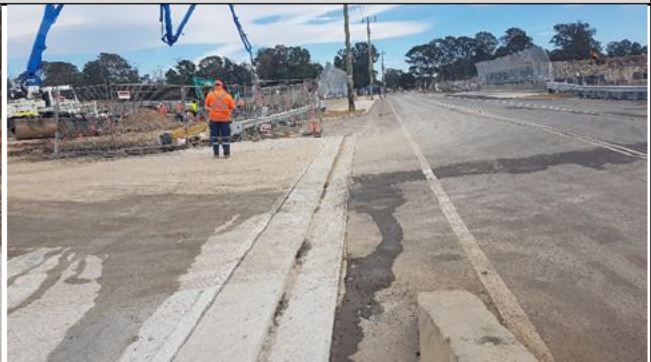
**Lansdowne Rd. view west – Increased street sweeper frequency required at eastern access**

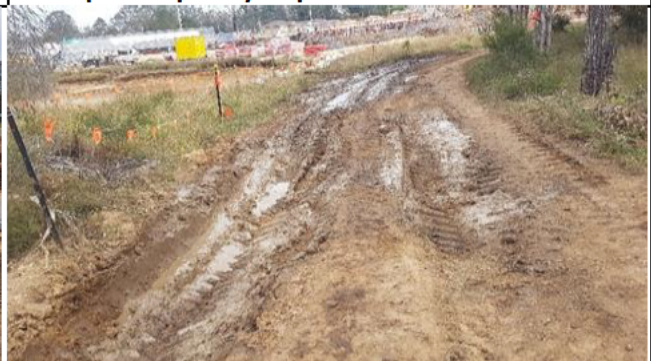
**Orchard hills– Internal access north of SB3 from station box to SE laydown area needs stabilising**

- Orchard Hills CPBG to stabilise internal cross access north of SB3, between south-eastern laydown area and station box, as it is being used by other than the light vehicles noted in the ESCP.

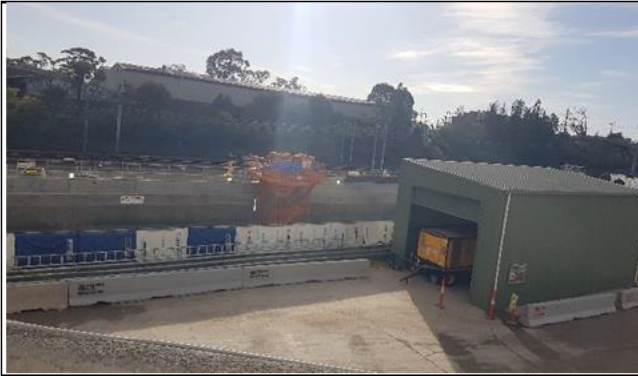
**St Marys: Noise blankets well installed along southern and eastern capping beams and upright**

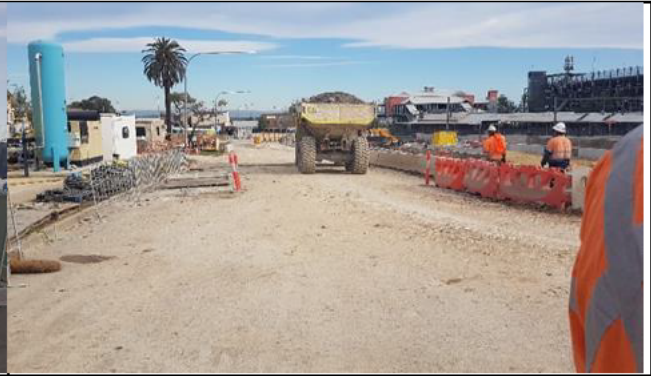
- **25/05/2023** - Key points/ issues raised during this inspection were as follows:
  - St Marys - Appreciable tracking noted on Station St (within the construction site) due to lack of stabilised approach between the spoil haul road, from the station box to the stockpile area, and the crossing at Station St. This has resulted in fines accumulations, increasing potential for dust generation and risk of overwhelming sediment controls at western boundary. CPBG to minimize tracking by providing sufficient stabilized runway on haul road from station box to Station St crossing, and/or increase frequency of positrack/ street sweeper use.

**St Marys: Appreciable tracking noted on Station St onsite from spoil haulage on unstabilised road.**

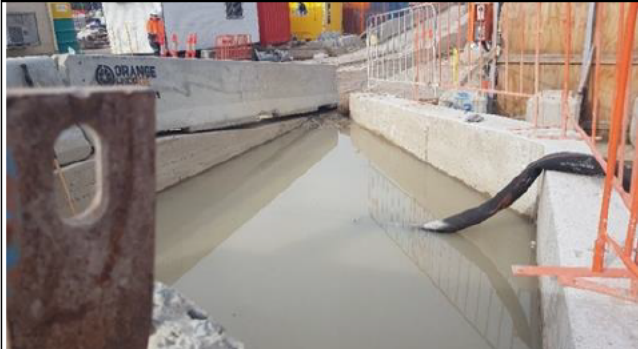
- St Marys - Inlet from Gidley St ( internal paved haul road) to Station St sump and pump has been restricted/blocked by jersey barriers, causing sedimentation and blockage at inlet that overflows over kerb and around the sump walls. CPBG to lift jersey barrier onto kerb/footpath and tie in to end of sump stub wall

**St Marys: Sump and pump installed on Station St at Gidley St (haul road), collects water off both**

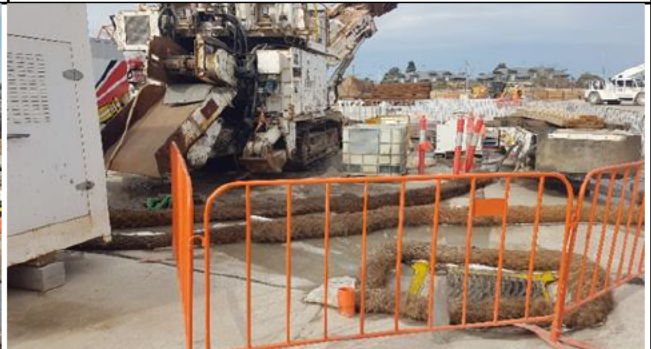
- St Marys – Appreciable sediment accumulations noted in area of sediment controls just upgradient of live stormwater pit in the north western corner of the laydown area. CPBG to clean sediment and soil accumulations in path to sediment controls above stormwater pit and monitor future accumulation. Diversion of upgradient waters to the sump and pump structure to the west of the stormwater pit should also be considered as this would reduce the monitoring and maintenance effort required

**St Marys: Sediment accumulations noted and at sediment controls and in areas upgradient of live stormwater pit in the NW of the laydown area**

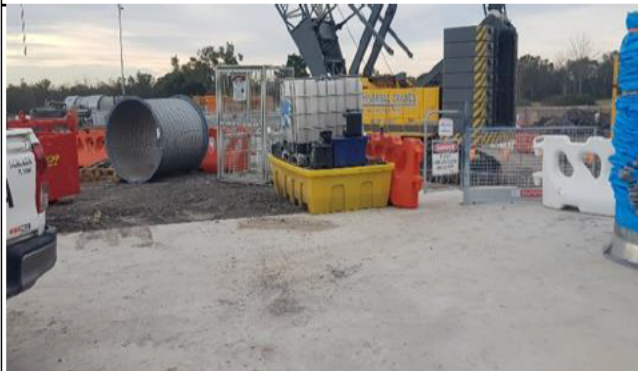
- Bringelly - Laydown area and maintenance compound very well managed

**Bringelly Services Facility – Laydown area and maintenance compound very well managed.**

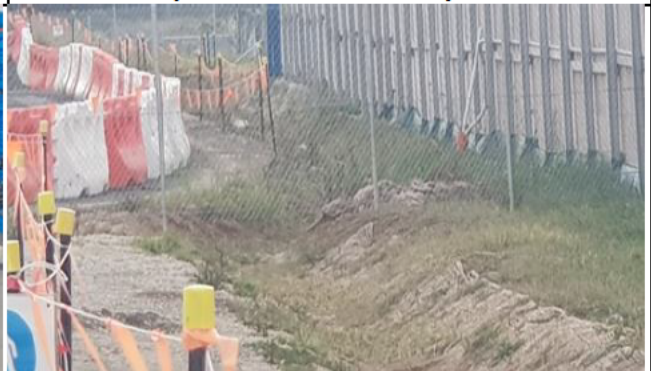
- Bringelly - Appreciable scouring of swale walls and sediment accumulation was noted that may compromise swale capacity. CPBG to reshape swale wall where heavily scoured and apply polymer to minimise ongoing scouring.

**Bringelly Services Facility northern swale – Southern swale wall requires stabilisation**

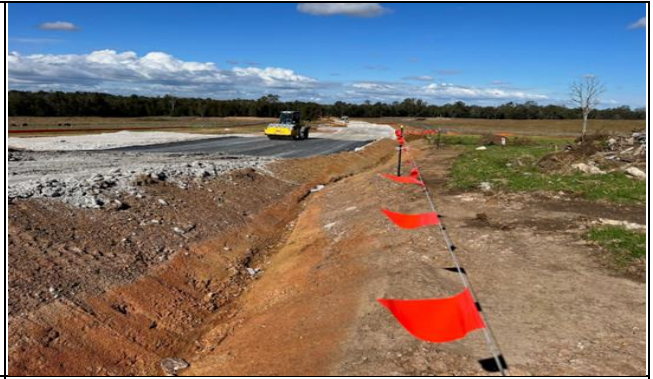
- V-drains have been installed on the edge of the sandstone haul roads at Luddenham south, however, some scour has started. Suggest reshaping these drains when topsoil is placed, and rock checks installed.

**Luddenham south – Scour noted in V-drains, so need reshaping and rock checks**

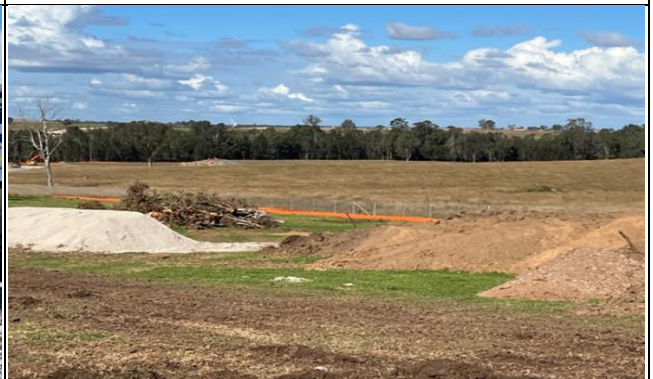
**Luddenham South - Remaining felled trees to be mulched or disposed of.**

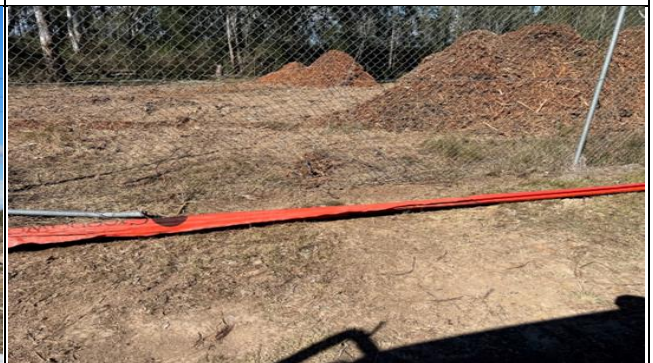
**Patons Lane - Sections of sediment fence at defence land need re-instatement**

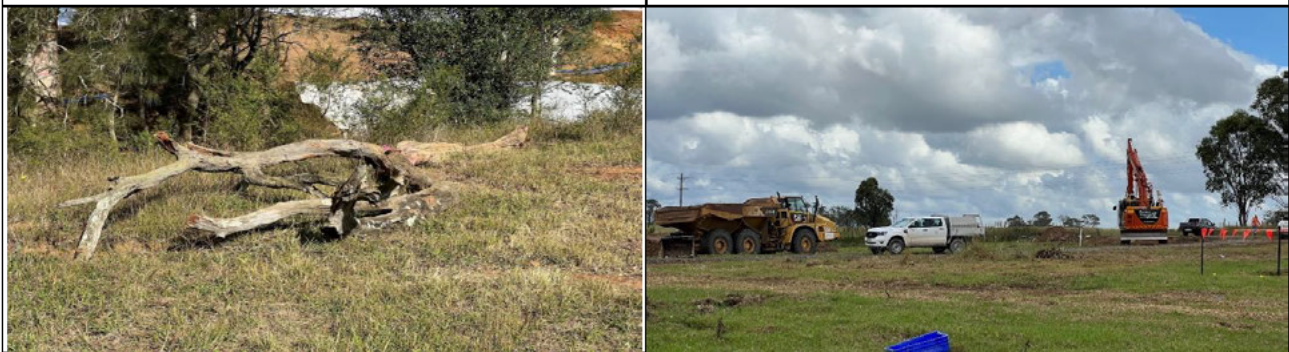
**SMF – After completion of the temporary creek crossings felled trees with hollows to be relocated**      **SMF - Retained trees at the northern end require segregation with fencing and signage.**
