7 February 2023
Ref: 201209-ER_DPIE-January 2022

RE: Sydney Metro - Sydney Metro Western Sydney Airport SSI 10051 – ER Monthly Report for January 2022

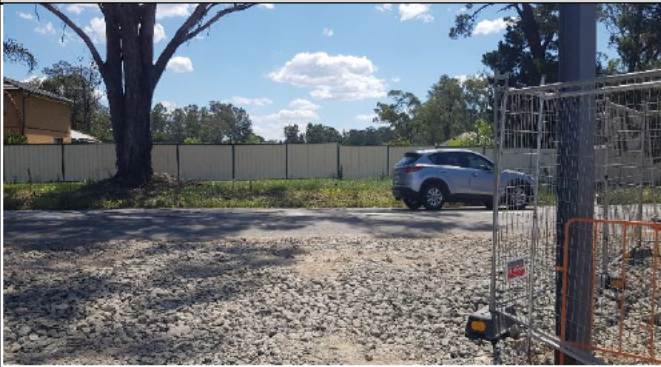
Orchard Hills central Kent Rd Access – No tracking observed

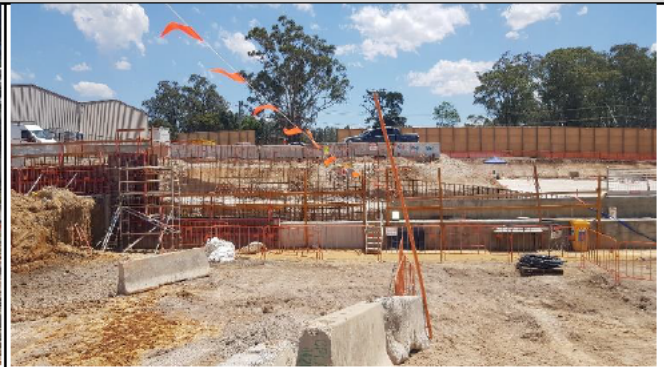
Orchard Hills central, view west – Capping Beam construction

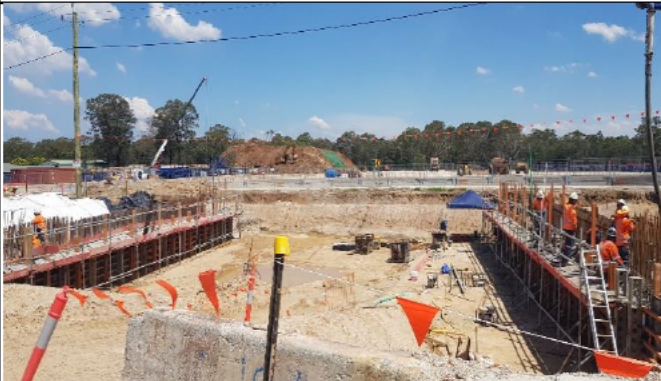
Orchard Hills view south – Capping beam FRP at Lansdowne Rd for bridge over station box.

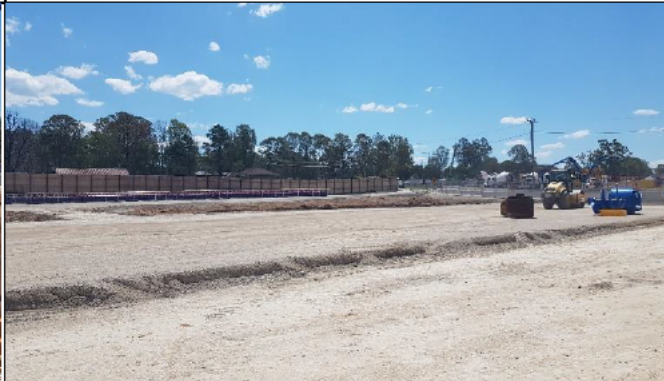
Orchard hills– view south at pilling pad preparation South of Lansdowne Rd .

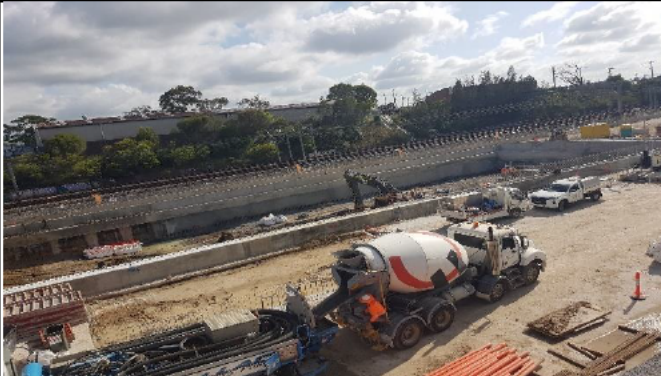
St Marys: View of works to the north showing eastern capping beam and station box excavation

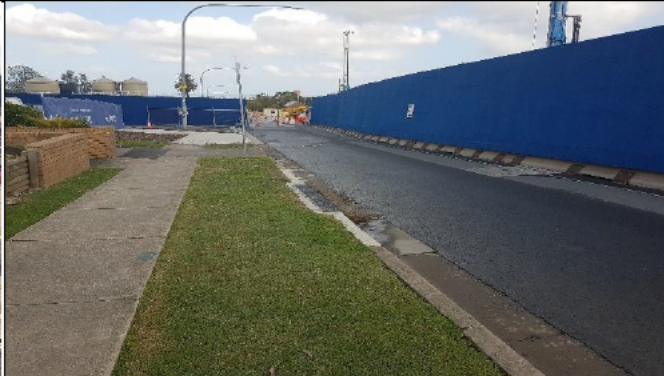
St Marys – Looking west along Station St.

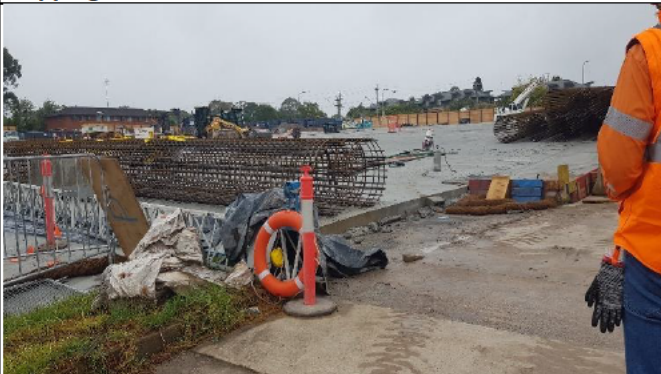
St Marys view south east to Station Plaza –laydown slab complete.

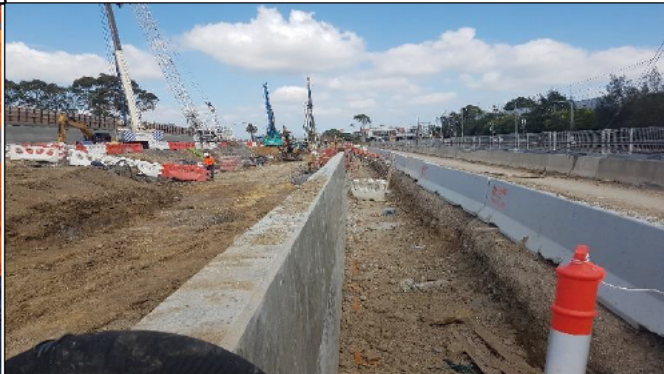
St Marys looking west from central area – along capping beam.

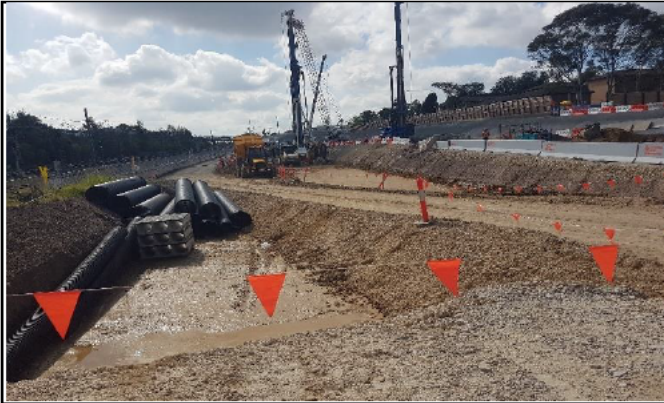
St Marys - View east from Station street at former Station Plaza.

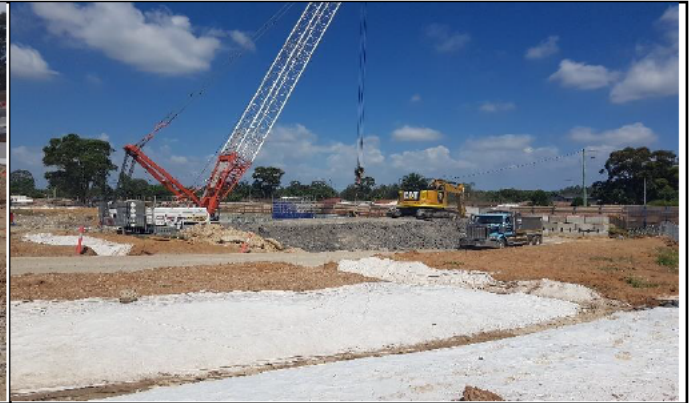
Claremont Meadows view northwest – Shaft excavation spoil.

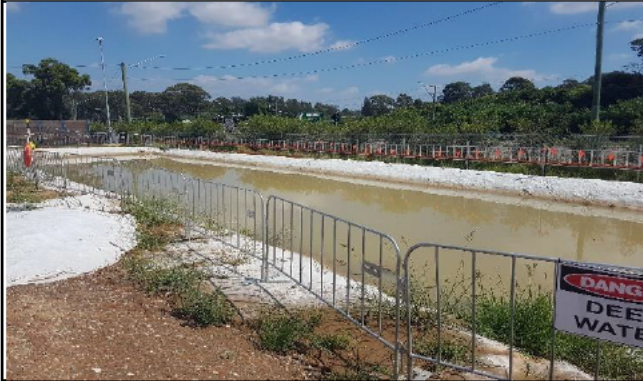
Claremont Meadows – View southwest along Great Western Highway of basin in operation

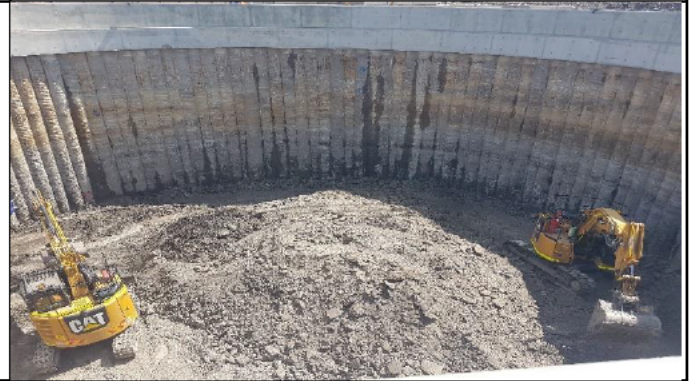
Claremont Meadows view west – Shaft bulk excavation

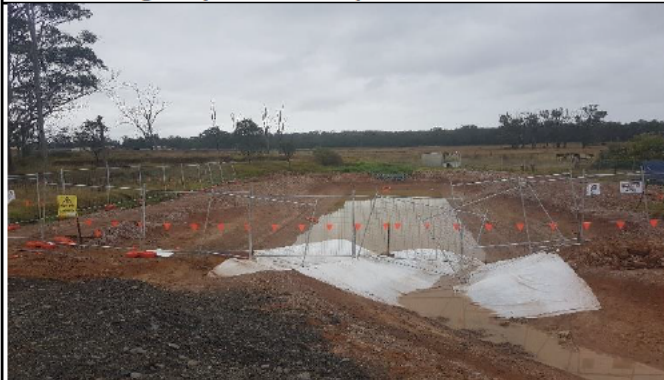
Bringelly Services Facility view north west–. Sed. Basin in operation

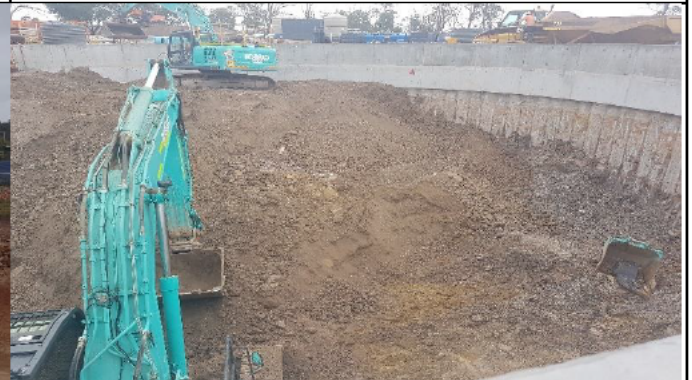
Bringelly Services Facility – Services shaft bulk excavation. Note completed capping beam and upstand

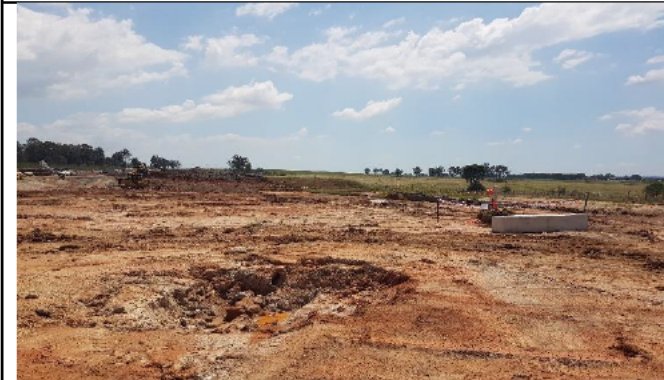
Aerotropolis : View southwest of surface soil stripping and asbestos removal in DSI moderate risk areas.

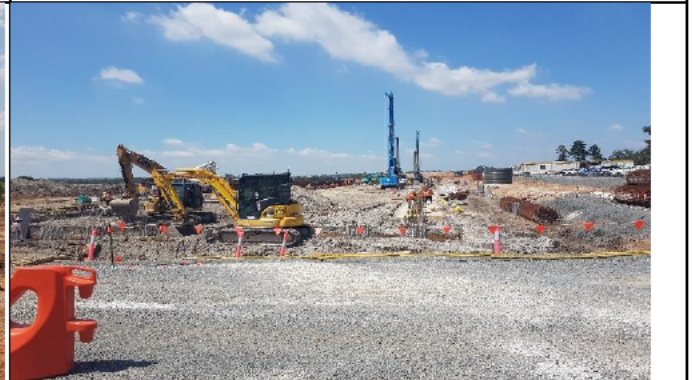
Aerotropolis : View north from entrance of DSI low risk area pile break back, blinding and capping beam FRP.

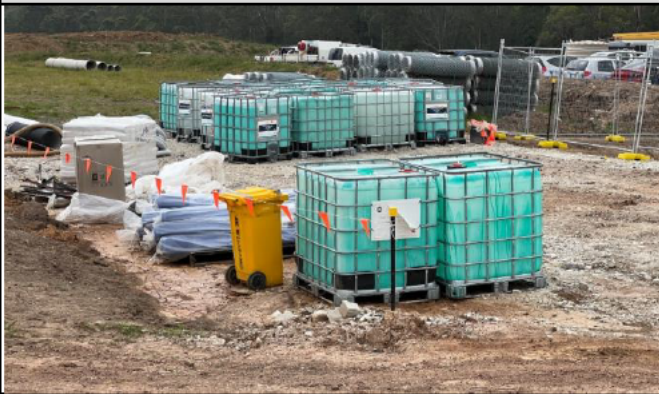
Patons Lane – Polymer compound has been ordered and used on site as an ERSED control

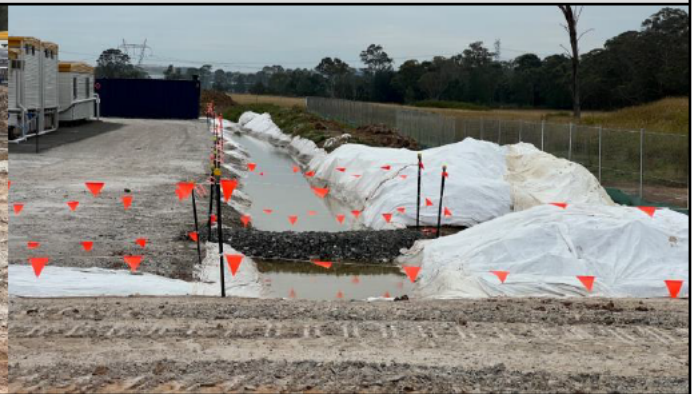
Patons Lane – The perimeter controls around the compound have been established and work as intended

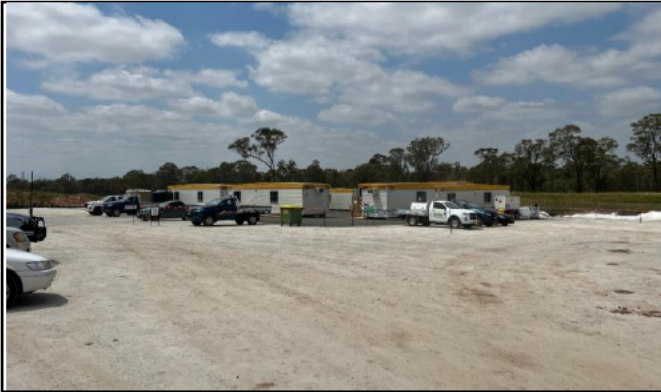
Patons Lane – The site compound is complete

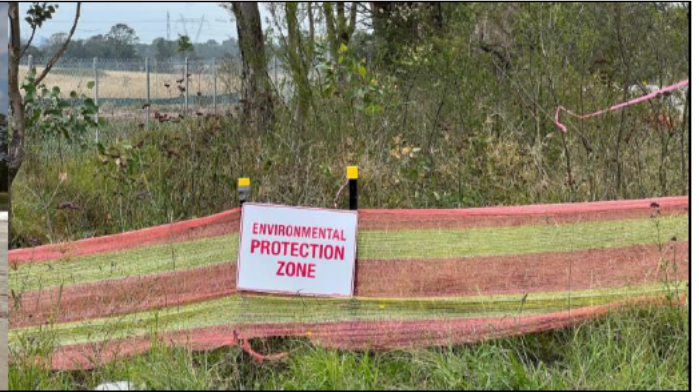
Patons Lane – Environmental protection zone signage was in place

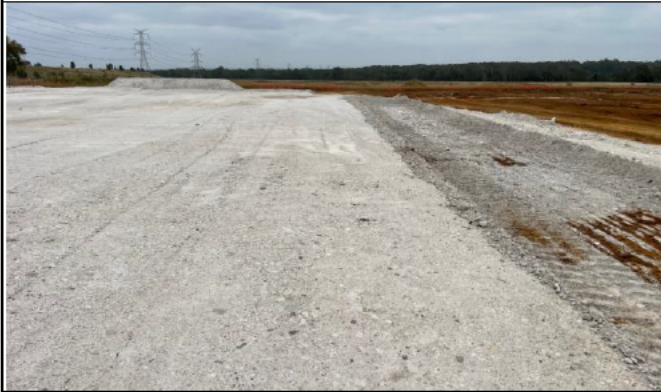
SMF – Crushed sandstone is starting to be spread out in the SMF

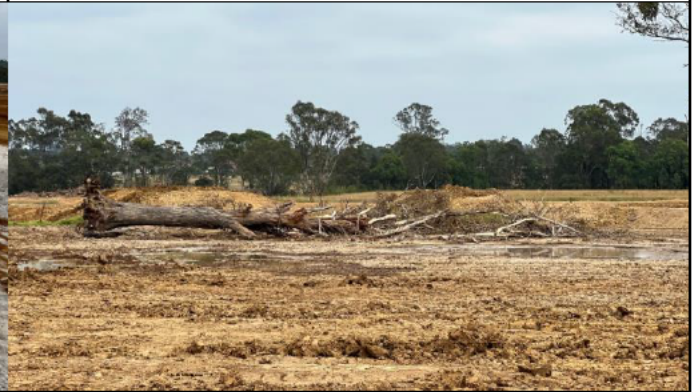
SMF - Trees have been cleared in the SMF with the remained needing ecologist supervision

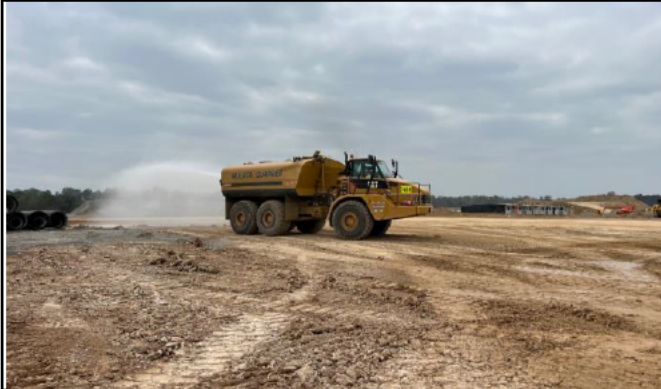
Elizabeth Drive - Moxy watercarts were in operation during the inspection

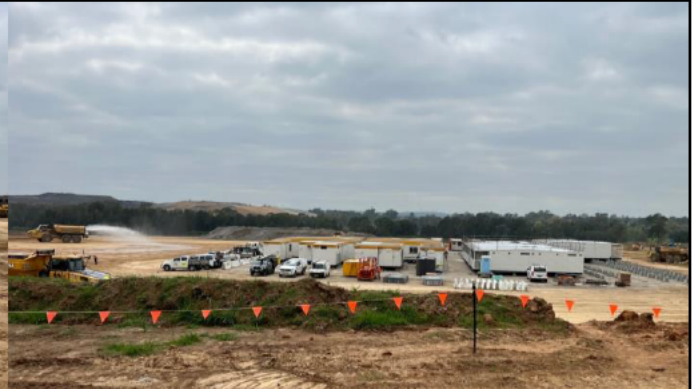
Elizabeth Drive - The site compound continues to be established

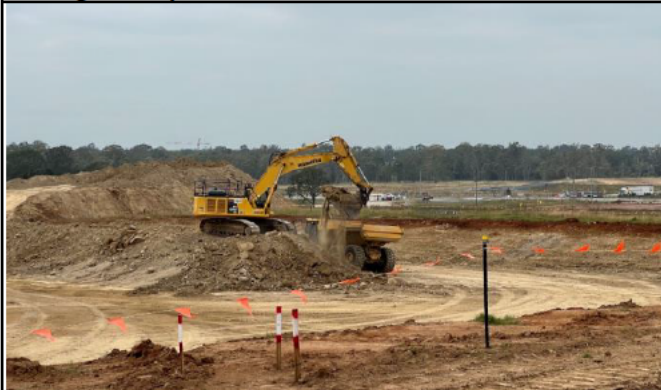
Elizabeth Drive – Earthworks continue to the south of the site compound

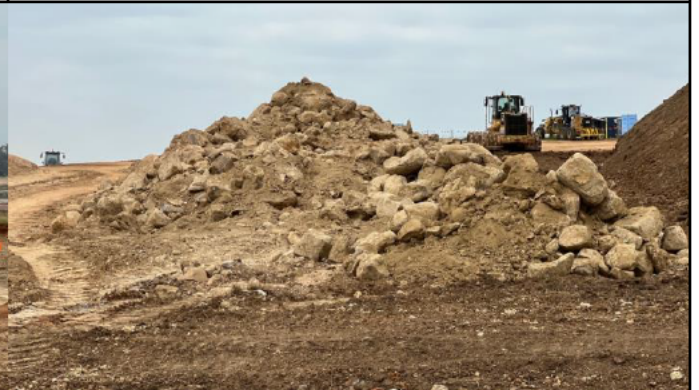
Elizabeth Drive – Rocks and boulders have been stockpiled for use in future ERSED controls

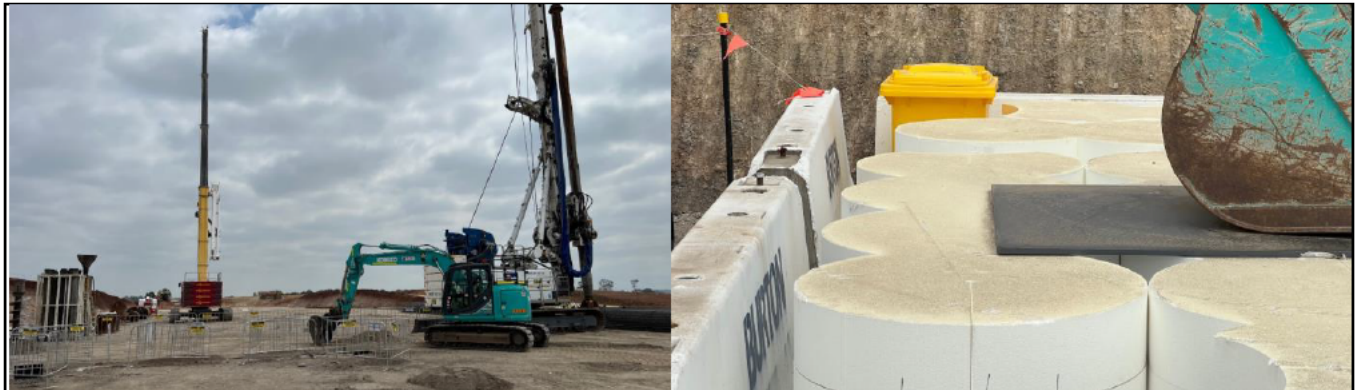
- 12/01/2023 (By ██████████ - Key points/ issues raised during this inspection were as follows:
 - Erosion and sediment controls were installed and were effective during the Christmas shutdown period
 - The project has invested in polymer binder to spray batters
 - A spill kit at the Elizabeth Drive piling pad was present however was not accessible
 - The project continues to monitor noise and dust levels at the SMF

Elizabeth Drive - Piling has commenced at the northern piling pad

Elizabeth Drive - A spill kit is present at the piling pad, however is not easily accessible
