7 December 2022

Ref: 201209-ER\_DPIE-November 2022

**RE: Sydney Metro - Sydney Metro Western Sydney Airport SSI 10051 – ER Monthly Report for November 2022**

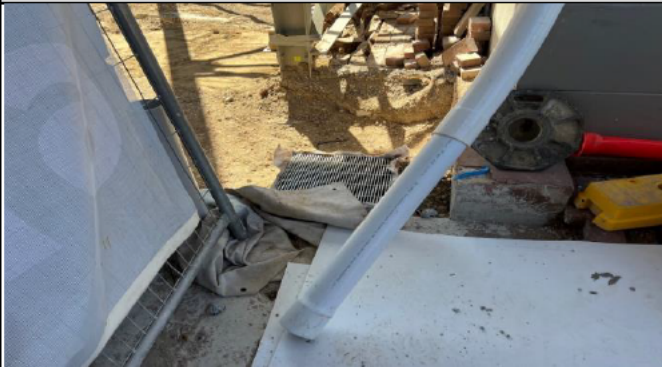
St Marys lift relocation – Stormwater from roof of the existing structures to be directed into live stormwater drainage lines

- 03/11/2022 - Key points/ issues raised during this inspection were as follows:
  - Existing stormwater pipes from gutters needed to be directed into stormwater pits to prevent flooding of the site
  - Care needed to be taken when operating machines on existing brick pavers to prevent inadvertent damage
  - The retained fig tree needs to be maintained by Sydney Trains on behalf of TAHE
- 17/11/2022 - Key points/ issues raised during this inspection were as follows:
  - An EWP was observed extended into the branches of existing trees, plant needs be kept clear of retained vegetation to prevent damage.
  - Drains in completed areas needed to be cleaned out, rubbish disposed of and controls removed to allow drainage to work as designed.
  - Controls such as tree protection and spill kits needed to remain in place until the project is completed and plant has been removed from the site.

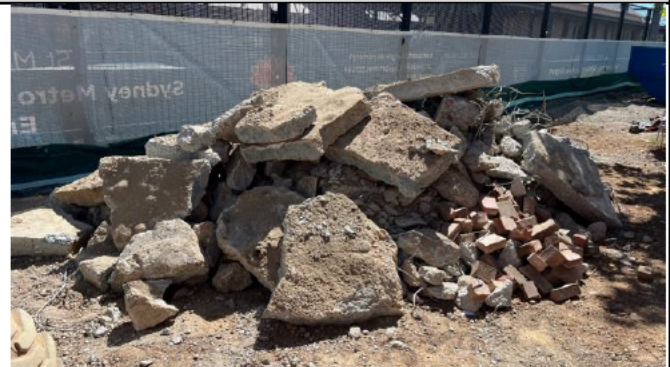
St Marys lift relocation – Concrete broken out was sent to concrete recyclers

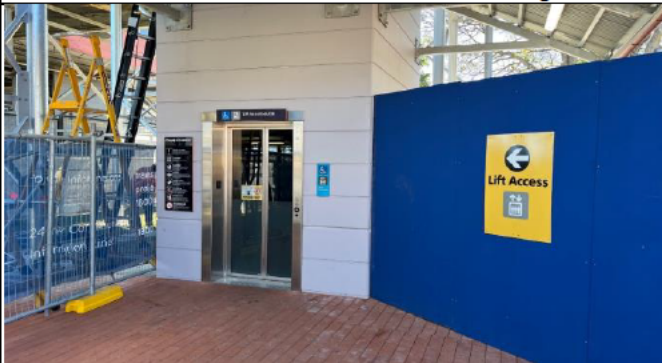
St Marys lift relocation – New lift shaft installed and operational

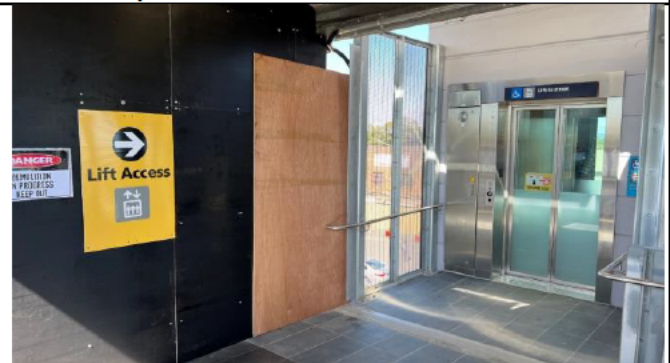
St Marys lift relocation – New lift shaft installed and operational

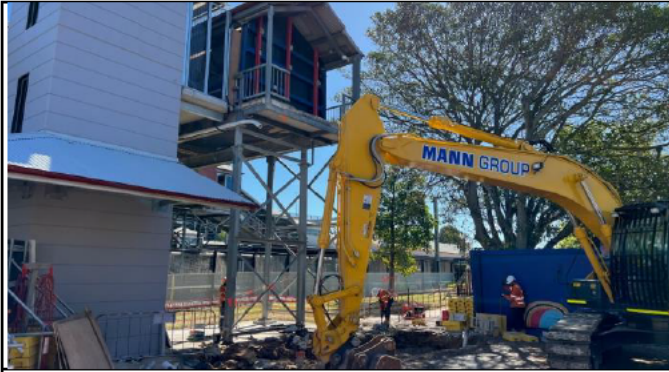
St Marys lift relocation – The old lift shaft has been demolished

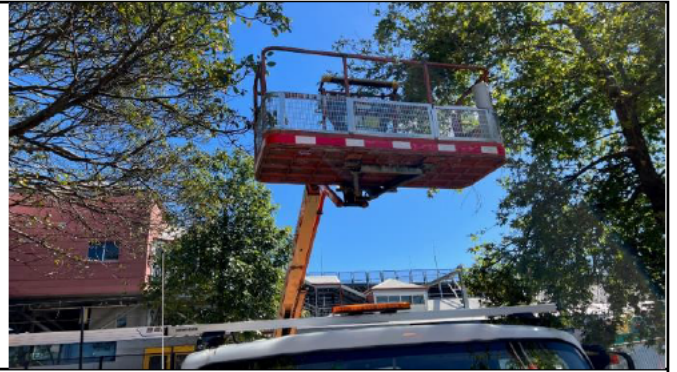
St Marys lift relocation – Care needed to be taken when parking equipment so it doesn't damage retained trees

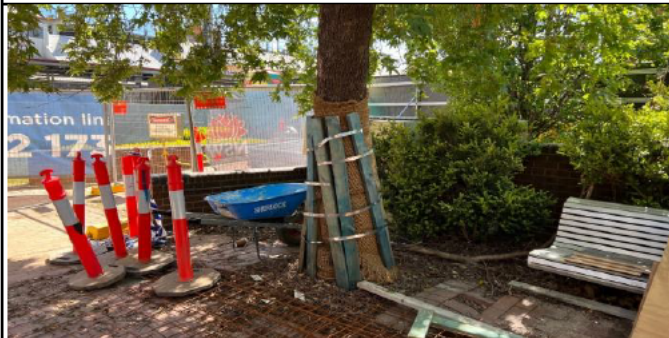
St Marys lift relocation – Tree protection has been installed and should remain until final works have been completed

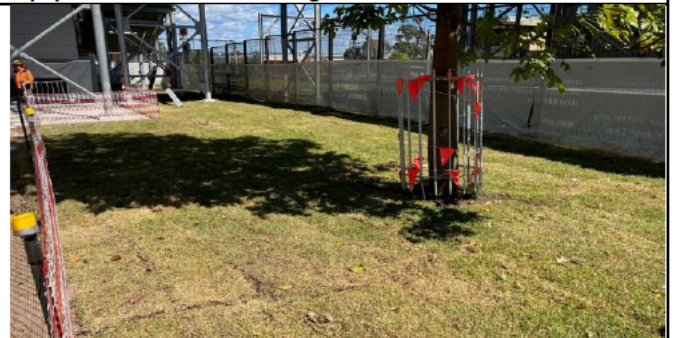
St Marys lift relocation - Landscaping commenced with planting of turf. The contractor to maintain this until project handover

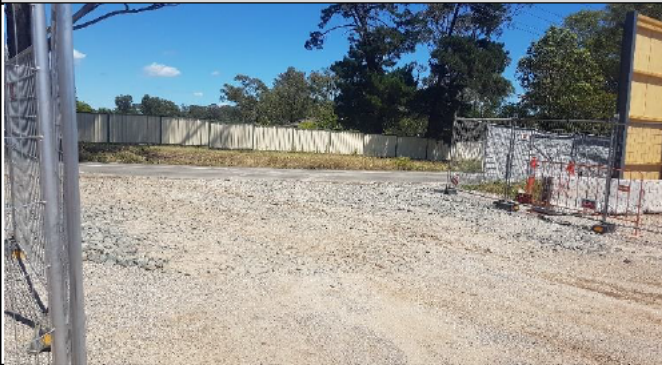
**Orchard Hills north Kent Rd Access – Tracking indicated additional stabilised surface and rumble grid required**

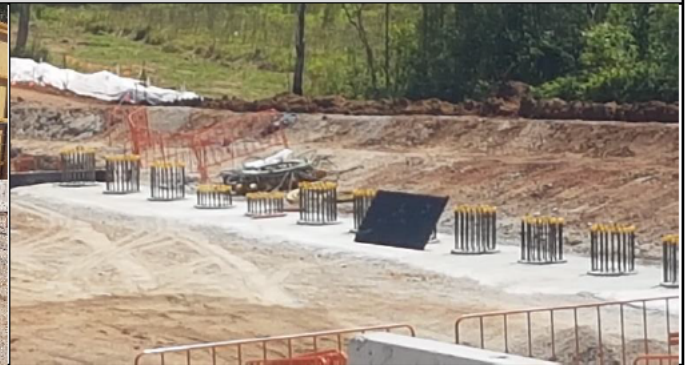
**Orchard Hills north – Pile blinding and break- back. A hydraulic pile crossing ring is being used, reducing noise**

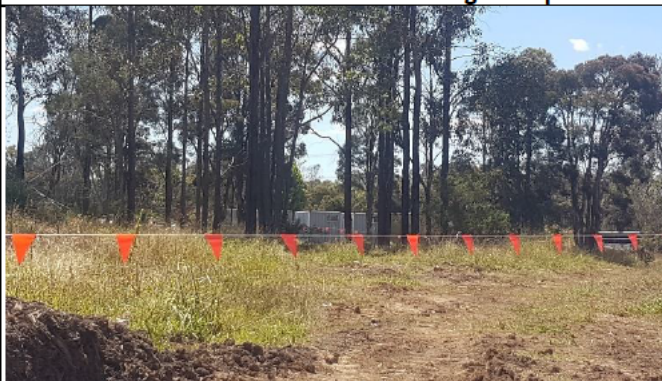
- At Orchard Hills in general - dust mitigation measures require improvements.
  - At Orchard Hills in general - Adequate signage required along PCT areas boundaries.

**Orchard Hills – PCT segregation bunting requires appropriate signage**

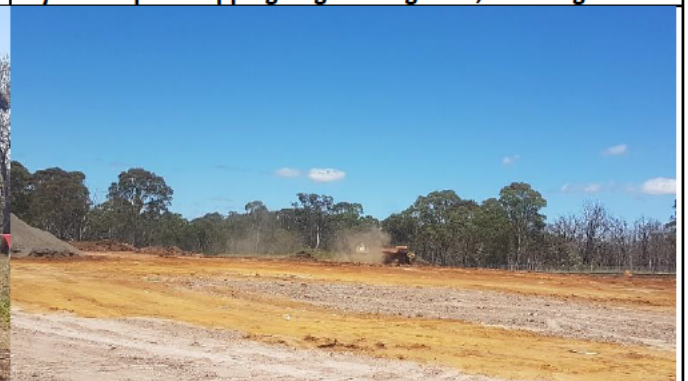
**Orchard hills– view south at works South of Lansdowne Rd . Dust mitigation measures require improvements**

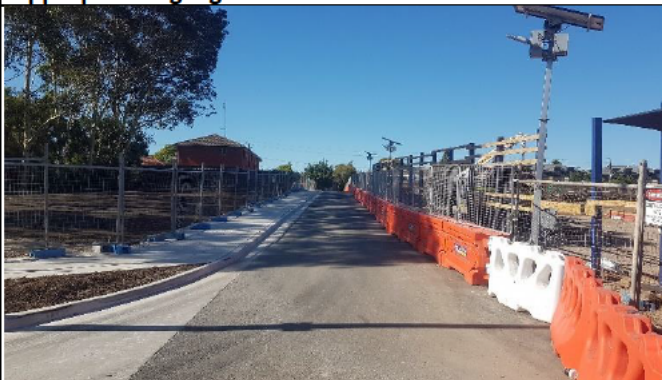
**St Marys view from Station St: Public access road along east of former Plaza, from Station street to Phillip St.**

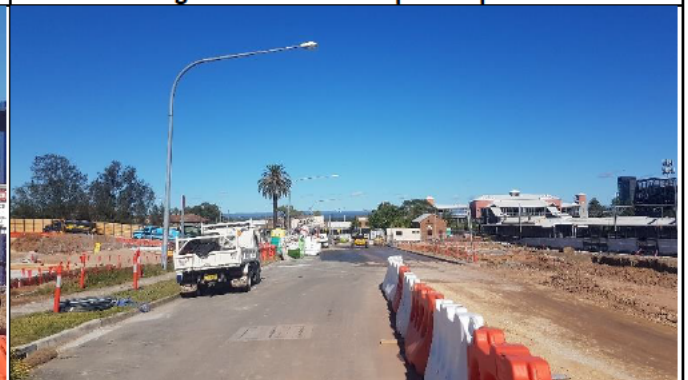
**St Marys – Looking west along Station St.**

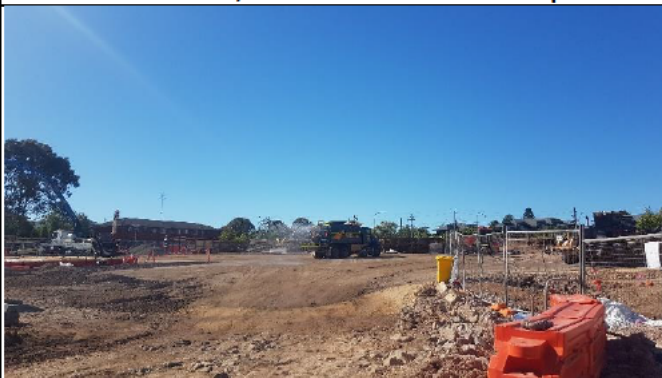
**St Marys looking south east to Station Plaza – Water cart in action.**

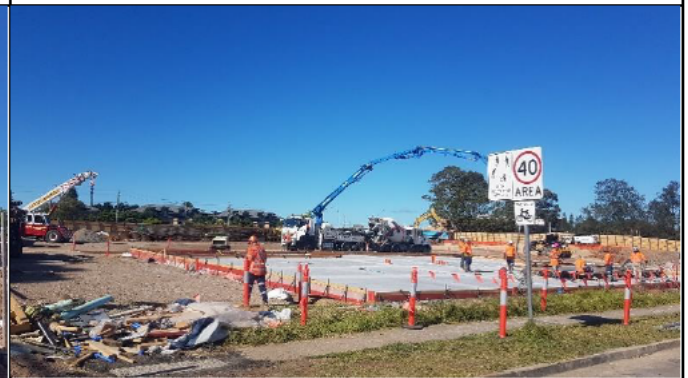
**St Marys looking south west at Station plaza– Water Treatment Plant slab construction.**

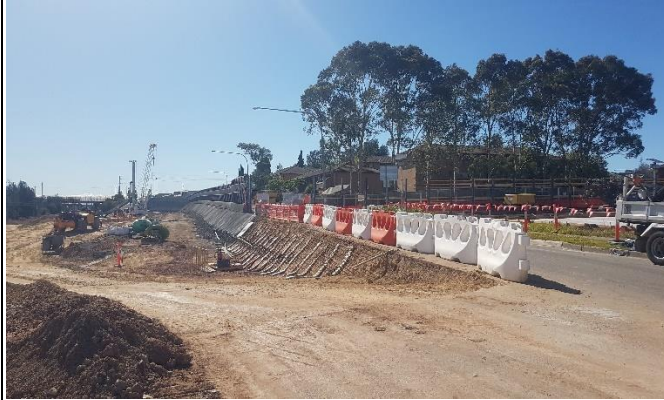
**St Marys - View east from Station street at former Station Plaza.**

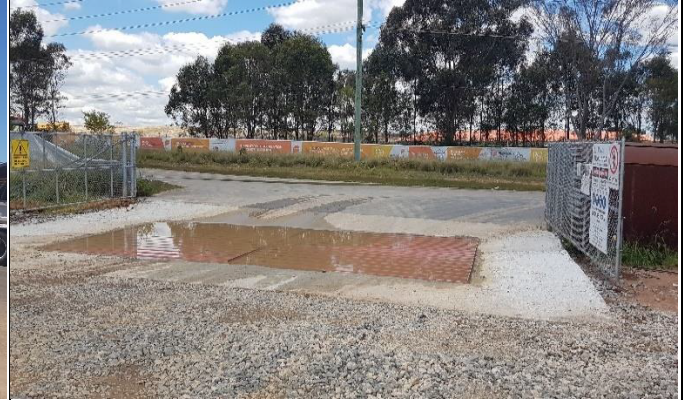
**Claremont Meadows southern access - southern access includes wheel wash depression.**

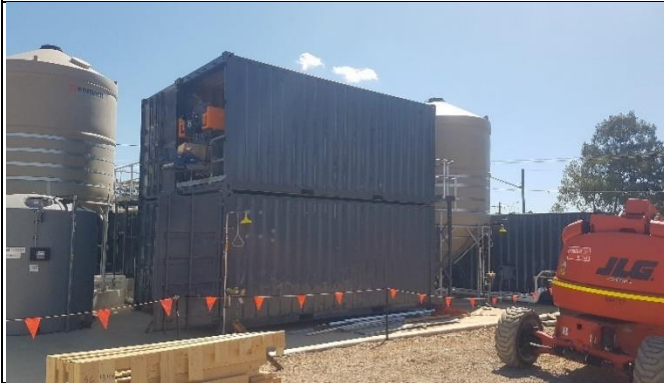
**Claremont Meadows – Water Treatment Plant southern elevation**

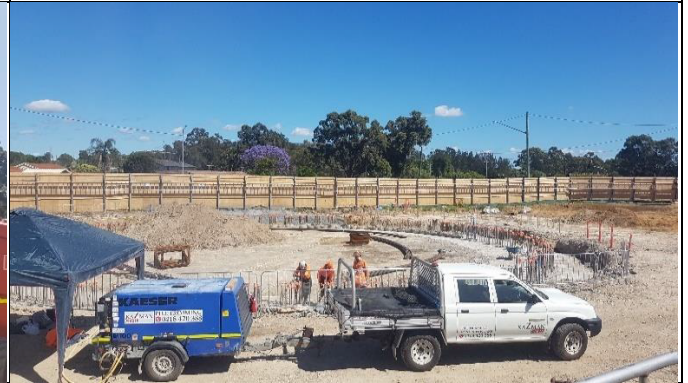
**Claremont Meadows view west – shaft pilling and blinding complete with break-back underway**

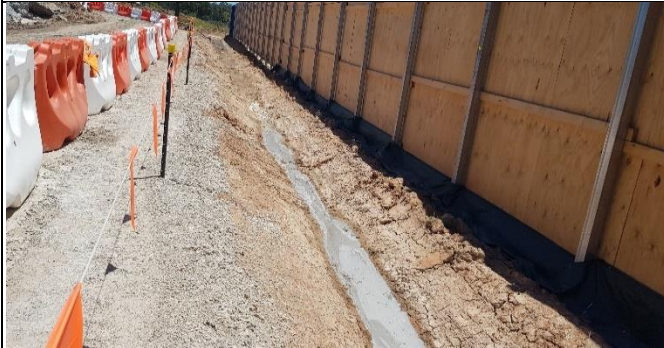
- At Claremont Meadows - Sediment basins require level gauges in accordance with the "Blue Book" and emptying within 5 days of last rain event.
  - At Bringelly - Concrete fines laden supernatant liquid from concrete washout trays was discharged into the dirty water swale along northern boundary. This practice should be stopped, swales should be cleaned immediately and incident report prepared outlining preventative measures.

**Bringelly Services Facility – Swale along Northern Boundary concrete fines discharged into swale**

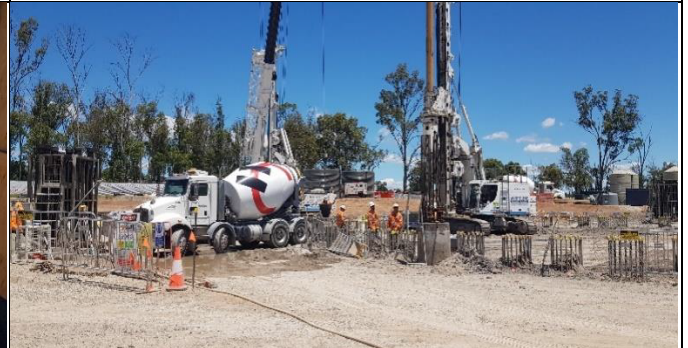
**Bringelly Services Facility – View south west of shaft pilling**

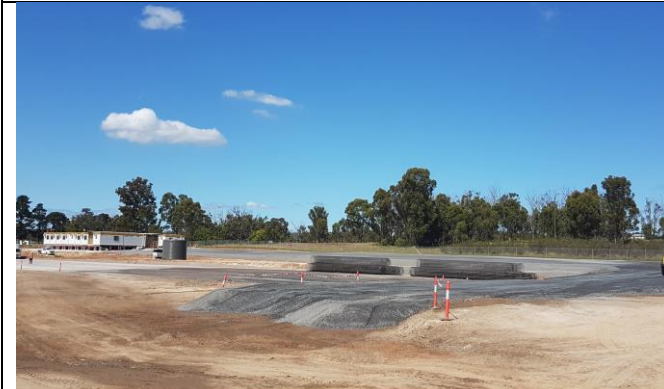
**Aerotropolis : View north east to pilling pad and compound construction beyond.**

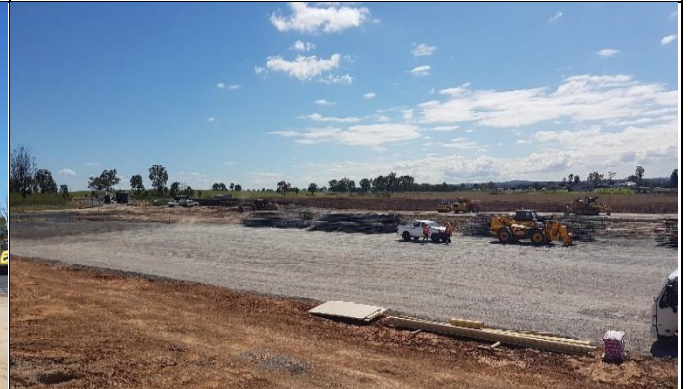
**Aerotropolis : View south west from compound to low risk area pilling pad.**

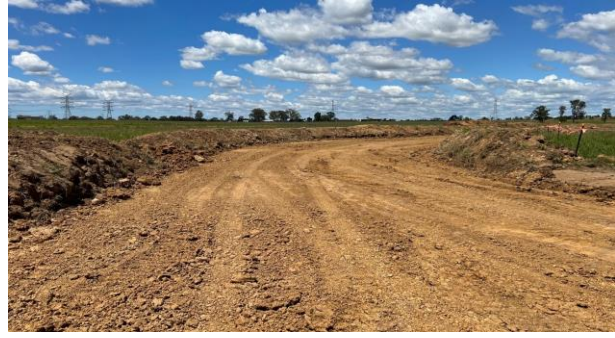
**SMF - Windrows formed on the perimeter of haul road , acting as dirty and clean water diversions**

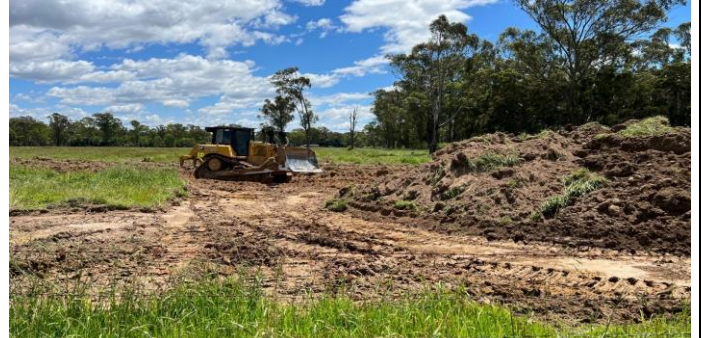
**SMF - Works commenced on the large sediment basin on the northern end of the SMF**

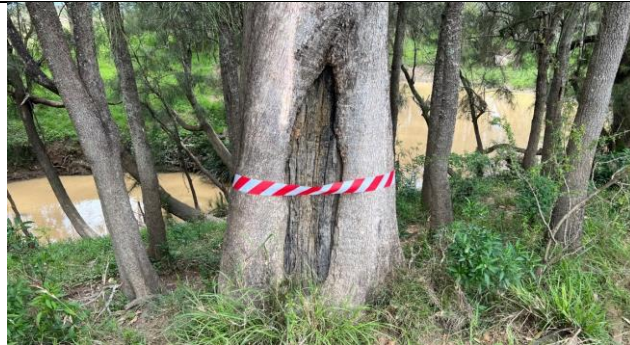
**Cosgroves Creek - Two potential scar trees identified and investigated by the project's heritage consultant**

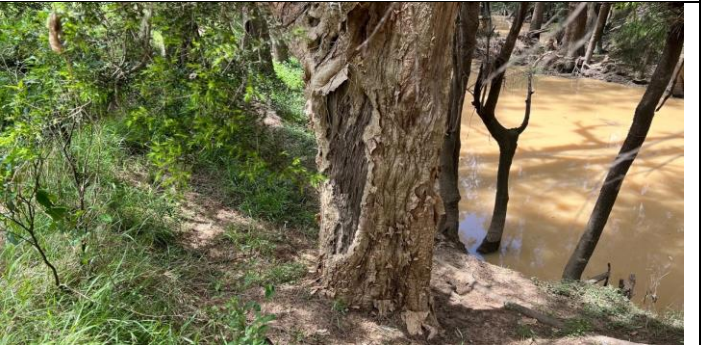
**Cosgroves Creek - The second scar tree is not as obvious**

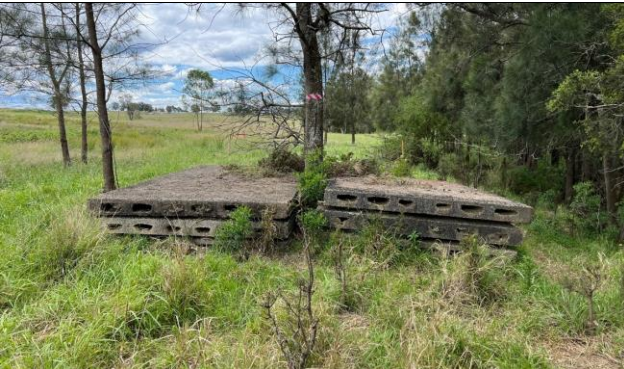
**Cosgroves Creek - Potential microbat habitat in concrete panels has been identified by the project ecologist**

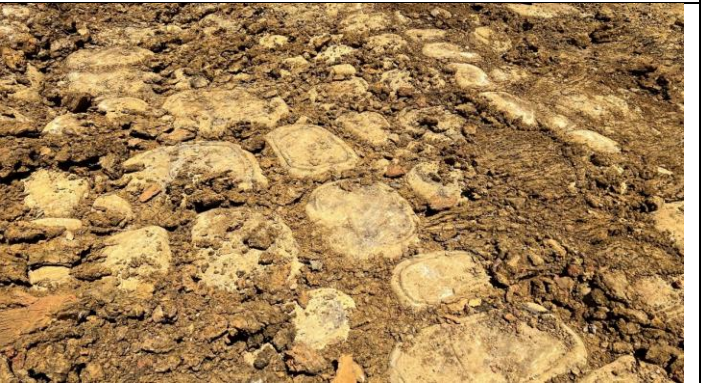
**Elizabeth Drive - Potential unexpected heritage find was identified by the archaeologist as part of Sydney Uni water experiment and can be removed**

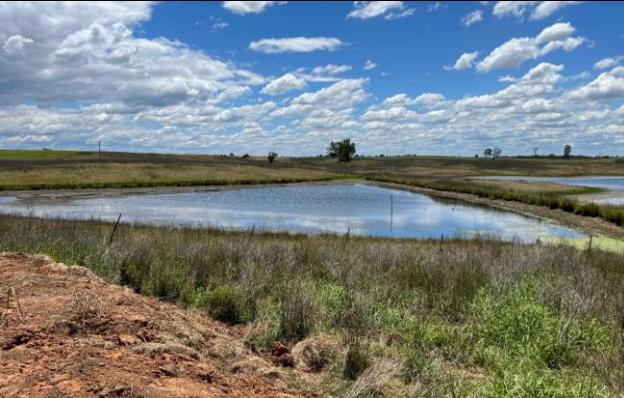
**Elizabeth Drive - The farm dam in AEC 42 is being progressively drawn down to allow sampling for the DSI**

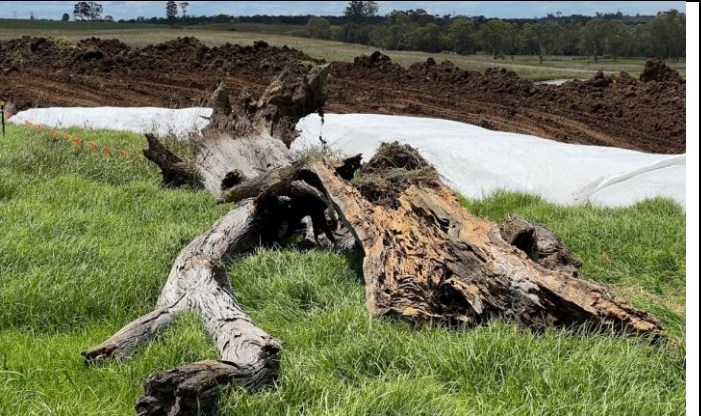
**Elizabeth Drive - The single dead tree from the compound site was felled but is too rotten – likely not usable**
