our reference: 21000264-ESCR-04-06-20230628

28 June 2023

**Soil Conservationist Inspection of Erosion and Sediment Controls;
Various Sites, Airport Metro SBT; 29 May and 9 June 2023**

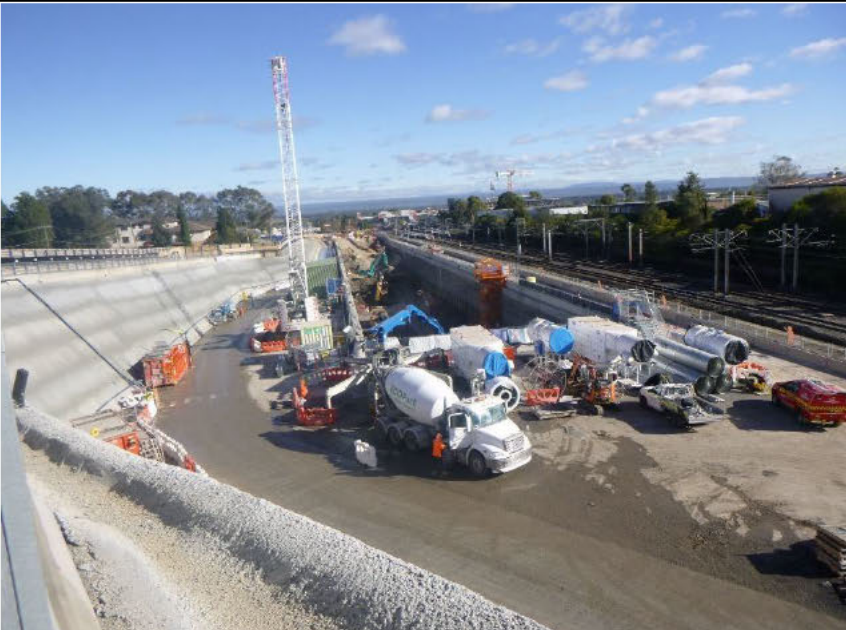
No	Location	Details	Photo (if Applicable)	Action or Recommendation	Priority (at the time of inspection)
1.	St Marys	<p>Positive feedback:</p> <p>Excellent use of long-term ground cover (concrete) to create a stable site.</p>

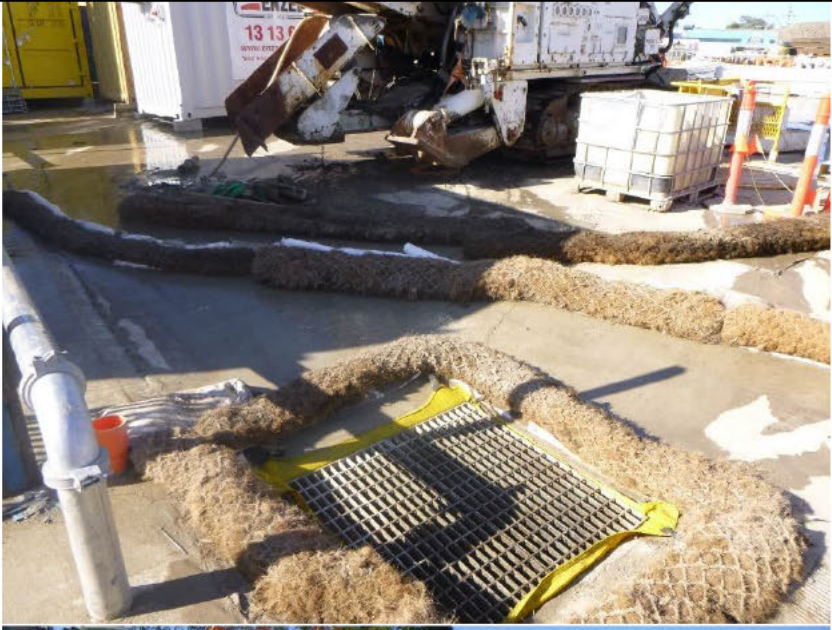
No	Location	Details	Photo (if Applicable)	Action or Recommendation	Priority (at the time of inspection)
3.	St Marys	<p>Positive feedback:</p> <p>Multiple levels of control around pit in laydown yard.</p>

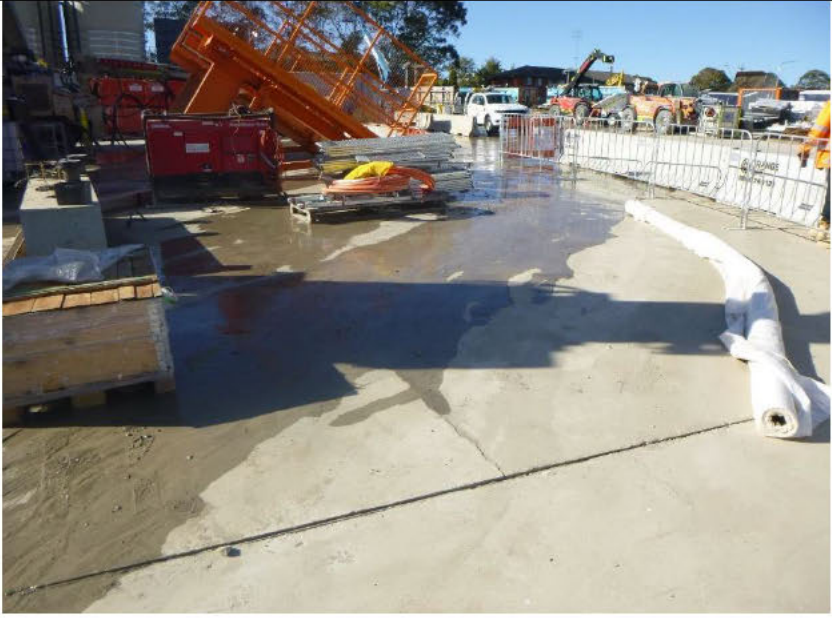
<p>Positive feedback</p>	<p>N/A</p>
4.	St Marys	<p>Runoff from the wheel wash trickles through the laydown yard and picks up small amounts of sediment on its way.</p>

<p>Continue to sweep the yard regularly and remove as much sediment as possible.</p> <p>Consider diverting runoff from the wheel wash to a sump close to the wheel wash for re-use or pumping to the WTP.</p>	<p>Medium</p>

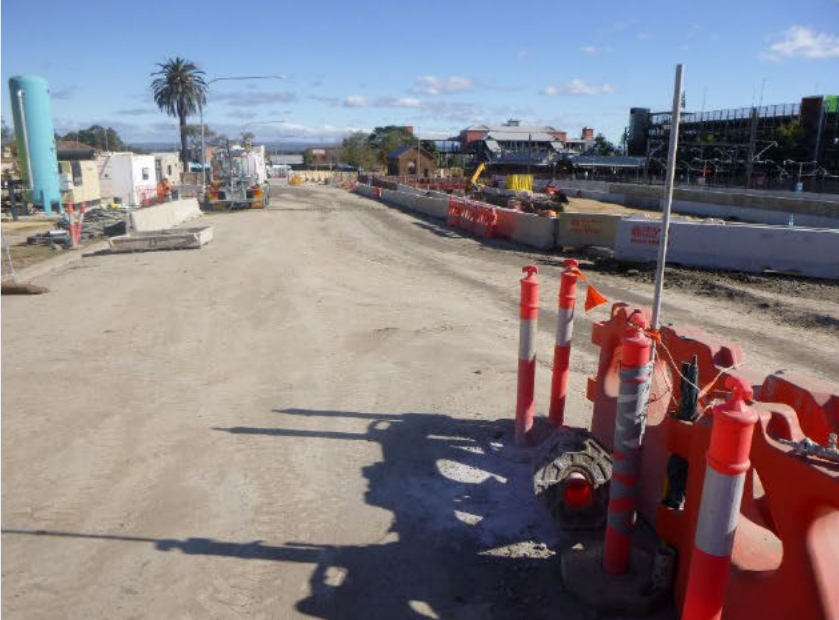
No	Location	Details	Photo (if Applicable)	Action or Recommendation	Priority (at the time of inspection)
5.	St Marys	<p>Moxy haul road shows significant sediment build-up.</p> <p>Sumps are in place, but ongoing sweeping is required.</p>

<p>Continue to sweep this clean prior to forecast rainfall to minimise the amount of sediment that runs to the sump.</p> <p>No other action is required here – the controls in place are appropriate.</p>	Ongoing medium priority
6.	St Marys	<p>Sump at entrance to moxy haul road.</p> <p>Risk of dirty water splashing over the kerb and missing the sump.</p>

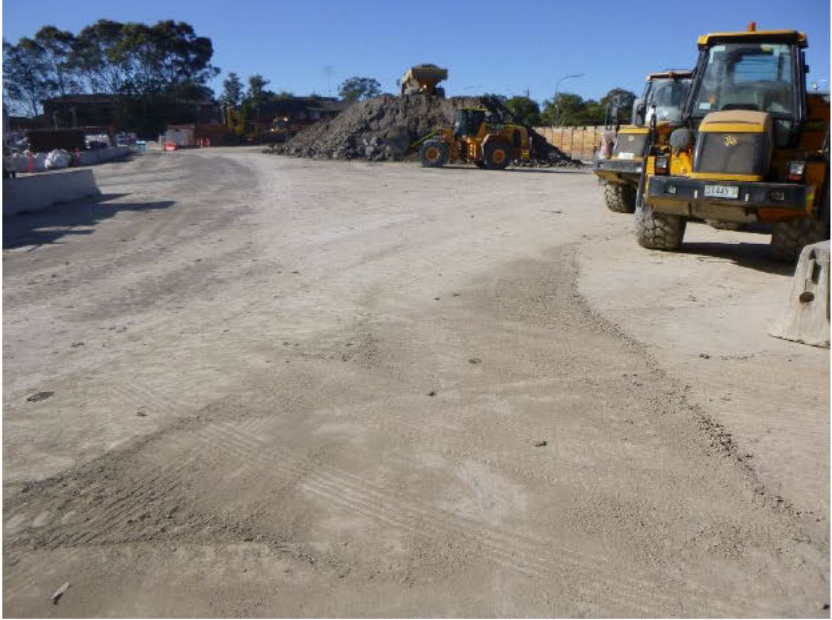
No	Location	Details	Photo (if Applicable)	Action or Recommendation	Priority (at the time of inspection)
7.	St Marys	<p>Positive feedback:</p> <p>Stockpiling is only occurring on the south side of the ridge in the concrete pad.</p> <p>This ensures that all sediment-laden runoff from the stockpiling area runs to the nib wall, not off to the north.</p>

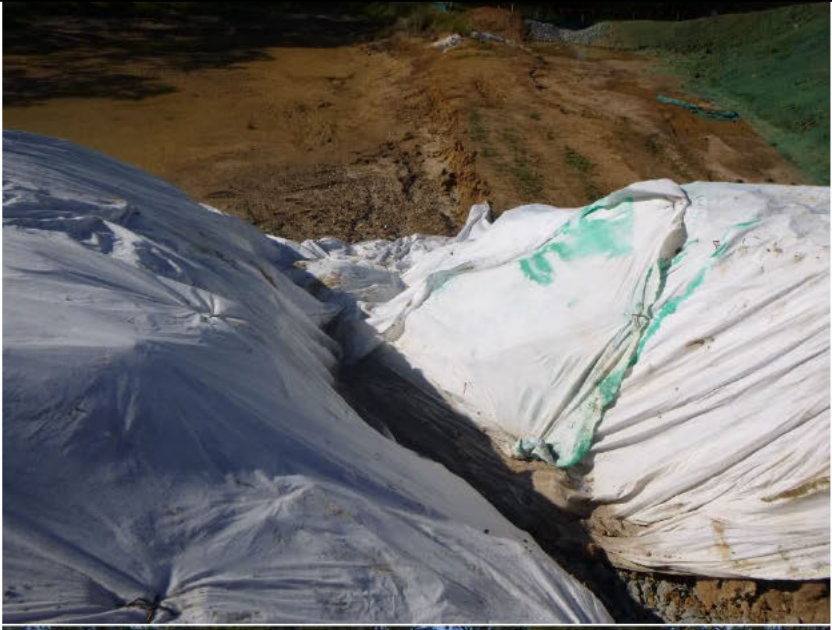
No	Location	Details	Photo (if Applicable)	Action or Recommendation	Priority (at the time of inspection)
11.	Orchard Hills	<p>Fabric is incorrectly laid.</p> <p>Needs to be lapped correctly, similar to roof tiles.</p>

<p>Lap the fabric correctly so that water won't go under the fabric.</p> <p>Upslope fabric must go over the downslope fabric.</p> <p>Note that the chutes are fine otherwise – there's no need for rock as well.</p>	Medium
12.	Orchard Hills	<p>Basin capacity needs to be checked to ensure it meets the ESCP minimum.</p>

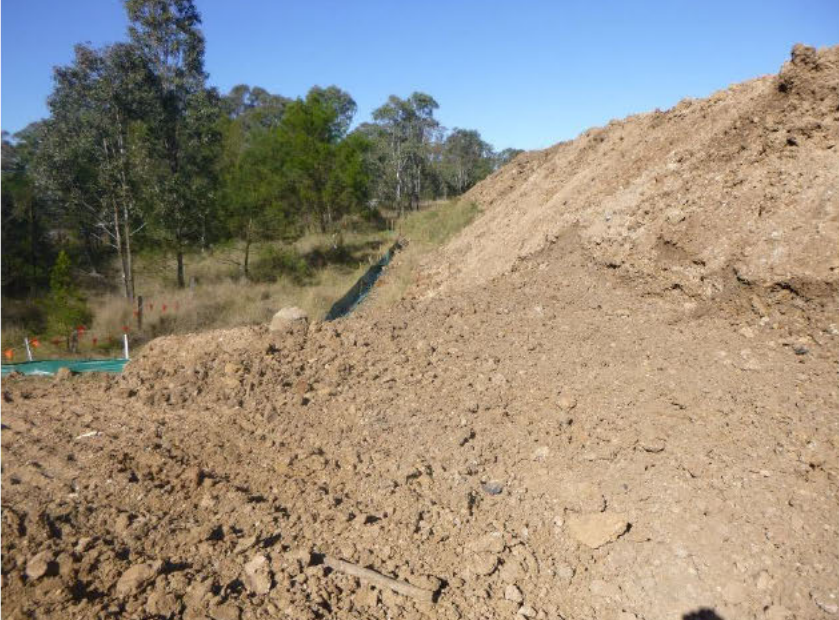
No	Location	Details	Photo (if Applicable)	Action or Recommendation	Priority (at the time of inspection)
13.	Orchard Hills	<p>Backside of the stockpile site:</p> <p>Inadequate installation of silt fence – not dug in properly.</p> <p>And</p> <p>Stockpiles require ground cover to reduce the risk of erosion.</p>

<p>Install the silt fence properly – trench it firmly into the ground to at least 150mm.</p> <p>And</p> <p>Spray the backside (east face) of the stockpile with polymer binder.</p>	<p>High</p> <p>High</p>
14.	Orchard Hills	<p>Runoff from part of the stockpile would miss the basin.</p>

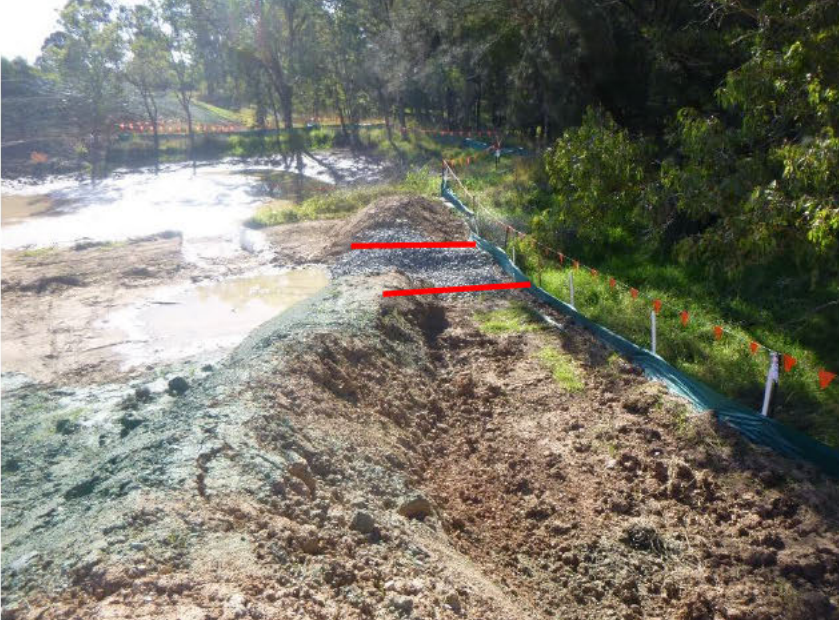
No	Location	Details	Photo (if Applicable)	Action or Recommendation	Priority (at the time of inspection)
15.	Orchard Hills	NE sediment basin spillway has a silt fence across it.

<p>Re-jig the silt fence along the sides of the rock-lined spillway as shown in red.</p> <p>Remove the silt fence from across the rock spillway.</p>	Low
16.	Orchard Hills	Eastern haul road – silt fences not dug in properly.

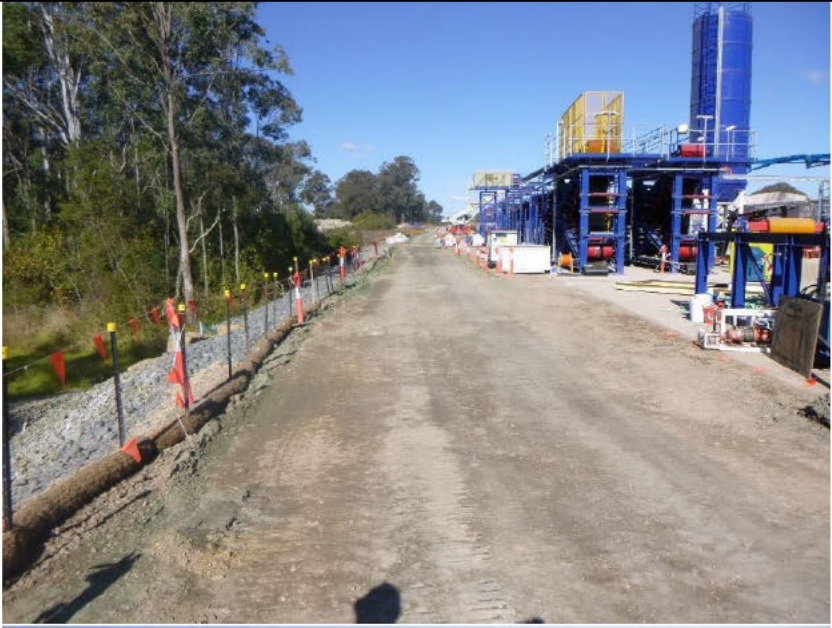
No	Location	Details	Photo (if Applicable)	Action or Recommendation	Priority (at the time of inspection)
17.	Orchard Hills	<p>Eastern haul road:</p> <p>Coir logs require minor housekeeping.</p> <p>And</p> <p>Polymer binder is good but top-dressing it on the road makes it slippery and it doesn't last very long. Use an alternative methodology to get better results.</p>

<p>Tidy up the controls along this edge so they provide adequate filtering of dirty water runoff from the haul road.</p> <p>And</p> <p>In future, blend the trafficable polymer into the road by:</p> <ol style="list-style-type: none"> 1. Ripping the road to 100mm with a grader or a toothed excavator bucket. 2. Spraying the trafficable binder (e.g. Vital HR), then 3. Rolling the road to blend the polymer binder and the road material together. 	<p>Medium</p> <p>Low</p>

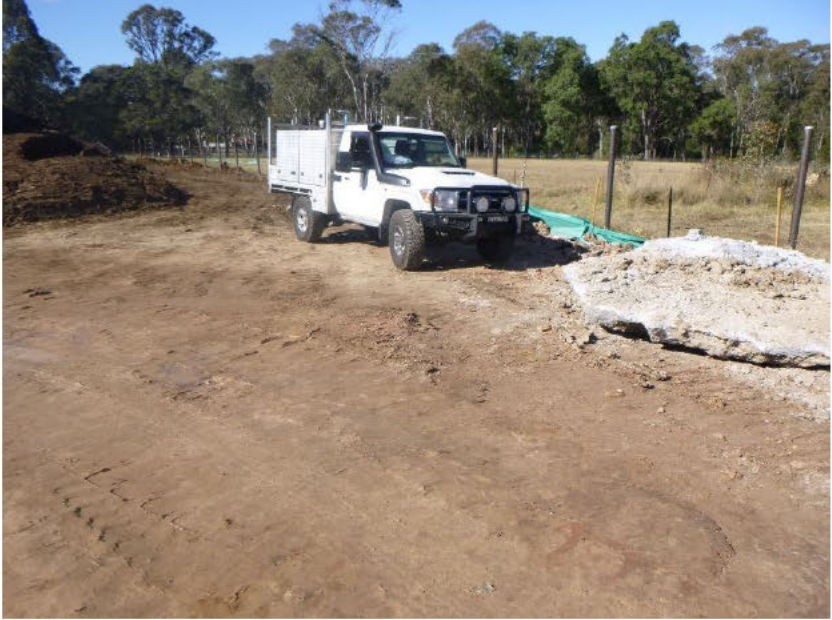
No	Location	Details	Photo (if Applicable)	Action or Recommendation	Priority (at the time of inspection)
19.	Orchard Hills, far south of the site	<p>Minimal controls in place along the southern boundary.</p> <p>Silt fences are poorly installed.</p>

<p>Ensure silt fences are properly installed:</p> <p>Trench them in at least 150mm deep. Returns at 20m intervals</p> <p>Posts at 2.5m centres (metal posts) or 1.5m centres (wooden posts)</p>	High
20.	Orchard Hills, just north of Lansdowne Rd	<p>Positive feedback:</p> <p>Good use of a temporary sump to detain dirty site water</p>

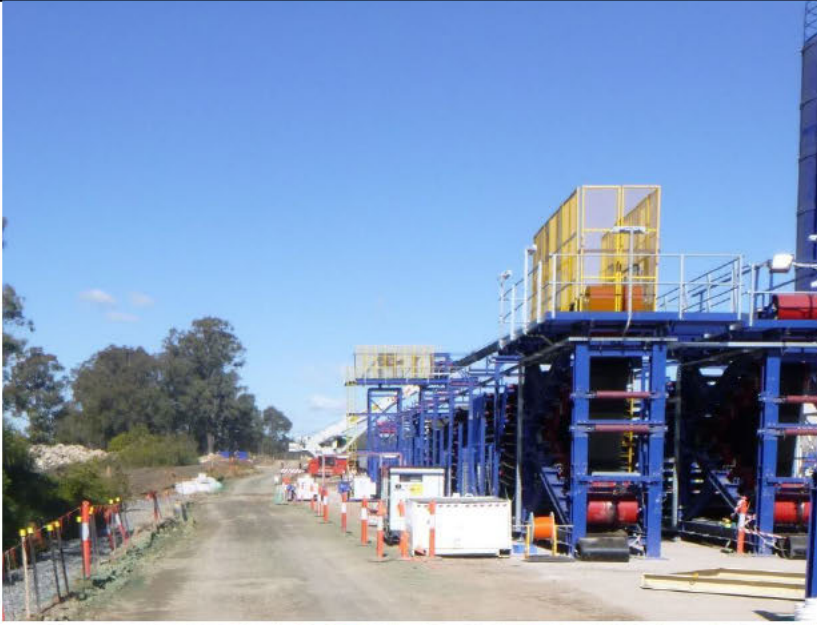
No	Location	Details	Photo (if Applicable)	Action or Recommendation	Priority (at the time of inspection)
21.	Orchard Hills	The proposed vegetation removal along the eastern boundary should include mulch bunds (or earth bunds) along the eastern edge.

If possible, reuse the mulched vegetation to create a mulch bund at least 500mm high along the eastern edge of the cleared area.	Low
22.	Orchard Hills	Swale drain along western edge, south of Lansdowne Road is suitable as is, and does not need to be stabilised further.

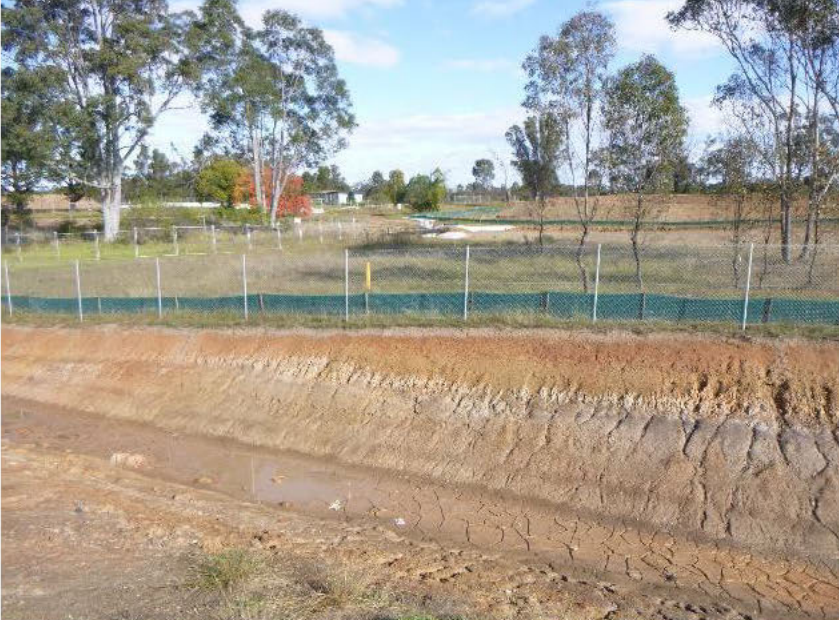
No	Location	Details	Photo (if Applicable)	Action or Recommendation	Priority (at the time of inspection)
23.	Aerotropolis	<p>The upslope catchment is being developed now, which will dramatically increase the amount of run-on into the Aerotropolis site.</p> <p>The clean water drain is still not complete.</p>

<p>The clean water drain should be completed and lined as soon as practicable.</p> <p>There is currently little or no rain on the forecast, so this is not a significant issue at this time. However, if the forecast changes and significant rain is likely, the present setup of this drain is likely to contribute to:</p> <ul style="list-style-type: none"> A. A high risk of dirty water discharging from the site; and B. Additional volumes of water for the project to have to floc, test and discharge. <p>Completing this drain will take time, so should be prioritized as much as practicable.</p>	High

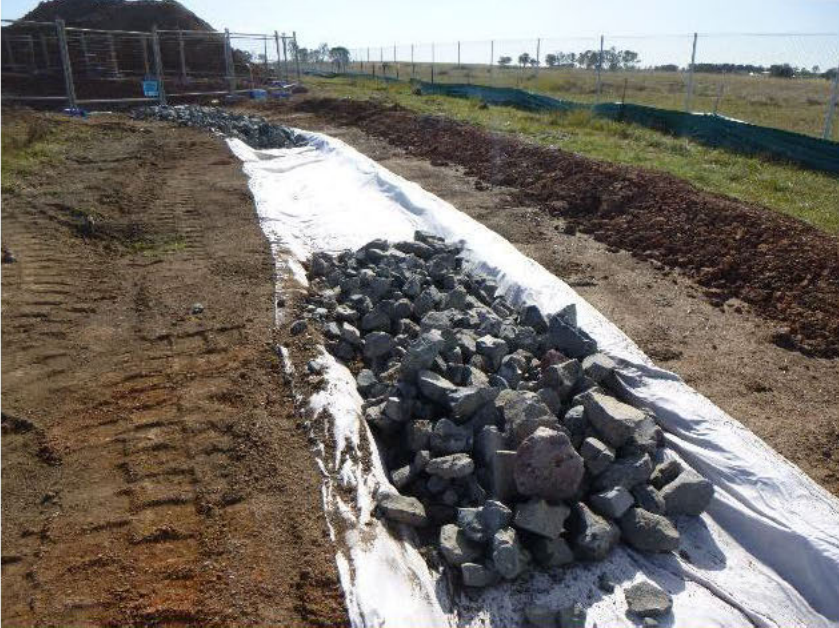
No	Location	Details	Photo (if Applicable)	Action or Recommendation	Priority (at the time of inspection)
27.	Aerotropolis	Spillway poorly constructed – the rock has filled up the swale.

Re-dig the spillway so that the finished level of the rock creates a trapezoidal profile and the water will flow in the channel, not around the sides of it.	Low
28.	Aerotropolis	Stockpile adjacent to the basin blocks a large amount of site water from reaching the basin.

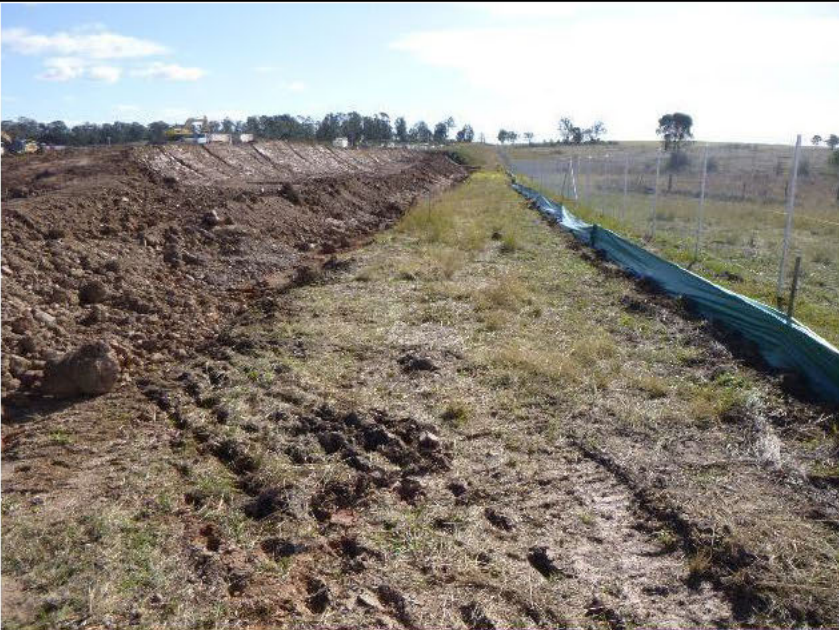
No	Location	Details	Photo (if Applicable)	Action or Recommendation	Priority (at the time of inspection)
29.	Aerotropolis	Dirty water runoff from this batter would flow to the low point, where there are only minimal controls.

Finish off the batter, veneer it with topsoil and vegetate it.	Medium
30.	Aerotropolis	Stockpile adjacent to the basin blocks a large amount of site water from reaching the basin.
