7 September 2023

Ref: 201209-ER\_DPIE-August 2023

**RE: Sydney Metro - Sydney Metro Western Sydney Airport SSI 10051 – ER Monthly Report for August 2023**

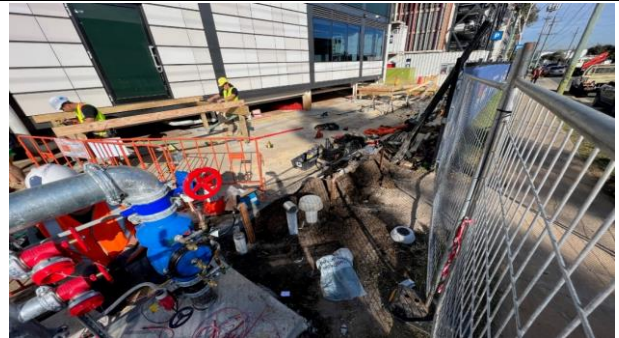
- **15/08/2023** - Key points/ issues raised during this inspection were as follows:
  - Works have progressed on the sewer connection and this has been done in a method that poses minimal environmental risk

**SPO - The sewer backfill is progressing, posing a minimal environmental risk**

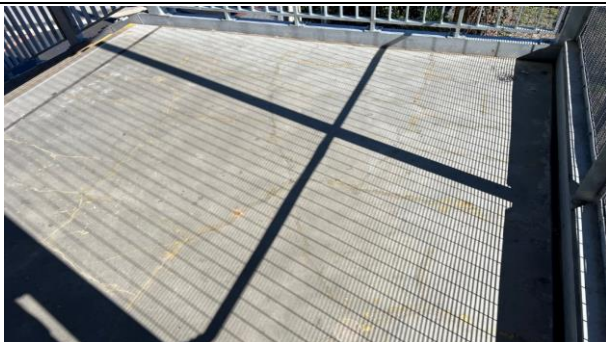
**FSM - The landing on the station stairs has cracks and needs to be scabbled in the upcoming OOHW**

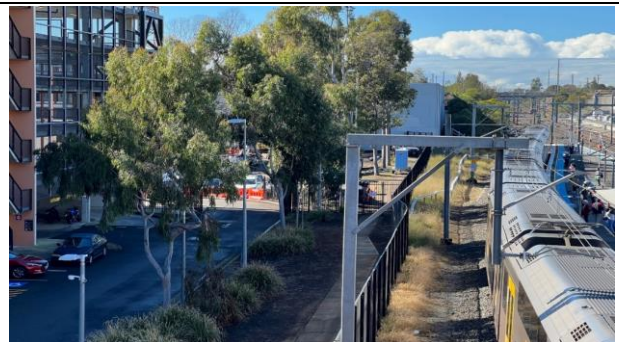
**FSM - The trees adjacent to the compound are due to be removed prior to crange works**

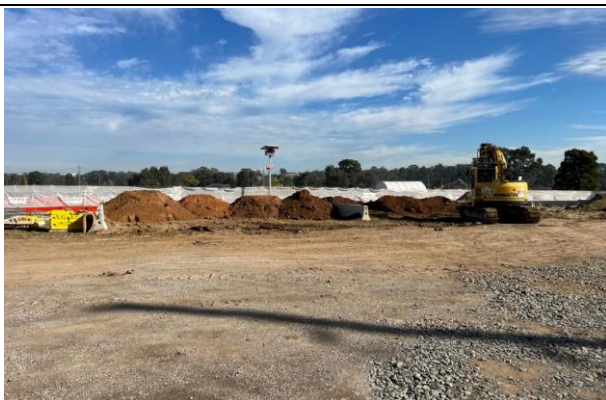
- The material storage bays at the site compound are neat and tidy with no signs of cross contamination
  - The project is using bulka bags as mobile waste storage, this is a good secondary application of these products.

**Site compound - The bays in the site compound were neat and tidy with no evidence of cross contamination**

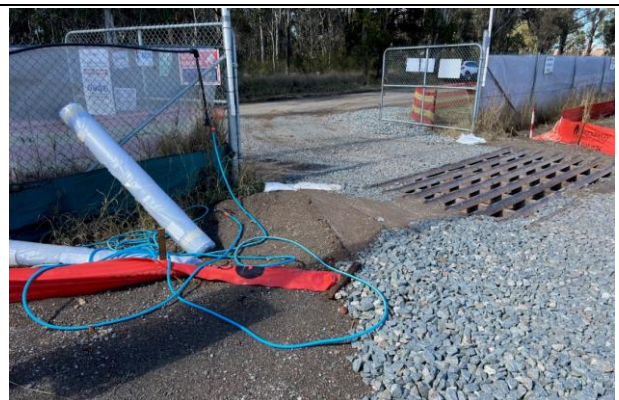
- The controls from the compound have prevented mud tracking, however, are required to be inspected and maintained as required
- **22/08/2023** - Key points/ issues raised during this inspection were as follows:

**Site compound - The ballast, hose and rumble grid have mitigated mud tracking from the compound**

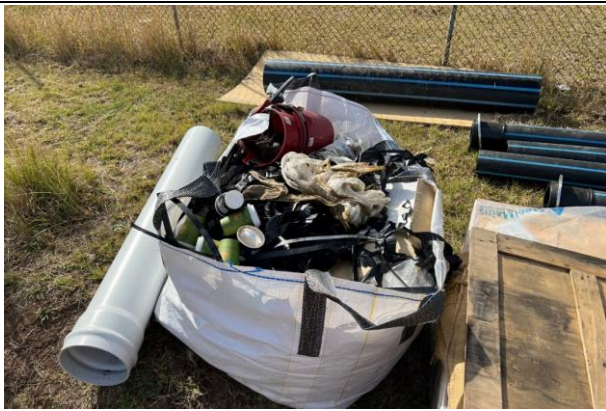
**Old Luddenham Rd - Bulka bags are being reused as mobile bins across alignment. Good practice.**

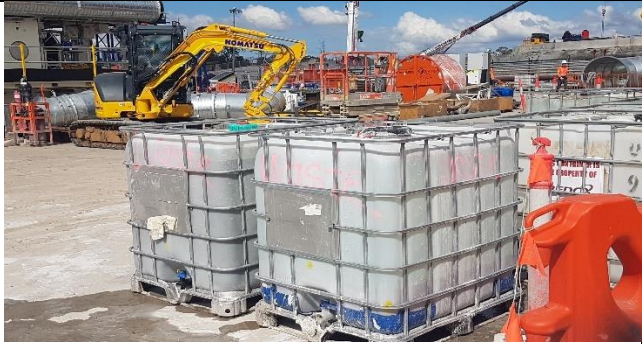
- Orchard Hills – General housekeeping and waste management practices require improvement as the SBT footprint shrinks and tunnelling operations ramp-up. In particular, storage of chemicals in IBCs requires dedicated areas/bunding, and tunnelling wastes in IBCs requires adequate labelling segregation and management accordingly.

**Orchard hills: storage of wastes in IBCs requires  
adequate labelling and segregation/management.**

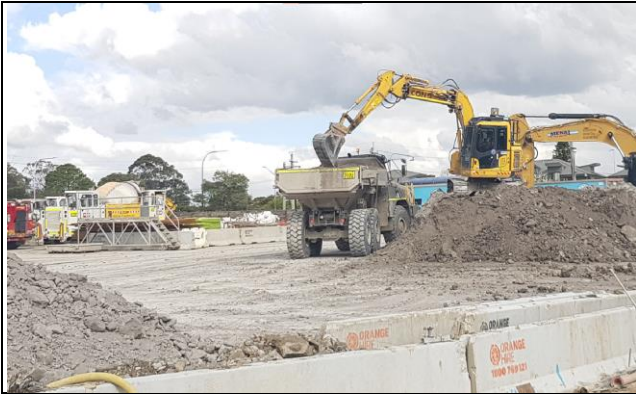
- General - substantive improvements were noted in environmental management across the project.
- St Marys – Significant effort noted to minimize height of soil stockpile and tracking to public roads, including two manual pressure washers after wheel wash and two road sweepers operating in concert with a water cart.

**View south east along Gidley St.: Height of spoil stockpiles reduce below hoarding.**

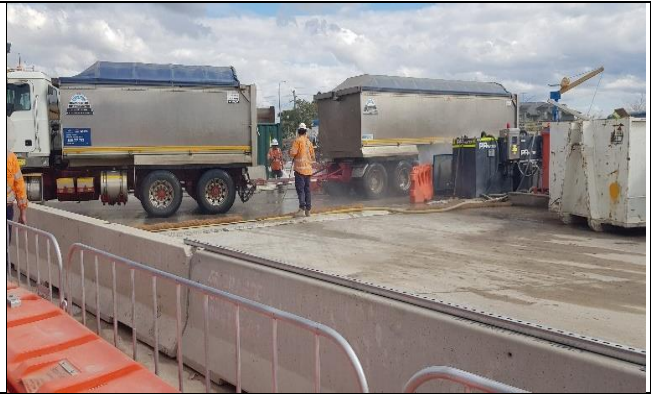
**St Marys: Manual wheel washing following automated wheel wash.**

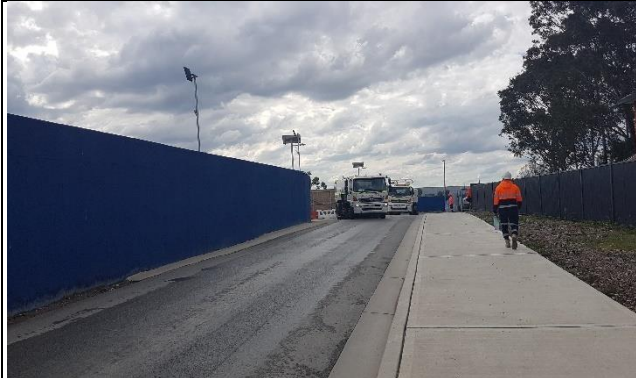
**St Marys Station St to Phillip St - Two Street sweepers and a water cart working in concert.**

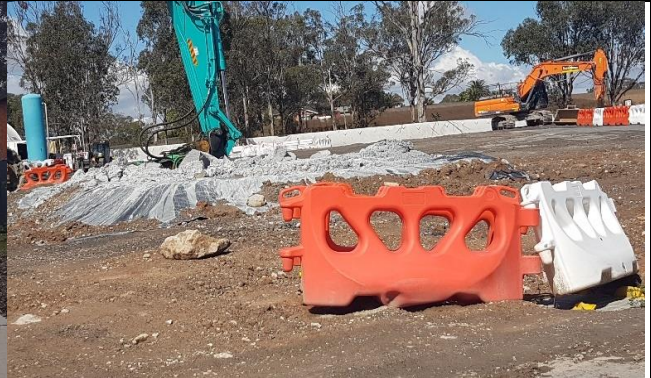
**Bringelly: Concrete washout overtopping with cured surplus concrete**

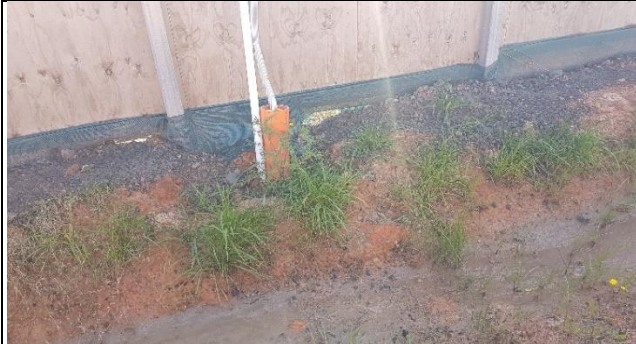
**Bringelly: Northern swale requires desilting and trimming and sediment fence requires repairs.**

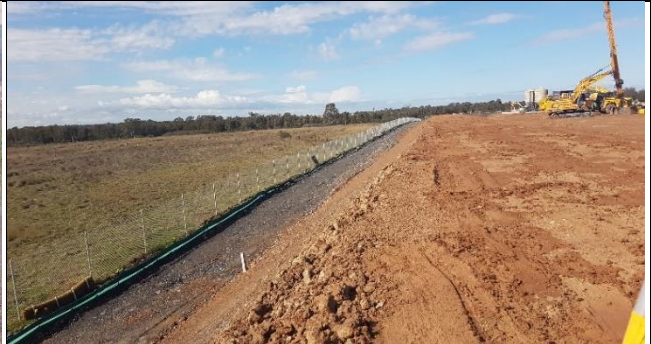
- Aerotropolis - Eastern dirty water swale, eastern embankment top and batter, and southern areas and berm require polymer (soil binder) application once dry.
- Aerotropolis - ESCP currently in preparation to consider the proposed spoil haul road along the southern clean water swale to the proposed western stockpile location, and the stockpile itself.
- Aerotropolis - Installation of eastern silt fence requires improvements (keying-in, and tension to prevent collapse).
- Bringelly – Northern swale requires desilting and trimming of sides and sediment fence requires repairs.
- Bringelly – Disused lead acid batteries require dedicated bunded storage.
- Bringelly – The concrete washout containment was noted overtopping with cured surplus concrete. CPBG to provide separate contained areas for curing surplus concrete and concrete washout respectively.

**Aerotropolis: Eastern dirty water swale, top and batter of embankment require stabilisation.**

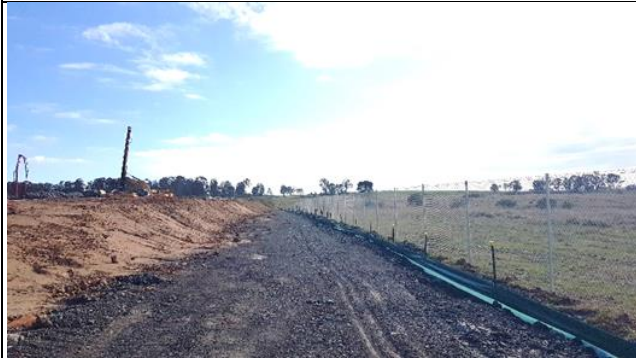
**Aerotropolis view north: eastern boundary silt fence requires keying-in, and tensioning.**

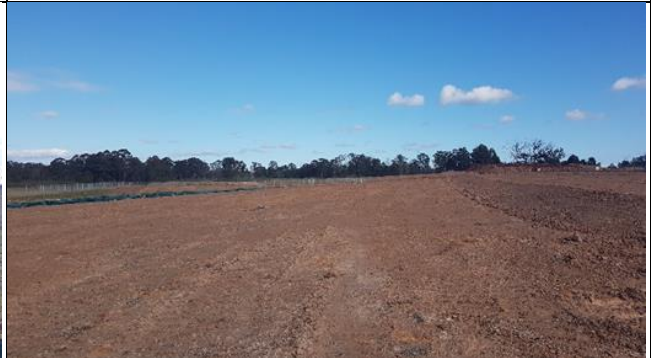
**Aerotropolis view south west: Southern areas and berm require polymer application once dry..**

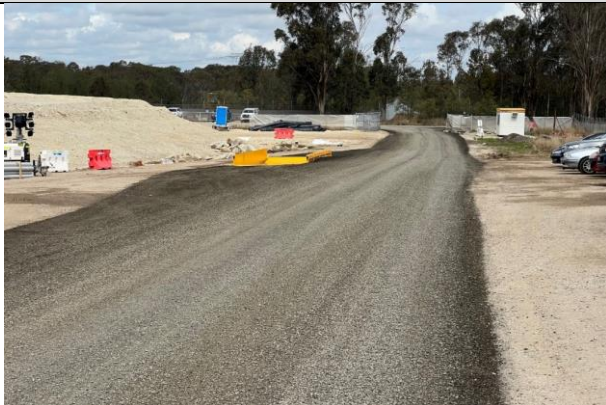
- At Patons Lane a wheel wash has been installed at the entry / exit point. Chip seal needs to be placed on the exit side of the wheel wash
  - Drainage line formation is appropriate at Blaxlands Creek. This is a works in progress and requires ERSED surface treatment to reduce scour risk

**Patons Lane - The wheel wash and chipseal at Patons lane has been installed**

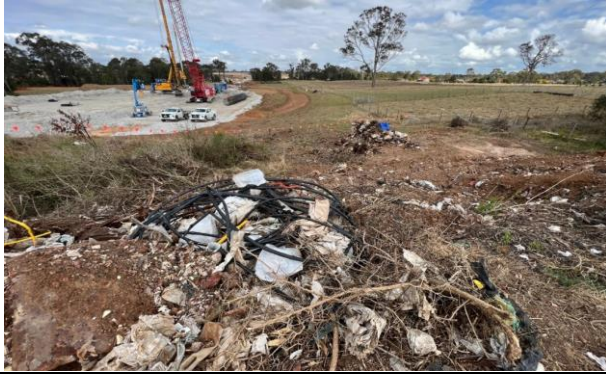
- The pump around at the unnamed tributary is being installed and will pump SBT discharge around the culvert works.
  - Unexpected landfill material has been found north of Blaxlands Creek. Sydney Metro and CPBUI are in discussions regarding how to handle and dispose of this material.

**Blaxland's Creek - Unexpected landfill material has been found north of Blaxland's Creek.**

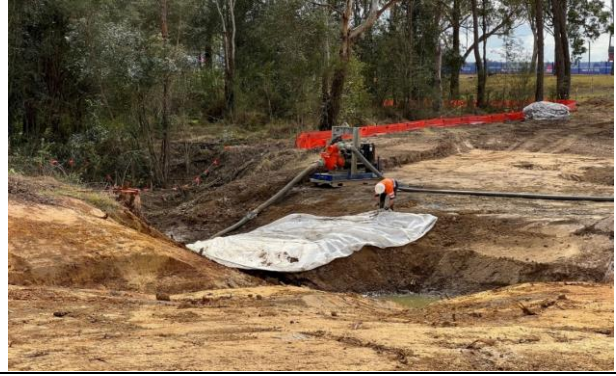
**Unnamed tributary - The pump around installed at the unnamed tributary to divert SBT discharge from culvert**

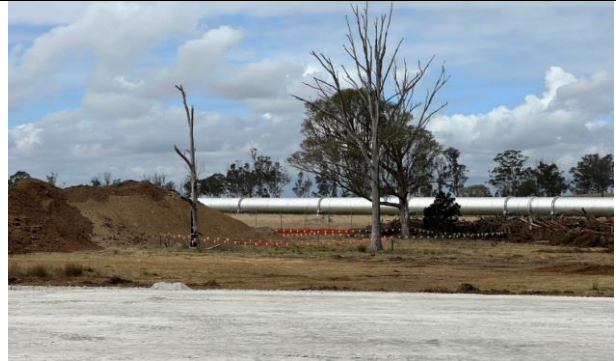
- At the Defence site Three trees (saplings and habitat tree) need to be flagged off to prevent accidental damage.
  - At Cosgrove’s Creek stockpiled material of differing composition should be removed from the flood basin.

**Defence Land - Habitat trees have been retained and flagged off**
