SITE AUDIT REPORT

ROAD INFRASTRUCTURE

AT 1C SYDNEY STEEL

ROAD, MARRICKVILLE

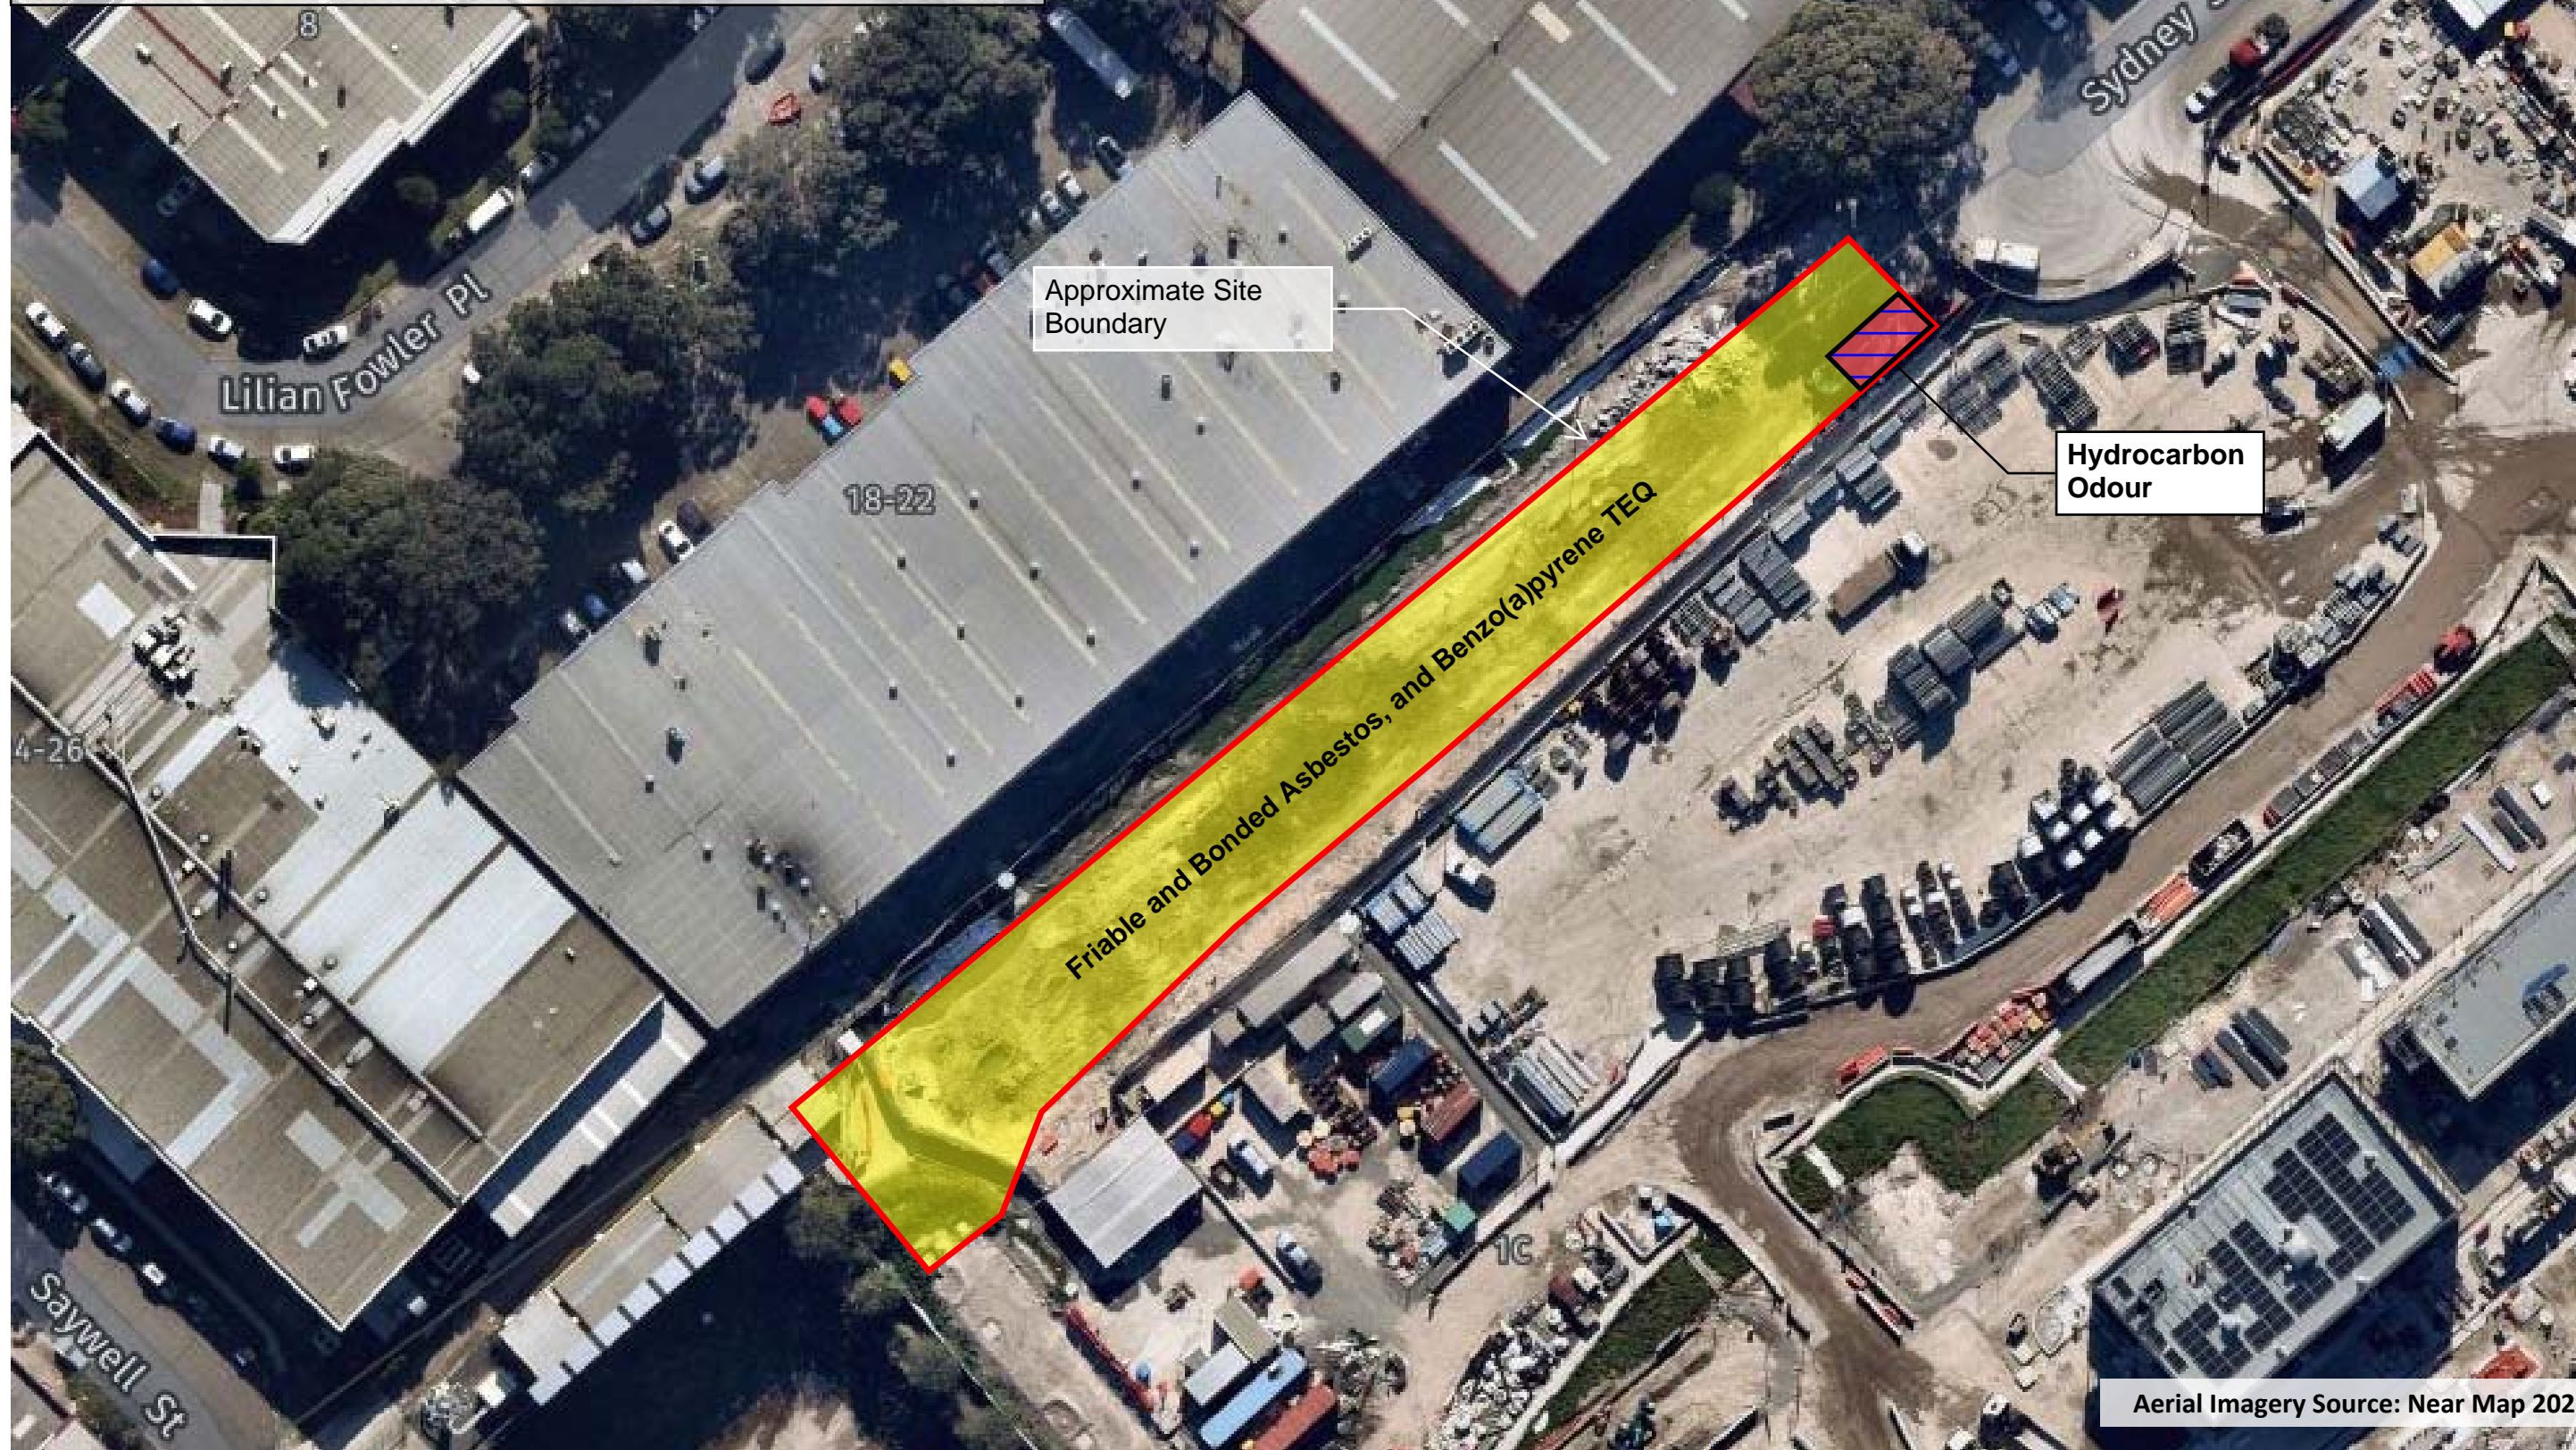
Area of Environmental Concern Plan

- Approx. Site Boundary
- Approx. Location of Friable and Bonded Asbestos, and Benzo(a)pyrene TEQ
- Approx. Location of Hydrocarbon Odour

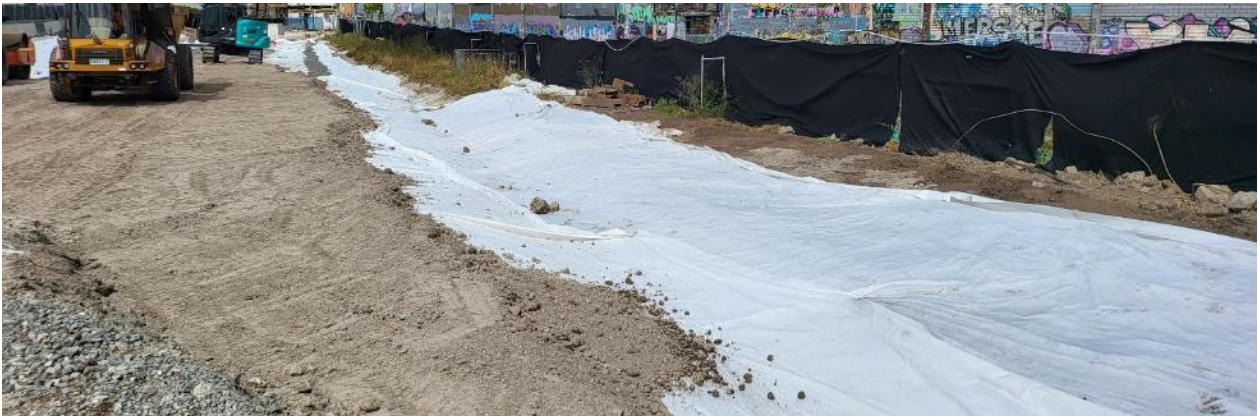
Image 6.2.2.1 View of geotextile marker layer along the north-western boundary of landscaped area.

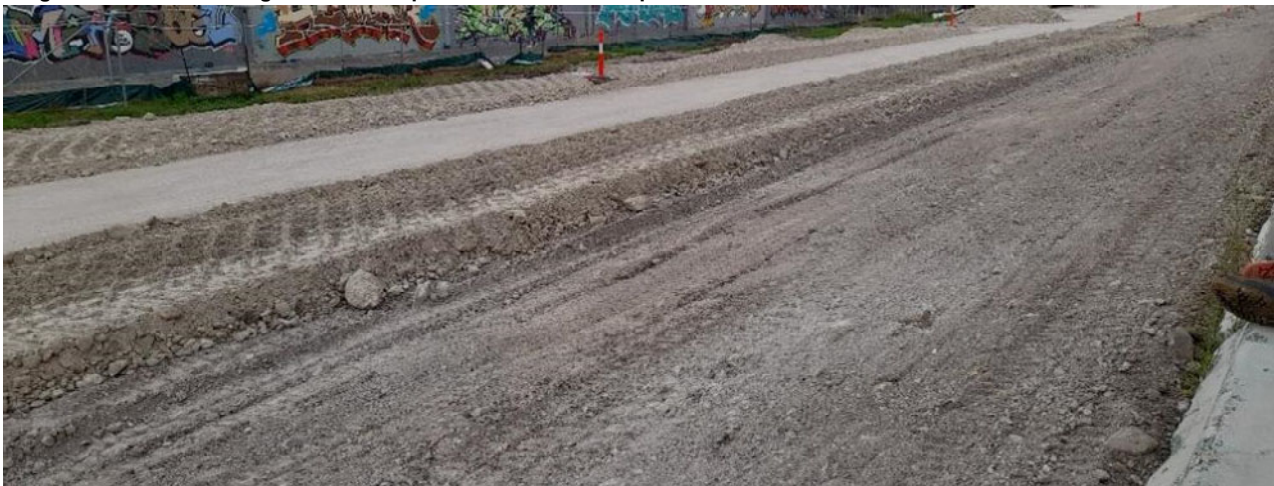
Image 6.2.2.2 View of subgrade material placed across landscaped area.

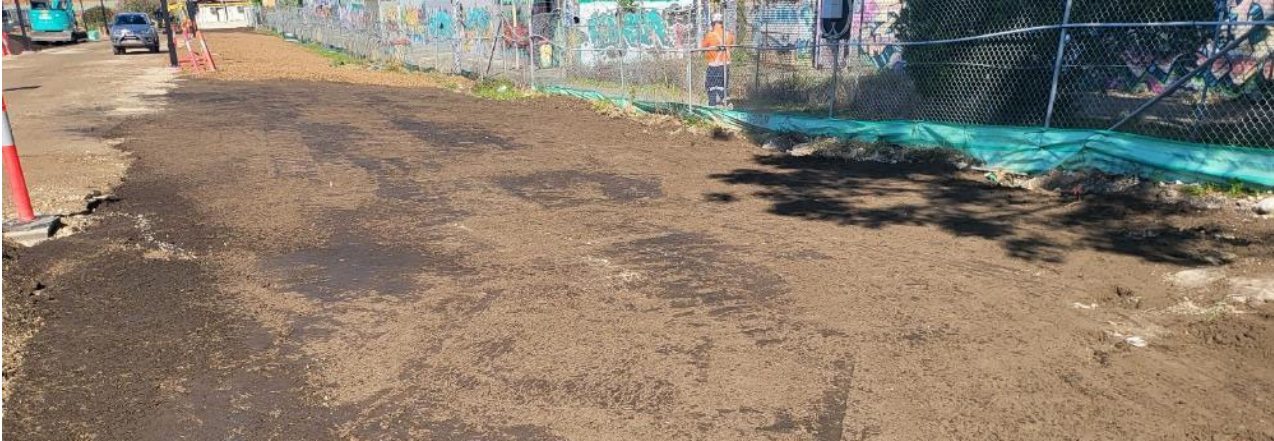
Image 6.2.2.3 View of topsoil material placed across landscaped area.

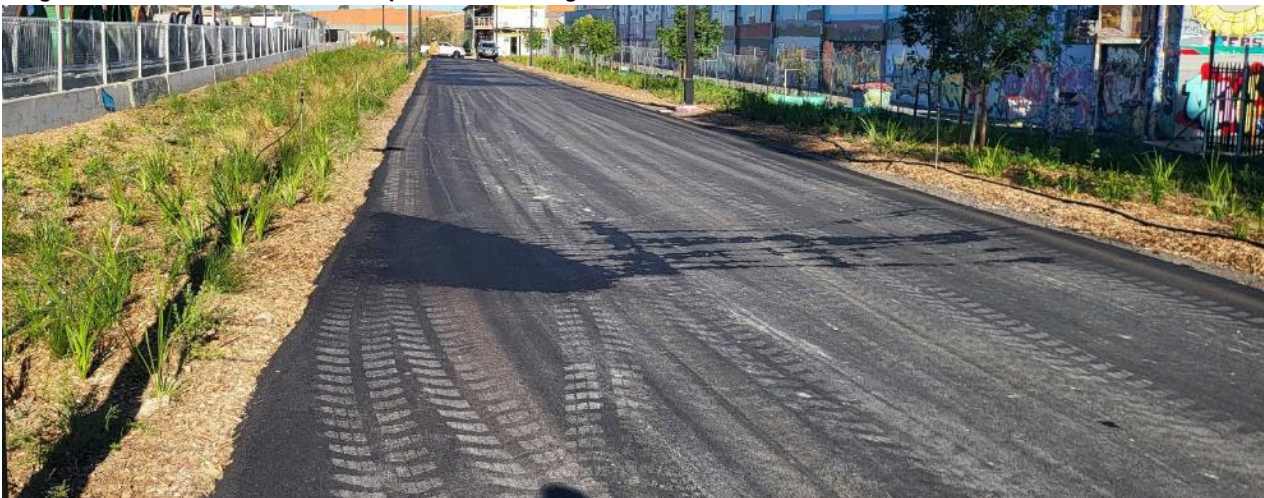
Image 6.2.2.4 View of finished landscaped area including mulch.
