Blues Point Archaeological Monitoring Report

Prepared by AMBS Ecology & Heritage
for Systems Connect

March 2023

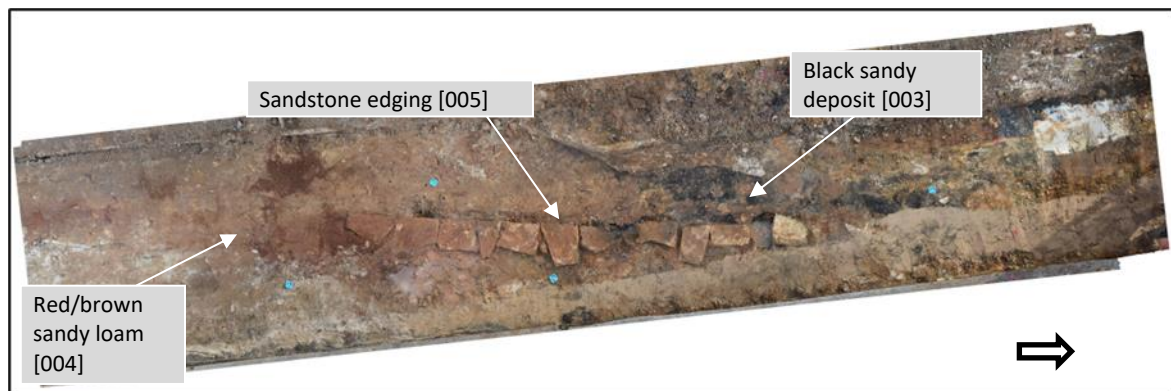
A line of sandstone blocks was first exposed during the preparation for the new road surface on the western side of the site (WZ1B). Once the existing concrete [001] was removed a yellow/brown sandy/silt deposit [002] was evident across much of the area. Under context 002, and at the level required for Systems Connect scope of work, a red/brown/orange sandy loam fill [004] was exposed along with a row of sandstone blocks [005], which extends north-south along the site. A patchy black sandy layer with sandstone inclusions [003] can be seen abutting the row of sandstone blocks and the 1887 wall at the far west of the site. At this level a clear cut to the east of the blocks was evident and filled with a sterile yellow sand [006]. To the west of the blocks the area was heavily disturbed with a large north-south running service pipe encased with concrete [007]. The blocks and the fill [004] can be seen continuing down the site and line up with the sandstone blocks and timber plank found in WZ1A (Figure 3.2). The blocks are positioned with their straight, worked edge on the western side closest to the heritage wall (1250mm), creating a gully/channel for the rainwater reducing the risk of water build up on the road. The top edge of the blocks were levelled and likely prepared for a top layer of either another course of sandstone blocks or a road surface. This was likely removed, during the later stage of the road's modification.

The blocks were irregular in size and shape, with varied lengths between 370mm-670mm. As no further excavations were required in this area the blocks were left insitu. Therefore, it is not known if there was a course under these blocks.

Figure 3.2: Orthophoto of sandstone blocks running north-south down Blues Point Road. Note the straight edge on the western side and the continuation of the red/brown fill. Archsurv Guy Hazell.

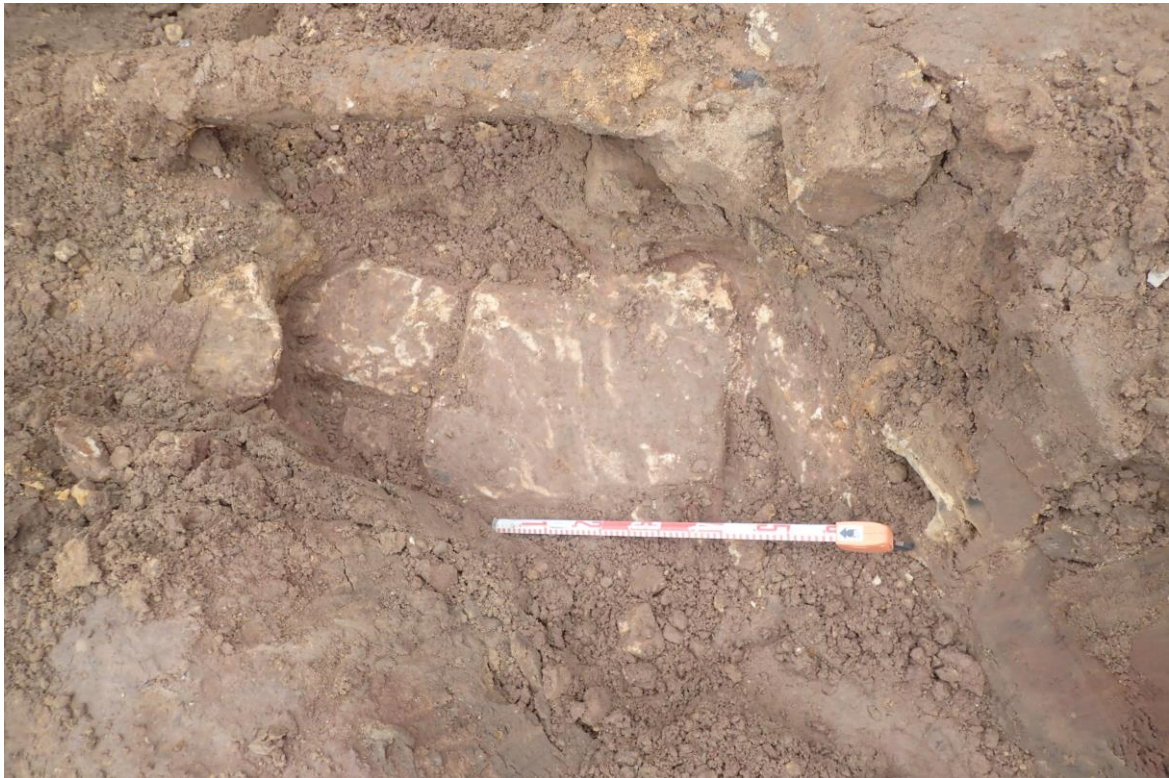
During excavation of WZ1A four sandstone blocks were revealed. Their alignment and fill were the same as context 005 to the north, as such it is evident that the four blocks were the southern termination of the context 005 (Figure 3.1). Two of the blocks had to be removed for the installation of a lamppost. On removal of the blocks, it was determined that there were no courses below. It also revealed a horizontal wooden plank [008] which was positioned floating in the red/brown sandy loam fill [004] that was used for the edging. Below context 004 was a dark grey mottled sand [009] with small sandstone inclusions. This was also observed immediately below the fill of the road base [002] next to the cliff face, suggesting that context 004 was an imported fill for the edging. The colour of the fill indicates that it was not locally sourced or that it has absorbed a mineral from one of the industrial uses on the site. Historic images show that this area of the site has repeatedly been used as an area for storage (Figure 3.6, Figure 3.6).

Figure 3.3: Sandstone blocks revealed at southern end of Blues Point Road, pre-excitation.

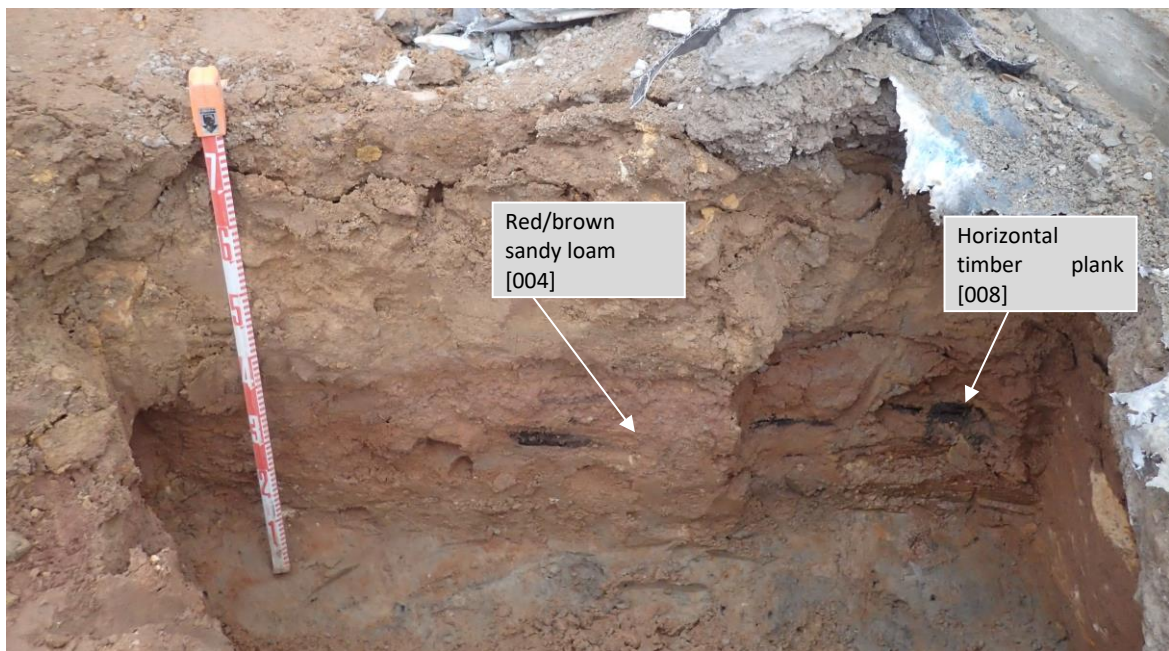
Figure 3.4: View of timber plank [008] in [004] after two sandstone blocks were removed.

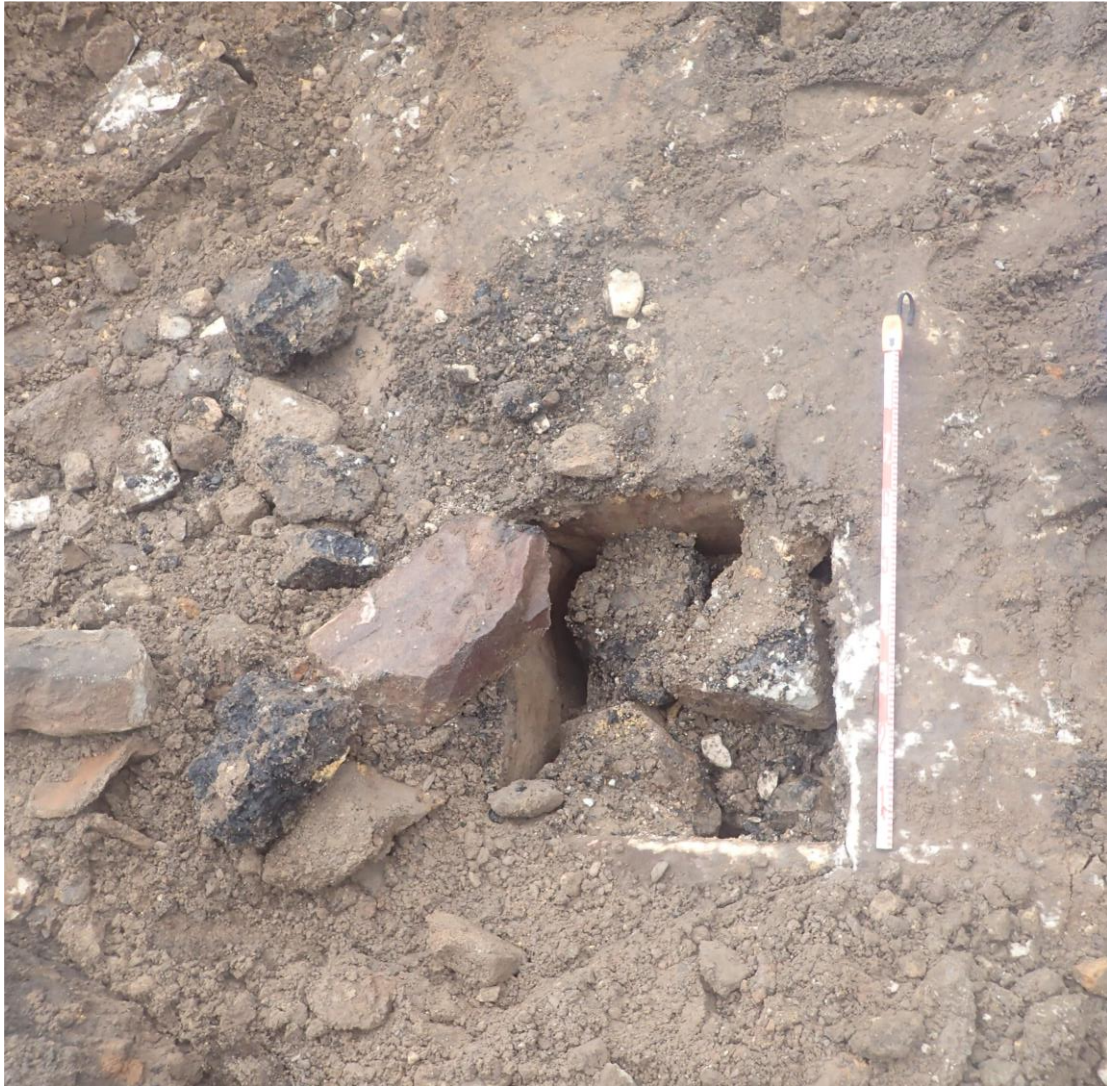
Figure 3.9: View of the brown, sandy/silty fill with large sandstone inclusions [014] on and in the sandstone drain [015].

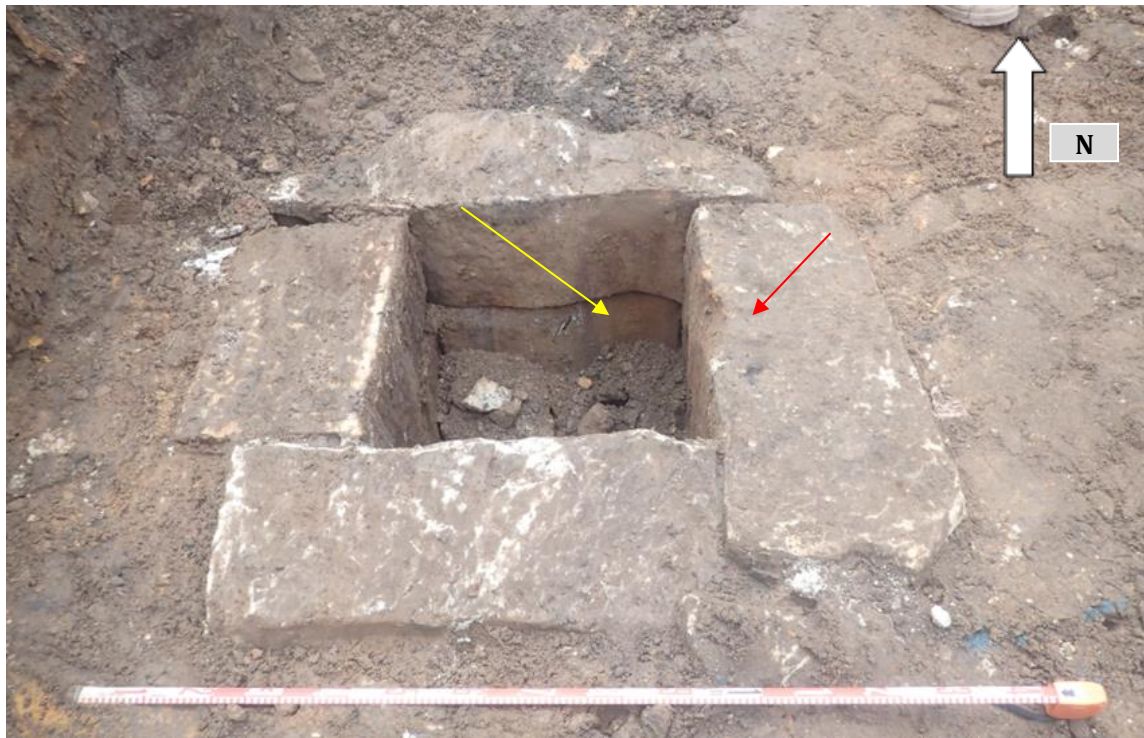
Figure 3.10: Image of the sandstone drain [015] in WZ3D. Note the worked (red arrow) and smooth, worn (yellow arrow) areas.

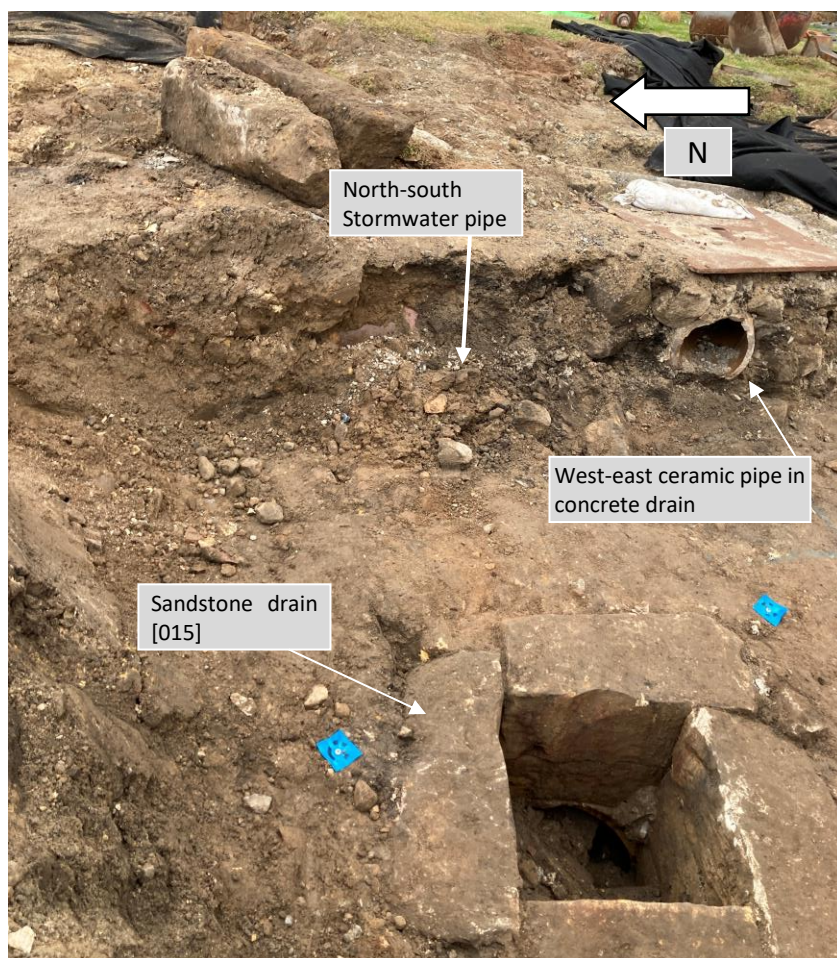
The scope of work in WZ3D required trenching to be excavated to 1020mm. The trench revealed a large ceramic service pipe running west to east [010], and a large stormwater pipe [011] running north to south into a large concrete drain [012] that is also open to the harbour. Below this was a layer of coal tar with small sandstone inclusions [013] above a dark brown sandy/silty fill with large sandstone inclusions [014] and a square sandstone structure [context 015], likely a drain or a silt trap. The pipe [011], broken during excavation, can be seen on both sides of the trench just above the top course of the sandstone drain (Figure 3.11, Figure 3.12).

Figure 3.11: Image of the sandstone drain [015] with part of the stormwater drainage pipe in the southeast corner running towards the harbour.

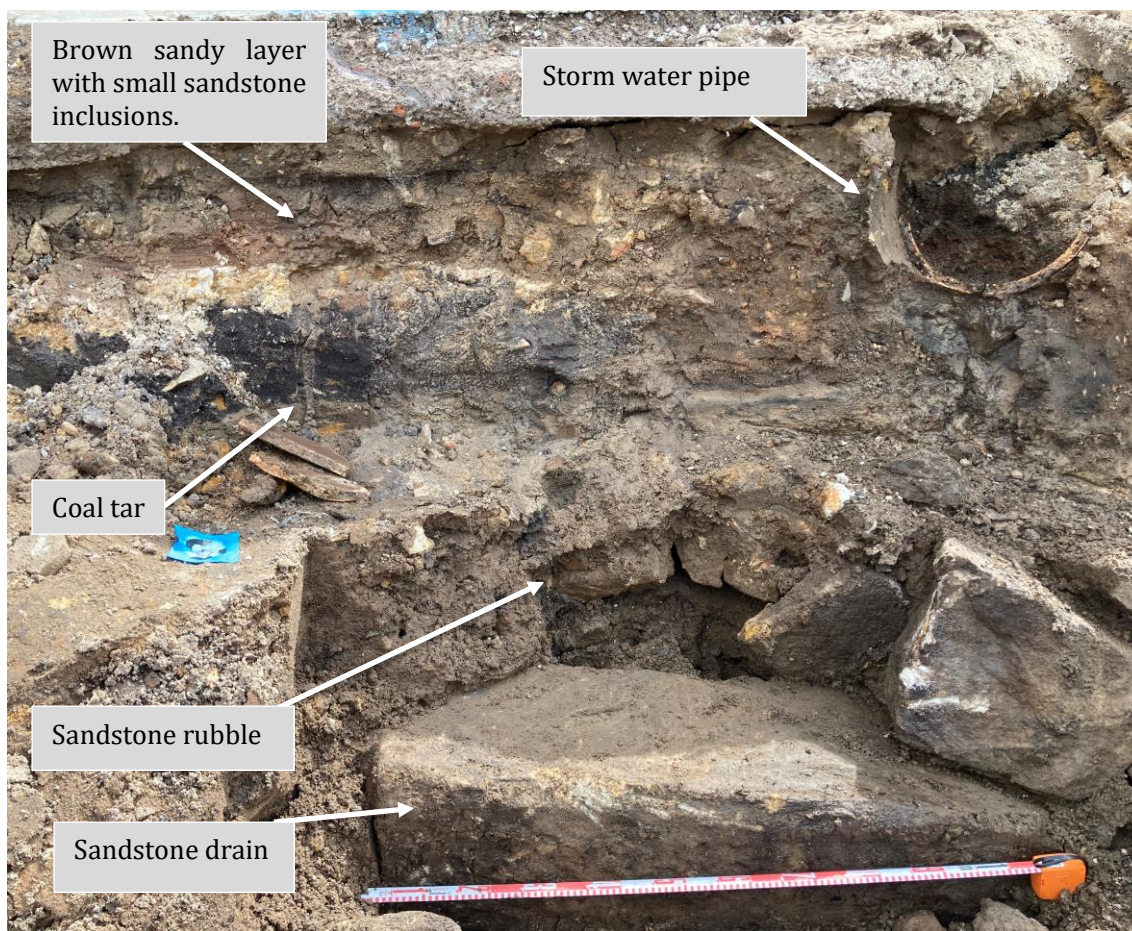
The drain consisted of four sandstone blocks, laid out in an open square shape and measured approximately 1.32m². The top course of blocks measured approximately 900mm to 1200mm in length, 300mm in height and 350mm in width. The blocks on the eastern side of the feature had a curved, worn area that was very smooth with no tool marks evident. This could potentially be attributed to water wear around a vertical drain pipe. The blocks on the southern side of the feature showed tool marks, indicating it had been modified but it is unclear as to why (Figure 3.10). The second course of blocks were approximately 600mm in length, with the curved mark continuing from the top course on the eastern side (Figure 3.10). The fill [014] on top of the drain was also found in the drain (Figure 3.9). Part of the stormwater drainage system for the area can also be seen at the base of the drain on the south-eastern corner. The drain was excavated for the new drainage systems, leaving one block in situ (Figure 3.12).

Figure 3.12The western lower sandstone block of the drain that was not removed. The sandy/silty fill with large sandstone inclusions is evident in this image. Above this is the coal tar level and above this is the west-east running pipe in a sandy brown layer with small sandstone inclusions.

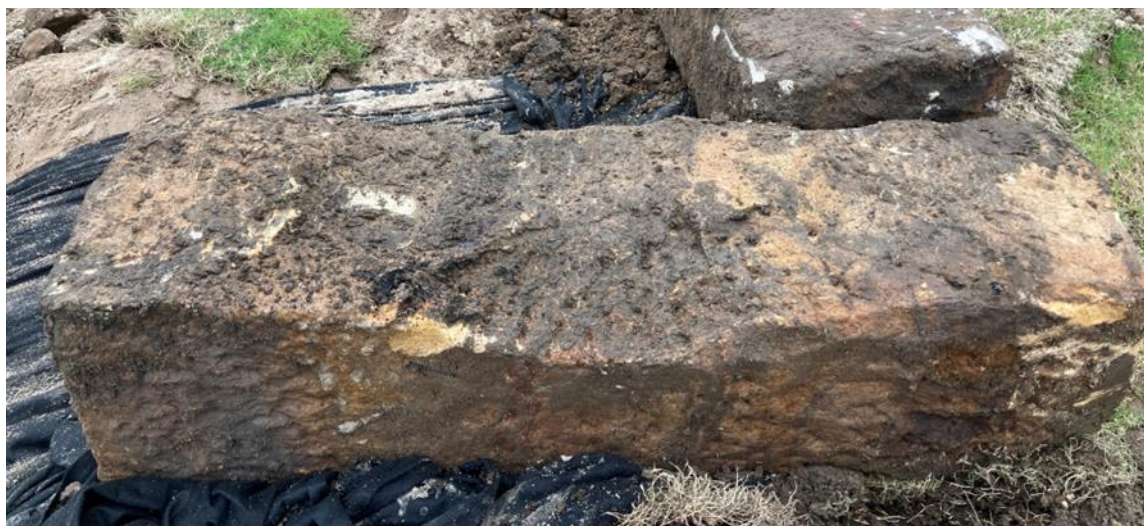
Figure 3.13:Detail of tool marks on the southern block from the drain [015].

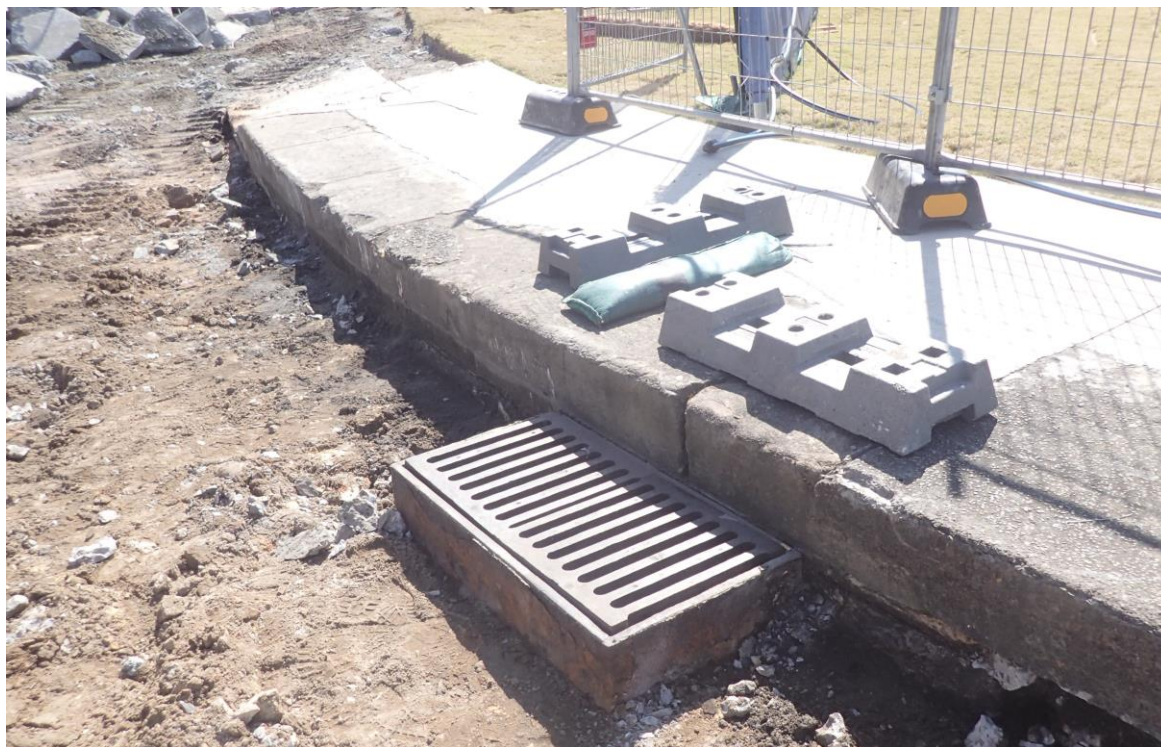
Excavations on the eastern side of the study area, in WZ3A, included the removal of concrete and a portion of the sandstone kerbing from the footpath still in use prior to this stage of work (Figure 3.14). The removal of concrete abutting the footpath to the west, exposed a second course of sandstone blocks under the kerbing (Figure 3.15, Figure 3.16). During further excavations for the

Figure 3.14: Partial footpath along Blues Point Road with sandstone kerbing still in use in 2022.

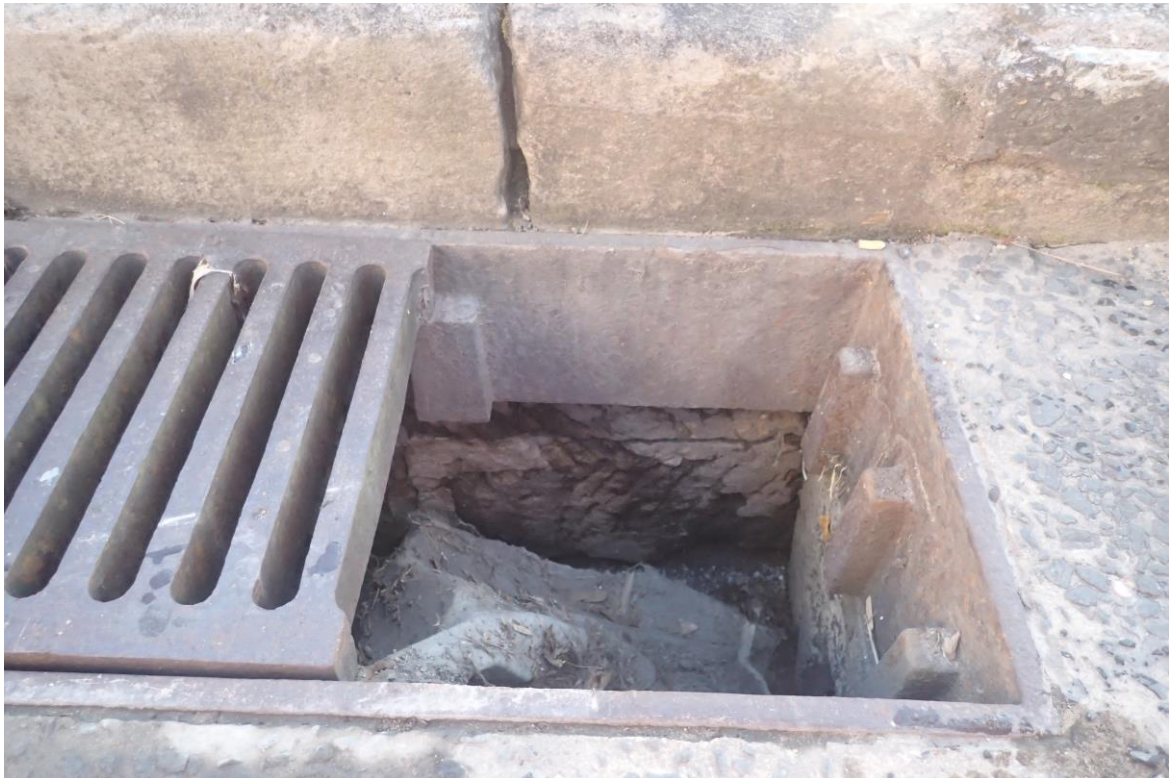
Figure 3.15: The sandstone wall below a course of dressed sandstone used as the footpath running down Blues Point Road.

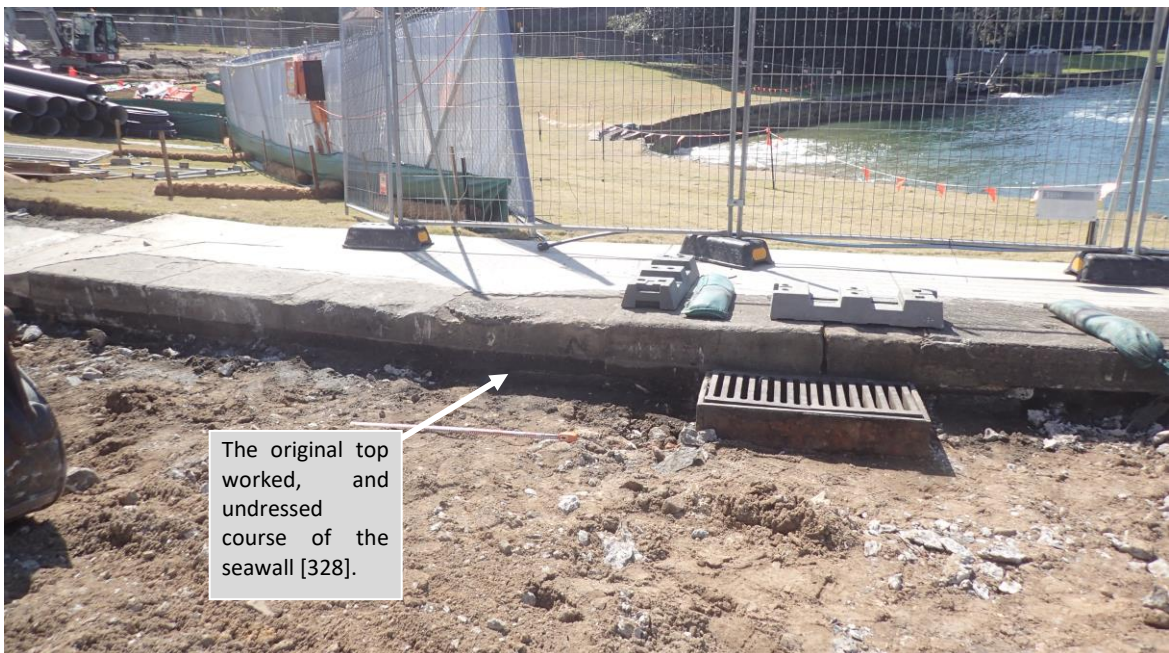
Figure 3.16: A North-eastern view of the footpath with its dressed top course of sandstone blocks incorporated into the footpath with the undressed and worked second course revealed during the removal of concrete.

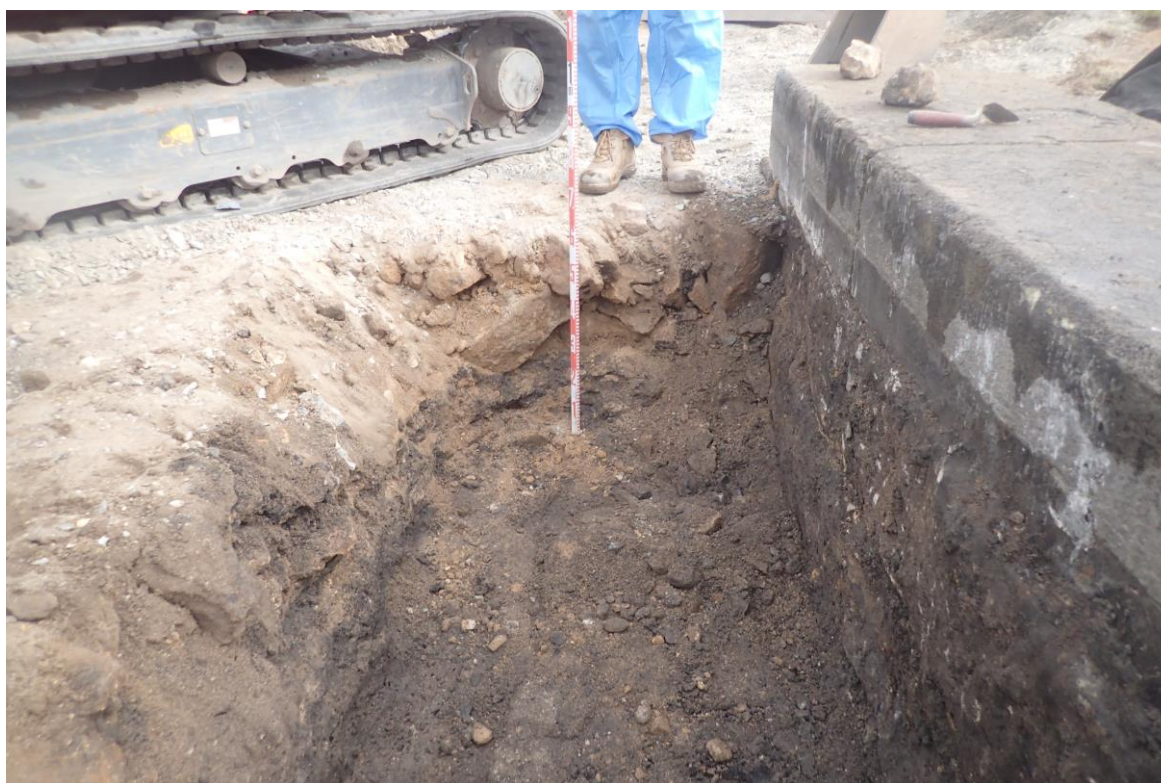
Figure 3.18: The vertical unworked side of the reduced sandstone seawall [328] with the sandstone kerbing above.

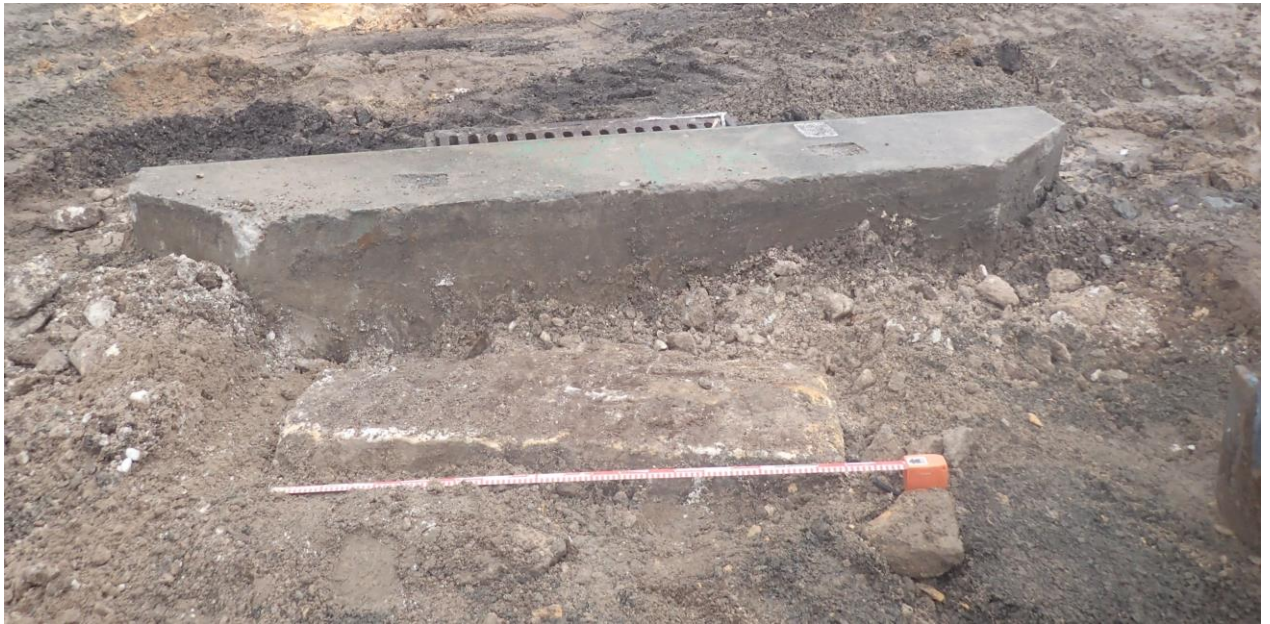
An isolated sandstone block was lying north-south alongside the stormwater drain and aligned with the 1857 seawall. The fill around the block was a light brown/grey sandy/silty layer. The sandstone block, measuring 1.10 meters in length, was removed for the installation of the drainage system, revealing a second course of sandstone blocks below, these were lying west-east (Figure 3.19, Figure 3.20, and Figure 3.21). These blocks were below the level needed for continuation of the works and remain in situ.

Figure 3.19: View to the west. A sandstone block likely from the 1857 sea wall [333] alongside the stormwater drain pre-excitation.

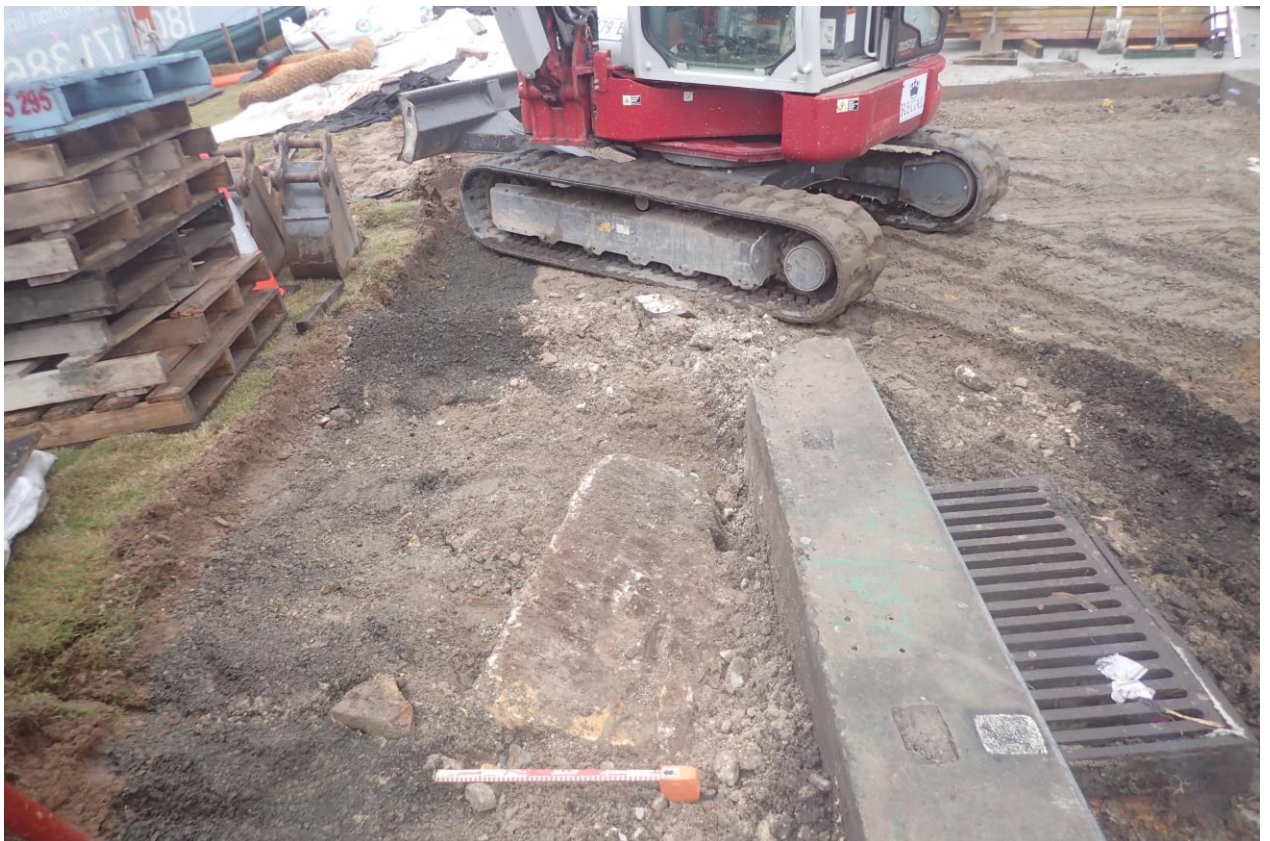
Figure 3.20: Isolated sandstone block potentially from the c.1850 sea wall alongside the stormwater drain and a modern concrete block. View to the south.

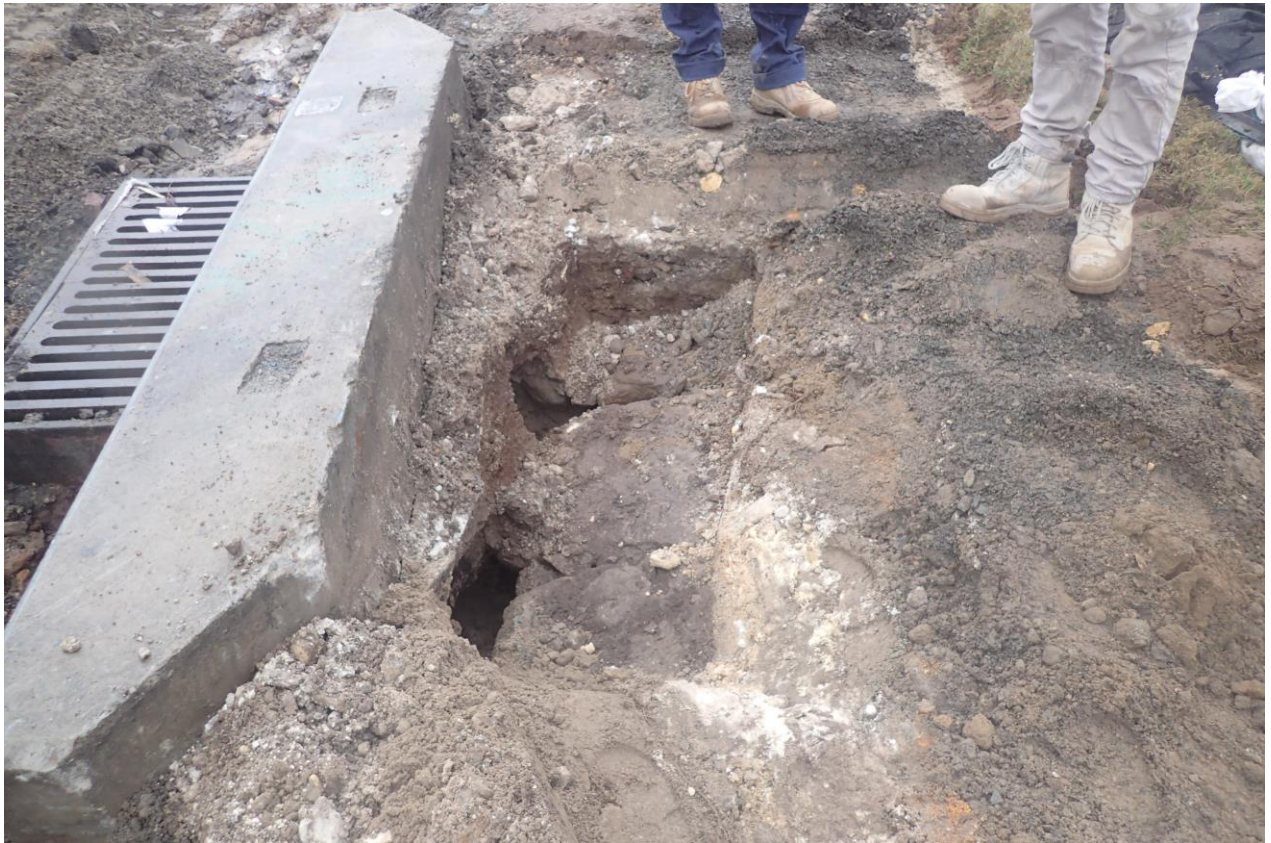
Figure 3.21: A second course of sandstone blocks, lying west-east witnessed below the isolated sandstone block potentially from the early seawall [328].

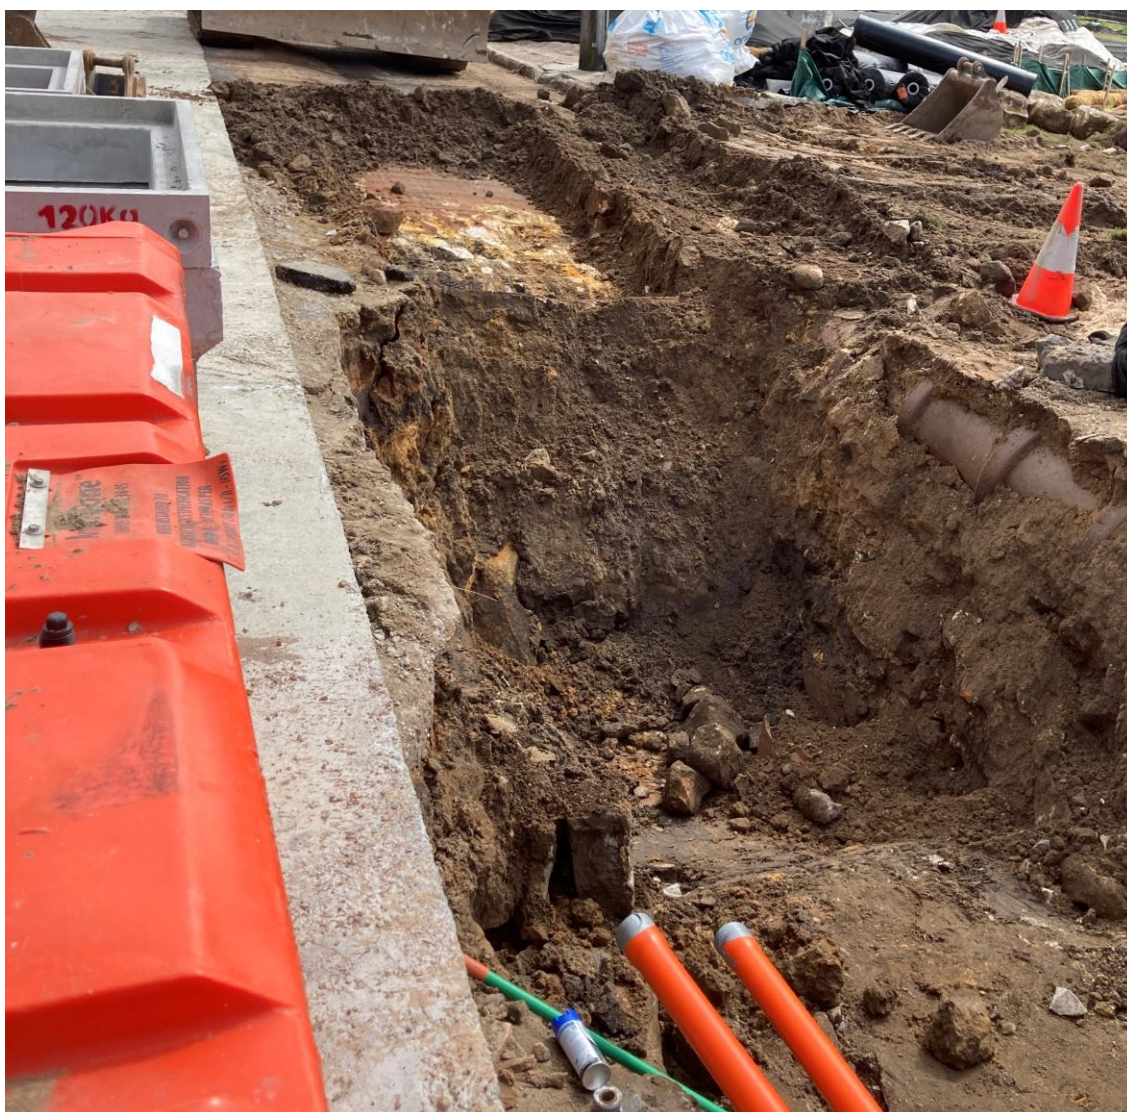
The trench in WZ3D ran alongside an unused terracotta service pipe, exposed during excavation (Figure 3.23). This is the continuation of the stormwater pipe [011] seen in WZ3E demonstrating the need for water management across the site.

Figure 3.23: Trench for a garden bed in WZ3D showing the exposed bedrock at the top of the trench, a service pipe on the right and the steep natural benching of the bedrock.

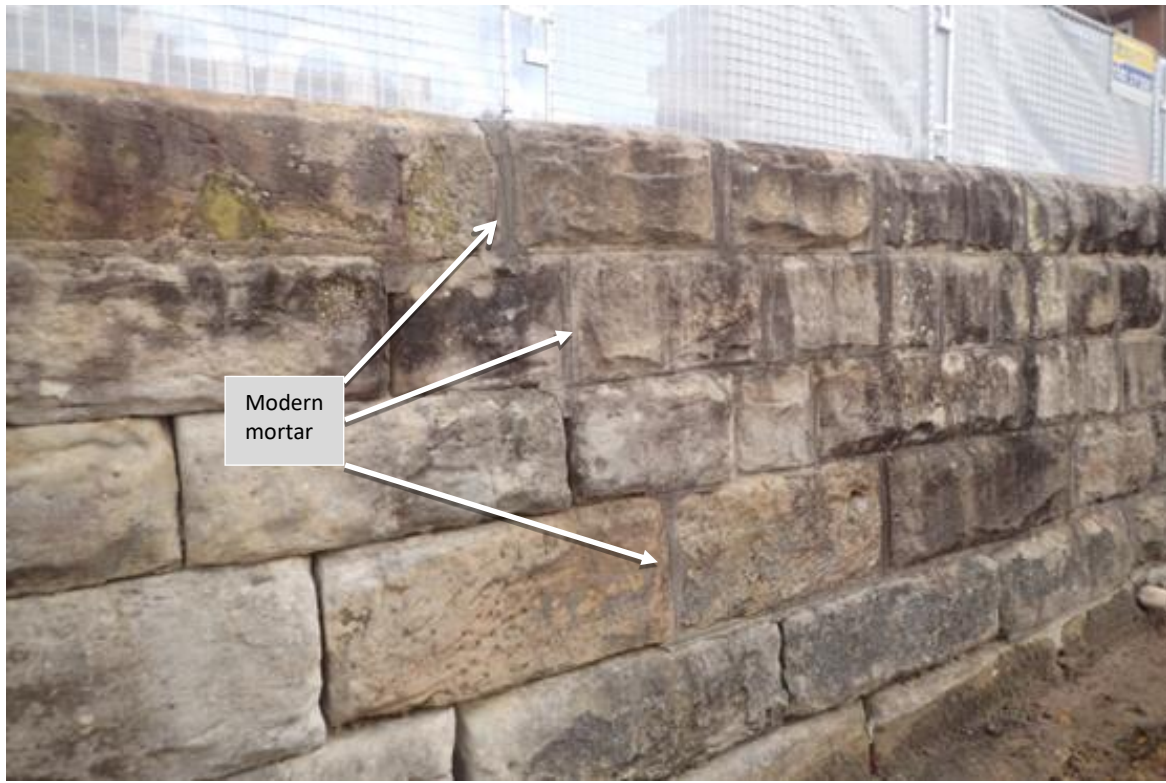
In WZ1D, the removal of a drain connected to the Blues point Tower, exposed the north end of the heritage wall foundations. The heritage wall was erected in 1887 by the Mayor D Munro Esq. On inspection it was noted that sandstone blocks had been robbed from a large section of the wall, the pipe inserted, the concrete drain installed and mortared to the Heritage wall. The wall was

replaced with mortar used to secure the blocks. Next to the concrete drain were partial remains of a wooden telegraph pole (Figure 3.24, Figure 3.25, Figure 3.26). The ongoing development of Blues Point and the construction of Blues Point tower in 1962 increasing the population of the area necessitated increased service installation.

Figure 3.24: Section of the 1887 wall that was removed and replaced for the installation of a service pipe and drain. The modern mortar used to rebuild the wall highlights the modification.

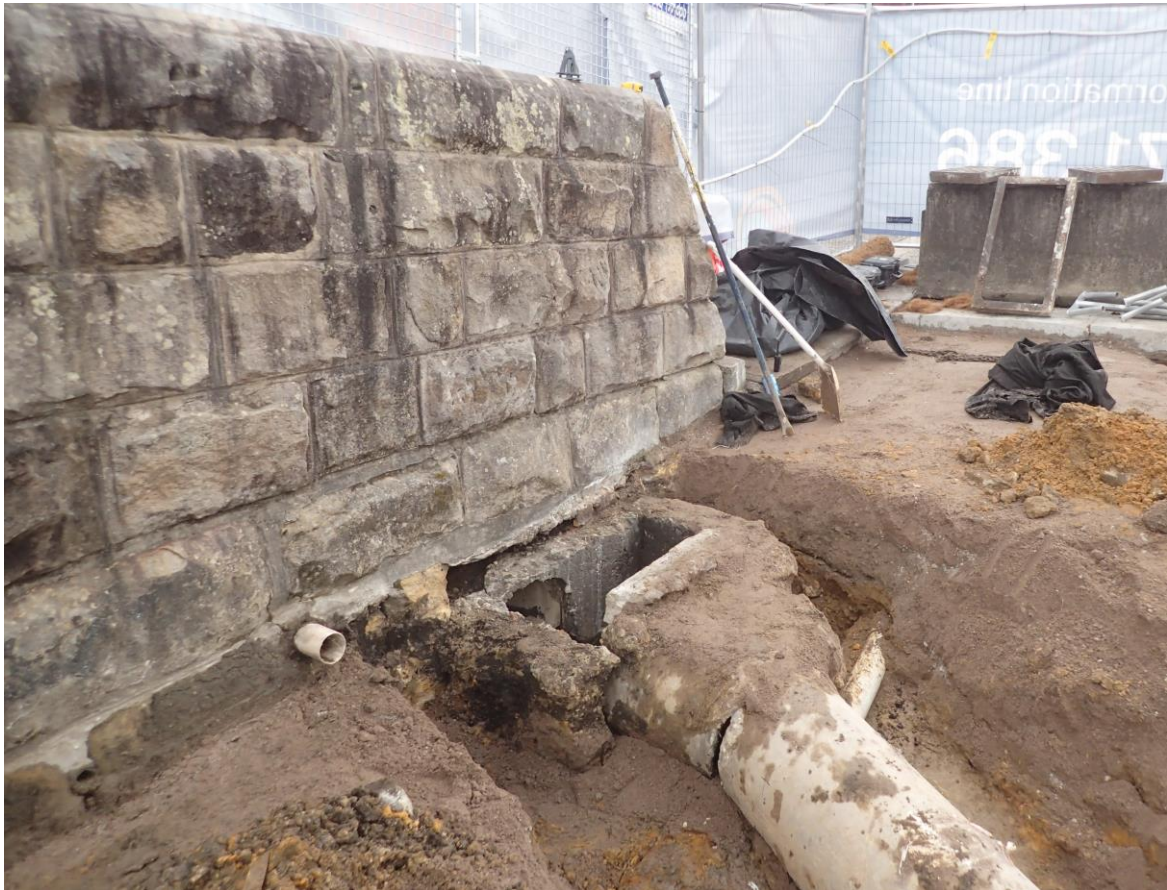
Figure 3.25: The concrete drain and connecting pipe laid under the northern most section of the heritage wall.

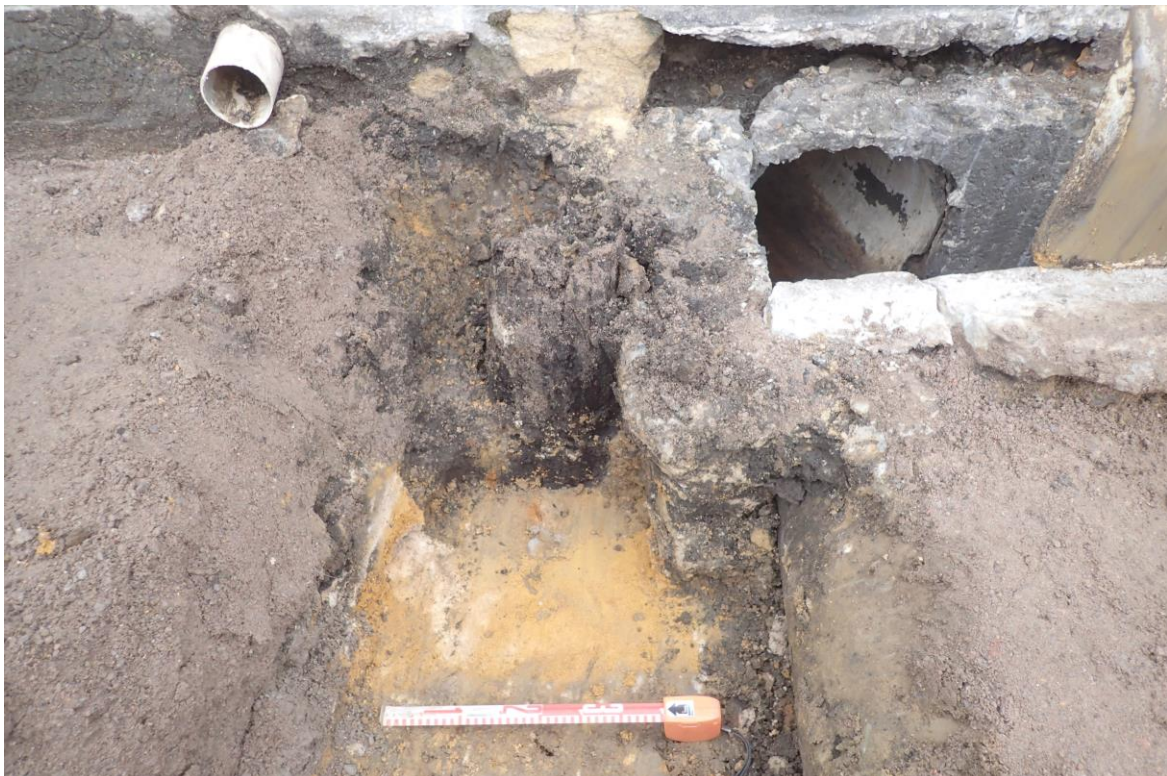
Figure 3.26: Detail of the remains of the wooden telegraph pole alongside the concrete drain with the plastic pipe.
