SITE AUDIT REPORT

ROAD INFRASTRUCTURE

AT 1C SYDNEY STEEL

ROAD, MARRICKVILLE

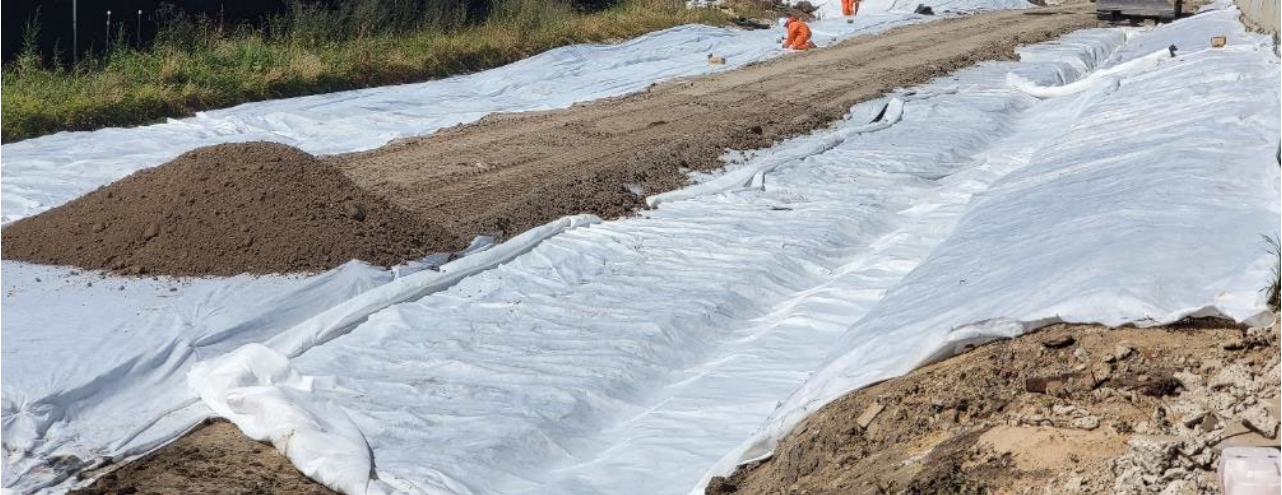
Image 6.2.1.1 View of geo-textile marker layer across public road facing portion north-east showing overlap.

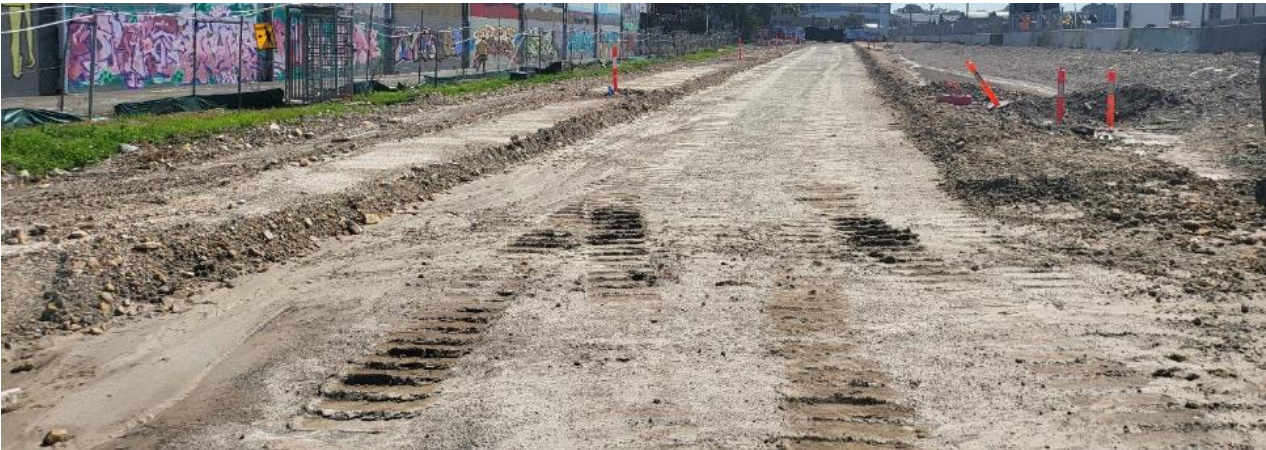
Image 6.2.1.2 View of subgrade material placed across public road portion.

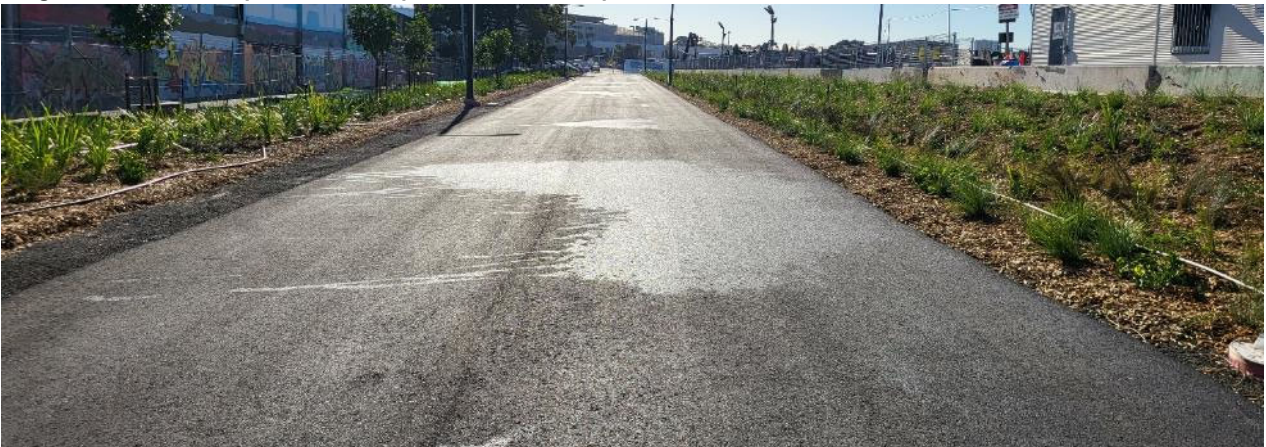
Image 6.2.1.3 View of asphalt emulsion placed across road portion.

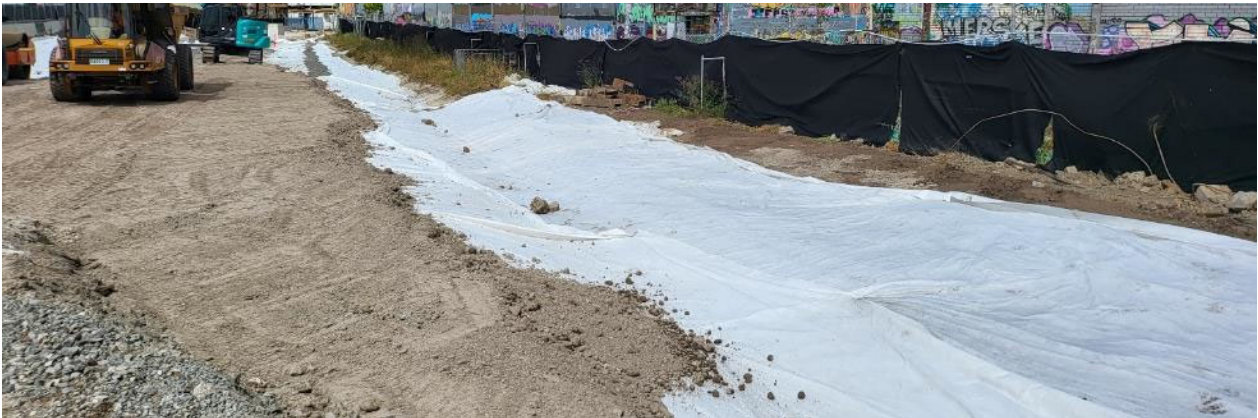
Image 6.2.2.1 View of geotextile marker layer along the north-western boundary of landscaped area.

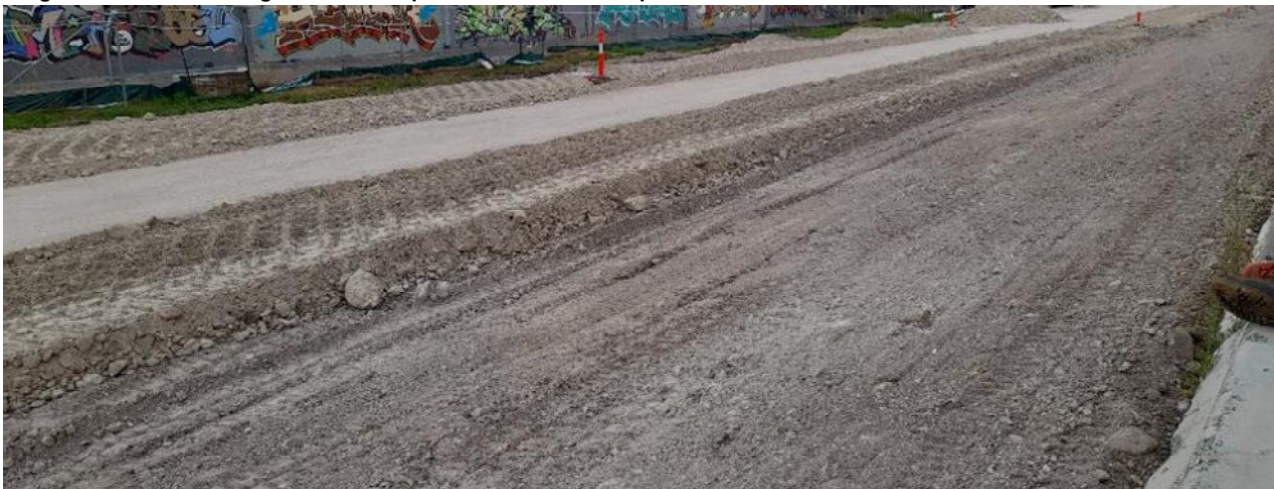
Image 6.2.2.2 View of subgrade material placed across landscaped area.

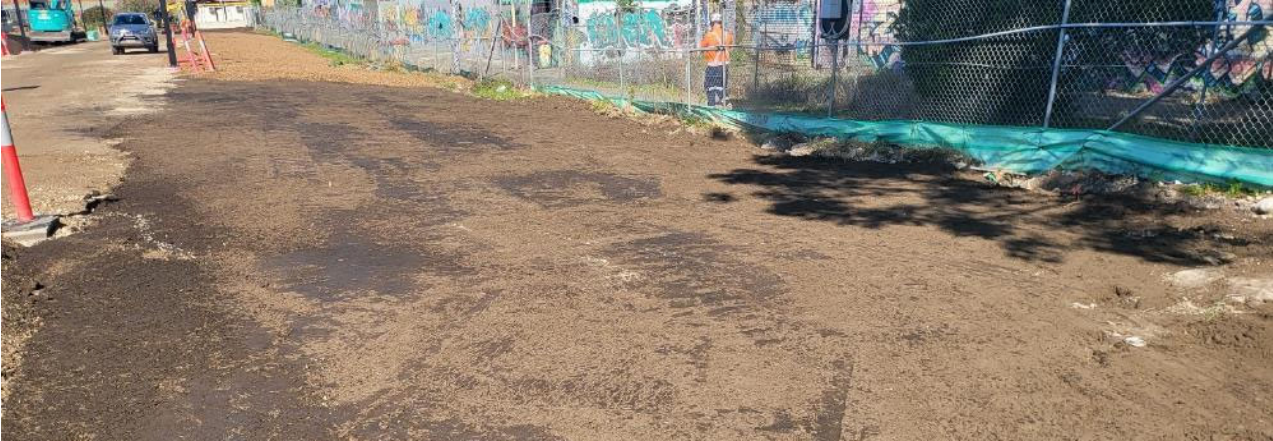
Image 6.2.2.3 View of topsoil material placed across landscaped area.

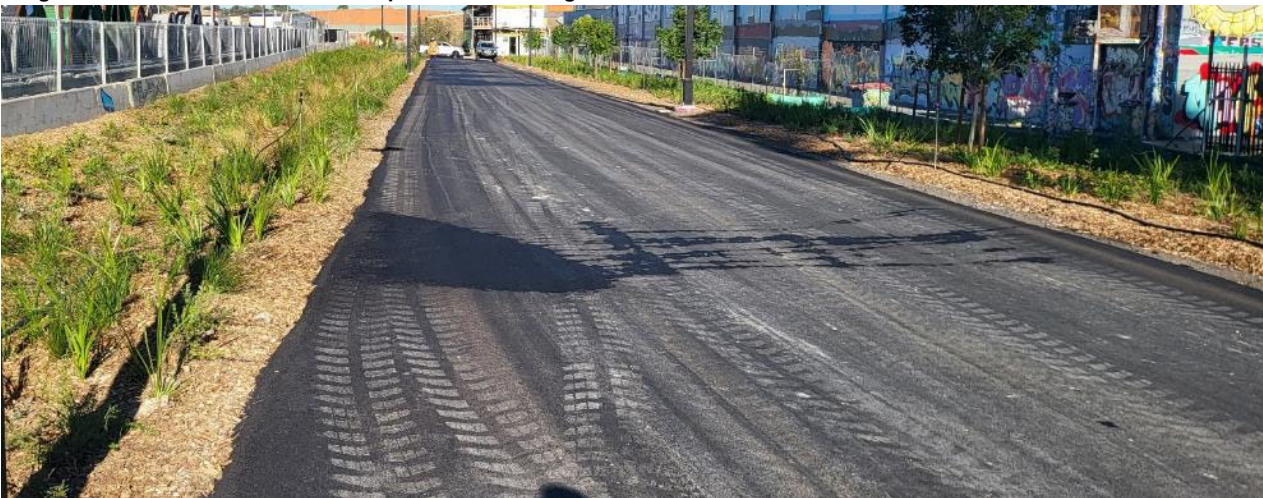
Image 6.2.2.4 View of finished landscaped area including mulch.
