# Planning Approval Consistency Assessment Form

SM-17-00000111

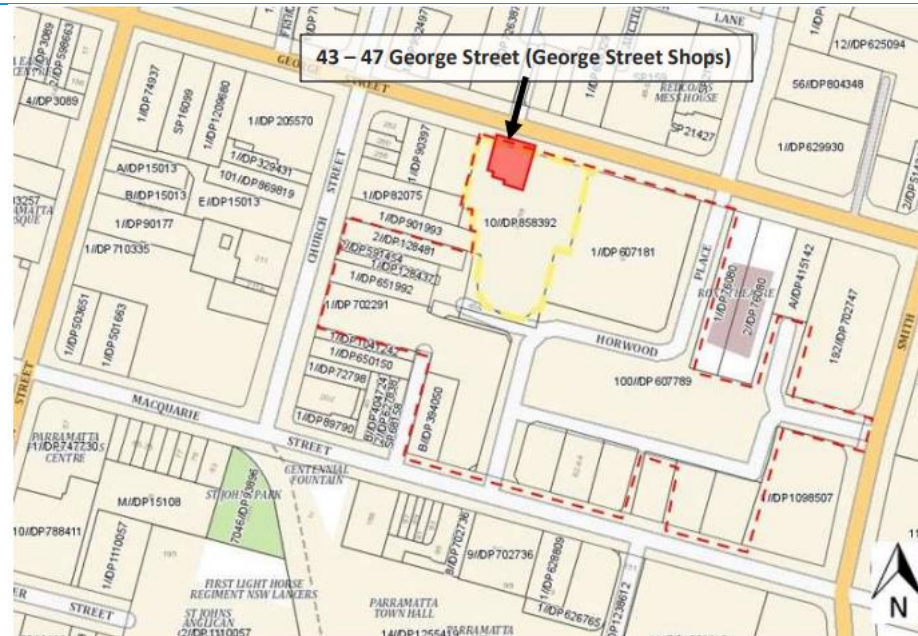
Figure 1 – Location of works. Cadastral plan showing the subject site at 43-47 George Street shaded in red with a continuous red outline. The extent of Parramatta Metro Precinct is indicated by a dashed red line; the lot boundary for 41-59 George Street is indicated by a dashed yellow line.

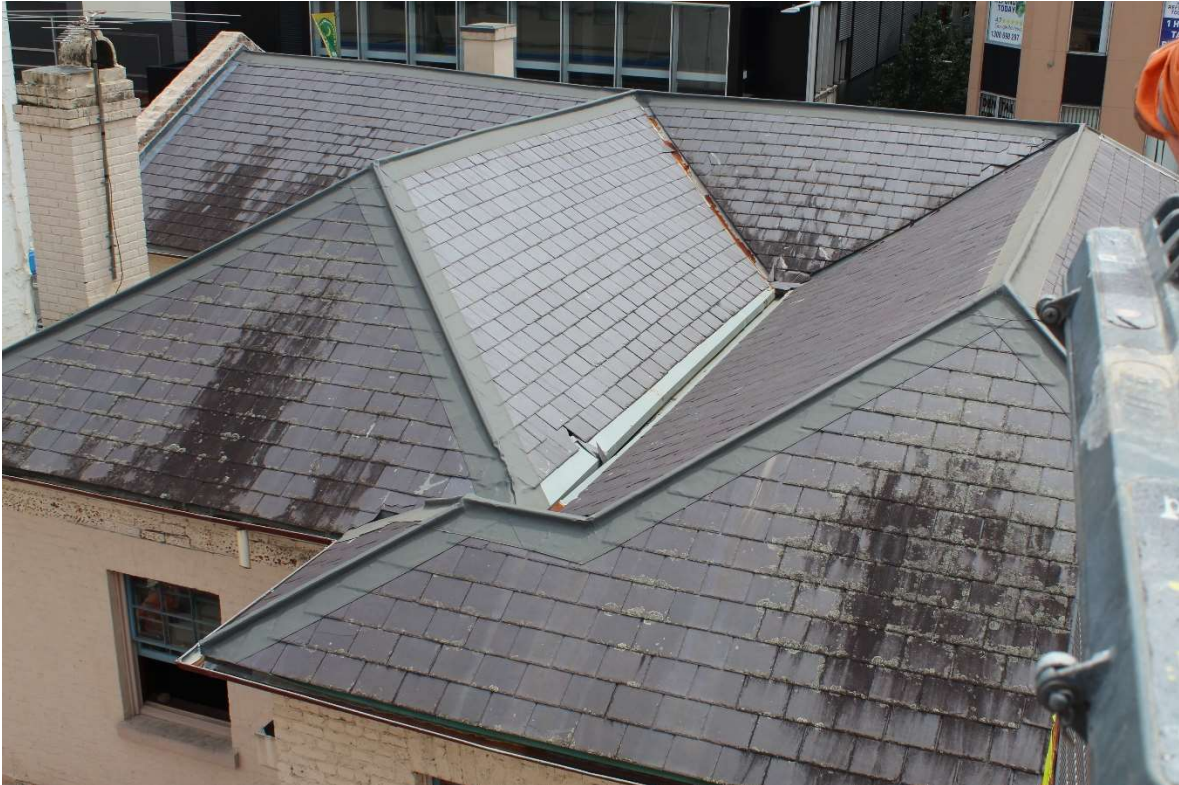
For Gamuda Laing O'Rourke Consortium (GLC)

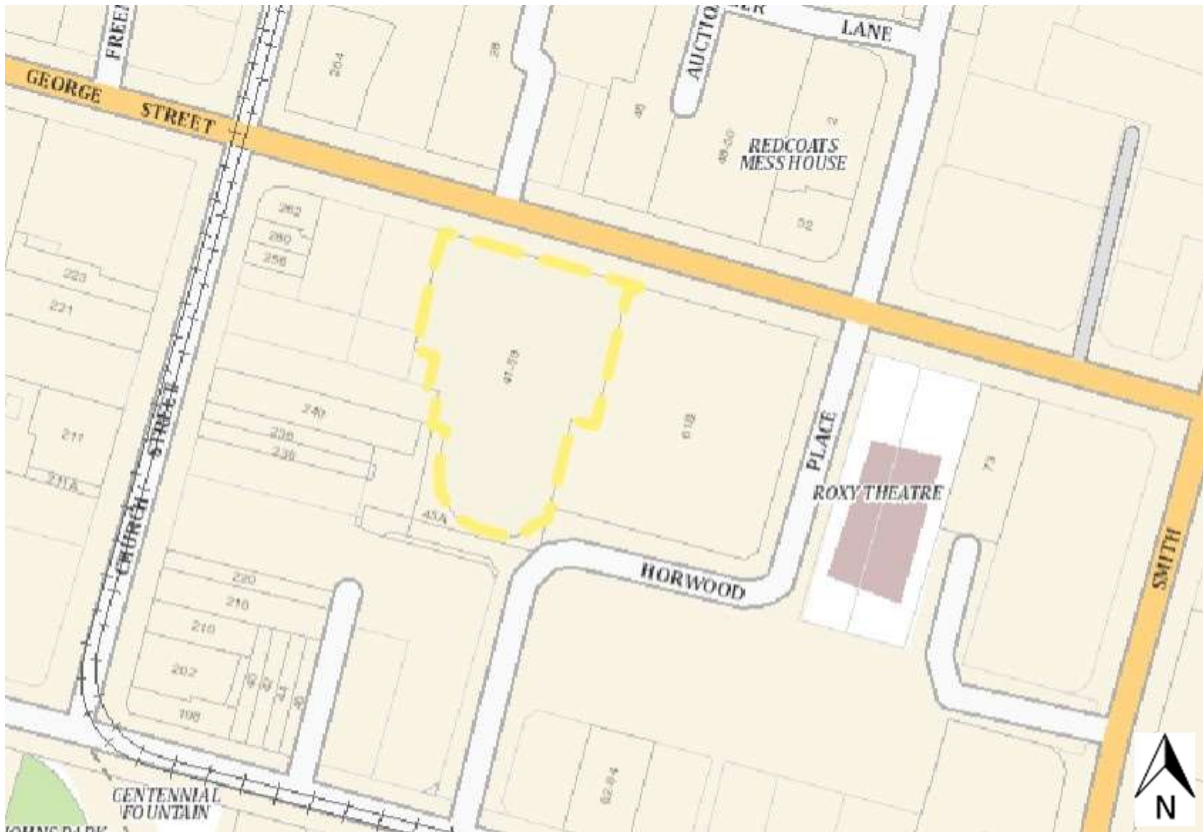
Figure 1-1: Lot plan for 41-59 George Street, Parramatta. Source: NSW ePlanning Spatial Viewer.

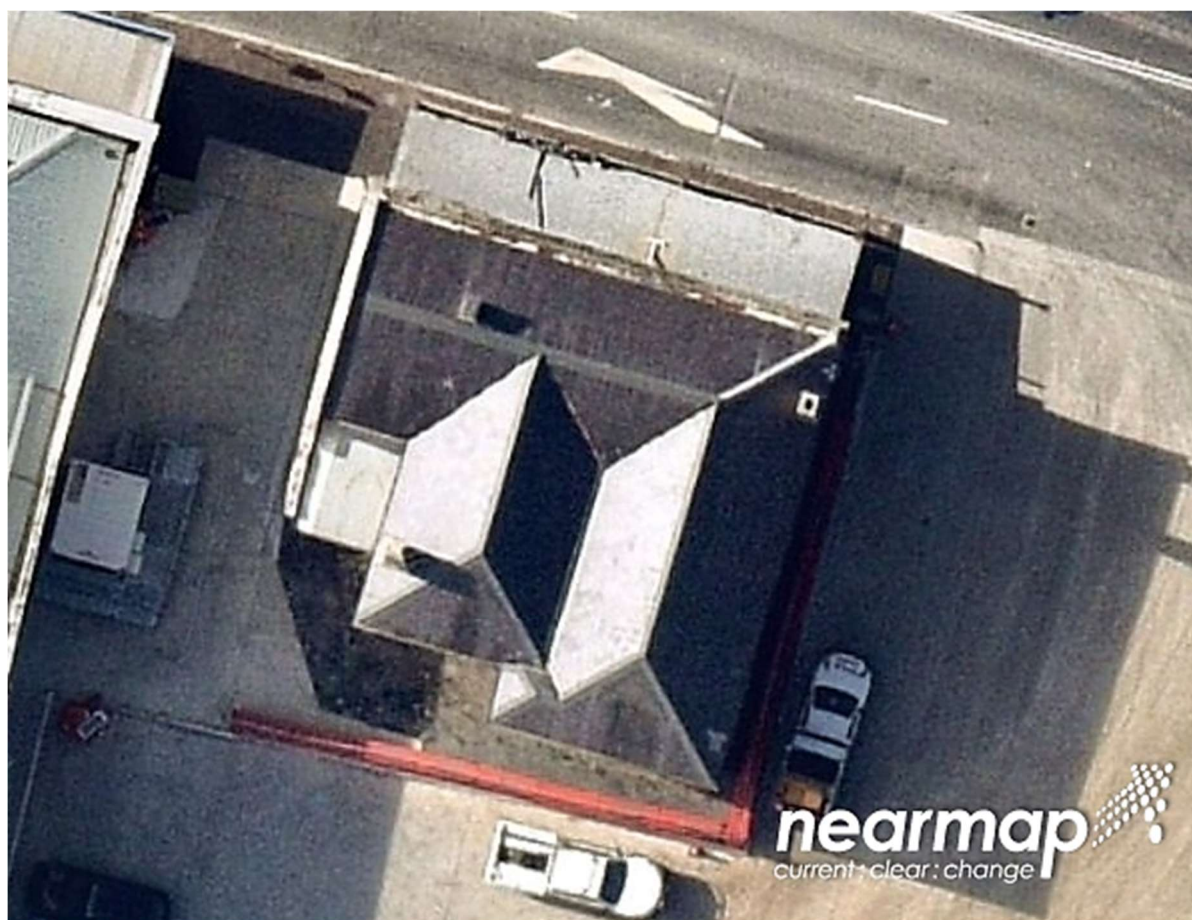
Figure 4-2: Aerial view of roof showing cross hipped slate roofs, location of chimneys and the corrugated steel roofs of the front awning and skillion to 43 George Street.

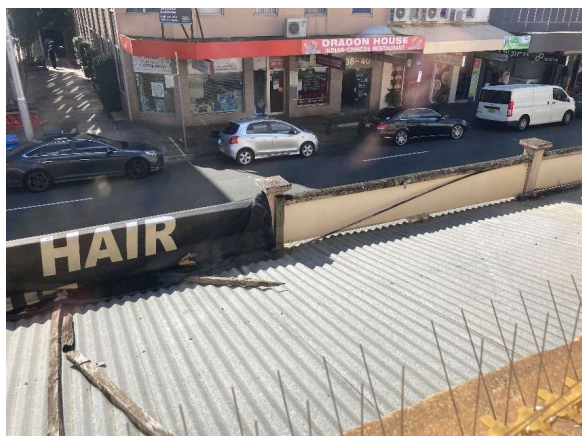
Figure 4-3: Corrugated steel roof of front awning and timber sign boards. Note miscellaneous timbers fixed to roofs for unidentified purpose. Source: OCP Architects (2022).

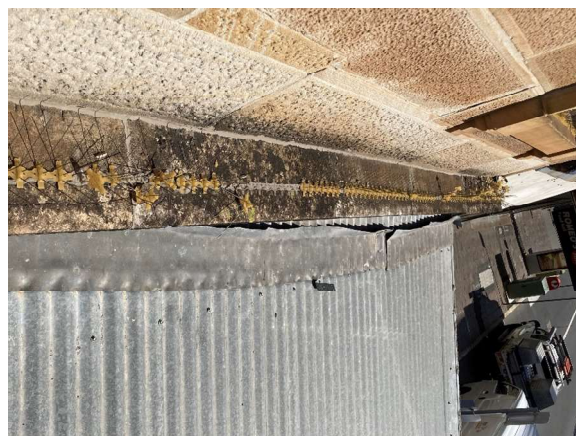
Figure 4-4: View of front awning at junction with sandstone wall. Source: OCP Architects (2022).

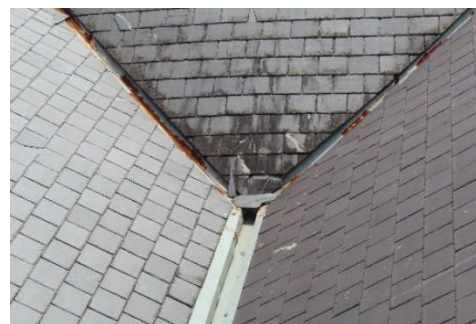
Figure 4-5: Detail view of rear face of main roof (over 45 & 47 George Street) showing slates in poor condition. Note also corroded galvanised steel valley gutters.

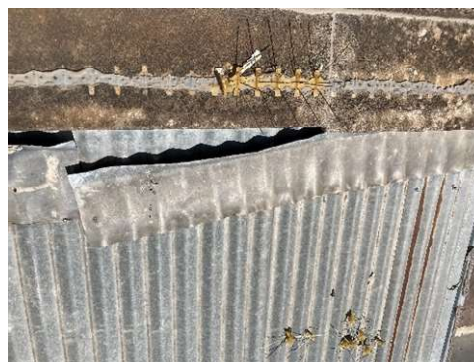
Figure 4-6: Dislocated abutment flashing at junction of sandstone north wall and verandah roof.

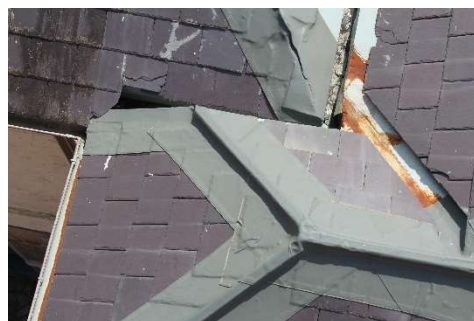
Figure 4-8: Synthetic flashing applied as a temporary measure to roof ridges.

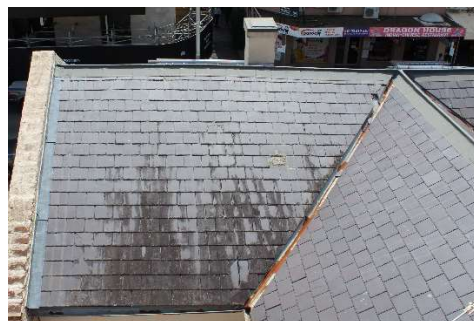
Figure 4-9: Example of galvanised steel roof valley, extensively corroded.

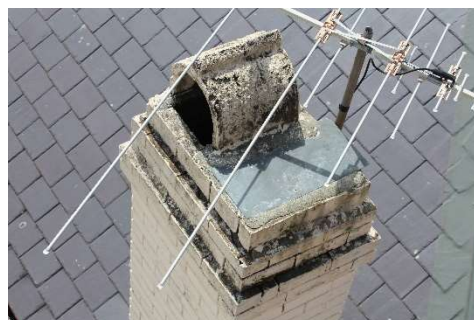
Figure 4-10: Extant cowl of south west chimney (Chimney 3). The adjacent cowl is missing.

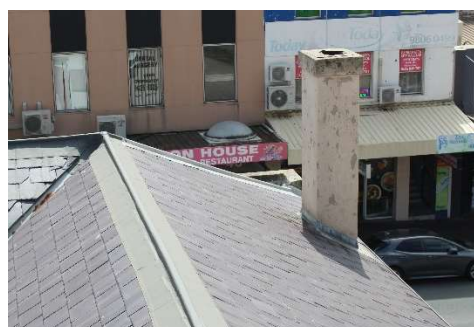
Figure 4-11: Capping of the north east chimney (Chimney 1) is damaged.

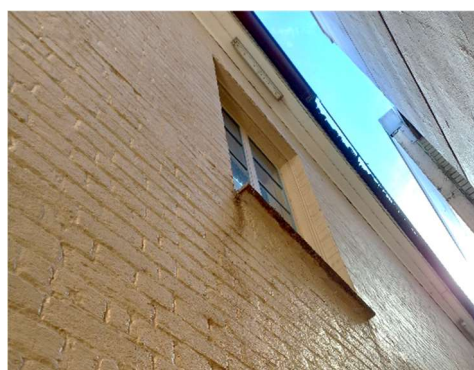
Figure 4-12: Corroded (disintegrated) gutter on east elevation (photo 2022).

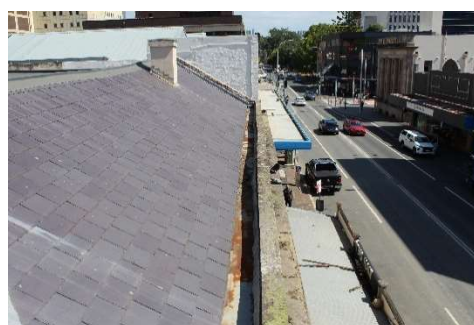
Figure 4-13: Corroded box gutter behind sandstone parapet of the north elevation.

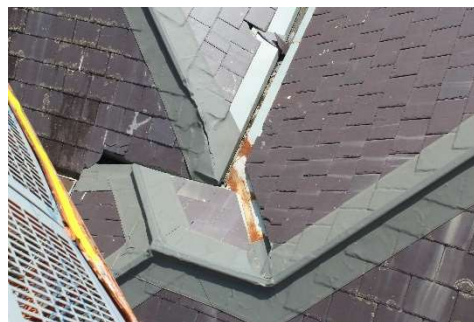
Figure 4-14: Middle box gutter and reconfigured roof structure.

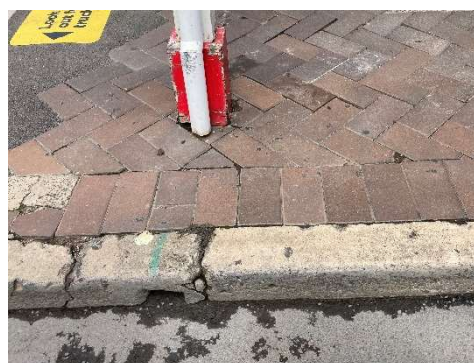
Figure 4-15: North verandah downpipe discharging to paving, also showing outlet in stone kerbing.

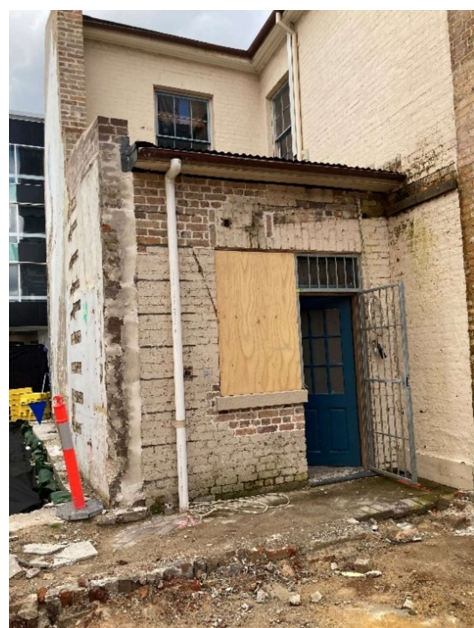
Figure 4-16: PVC downpipe on rear elevation, skillion addition.

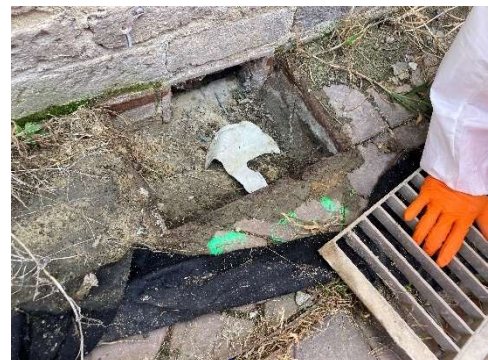
Figure 4-18: Horizontal grated pit adjacent to sub-floor wall vent.

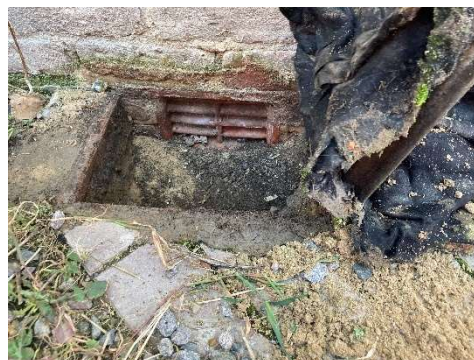
Figure 4-19: Detail view of sub-floor vent and relationship to external ground level.

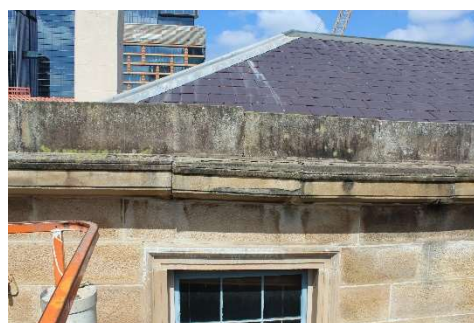
Figure 4-20: Open joints of parapet stones.

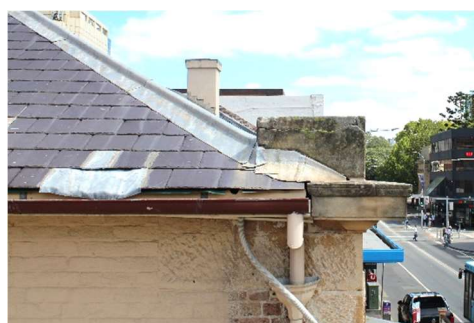
Figure 4-21: Extensive cracking through full section of north east parapet stone.

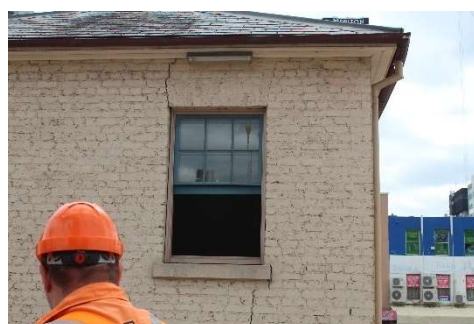
Figure 4-22: Cracking brickwork around rear first floor window of 47 George Street.

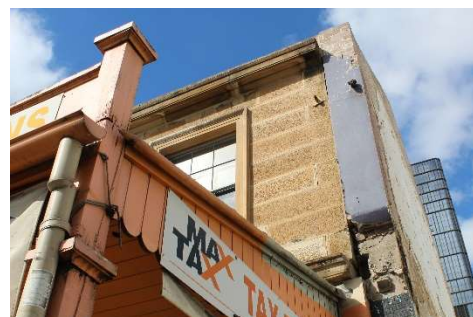
Figure 4-23: Western end of the timber verandah structure, showing evidence of rotting timber and peeling paint.

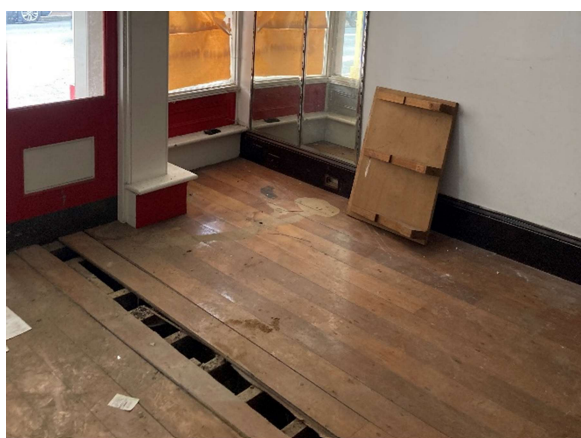
Figure 4-24: Area of damaged flooring, previously buckled owing to the effects of moisture,.

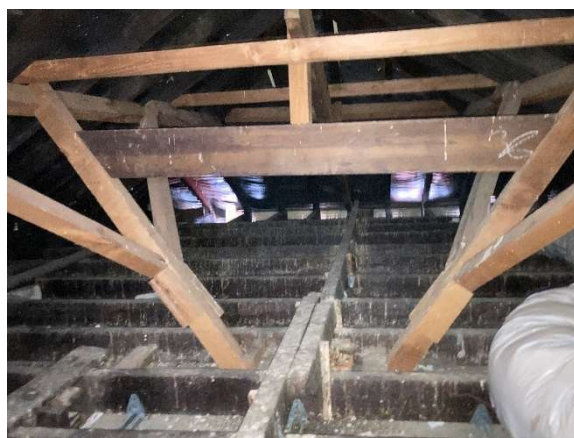
Figure 4-25: Roof structure viewed from within the manhole.

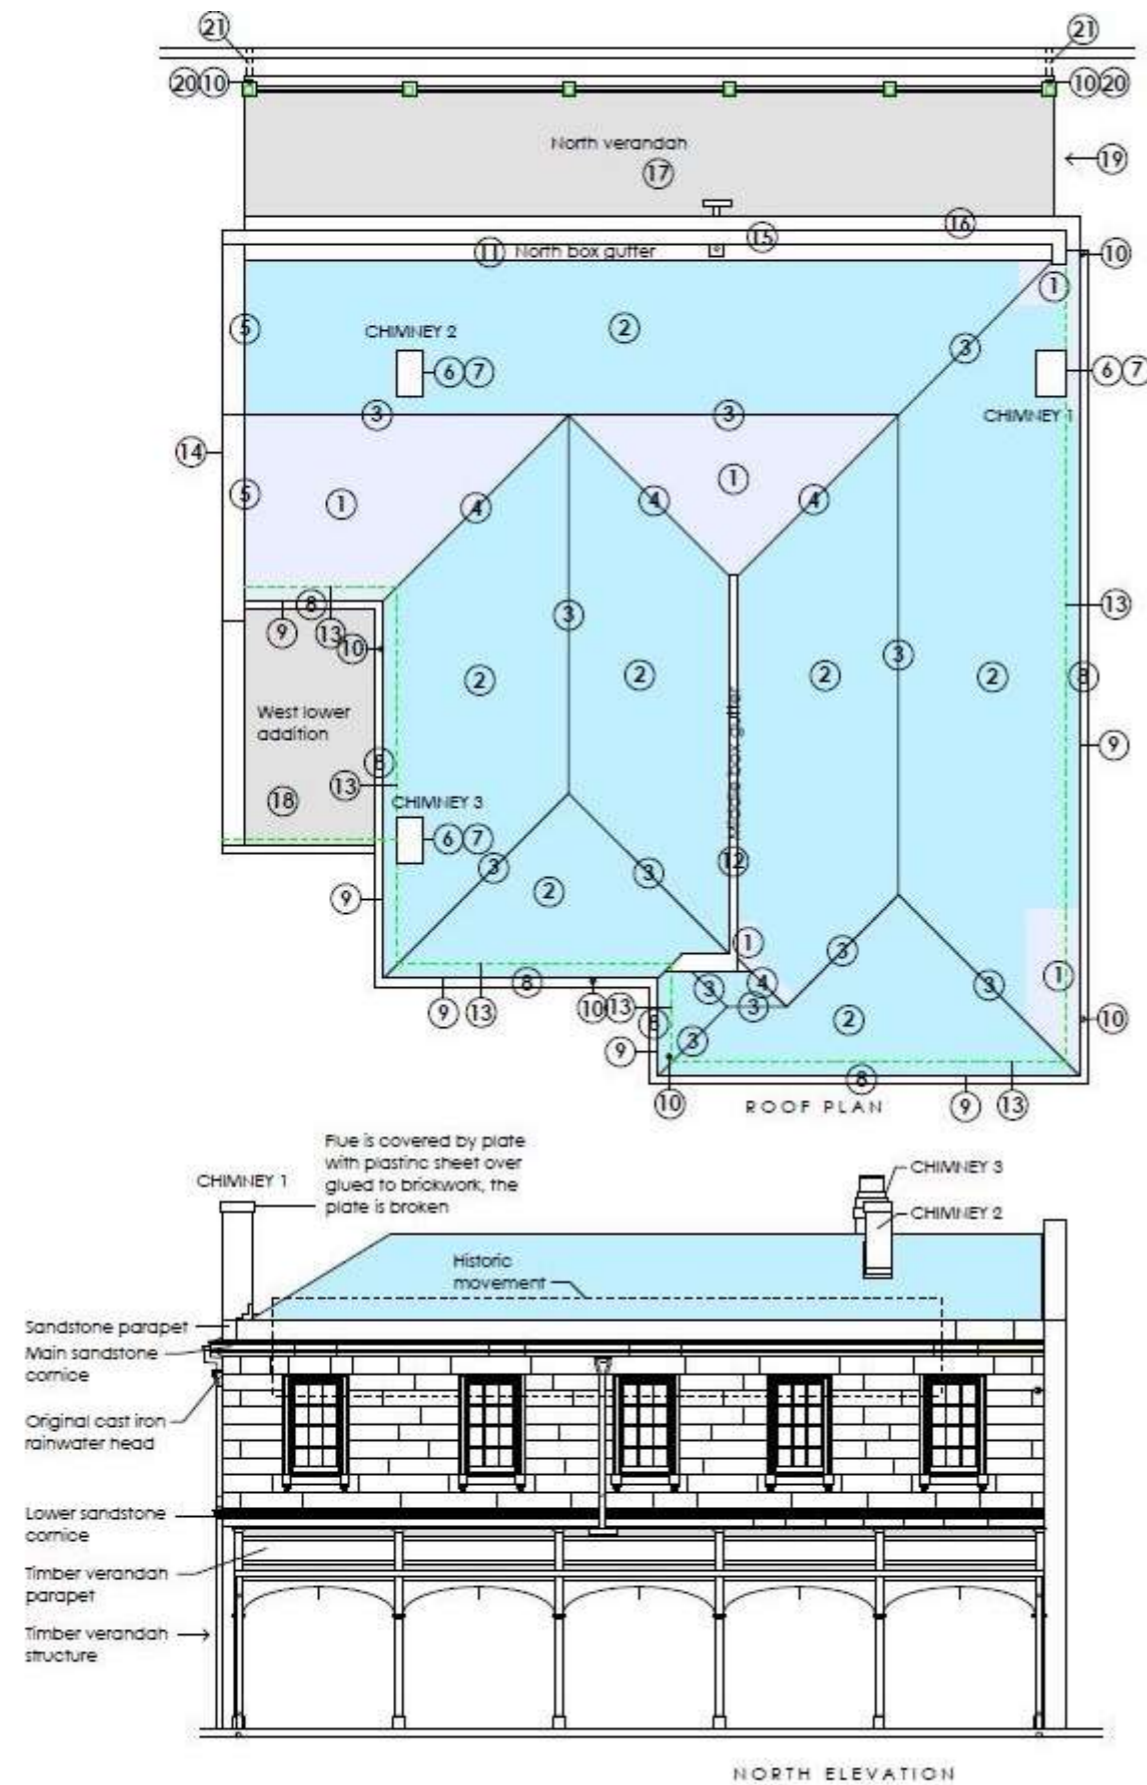
Figure 4-26: Condition Assessment Drawing (Roof Plan and North Elevation). Source: OCP Architects 2024.

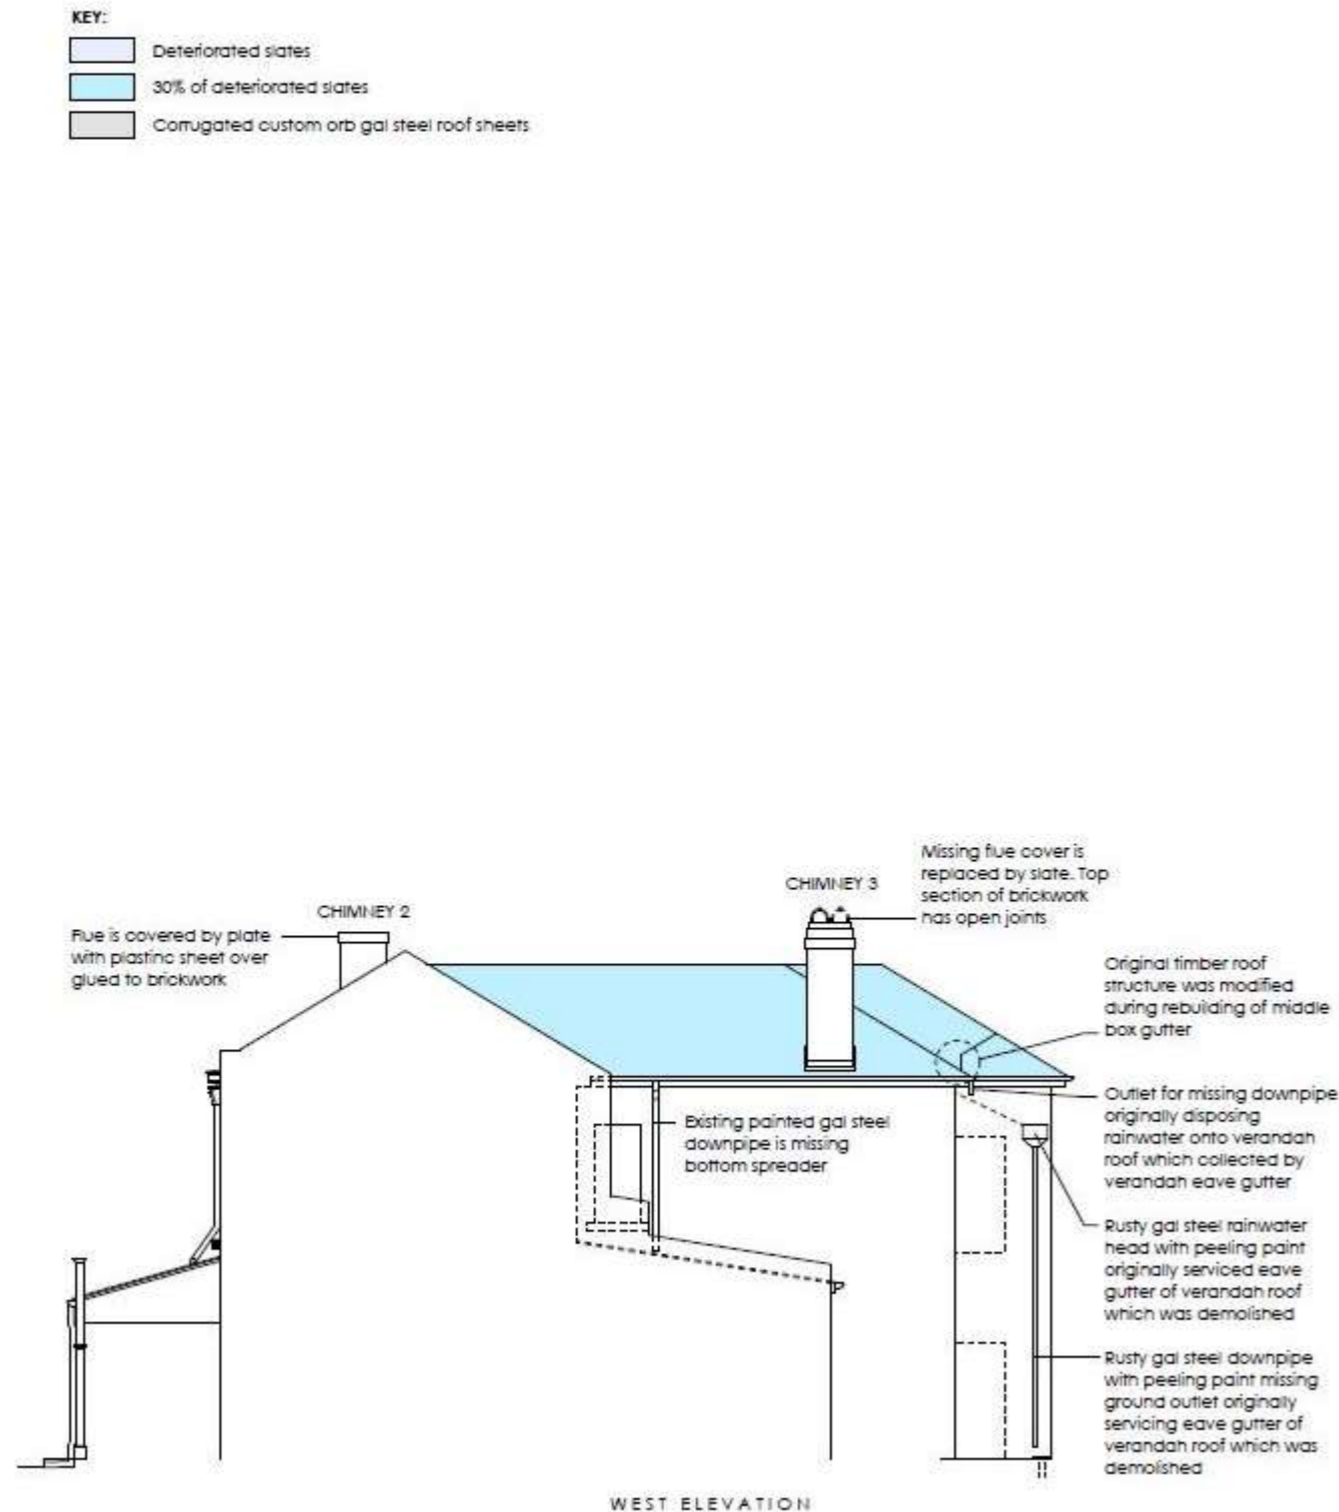
Figure 4-27: Condition Assessment Drawing (West Elevation). Source: OCP Architects 2024.

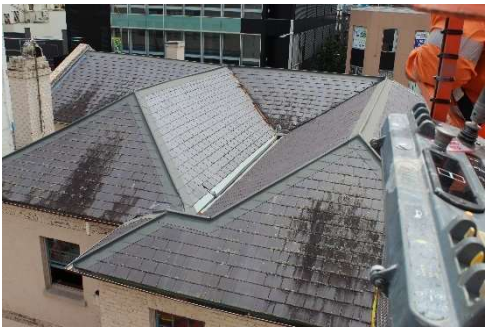
<p><b>Recommendation:</b></p> <ol style="list-style-type: none"> <li>1. Remove existing slates in poor condition and replace with new Penhryn Welsh slates (500 x 300 x 6mm). Retain individual slates in sound condition for use in localised repairs over the remaining roof areas (salvaged slates will match existing slates on visible faces).</li> <li>2. Allow to replace approximately 30% of existing slates to remaining roof faces.</li> <li>3. Install all associated flashings in lead.</li> </ol> <p><b>Priority 1</b> (short term)</p>			
EXT 2 Sheet Metal Roofs	Corrugated galvanised steel roof sheeting: <b>Moderate</b> (reconstruction 1990s)	Fair to poor

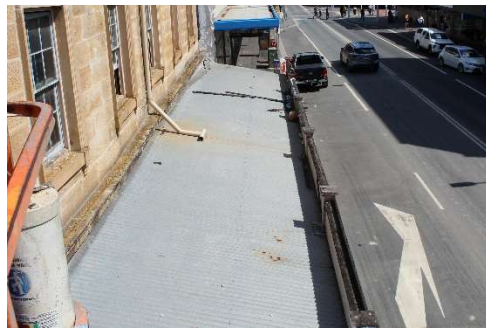
<p><b>Recommendation:</b></p> <p>Remove existing corrugated metal sheet roofs (verandah roof and rear skillion roof) and replace with corrugated custom orb roof sheets. Install all associated flashings in lead.</p> <p><b>Priority 1</b> (short term)</p>

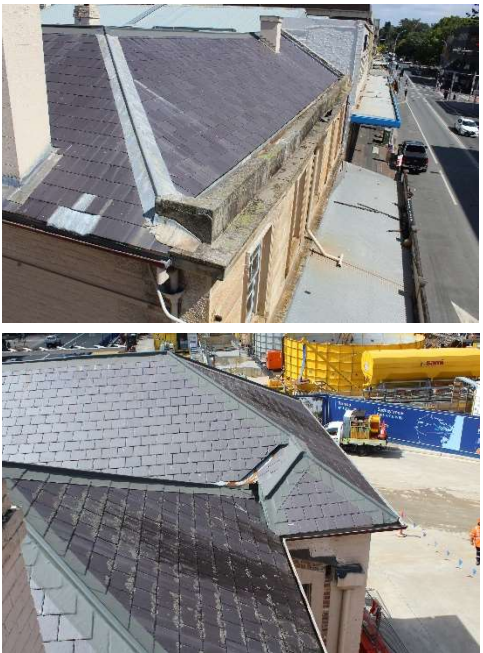
<p><b>Recommendation:</b>                      Install new hardwood cored lead ridges and hips.</p> <p><b>Priority 2:</b> Work is not urgent owing to temporary ridges, however ridges would be affected by other essential works e.g. slate repairs. It would therefore be more logical and cost effective to proceed with this work in conjunction with other Priority 1 roof works.</p>			
EXT 4 Roof Valleys	Galvanised steel valleys: <b>Little</b> (1990s)	Poor

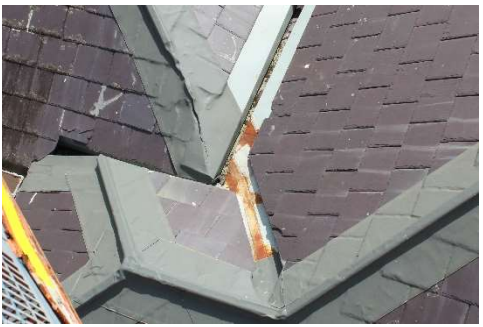
<p><b>Recommendation:</b>                      Install new lead valleys onto new timber underlay.</p> <p><b>Priority 1</b> (short term)</p>

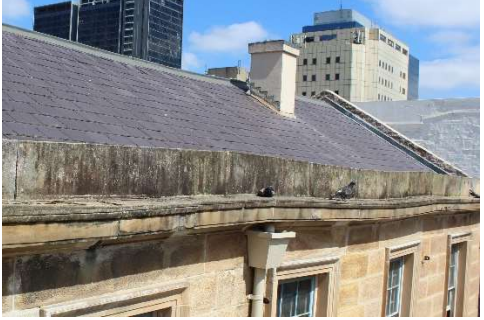
Tall brick chimney (rear of 45 George Street): <b>High</b>	Fair to poor Introduced covers have deteriorated; lead flashing in fair conditions; loose and flaking paint on masonry surfaces.

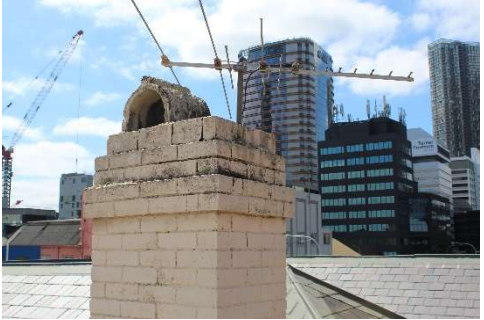
Rendered chimney - (front NE corner): <b>Moderate</b> (reconstruction)

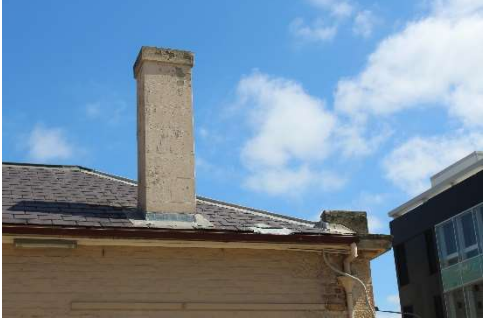
<p><b>Recommendation:</b>                  Structural Engineer should review for potential seismic strengthening.</p> <p><b>Priority 1</b> (short term)                  Replace introduced covers to chimney flues to ensure water ingress. This work must be coordinate with sub-floor ventilation strategy to be determined.</p> <p><b>Priority 1</b> (short term)                  Report 30% brick masonry chimney (Chimney 3).</p> <p><b>Priority 1</b> (short term)                  Repaint masonry and replace lead flashings around each chimney.</p> <p><b>Priority 2</b></p>

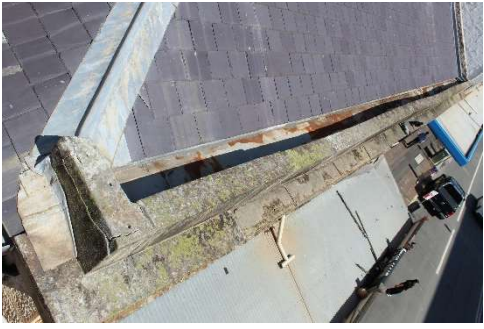
<p><b>Recommendations:</b></p> <ol style="list-style-type: none"> <li>1. Replace corroded box gutter (north elevation behind front parapet) with new expandable lead lining with minimum 1 in 100 fall.</li> <li>2. Remove existing central box gutter including underlay. Reconstruct timber underlay to original shape and fall and line with lead. Rebuild hipped roof timber structure at south end of central box gutter to original shape to support reinstatement of functional box gutter.</li> <li>3. Replace all existing eaves gutters with new 150mm copper ogee gutters with minimum 1 in 100 fall. New gutters to have support brackets and over straps at maximum 1200mm centres.</li> </ol> <p>Paint gutters, including backs, prior to installation.</p> <p><b>Priority 1</b> (short term)</p>

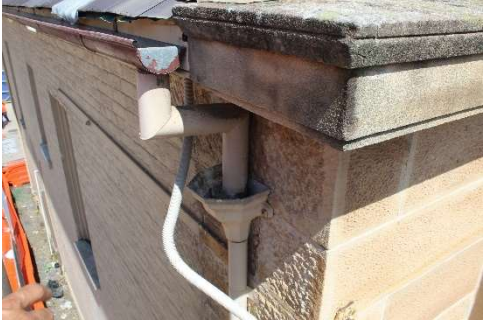
<p><b>Recommendations:</b></p> <p>Retain existing fluted cast iron rain water head (NE corner).</p> <p>Replace rainwater head on north elevation with copper rainwater head to match profile of fluted RWH (NE corner).</p> <p>Replace existing downpipes with 100mm dia. copper downpipes secured by copper astragals to traditional profile (fixed to masonry using grade 316 stainless steel fixings). Provide 1.5m high bottom section in cast iron in accessible locations.</p> <p>Provide new copper spreaders in locations shown.</p> <p>Install 3/No. 100mm dia. underground outlets below footpath to be discharged to street gutter.</p> <p><b>Priority 1</b></p>

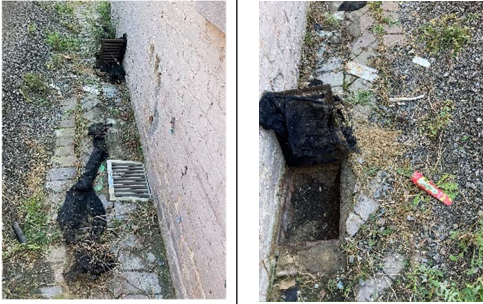
<p><b>Recommendations:</b></p> <p>Remove existing vents and grilles and provide new 100mm dia. vertical copper air vents extending between the subfloor area and the underside of the eaves. Secure by copper astragals to traditional profile (fixed to masonry using grade 316 stainless steel fixings).</p>

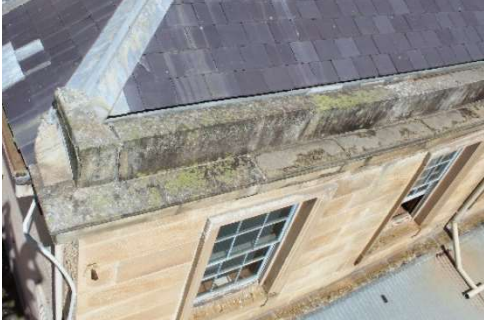
<p><b>Recommendations:</b></p> <p>Localised stone indents (approximately 30% of stone cornice at parapet level) and replace 1/No. damaged stone as shown on drawings.</p> <p>Provide new lead weathering to north sandstone cornice and parapet wall.</p> <p><b>Priority 2</b></p>			
EXT 12 Brick Walls	<b>High</b>	Fair Movement evident in west gabled end wall. Some cracking and repairs to previous penetrations required. Repointing required.

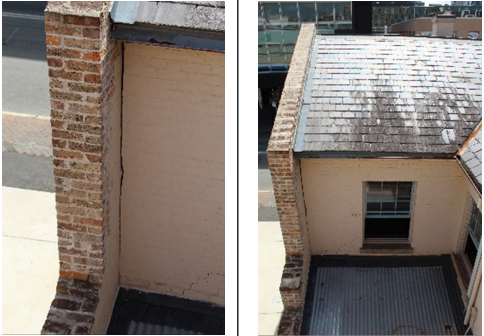
<p><b>Recommendations:</b></p> <p>Engage Structural Engineer to investigate movement in west brick wall and cracking in brickwork.</p> <p>Install new lead capping to west brick gabled wall.</p> <p>Replace synthetic flashing along west brick gabled wall with new lead flashing.</p> <p><b>Priority 1</b></p>

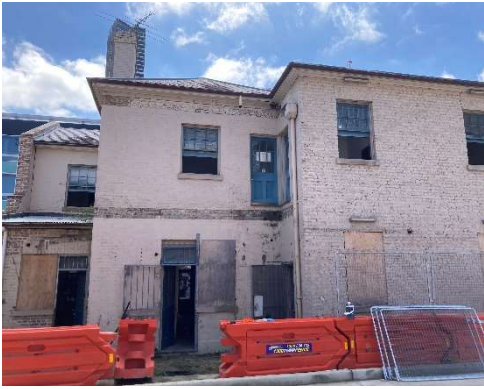
<p><b>Recommendation:</b>                      Provide weatherproof door seals to exposed external doors to prevent ingress of wind driven rain in storm events. (Note: Applies to external doors that are not sheltered i.e. excludes Ground Floor entry doors to tenancies).</p>

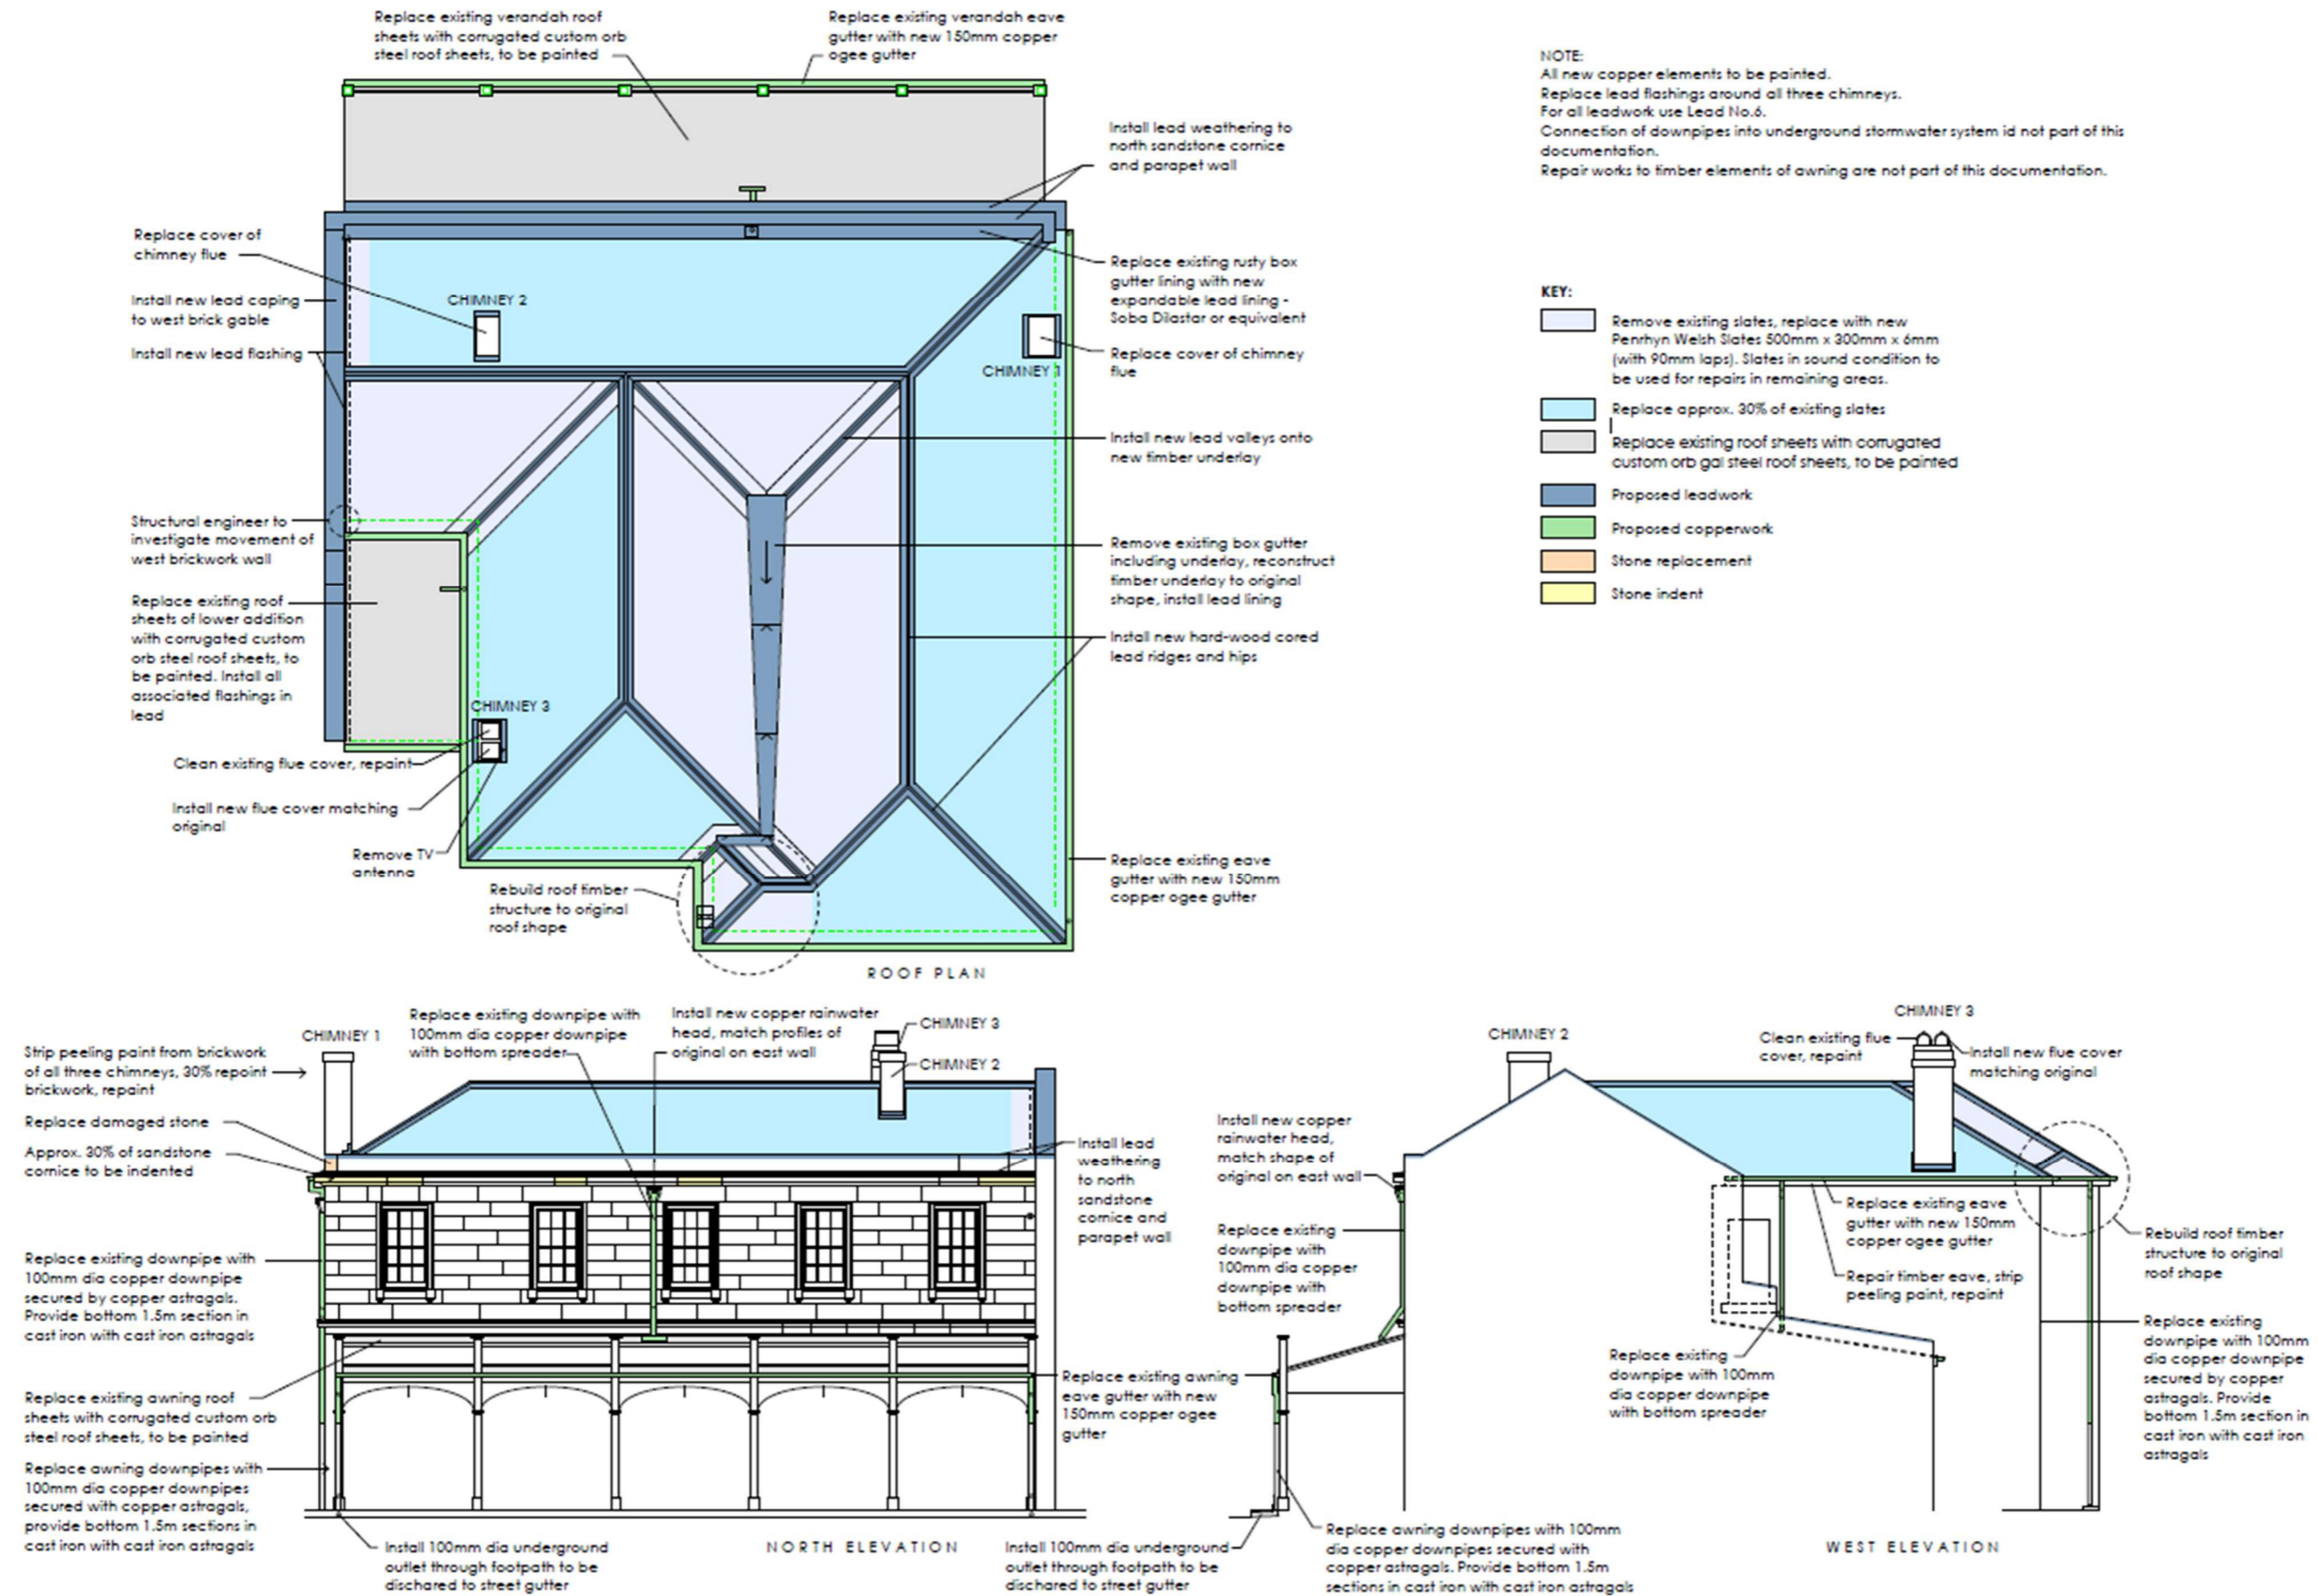
Figure 4-29: Recommended remediation works to the George Street Shops to address condition defects of the building. Remediation works to stormwater and sewer systems, and repair works to timber elements not shown. Source: OCP Architects 2024.

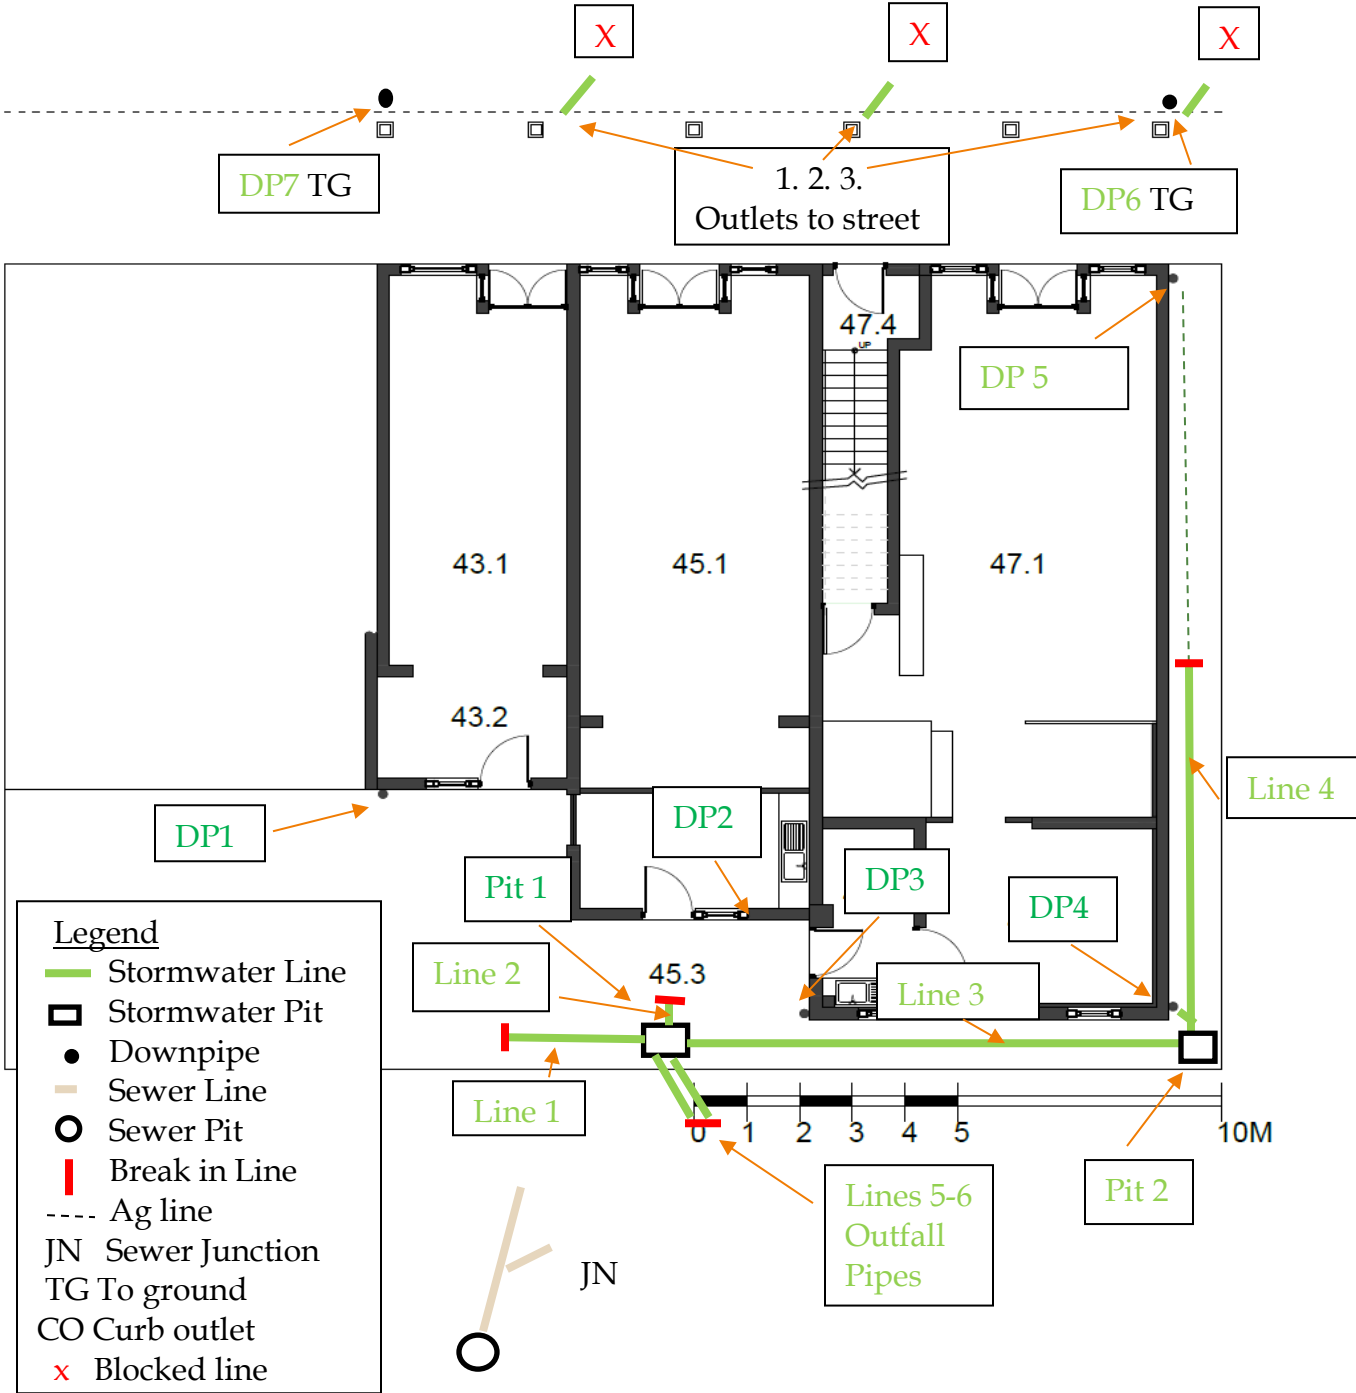
## DRAINAGE INVESTIGATION

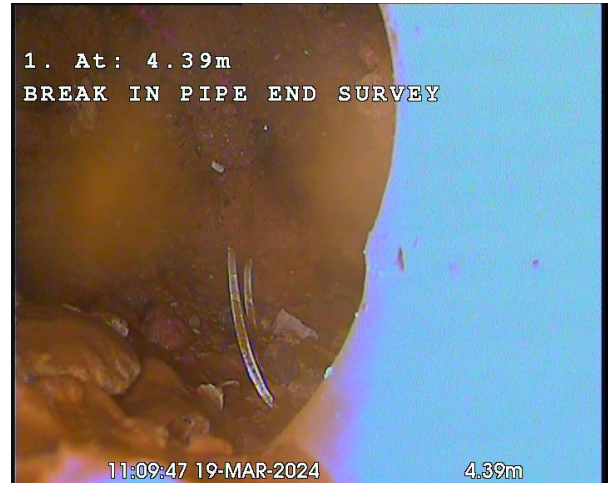
Pit 1 Line 2 to DP 2

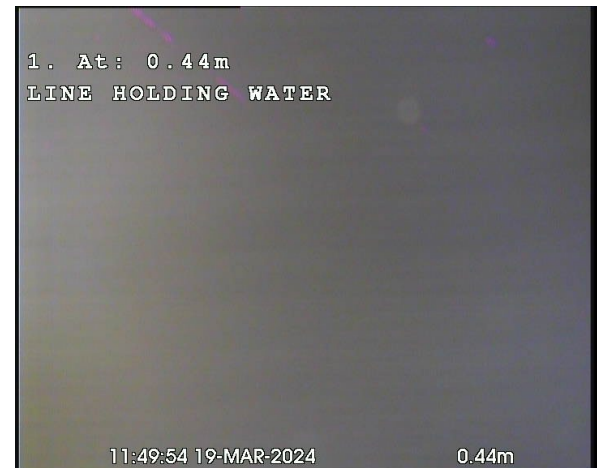
Pit 2 Line 4 to DP 5  
CCTV Inspection was carried out from pit 2 upstream to DP4, the initial inspection found the asset to be blocked with debris and gravel, high pressure jetting was performed but the asset is completely blocked. CCTV Inspection was performed but the asset is completely blocked with gravel indicating that there is major break in the line, CCTV inspection was abandoned, and visual inspection found that the asset is connected to an AG Line. This connection is possibly broken or detached

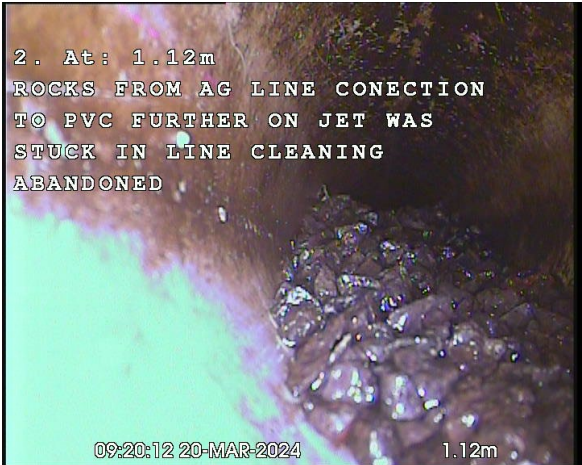
DP 1  
Is a 90mm PVC Downpipe and no CCTV Inspection was completed due to no access to the asset

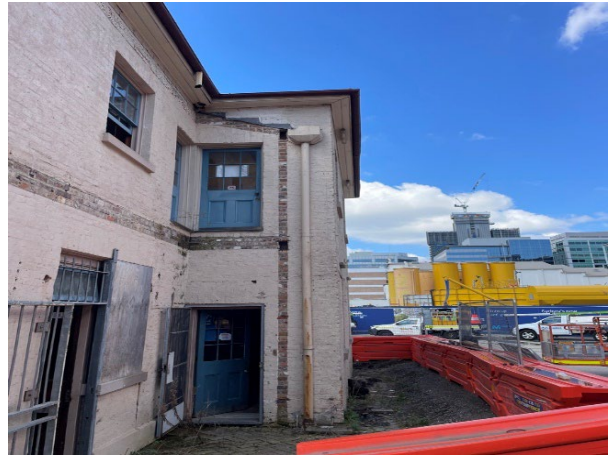
Is a 100mm galvanized steel downpipe and access was not possible without cutting the downpipe, the condition of the downpipe is heavily rusted.
