# Planning Approval Consistency Assessment Form

SM-17-00000111

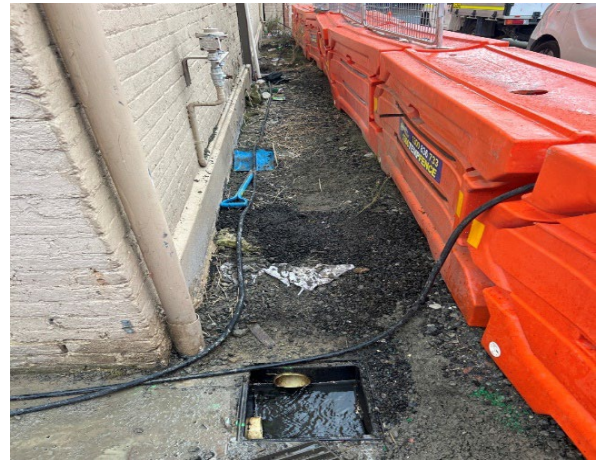
Is a 100mm galvanized steel downpipe and access was not possible without cutting the downpipe. It was identified that the downpipe exits into line 4.

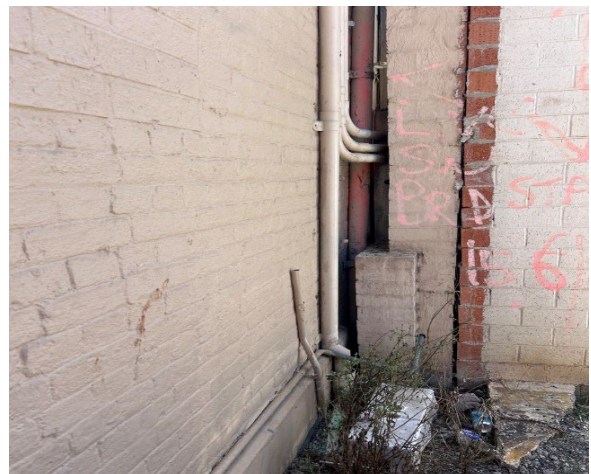
## DRAINAGE INVESTIGATION

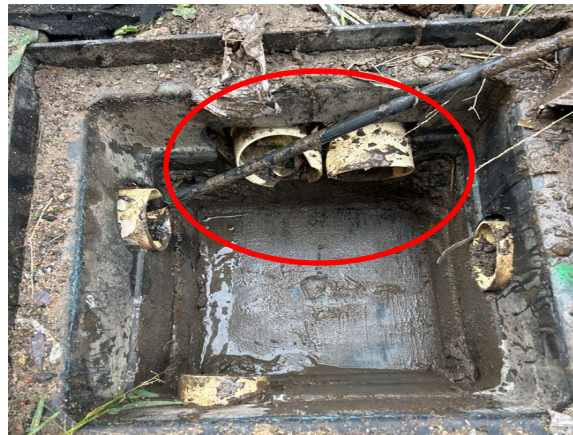
Has 5 lines in the pit the twin lines 5.6 are completely smashed and no CCTV Inspection was possible. CCTV Inspection of Line 1 goes to towards DP1 but has a major break, line 2 also has a break and cannot be cleared this line appears to be heading towards the building, Line 3 is clear to pit 2 with no defects.

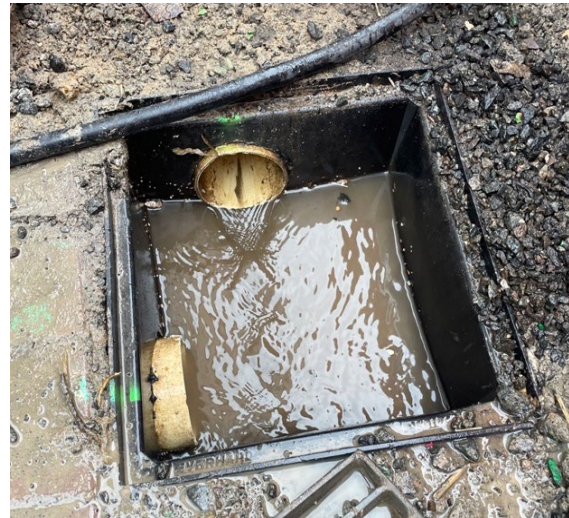
CCTV Inspection was carried out from pit 2 upstream to DP5, the initial inspection found the asset to be blocked with debris and gravel, high pressure jetting was performed but the asset is completely blocked. CCTV Inspection was performed but the asset is completely blocked with gravel indicating that there is major break in the line, CCTV inspection was abandoned, and visual inspection found that the asset is connected to an AG Line. This connection is possibly broken or detached allowing gravel to enter the stormwater asset.

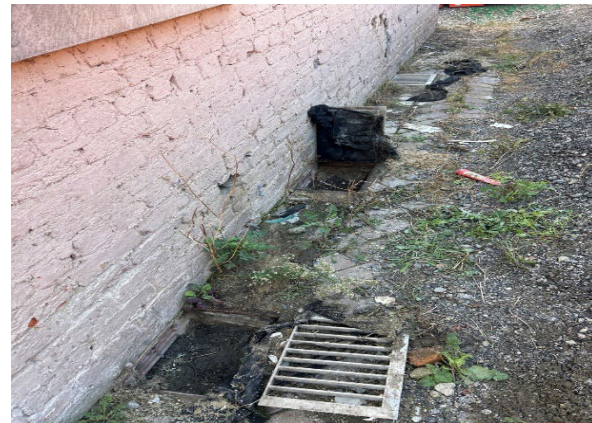
Visual inspection of the under-floor venting identified that the vent configuration has the potential for water to ingress under the building. It was identified that the vents are lower than the ground level and there was moss and wet soil in the venting pits when the grates were lifted for inspection.

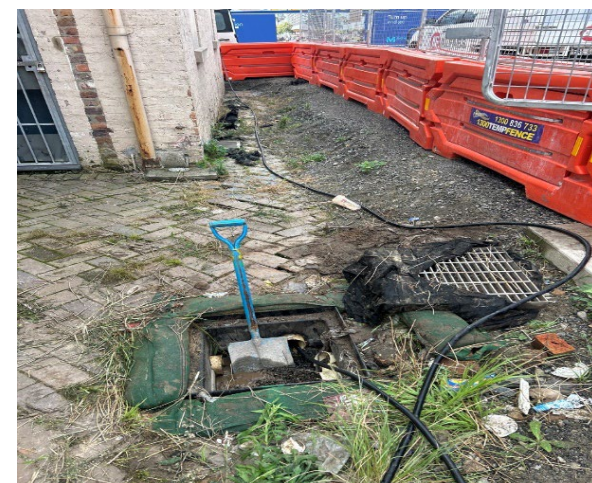
Inspection of the rear of the site identified that the surrounding area has been built up and is higher than the building ground level, the fact that there is no adequate drainage outfall, and that the stormwater pipes have no functioning exit pipes is allowing stormwater to saturate the area, the over supply of water has the potential to build up and enter the venting pits and travel under the building, this would be contributing to issue associated with water damage.

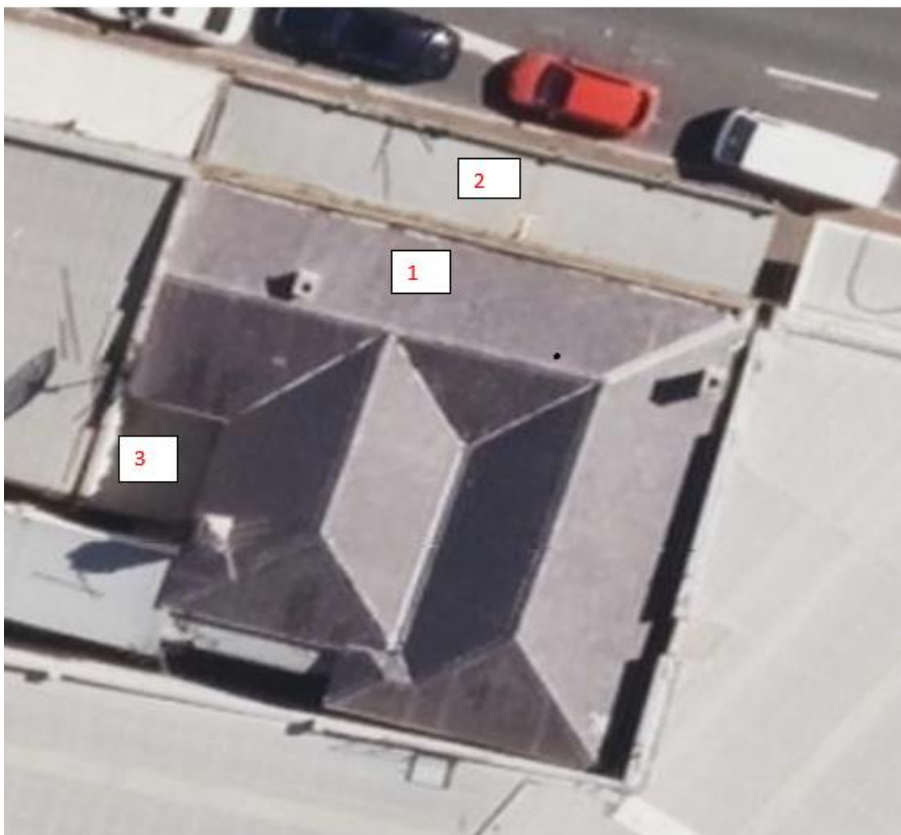
Roof 1: Main slate roof

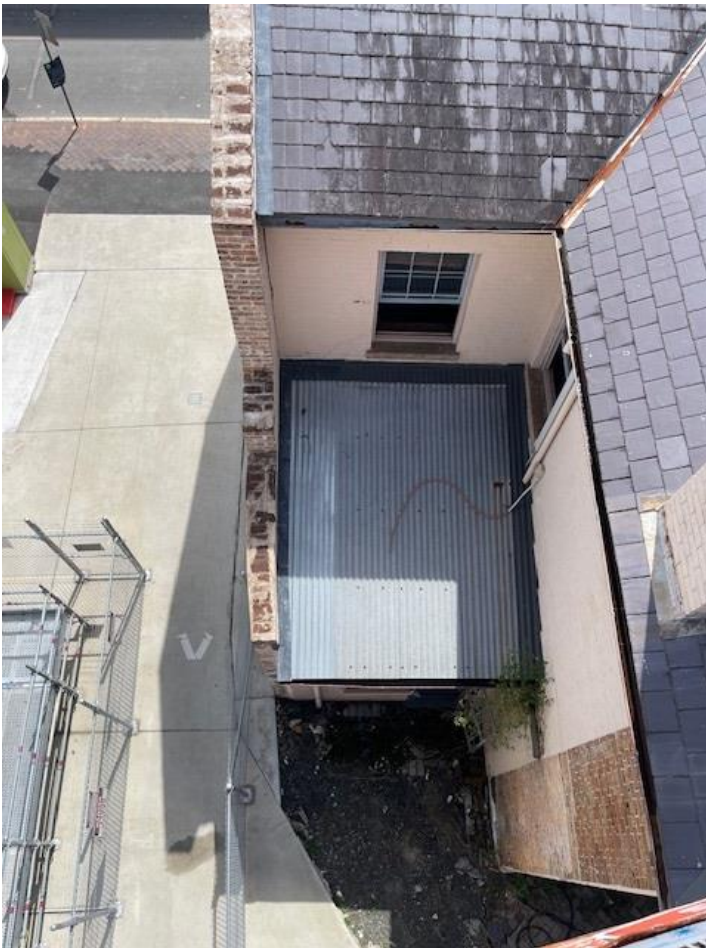
Figure 5: Lower South metal roof sheeting

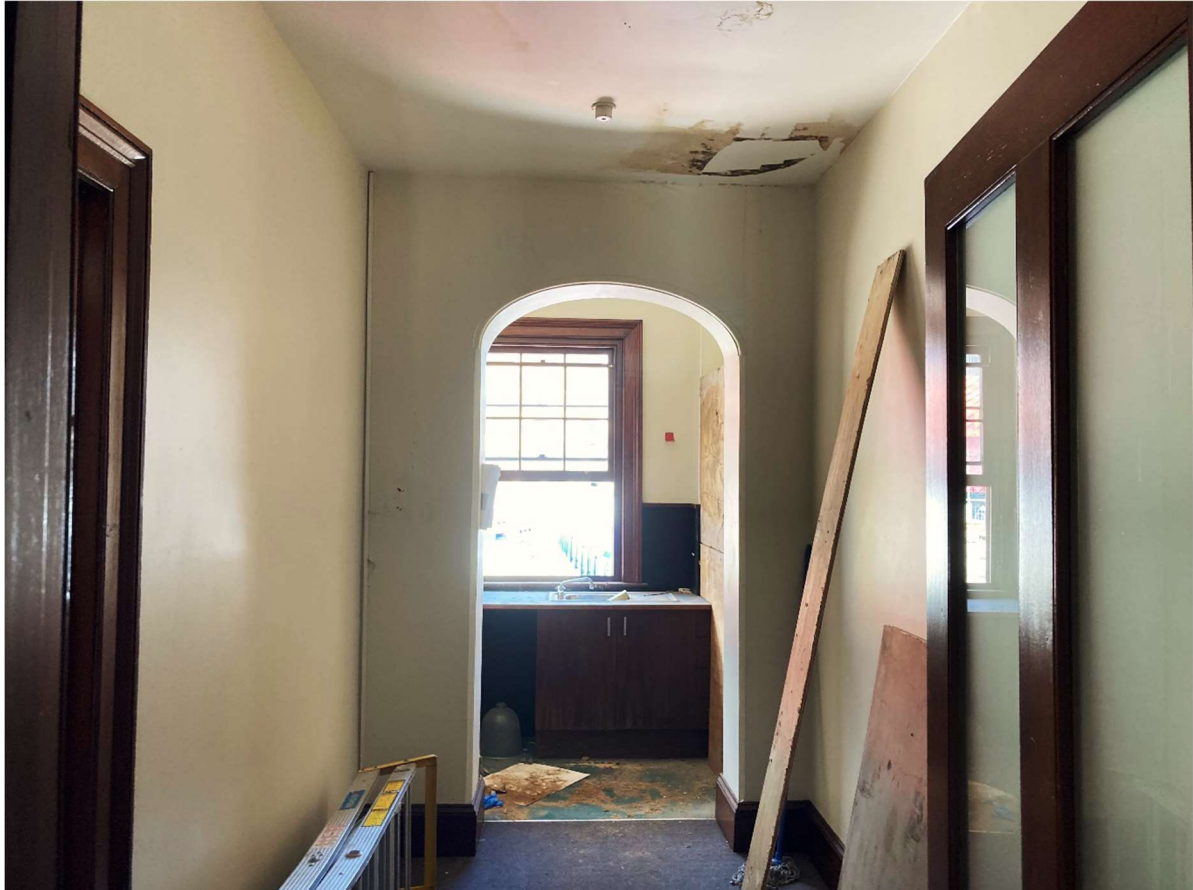
For Gamuda Laing O'Rourke Consortium (GLC)

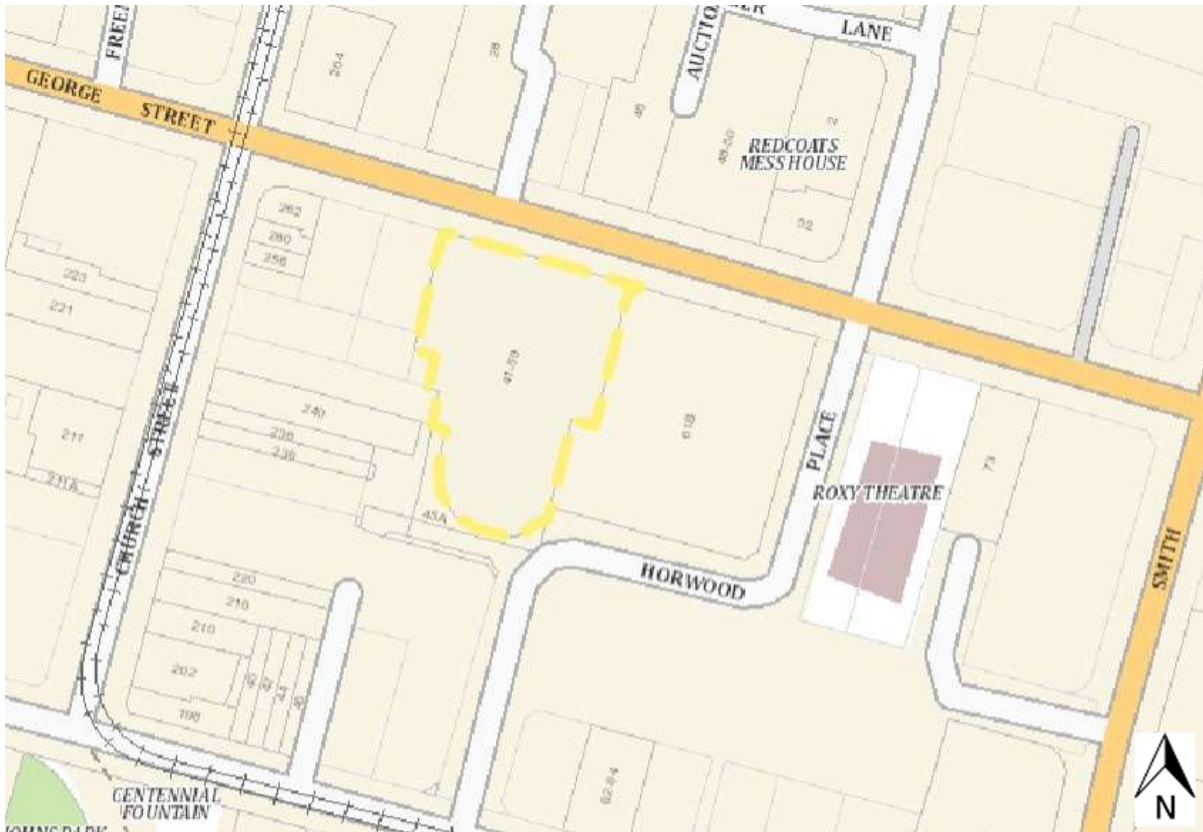
Figure 1-1: Lot plan for 41-59 George Street, Parramatta. Source: NSW ePlanning Spatial Viewer.

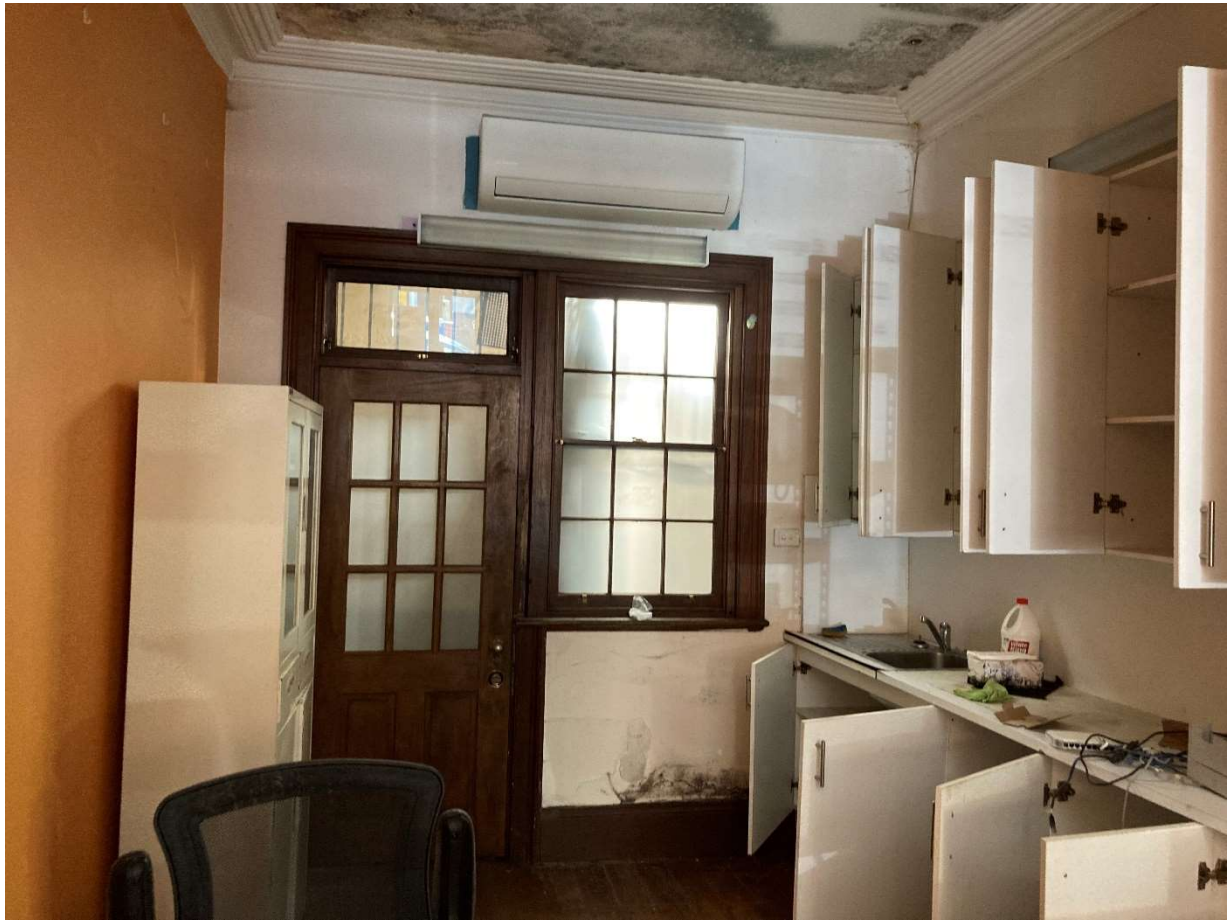
Figure 4-2: General view into rear of shop at 43 George Street (ground floor) in 2022.

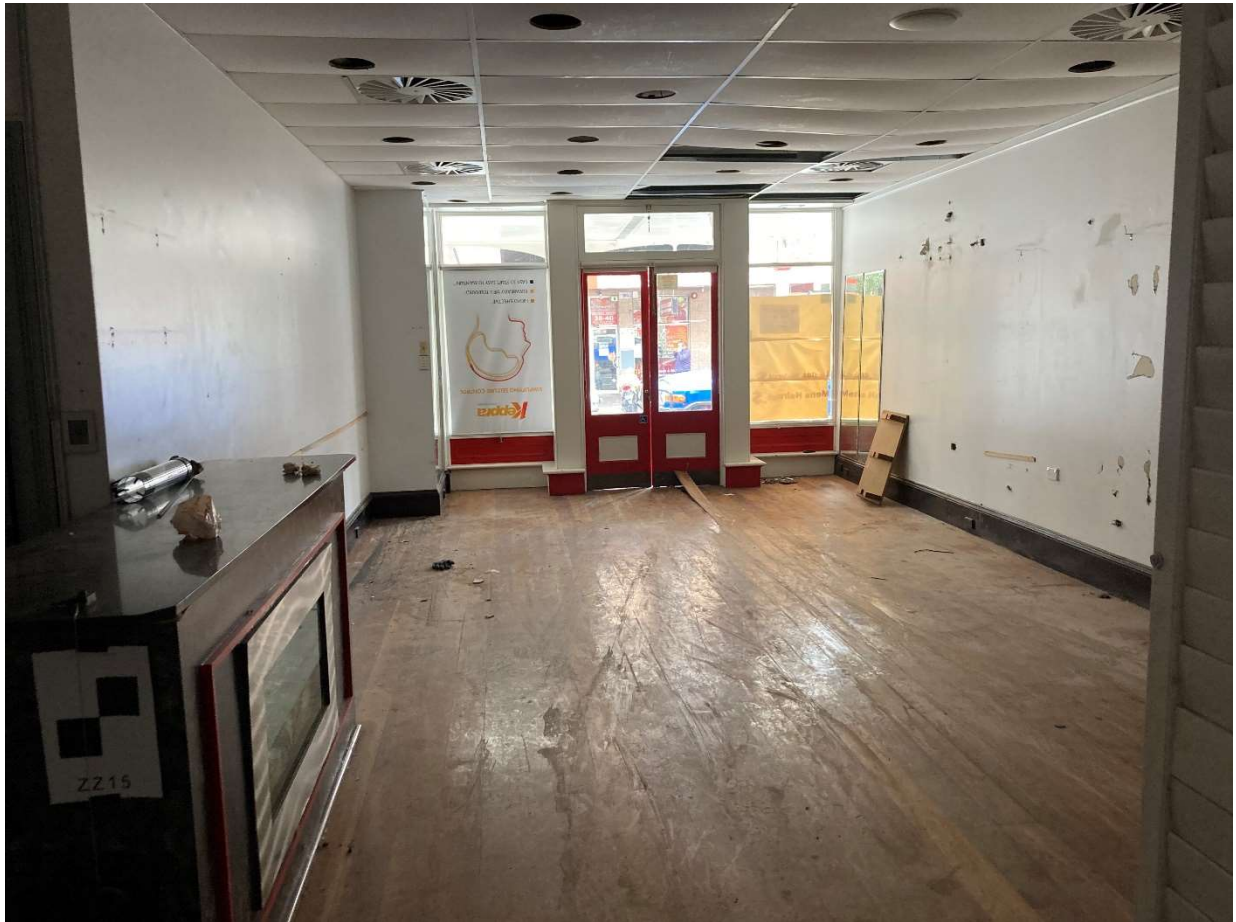
Figure 4-5: General view north in shop at 47 George Street (ground floor) in 2022. Note buckling floor, evidencing high moisture levels.

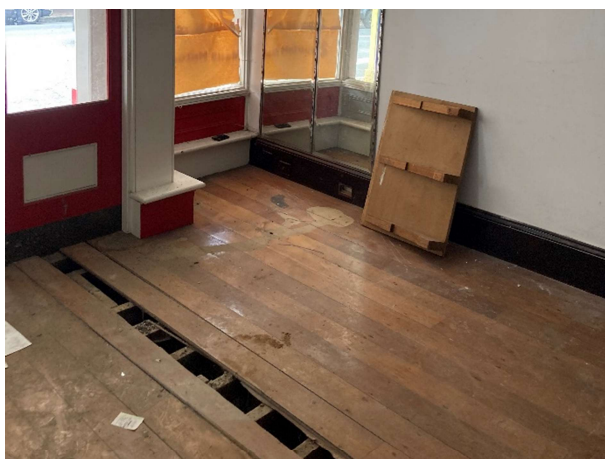
Figure 4-6: Detail view of floor in 47 George Street in 2024, showing damage associated with high moisture levels.

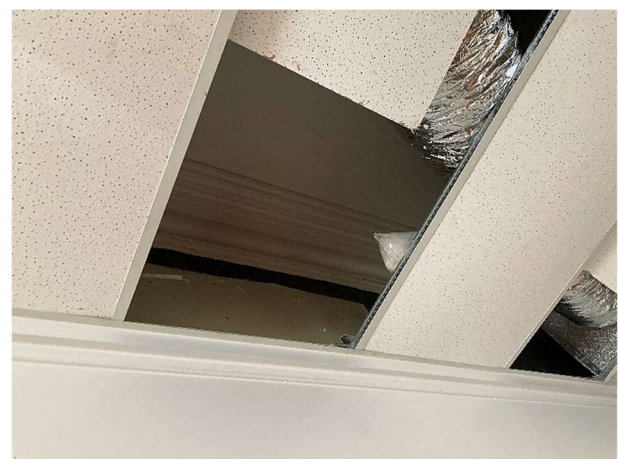
Figure 4-7: Evidence of plaster ceiling above suspended ceiling in shop at 47 George Street. Closer, destructive investigation would be required to determine fabric

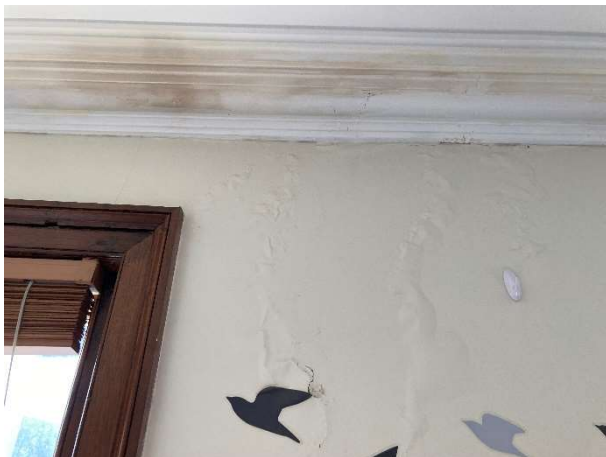
Figure 4-9: Detail view of water damage affecting north cornice and wall, 47 George Street.

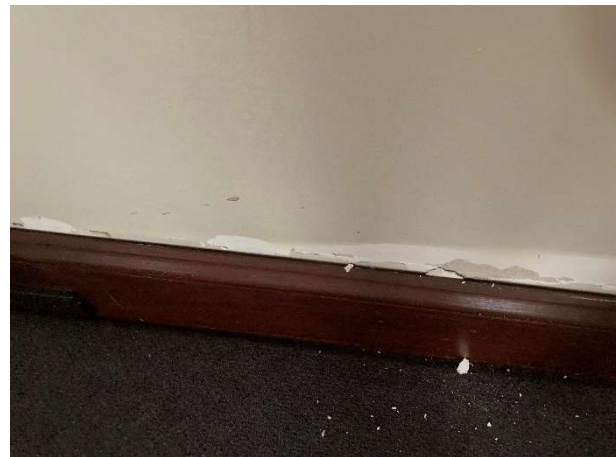
Figure 4-10: Evidence of moisture adversely affecting rendered masonry walls in 47 George Street.

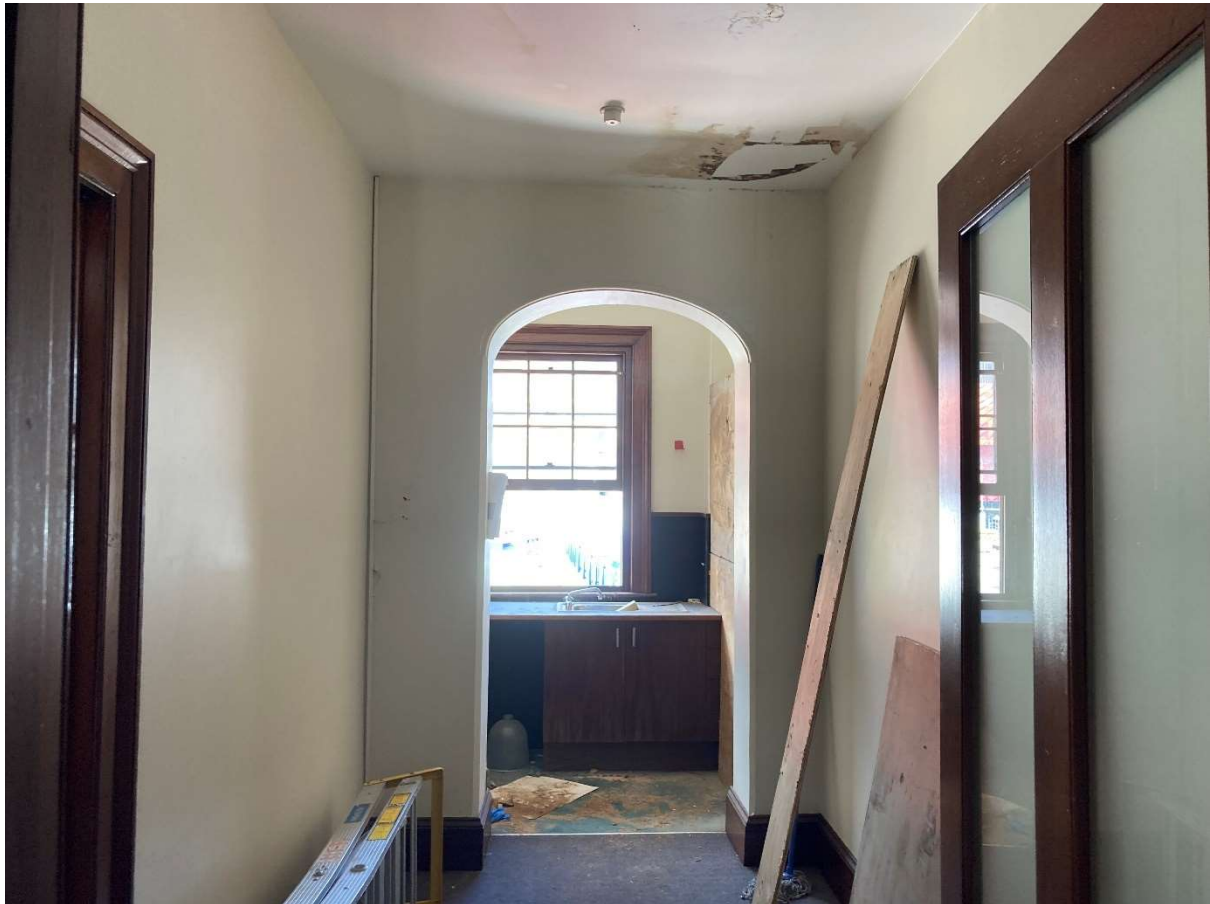
Figure 4-11: General view of first floor hallway looking to kitchenette at rear.

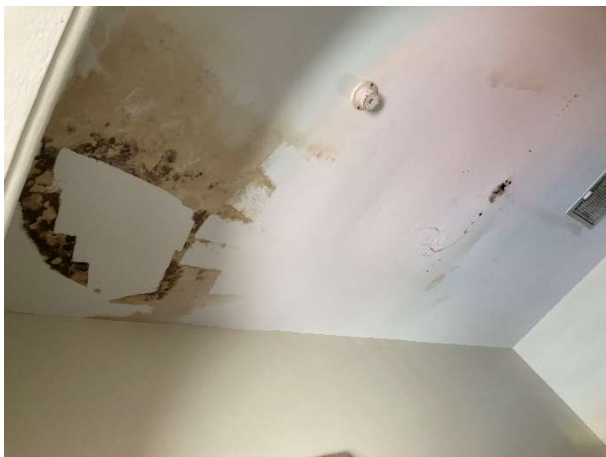
Figure 4-12: Water damage and mould affecting ceiling in first floor hallway.

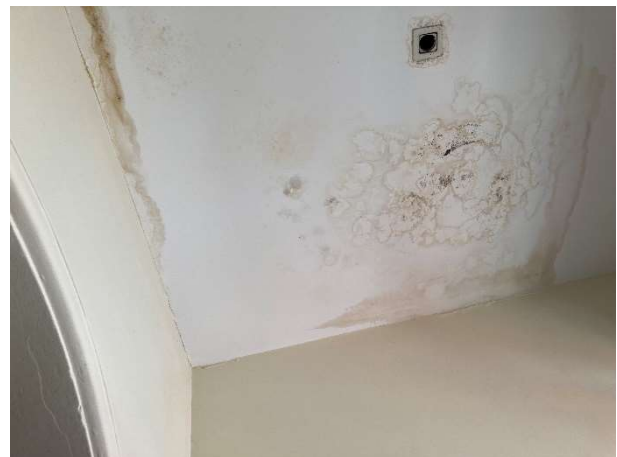
Figure 4-13: Water damage and mould affecting ceiling in first floor hallway.

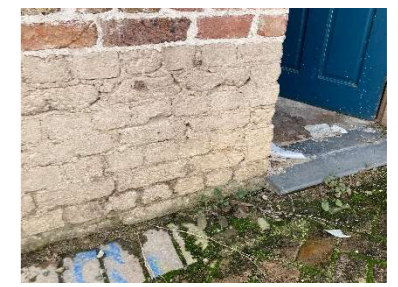
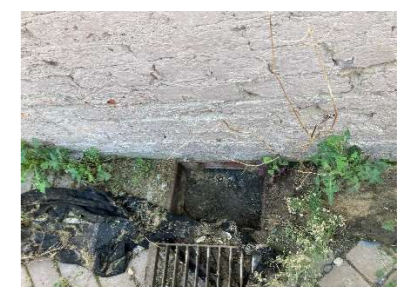
No visible DPC in external masonry walls

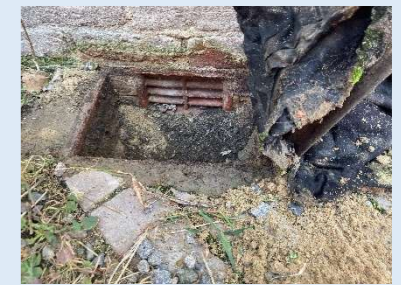
Existing sub floor wall vent; positioned below ground level

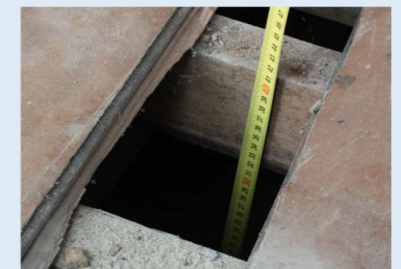
Clearance beneath joist is currently in the order of 300mm (Shop 47)

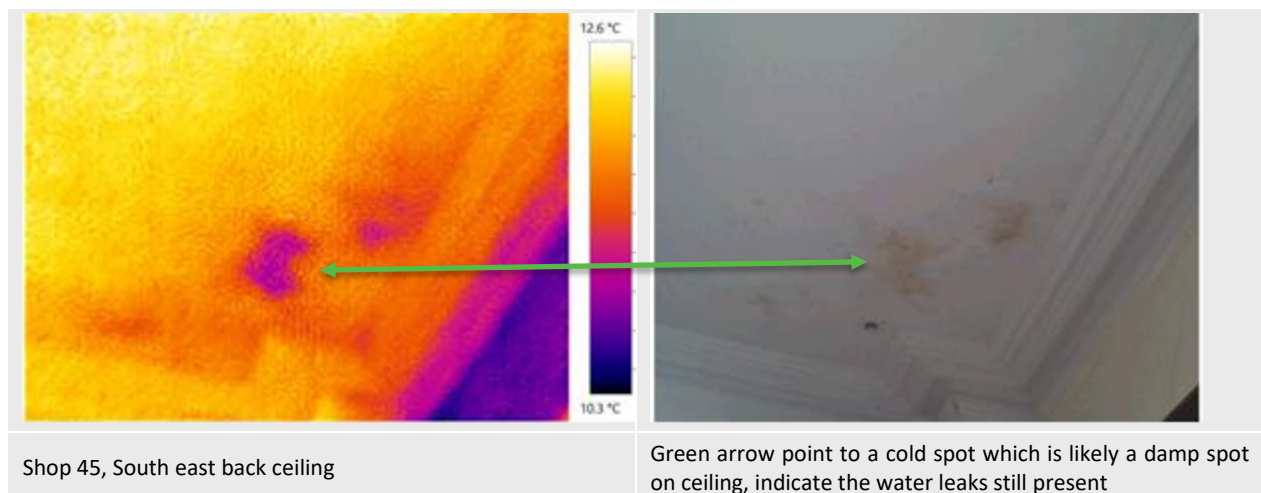
**Figure 4.1 Thermal Image survey and Photographs of the Moisture Test**

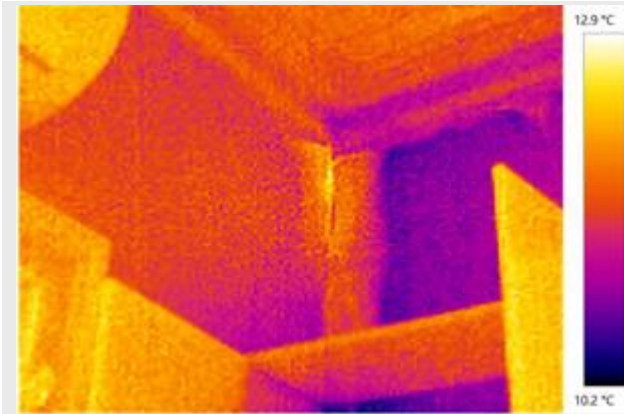
Shop 43, south west back wall

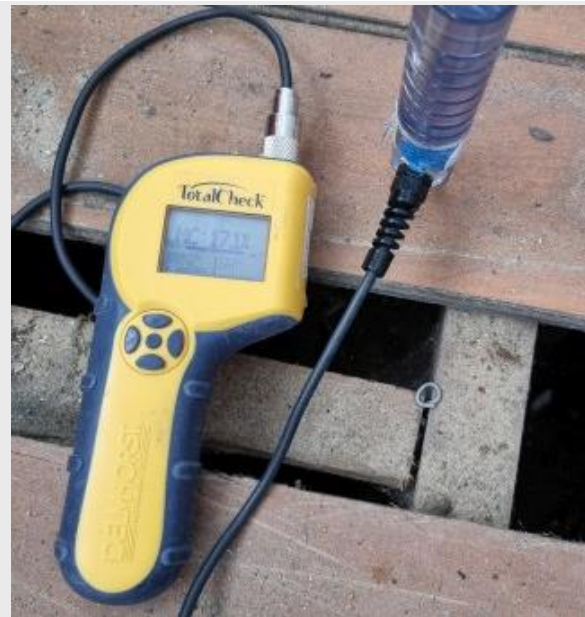
Shop 47 floorboard of 17.1% indicate high moisture condition

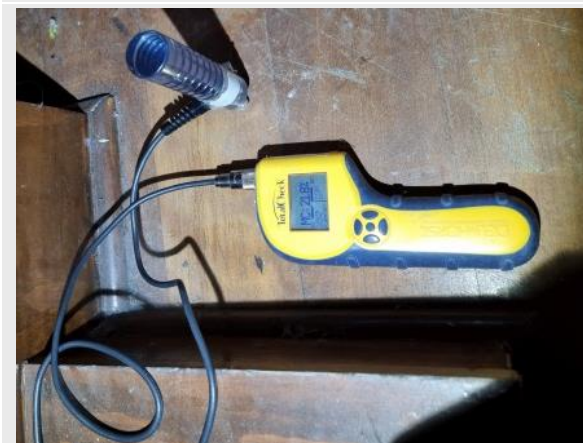
Shop 47 south floorboard of 21.8.1% indicate too high moisture condition

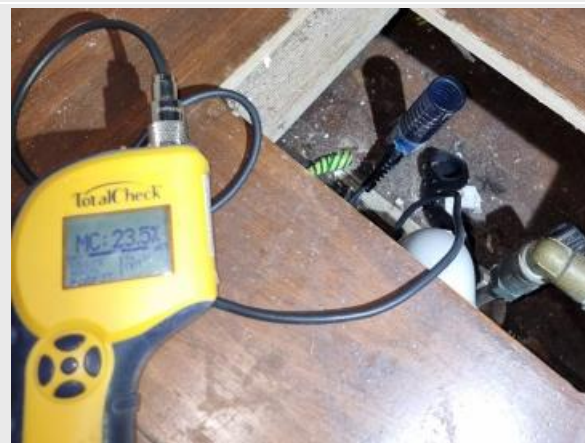
Shop 47 south floorboard of 23.5% indicate too high moisture condition

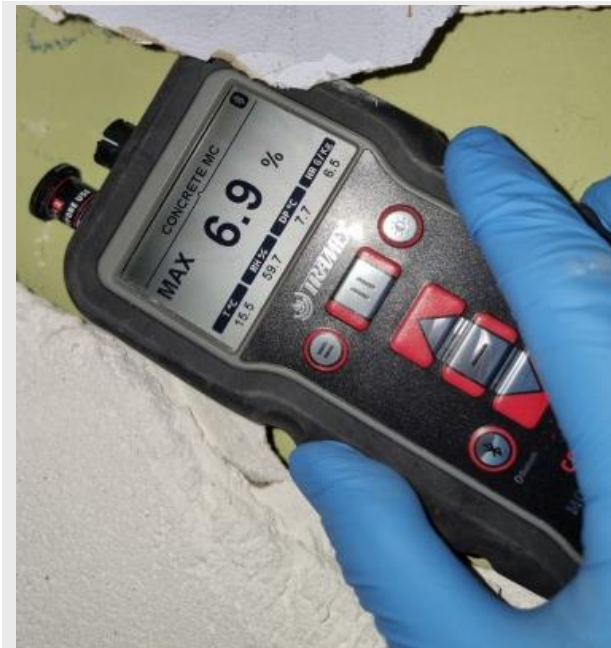
Shop 47, east wall, rendered brick wall - very high (6.9%) moisture content.

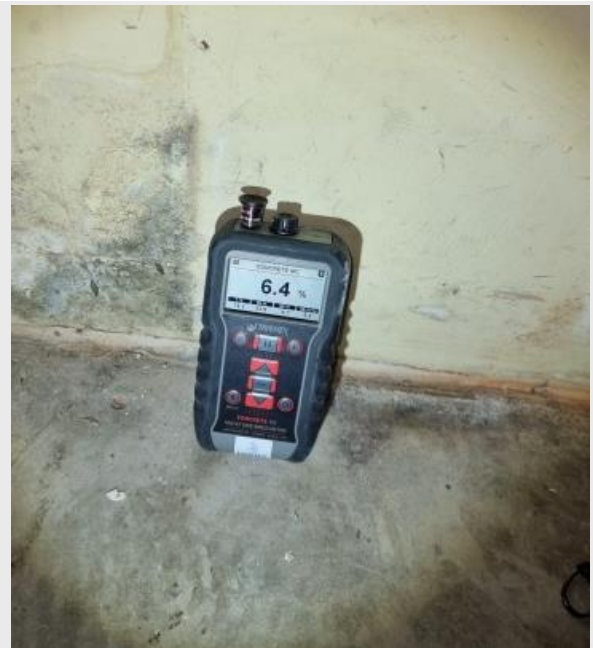
Shop 47, storeroom under stair, low west wall - very high (6.4%) moisture content.

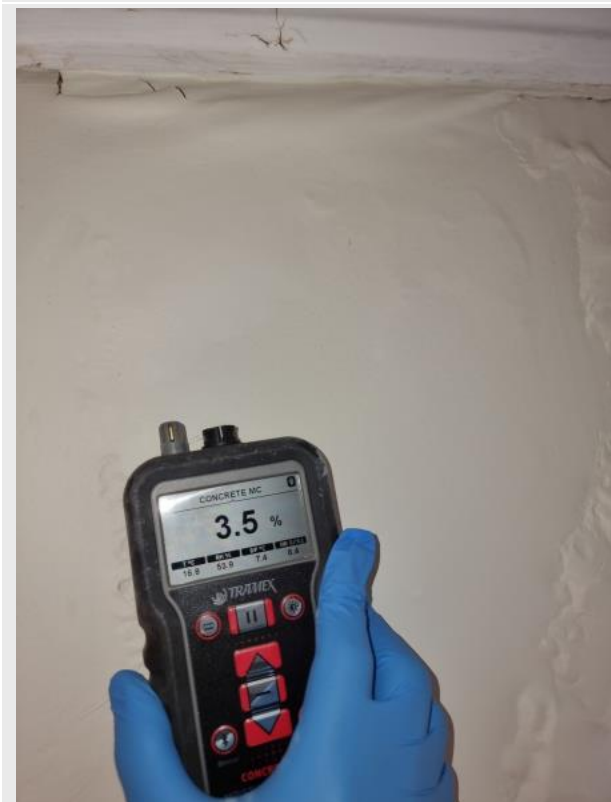
Level 1, Room 1, north wall above window - 3.5% on rendered wall, moisture level still too high.

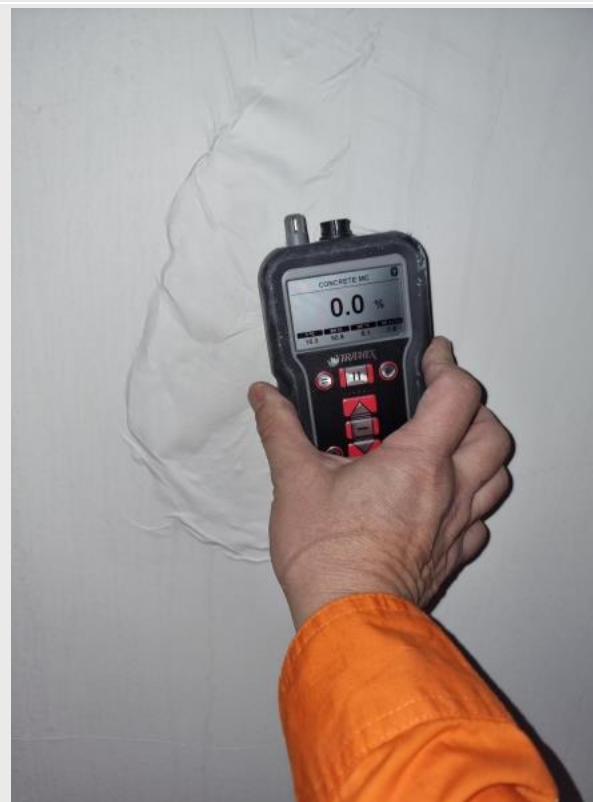
Level 1, Room 1, north wall at low height - results indicate normal dry rendered wall.
