7 February 2025 Ref: 170108-ER_DPHI Jan 2025

RE: Sydney Metro City and South West – ER Monthly Reports for January 2025

2. Southwest Metro Corridor Package 3 (SWM3) JHLOR

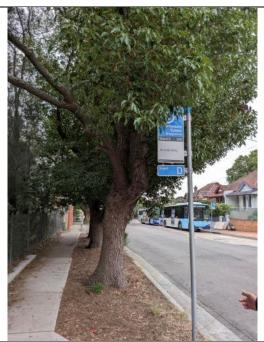
Figure 4 – Canterbury Station - Review of station precinct trees underway as there is a clash with upcoming light pole installation and loc. ation of the existing street trees.

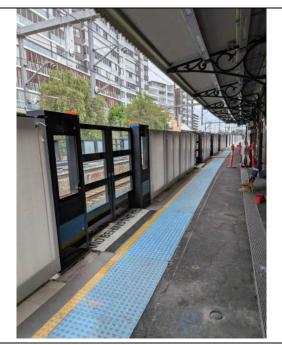
Figure 5 – Canterbury Station - Platform screen doors installed, protection measures installed to prevent any damage during tactile removal and other platform works.

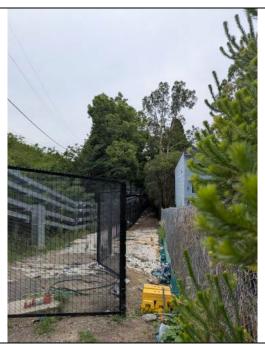
Figure 17 – Hurlstone Park – Security fencing installation complete.

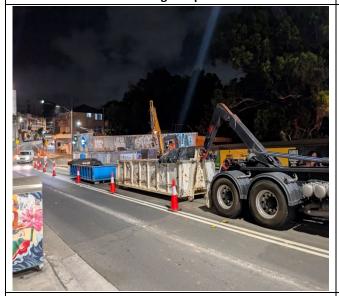
Figure 5 – Illawarra Road, Marrickville – Footpath excavation in progress, spoil being transferred to skip bins.

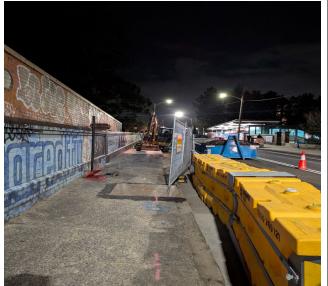
Figure 6 – Illawarra Road, Marrickville – Footpath excavation in progress.
