# Sydney Metro Chatswood to Sydenham

Technical paper 5

Aboriginal Heritage – Archaeological  
Assessment

May 2016

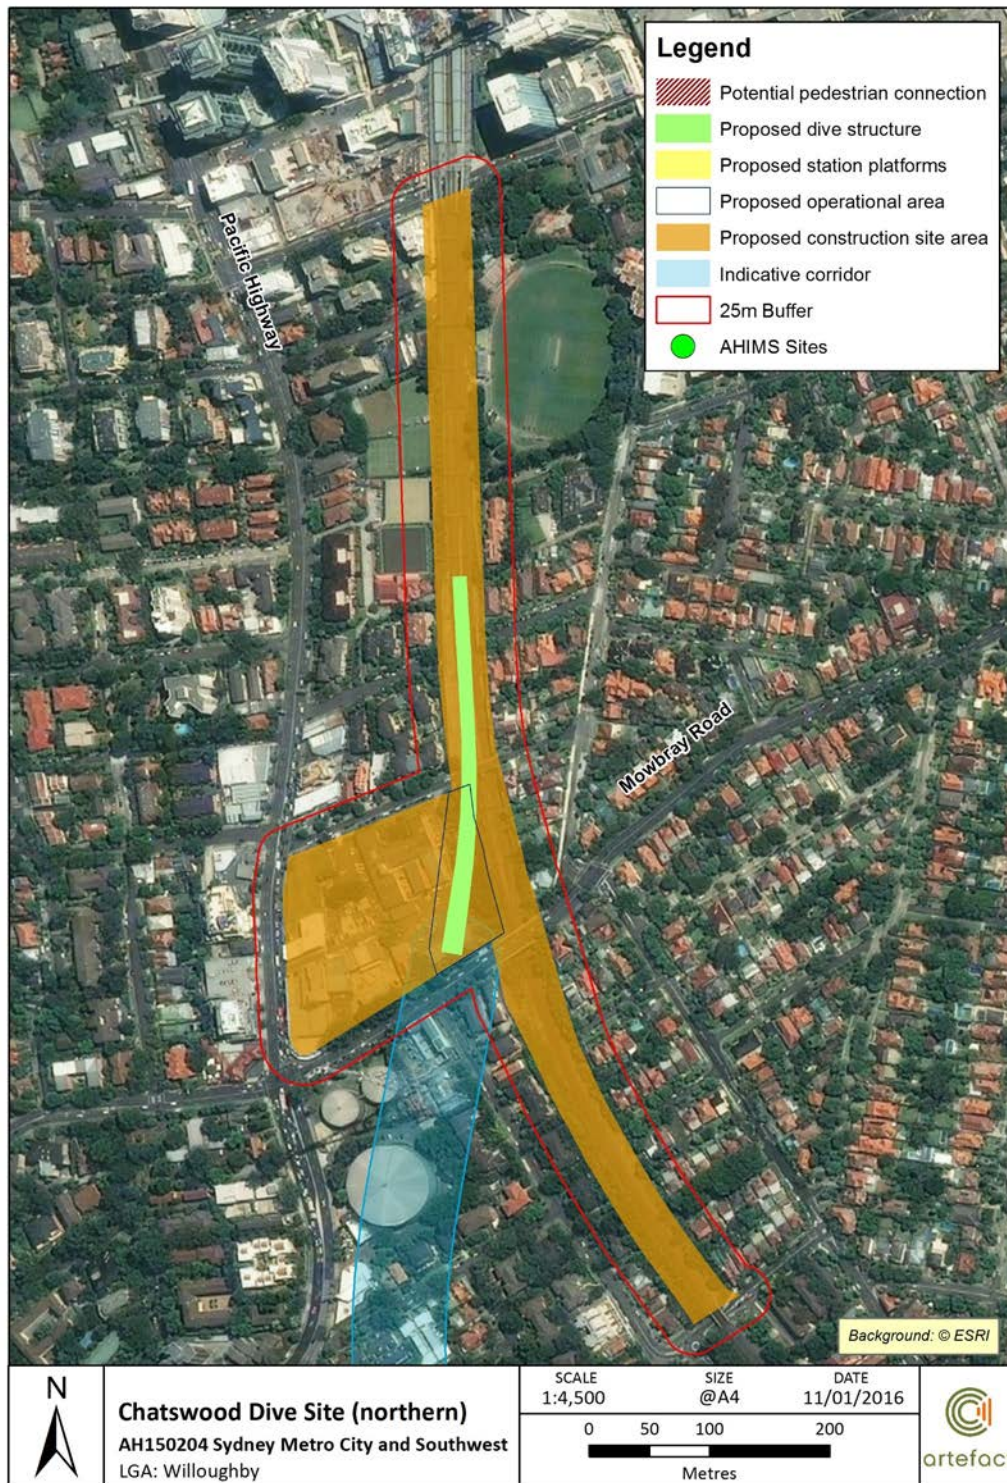
Figure 9: Location of the Chatswood dive site (northern)

The Chatswood dive site would be about 24,000 square metres in area and located adjacent to the T1 North Shore Line in Chatswood (see Figure 9). The site formerly included a service station and is currently occupied by an Ausgrid depot and a number of commercial and retail buildings.

No recorded Aboriginal sites are located within 100 metres of Chatswood dive site (see Figure 9). The closest recorded Aboriginal site is AHIMS site 45-6-2938, a surface artefact(s) site recorded adjacent to the rail corridor 1.6 kilometres to the south.

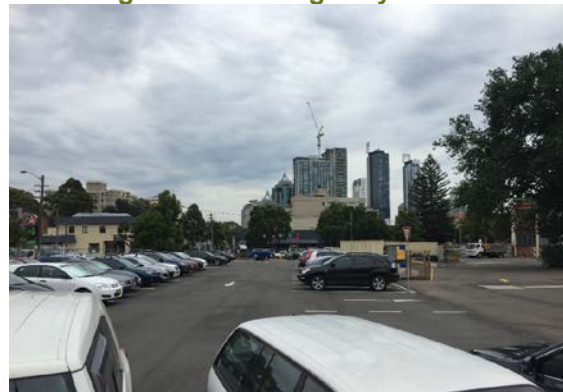
**Plate 2: View north across hardstand car park bordering the Pacific Highway**

The construction of commercial buildings, roads and the large rail cutting through the Chatswood dive site is likely to have impacted or removed portions of any remaining natural deposits at the northern dive site. A petrol station was located in the northwestern portion of the site at the corner of the Pacific Highway and Nelson Street. That area is likely to have undergone sub-surface disturbance related to installation and subsequent removal of underground petrol tanks. The least impacted portion of the site is likely to be the area currently beneath a hardstand car park between Bryson Street and Nelson Street and immediately east of the former petrol station site. In that area a number residential dwellings have been demolished within the last six years and the area covered by bitumen to form a hardstand car park.

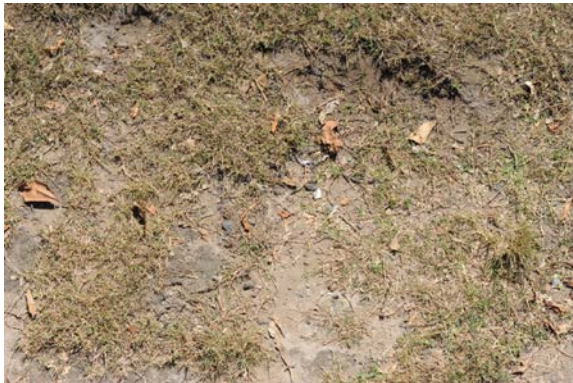
**Plate 10: Example of historical material observed on ground surface in southern portion of Blues Point Temporary Site – metal, crushed gravel, mixed sandy silt deposit**

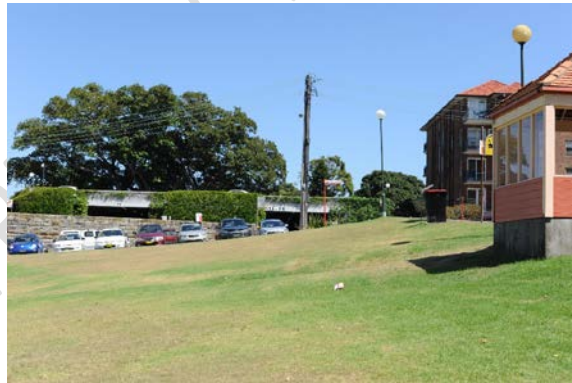
**Plate 11: View west across the proposed TBM extraction location in the northwest corner of the Blues Point Temporary Site**

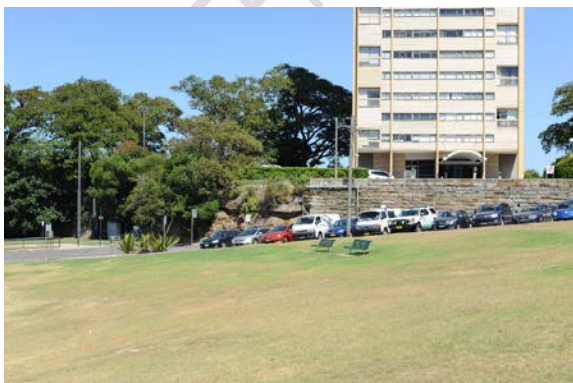
**Plate 12: View southwest across the Blues Point Temporary Site. The area to the south of the park benches was a large cut filled with structures until the Second World War, and has now been back-filled.**

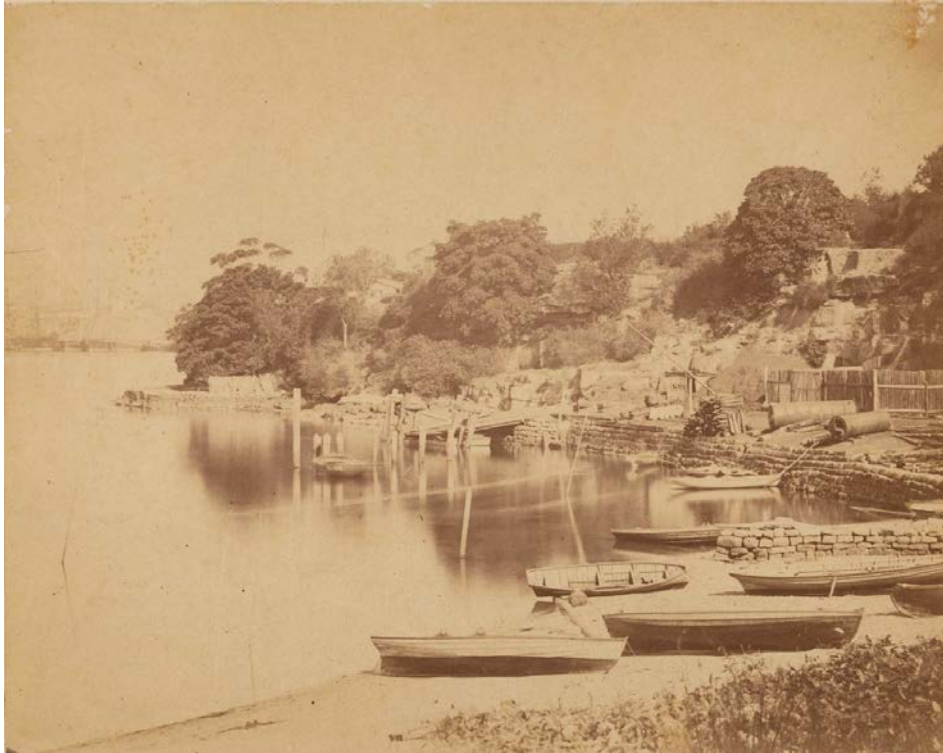
**Figure 15: View west across Blues Point, image captured in 1858-1859, showing the area prior to extensive quarrying and more expansive reclamation (State Library of NSW SPF 799)**

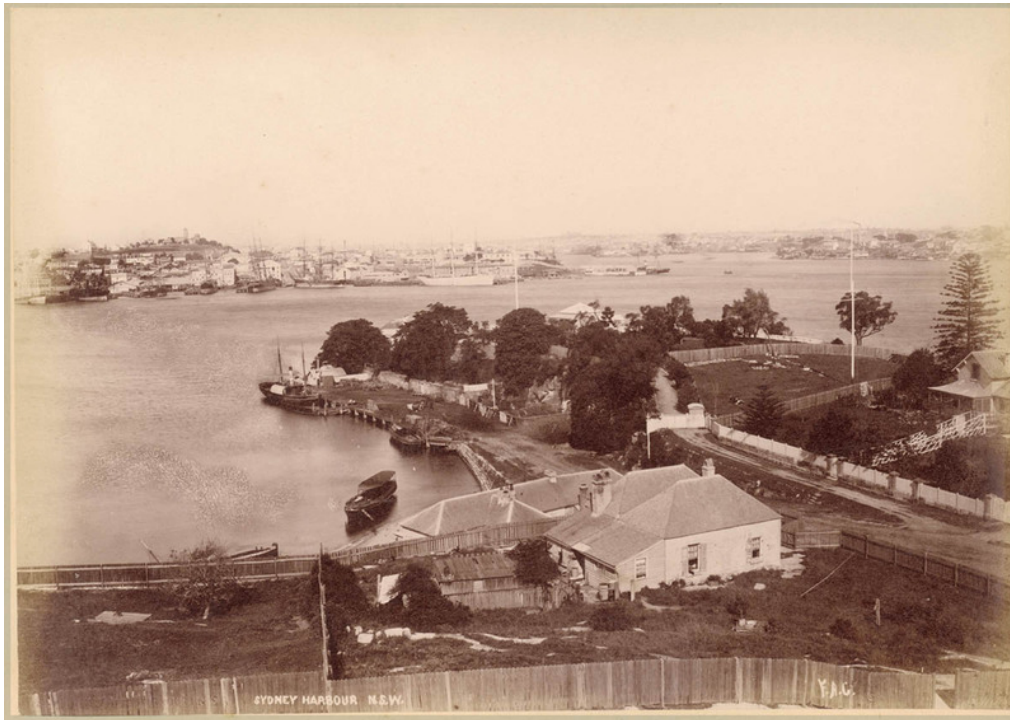
**Figure 17: View southwest over Blues Point. In comparison to Figure 16, this image shows extension of structure within study area, vegetation clearance across Blues Point, formalisation of wharfage and shoreline, quarrying activity. Date of image ca. 1890s (State Library of NSW SPF 935).**

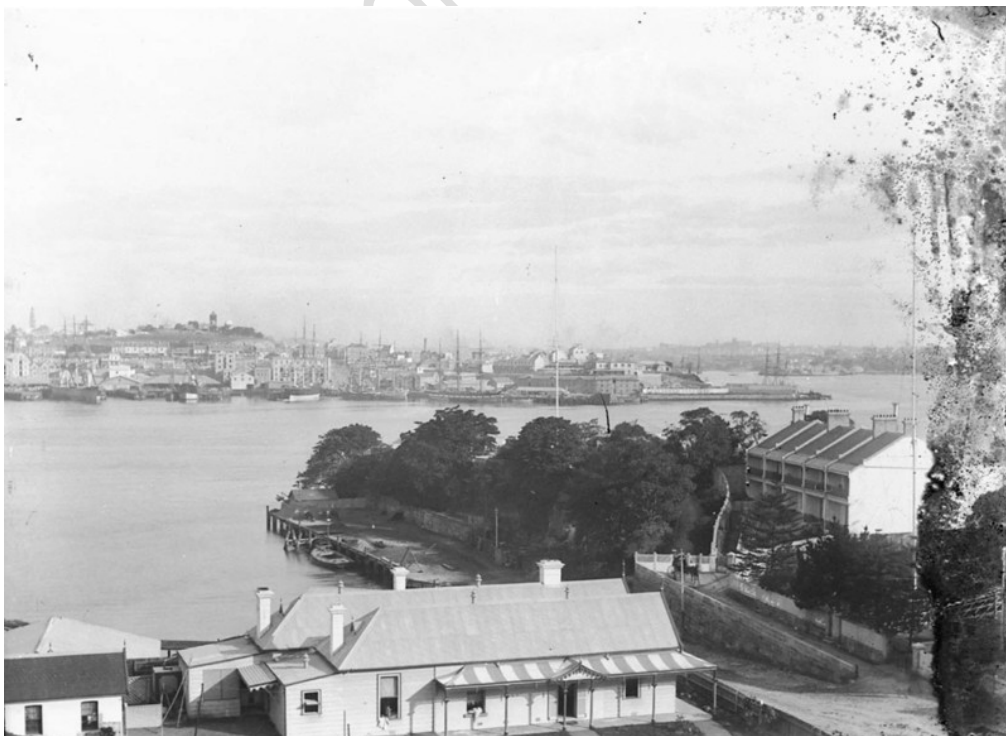
**Figure 18: View southwest across Blues Point. In comparison to Figures 16 and 17 shows extension of dwelling that was located overlooking Cliff Lane (subsequently demolished when Cliff Lane was widened to accommodate a tram line to McMahons Point). Building within the study area is only just discernible above roofline of dwelling in foreground. Access track to Blues Point has been formalised with sandstone retaining wall, which is extant. Date of image 1900-1910 (State Library of NSW ON2 474)**

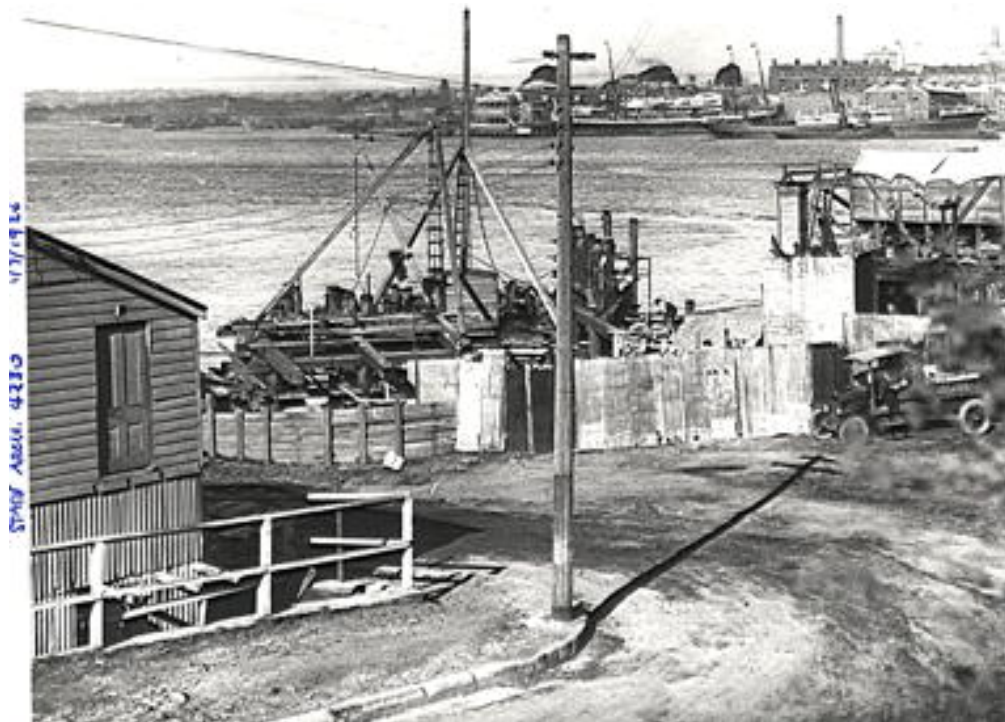
**Figure 19: 1 July 1924 view across the southern portion of the Blues Point Temporary Site, showing structure built in excavated area to the east of Blues Point Road (subsequently demolished and back-filled following the Second World War) and punt access (City of Sydney Archives 079\079847)**

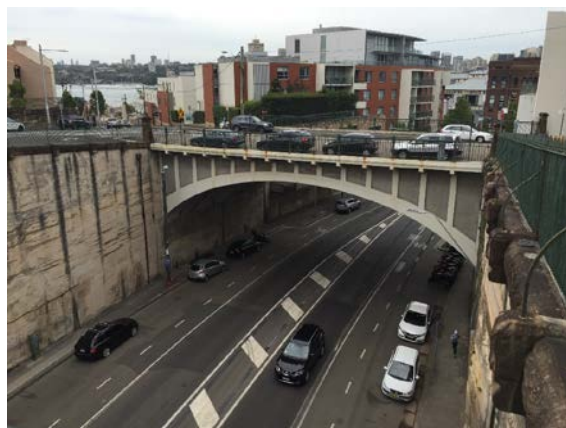
**Plate 17: View north onto Hickson Road from Argyle Place, showing the deep cutting and Windmill Street overpass**

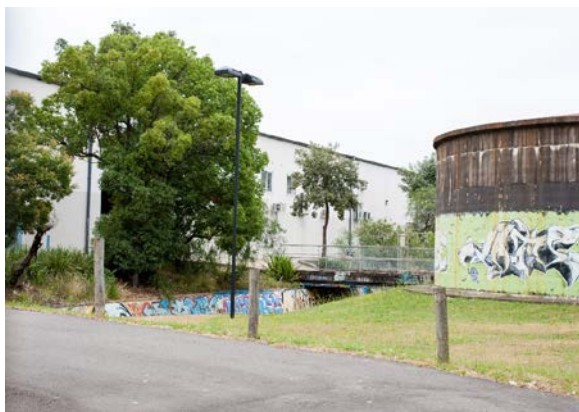
**Plate 24: View southwest of Murray Street showing canal**

Although the site inspection documented an extensive built environment and corresponding drainage modification, the deep nature of the residual underlying sediments indicates that there is likely to be some remaining archaeological potential at the southern dive site. The extent and location of that archaeological potential would be dependent on the depth and extent of impacts from building and canal construction and installation of underground services.

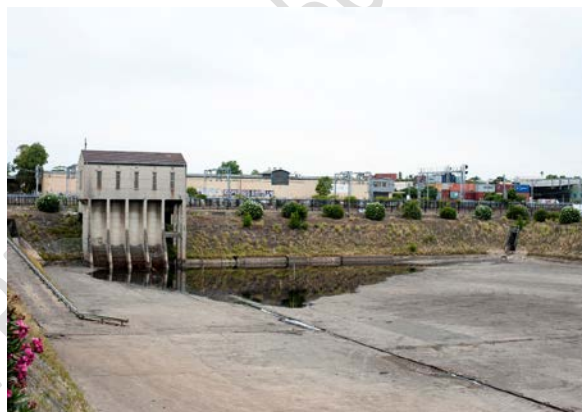
**Plate 25: View south across Sydenham Drainage Pit and Pumping Station**
