## Consistency Assessment Approval Form – Protection of the High Street cutting at Barangaroo

**ATTACHMENT A:** High Street Cutting, Millers Point – Statement of Heritage Impact (AMBS, June 2017)

# High Street Cutting, Millers Point Statement of Heritage Impact

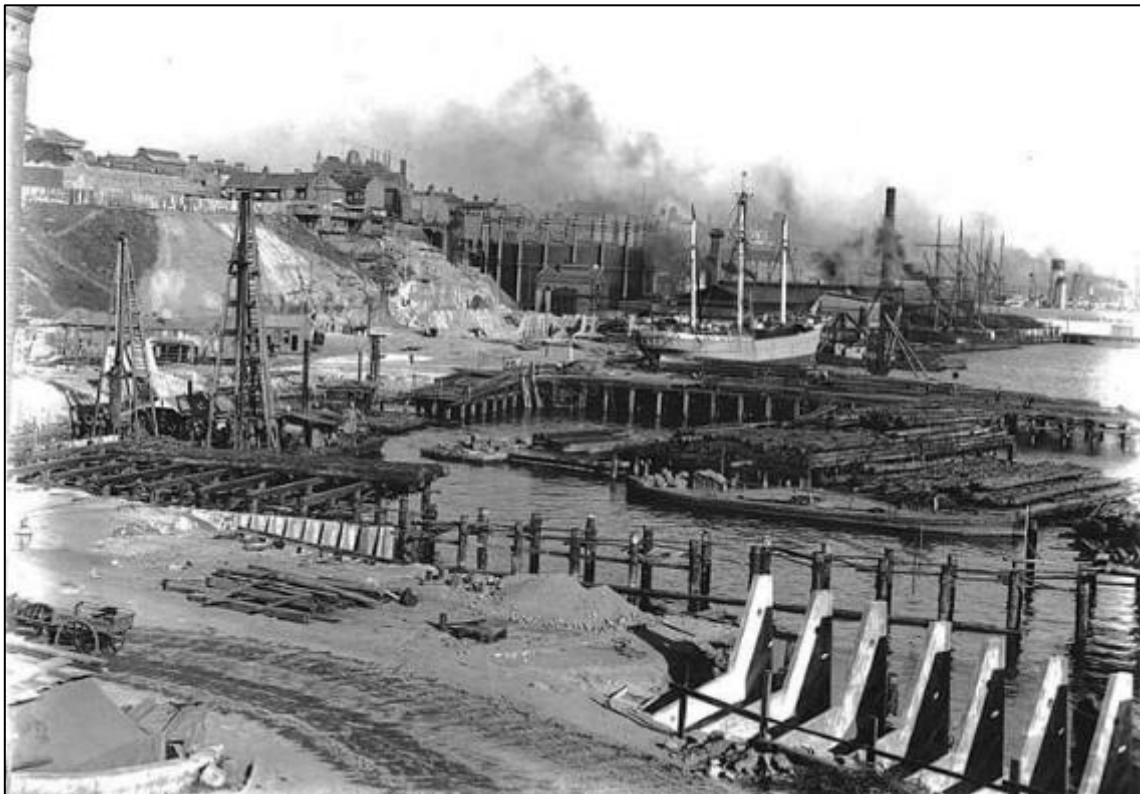
Figure 2.10 Photograph taken 1909 of the reconstruction of the East Darling Harbour wharves to the north of the Gas Works. Note that the retaining wall supporting High Street has not been built (View of the reconstruction of Darling Harbour from Millers Point showing Dalgetys Wharf No.1 partly completed. The sailing ship 'Macquarie' is shown being unrigged before being reborn as the coal hulk 'Fortuna' Dated: 1/1/1909 Digital ID: 9856\_a017\_A017000007. <https://www.records.nsw.gov.au/series/9856?title=&page=5>).

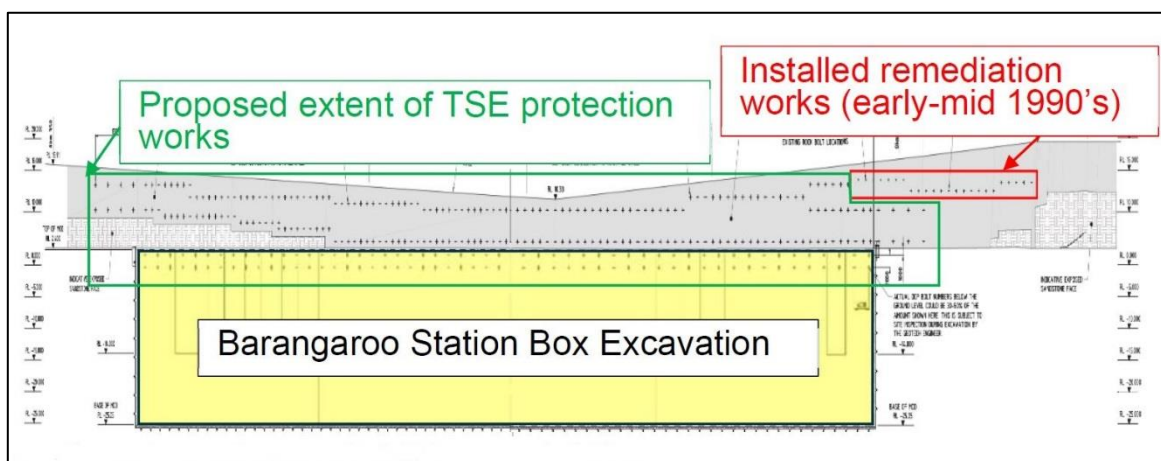
Figure 3.1 The extent of the 1995 remediation works in red, and the extent of the proposed TSE Protection Works (JHCPBG 2017:8, Figure 3).

However, similar stabilisation works were undertaken in 1995, when approximately 50m of the High Street cutting was remediated with the installation of rock anchors and weep holes at the southern end of the cutting. In total, 25 rock anchors of variable lengths from 9.4m to 14.2m embedding either 6.0m (Type A) or 3.0m (Type B), with anchors ranging in length from 9.4m to 14.2m (Figure 3.1). The anchor heads were recessed into the concrete wall, and rendered flush to minimise adverse effects on the aesthetic significance of the wall (Figure 3.2). At the same time and 23 weep holes were installed as part of these works (JHCPBG 2017:6). The works are described in detail in Appendix A of the JHCPBG report.

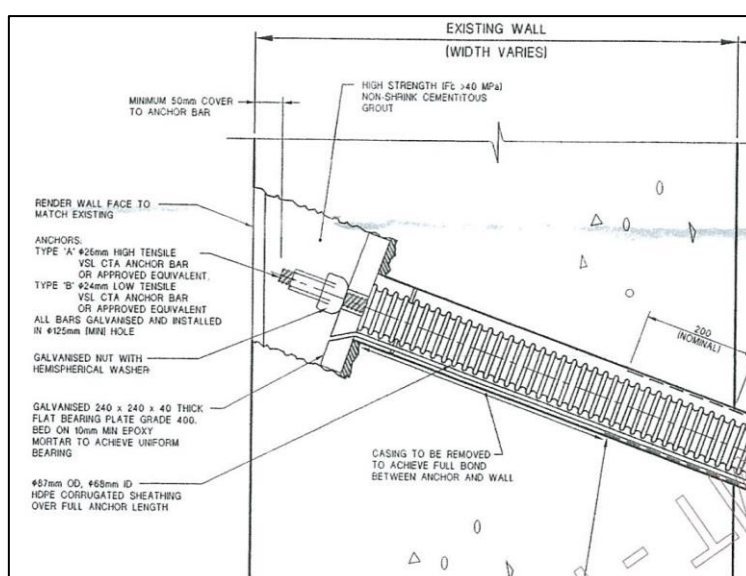
Figure 3.2 Detail of the methodology for the rock anchors used in the 1995 remediation works, whereby anchor heads were recessed into the concrete wall and rendered flush (JHCPBG 2017: Appendix A, Drawing 03).

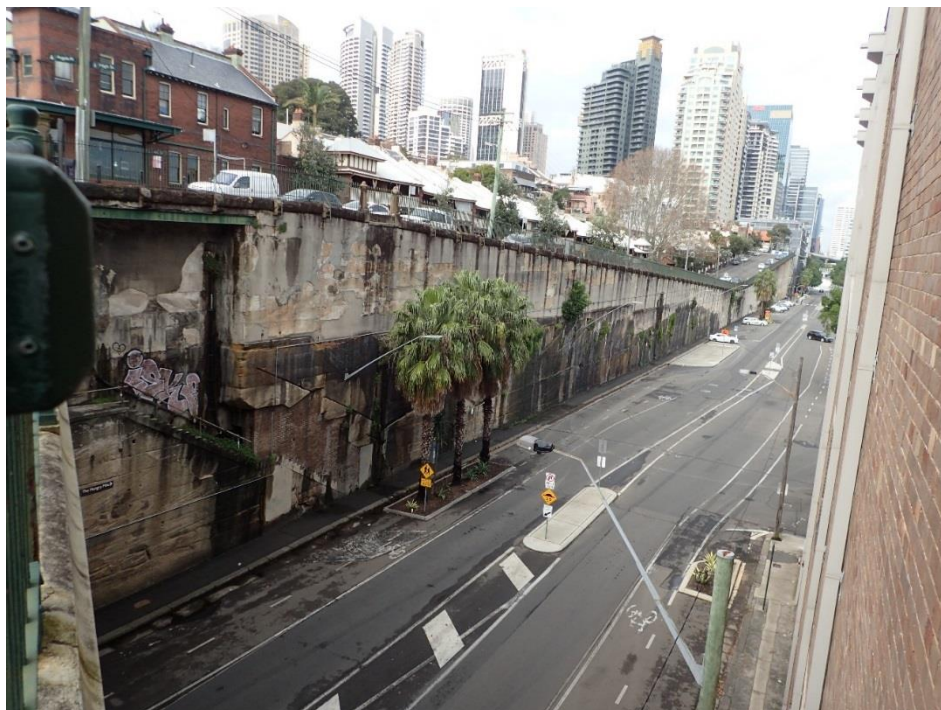
**Figure 4.1** View north-east from the Munn Street bridge. The slope falls away to a dip and rises again to the south seems to mark the pattern of quarrying.

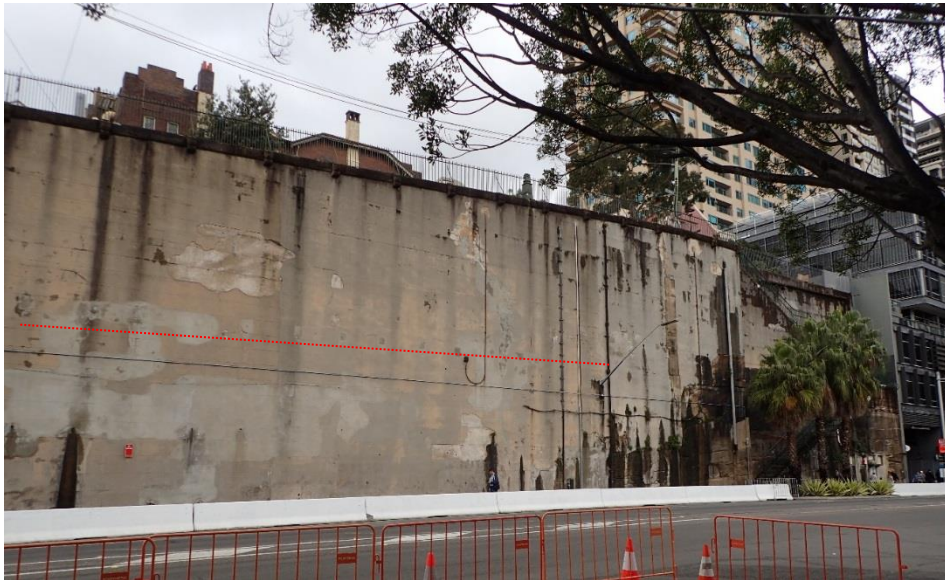
**Figure 4.2** View south-east where a greater quantity of the natural sandstone has been removed. A line of the 1995 anchors is indicated.

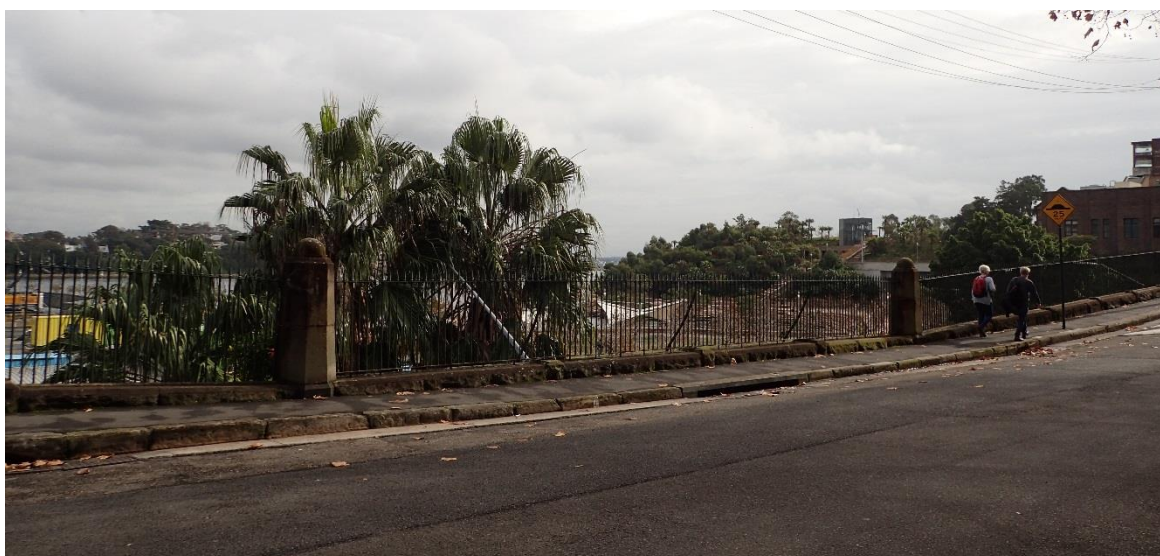
Figure 4.4 Along the palisade fence are two sandstone posts marking the location of the dip in the road and of the overhead bridge.

The cutting back of the sandstone bedrock to form Hickson Road in 1909, reveals a pattern of natural sandstone and infill material, comprising sandstone blocks, in-situ concrete and brick which has been surfaced in a cement render. The line of the natural sandstone rises to the north and south which likely reflects the quarrying in this area from the early nineteenth century (Figure 4.1 and Figure 4.2). This pattern is also reflected in the formation of the retaining wall supporting High Street, which also dips in the central area. This may reflect a greater loss of natural sandstone extending further to the east, or perhaps the convenient height for the connecting bridge between High Street and the wharf buildings (see Figure 2.11 above). The location of the overhead bridge is identifiable by the carved sandstone corbel set into the wall at the dip and the two carved sandstone posts in the palisade fence above (Figure 4.3 and Figure 4.4). The palisade fence along the top of the wall is concreted into the sandstone coping (Figure 4.5).

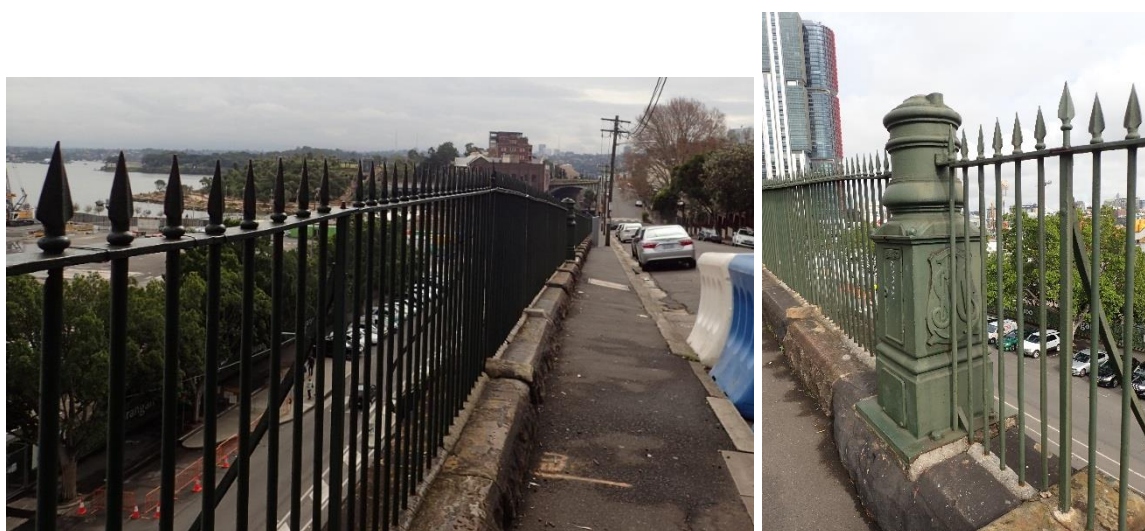
Figure 4.5 View north along the palisade fence (left), and detail of one of the cast iron posts supporting the fence. The fence is concreted into sandstone coping.

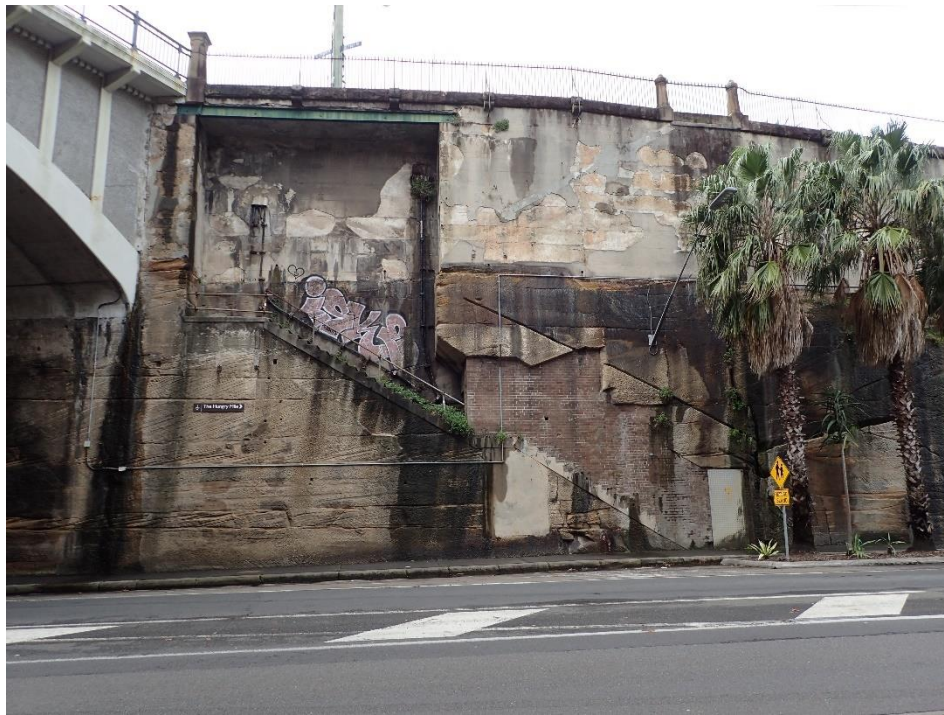
Figure 4.6 View east to the Hickson Steps. Note the brick infill rendering the steps unusable. The sign, left, identifies 'The Hungry Mile' and the steel door to the right identifies buried RailCorp electrical cables.

Hickson Steps rise up in two flights to halt against the Munn Street bridge abutment. The lower flight originally ran beneath a sandstone overhang, which has been bricked in; however, when this was done is not known (Figure 4.6). In addition, although the steps are described in the Inventory as being *associated with the widening of George Street North to allow access to Hickson Road and Pier 1*, it is unclear how this was achieved (REP Inventory for Hickson Steps) (Figure 4.7). It is worth noting that above the steps are two of the sandstone posts, likely marking the location of access to the steps.

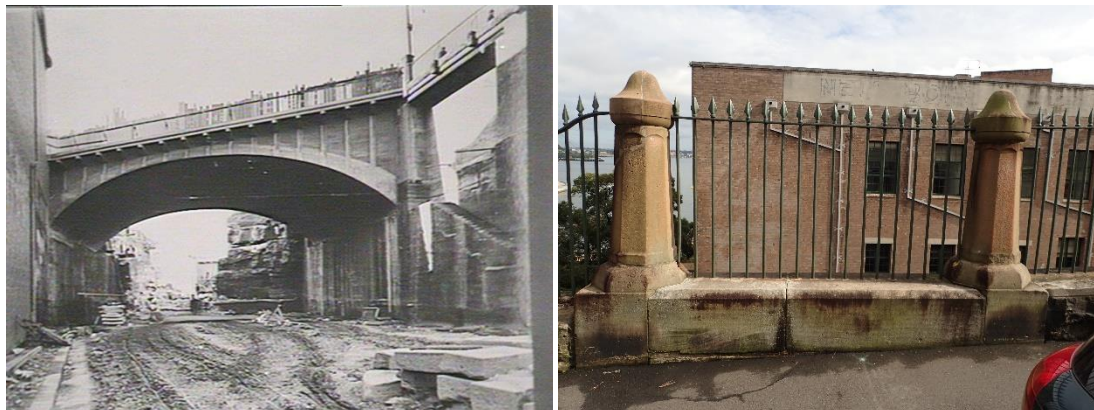
Figure 4.7 The steps do not extend to High Street in this image of the *Reinforced concrete bridge, Munn St over Hickson Rd, Millers Pt.* Note sandstone blocks for the construction of the wall in the foreground (left slnsw #FL1866347). It seems likely that the sandstone posts mark the access to the steps, seen here with the Dalgety Bond Stores beyond.

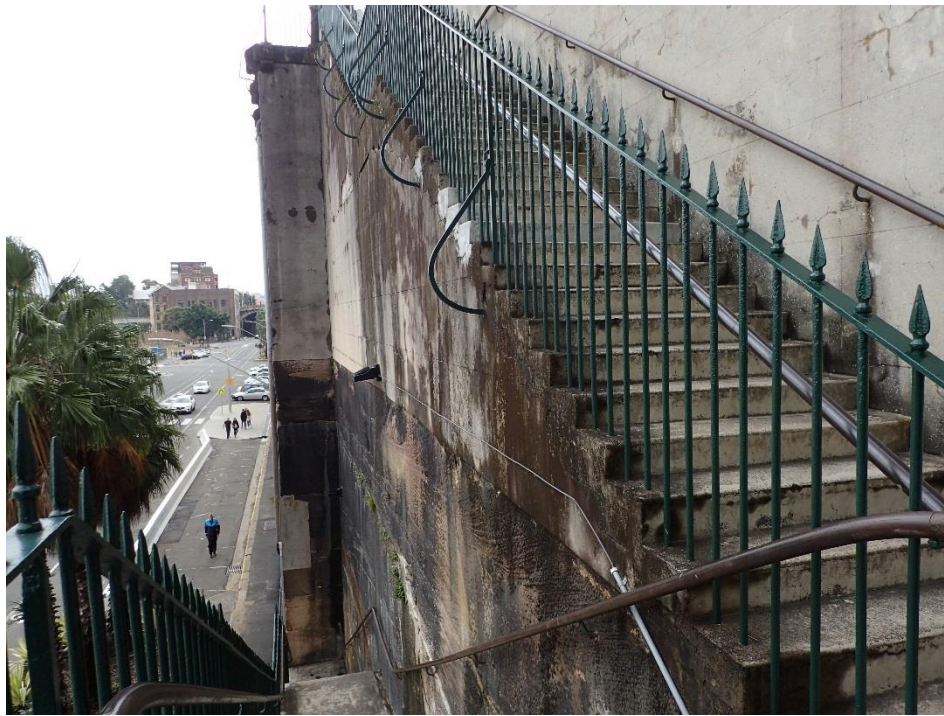
**Figure 4.8** View from the High Street Steps central landing along Hickson Road. Note the original handrails are extant.

The High Street Steps rise from Hickson Road to High Street in four flights (Figure 4.8). The lower two flights lead to the south and are cut into the natural sandstone and are cement rendered, while the upper two flights lead to the north and are integral with the retaining wall and are also cement rendered. There is some evidence of cracking in the steps and a patch of eroded render may expose an underlying brick (Figure 4.9). The original brass handrails are extant, but a later palisade fence has been added to ensure compliance with modern safety standards.

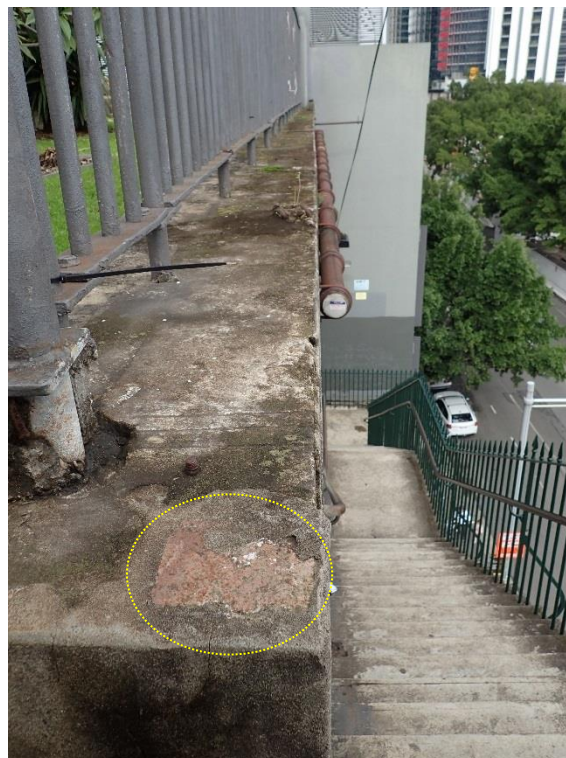
**Figure 4.9** View down the upper flights of steps from High Street. Note eroded render exposing what appears to be a brick.

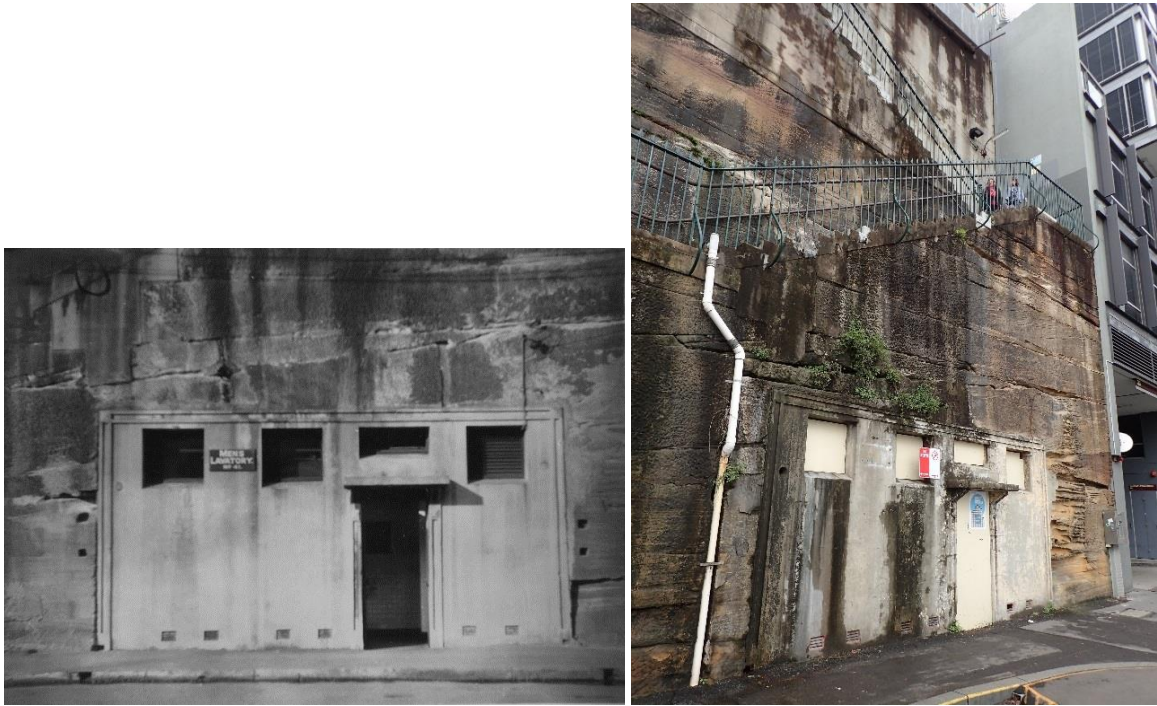
Figure 4.10 There has been little external change to the Men's Lavatory since 1934, when the photo. Left, was taken other than removal of the identifying sign ([http://www.photosau.com.au/cos/scripts/home.asp#NSCA CRS 538/049](http://www.photosau.com.au/cos/scripts/home.asp#NSCA%20CRS%20538/049)).

Set into the bedrock beneath the steps the 'Men's Lavatory' is extant, presumably part of the original construction of the wall and steps (Figure 4.10). The southern edge of the Steps abut the adjacent modern building occupied by TNS Australia, leaving a gap between the two structures (Figure 4.11). To the north of the Steps, is a concrete column rising from street level, and an adjacent bricked in section supporting a down pipe; however, it is not known when these were

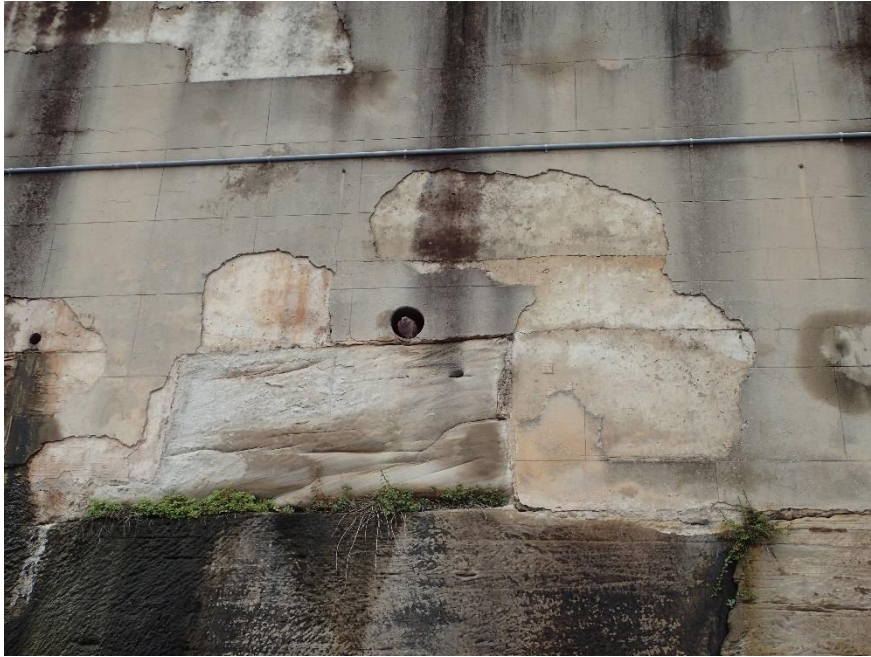
**Figure 4.13** A section of the cutting and wall. The render is scored to replicate masonry blocks and is aligned along the line of the natural bedrock, above which the underlying sandstone blocks have been exposed. Note, the weep hole has been colonised by a pigeon.

The cement rendering appears to be applied to the fabric of the retaining wall but not the natural sandstone. As analysis has only been possible from street level, it should therefore be understood that there may be differences along the upper section of the wall. The cement render has been scored to replicate large masonry blocks and where patches have fallen off, the fabric of the structure of the wall is exposed (Figure 4.13). The original render has a high shell content, it is however also very strong indicating a mix of shell lime with Portland cement, unlike areas of modern patch repairs which appears to be a Portland cement without the inclusion of shell lime (Figure 4.14). The original render was applied in up to three layers, with each layer scored to provide purchase for the next layer (Figure 4.15). In addition, there at least some sections of concrete with a dense gravel aggregate (Figure 4.16).

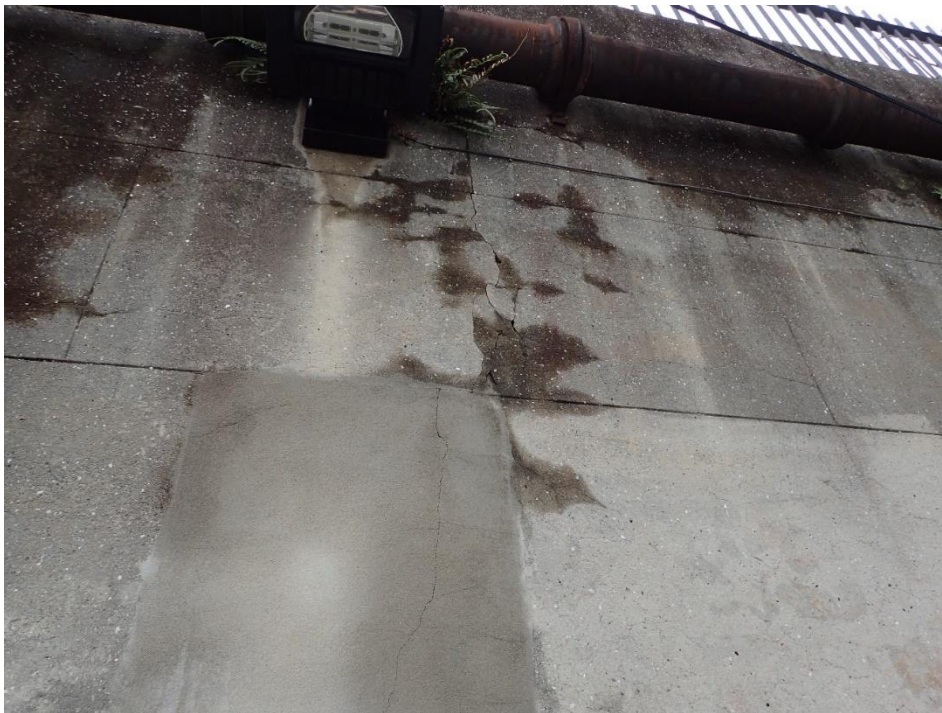
**Figure 4.14** A patch of modern cement render surrounded by the original render. The white flecks are shell fragments.

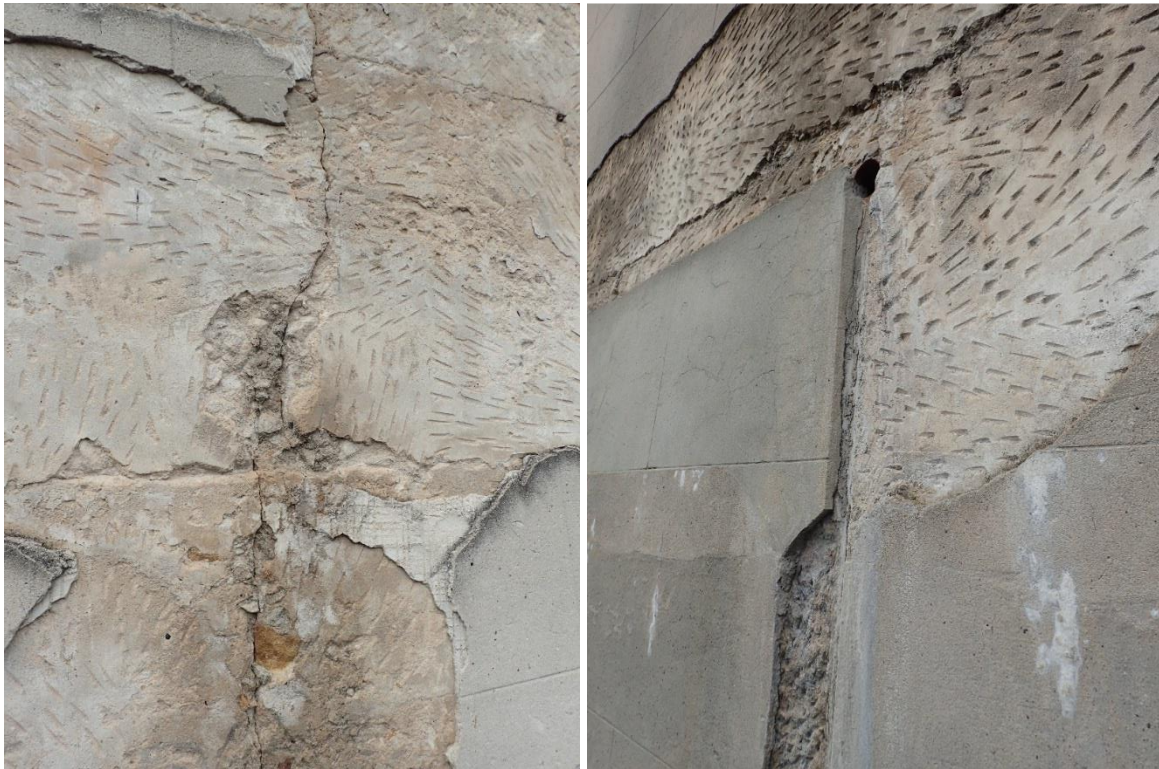
**Figure 4.15** Exposed patches of render indicate that at least some sections have three layers of render and the lower layers are pecked to create a rough surface for the next layer (left). Drainage channels have been shaped into the render below the original weepholes (right).

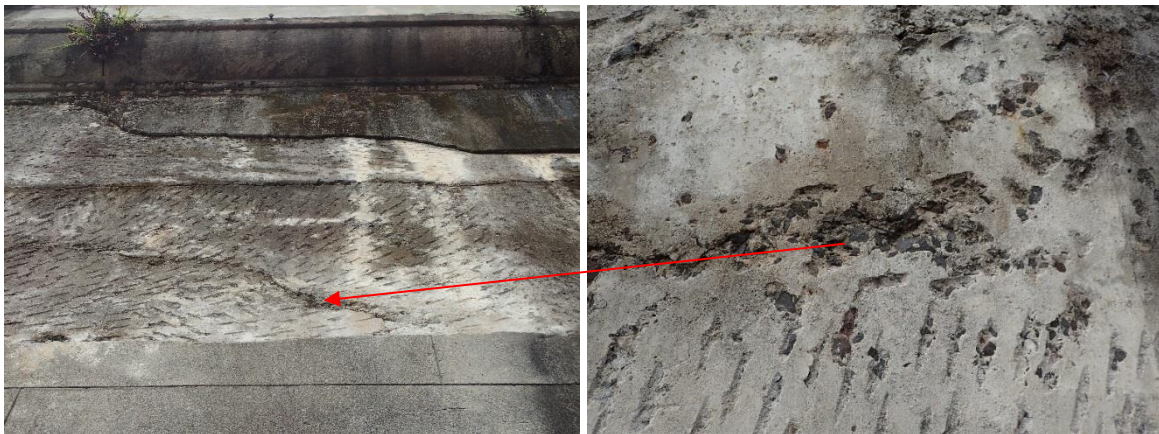
**Figure 4.16** There are sections of concrete with dense gravel aggregate.

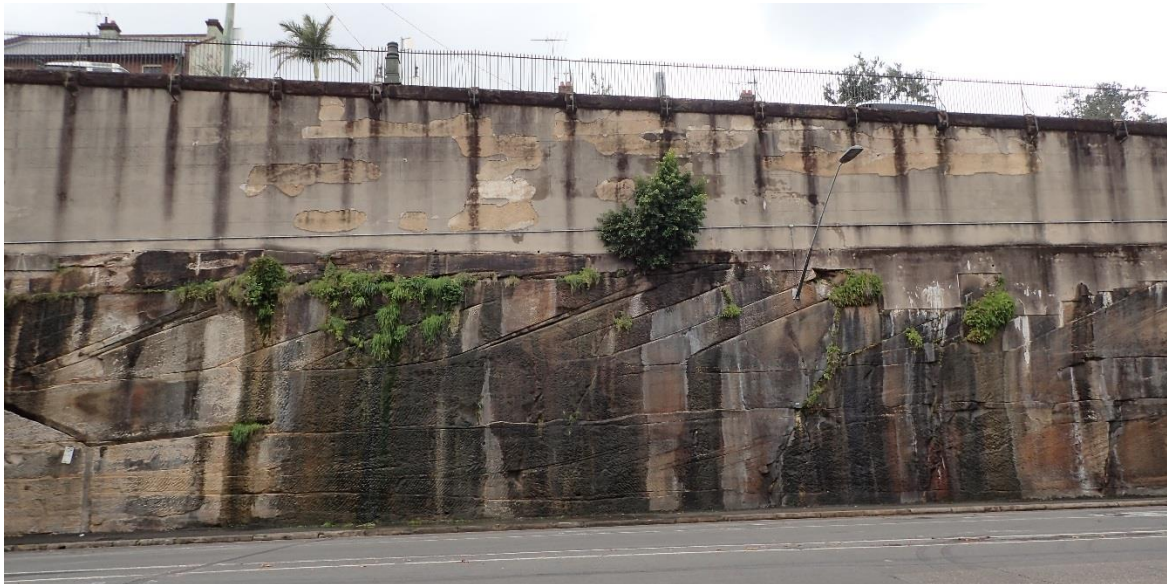
**Figure 4.18** A series of modern lights attached to the wall and cutting with attached signs *Supplied from meter panel/for outages call City of Sydney 1300 651 301*. Note the colonising grasses and ferns, and the stratigraphic layering of the bedrock.

There are cracks across the surface of the wall; however, it is not known whether these are merely surface cracks, or represent underlying faults. There are also generations of attached services, including a series of relatively modern street lights, bolted to the face of the wall, and exposed gaps have been colonised by ferns and grasses (Figure 4.17 and Figure 4.18).

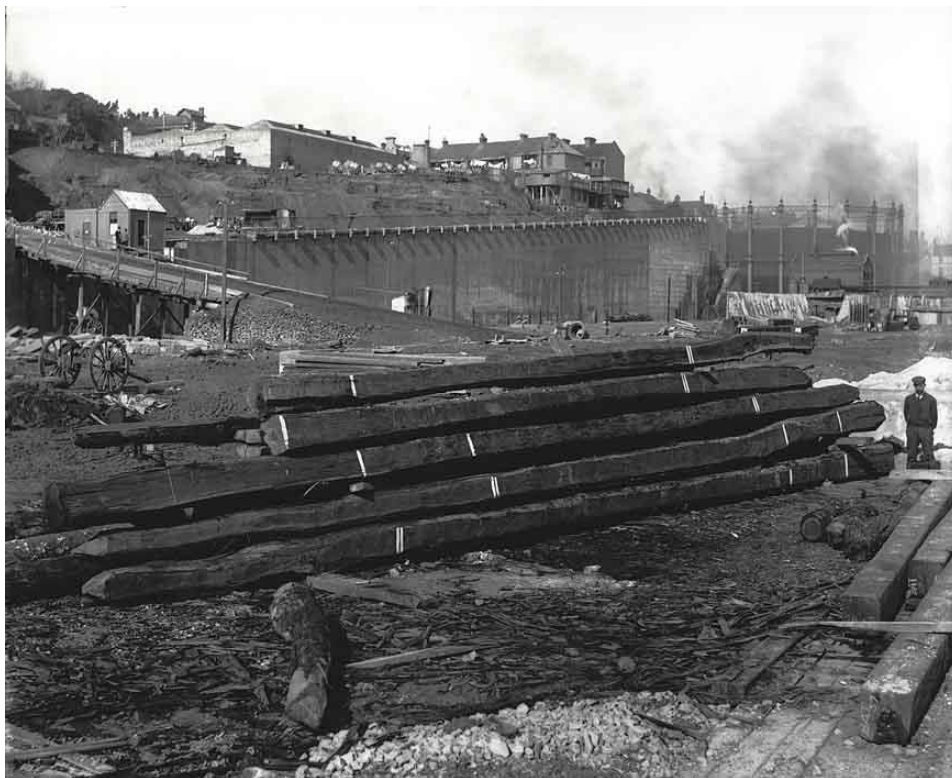
**Figure 4.21** Photograph of the construction of Hickson Road showing what appears to be the overbridge which later linked High Street with the Darling Harbour wharves. Also note the mounds of fill above the wall ([https://s3-ap-southeast-2.amazonaws.com/srns-public-photos/9856\\_a017\\_A01700025.jpg](https://s3-ap-southeast-2.amazonaws.com/srns-public-photos/9856_a017_A01700025.jpg)).

Historic photos indicate that the wall above the cutting was constructed with sandstone or concrete block, which would have provided a more robust structure than a brick alternative (Figure 4.19 and Figure 4.20). In addition, it appears that the overbridge from the wharf to the central section of High Street was initially built to assist in the construction works (Figure 4.21).

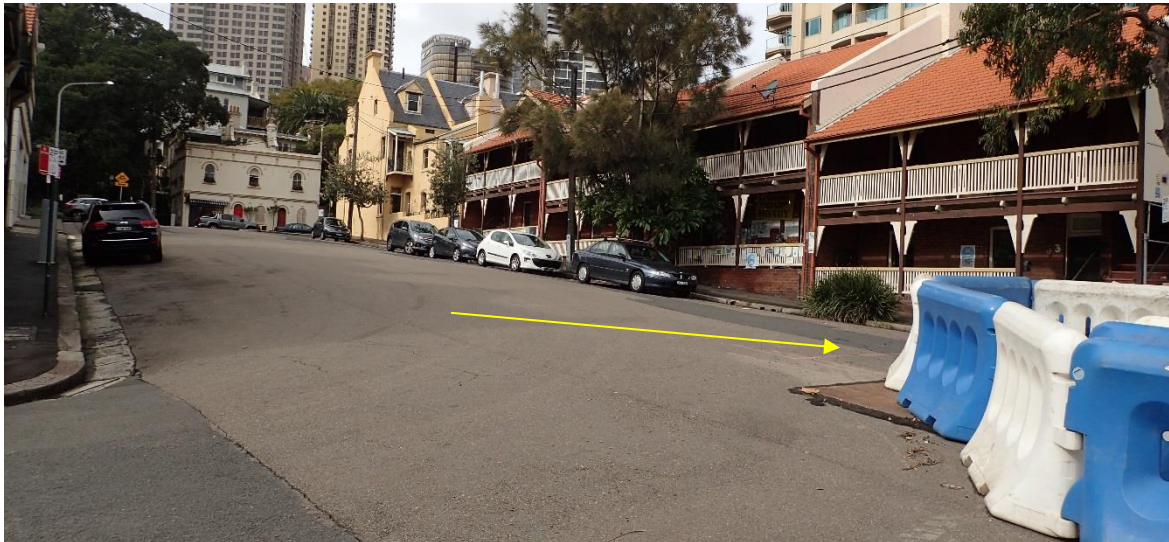
Figure 4.22 The trench along the south side of the east-west High Street return.

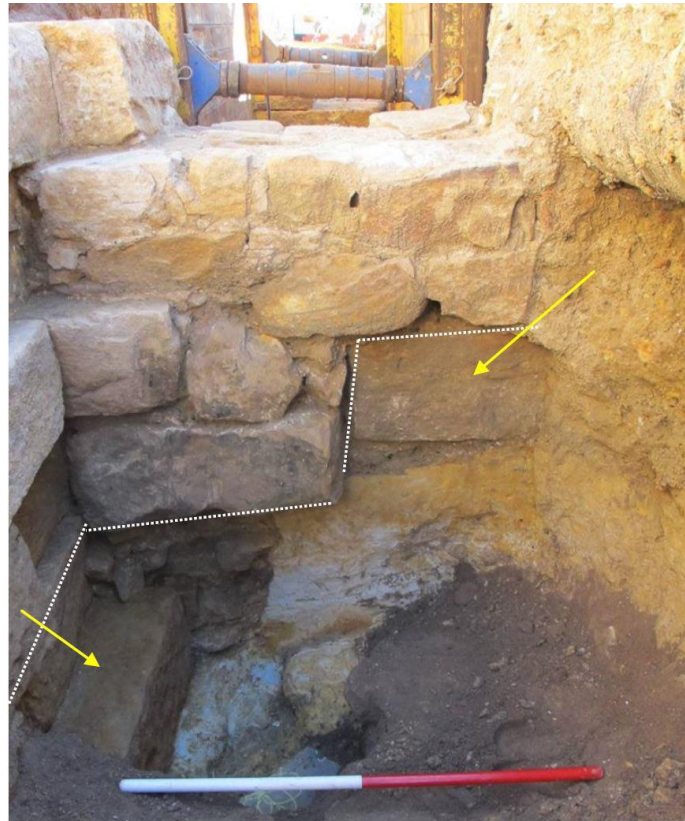
Figure 4.24 View of the cross-wall 13805 in Bay B looking west. Below the dashed line are the potential remains of the earlier 1830s building. The yellow arrows indicate the stones that appear to be different to those used in the upper courses. Scale 1m (Casey & Lowe 2012:36, Fig. 3:33).

- Substantial sandstone walls and foundations, representing the foundations and part of the ground floor of a mid- late-nineteenth century building, initially identified as likely being associated with a sandstone building constructed by Thomas Agar in the 1830s.
- The remains comprised sections of a main east-west wall, defining the south side of the building, five internal cross-walls and a western external wall. The building had at least six internal spaces or rooms. The archaeological evidence indicated an 1850s or later date (Figure 4.23 and Figure 4.24).
- Evidence of a brick building, or room, added to the western end in the late nineteenth century, which included a fireplace was also exposed.

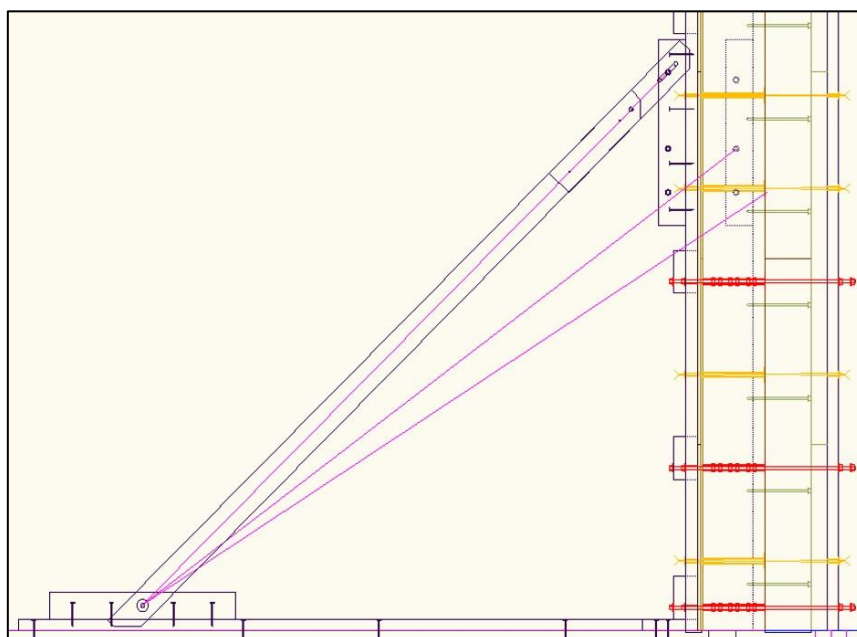
**Figure 4.27 Elevation of the likely appearance and scale of the retaining props installed on the High Street cutting (JHCPBG).**

The retaining props would be installed at 2m-3m intervals along the High Street Cutting and retaining wall and the process would entail drilling into the wall to fix the props and embedding the footings, at the same intervals, into the Hickson Road easement (Figure 4.27 and Figure 4.28). During the process there is a high likelihood that significant areas of the fabric would be damaged. Installing reaction footings is not considered in the short term (construction) phase of the TSE works, due to the need to excavate this area for the construction of the Barangaroo Metro station. Similarly, the long term (permanent, post-construction phase) design for Hickson Road requires the area to be reinstated to its current state. Props would therefore need to be removed and would not offer long term protection to the wall, however it is not clear whether this would have a serious structural impact on the wall or not.

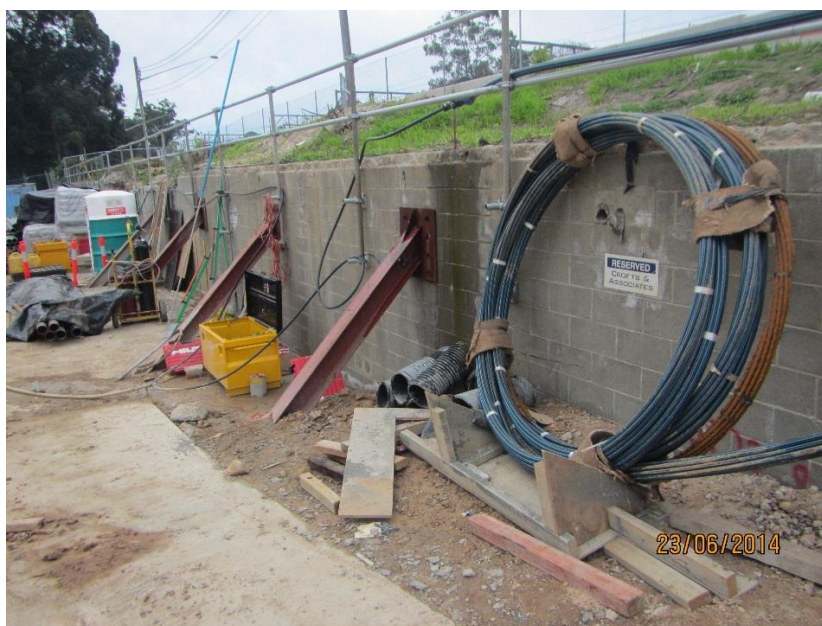
**Figure 4.28** An example of retaining props, albeit at a much smaller scale than would be required for the High Street cutting (JHCPBG).

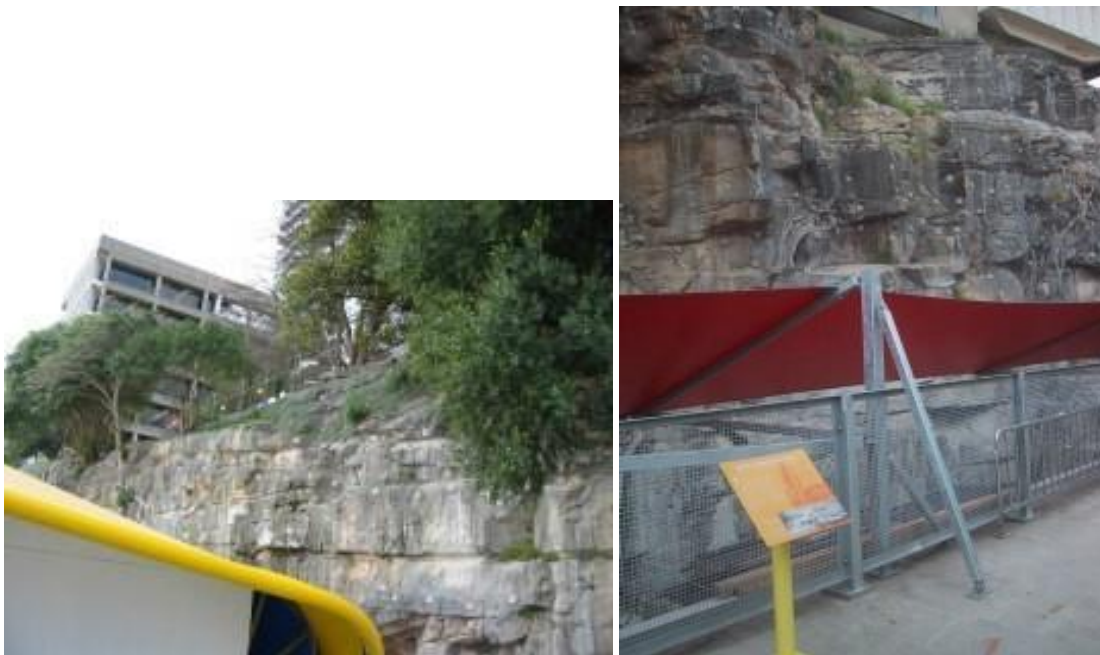
Figure 4.30 Rock bolting of the sandstone cliff, Site C, Luna Park undertaken prior to 2006 (OCP 2006:23).

Rock bolting has been used successfully to stabilise natural sandstone embankments and cliff faces associated with items listed on the SHR (Figure 4.30 - Figure 4.32). However, unlike standard rock bolting, the retention anchors will be recessed and patched, thus minimising the visual effect on the cement render of the retaining wall (Figure 4.33). In addition, the patching cement would replicate, as far as possible, the composition and colour of the existing cement render (Figure 4.34, see also Appendix D to the JHCPBG report). The replacement render should consider the composition of the original render in order to ensure that a too hard cement patch does not cause cracking or collapse of the original render.

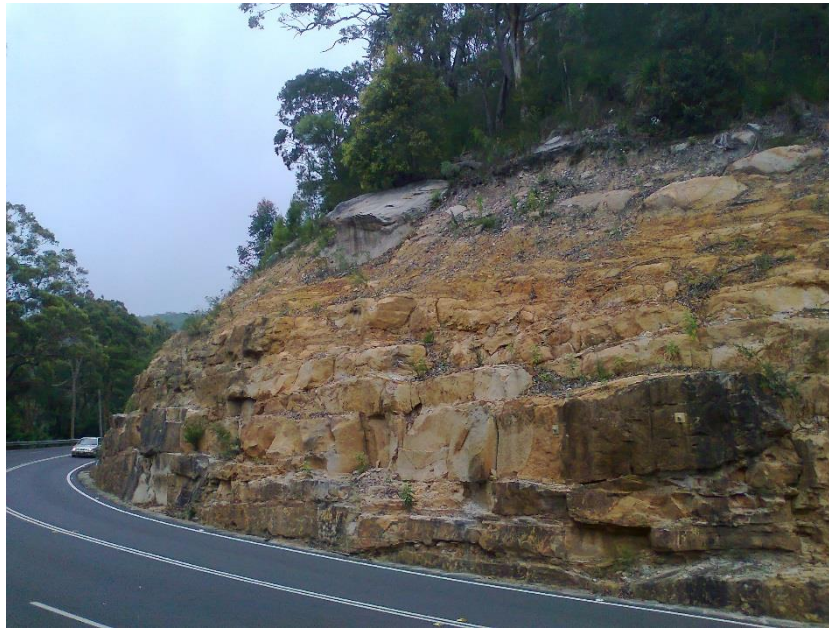
**Figure 4.31** Rock bolting the natural sandstone on the Old Northern Road at Wiseman's Ferry (RMS Engineering Services).

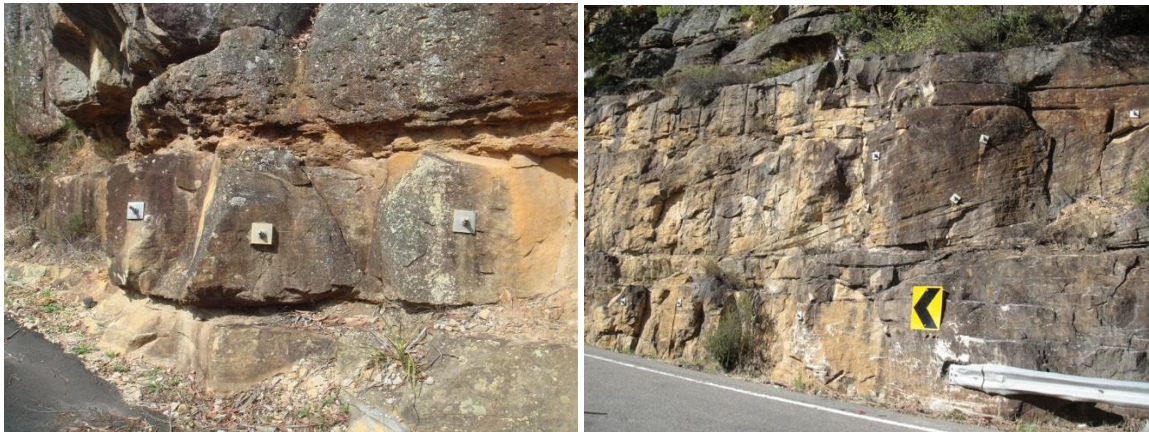
**Figure 4.32** Detail of the rock bolting on the Old Northern Road at Wiseman's Ferry (RMS Engineering Services).

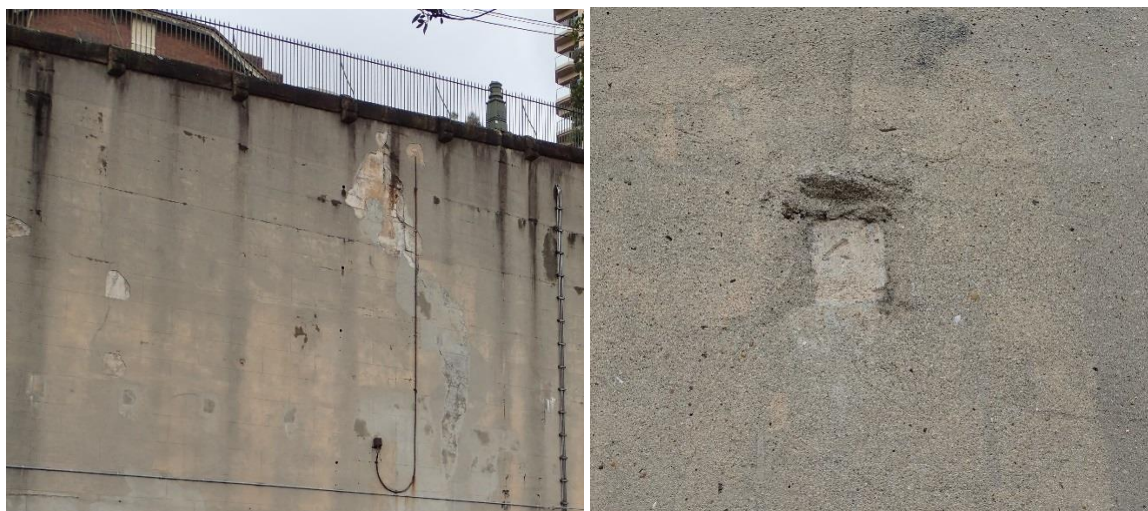
**Figure 4.33** 1995 retention anchors along a section of the High Street retaining wall (left), and a detail of the recessed and patched anchor.

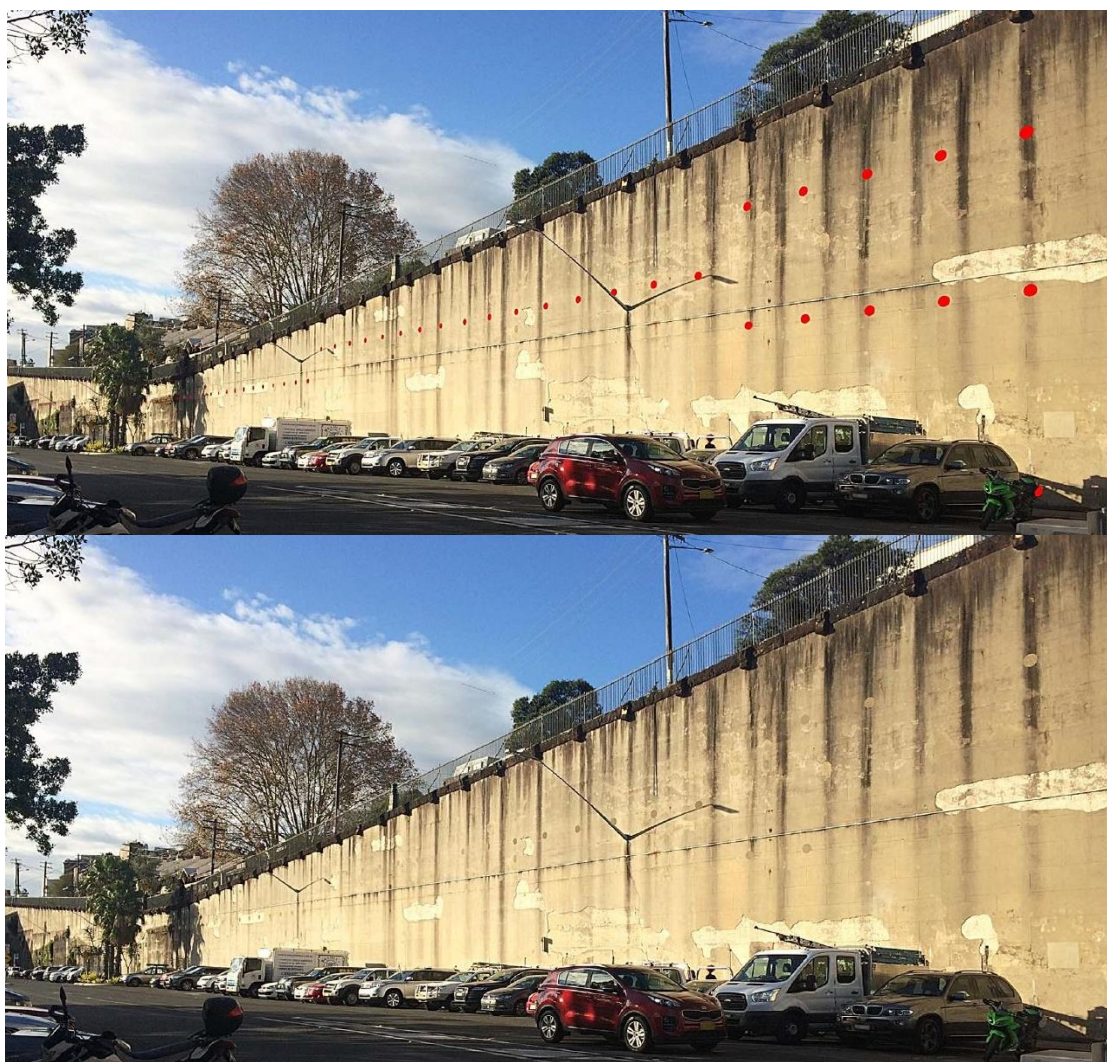
**Figure 4.34** Photomontage of the appearance of the retention anchors following patching. The image above shows the locations in red, while the image below is the after patching appearance (JHCPBG Appendix D).

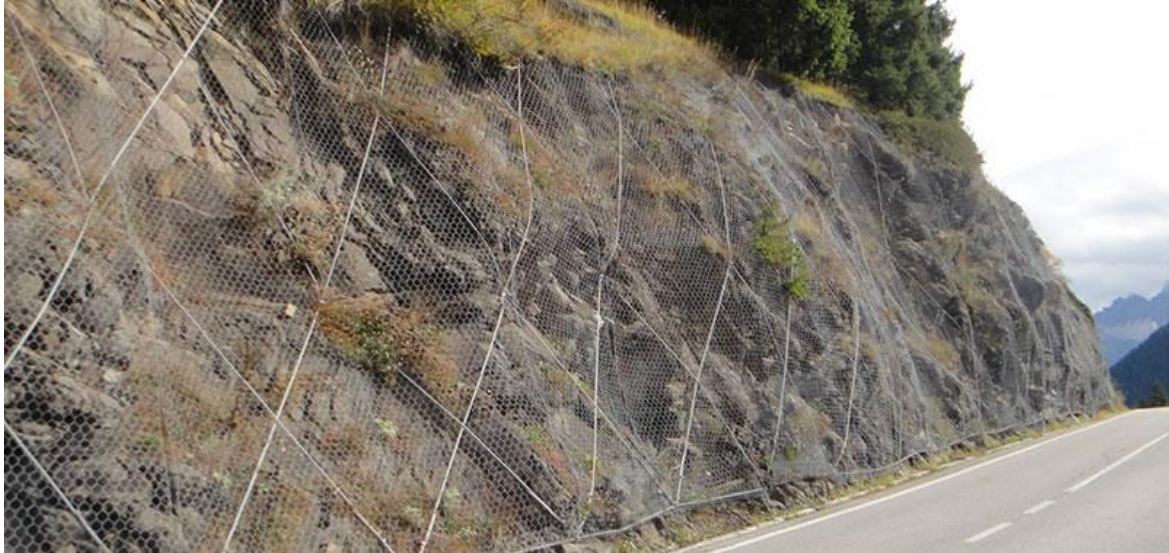
**Figure 4.35 Protective netting attached to a road embankment (JHCPBG).**

The installation of protection netting or mesh to the High Street cutting would be a short term measure to protect the public and construction workers from injury should any minor damage to the wall cause render to crack and fall away. The netting would be in a form similar to that used on rock-retention systems, albeit the much smaller piece size of a piece of render would not demand that the netting be affixed with large rockbolts as is usually the case. Options are currently being investigated which would provide a minimal impact on the wall, should it be required.
