# Independent Environmental Audit on Sydney Metro City & Southwest – TSE Works

## Final Report

**Contract works: Tunnel, Stations & Excavation Works (TSE)**

**Scope: Barangaroo Spoil barging compliance and operational readiness**

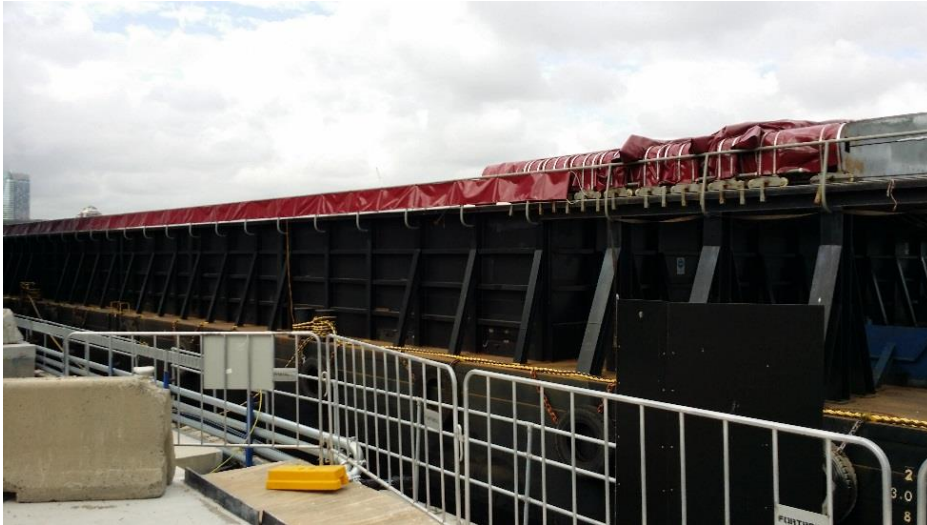
**Above:** Moored Barge showing steel wall for spoil containment and retractable protective cover (closed as shown)

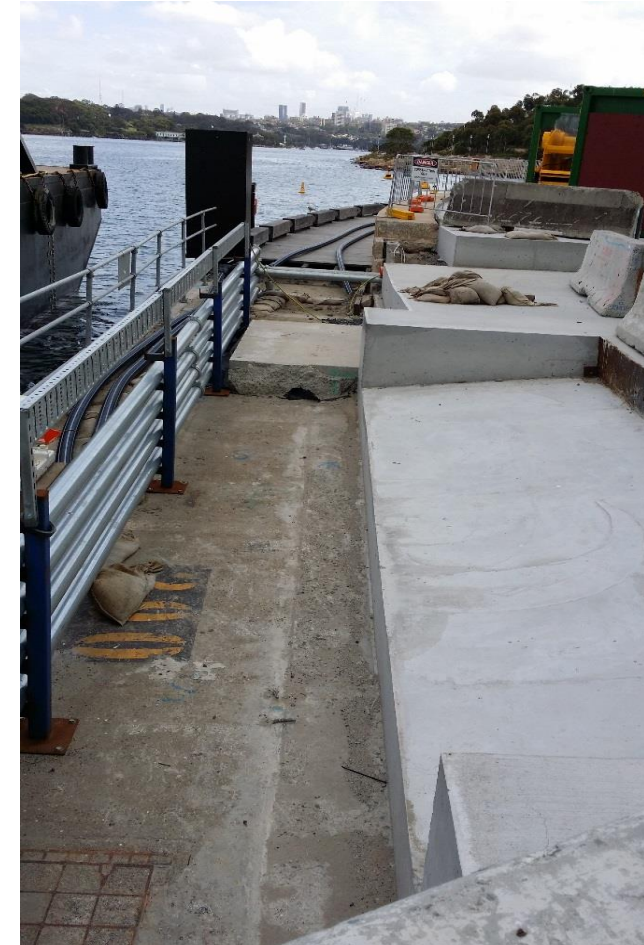
**Right (alongside):** Varied arrangements observed alongside the wharf edge, such as random sandbags and jersey kerbs, however no definitive uninterrupted barrier to prevent liquid or solid silt or sediment flowing over the edge.

1.	Physical spoil spillage mitigation measures around the Barangaroo wharf loading area needed to be enhanced before commencement of barging, and should correlate with the Site Environmental Plan and Erosion & Sediment Control Plan.	Low

1.	<p>Physical sediment or silt control measures needed to be enhanced in the vicinity of the conveyor loading point, alongside or near the wharf / water edge (silt control), to ensure ongoing compliance with MCoA E65</p> <p><i>It was noted that the loading zone was concrete and predominantly sloping away from the edge, however there were components that were not and Management Plans were conflicting in the depiction of barrier controls e.g.</i></p> <ul style="list-style-type: none"> <li>• Site Environment Plan had an unbroken retaining wall</li> <li>• Progressive ERSED Plan requires sandbags instead</li> </ul> <p><i>None of the above measures were implemented in entirety and/or presenting an impregnable barrier, as can be seen from the Photograph in Appendix 1B.</i></p> <p><i>JHCPBG noted that the conveyor delivered subsequent to this audit had top and bottom covers in place and were being used as another mitigation measure.</i></p>	Waterway pollution potential	Low	<p><b>Action to be taken by JHCPBG:</b> Hard barriers to be installed around the top edge of the load out area, plus a line of sandbags on the inside edge to prevent any runoff leaving site (noting the slab drains back in towards site). Also, silt curtains to be installed in the gap between wharf/barge. Lastly, old sandbags and materials would be removed from the area.</p> <p><b>Responsible person:</b> Environment, Approvals, Sustainability &amp; Interface Manager</p> <p><b>Due date:</b> 13 December 2018, or prior to barging.</p> <p><i>Prior to finalisation of this report, JHCPBG noted that the action had been undertaken.</i></p>
