Pre-Construction Minor Works Approval Form

Part 1: Application	
Contractor:	RPS Pty Ltd
Project:	Sydney Metro – Utility Investigations
Application Title: (e.g. Smith St trenching works)	Utility investigations including slit trenching: - Hickson Rd Barangaroo
Application Number:	4
Application Date:	Original submission: 03/02/17 Resubmission: 10/02/17
Planning Approval:	Chatswood to Sydenham
Minor Works Categories: <ul style="list-style-type: none"> Highlight as applicable. If Items 4, 8 or 11 are applicable, this form must be endorsed by an Environmental Representative. 	<ol style="list-style-type: none"> Survey, survey facilitation and investigations works (including road and building dilapidation survey works, drilling and excavation). Treatment of contaminated sites. Establishment of ancillary facilities (excluding demolition), including construction of ancillary facility access roads and providing facility utilities. Operation of ancillary facilities that have minimal impact on the environment and community. Minor clearing and relocation of vegetation (including native). Installation of mitigation measures, including erosion and sediment controls, temporary exclusion fencing fo

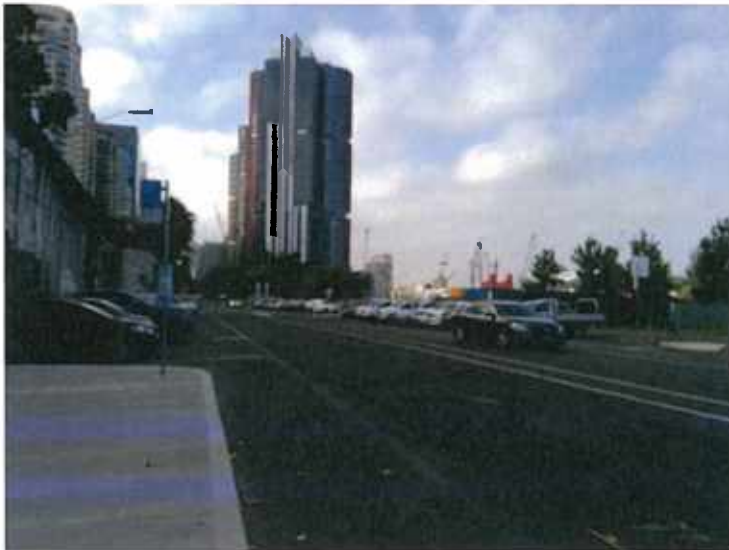
Plate 6.1 View south from northern end of study area,

The Hickson Road surface showed evidence of resurfacing and there appears to have been recent kerbing works along the northern portion of the site (Plate 6.1). The Hickson Road cut has been covered in concrete which is falling away in some places as well as brick and in some cases the natural sandstone is visible (Plate 6.4). Subsurface utilities were also noted throughout the site (Plate 6.4). The Dalgety's Bond Store located on the north western corner of the study area spans the Hickson Road level and upper Munn Street level (Plate 6.5).

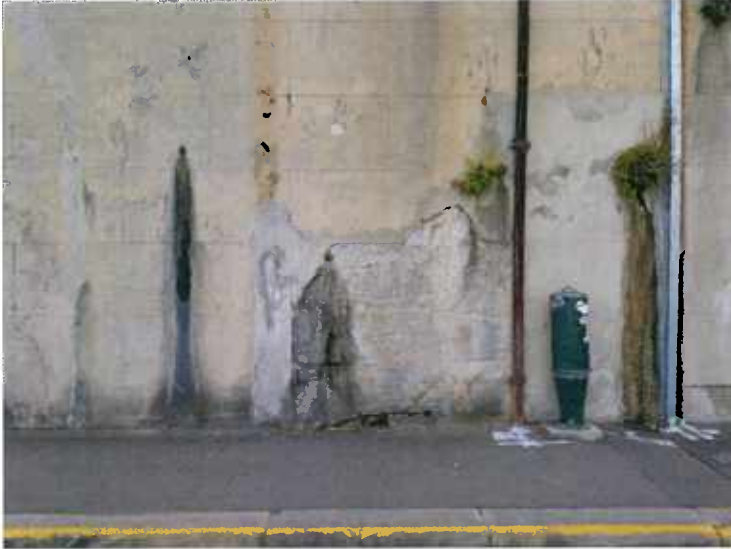
Plate 6.4 Section of cut where concrete has fallen away revealing sandstone beneath, also note Telstra pillar indicating subsurface utilities
