# Sydney Metro City & Southwest Sydenham to Bankstown Upgrade

Technical Paper 4

Aboriginal Heritage Impact  
Assessment

August 2017

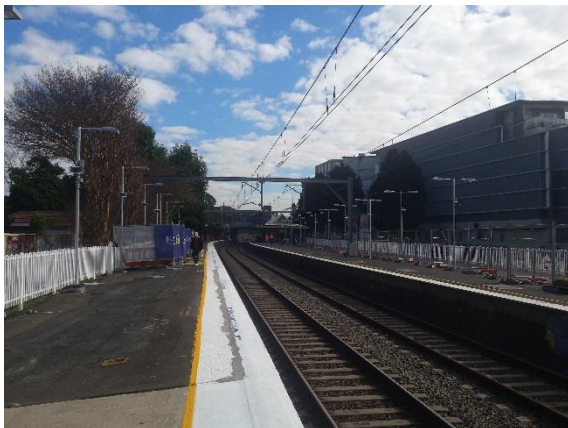
There was very little surface visibility outside the rail corridor due to sealed roads, pathways, structures and grass (Plate 2). Surface visibility improved within the rail corridor, however it was still fairly limited due to rail station infrastructure and ballast. Areas of improved ground surface visibility were observed within the rail corridor to the east of Marrickville Station. Exposures were noted within an area where erosion had occurred (Plate 3).

**Plate 2: Marrickville Station survey unit view east**

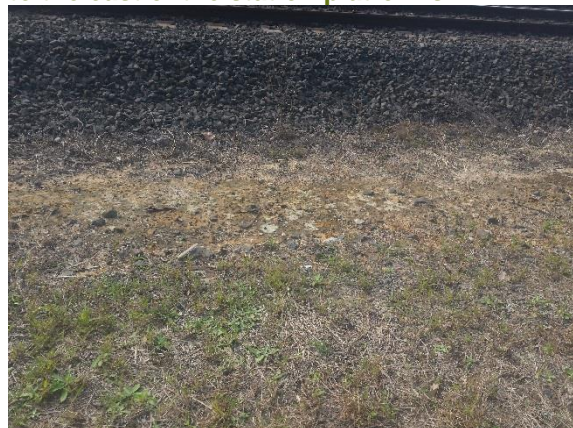
**Plate 3: Marrickville Station survey unit-small area of erosion observed within the rail corridor to the east of the station platforms**

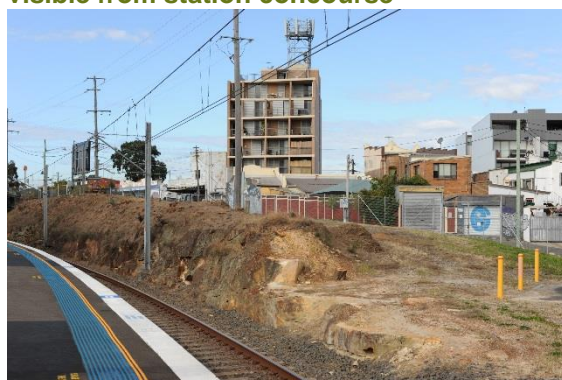
**Plate 5: Underlying Hawkesbury sandstone is visible from station concourse**

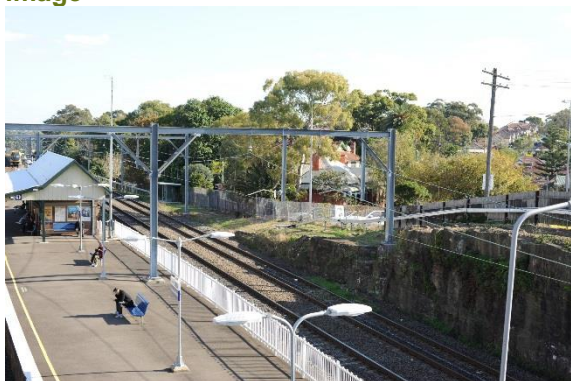
**Plate 6: View west from the upper concourse area. The original crest and slope landform can be seen on the right hand side of the image**

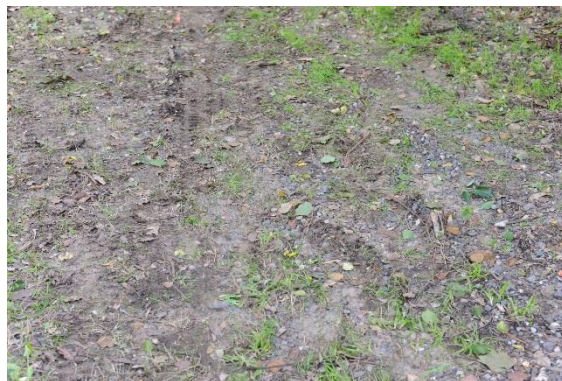
**Plate 7: Exposures down track of Hurlstone Park within the rail corridor. Introduced fill was evident within exposures**

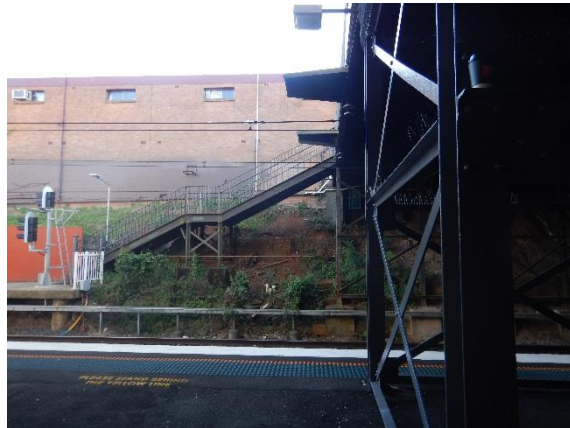
Visibility was low throughout the survey unit due to the built up nature of the area. Visibility was impeded by sealed surfaces, structures and vegetation. Some surface visibility within the rail corridor was observed across the proposed compound area (Plate 10). Introduced gravels were evident across the ground surface. No Aboriginal objects were identified. As with the majority of stations in the study area, the Campsie Station is located within a cut below street level (Plate 11).

**Plate 11: Campsie Station is located within a cut below street level**

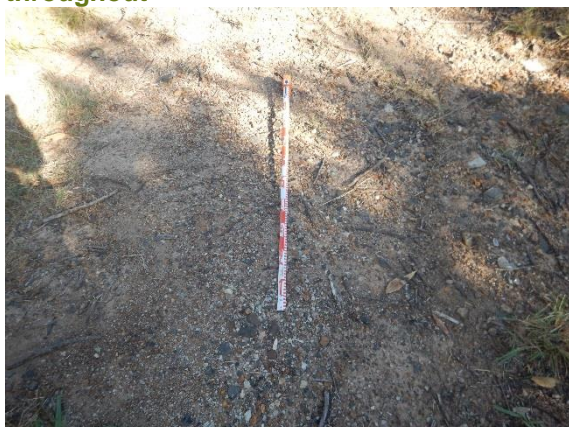
**Plate 12: Exposures were rare within the survey unit and no Aboriginal objects were identified. Introduced fill was evident throughout**

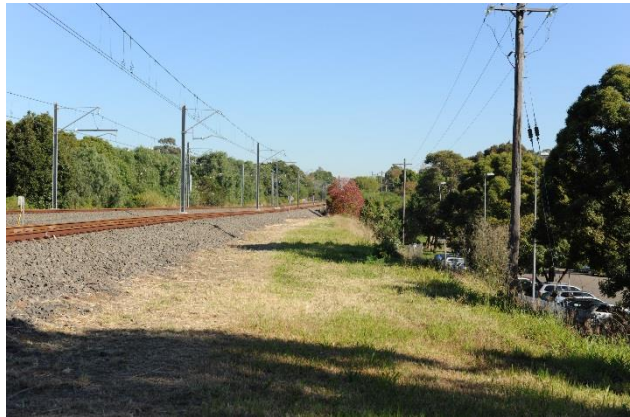
**Plate 15: View west across proposed construction compound adjacent to Lakemba Station. The rail is located on an artificial embankment above street level at this location**

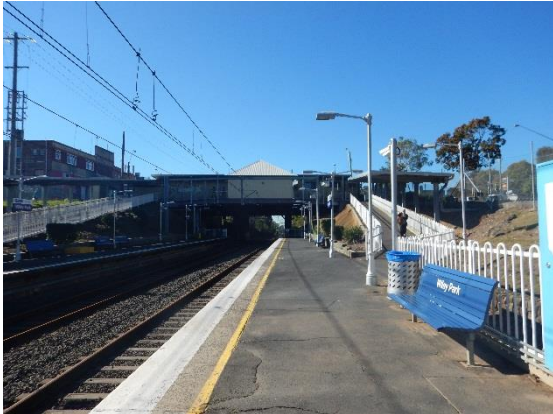
**Plate 16: Wiley Park Station view east along Platform two. The east portion of the station is cut below street level**

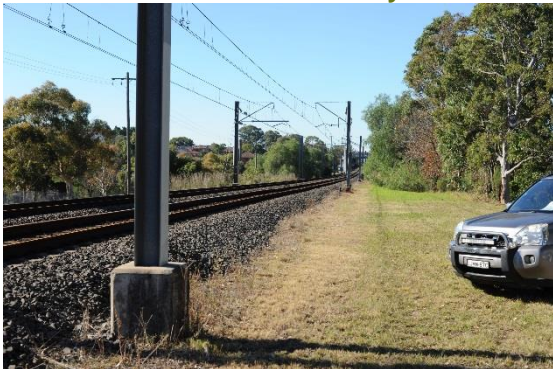
**Plate 18: View east along proposed construction compound adjacent to Wiley Park. Dense vegetation and rail infrastructure reduced visibility to zero**

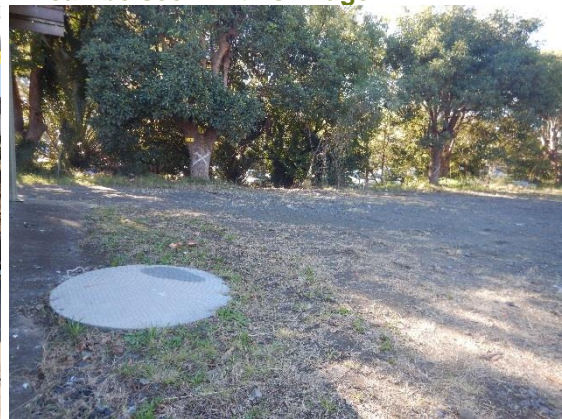
The station platforms and rail are located within a shallow cut below street level (Plate 19). The construction compound to the north of Punchbowl Station was found to have been heavily disturbed. Large quantities of fill were evident across the site and it appears that the area is currently used as a construction compound during rail possessions (Plate 20).

**Plate 20: View across portion of proposed construction compound (north of Punchbowl Station). A drain and introduced fill can be seen in this image**

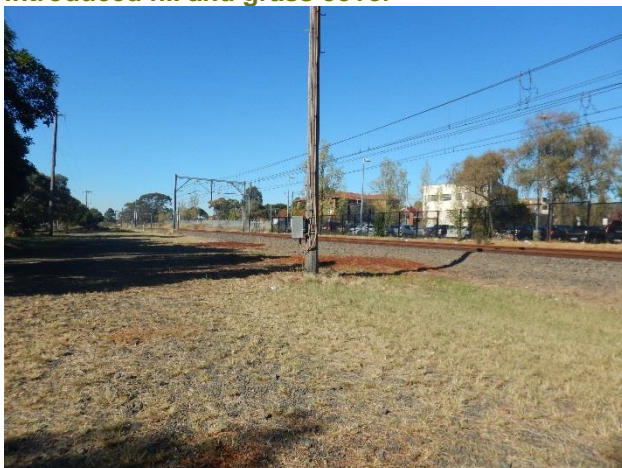
**Plate 21: View east across proposed construction compound (north of Punchbowl Station). Visibility is low across area due to introduced fill and grass cover**

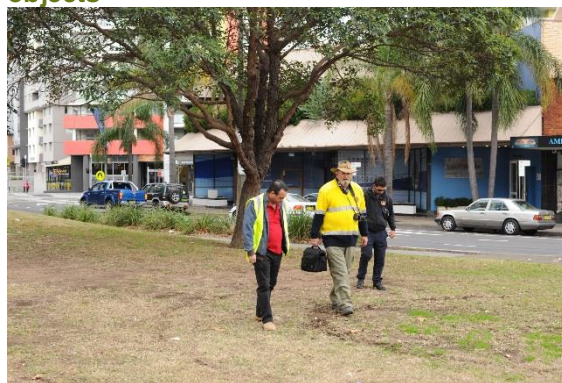
**Plate 23: Bankstown Station survey unit, exposures were inspected for Aboriginal objects**

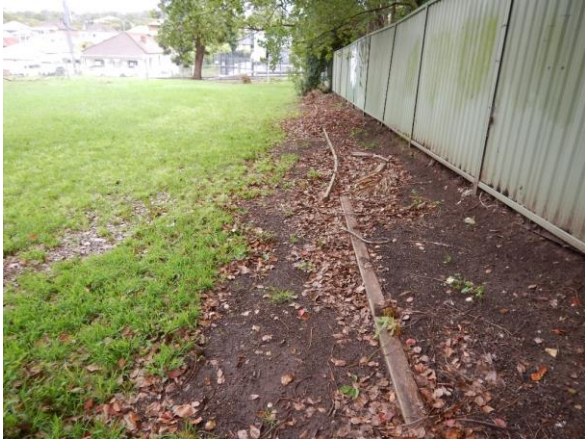
**Plate 30: Introduced topsoil at northern edge of survey unit, west aspect**

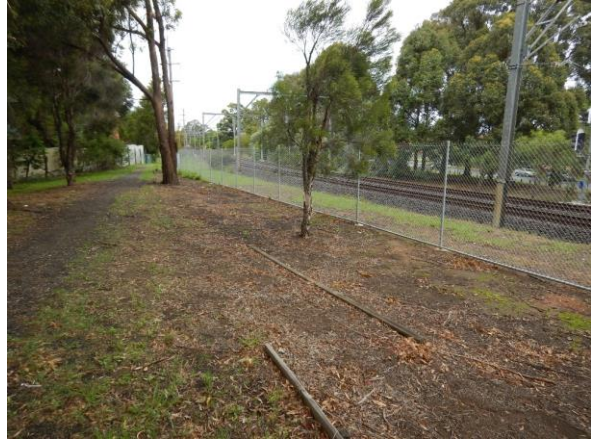
**Plate 31: View of introduced soil and exposed underlying clay, south aspect**
