6. BUILT HERITAGE ASSESSMENT

6.1 Marrickville Station Catchment

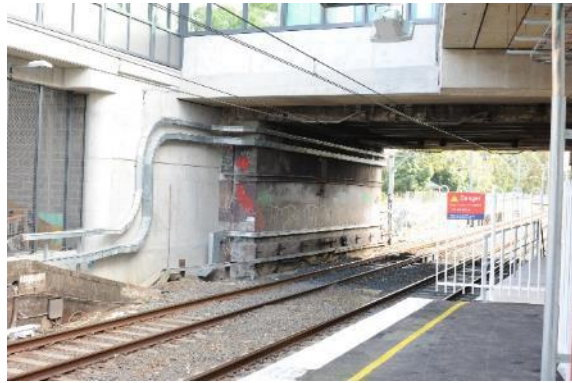
Figure 130: View of overbridge, west aspect

Marrickville Station consists of one wayside platform (Platform 2) to the south and an island platform (Platform 1) to the north (Figure 119 to Figure 128). Passenger rail only uses the south side of the island platform, with the Metropolitan Goods Line running on the north. The station buildings are original, as is the booking office at the western end of Platform 2 (Figure 124). The station is accessed via the stairs from the Illawarra Road overbridge and via a second set of stairs on the south which give access to Platform 2 (Figure 129, Figure 130).

Existing views from the new Illawarra Road overbridge would not be significantly impacted compared to existing views and vistas. The proposed replacement of the Illawarra Road overbridge with a sympathetically designed structure would have a moderate visual impact on the station group, although views from the overbridge to the significant station buildings would be retained.

13.1 Associated Sites	<p><i>Support the upgrading of the Illawarra Road bridge in rationalising the services and removing the vandalism and graffiti damage</i></p> <p>The bridge has found to be in such poor condition that options for upgrade have been discounted</p>

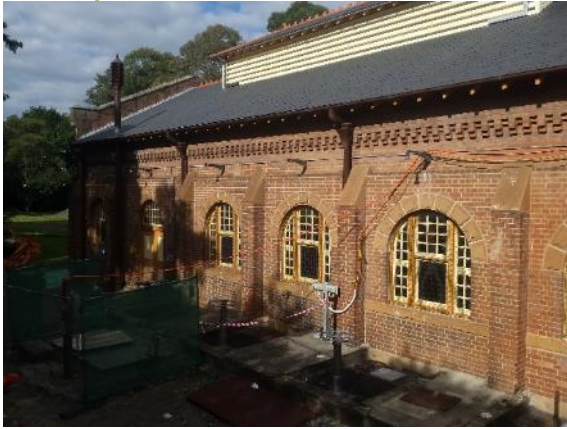
Figure 131: View of pumping station, south-east aspect

The complex consists of a combined boiler house and engine room, a large chimney stack and a residence (Figure 131 to Figure 142). The pumping station/ boiler house is designed in classic Federation Romanesque style (Figure 131, Figure 135). Decorative Gothic buttresses with steep copings flank its sides, round headed windows surmounted by arches of rusticated sandstone typify the window openings, and the walls and gables are accentuated by machicolation motifs. The gables have sandstone copings with bracketed kneelers. The windows are small paned figured glass with pivotal awnings typical of the Federation style. The internal doors are round headed diagonal panelled double doors and are similar in style to the external doors.

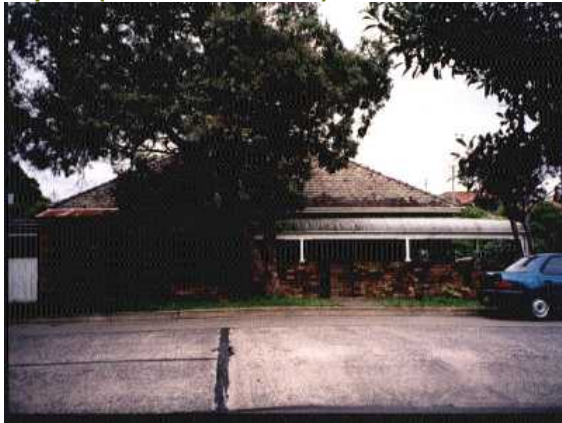
Figure 143: View of Stone house, north-east aspect (Source: OEH SHI)

The house is the largest of the rock faced sandstone houses found in close proximity of early sandstone quarries in Marrickville. It has smooth faced cut stone quoins and surrounds to the French door openings on the verandah, a slate roof and late Victorian columns. The original detailing to the doors and windows has been lost. Modifications to the house include the addition of security features, brick and metal boundary wall treatment along Myrtle Street and a metal and timber lean-to addition to the west of the original dwelling (Figure 143).

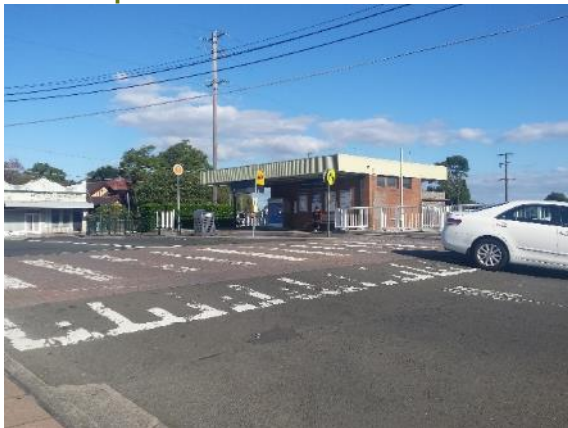
Figure 170: View of overhead booking office, south aspect

Hurlstone Park Station was designed and built by NSW Government Railways. Hurlstone Park Station was opened as Fern Hill on 27 November 1894. It was renamed Hurlstone Park on 19 August 1911. In this year the Metropolitan Goods line was built past the station as well as a new Down platform. In 1915 the original timber station building was replaced by brick buildings on both platforms and an overhead booking office (Figure 170 to Figure 181). The latter was replaced in the 1980s by a new booking office (Figure 170).

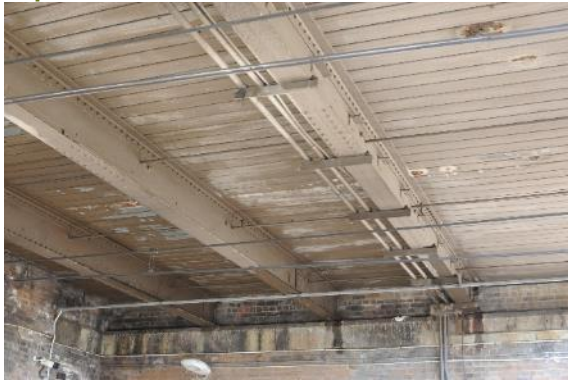
Figure 182: View of overbridge, north-east aspect

Hurlstone Park Station consists of one wayside platform on the south and an island platform on the north. Passenger rail only uses the south side of the island platform, with the Metropolitan Goods Line running on the north. The station is accessed via the overbridge and overhead booking office from Floss Street. The overbridge is excluded from the heritage listing (Figure 182, Figure 183).

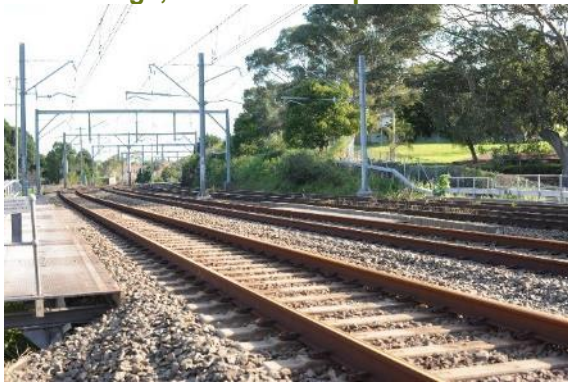
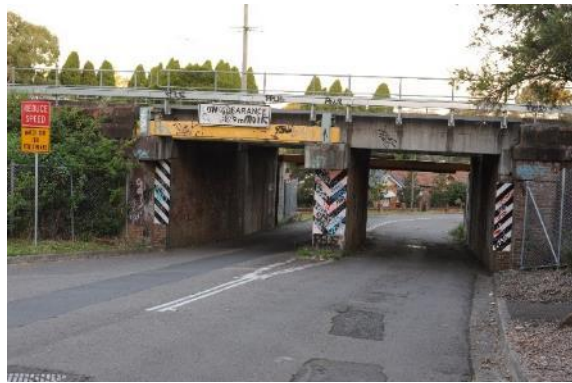
Figure 184: View of railway corridor section of underbridge, south-west aspect **Figure 185: View of underbridge, south aspect**

The Hurlstone Park Railway Underbridge was designed by engineering staff, New South Wales Government Railways and constructed by day labour. It consists of a single span, double track, prestressed concrete girder railway bridge, with 9.85 metre clear span between brick abutments, consisting of parallel, post-tensioned precast I-shaped concrete girders transversely post-tensioned in-situ to create a homogeneous structure carrying ballasted tracks (Figure 184 to Figure 187). The concrete girders rest on concrete padstones on top of each brick abutment. The bridge carries the double track Bankstown Railway over Foord Avenue. It was constructed shortly after the first prestressed bridge at Dombarton in 1962.

The viaduct is in good condition with the following defects: spalling concrete girders, minor cracks in headstock and water seepage through abutments. No recent condition report for the M25 part of the bridge has been reviewed.

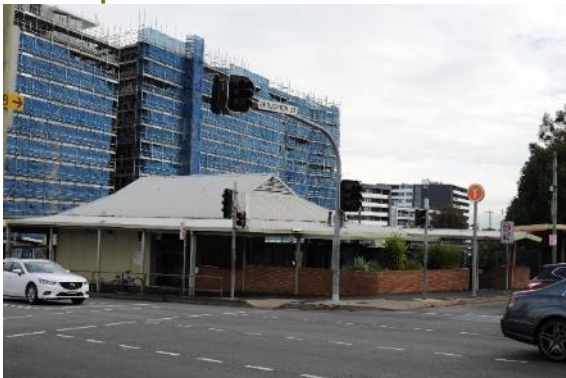
Figure 197: View of overhead booking office, west aspect

Canterbury Station was designed by N.S.W. Government Railways and built by J.J. Scouller. Canterbury Station consists of one wayside (Platform 2) on the south and one island (Platform 1) on the north, with both original platform buildings remaining (Figure 189 to Figure 194). The northern side of the island platform is not used for passenger services. The wayside platform is accessed from the footbridge via a ramp, while the island platform is accessed by stairs (Figure 195, Figure 196). An overhead booking office accessed from the Canterbury Road overbridge on the east and from Broughton Street on the north was rebuilt in the late 1980s (Figure 197). The railway was electrified in 1926.

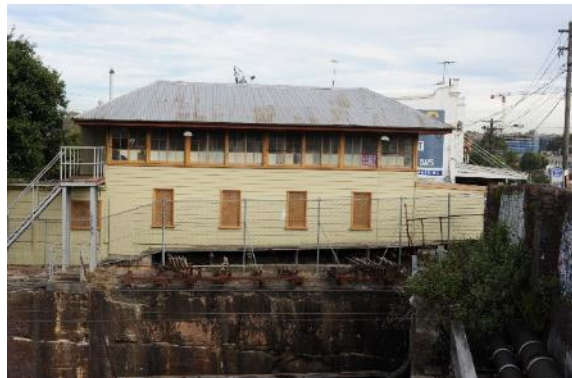
Figure 198: View of signal box, south aspect

Canterbury signal box was commissioned on 13 December 1915 as part of the resignalling and track alterations of Canterbury station in preparation for the opening of the new Metropolitan Goods Line from Lidcombe via Enfield Marshalling Yards to Rozelle, in April 1916 (Figure 198). The signal box was constructed with a mechanical interlocking lever frame using 68 of the 72 possible lever positions, which controlled the operation of signals and points in a set sequence.

Two extensions have been added to the signal box. The western annex in 1937, and the eastern annex in 1968 to provide additional space to accommodate signalling relays, circuits and equipment. In 1994 a start was made on replacing the life expired signalling system and equipment on the Bankstown Line and the Metropolitan Goods Line. This resulted in the closure of Canterbury signal box on the weekend of 30/31 December 1996. After its closure it was sealed in its 'as closed condition' by the Heritage Section of the State Rail Authority to preserve the building and its internal signalling equipment.

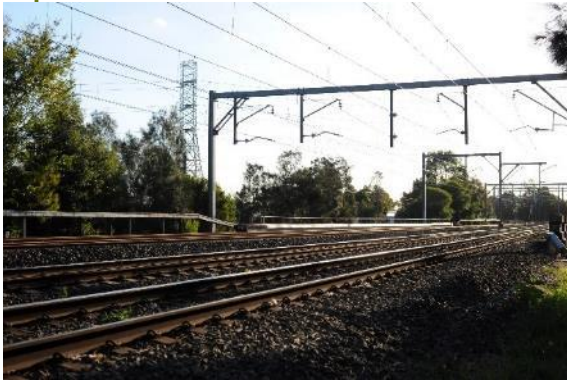
Figure 199: View of railway corridor, west aspect

The bridge was constructed in 1916 by day labour and designed by NSW Government Railways. It is a three span, double track, brick arch railway bridge, with 16.16 metres clear spans between intermediate foundations and abutments (Figure 199 to Figure 202). The arches are semi-circular in elevation with plain brick spandrel walls and stone coursing above the crown of the arches. The bridge is in good condition with some minor cracking and staining of the brickwork.

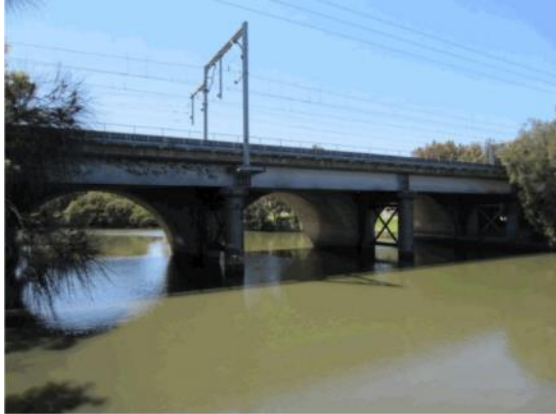
Figure 203: View of Canterbury (Cooks River) Underbridge - Main Line, north-east aspect (Sydney trains)

The bridge is located on the Bankstown Line and is adjacent to the 1916 brick arch Canterbury (Cooks River) Underbridge that is part of the goods line. The original bridge was constructed in 1895. The bridge directly adjoins the structure of the 1916 brick underbridge. The existing bridge is a replacement bridge to the original 1895 bridge which was planned with a similar structure to the original but with welded steel deck girders and precast concrete units on top. It was designed by McMillan Britton & Kell and the work was undertaken in 1993.

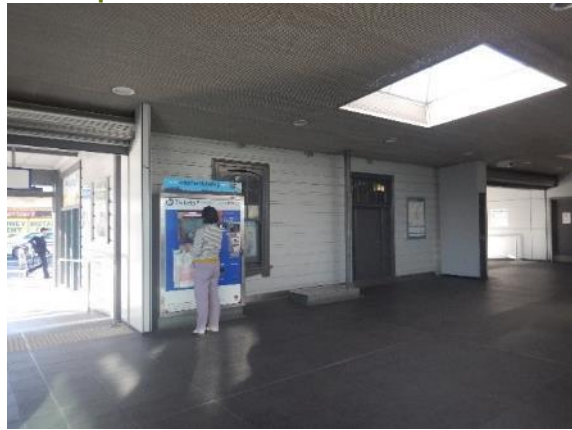
Figure 209: View of overhead booking office, east aspect

Part of the TAP program at Campsie included a new overhead concourse. Remnant elements of the original booking office building were retained within the concourse and a Dutch gable roof profile was constructed at the street elevation. The original booking hall and the northern section of the building were removed; as were the ticket windows, ticket collector's cabin; and the majority of doors and windows.¹²⁴

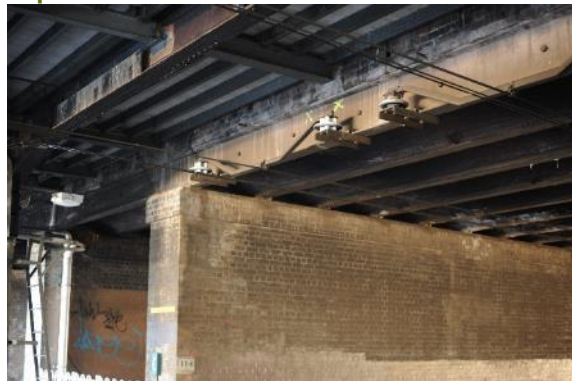
Figure 213: View of overbridge, north-west aspect

Campsie Station was designed and built by NSW Government Railways between 1895-1915. Campsie Station consists of one wayside platform on the south and an island platform on the north, both with original station buildings (Figure 206, Figure 207). Passenger rail only uses the south side of the island platform, with the Metropolitan Goods Line running on the north. Most of the overhead booking office and the access stairs are modern, with part of the original 1915 booking office being adapted (Figure 208 to Figure 211). The station is accessed from the Beamish Street overbridge (Figure 212 to Figure 215). Beamish Street is the main commercial shopping strip in Campsie.

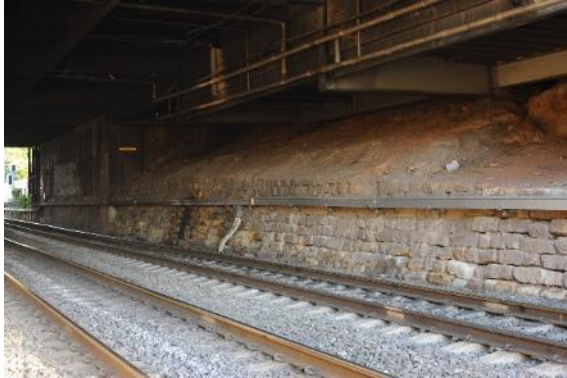
Figure 214: View of overbridge and stone retaining wall, west aspect

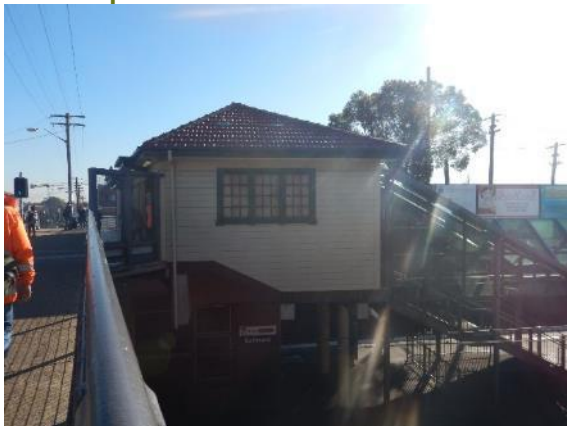
Figure 217: View of overhead booking office, north aspect

The overhead timber booking office at Belmore was constructed c.1937 at the top of the steps fronting onto the down side of Burwood Road to take the ticket selling and parcel functions. The change was also made to most other stations built to a similar configuration. The station master's office remained in the platform building for another forty years, but this function too has now moved to the street level building and the platform building remains largely unused.

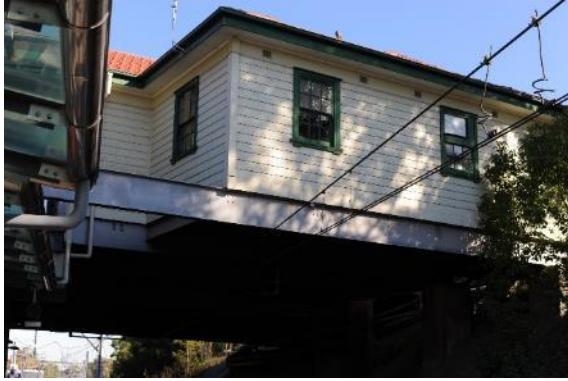
Figure 227: View of overhead booking office, west aspect

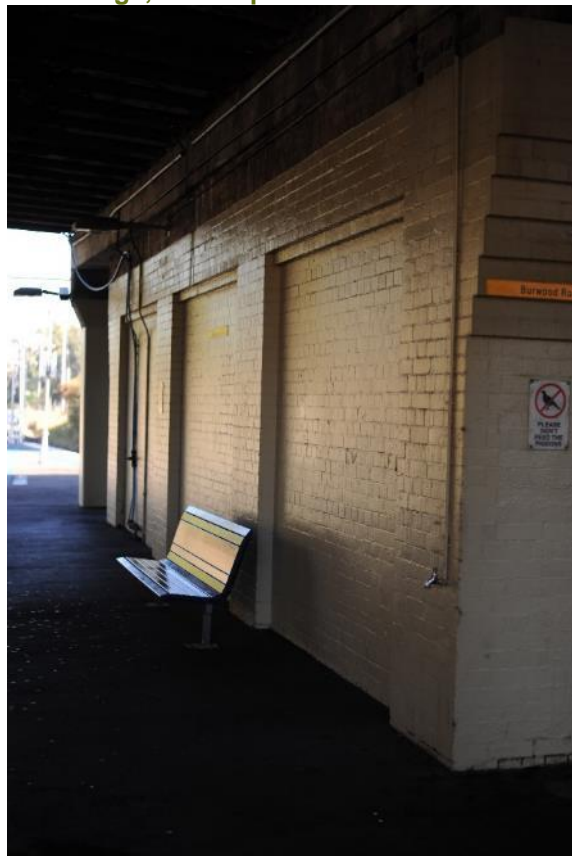
Figure 230: View of brick abutments under overbridge, east aspect

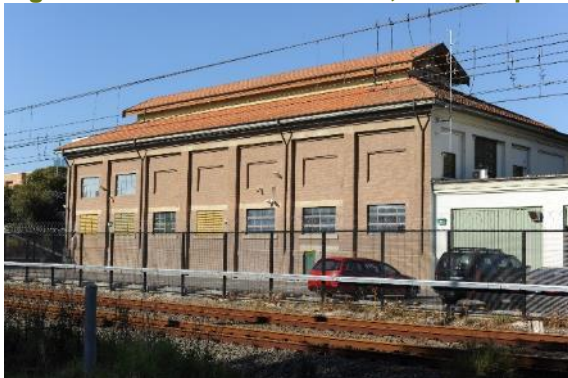
Figure 231: View of substation, south aspect

In 1925-26 a number of works were undertaken in preparation for electrification of the line including a substation and platform extension (Figure 231). The substation is now used as a signals training facility.

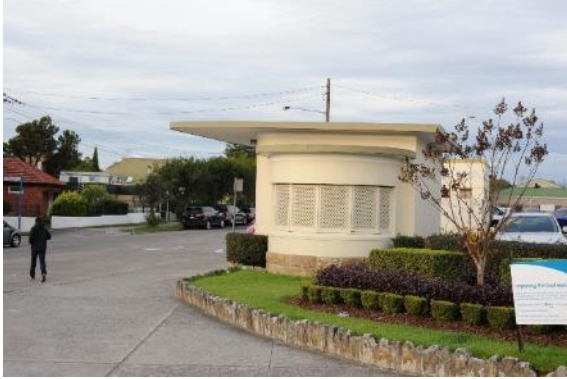
The bus shelter was built circa 1940s and the lavatories were added in the 1950s. This was the bus terminus for many years thus requiring some capital investment. The bus shelter is a modern style rendered masonry bus shelter with a flat concrete roof. The toilets are rendered masonry located adjacent to the bus shelter and are decorated with fluted pilasters and a wavy patterned parapet.

Figure 232: View of bus shelter, east aspect

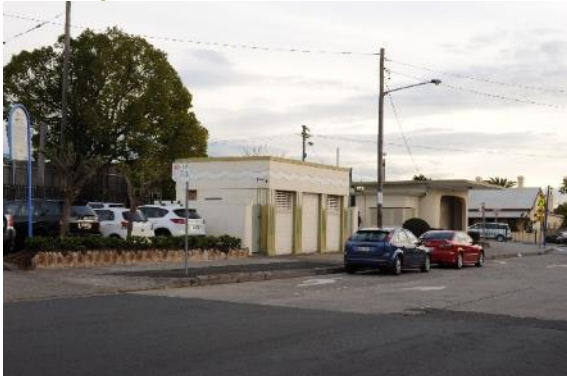
Figure 234: View of public lavatories, south-west aspect

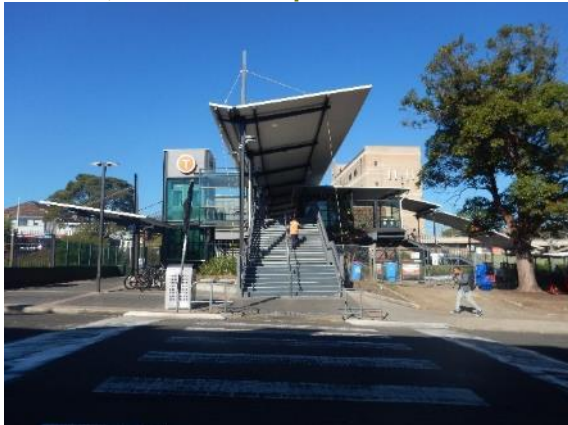
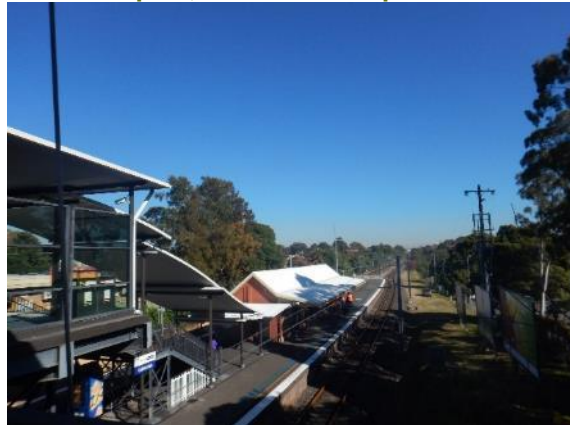
Figure 238: View of station entrance with 2001 editions, south-east aspect **Figure 239: View of platform and stairs with 2001 canopies, south-west aspect**

Lakemba Station was designed and built by NSW Government Railways between 1909 and 1926. Lakemba Station has a single island platform with the original platform building and a large modern footbridge, booking office, central concourse, concessionaire, and easy access lift (Figure 238 to Figure 253). The footbridge is accessed from Railway Parade to the north and The Boulevard to the south, both commercial shopping strips.

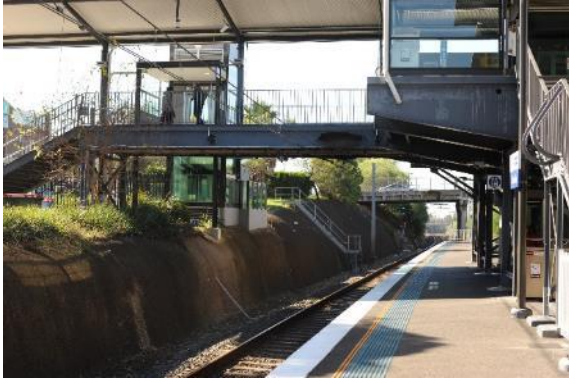
Figure 246: View of footbridge, north-east aspect

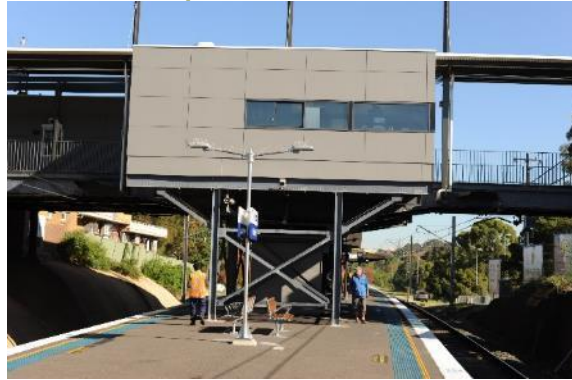
Figure 249: View of overhead booking office, south-west aspect
