SYDENHAM TO BANKSTOWN
**ENVIRONMENTAL
IMPACT
STATEMENT**

> Technical Paper 3 - Non-Aboriginal
heritage impact assessment

Non-Aboriginal Heritage Impact
Assessment

Report to Transport for NSW

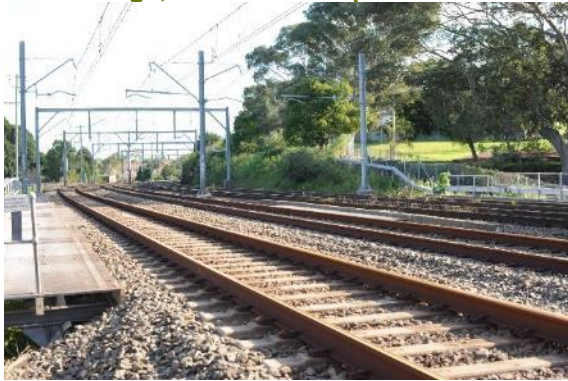
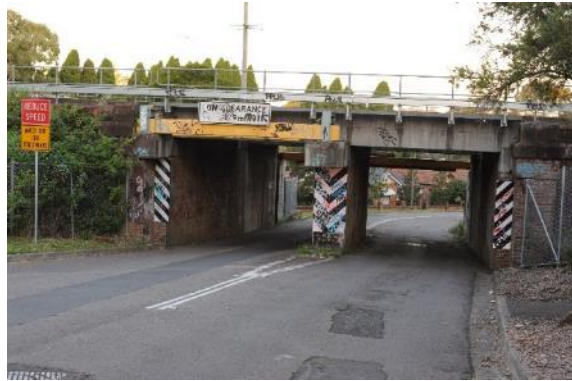
Figure 184: View of railway corridor section of underbridge, south-west aspect **Figure 185: View of underbridge, south aspect**

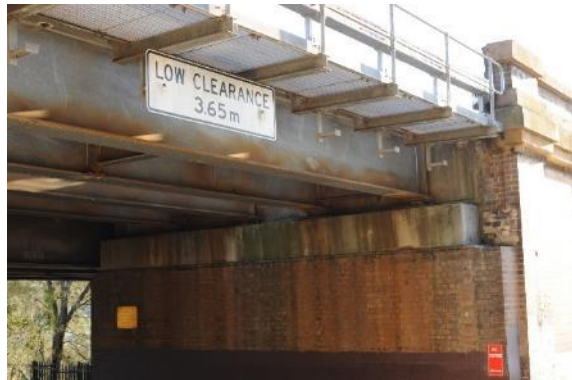
Figure 202: View of underbridge, west aspect
