# Sydney Metro City & Southwest Sydenham to Bankstown Upgrade

Technical Paper 4

Aboriginal Heritage Impact  
Assessment

August 2017

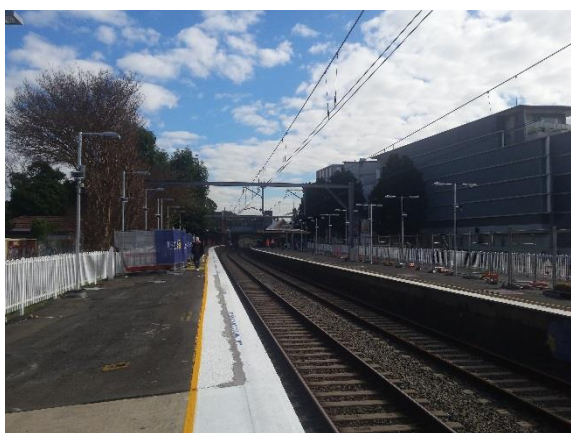
**Plate 2: Marrickville Station survey unit view east**

There was very little surface visibility outside the rail corridor due to sealed roads, pathways, structures and grass (Plate 2). Surface visibility improved within the rail corridor, however it was still fairly limited due to rail station infrastructure and ballast. Areas of improved ground surface visibility were observed within the rail corridor to the east of Marrickville Station. Exposures were noted within an area where erosion had occurred (Plate 3).

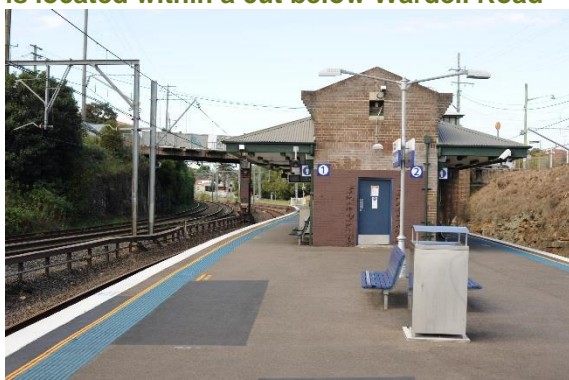
**Plate 4: View west along platform, rail corridor is located within a cut below Wardell Road**

The Dulwich Hill Station survey unit is located within a highly disturbed and modified landform. Any archaeological deposits would have been disturbed during the construction of the rail corridor which involved construction of a large cutting through underlying Hawkesbury Sandstone. Therefore, the archaeological potential of the survey unit is considered to be nil to low.

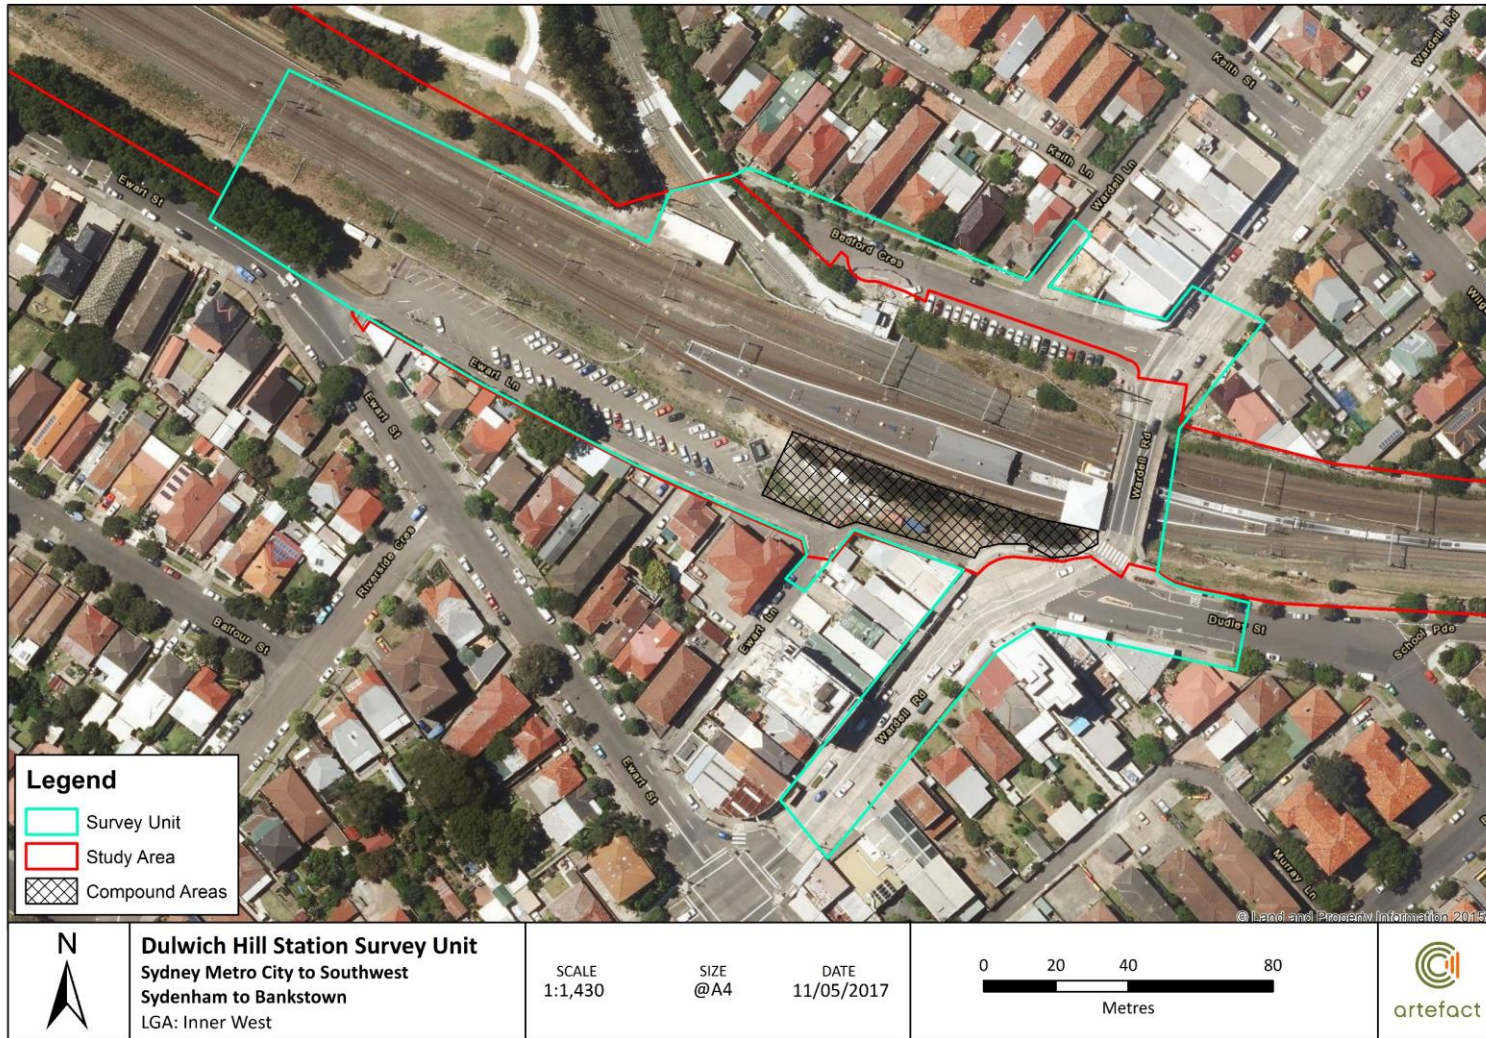
Figure 8: Dulwich Hill Station survey unit

The Dulwich Hill Station survey unit consists of the current Dulwich Hill Station concourse, platforms, the Dulwich Hill Light Rail Station platform and surrounds (see Figure 8). It includes the Wardell Road overbridge and extends west along Ewart Lane. The survey unit also spans Bedford Crescent, and portions of Dudley Street and Wardell Lane and a construction compound.

Due to the landscape context and largely modified nature of the Dulwich Hill Station survey unit the archaeological potential has been assessed as nil to low. Therefore, it is unlikely that the project would impact Aboriginal objects.

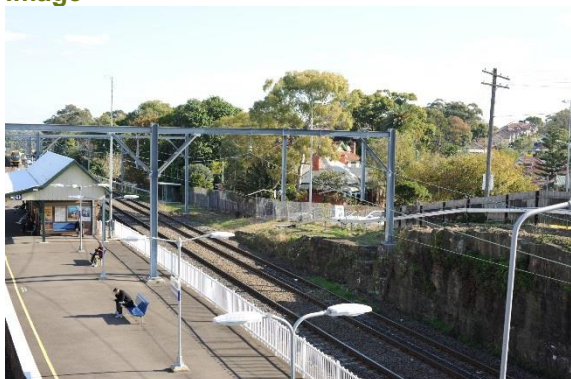
**Plate 6: View west from the upper concourse area. The original crest and slope landform can be seen on the right hand side of the image**

Visibility was generally limited throughout the survey unit. Outside of the rail corridor visibility was impeded by sealed roads, pathways, carparks and structures. Inside the rail corridor visibility was impeded by structures, sealed surfaces, rail ballast and vegetation. Some exposures did occur within areas of erosion within the corridor, where introduced fill was observed and no Aboriginal objects were identified.

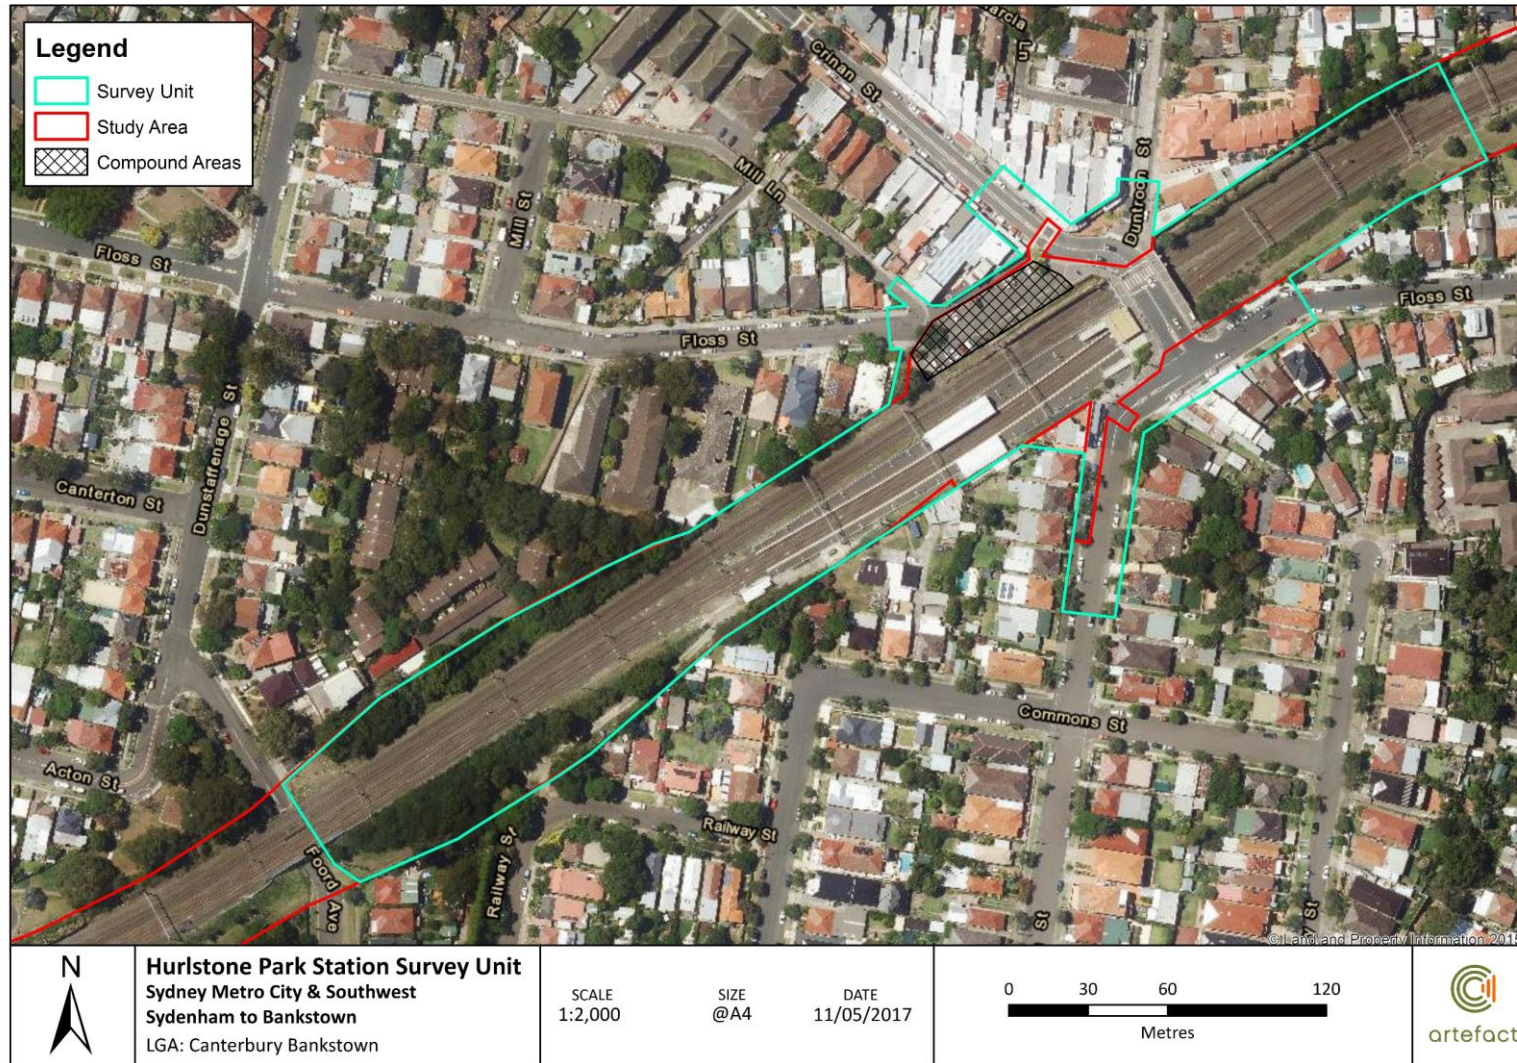
Figure 9: Hurlstone Park Station survey unit

The Hurlstone Park Station survey unit extends approximately 130 metres to the east of the Crinan Street overbridge and approximately 370 metres to the west (see Figure 9). The survey unit encompasses portions of Duntroon Street, Crinan Street, Mill Lane, Floss Street and surrounds. The survey unit also includes a proposed construction compound (see Figure 9).

No identified Aboriginal sites would be impacted by construction or operation of the project within the Hurlstone Park Station survey unit (see Figure 9).

Due to the landscape context and largely modified nature of the Hurlstone Park Station survey unit the archaeological potential has been assessed as nil to low. Therefore, it is unlikely that the proposed works would impact Aboriginal objects.

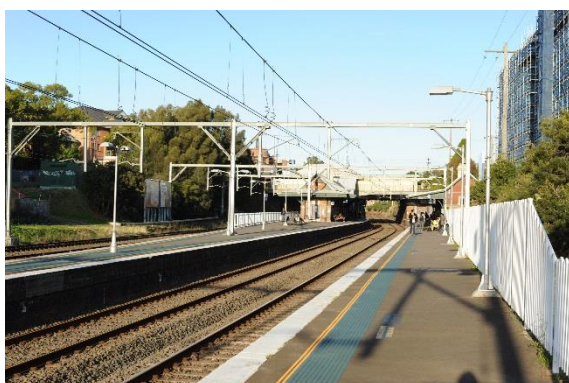
The Canterbury Station survey unit includes the Canterbury Station concourse, platforms and rail corridor and surrounds (Plate 8, see Figure 10). It extends approximately 115 metres east of the Canterbury Road overbridge and approximately 50 metres west from the station platforms. The survey unit encompasses portions of the surrounding streets, including Broughton Street, Charles Street and Canterbury Road and the major intersection to the north of the station concourse. The survey unit includes the buildings at the corner of Charles Street and Canterbury Road. The survey unit includes two proposed construction compounds.

The eastern portion of the survey unit has been cut into the existing crest landform beneath Canterbury Road. The western portion of the survey unit has been filled and raised above the surrounding landform.

**Plate 8: Canterbury Station, view east from western edge of platform three**

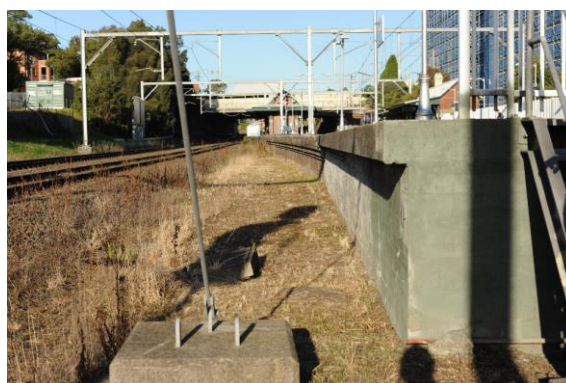
**Plate 9: View east from western edge of platform one**

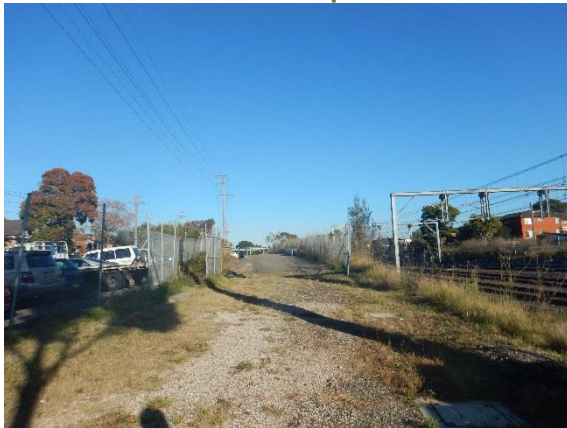
**Plate 10: View west across the project area, west of Platform 1 at Campsie Station**

Visibility was low throughout the survey unit due to the built up nature of the area. Visibility was impeded by sealed surfaces, structures and vegetation. Some surface visibility within the rail corridor was observed across the proposed compound area (Plate 10). Introduced gravels were evident across the ground surface. No Aboriginal objects were identified. As with the majority of stations in the study area, the Campsie Station is located within a cut below street level (Plate 11).

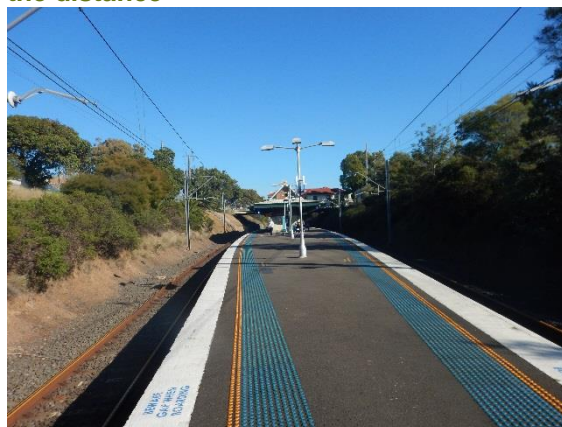
**Plate 13: Belmore station view west along platforms 1 and 2. This photo shows the cutting and Burwood Avenue overbridge in the distance**

The Belmore Station survey unit is located within a heavily urbanised and developed area. The existing station and rail is located within a cut below street level. This indicates that any archaeological deposits within this area would have been highly disturbed during construction. Therefore the archaeological potential within the rail corridor and areas that have been highly disturbed is considered to be nil to low.

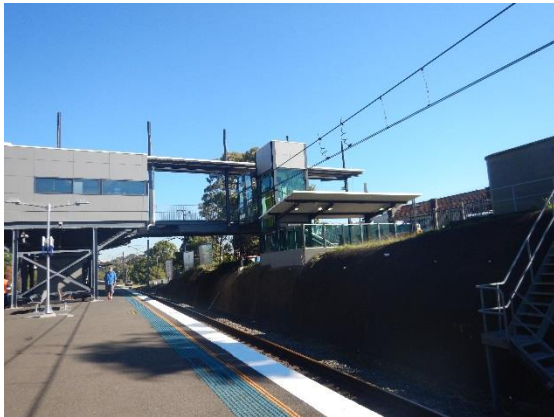
**Plate 14: Lakemba Station view west along Platform 1. This image shows the shallow cut in which the station and rail is located**

The Lakemba Station survey unit is located within a heavily urbanised and developed area. The rail corridor has been artificially cut into the natural landform in the eastern portion of the survey unit and built up on an artificial embankment to the west. The construction of the corridor and station would have disturbed any intact archaeological deposits that may have been located within these areas. There are no major watercourses located nearby. The archaeological potential of the Lakemba Station survey unit is considered to be nil to low.

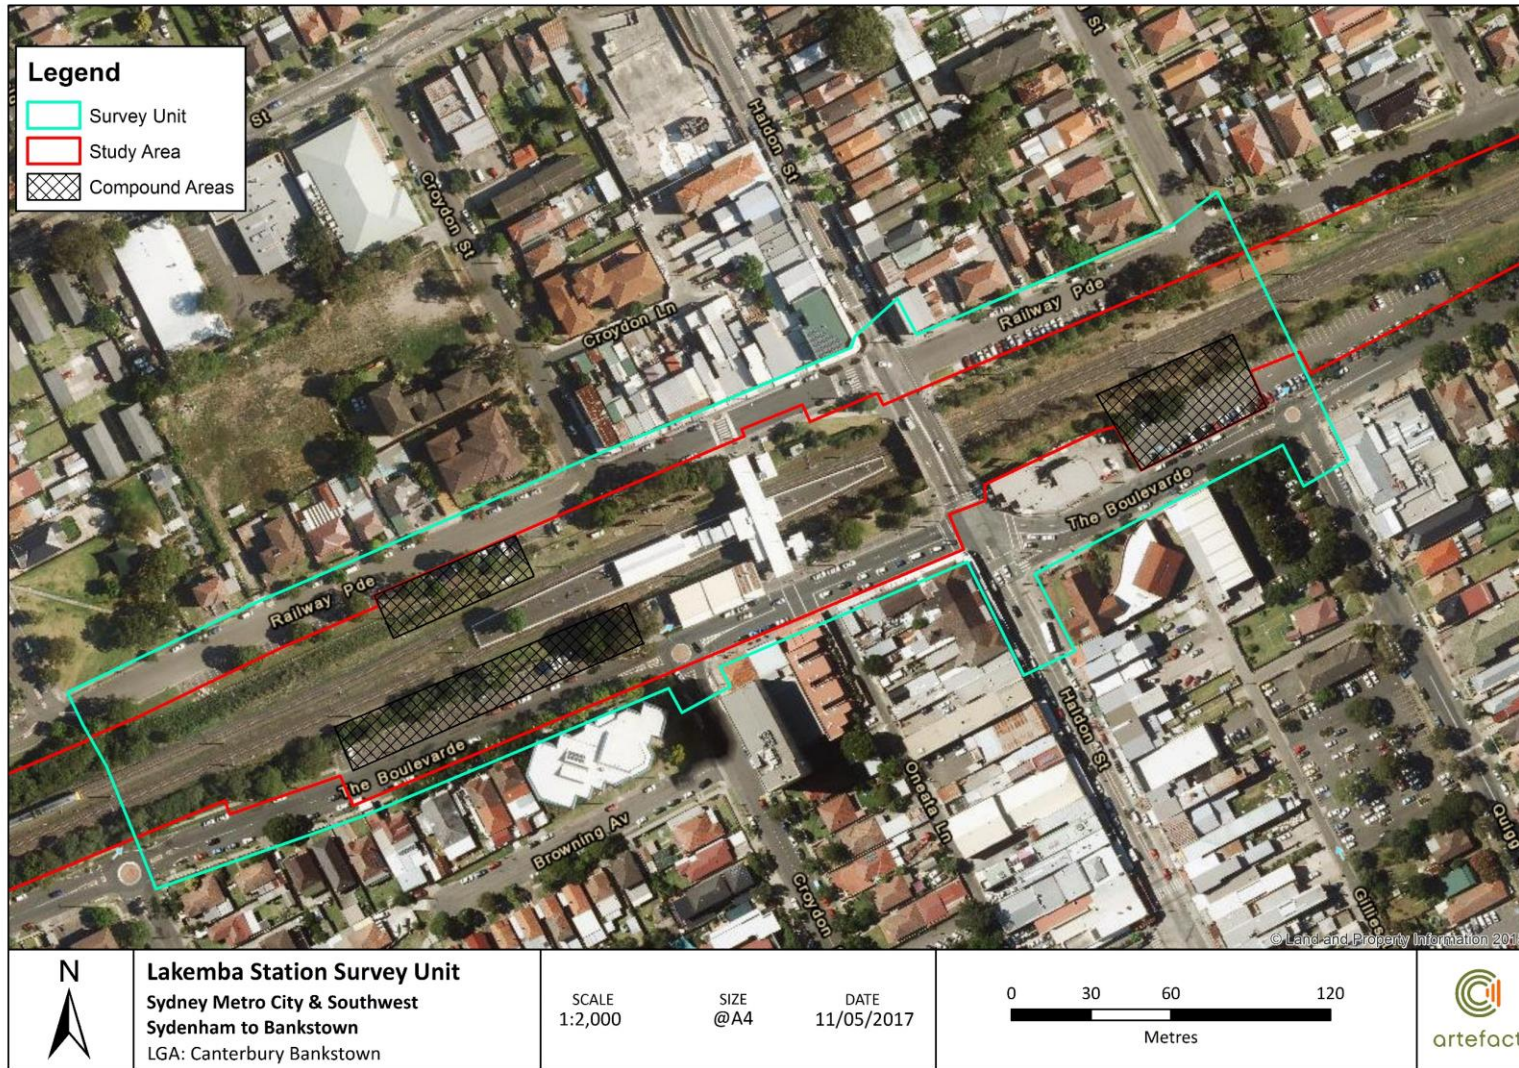
Figure 13: Lakemba Station survey unit

Due to the landscape context and largely modified nature of the Lakemba Station survey unit the archaeological potential has been assessed as nil to low. Therefore, it is unlikely that the project would impact Aboriginal objects.

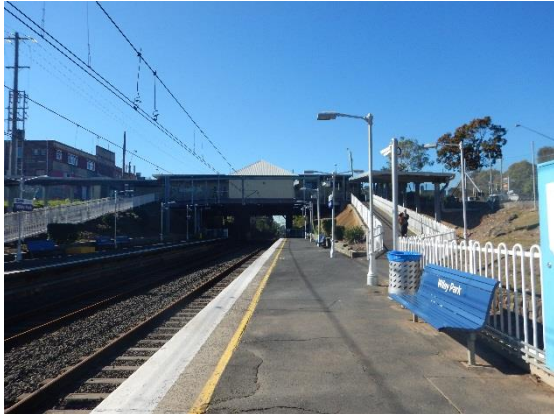
**Plate 16: Wiley Park Station view east along Platform two. The east portion of the station is cut below street level**

The Wiley Park Station survey unit is located within a heavily urbanised and developed area. A large portion of the rail corridor has been cut into the natural ridge crest landform within the eastern portion of the survey unit which is located approximately 70 metres east of Coxs Creek. Whilst Aboriginal objects may occur in subsurface contexts in close proximity to watercourses, the highly erosive nature of the surrounding Blacktown soil landscape and high levels of disturbance observed indicate that

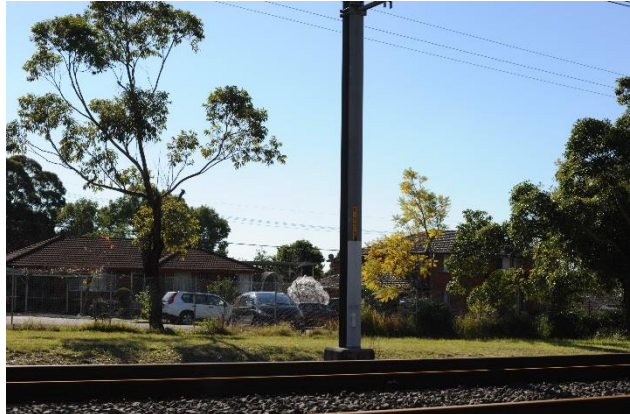
**Plate 17: View north from western end of proposed construction compound. Rail at street level**

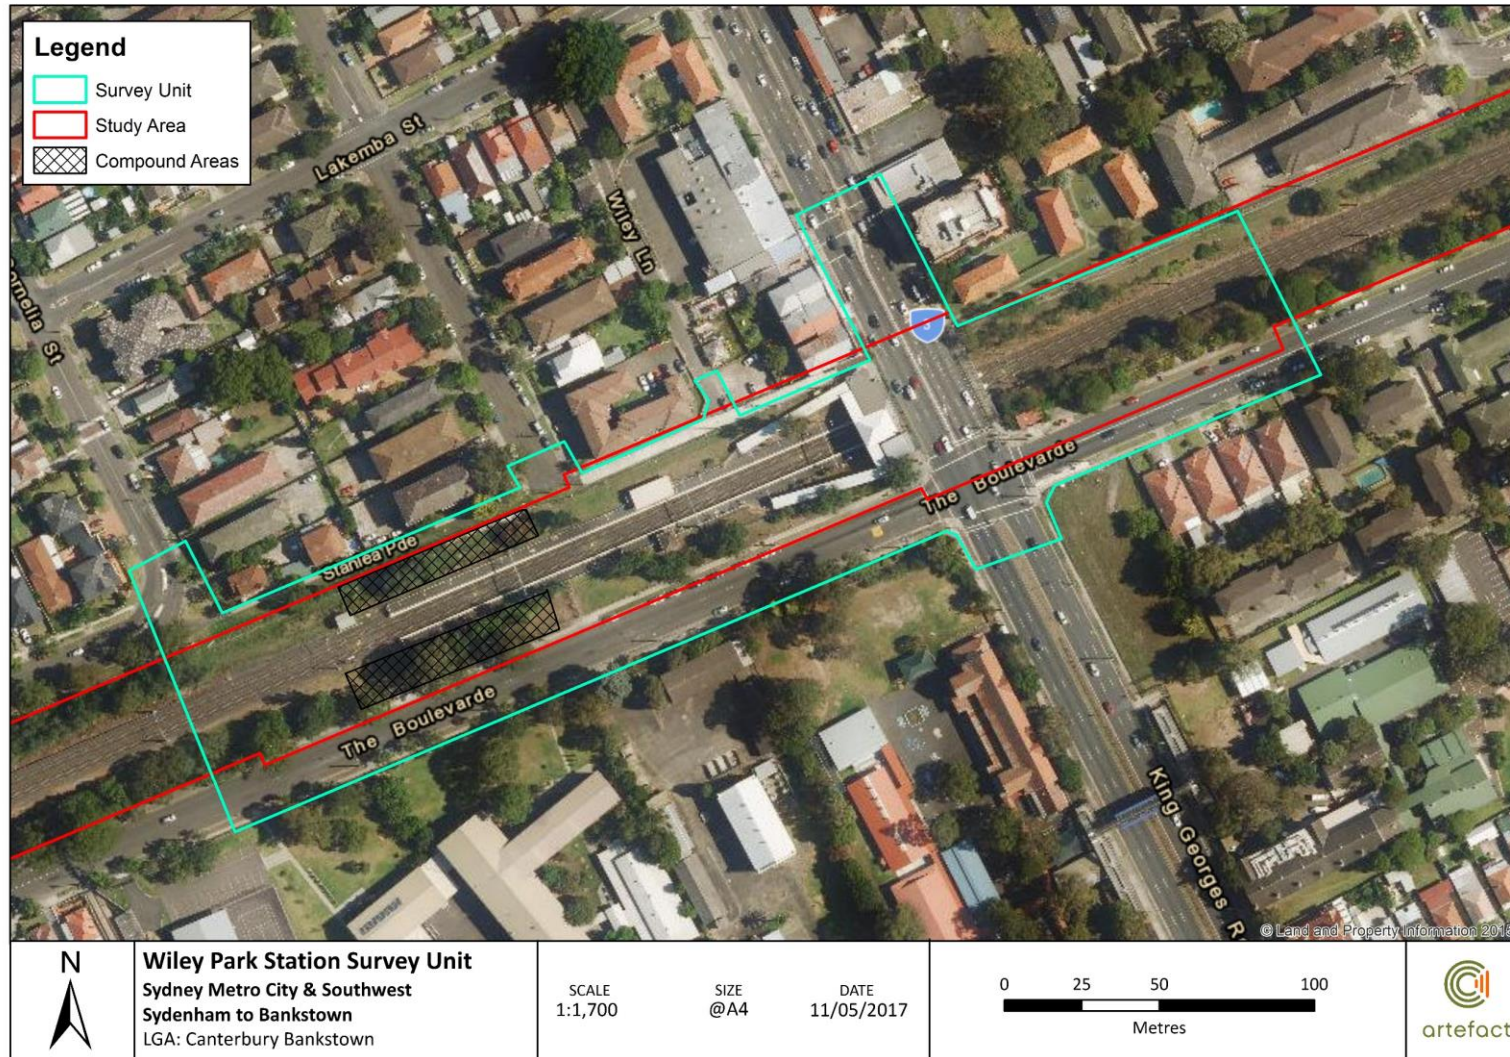
Figure 14: Wiley Park Station survey unit

No identified Aboriginal sites would be impacted by construction or operation of the project within the Wiley Park Station survey unit (see Figure 14).

Due to the landscape context and largely modified nature of the Wiley Park Station survey unit the archaeological potential has been assessed as nil to low. Therefore, it is unlikely that the project would impact Aboriginal objects.

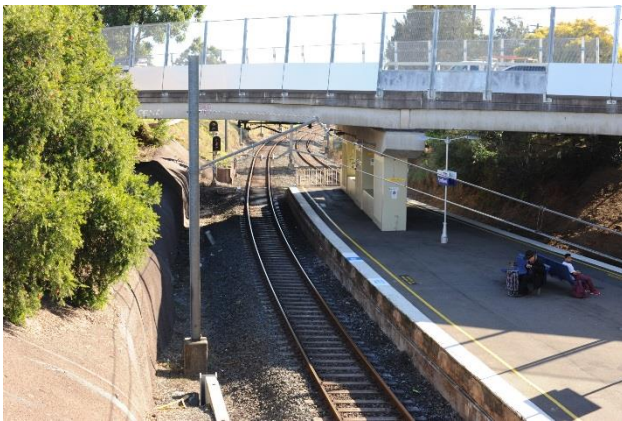
**Plate 19: Punchbowl Station view west from concourse. The rail corridor is located within a cut**

The station platforms and rail are located within a shallow cut below street level (Plate 19). The construction compound to the north of Punchbowl Station was found to have been heavily disturbed. Large quantities of fill were evident across the site and it appears that the area is currently used as a construction compound during rail possessions (Plate 20).

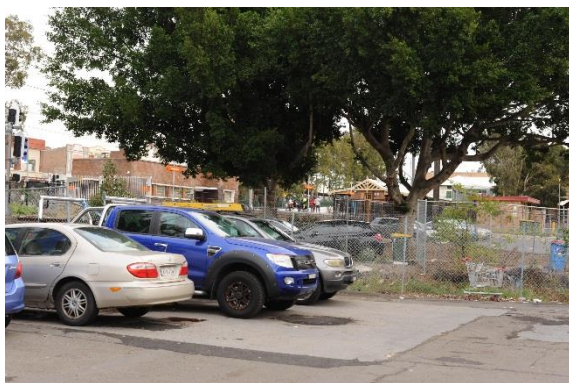
The survey unit predominantly consists of sealed surfaces and structures; therefore, visibility was generally nil. Some green spaces are located outside of the rail corridor and exposures occurred near the roots of trees in these areas. These exposures were inspected for Aboriginal objects; however, none were identified.

**Plate 22: View west across location of proposed construction compound**

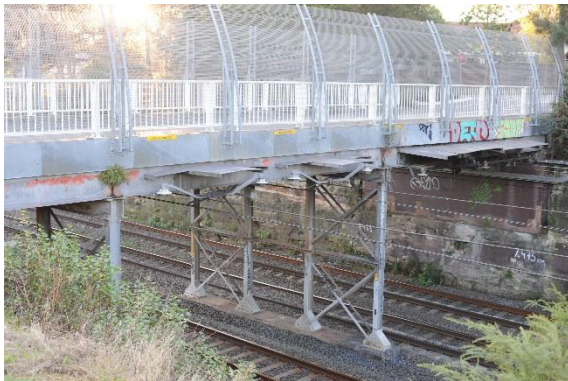
Visibility was generally low throughout the corridor, impeded by vegetation, structures, fill, rail track and ballast. Soil exposures occurred within areas of erosion in vehicle access tracks and cuts, however no Aboriginal objects were identified within these areas. Impacts within the rail corridor are extensive, and include landform modification, subsurface infrastructure such as gas pipelines and galvanised steel troughs (GSTs), electricity and telecommunications cables as well as rail infrastructure such as overhead wiring structures.

**Plate 24: Albermarle Road Bridge located between Marrickville and Dulwich Hill**

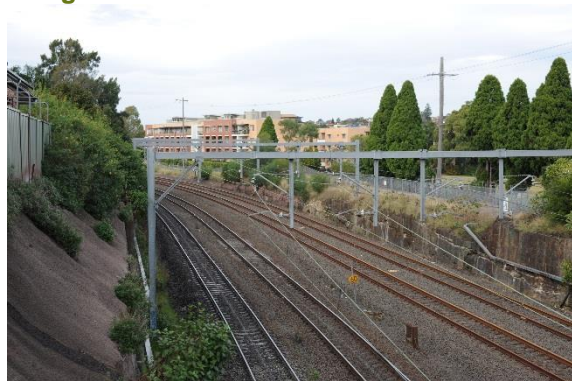
**Plate 25: View east from Canterbury Road Bridge**

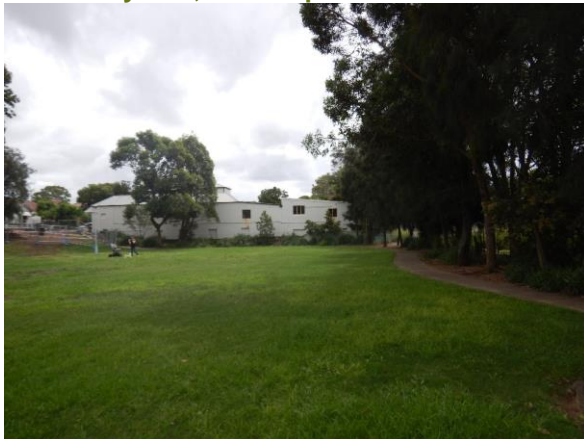
This section of the survey unit is located on level ground to the south of the rail corridor currently used as open space in the public park. This portion of the survey unit is located on a slight depression in the local landscape, however the ground has been levelled flat and topsoil has been redeposited. Introduced grasses and planted gardens surround this western portion of the survey unit.

**Plate 26: Level ground in western portion of the survey unit, west aspect**

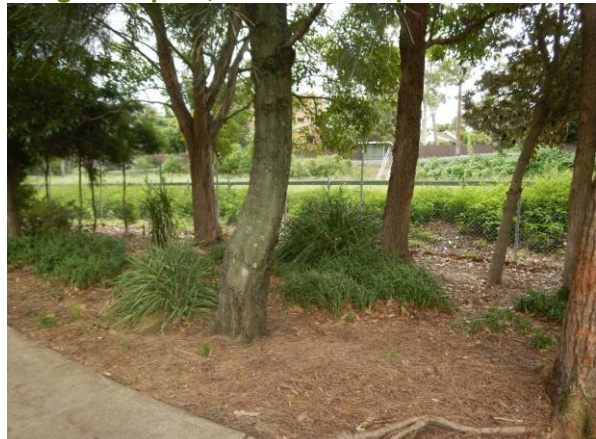
**Plate 27: Planted Casuarina trees on outer margins of park, north-west aspect**

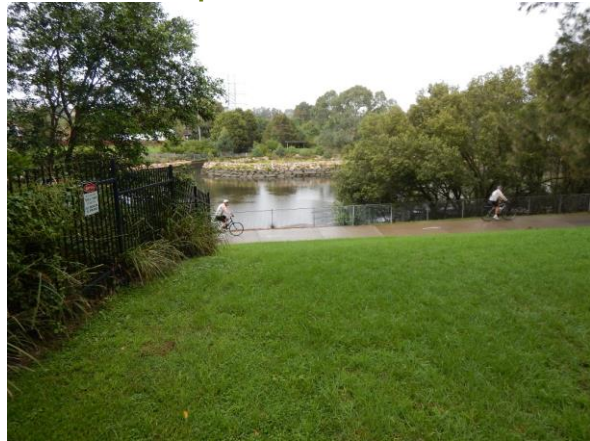
**Plate 29: View of artificial ground and the concrete abutment at foreshore of the Cooks River, south aspect**

The majority of this section of the survey unit consists of artificially cut or artificially filled ground. The steep hillslope on the northern bank of the Cooks River has been terraced to create level surfaces, with multiple retaining walls to stabilise the slope. Numerous services and stormwater drainage channels cut through the study area, with major sewerage lines along the alignment of Close Street. Stormwater drainage lines and culverts run along the eastern extent of the survey unit.

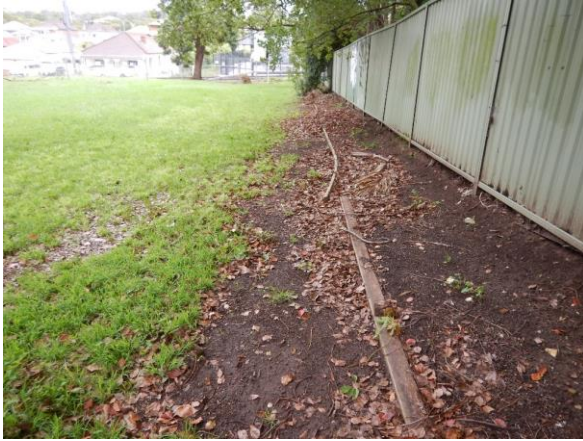
**Plate 30: Introduced topsoil at northern edge of survey unit, west aspect**

The ground in this section of survey unit has been heavily eroded and redressed with imported soils. Clay exposures reveal the original shallow depth of the original topsoil in the area. As such, the original topsoil has been almost entirely removed from the study area.

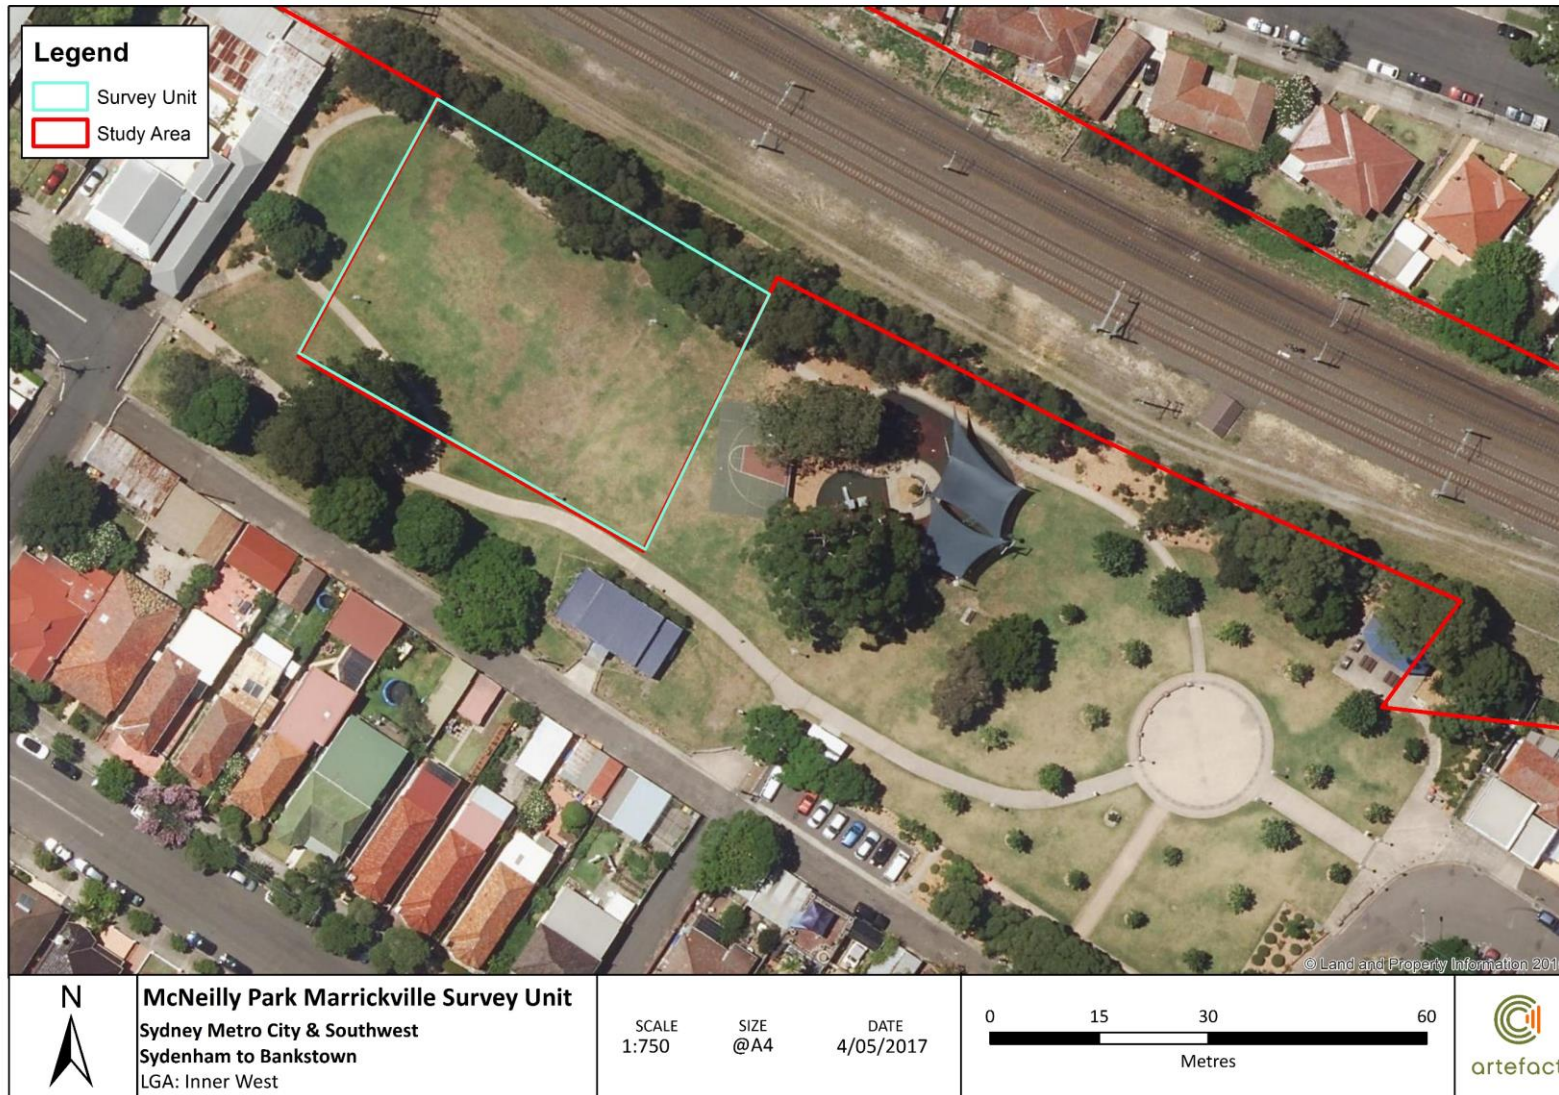
Figure 18: Additional Survey Unit – McNeilly Park Marrickville

No identified Aboriginal sites would be impacted by construction or operation of the project within this section of the survey unit.
