# Sydney Metro Northwest White Hart Inn & Stranger's Cottage

Old Windsor Road to White Hart Drive  
Beaumont Hills

## Archaeological test excavation report

Prepared for Transport for NSW | 1 February 2016

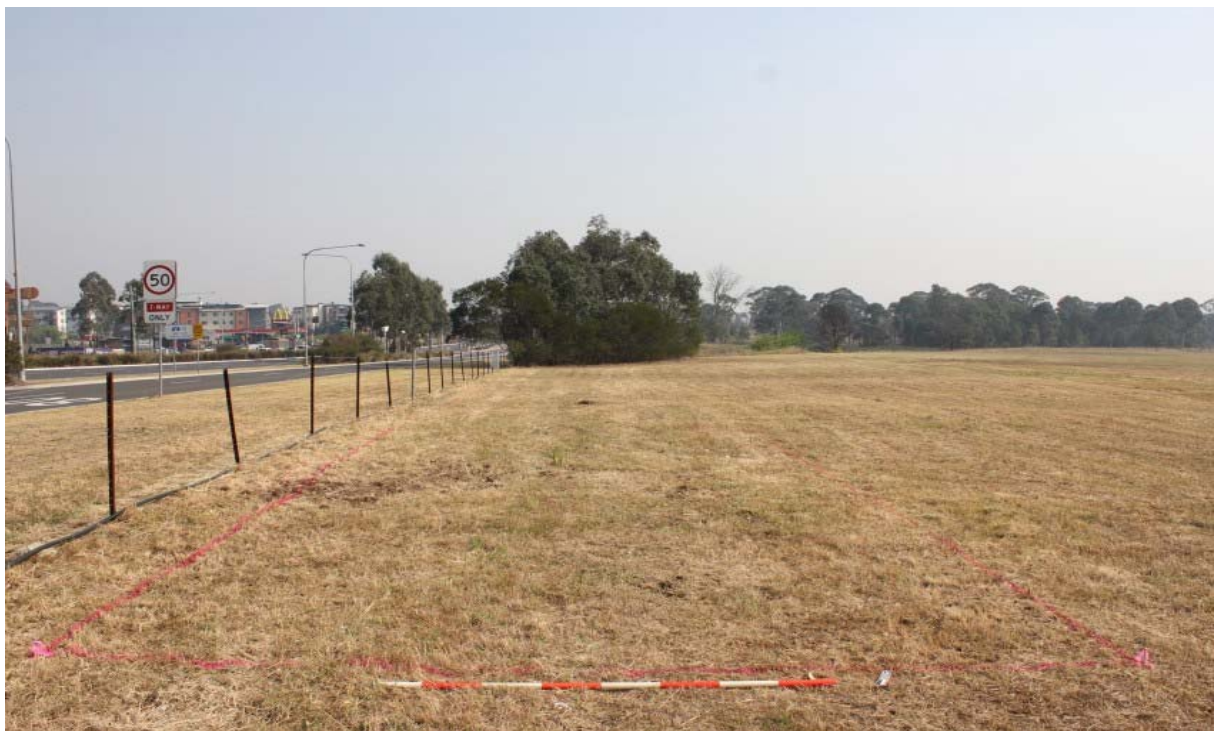
The surface was covered in a thin deposit of topsoil and grass [001] across the entire site (Plate 4.1).

**Plate 4.1** The site prior to archaeological excavation showing the area marked into a grid. View north; scale 2 m.

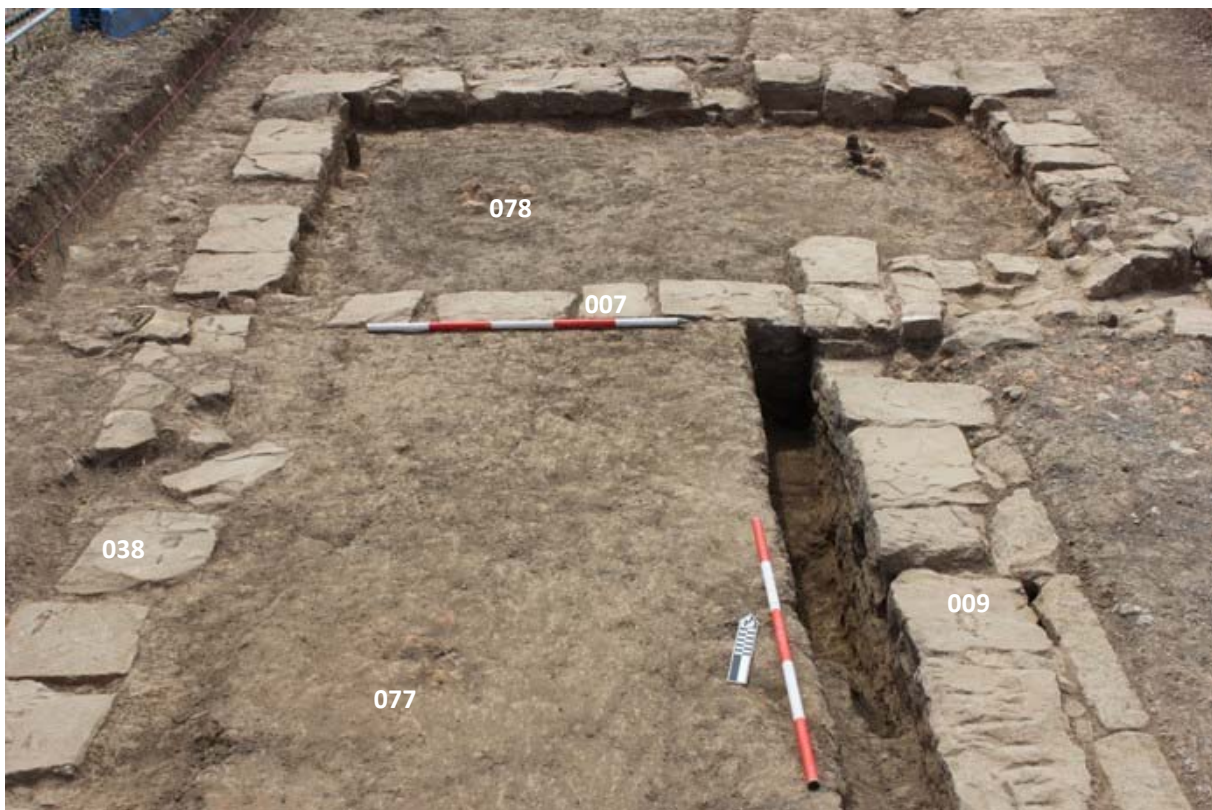
**Plate 4.2** The northern extent of the main inn building showing the sondage against the rear veranda footings [009]. View north; scales 1 m each.

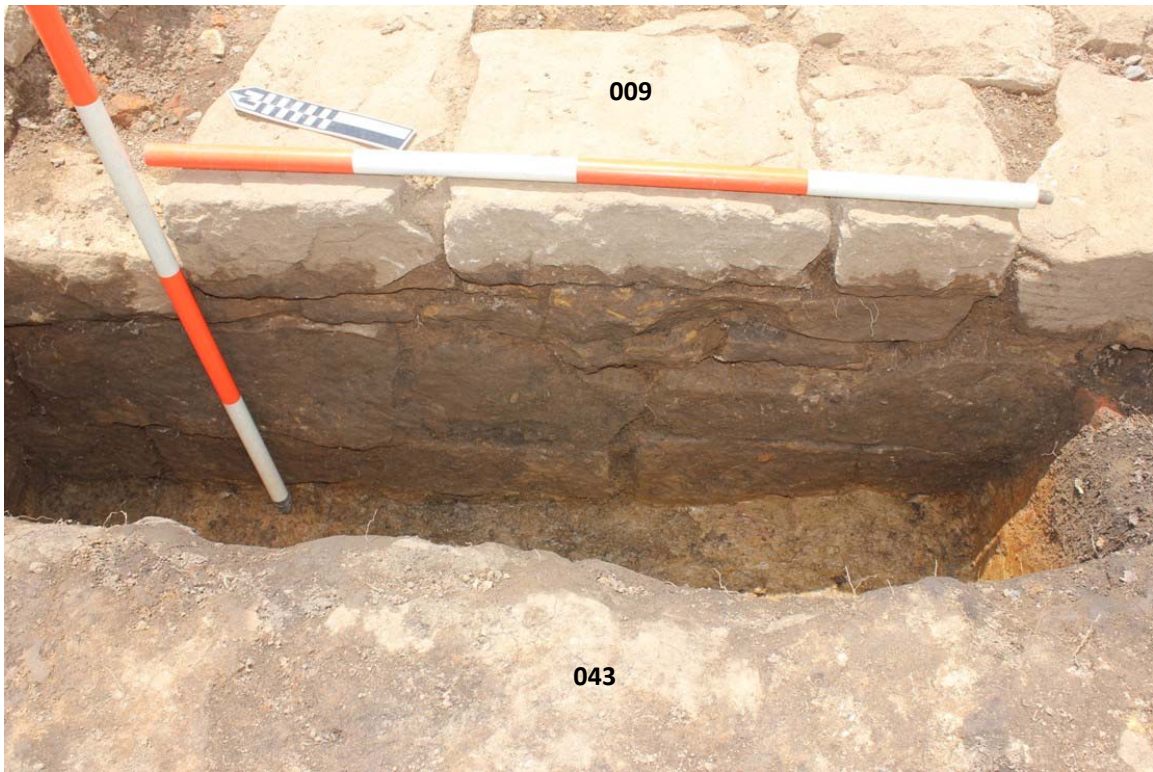
Three courses of sandstone were revealed in a small sondage against the rear wall of the veranda [009]. Levelling stones are present beneath the surviving top course. The pale deposit at the bottom of the photograph is a surface [043] probably created during the construction phase of the inn. This surface is shown more clearly after rain (Plate 4.6).

Plate 4.5 Detail of the sondage against the rear wall of the veranda [009]. East at top; 1 m scales.

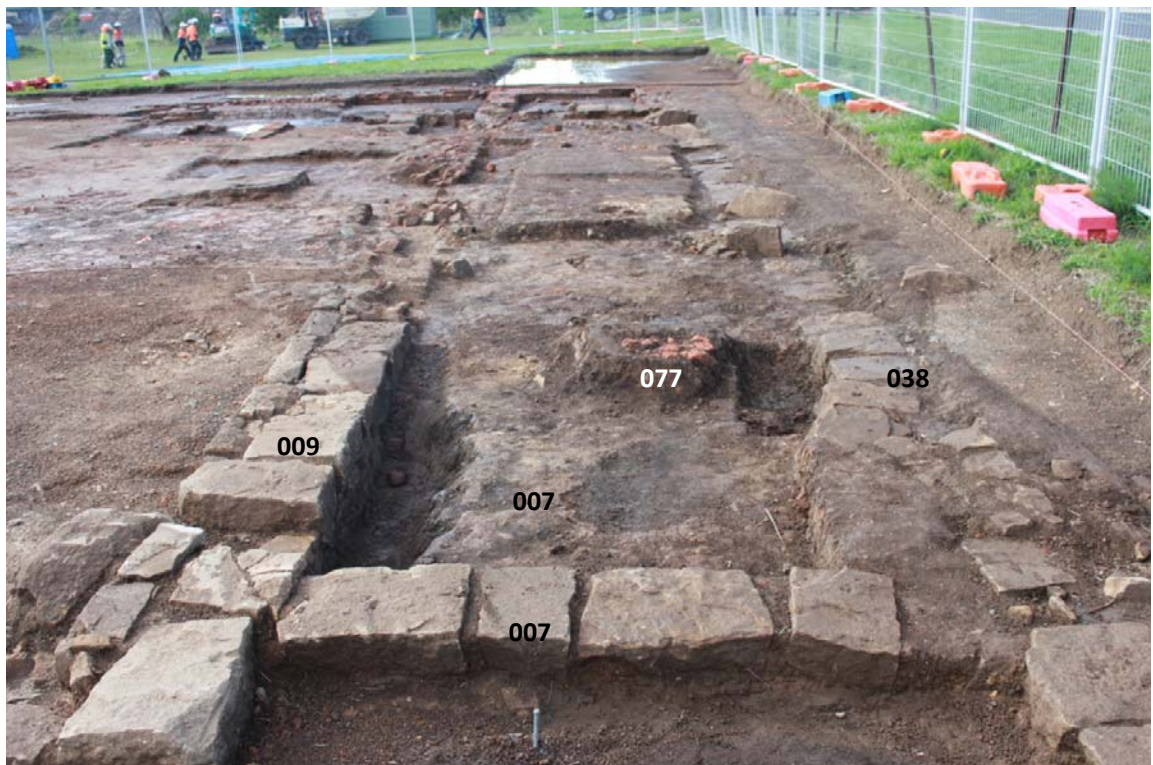
Plate 4.6 The front of the inn from the northern wing room. Note the thin crust in the foreground, which is a surface that developed after the sandstone footings were placed. View south.

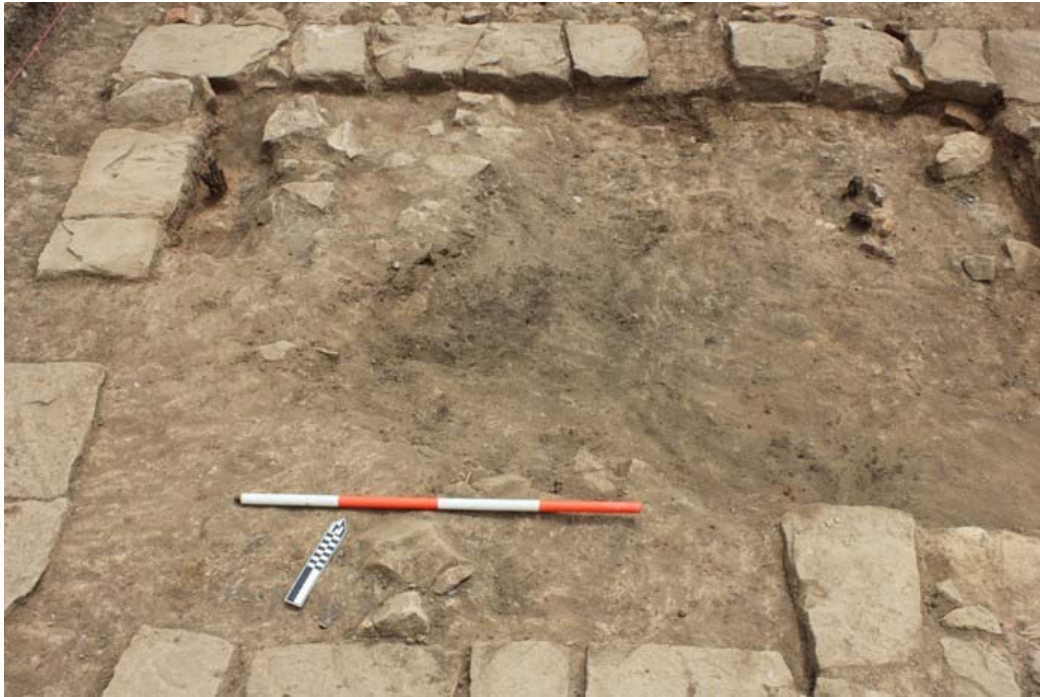
**Plate 4.7** Sandstone footings of the northern wing room at the start of the test excavation. View north; scales 1 m each.

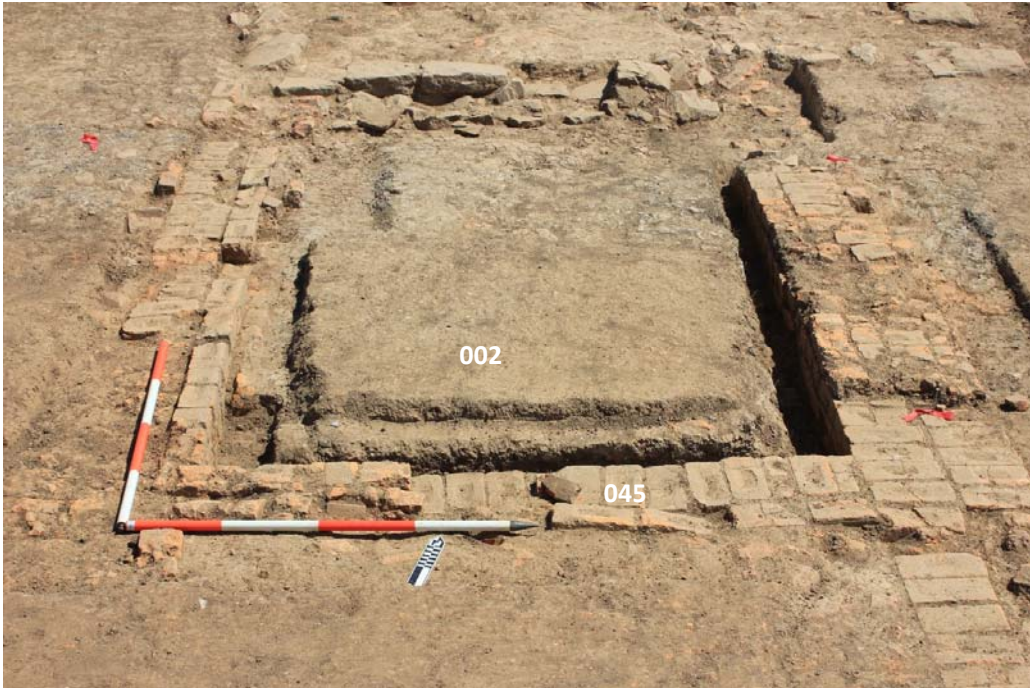
**Plate 4.11 Southern wing room addition. View north; 1 m scales.**

Plate 4.11 demonstrates the stratigraphy that was recorded on site: demolition [002], over shale [029], over relict topsoil [049]. The relict topsoil displayed trench cuts. The bricks visible in Plate 4.13 representing [054] were loose and removed in this photograph and the underlying bricks are just visible in this photograph.

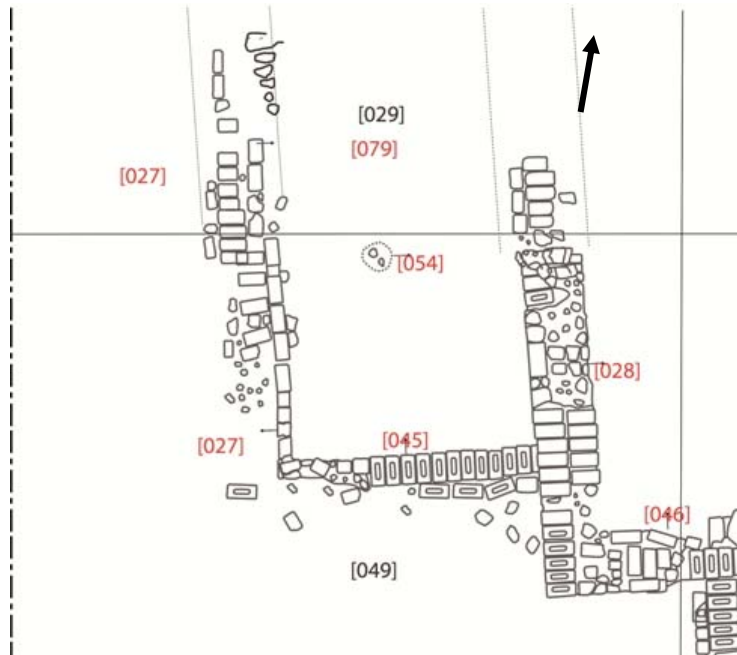
**Plate 4.12 Site plan detail of the southern wing room addition.**

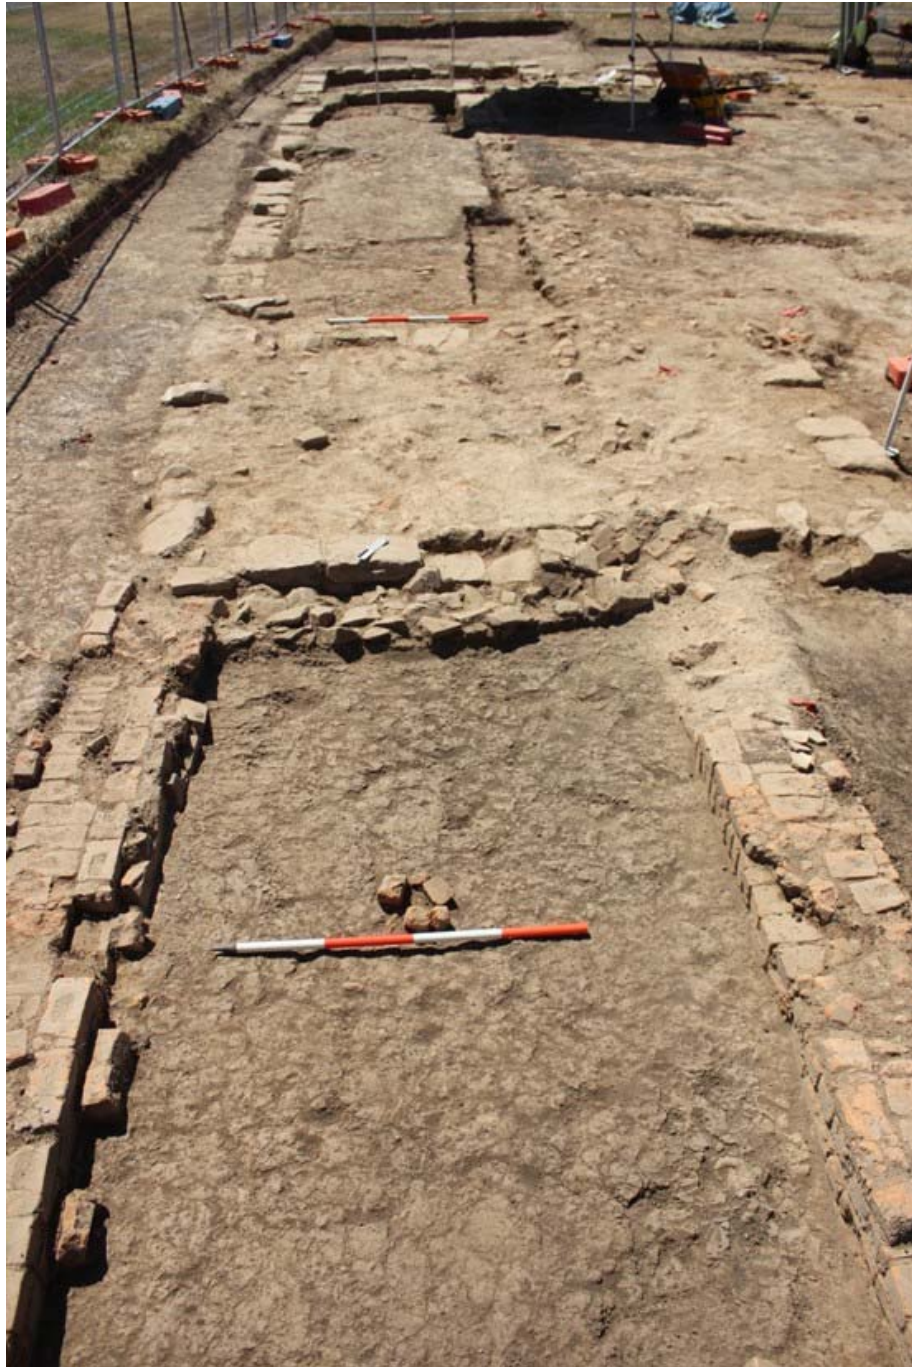
**Plate 4.13** View north along the front of the building. View to the north, north-west; scales 1 m each.

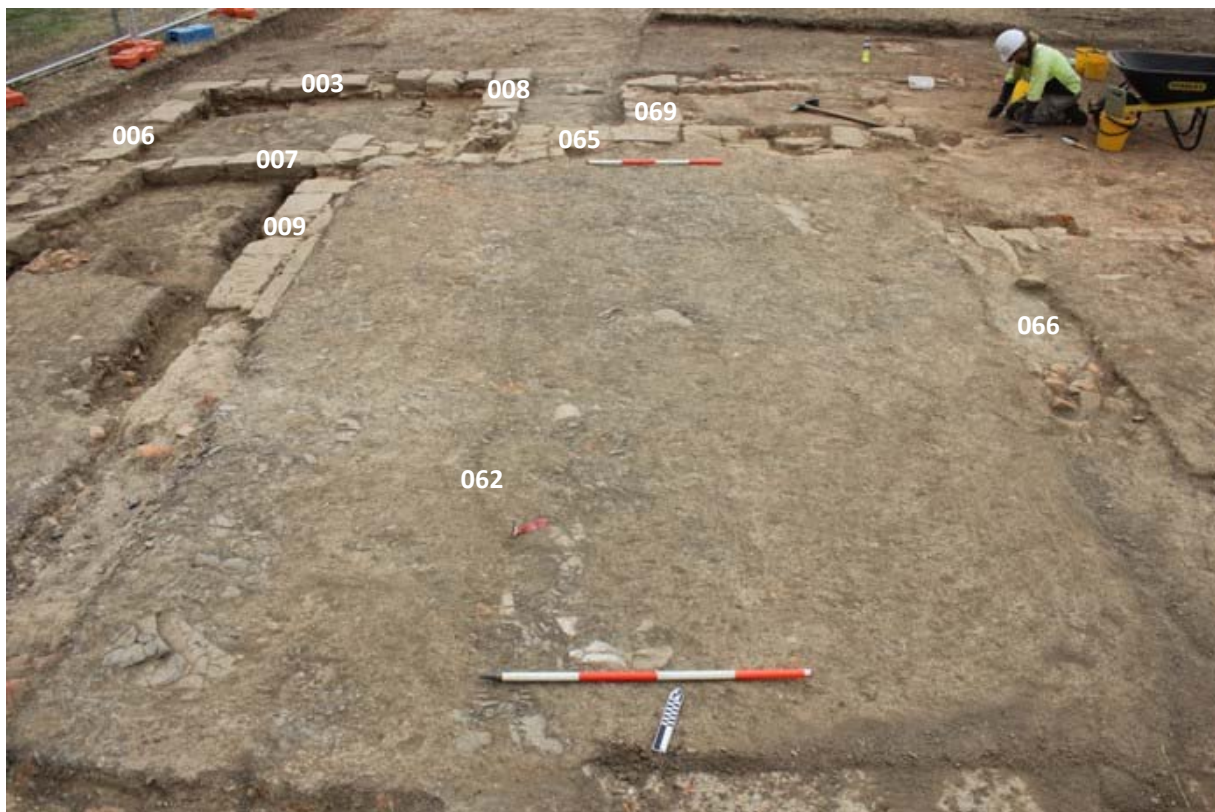
**Plate 4.14** The dining room (Space 5) with shale floor. The north wing of the building is visible at the top left corner. View north; scales 1 m each.

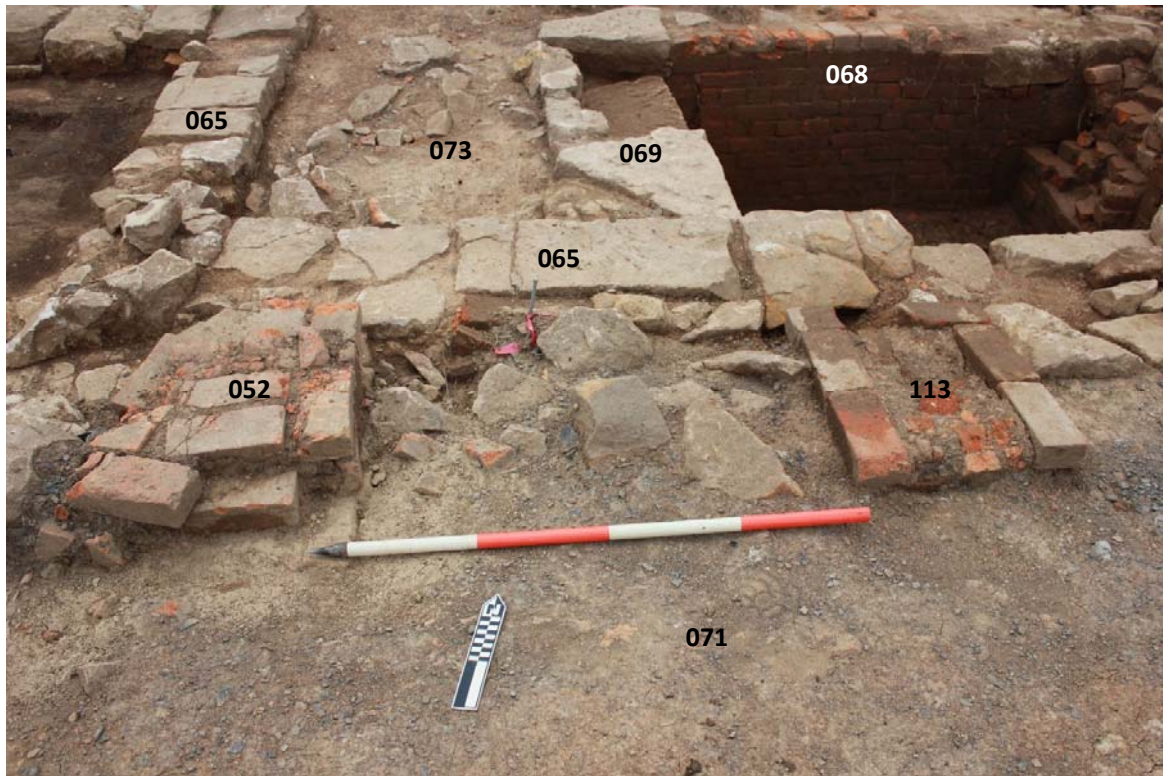
Plate 4.15 Northern end of the dining room (space 5) with possible fireplace footings [052] and [113].

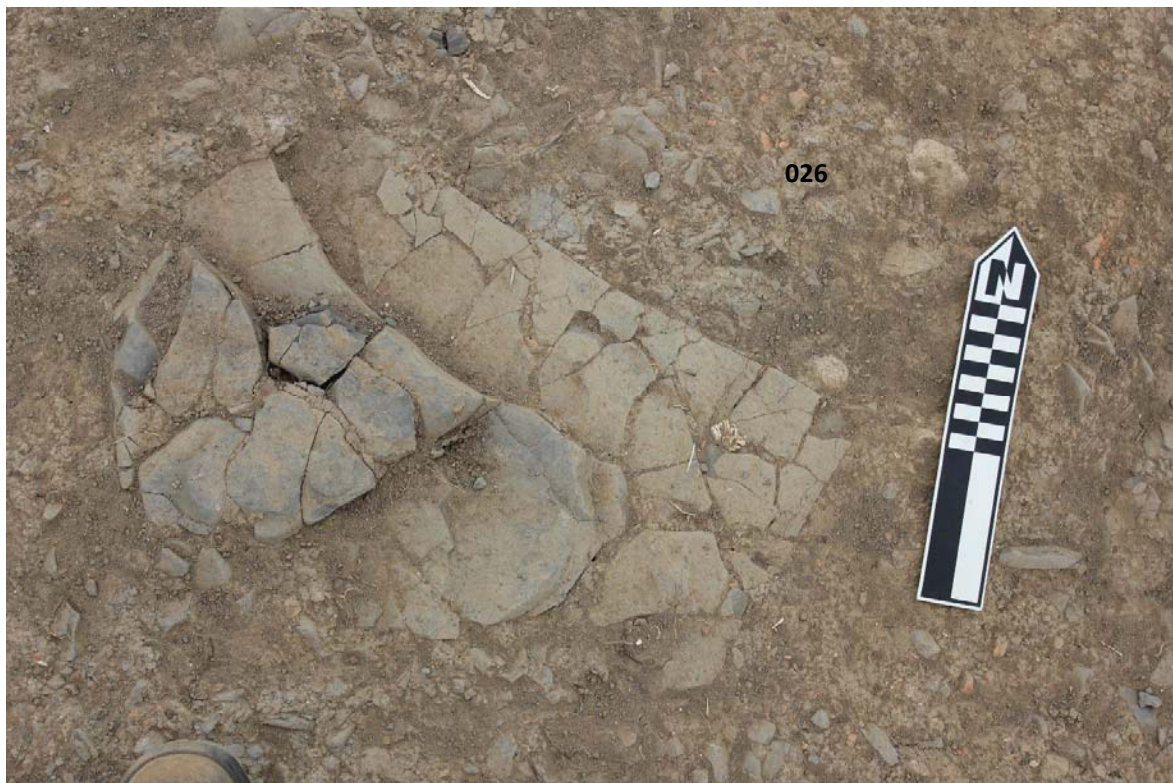
Plate 4.16 Detail of large fragments of shale [026] recorded in space 5 (south west corner). Note that the fragments form what appears to be a large tile. Scale 20 cm.

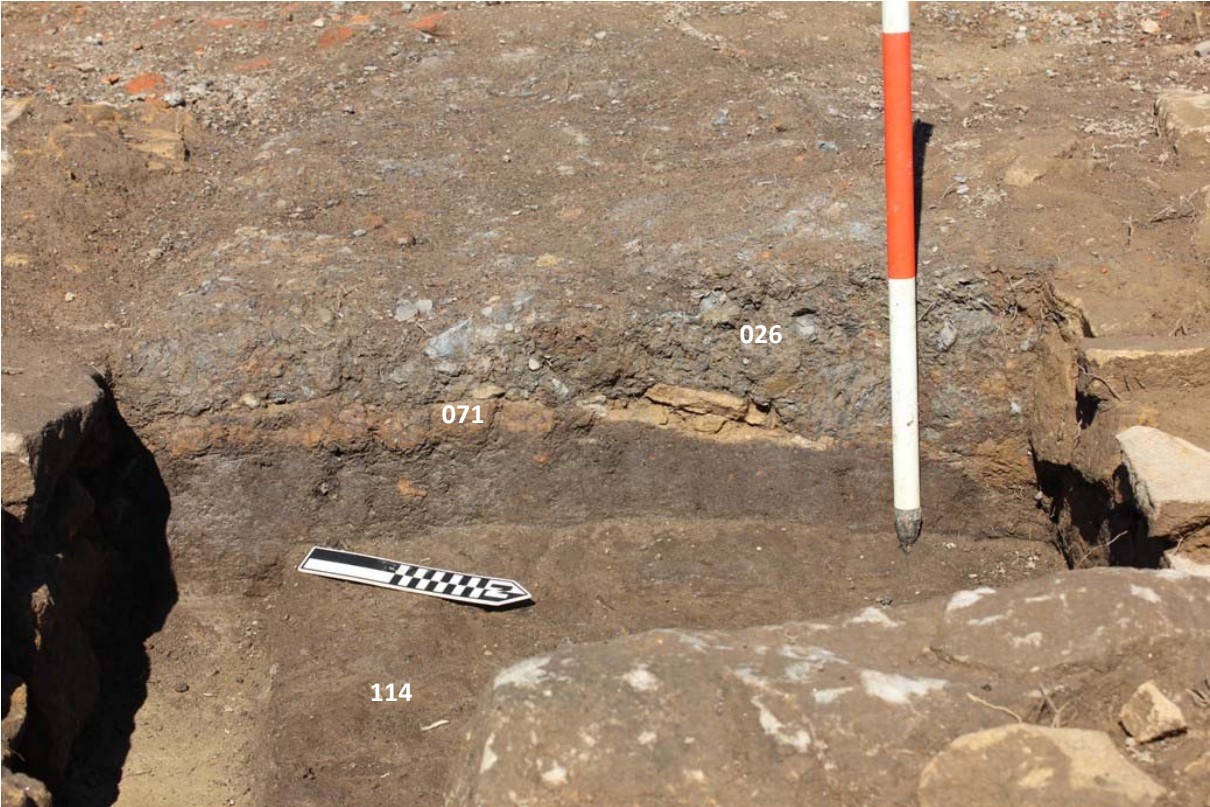
**Plate 4.18** Stratigraphy within the rear threshold of the early inn (Space 5). View west; scale increments 25 cm.

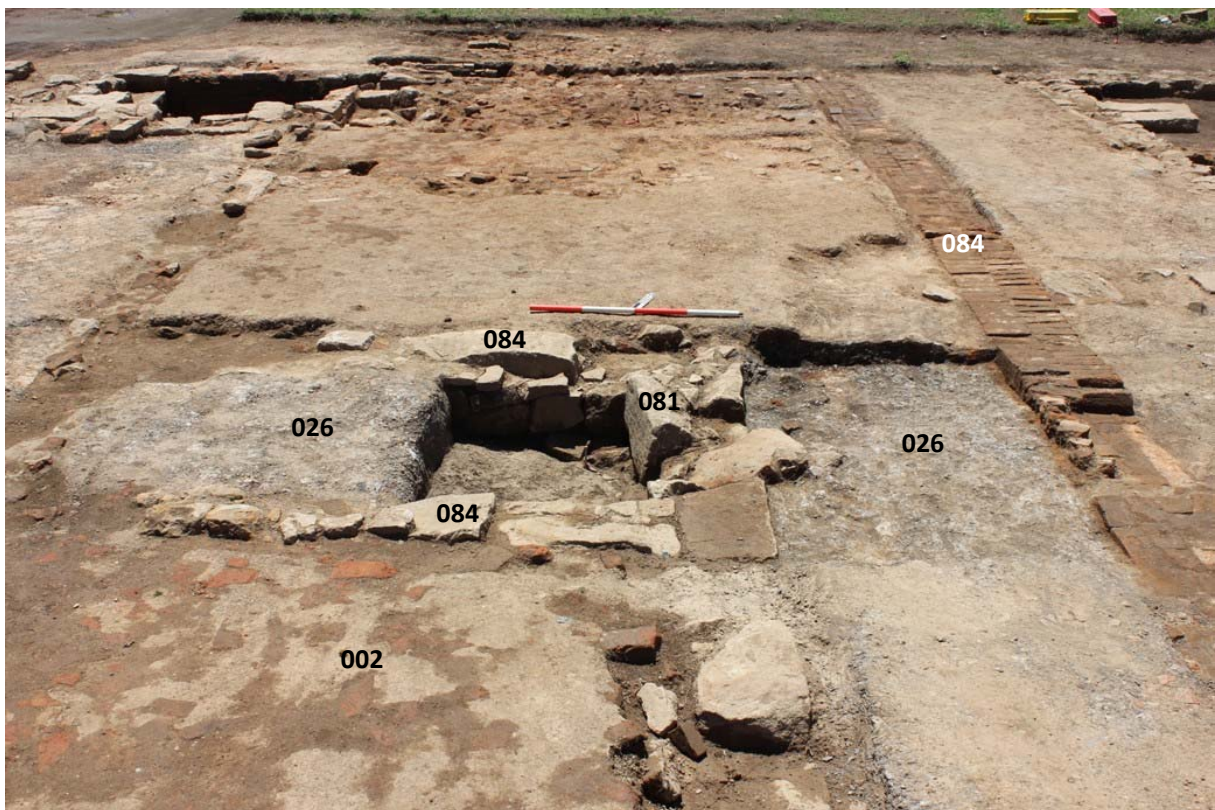
**Plate 4.20** Rear of the main inn building. View north; scale 1 m.

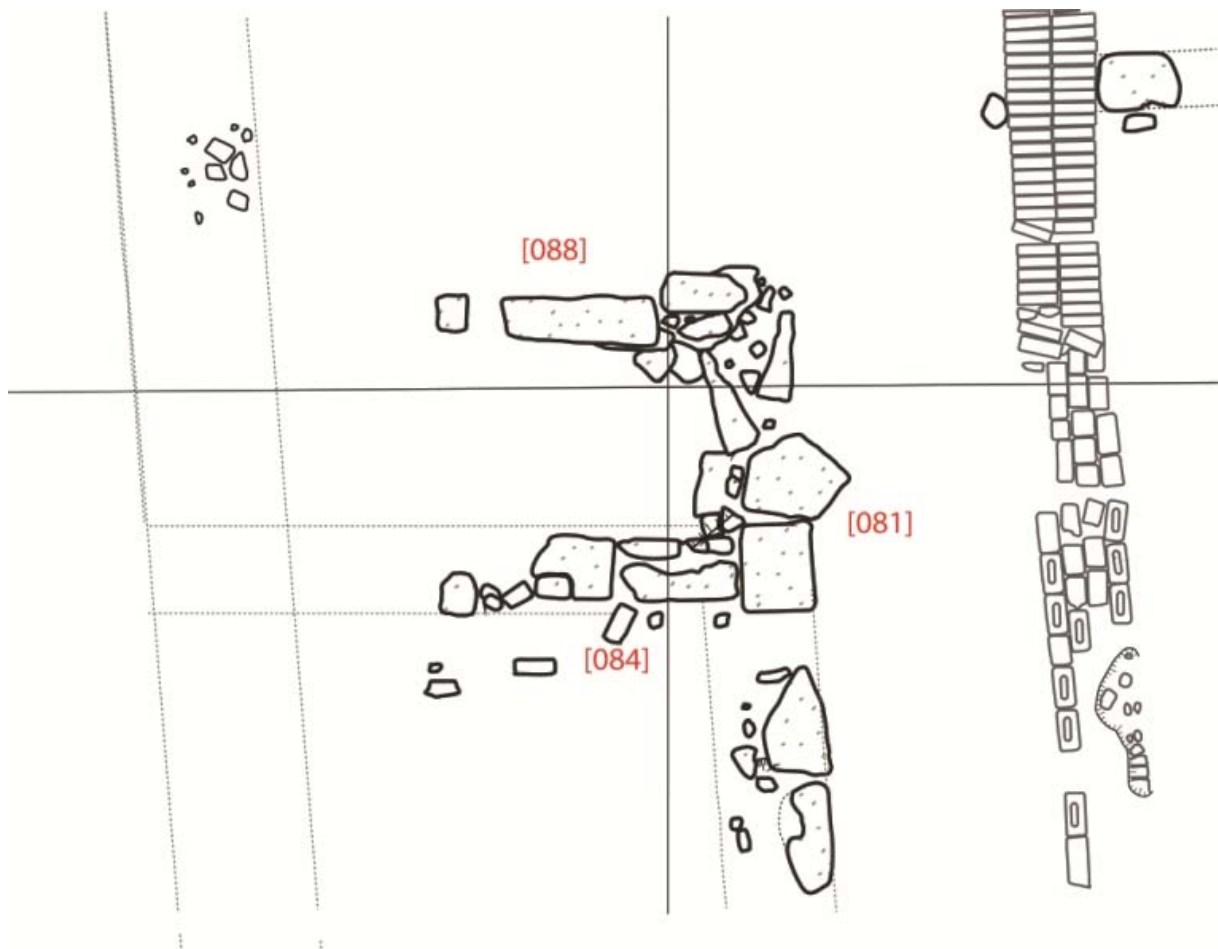
**Plate 4.21 Site plan detail of the feature in Space 5. It is possible that this feature is an original back doorway before the back of the inn was extended.**

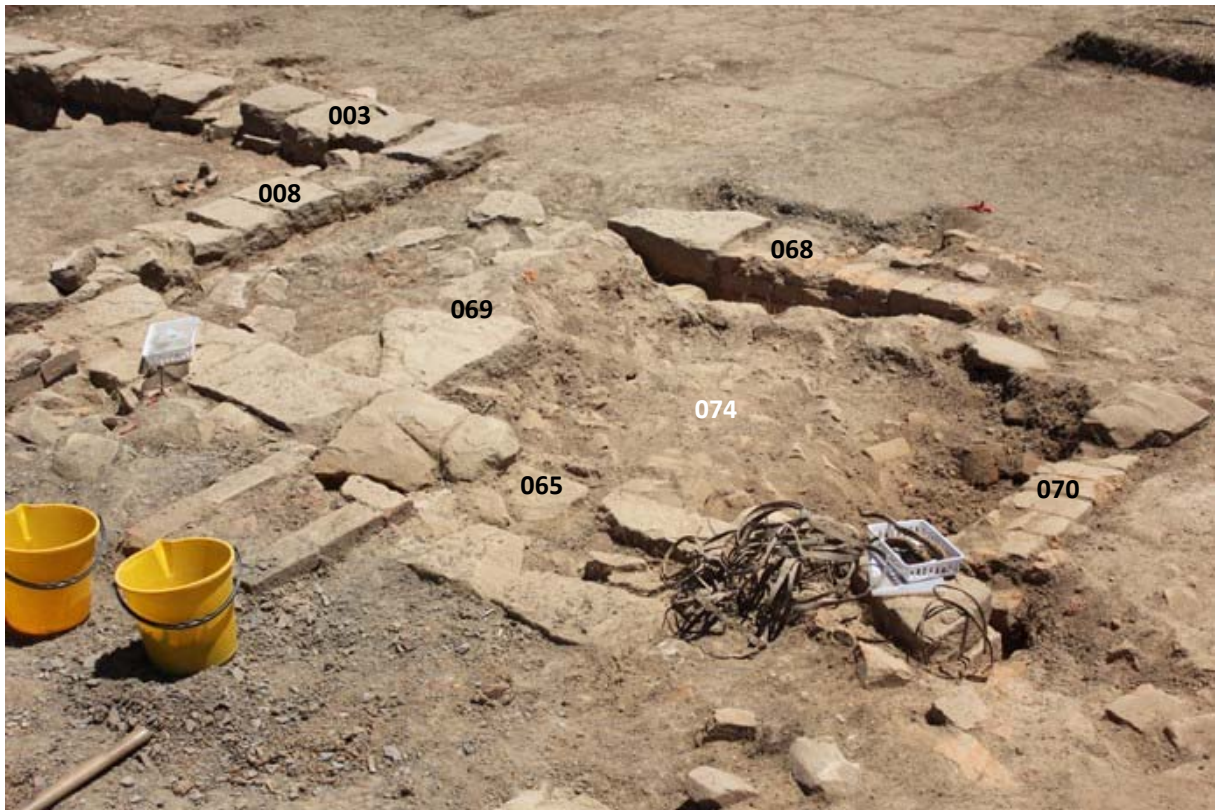
Three large sandstone blocks were uncovered during the test excavation; two had an entire face uncovered, the third is emerging from the unexcavated deposit below (Plate 4.25). The three blocks form a feature that slants slightly from west to east continue to a deeper part of the site. The total depth of the space was not been determined as excavations were halted to assess its stability and in anticipation of a conservation outcome. This configuration suggests that access to the space may have been possible from the outside and that the large sandstone blocks could have been a slide into the cellar or support for a timber slide or stairs. To the south of a slanting sandstone wall are sandstone footings seen in other parts of the building. The walls/footings to the north and east are composed of sandstock brick built against the sandstone blocks.

**Plate 4.22** The cellar (Space 6) after the removal of modern topsoil and top layer of demolition. View north-west.

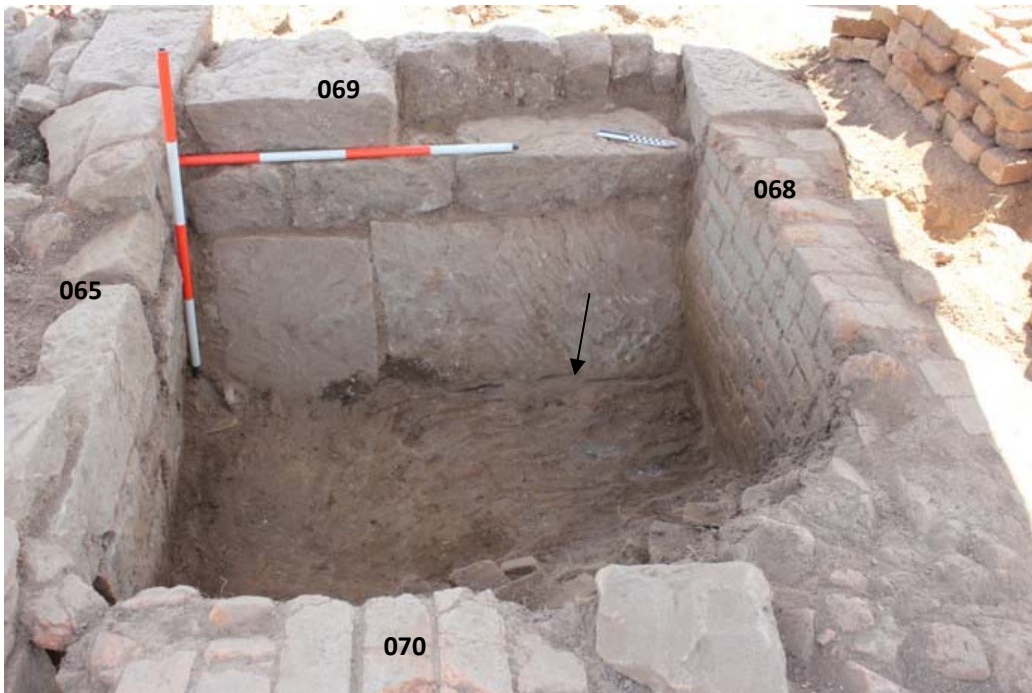
**Plate 4.24** View into the sub-surface area that is considered to be the entrance to a cellar.

Note the slanting sandstone blocks in Plate 4.24; there is another sandstone block emerging from the deposit that was not excavated. The wall directly above them (and under the north arrow) is possibly a footing for an external wall or threshold and is shown in context in Plate 4.14.

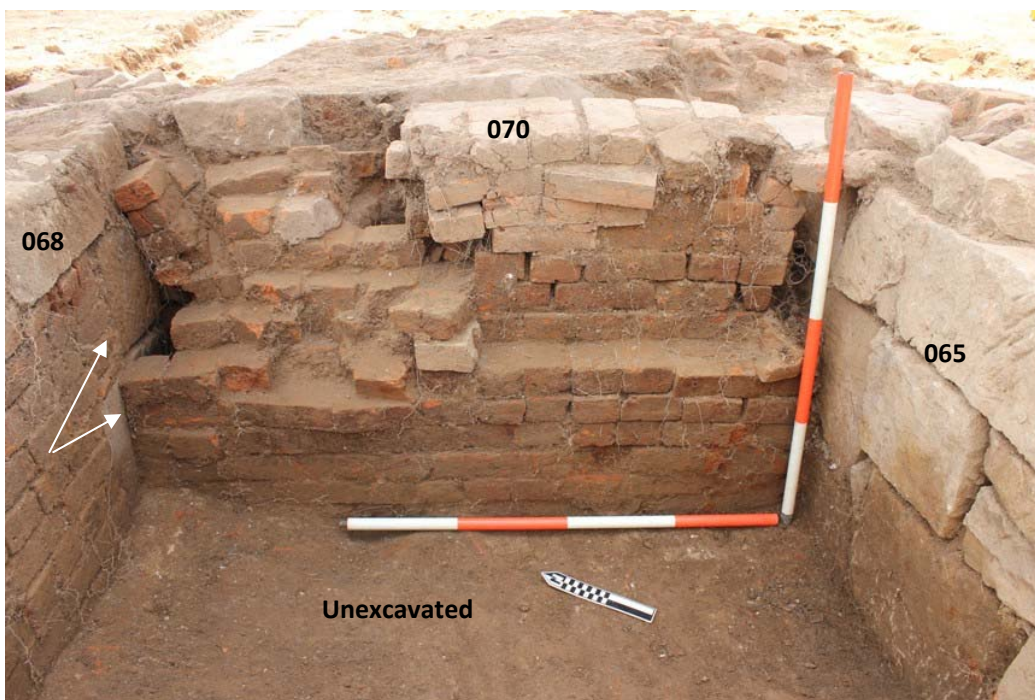
Plate 4.25 is the top part of the cellar looking west. The top two slanting sandstone blocks are clearly visible; the lower block that was emerging from the clay fill is indicated with an arrow.

**Plate 4.25** The cellar to the base of the demolition fill deposit. View west; scales 1 m each.

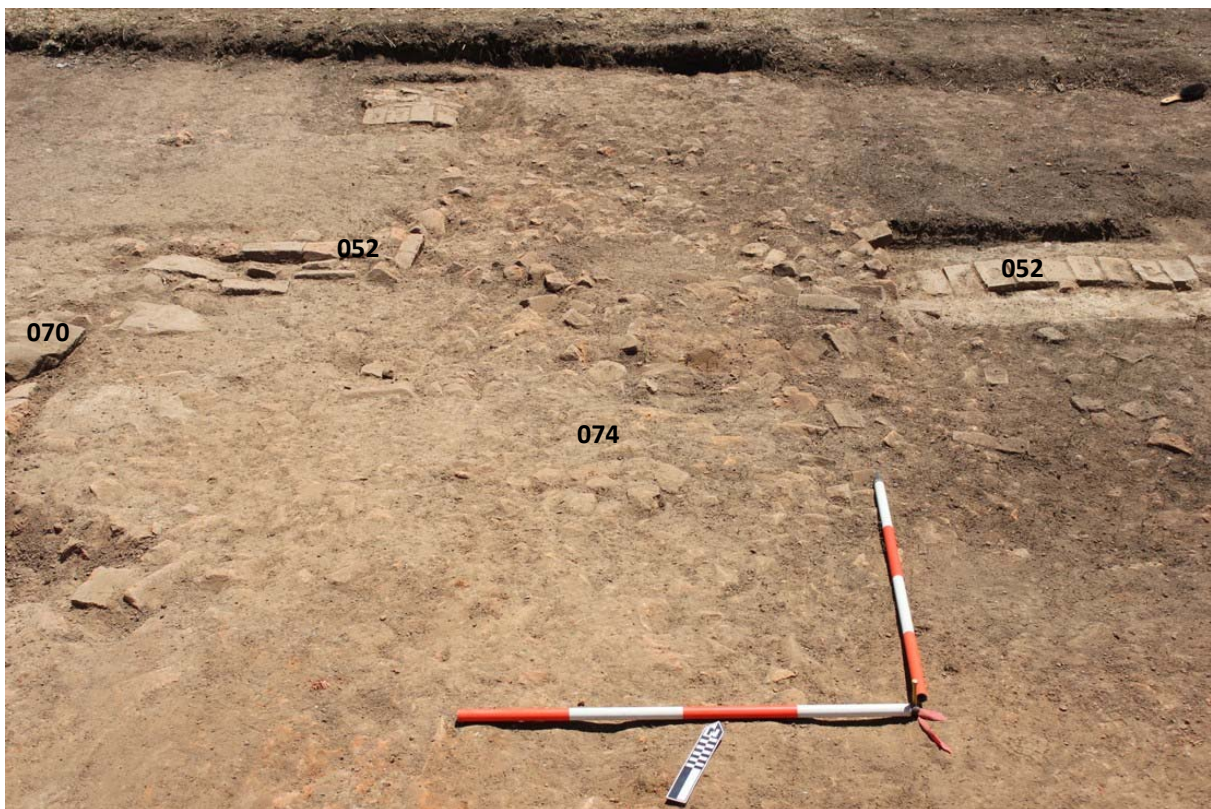
The most obvious scenario that is supported by the visible archaeology is that a void exists beneath [074] as it is a continuation of the cellar. The spread of the brick rubble to the north suggests either the continuation of the void beyond the brick strip footing or is the spread of debris at demolition. This deposit was not excavated (Plate 4.27). It may be a continuation of the cellar given the similarity of the excavated fill in the void; this area of the site did not feel as stable, or hard packed as other areas when walked over.

**Plate 4.27** Brick rubble to the east of the cellar (Space 7). View north; scales 1 m each.

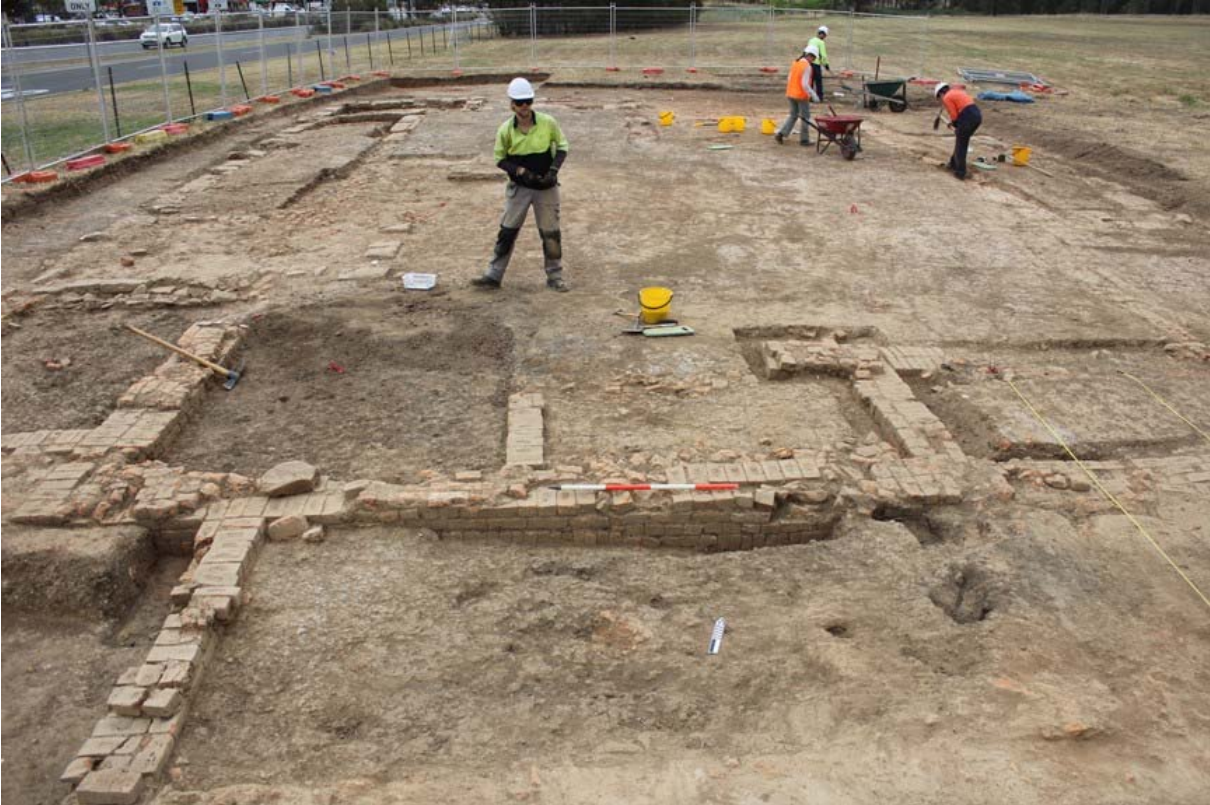
Plate 4.28 Overall view of the southern section of the main inn building. View north; scale 1 m.

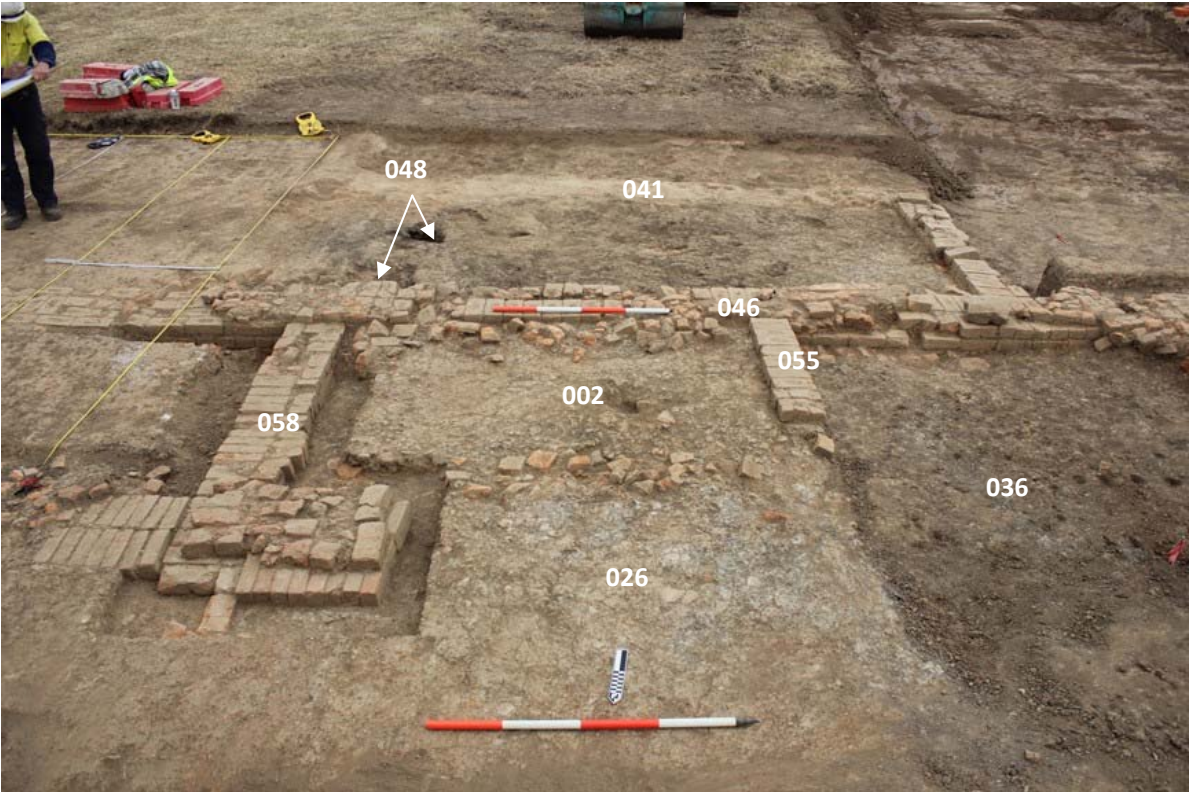
Plate 4.29 Space 8 at the southern end of the main inn building.

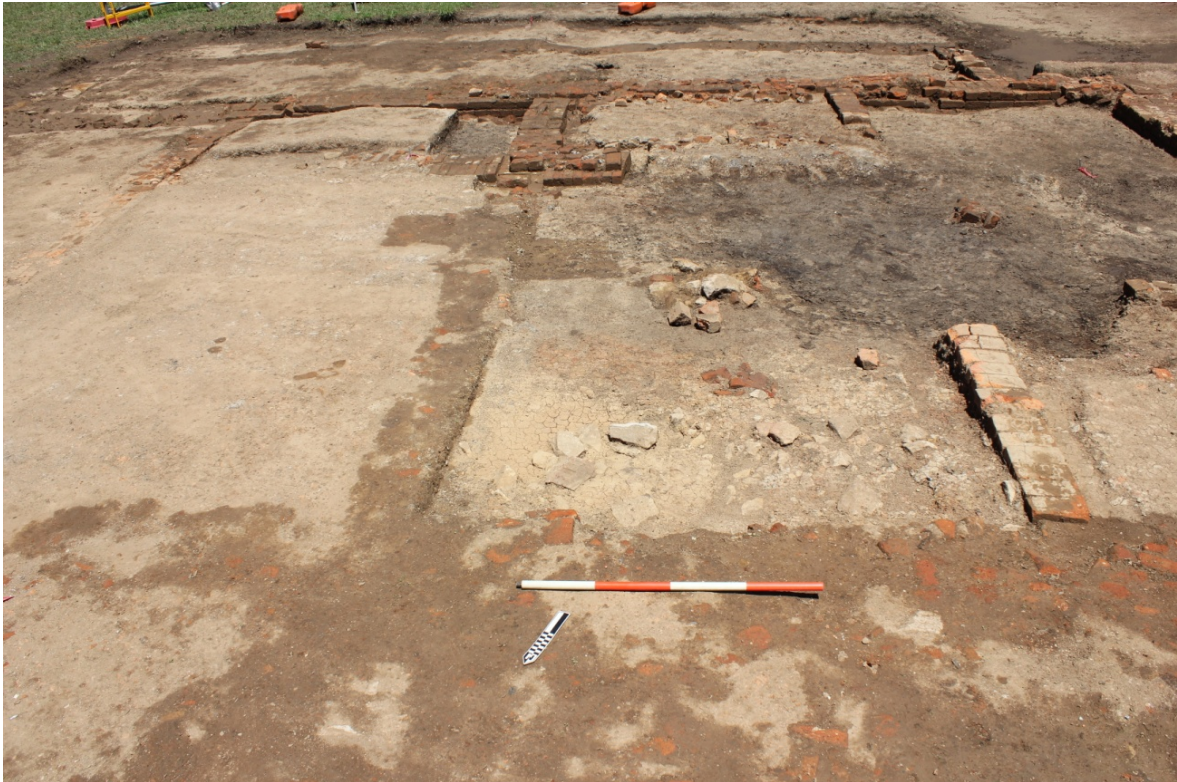
Plate 4.30 The rooms in the southern end of the main inn building showing areas of buried brick structures after rain. View south; scale 1 m.

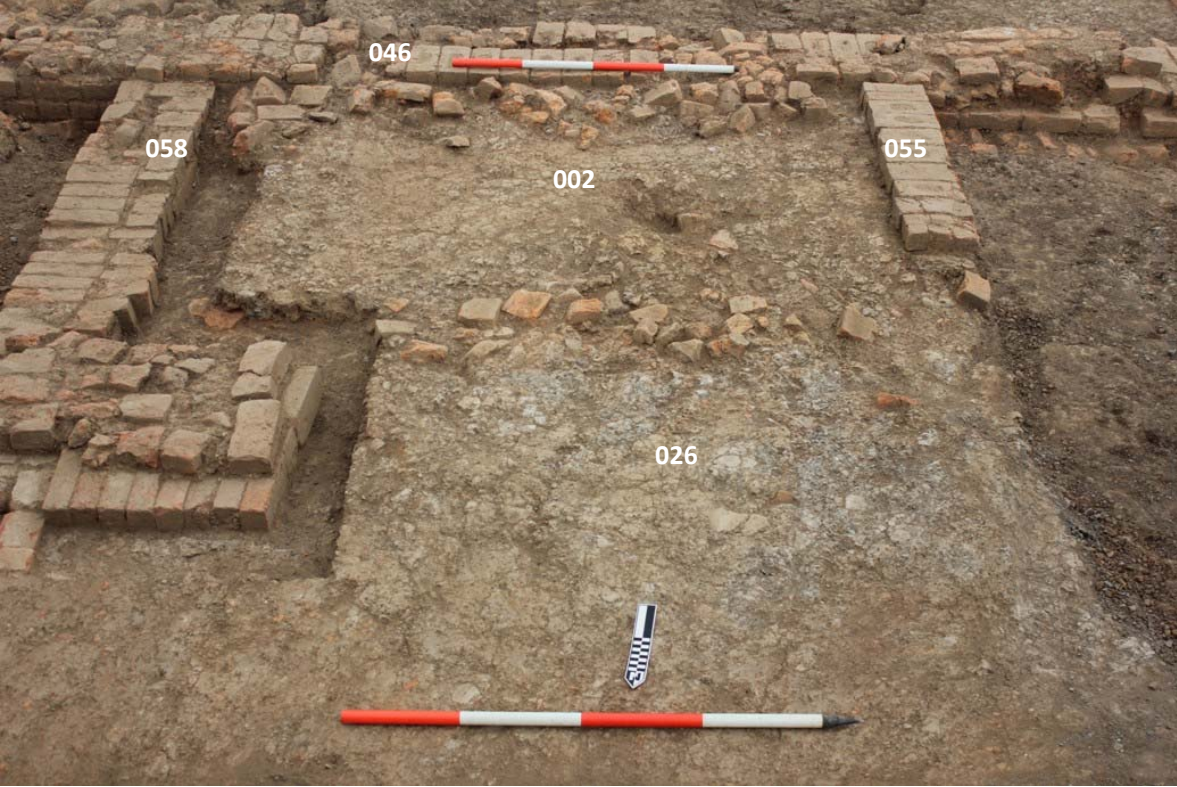
Plate 4.31 Detail of the southern section of the main inn building. View south; scales 1 m each.

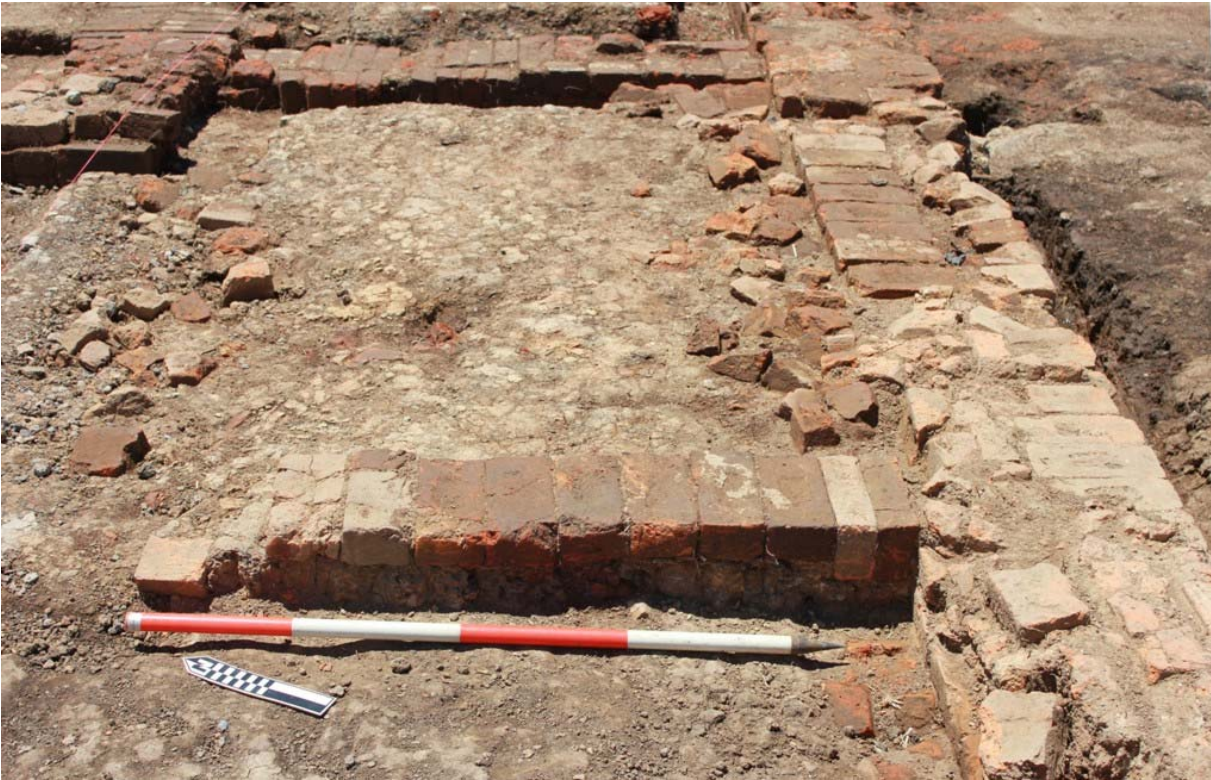
Plate 4.32 Demolition used as levelling fill beneath the brick bearing wall [055]. View east; 1 m scale.

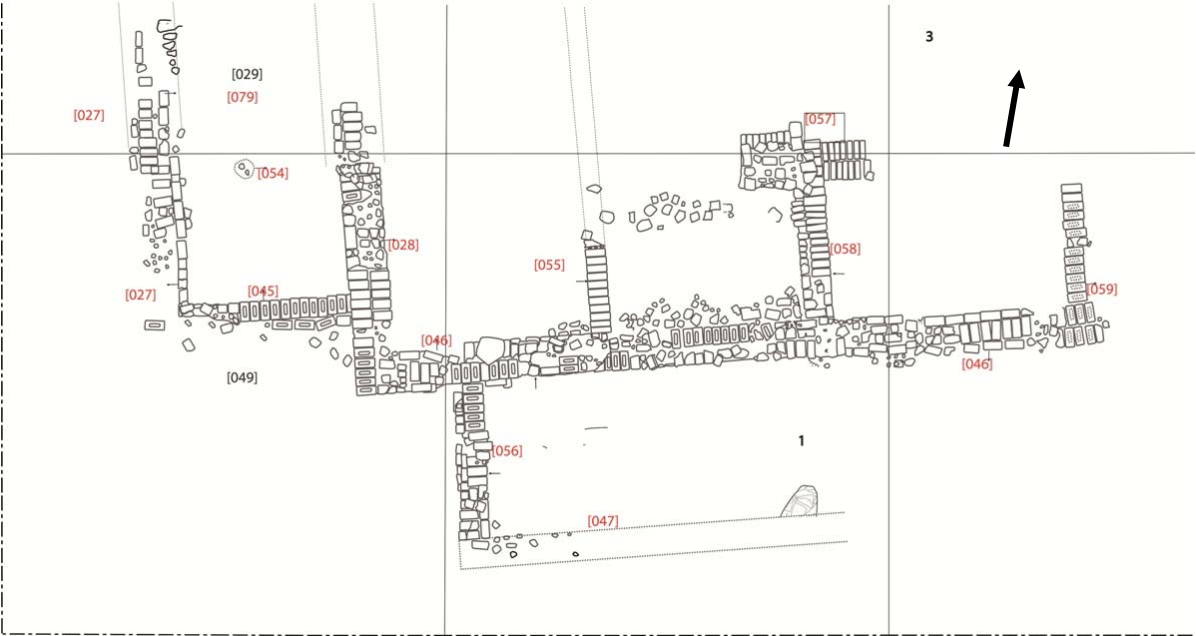
Plate 4.33 Site plan detail with the rear rooms at the southern end of the building.
