# Sydney Metro Northwest White Hart Inn & Stranger's Cottage

Old Windsor Road to White Hart Drive  
Beaumont Hills

## Archaeological test excavation report

Prepared for Transport for NSW | 1 February 2016

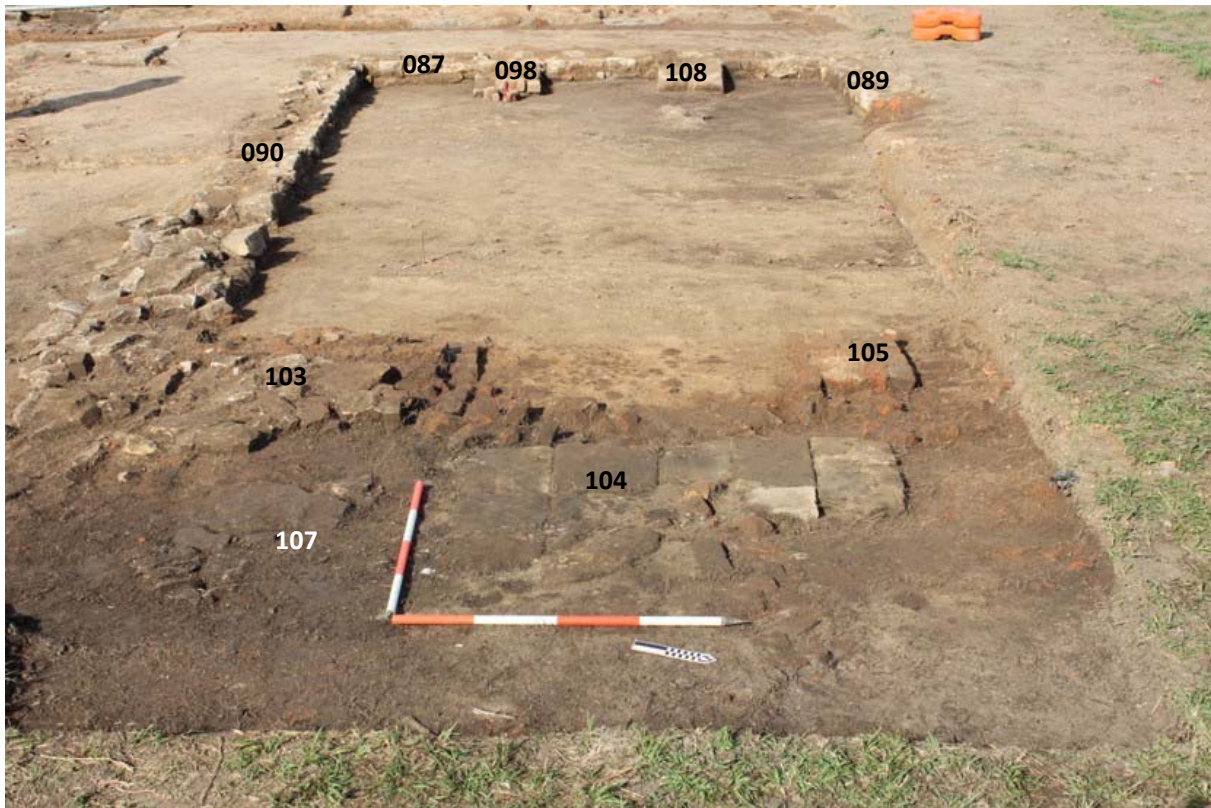
A detached room at the north east corner of the main building is considered to be a kitchen (9), strongly suggested by the large fireplace base on the western end as well as by virtue of its separation from the main part of the inn. The kitchen wing is 13 m long by 5 m wide. Kitchens were often separate from the buildings they serviced, in both commercial and domestic contexts, to reduce the potential of the entire building burning if the kitchen caught fire. The footings for the kitchen area were made of fragmented sandstone, randomly coursed but neatly edged, much like a dry stone wall [090], [087], [089] and [103]. Context [105] is brick pier in a square configuration.

The rear of the kitchen faces east and is defined by footings for a rear wall and sandstone flagging [104] representing a large hearth. While the hearth was indoors, the chimney of this building protruded from the main building envelope. The deposit [107] (Plate 4.36 for close up image) on the outside of the building was carbon rich and contained ceramic sherds, bones and glass fragments suggesting an area where the chimney sweepings were deposited, or post-demolition deposition. The east side of the kitchen including [107] remains unexcavated.

**Plate 4.34 Detached kitchen. View west; scales 1 m each.**

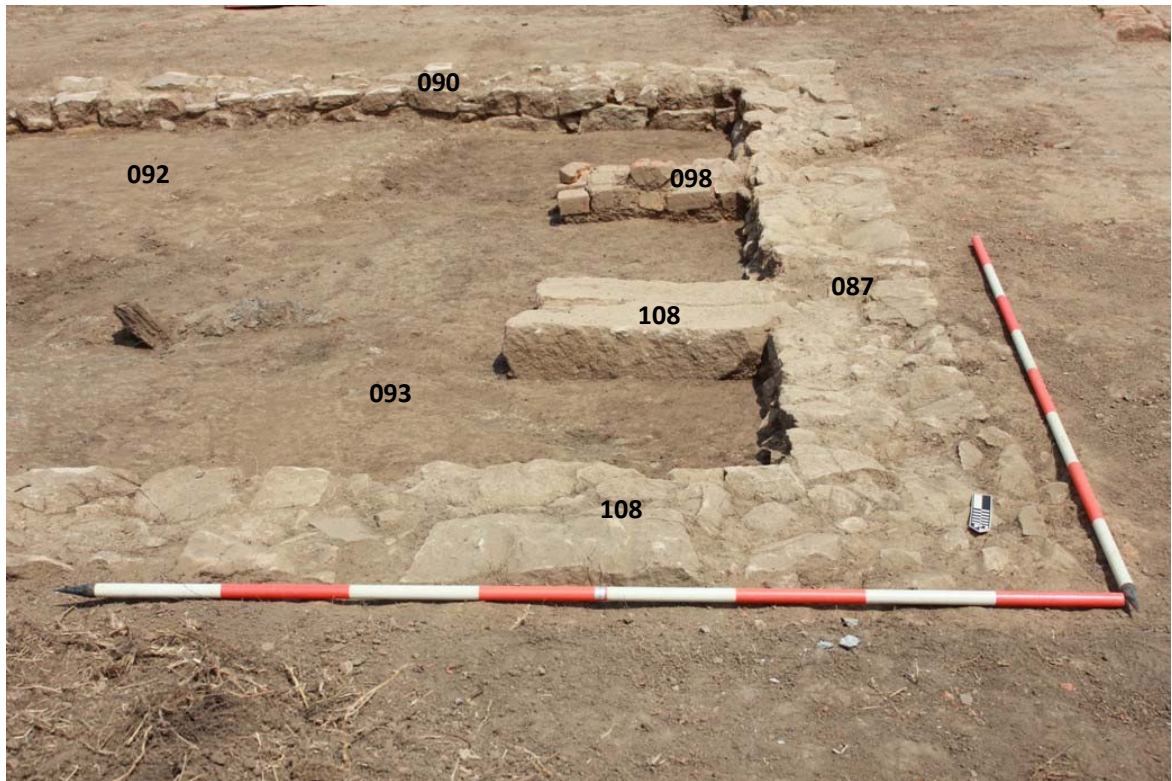
The footings on the western wall [087] may have been fireplace base also. Footing [108] is made up of two long sandstone blocks. Footing [098] is bricks on sandstone blocks.

**Plate 4.35** The eastern end of the kitchen (Space 9). View south; scales 2 m each.

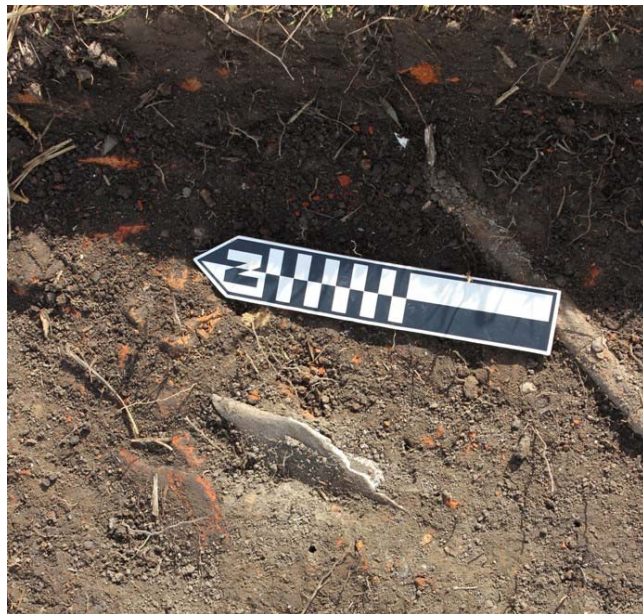
The archaeological deposits that were partially excavated in the kitchen area included crushed shale [092] over what appears to be topsoil [093]. Trench cuts were not visible in this deposit, making it difficult to determine if the strip footings were built directly on topsoil or if it was redeposited against the strip footings. The kitchen area was not fully excavated.

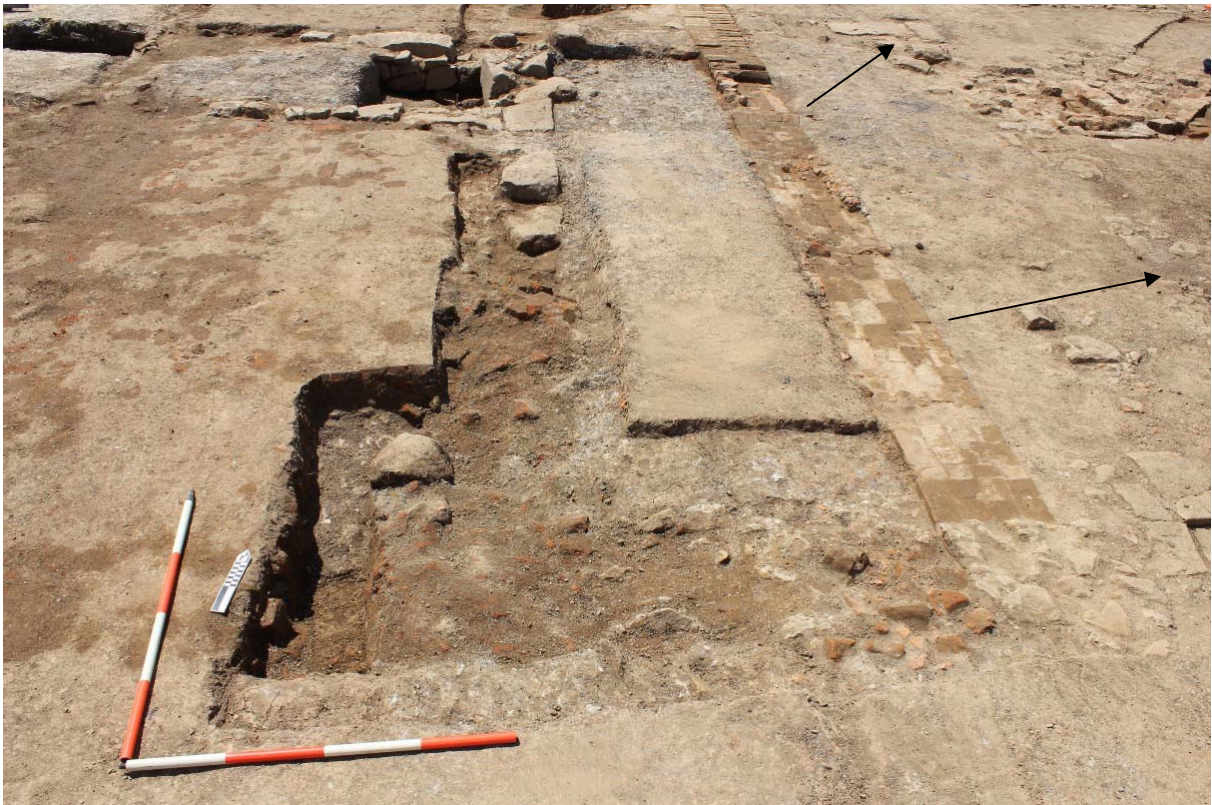
Space 10 is at the rear of the main inn building. It is 1.3 m wide and 6.2 m long (internal) and in the centre of the main inn building rear. This space is defined by sandstone block footings on the north [091], east [064] and south [096] and the brick strip footing [063] to the west. [063] is the rear wall of the main inn building. The brick pathway (11; refer below) joins the kitchen building with the main inn building at the rear veranda. Clarification of the fabric where the north footing [091] crosses the brick strip footing [063] showed that the brick did not cut through the sandstone indicating that the sandstone feature was built against the rear brick footings (or wall). While the three external footings are sandstone blocks, it is likely that these belong to the extension of the inn and are not part of the original configuration.

**Plate 4.37** The rear veranda (Space 10) indicated by an arrow. This space is defined by sandstone blocks to the east and the sandstock brick wall on its west.

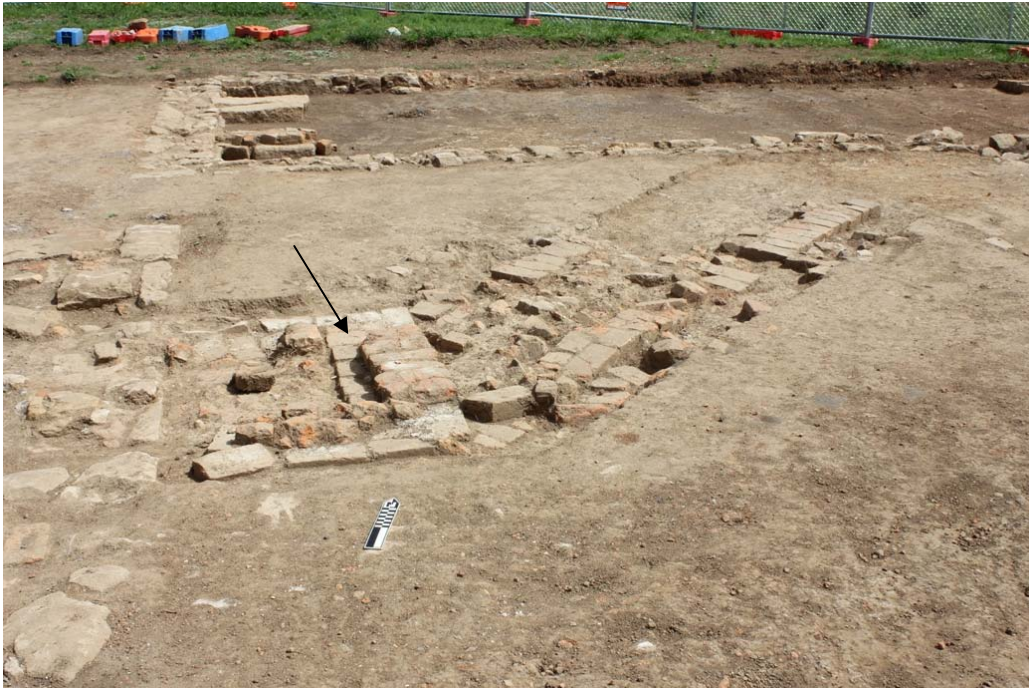
**Plate 4.39** Brick pathway [110] (Space 11) connecting the main inn building with the kitchen. The rear veranda (Space 10) is on the right. View north.

A brick feature [110] was uncovered beneath the grass/topsoil deposit [001] at the rear of the main building and adjacent to the kitchen. Further clarification suggests that this feature was a brick path joining the kitchen to the main inn building. The rectangular configuration of bricks abutting the main inn building (indicated by an arrow Plate 4.39) suggests one or more steps up from the yard to the back of the inn.

The pathway is approximately 4.5 m long and 1 m wide and survives in a fragmented but interpretable state. This feature was clarified to an extent but not excavated so it is not possible to definitively comment on its construction method. Based on the deeper bricks close to the main inn building, it appears that the pathway was cut into the surface of the ground (refer also to Plate 4.40).

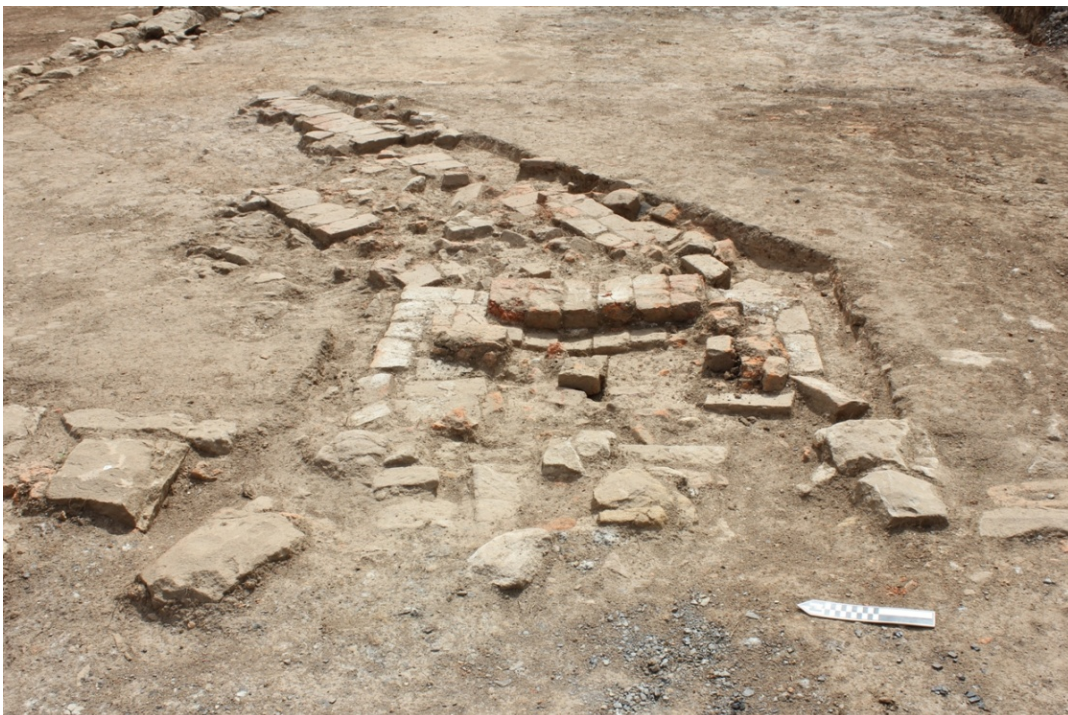
**Plate 4.40** The brick path from the rear of the inn. The photograph was taken from Space 10. View east.

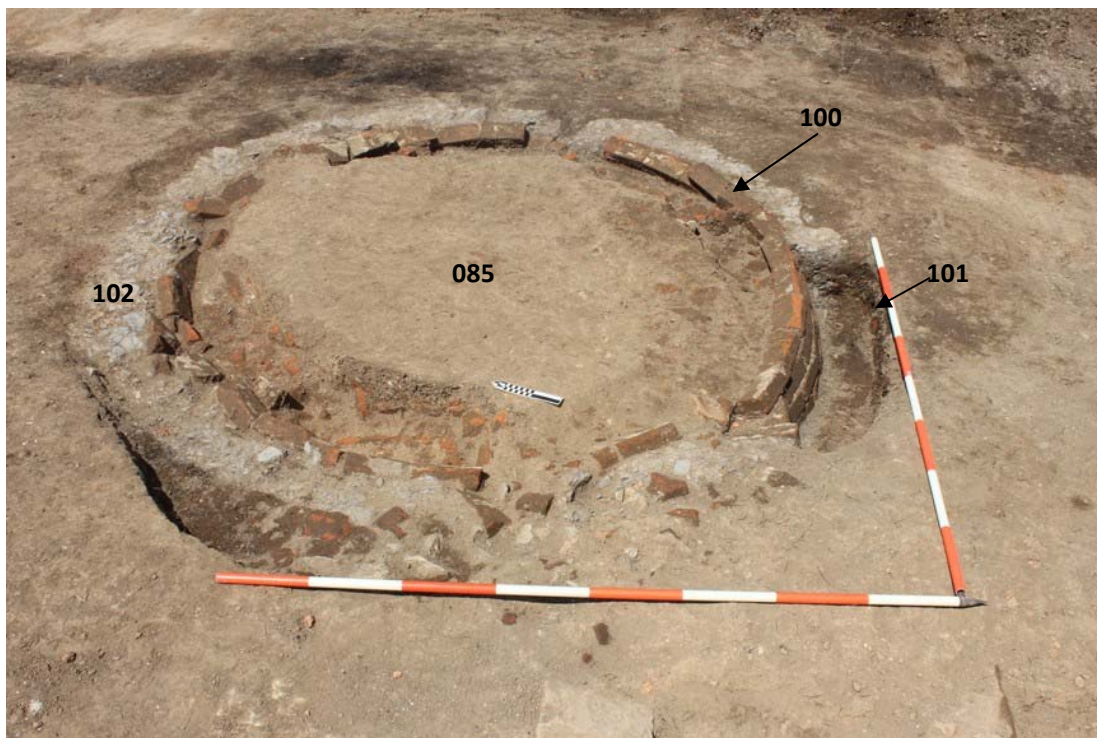
The deposit within the cistern was not excavated (Plate 4.41). It is likely that the site of the demolished White Hart Inn was visited by two visitors on a trip around western Sydney in 1937. They reported that they found some bricks, a mounting block and “an ancient well in perfect preservation with clear water in it” (*Sydney Mail* 24 February 1937, p.42). If it was the site of the old inn that was described in the article, it suggests that the cistern still held water (as the words “cisterns” and “wells” are often mistakenly interchanged), which in turn suggests a second phase of demolition or site clearance. If this is the case, the fill [085] within the cistern was deposited in the later twentieth century.

**Plate 4.41** The cistern (Space 12) located at the rear of the inn building. View east; 2 m scales.

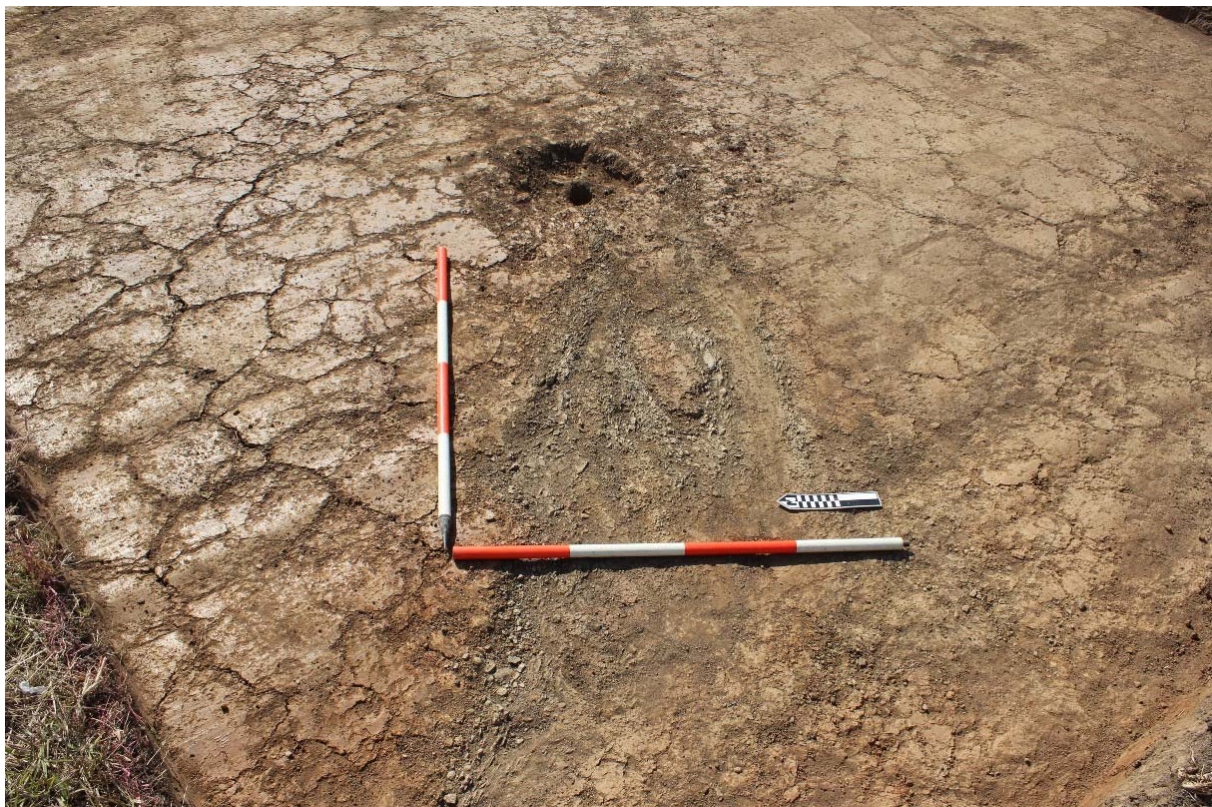
The hole visible in Plate 4.43 was made by a vinegar bottle that appeared to have been pushed through the top, neck first.

**Plate 4.43** The natural B soil horizon below topsoil immediately north of the inn. View south east; 1 m scales.

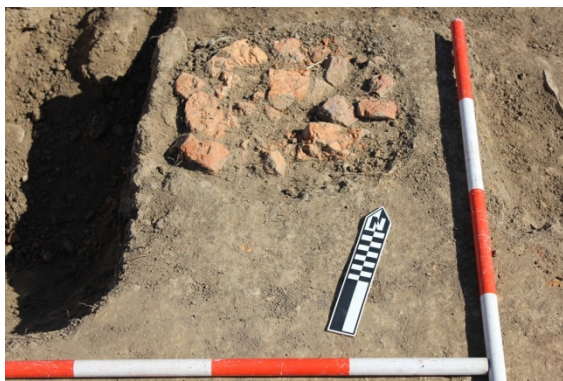
Plate 4.44 Pier [077] at the northern end of the veranda.

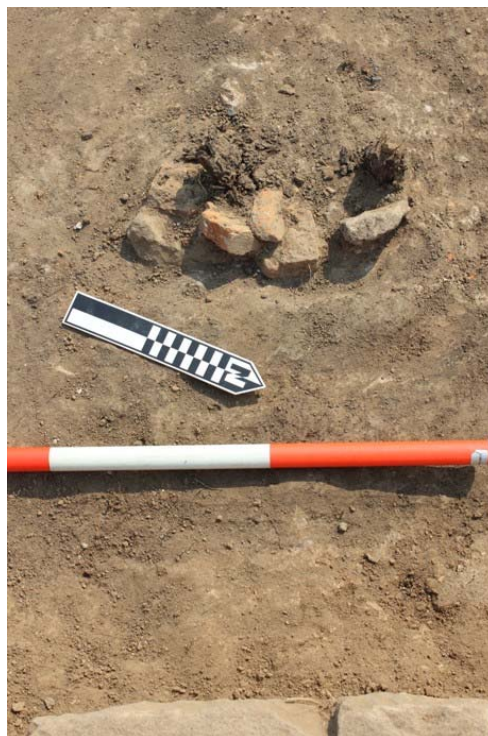
Plate 4.45 Pier [076] toward the middle of the veranda.

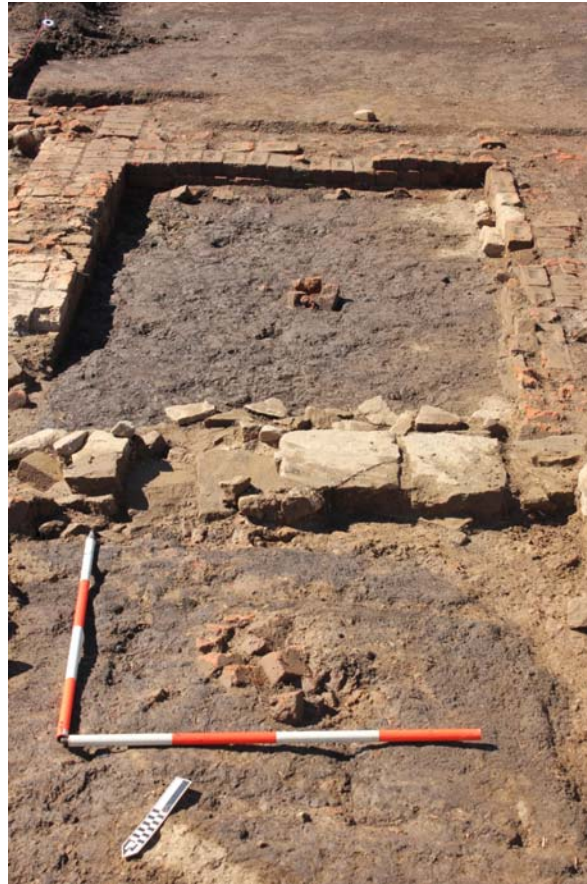
**Plate 4.47** Brick piers [051] (foreground) and [054] at the front of the inn. The bricks in the foreground are in the original south wing room (Space 3) before it was replaced by the second wing room (Space 4).

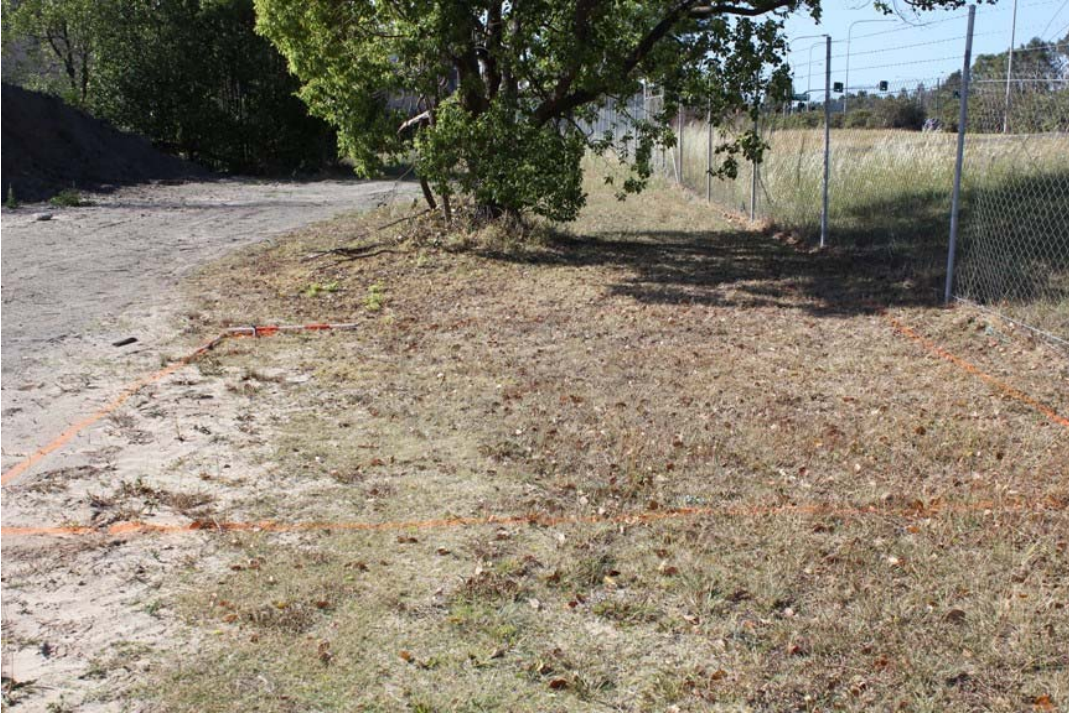
Plate 5.1 Estimated location of the Stranger’s cottage. View south; 1 m scale.

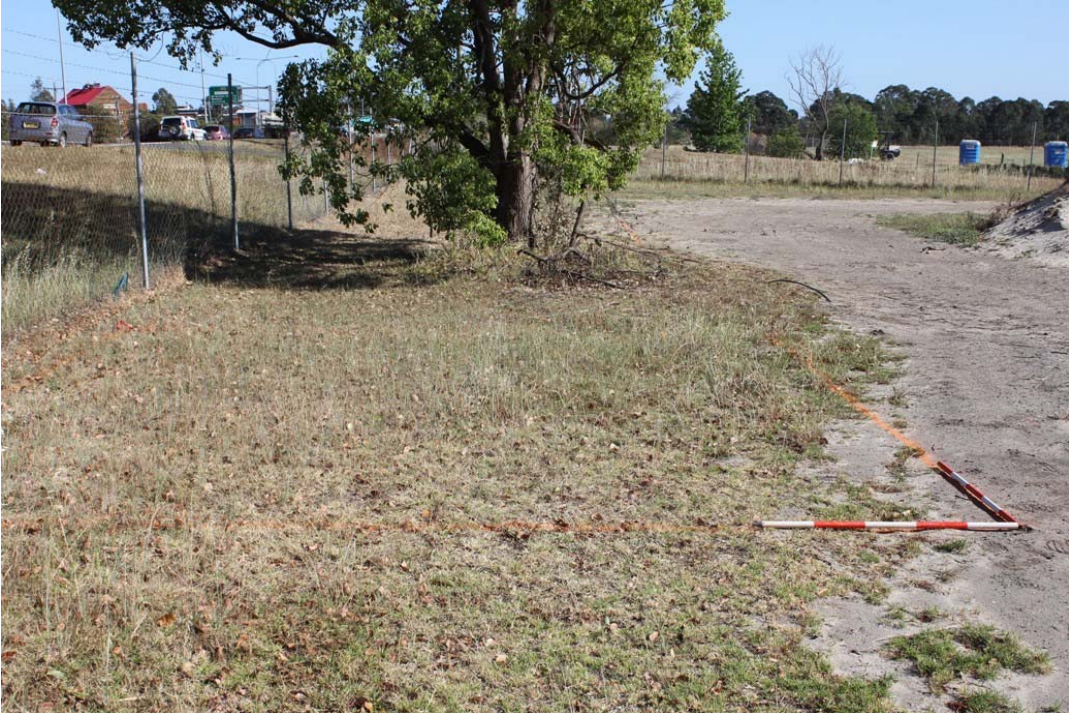
Plate 5.2 Estimated location of the Stranger’s cottage. View north; 1 m scale.

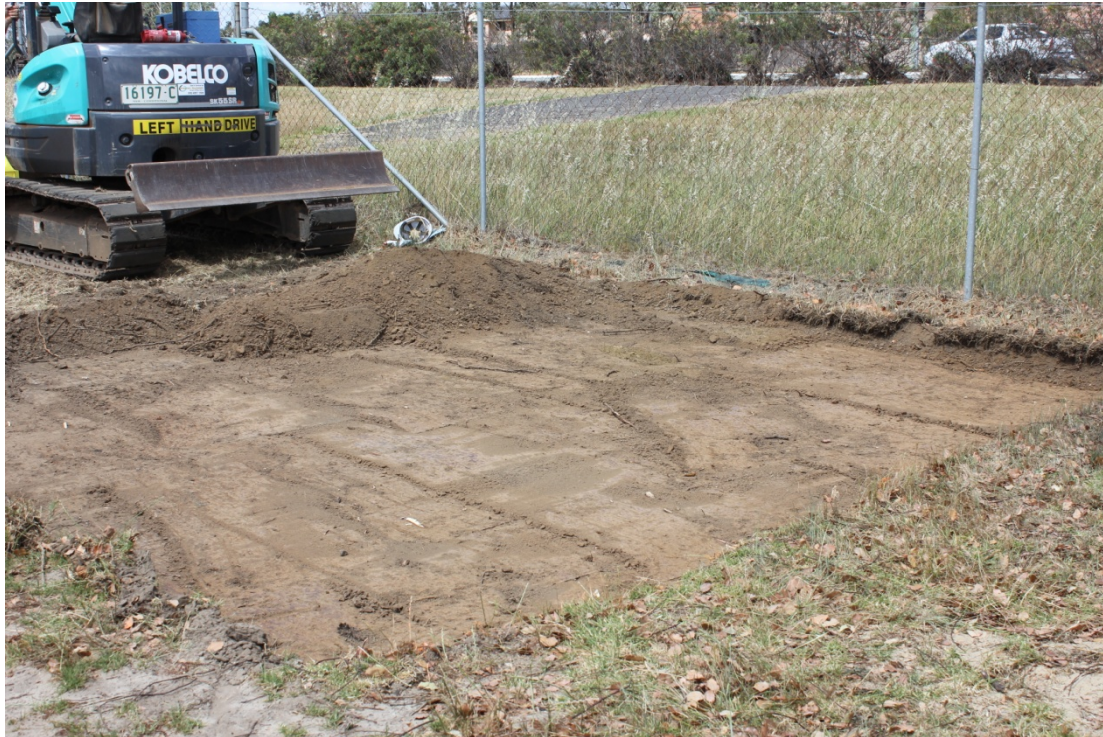
**Plate 5.3** Grass and topsoil removal – Stranger’s cottage site. View south-west.

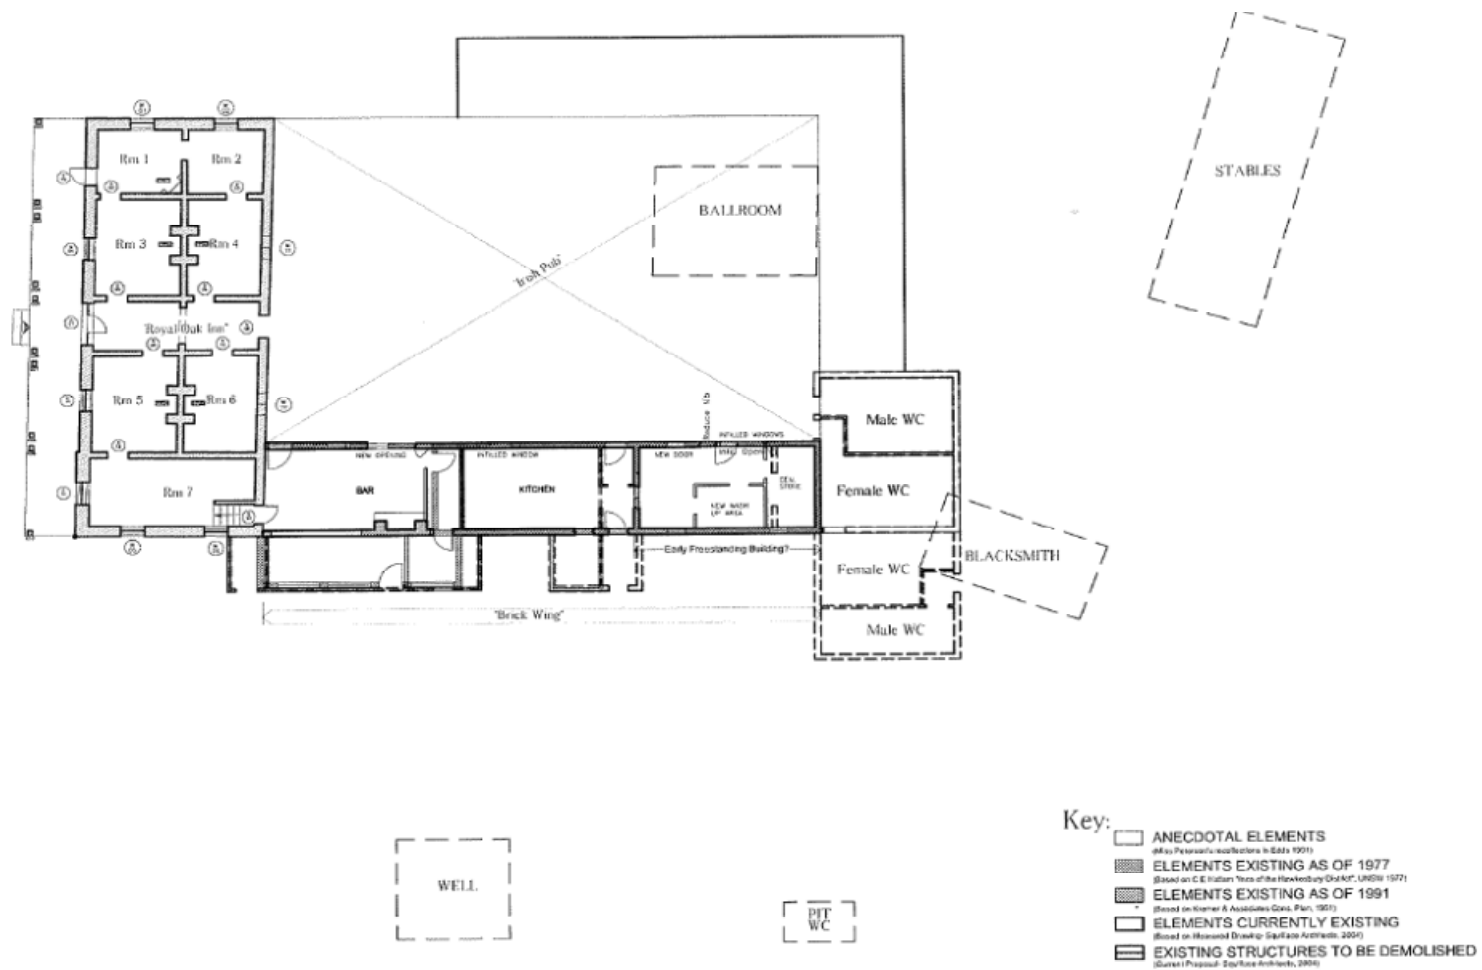
Plate 7.3 The Mean Fiddler layout with potential structures located to the rear and south of the main building (dashed). (Source: Archnex Designs 2006, Appendix A).

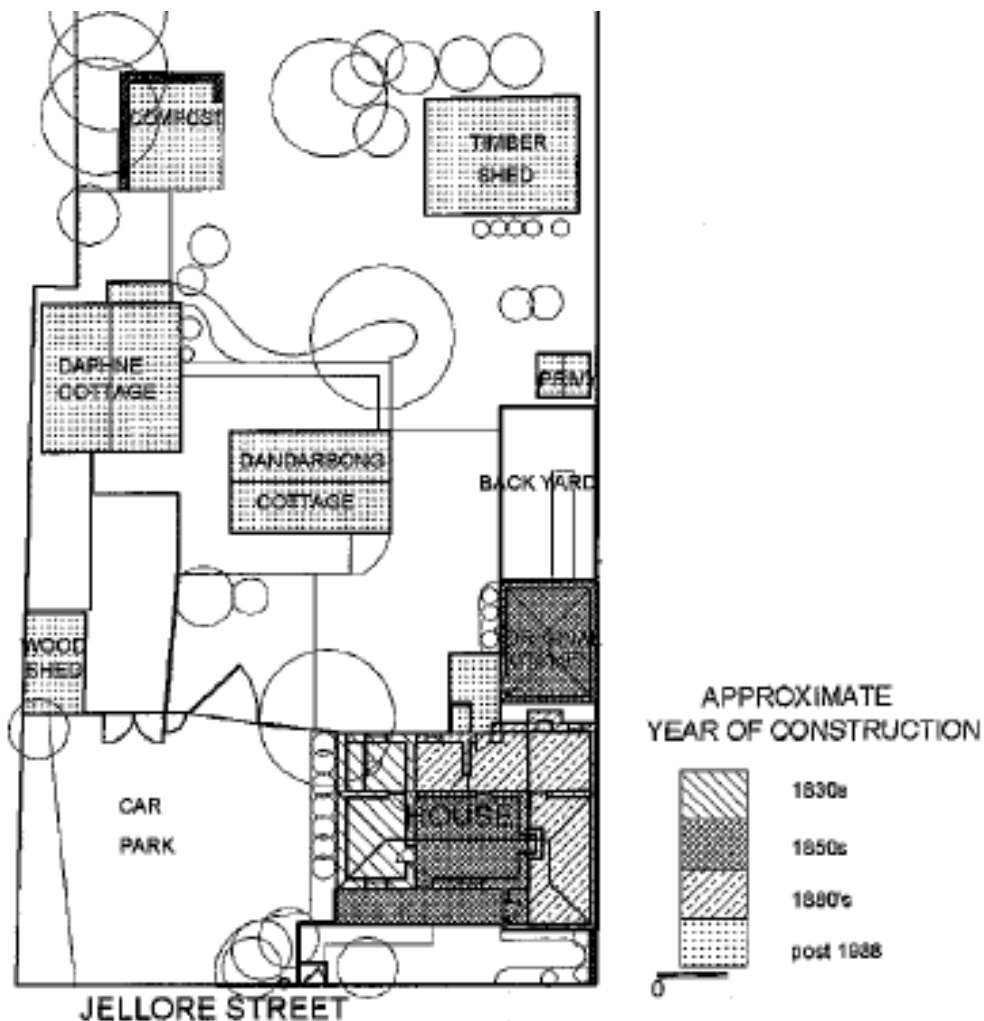
**Plate 7.5** The Coach and Horses Inn showing the different phases of construction. (Source Webb and Webb 2009, Figure 10).

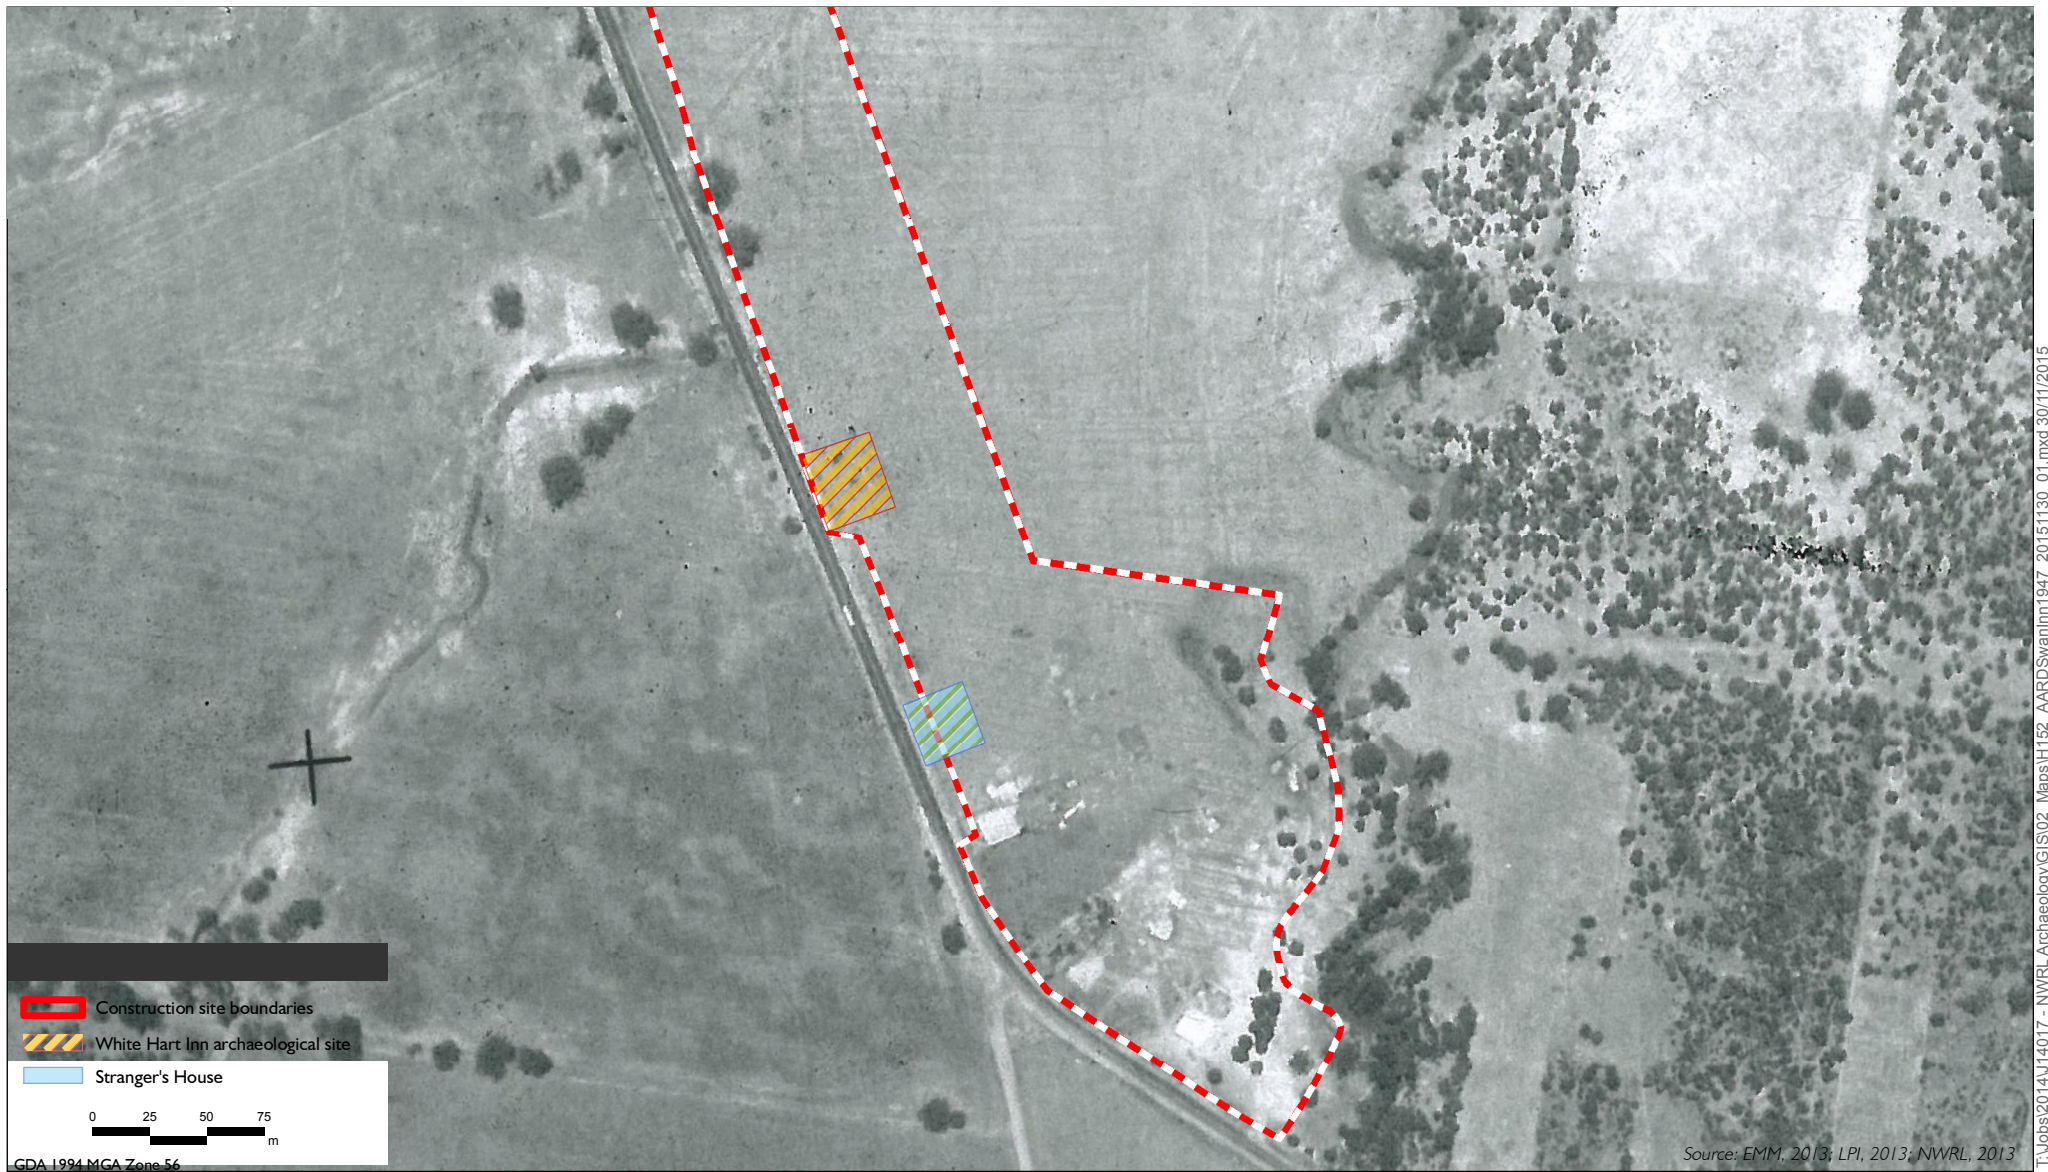
Figure I.3

Aerial photograph Windsor and Old Windsor Roads 1947

The 1943 (Figure 1.2) and 1947 (Figure 1.3) aerial photographs show a structure approximately 100 m from the junction of Windsor and Old Windsor Roads. The surrounding area is cleared bare paddocks. By 1956 (Figure 1.4) many structures have been added and the land has been subject to disturbance through the creation of driveways and paths through. It is similar in 1961 (Figure 1.5) and 1965 (Figure 1.6) with many buildings still present.

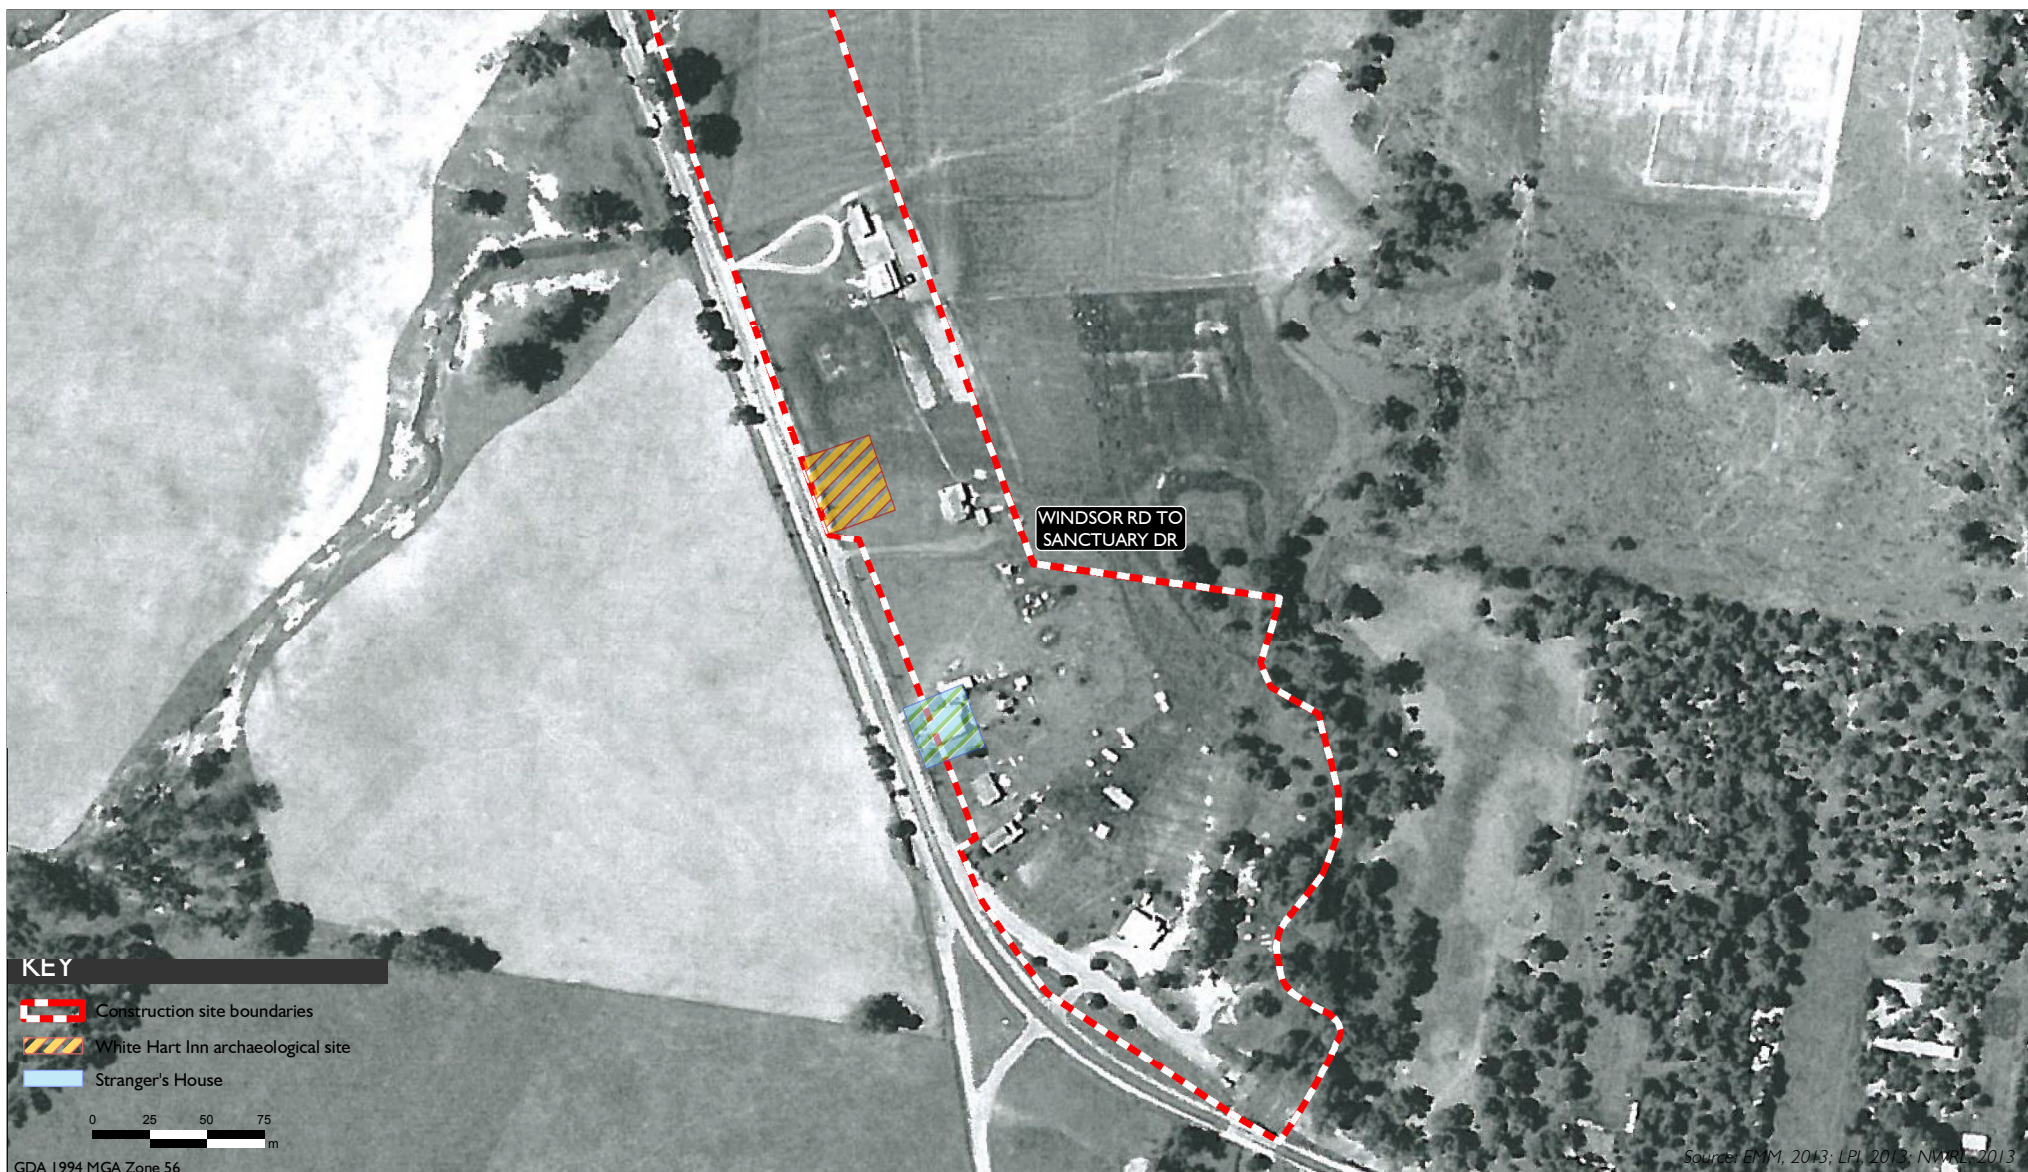
Figure I.4

Aerial photograph Windsor and Old Windsor Roads 1956

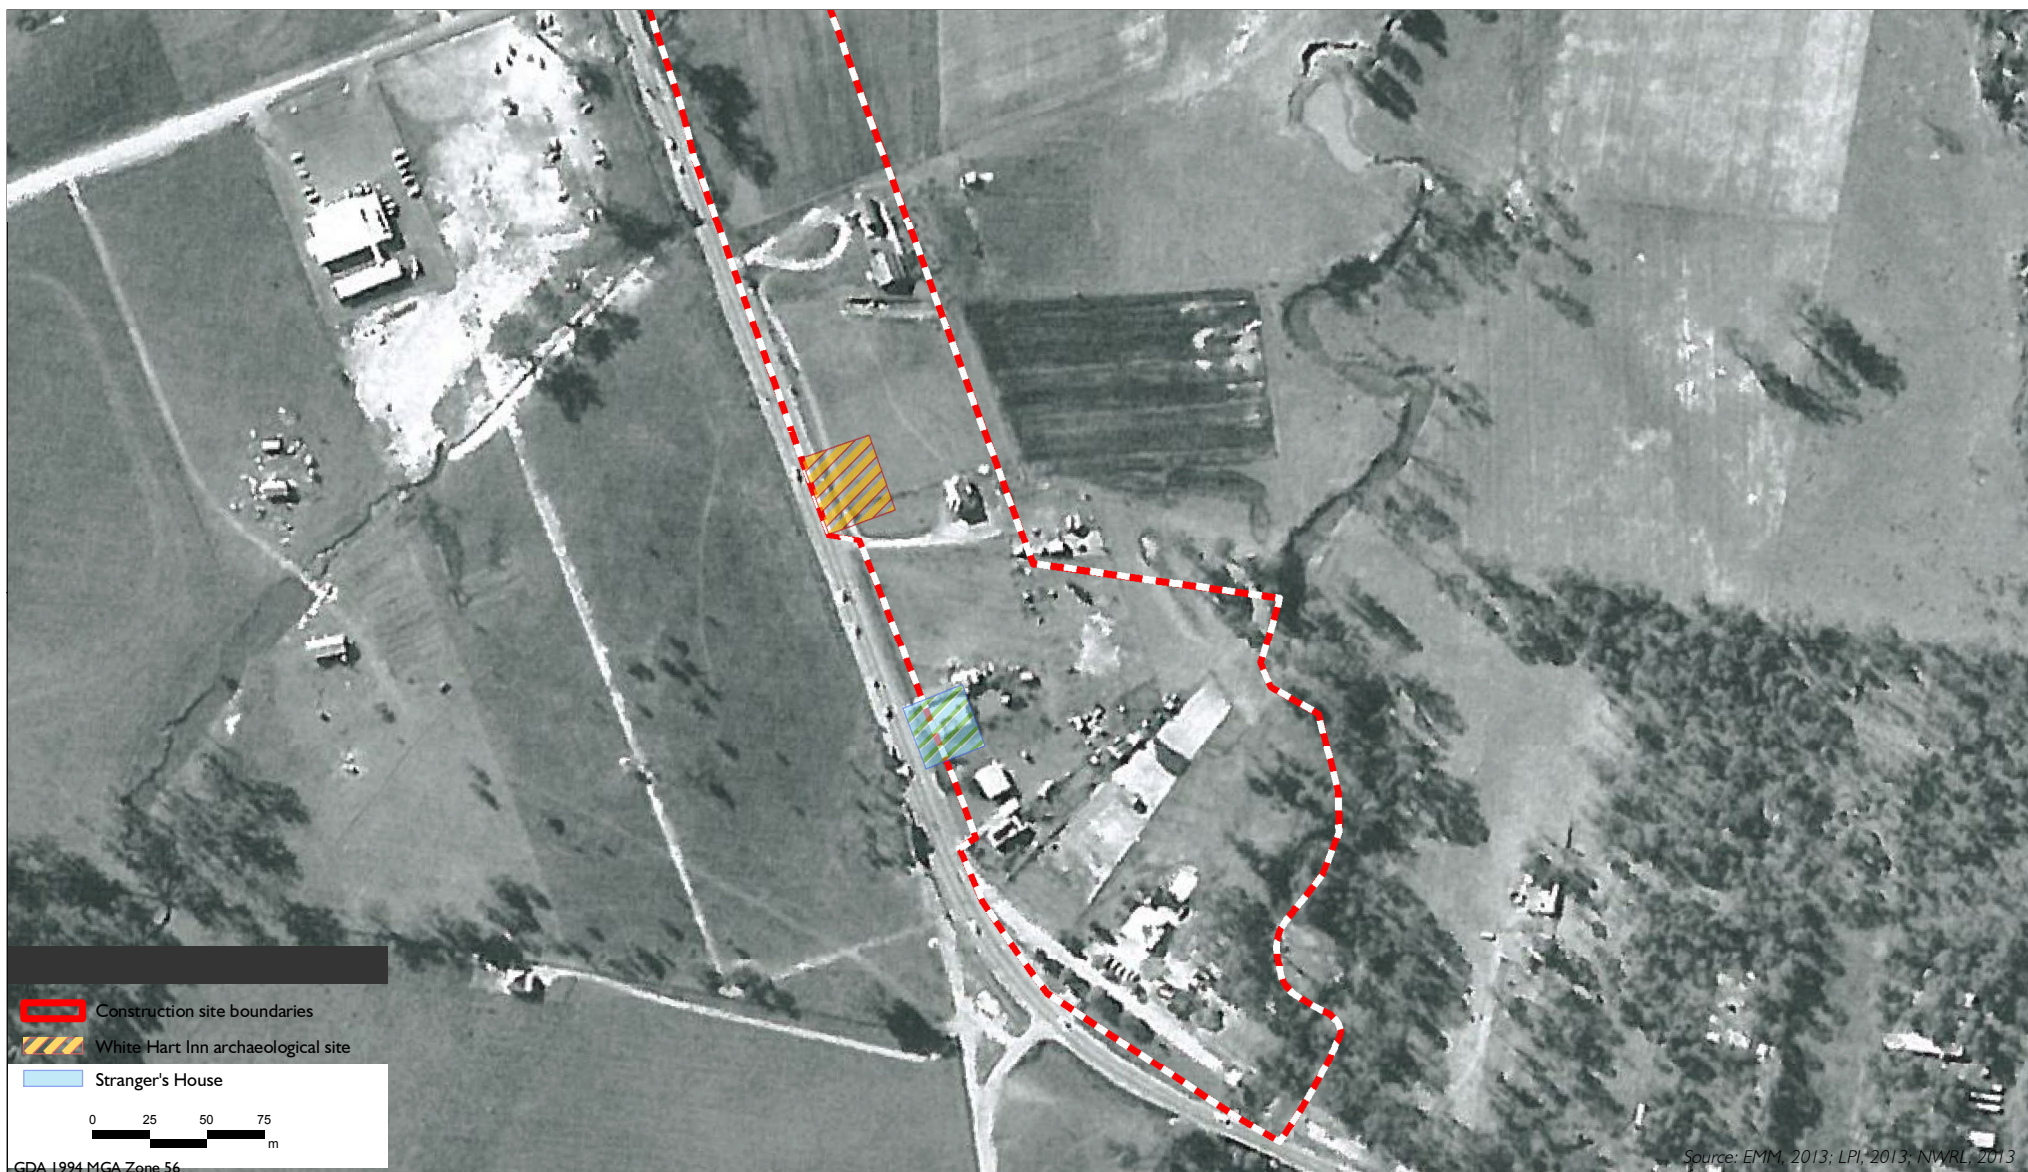
Figure 1.7

Aerial photograph Windsor and Old Windsor Roads 1970

In the 1970 (Figure 1.7) and 1978 (Figure 1.8) aerial photographs the general area remains cleared grassy paddocks with structures located throughout the study area. The section of land at the junction of Windsor and Old Windsor Roads is heavily populated with structures and large areas of cleared and developed land. By 1982 (Figure 1.9) the area in the south of the aerial photograph remains heavily populated, however in the north, a structure visible in the 1956 aerial photograph, appears to be abandoned; in the 1994 aerial photograph (Figure 1.10) this structure is removed. The 2002 aerial photograph (Figure 1.11) shows the increasing housing development surrounding the study area which remains bare in the north and industrialised in the south.
