# Sydney Metro Northwest White Hart Inn & Stranger's Cottage

Old Windsor Road to White Hart Drive  
Beaumont Hills

## Archaeological test excavation report

Prepared for Transport for NSW | 1 February 2016

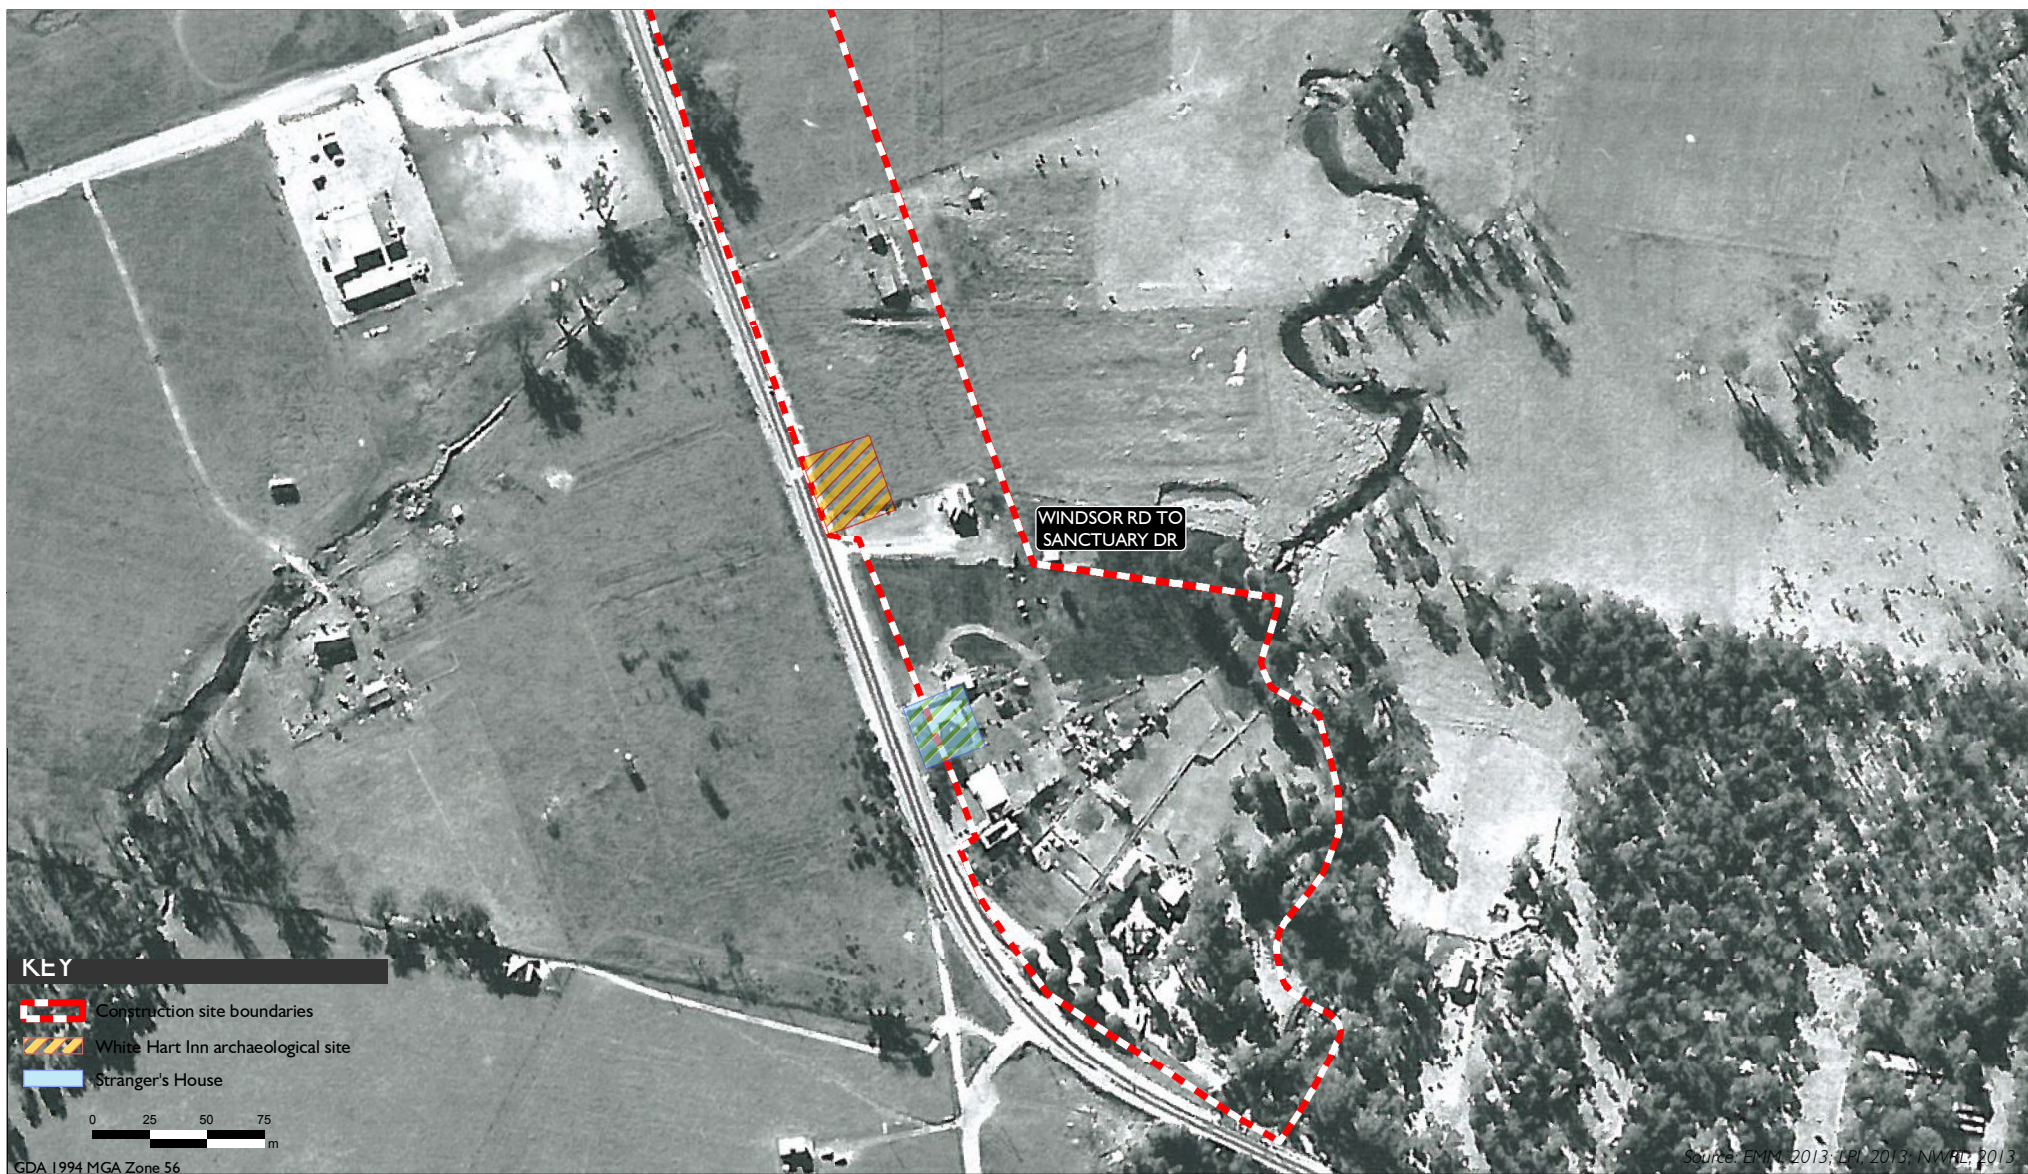
Figure 1.8

Aerial photograph Windsor and Old Windsor Roads 1978

In the 1970 (Figure 1.7) and 1978 (Figure 1.8) aerial photographs the general area remains cleared grassy paddocks with structures located throughout the study area. The section of land at the junction of Windsor and Old Windsor Roads is heavily populated with structures and large areas of cleared and developed land. By 1982 (Figure 1.9) the area in the south of the aerial photograph remains heavily populated, however in the north, a structure visible in the 1956 aerial photograph, appears to be abandoned; in the 1994 aerial photograph (Figure 1.10) this structure is removed. The 2002 aerial photograph (Figure 1.11) shows the increasing housing development surrounding the study area which remains bare in the north and industrialised in the south.

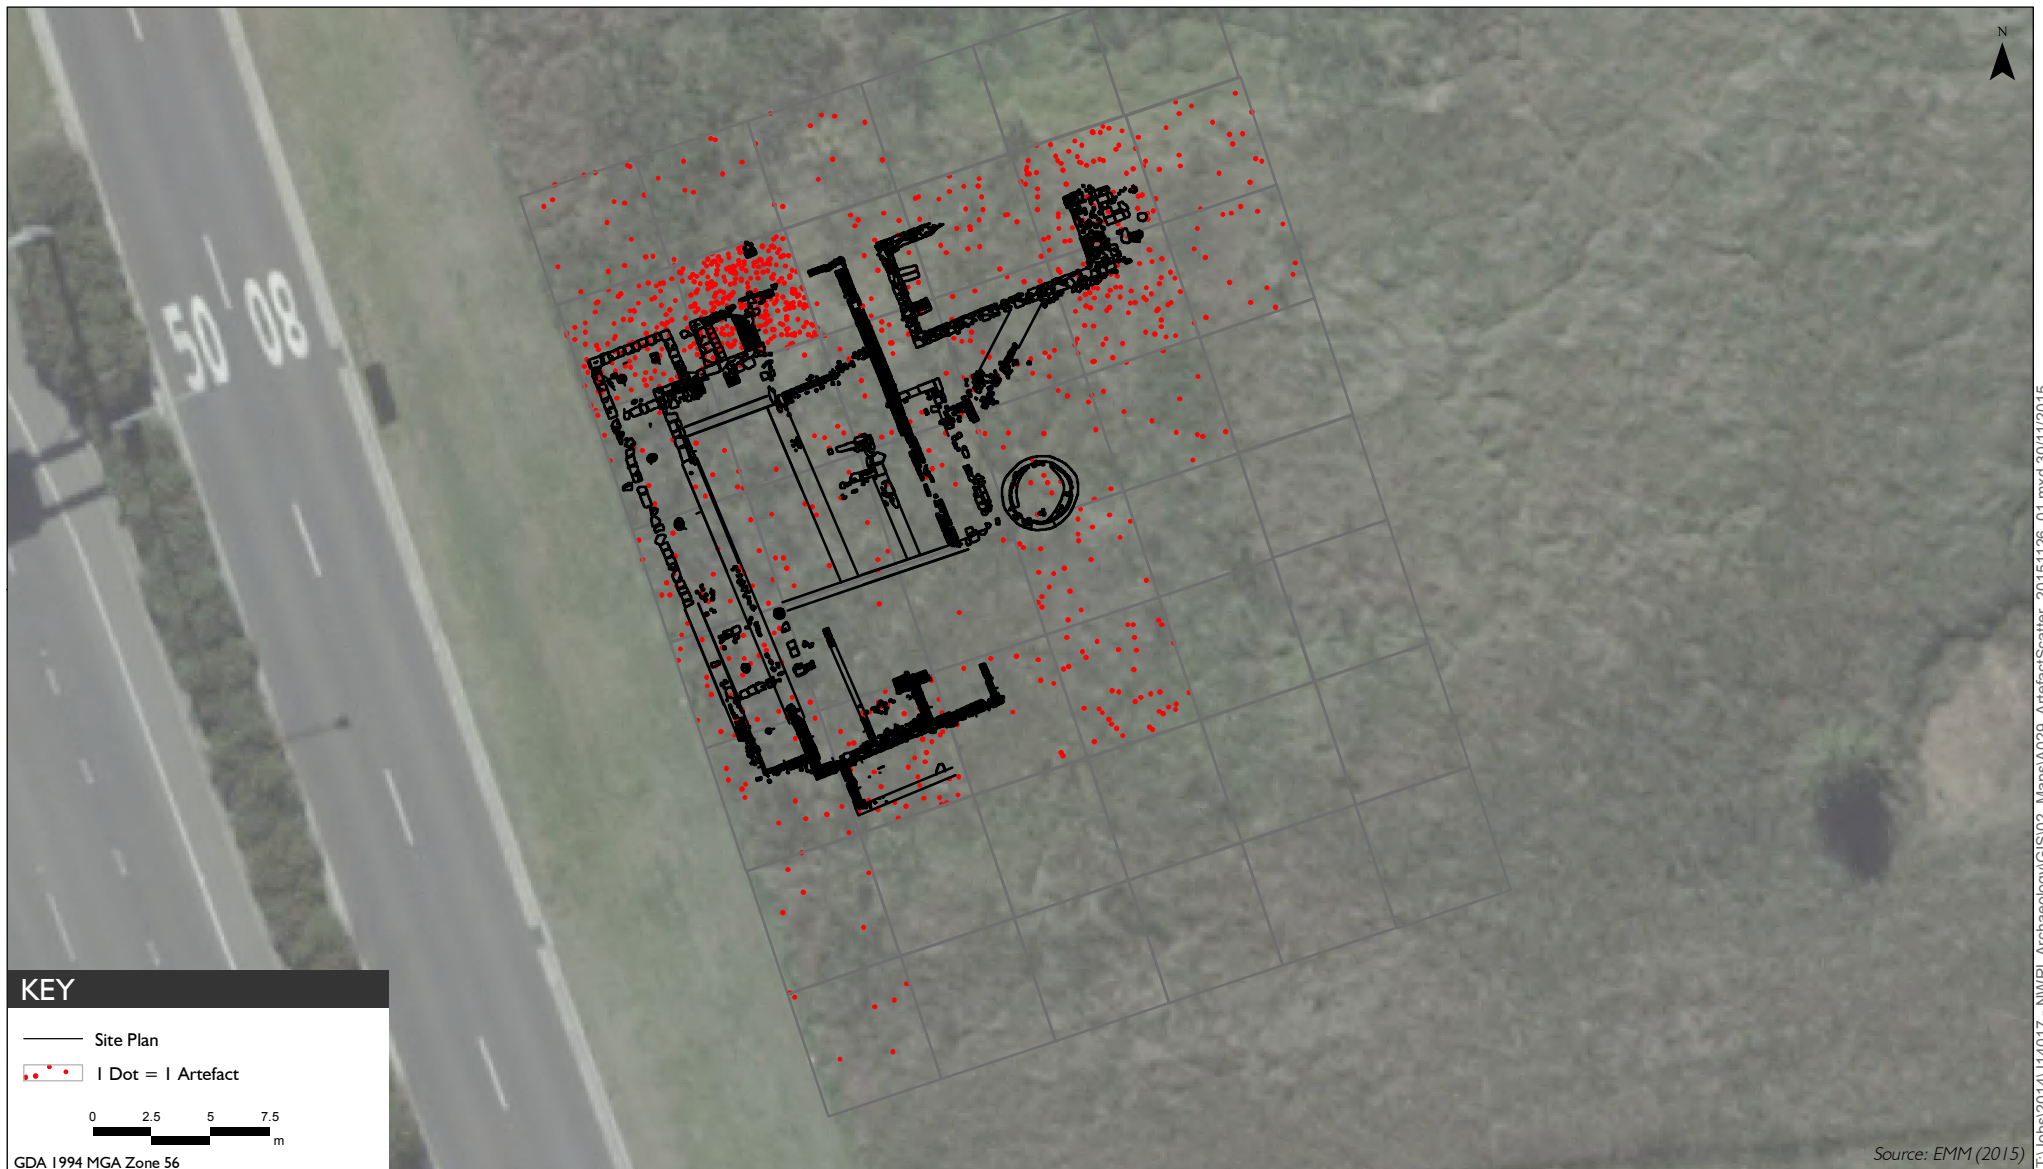
Location of artefacts is randomised within the relevant grid square and not their exact location

**Artefact distribution in main excavation area**

Figure 1.1 provides information on the distribution of the artefact across the excavated areas of the site. The highest concentrations of artefacts were recorded in the northern sections of the site. This area was the cellar and contained some of the large sandstone blocks. A cavity such as a cellar was a priority for filling during demolition so it is common for these spaces to contain the highest numbers of artefacts. Overall, the figure may also show the pattern of demolition for the site with a generally higher concentration of artefacts in squares towards the north, suggesting that the demolition of the site moved in a northern direction.

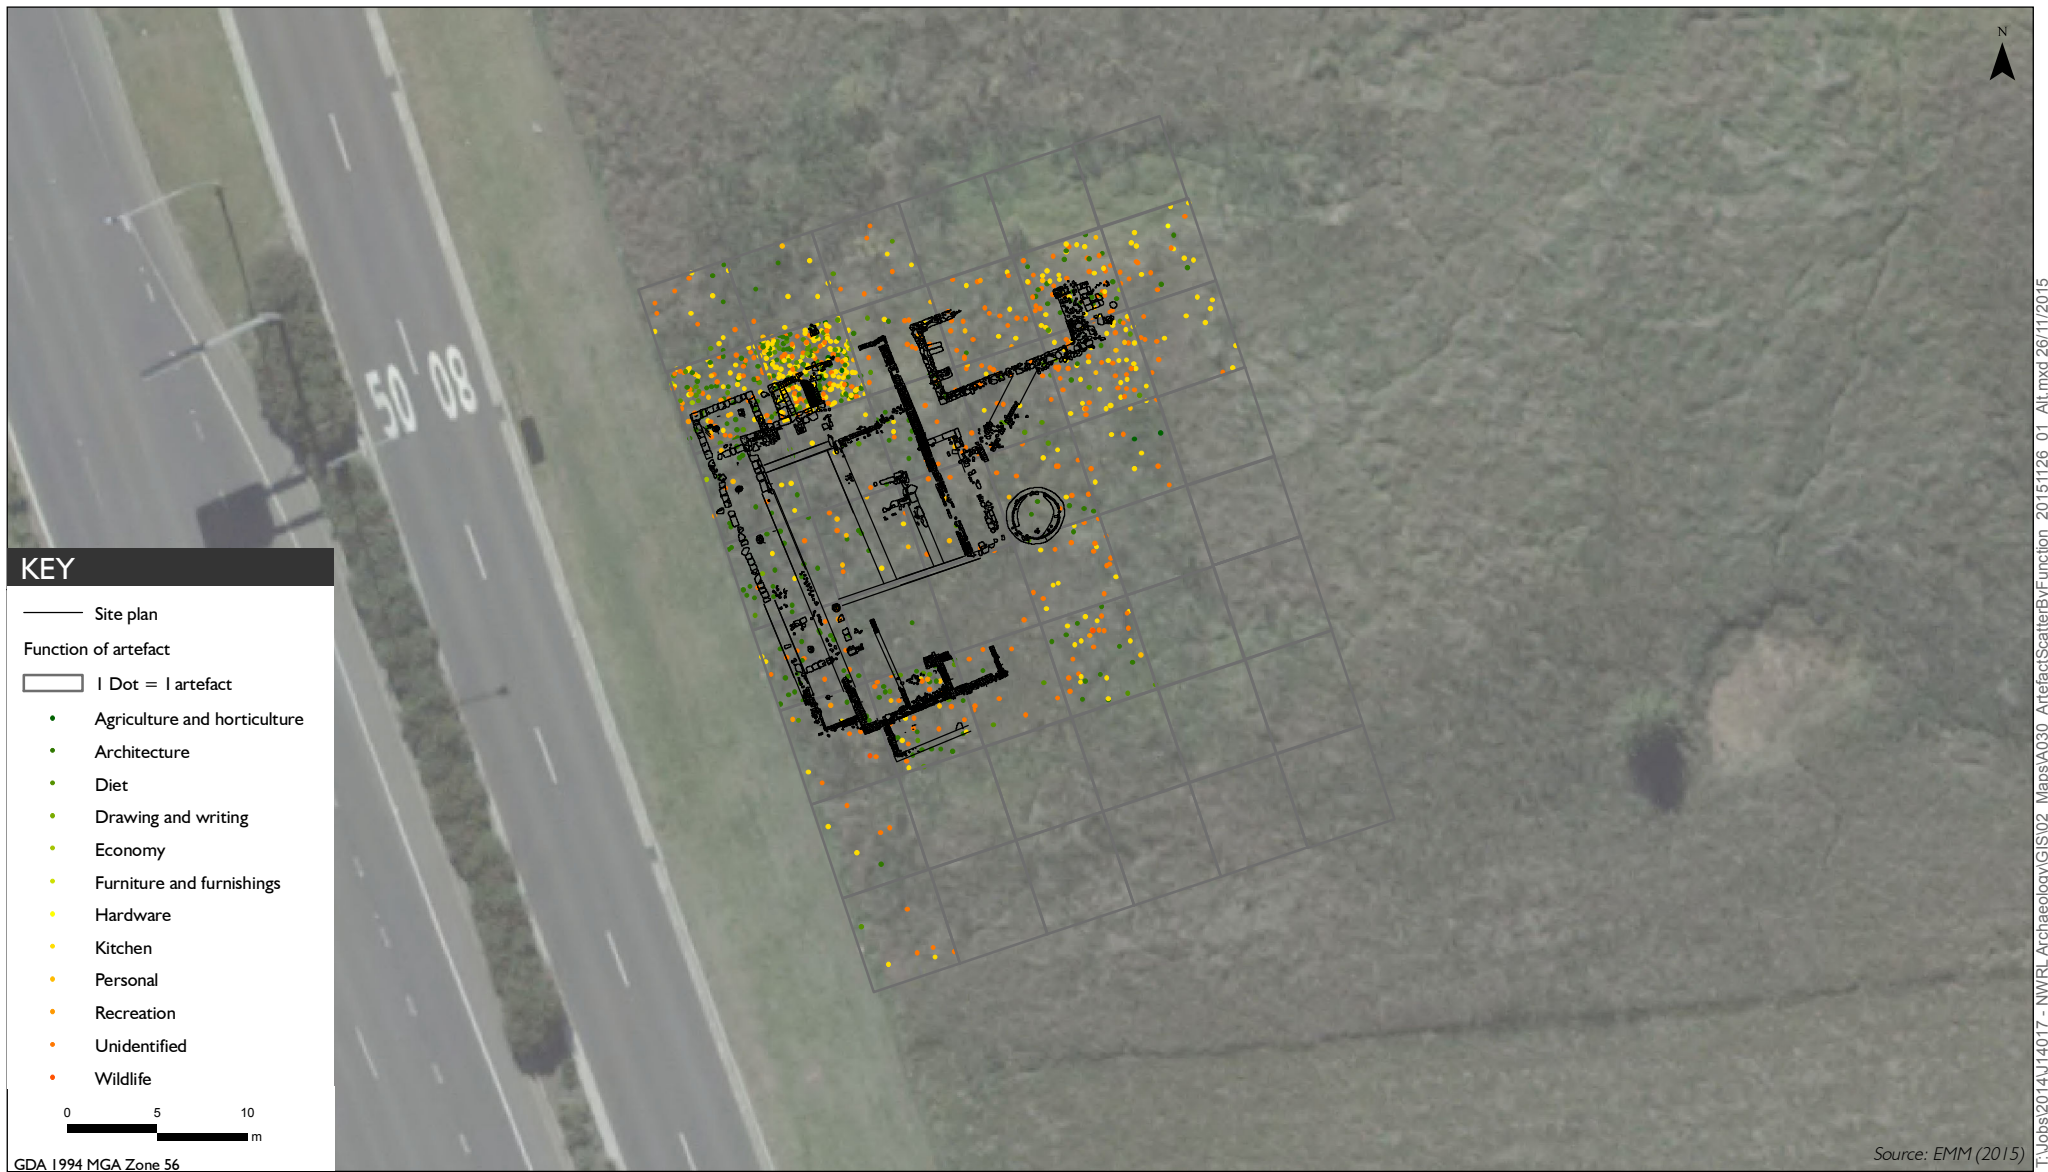
Artefact distribution in main excavation area based on function

Figure 1.2 presents the distribution of the artefacts at the White Hart Inn based on their functional categories. This figure more clearly shows the concentrations of artefacts in the northern section of the site. Distributional analysis based on function however does not offer much additional information. The demolition of the site appears to have been comprehensive enough to remove information about the possible uses of the site from the upper layers. Areas of the site not excavated may be able to provide this information in the future. As a result of the demolition patterns on the site, very little information about the functions of the various areas of the inn could be ascertained from the artefacts. Information regarding the use of the inn and its associated structures thus comes from the excavation information only.

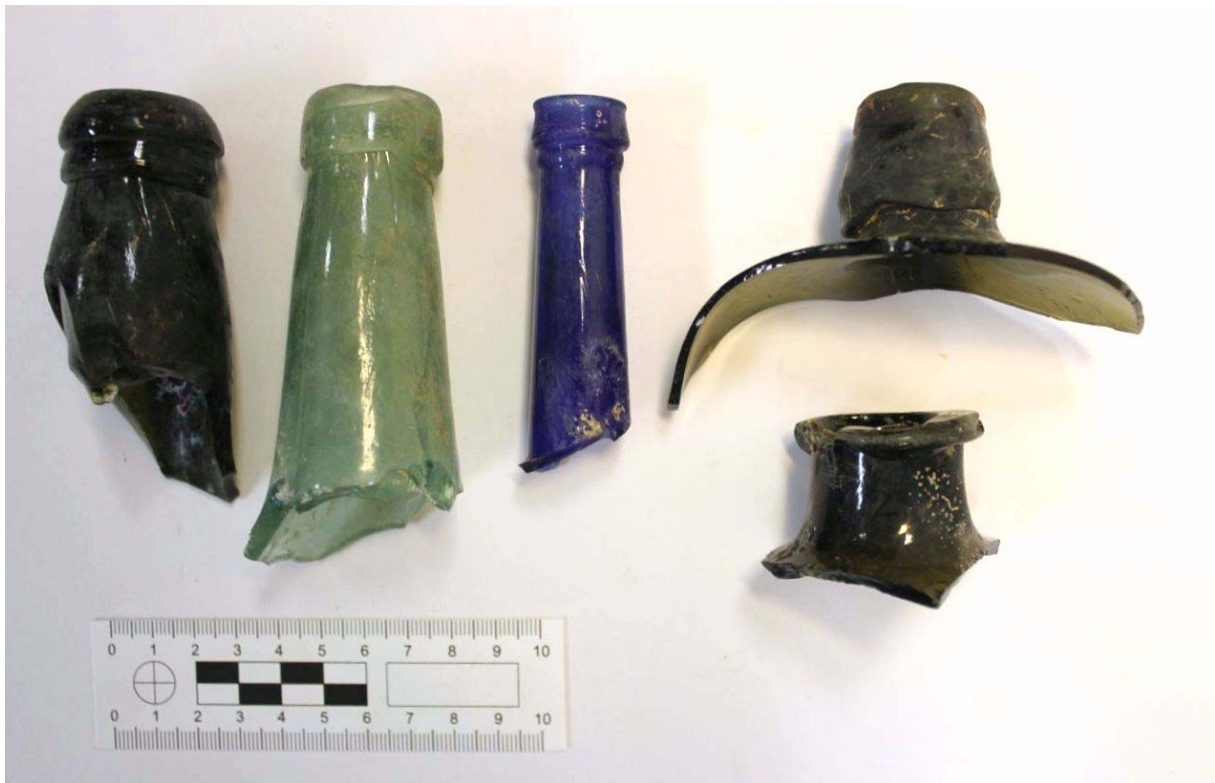
**Plate 1.2** Glass bottle finishes from context [074].

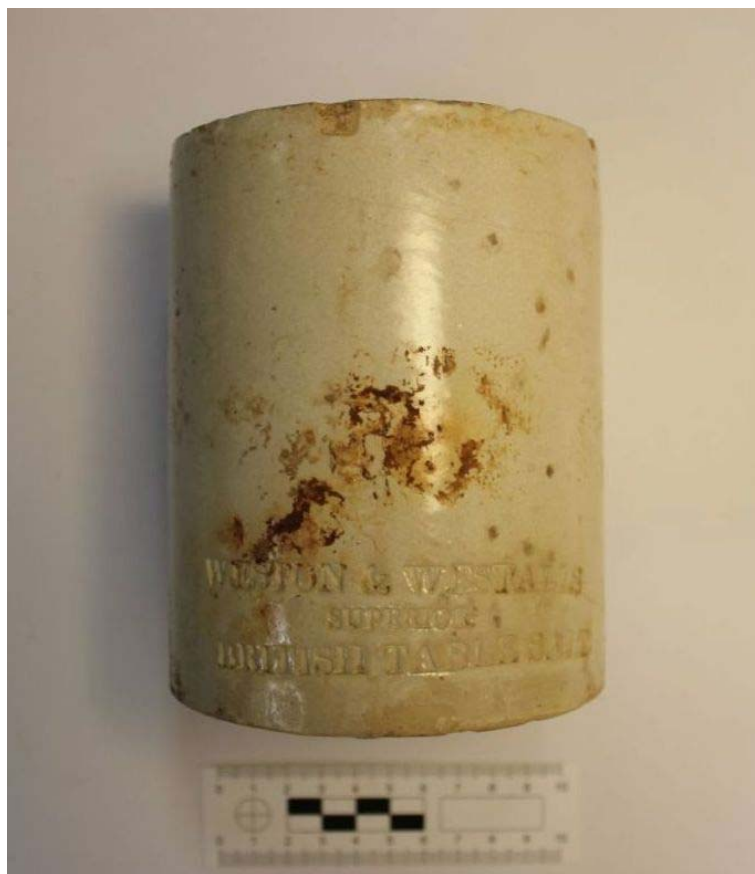
Plate 1.12 Weston and Westalis salt jar.

A large table salt jar inscribed 'Weston and Westalis Superior British Table Salt' was recovered from the cellar. Salt was another common and widely used condiment and preserver and would have been essential in the food service of an inn as well as a residence (Plate 1.12).

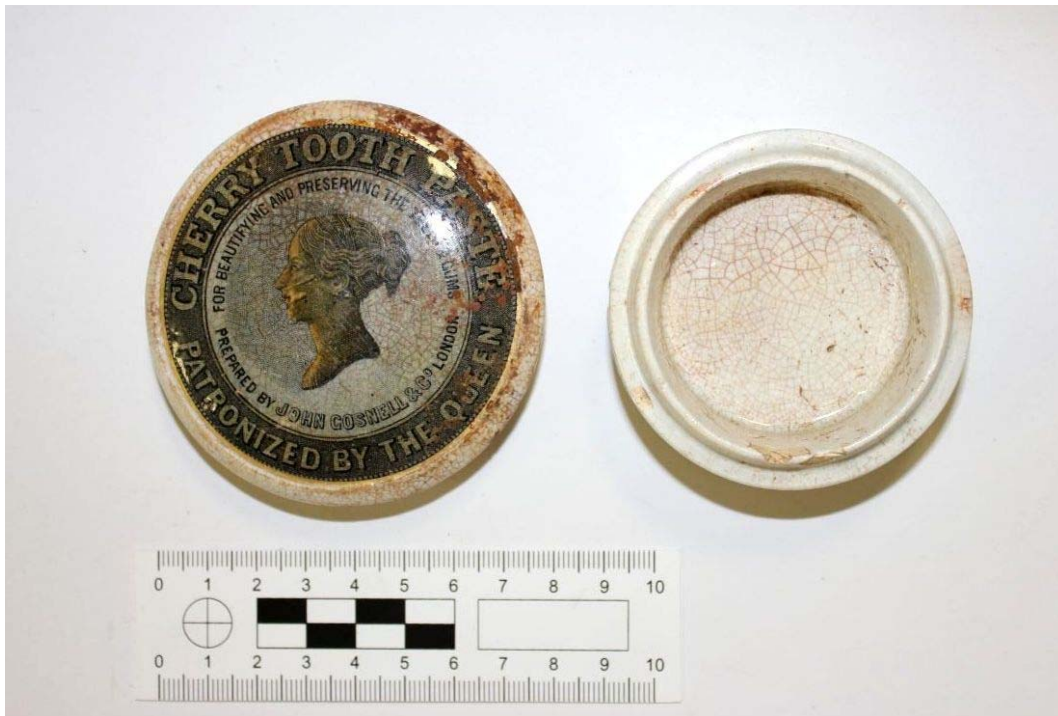
Plate 1.13 Toothpaste jar.

Personal grooming items, including fragments of perfume bottles and a toothpaste jar, were uncovered. The toothpaste jar (Plate 1.13) was inscribed 'Cherry toothpaste patronised by the queen for beautifying and preserving teeth and gums prepared by John Gosnell and Co London'. This type of jar was popular in the mid to late-nineteenth century.

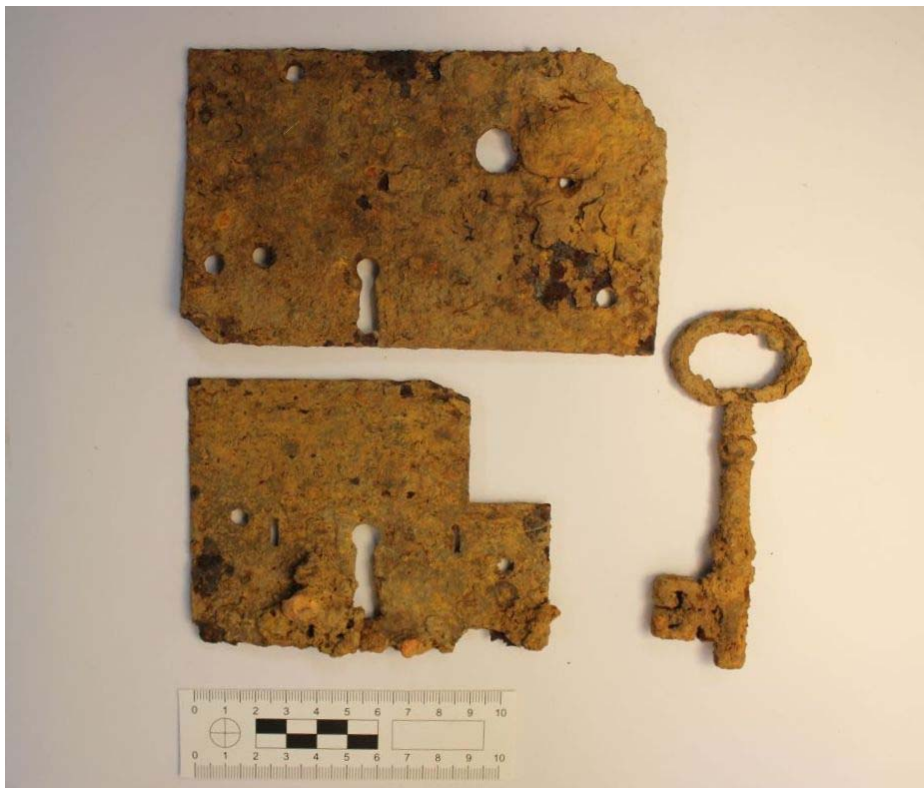
**Plate 1.15** Lock plates and a key.

One of the most interesting metal objects uncovered was a door key plate, possibly for an entry door in the inn building. A lock plate and a local mechanism and a key were also recovered (Plate 1.15).

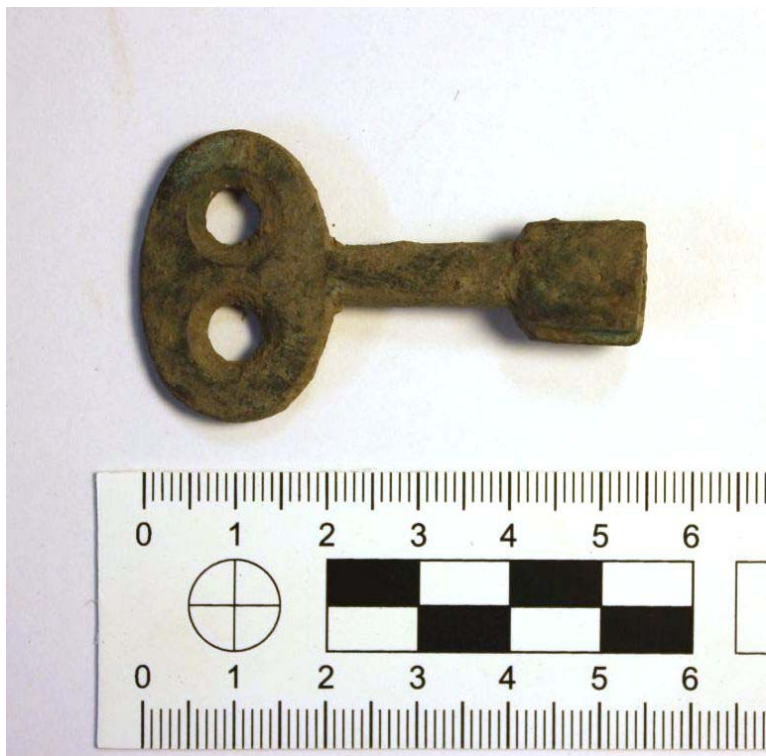
**Plate 1.16** Winding key.

A small copper winding key, possibly for a clock was also identified (Plate 1.16).

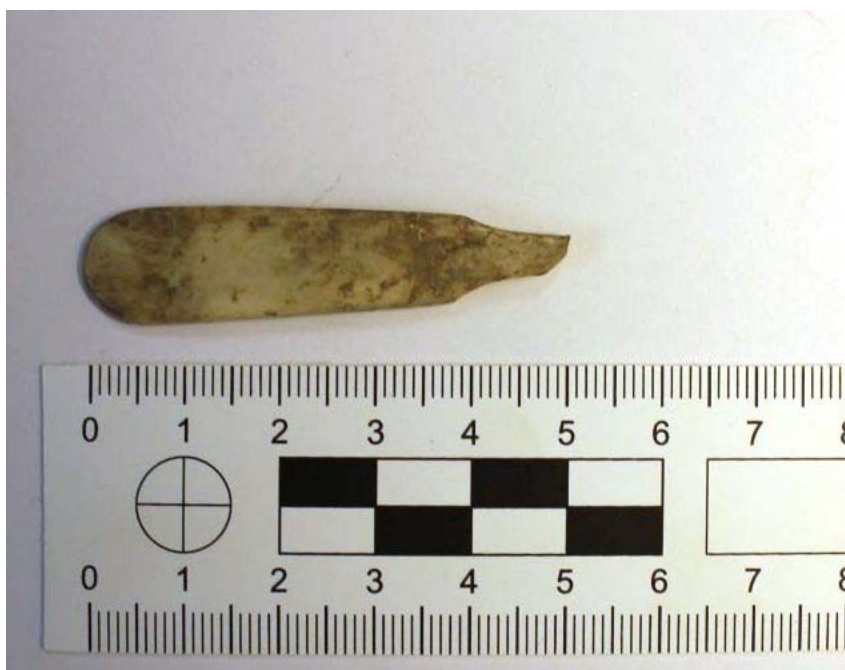
Plate 1.18 Bone cutlery handle.

A complete cowry shell was found in the cellar. This is an unusual item, even more so to have survived intact. Items such as cowry shells were part of Victorian era cabinets of curiosities, which were popular with amateur and professional scientists who displayed their collections for visitors. It is conceivable that the inn may have had a small glass cabinet to display interesting items from the local and wider area including a cowry shell. Just as plausible is that the shell belonged to an individual who stayed in the building. A bone handle for cutlery was identified (Plate 1.18).
