**RE: Sydney Metro City & South West – ER Monthly Reports for January 2022**

The attached summaries detail the key activities undertaken by Environmental Representatives for Sydney Metro – City and South West Chatswood to Sydenham for the month of **January 2022**.

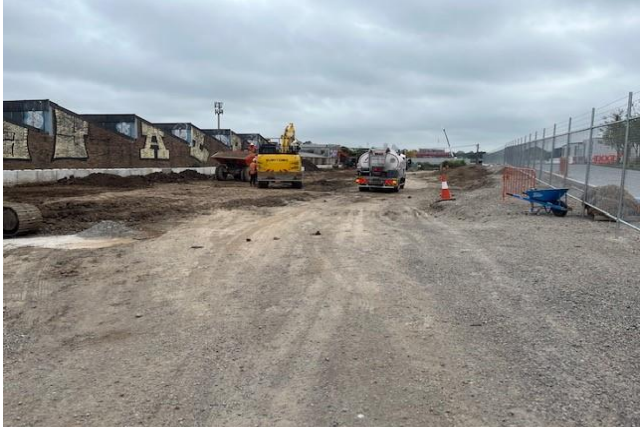
<p>Temporary fencing had been tied with ropes to street tree branches along Railway Parade, risking tree damage. Shade cloth to be replaced if safe to do so.</p>	<p>Backfill of the Development Area was ongoing</p>

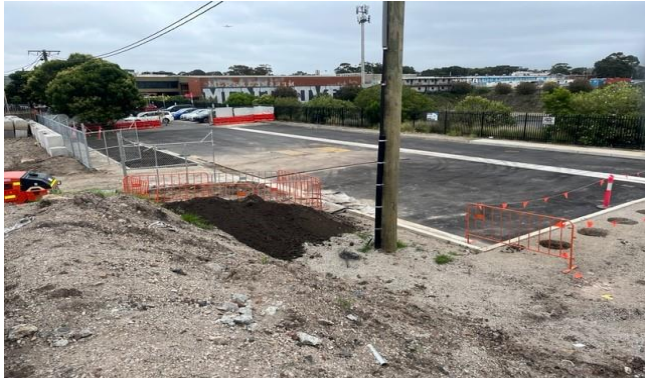
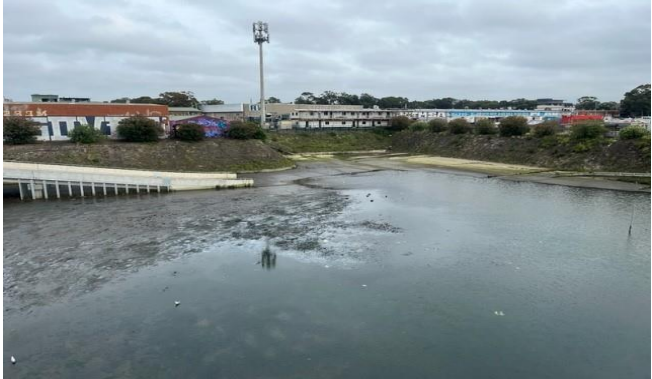
<p>The Garden Street access had been sealed with asphalt, with kerbs and footpaths established. Controls were in place around the stormwater drain.</p>	<p>Sydenham Pit was free from project vehicles and materials. Handover to Sydney Water was complete, <i>evidence of the process has been requested</i>. The pit was required to be cleaned prior to handover, then removed from the JHLOR EPL.</p>

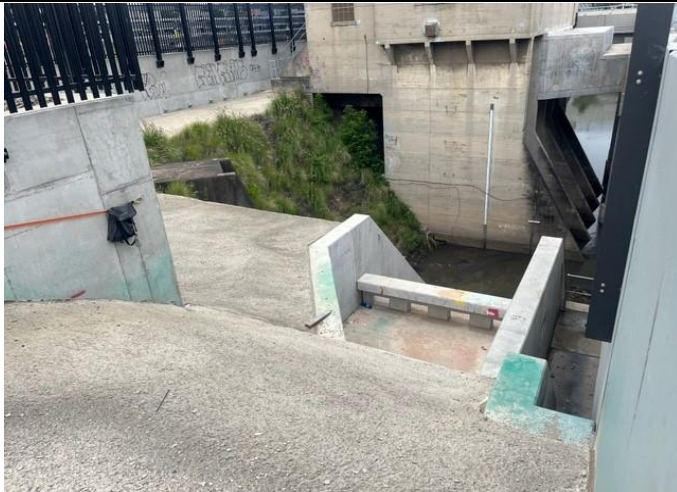
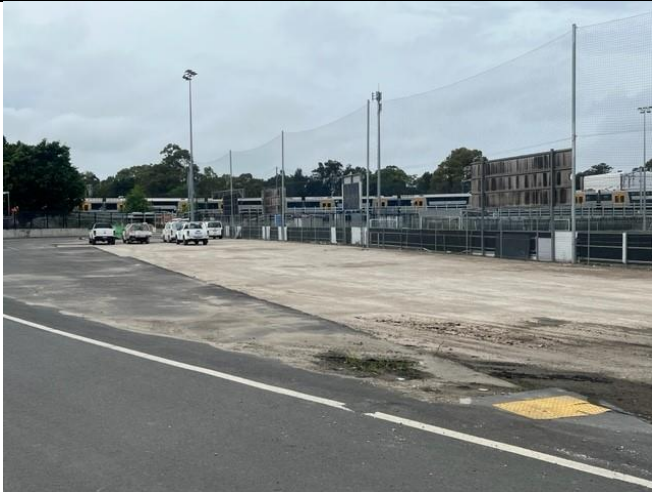
<p>Areas surrounding Sydenham Pit were sealed and the structure complete.</p>	<p>Fraser Park Ancillary Facility: Demobilisation and clean-up complete including removal of site sheds, generators, storage containers and amenities. <i>Condition of site for handback to Fraser Park Football Club to be confirmed (as per lease agreement).</i></p>

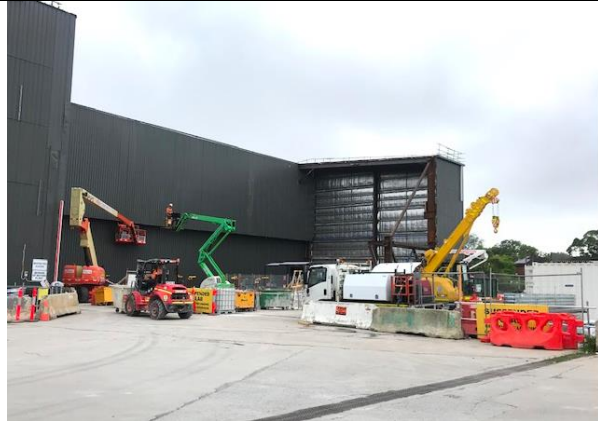
**Northern Hub - CDS Yard: Gantry shed (south- eastern side) modification progressing.**

- Housekeeping/dust management – external yard areas observed to be generally tidy.
- Gantry shed (south -eastern side) modification progressing. SC discussed staging of gantry shed modifications to manage potential noise impacts and that the new section of shed was built prior to removing previous section of gantry shed, to ensure no gaps.

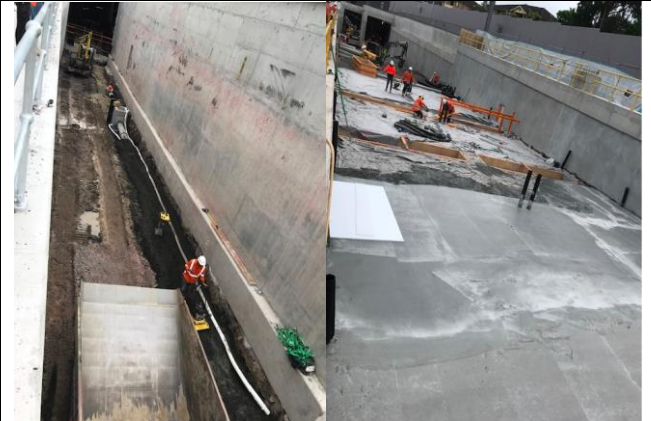
**Northern connection: Drainage works on Up Line and drainage blanket works under way prior to track being placed. Blinding works completed.**

- Northern Connection - drainage works on Up Line and drainage blanket works under way prior to track being placed.
- PMF Pit (Northern Connection) - FRP works underway for approach slab and PMF drainage noted. SC informed the ER that PMF drainage is not yet live.

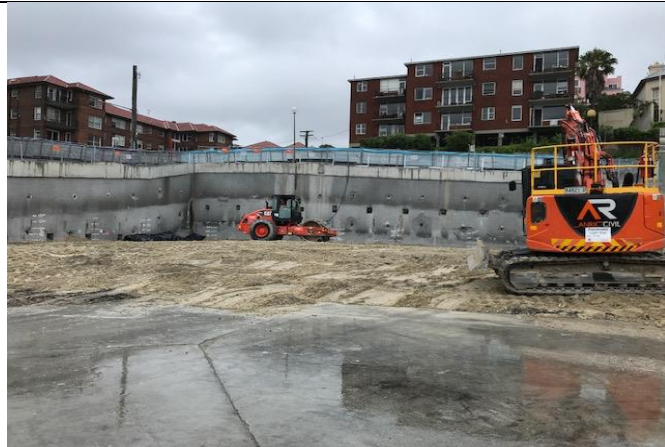
**Blues Point Access Site: Placement of fill underway to restore the surface level of the worksite.**

- Site access/ egress point observed to be free of tracking at the time of inspection and rumble grid remains in place.
- Placement of fill underway to restore the surface level of the worksite. SC informed the ER that respite was being applied during the use of the roller. SC informed the ER that progressive rehabilitation of the site is being planned with ERSED plan in development by SEEC.

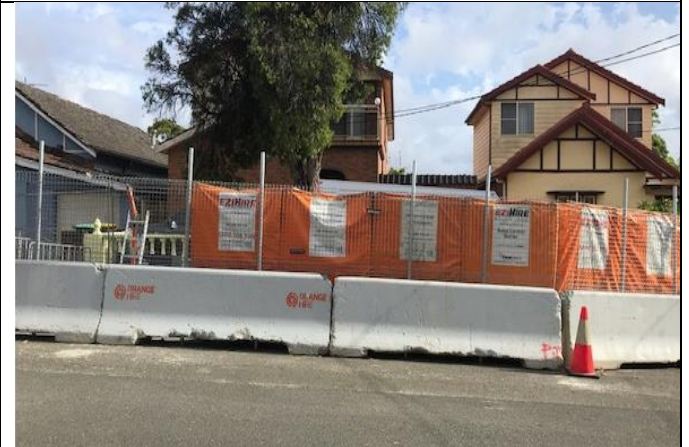
**Anzac St – Joint Bay worksite: Noise control barriers in place. Compressor within trailer and generator were operating at time of inspection.**

- Anzac St - Noise control barriers in place. Compressor within trailer and generator were operating at time of inspection.
- Anzac St - Observed generator being re-fuelled. Suggested use of plant nappy or similar for future re-fuelling operations to contain potential spills.

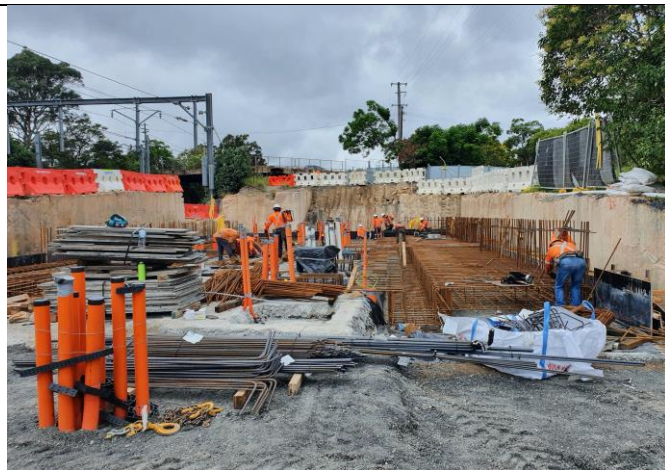
**Canterbury TSS – CSR and FRP works continuing.**

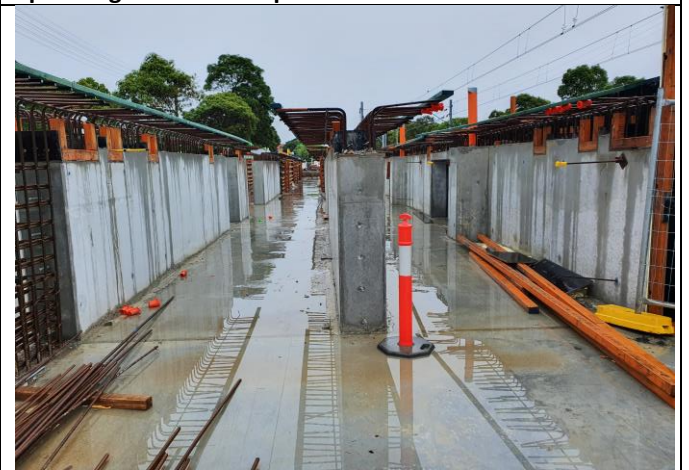
**Lakemba TSS – TSS base poured, FRP ongoing for walls.**

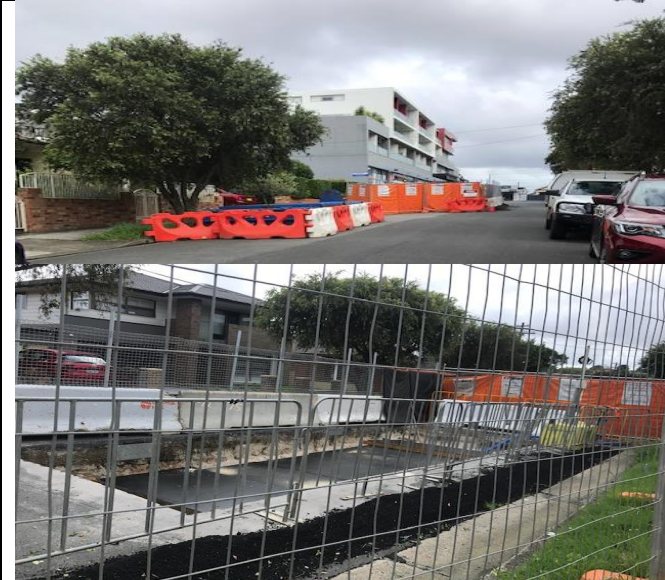
**Cooks Ave– Joint Bay worksite: Noise control barriers and bund in place around worksite (good control), preventing water from entering SC’s worksite**

- Cooks Ave– Noise control barriers and bund in place around worksite (good control), preventing water from entering SC's worksite. Noted water in kerb drain from Onslow Ln (unrelated to any SC works).

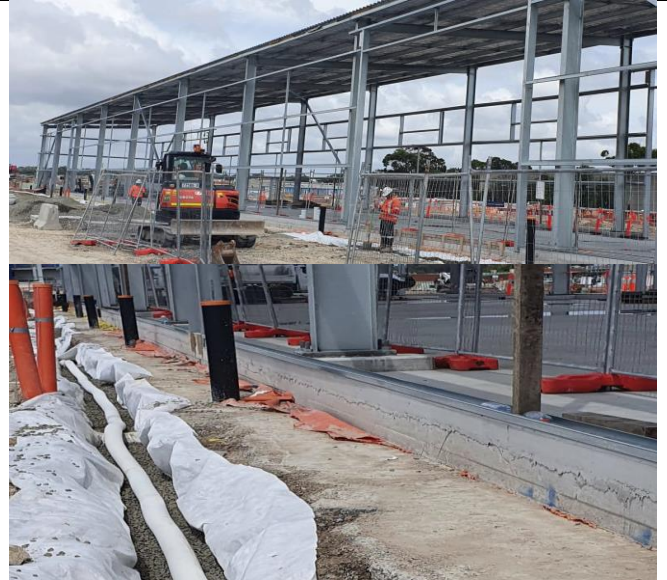
**SMTF S - Covered Shed – sub-soil placement / drainage works underway**

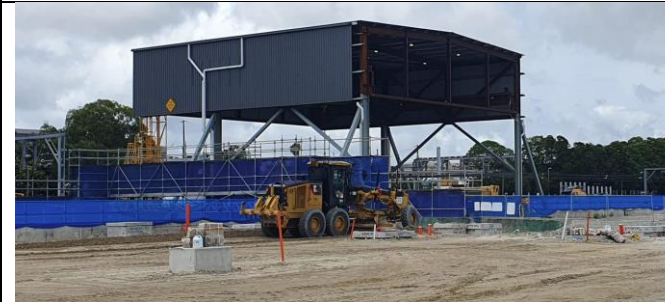
**SMTF S - Stabling Yard – grading works in progress.**

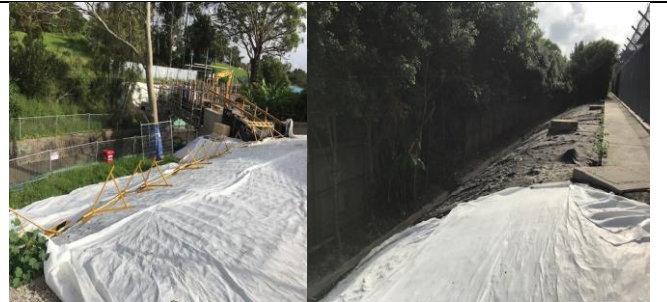
**Pat O’Connor Reserve - Cable bridge worksite (Ausgrid side) – Batters remain covered and noted to have held up well, over the Christmas shutdown period.**

- Minor Ancillary Facility - Tree protection and stabilised access to Minor Ancillary Facility (MAF) remains in place.
- No graffiti observed on shade cloth installed around MAF.
- Pat O'Connor Reserve (Ausgrid side) - It was noted that stockpiles remain covered.
- Batters remain covered and noted to have held up well, over the Christmas shutdown period including wet weather events. Sediment fence remains in place, along bridge worksite.
- Minor concrete observed on ground on piling pad and discussion held with SC to ensure concrete washout is contained within designated concrete washout bay during works/removal of concrete washout.
- Section of shade cloth (blown over) to be re-attached on ATF. Note raised for SC to action.
- Tree delineation fencing and barriers remains in place. Additional row of sediment bags noted.

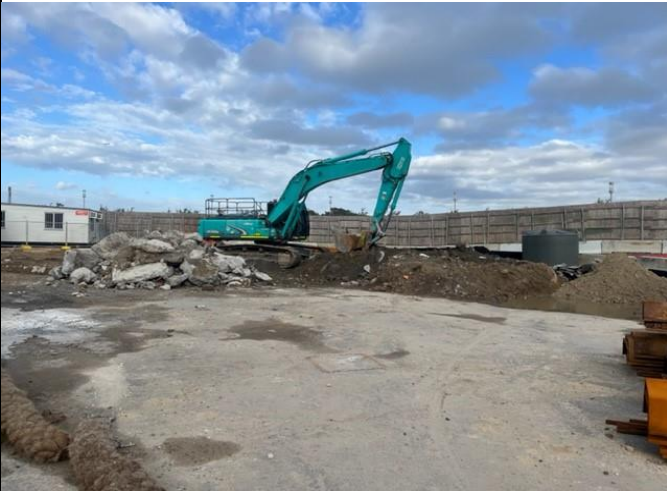
Excavation of the stormwater trench at the western end of the site was on hold pending redesign for a solution to manage water ingress.

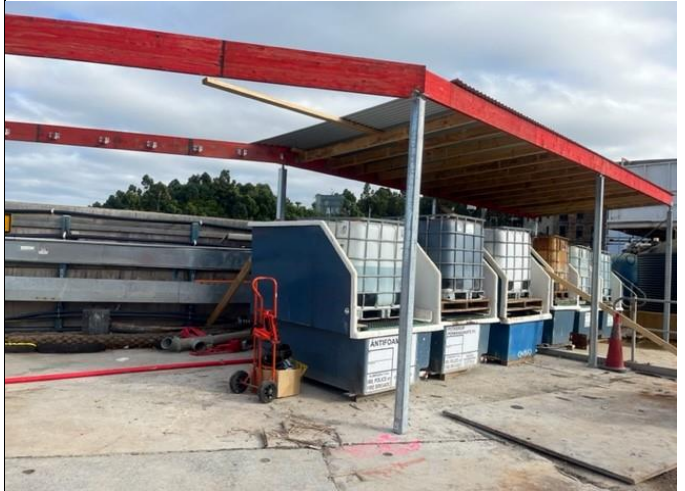
Roofed storage for IBCs containing water treatment chemicals was almost complete. Compliant storage and labelling improvements were also underway.

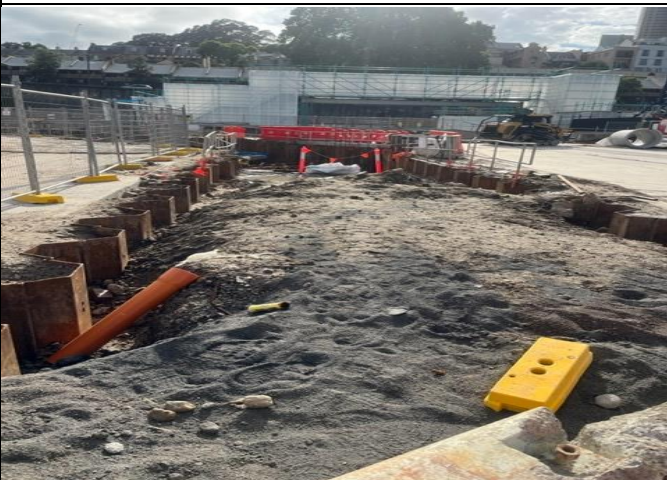
Backfill of the stormwater trench in the centre of the site. Pipe and pit complete.

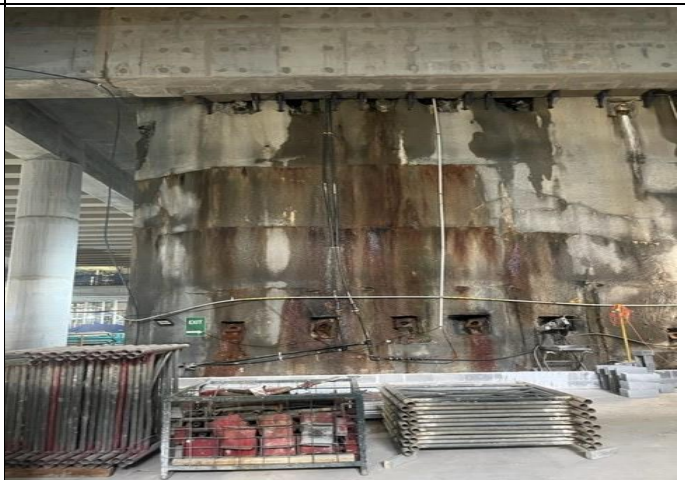
Groundwater seepage from the unsealed wall of the station box – future Aqualand development area

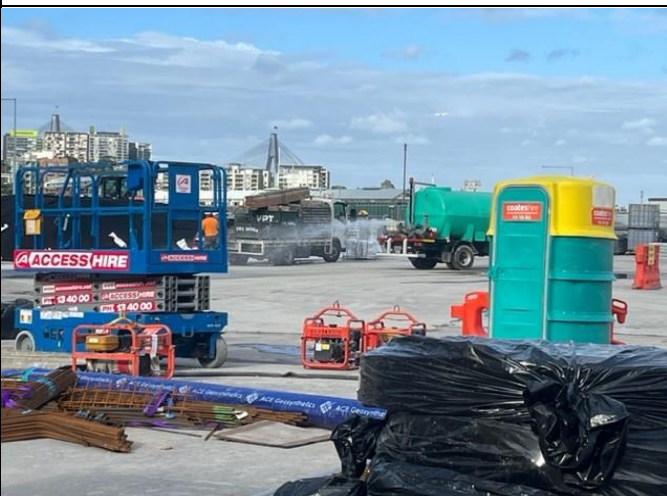
A water cart was in use to reduce impacts from a fine layer of bulldust across the site. BESIX Watpac advised a street sweeper was also in use as required.

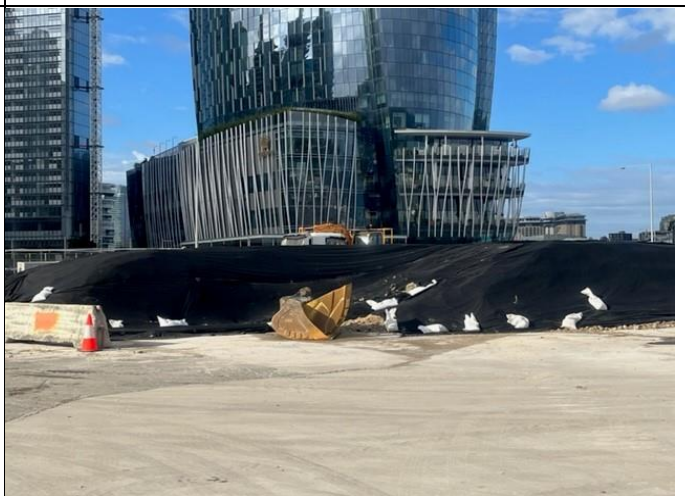
Spoil imported from the Rozelle Interchange was covered to reduce runoff and dust impacts. Import records to be provided by the contractor.

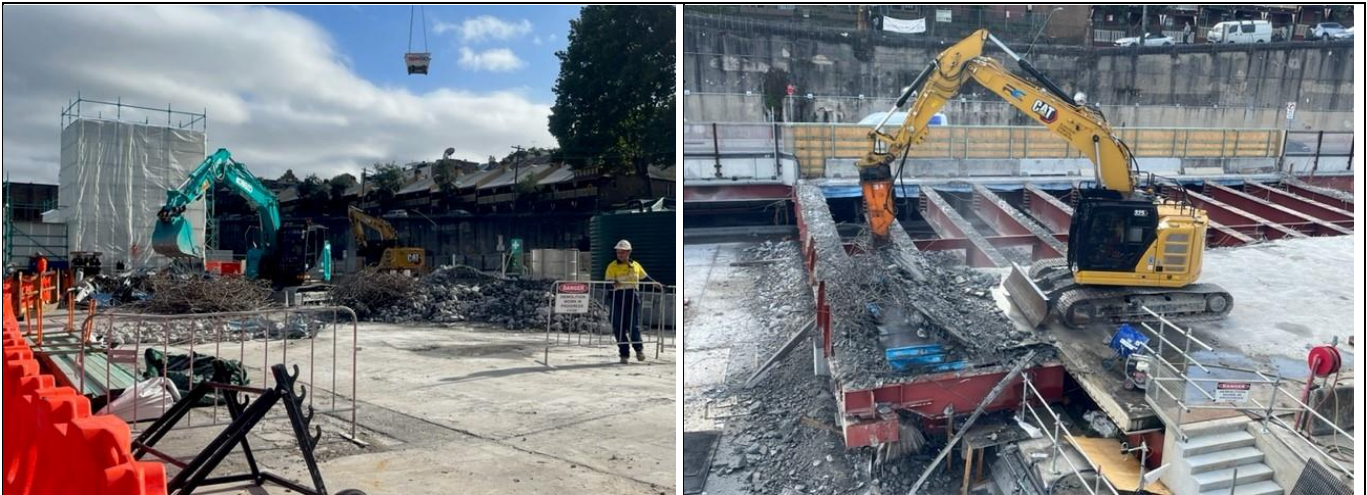
**Demolition of the bridge deck adjacent to Hickson Road was underway.**

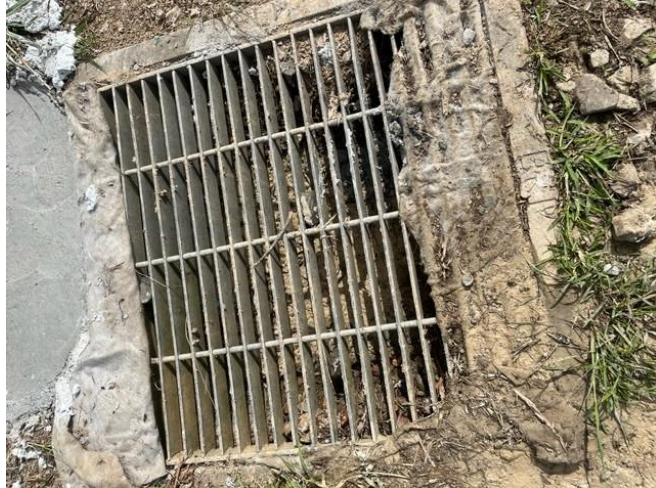
- While most drain grates were protected with sandbags and geofabric, two grates observed were heavy with sediment and required maintenance.
- One small sapling (or small specimen) marked with a pink ribbon (to indicate TEC member status) had been damaged/died. Investigation ongoing.
- Pipes and bags of cement were stored under the dripline of trees.

**Moreton Street, Lakemba/ Belmore: Drainage grates requiring maintenance.**

Actions were raised for the above issues, and all actions were in the process of being investigated / closed-out by JHLOR.

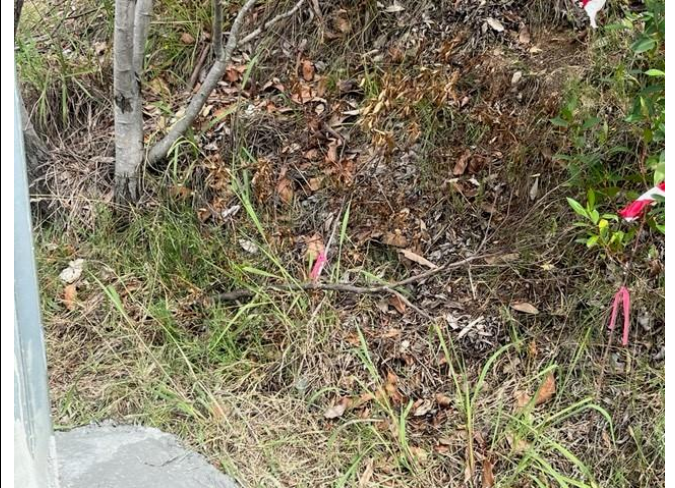
**Moreton Street, Lakemba/Belmore: One small sapling (or small specimen) marked with a pink ribbon had been damaged/died. JHLOR to determine whether the damaged sapling is a species member of the TEC and action as appropriate. Ecologist to conduct a post-works inspection of the area to confirm recommendations in the pre-clearance inspection were implemented, and confirm no damage outside of that approved occurred.**

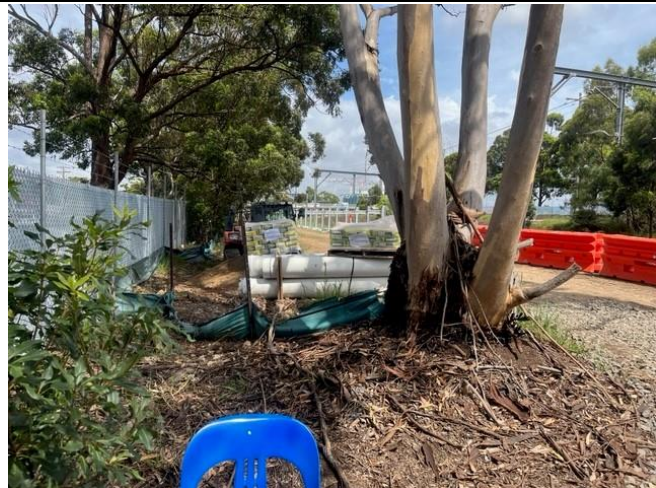
**Stacey Street ULX, City-side (Gate PB15): Pipes and bags of cement were stored under the dripline of trees.**

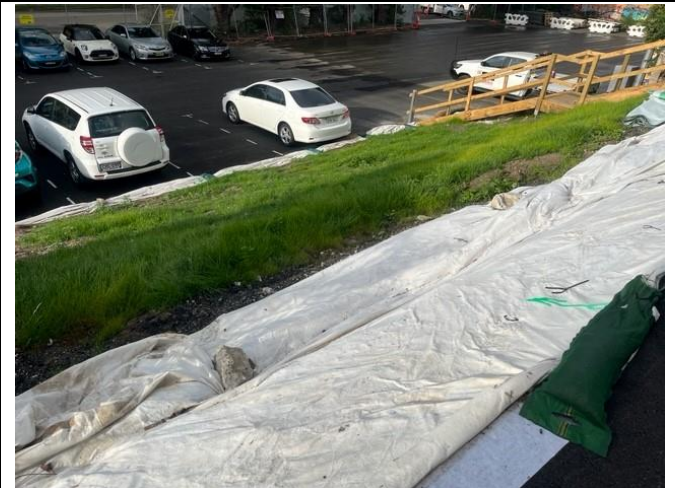
**Canterbury compound: The slope from the main compound area to the lower carpark had been stabilised with grass, geofabric and sandbags at the base.**
