# Site Audit Statement

Site audit statement no. KJL271-1

Address       The Speedway Portion, Sydney Eastern Creek Motor Sports, Ferrers Road,  
Eastern Creek, NSW

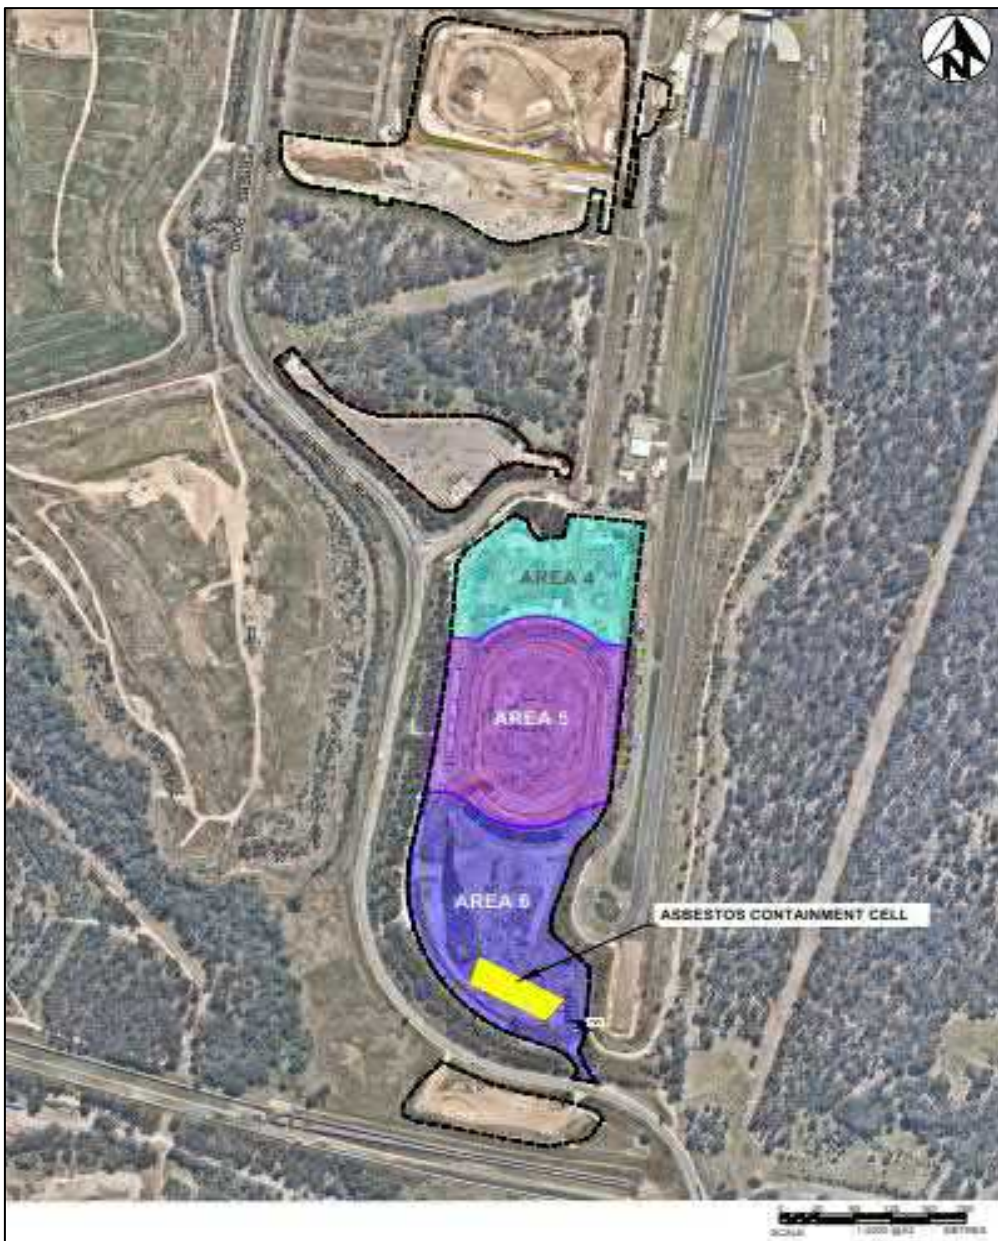
**Figure 1** - Sydney Speedway project footprint outlined in black and the location of areas 4, 5, 6 and the asbestos containment cell ('site') (photograph from Nearmap; accessed on 27.10.2021).

The site has an approximate combined area of 10.47 hectares (ha) and was formerly utilised as a recreational/professional speedway and a 4WD training facility. The location of the Sydney Speedway project footprint, the site boundaries and the asbestos containment cell applicable to the EMP is depicted in **Figure 1** and in *Appendix I – Figures*.

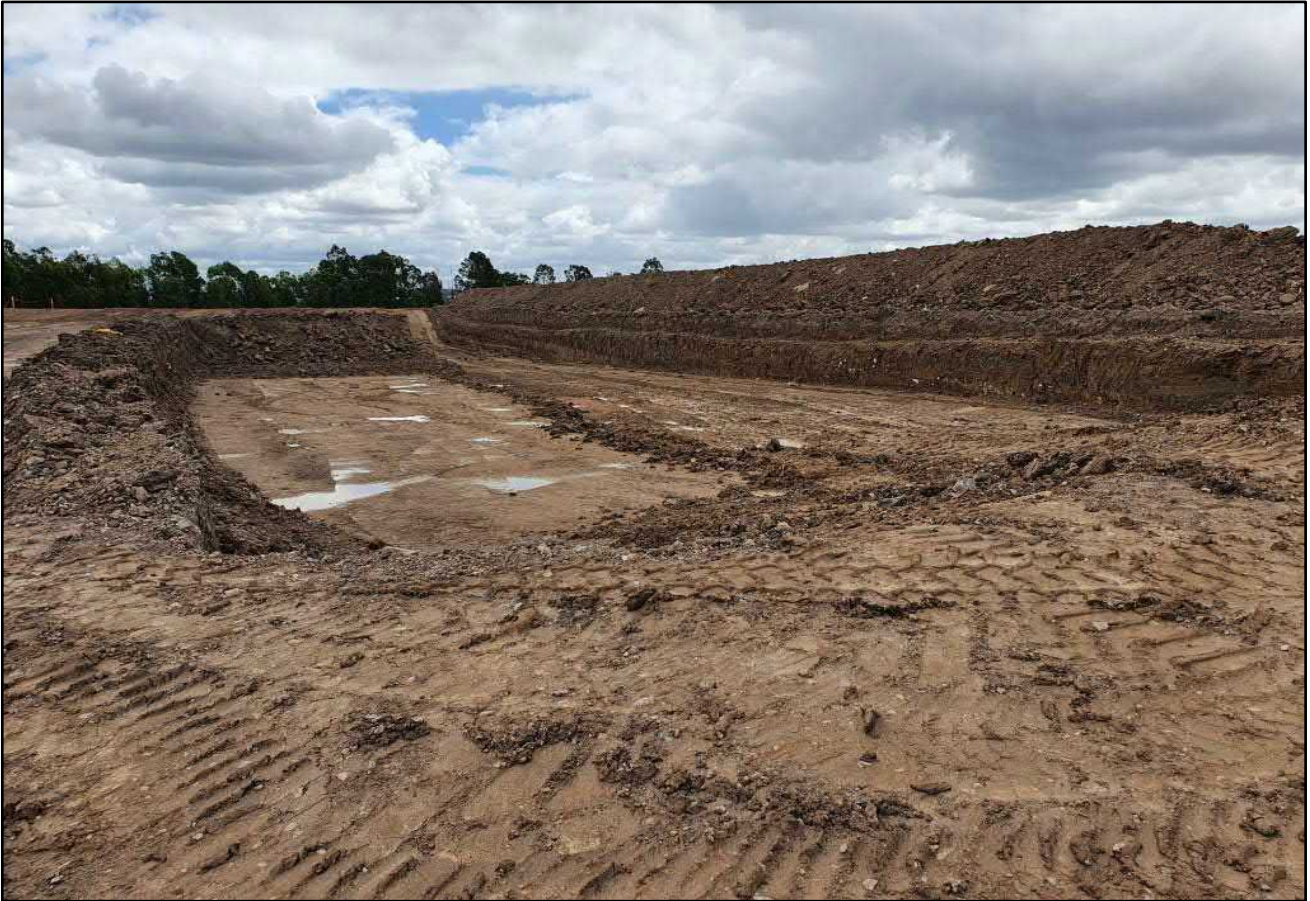
**Photograph 1.** Asbestos containment cell following bulk earthworks (as supplied by the client).

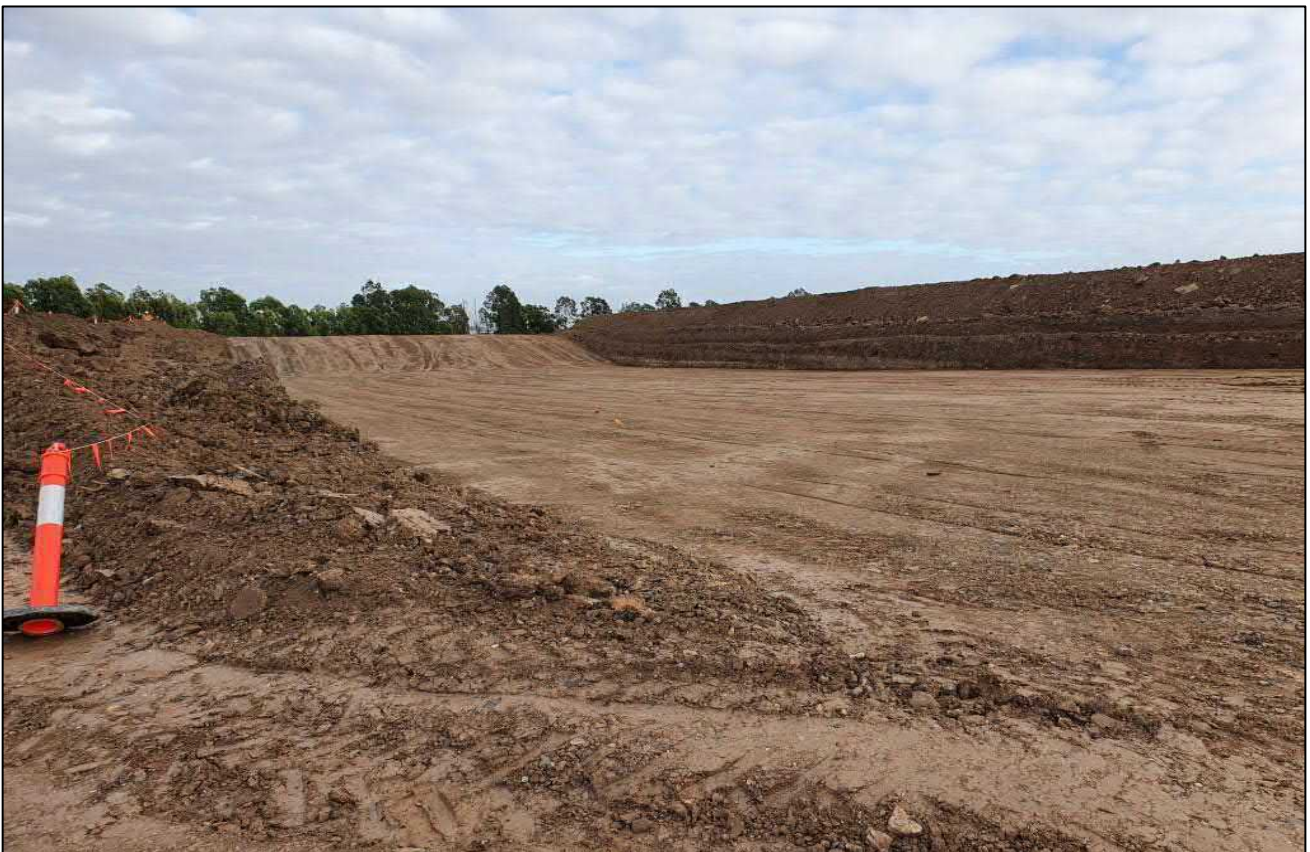
**Photograph 2.** Asbestos containment cell following the relocation of the asbestos-contaminated material (as supplied by the client).

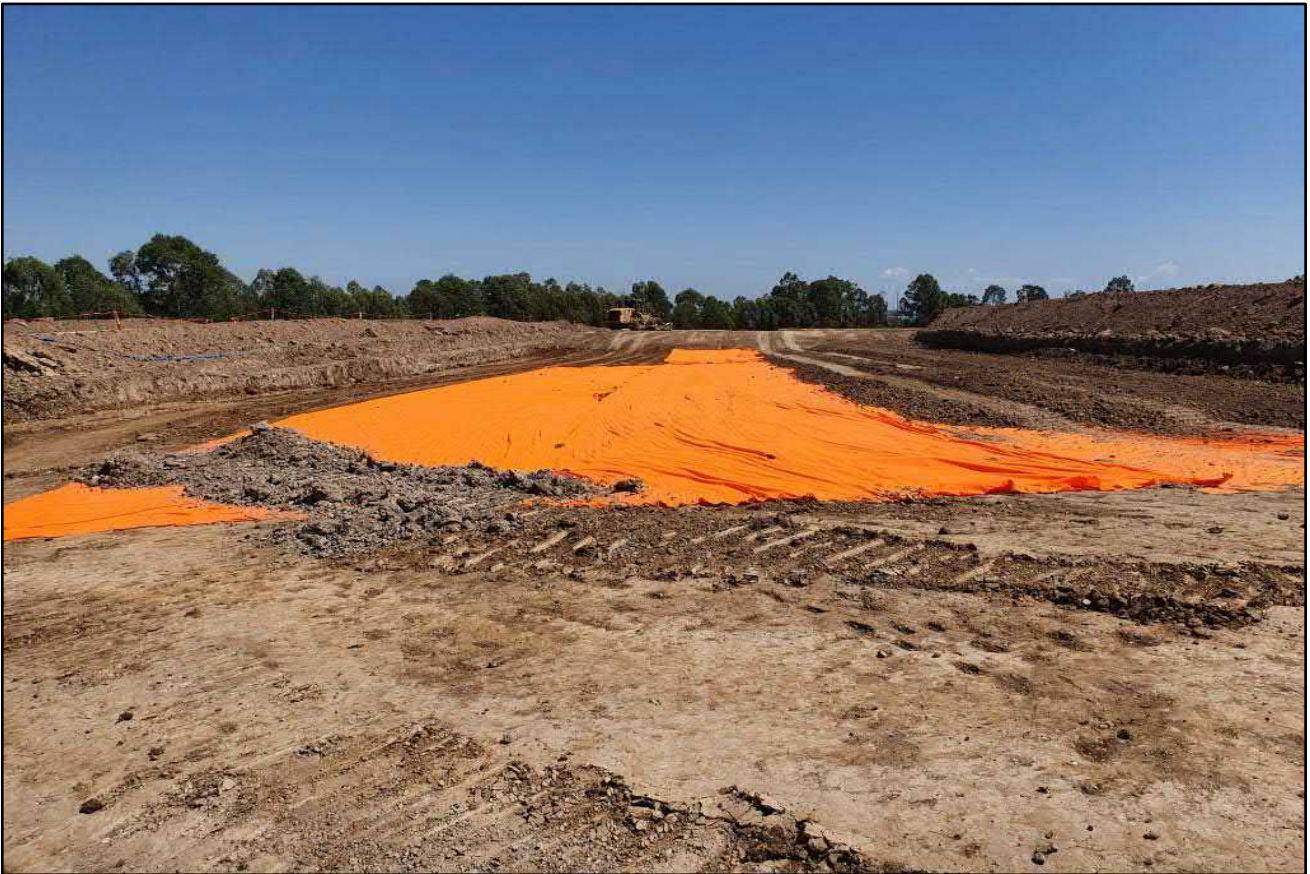
**Photograph 3.** Asbestos containment cell following application of the geotextile marker layer (as supplied by the client).

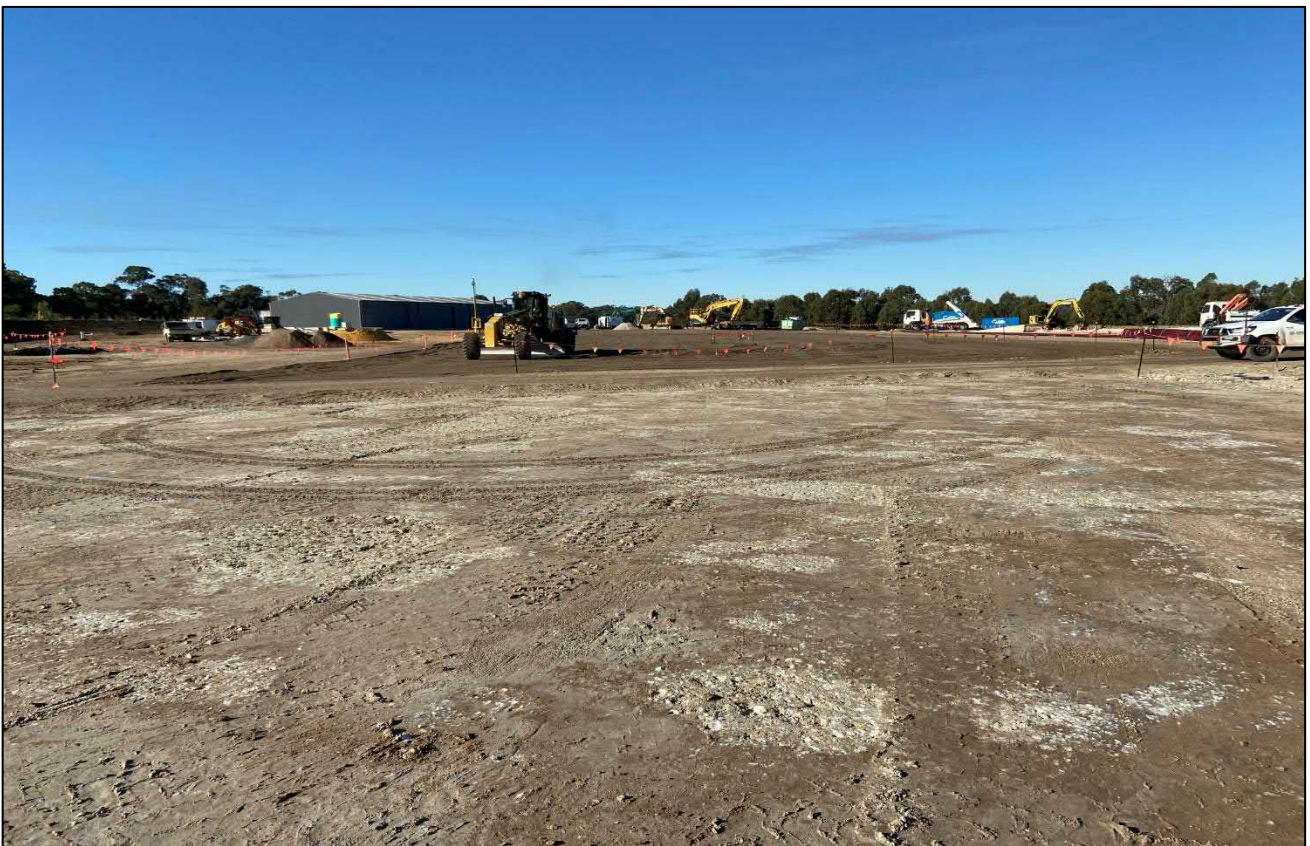
**Photograph 4.** Asbestos containment cell following the application of the sub-grade layer (as supplied by the client).

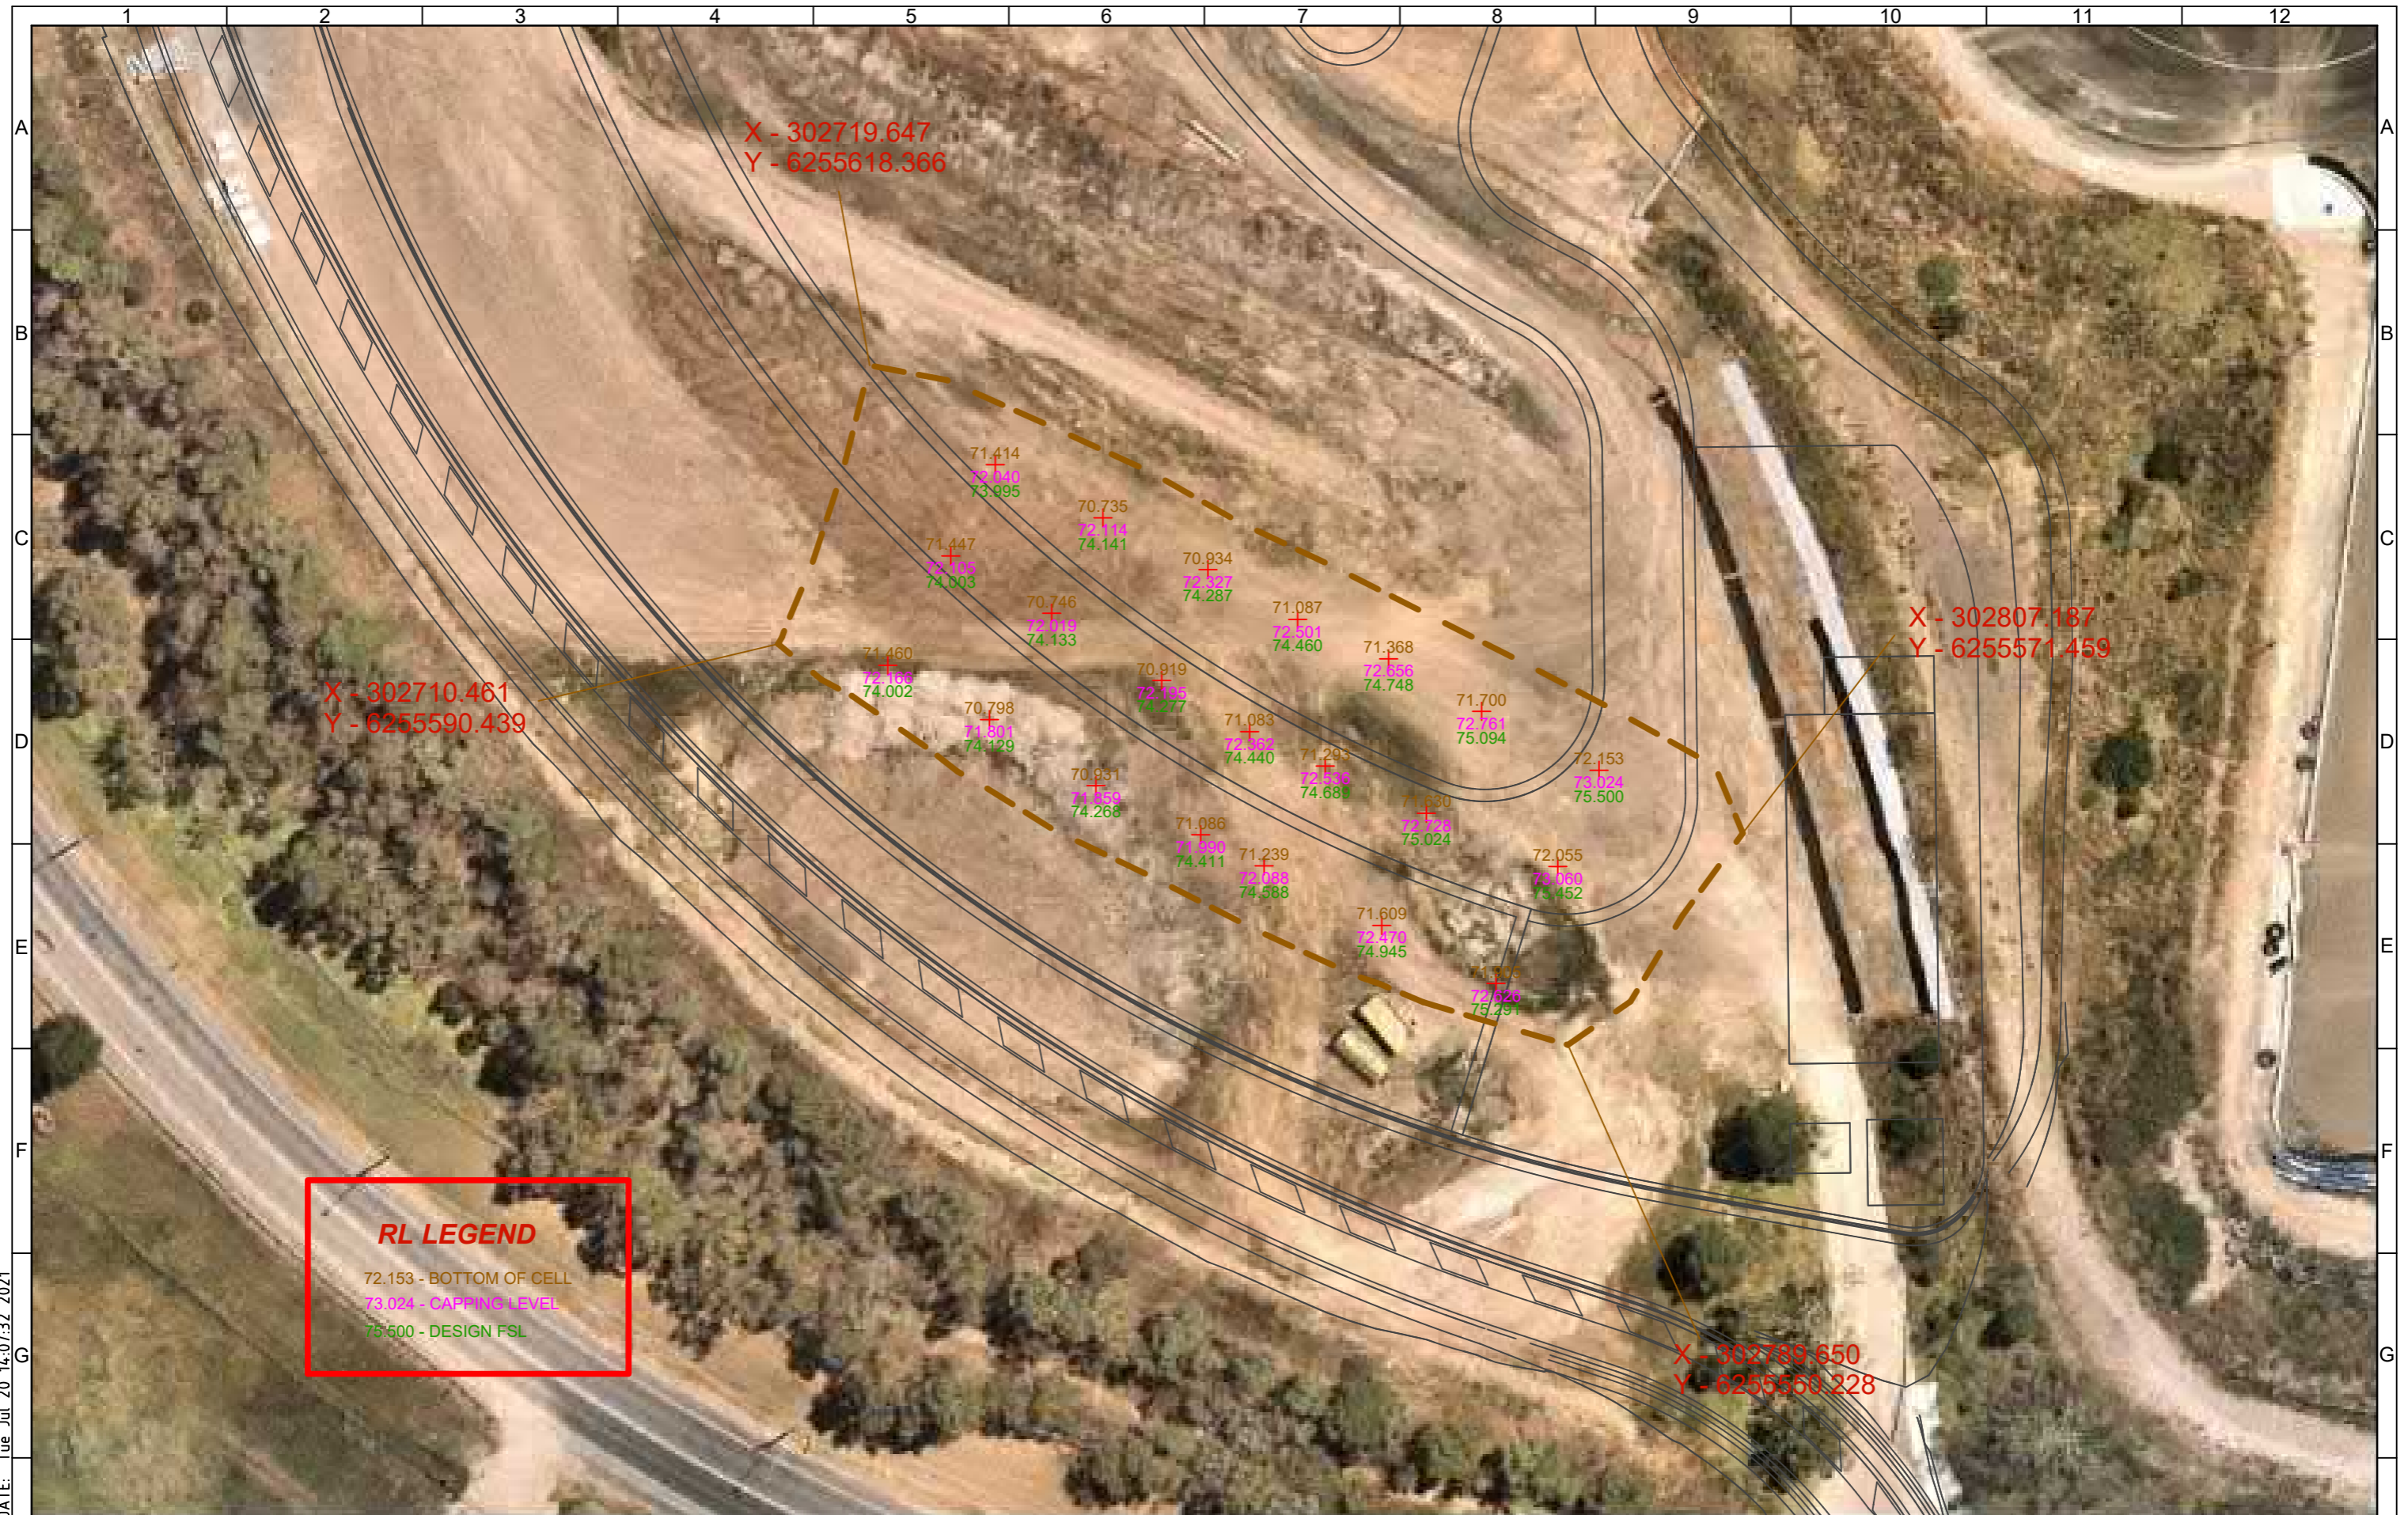
**RL LEGEND**  
 72.153 - BOTTOM OF CELL  
 73.024 - CAPPING LEVEL  
 75.500 - DESIGN FSL
