# St Marys Railway Station, St Marys: Archival Recording

FINAL REPORT

Prepared for Ward Civil on behalf of Transport for NSW and Sydney Metro

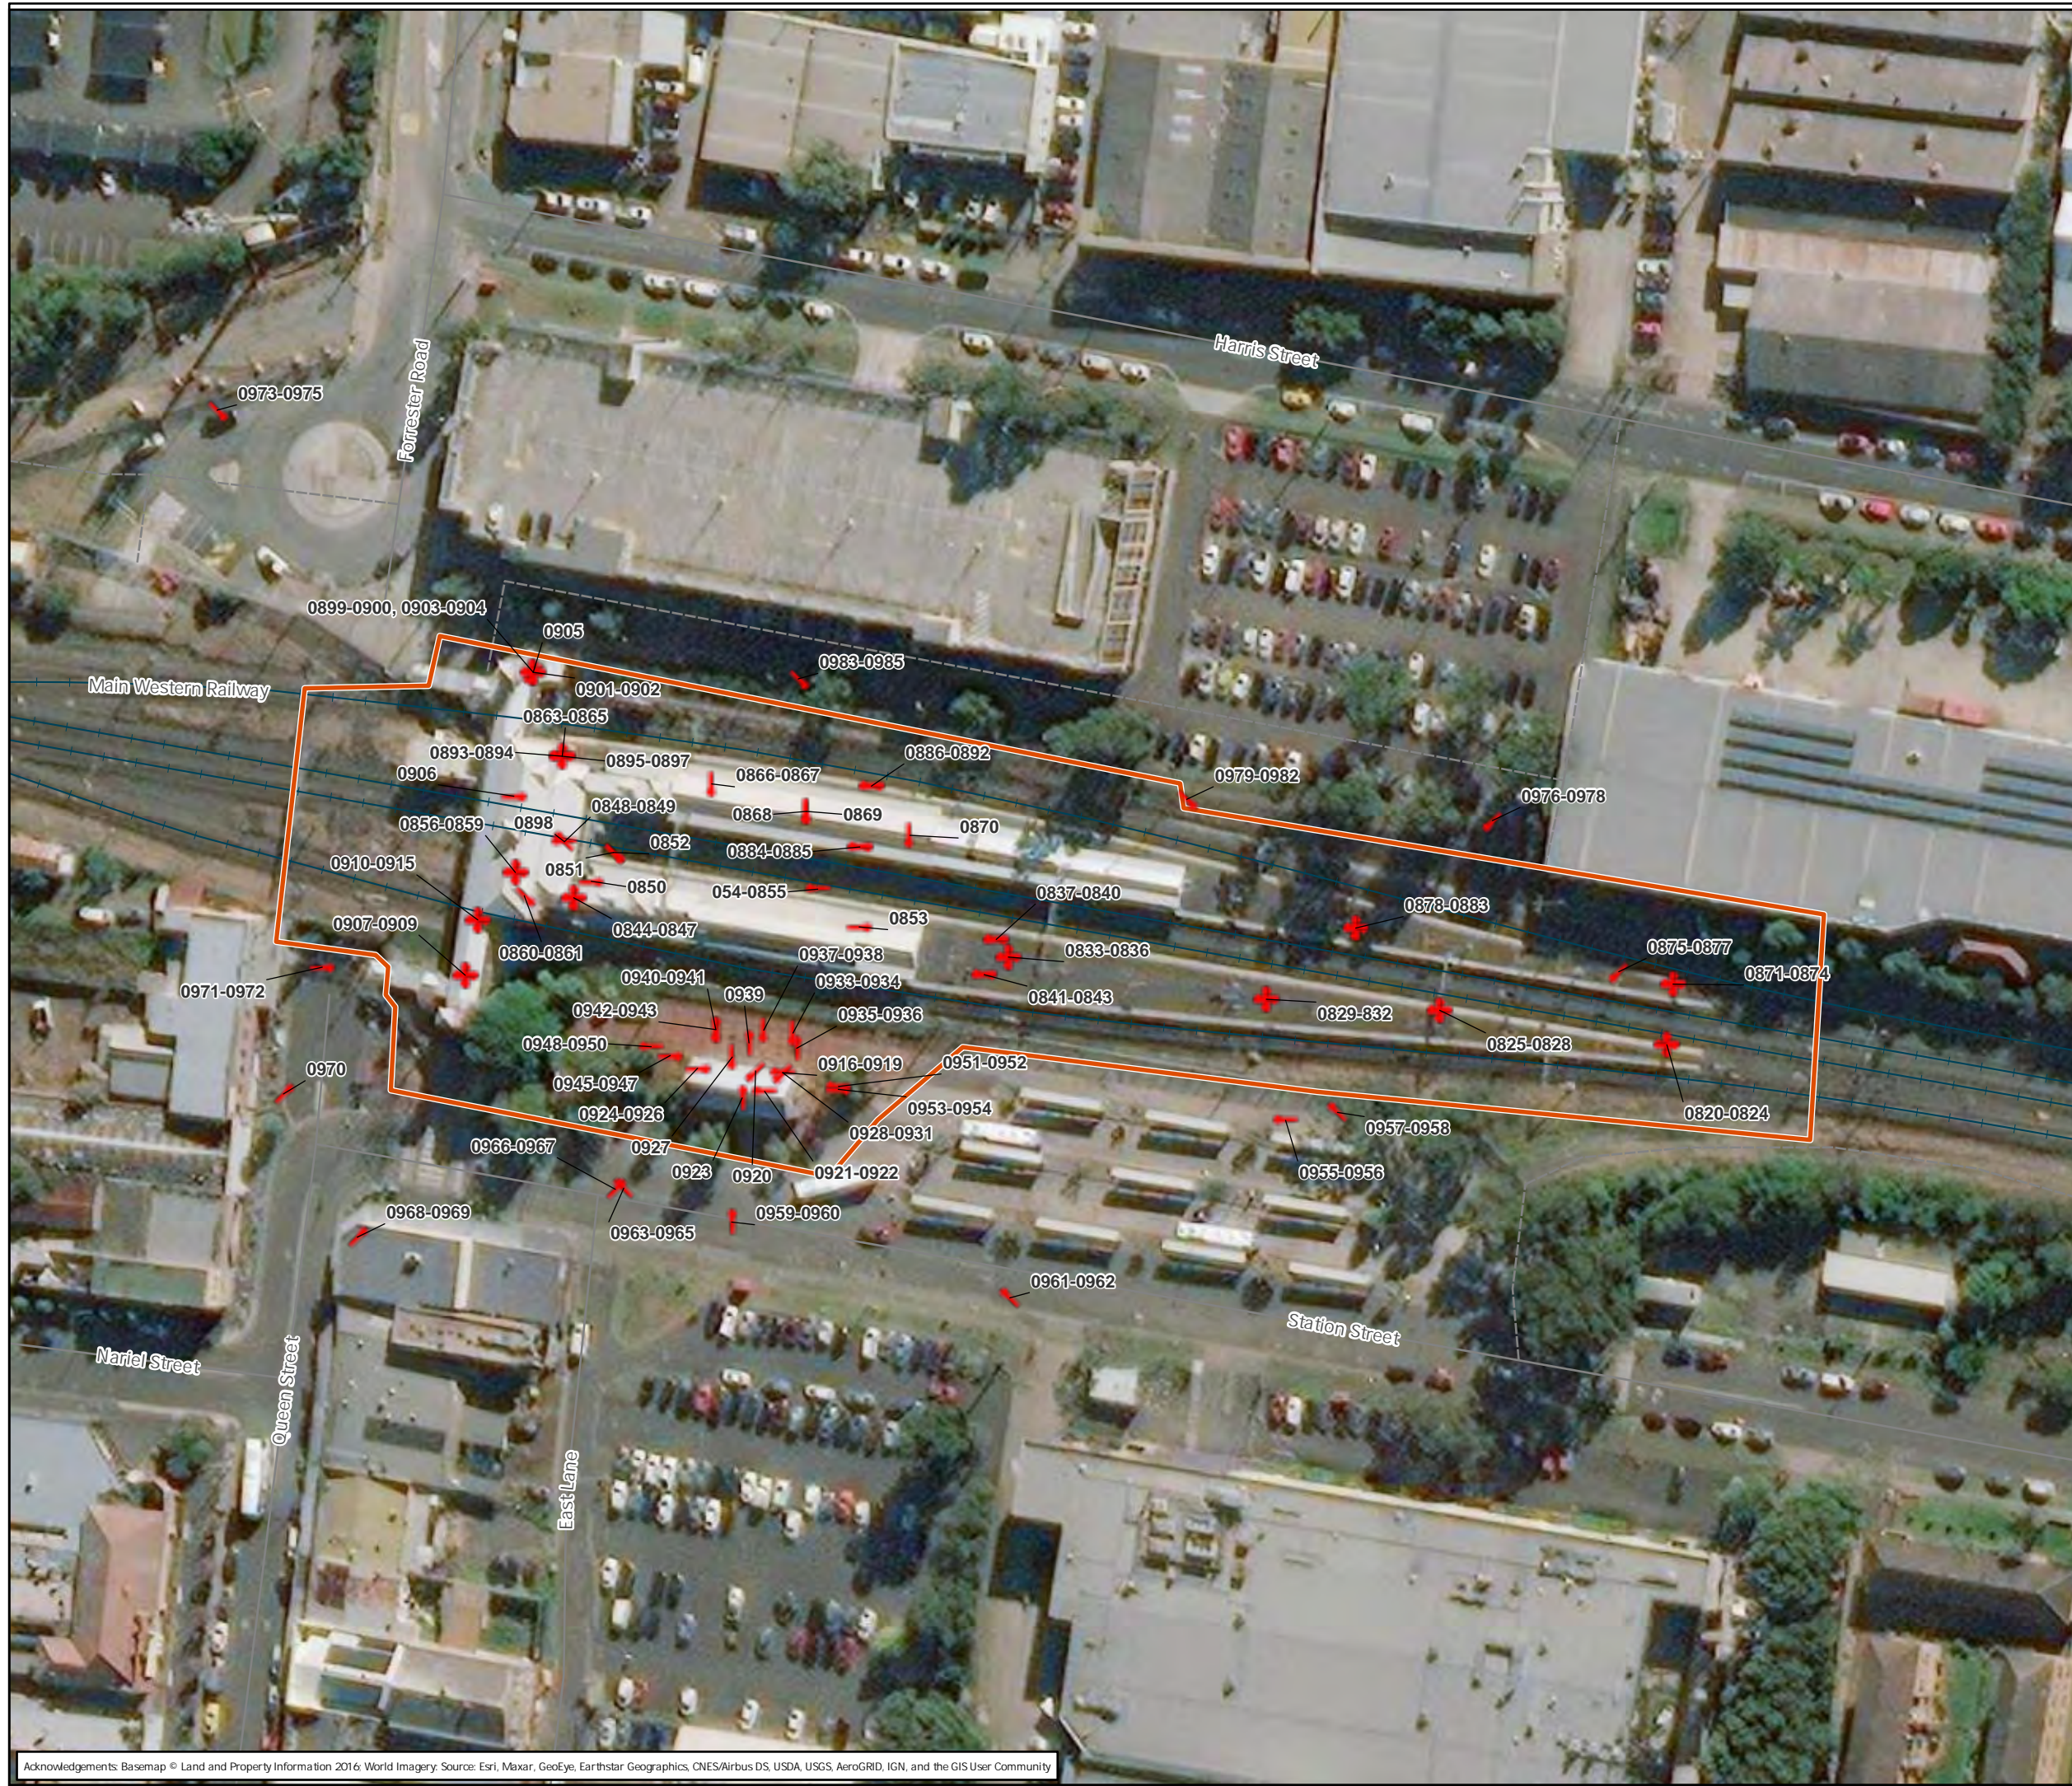
Figure 4 Photo points for St Mary's Railway Station

The following section contains maps showing the locations of the photographs (Figure 4). This section is followed by a photographic catalogue of all images taken of the study area referenced against the photographic index and maps.
