# Planning Approval Consistency Assessment Form

<b>Assessment name:</b>	Sydney Metro West – High Risk Boreholes and Monitoring Well Sites Outside Approved Construction Boundary
<b>Prepared by:</b>	GLC
<b>Prepared for:</b>	Sydney Metro
<b>Assessment number:</b>	GLC07
<b>Status:</b>	Final (January 2023)
<b>Version:</b>	B
<b>Planning approval:</b>	SSI 10038
<b>Date required:</b>	January 2023
<b>iCentral number:</b>	SM-23-00001975
© Sydney Metro 2020

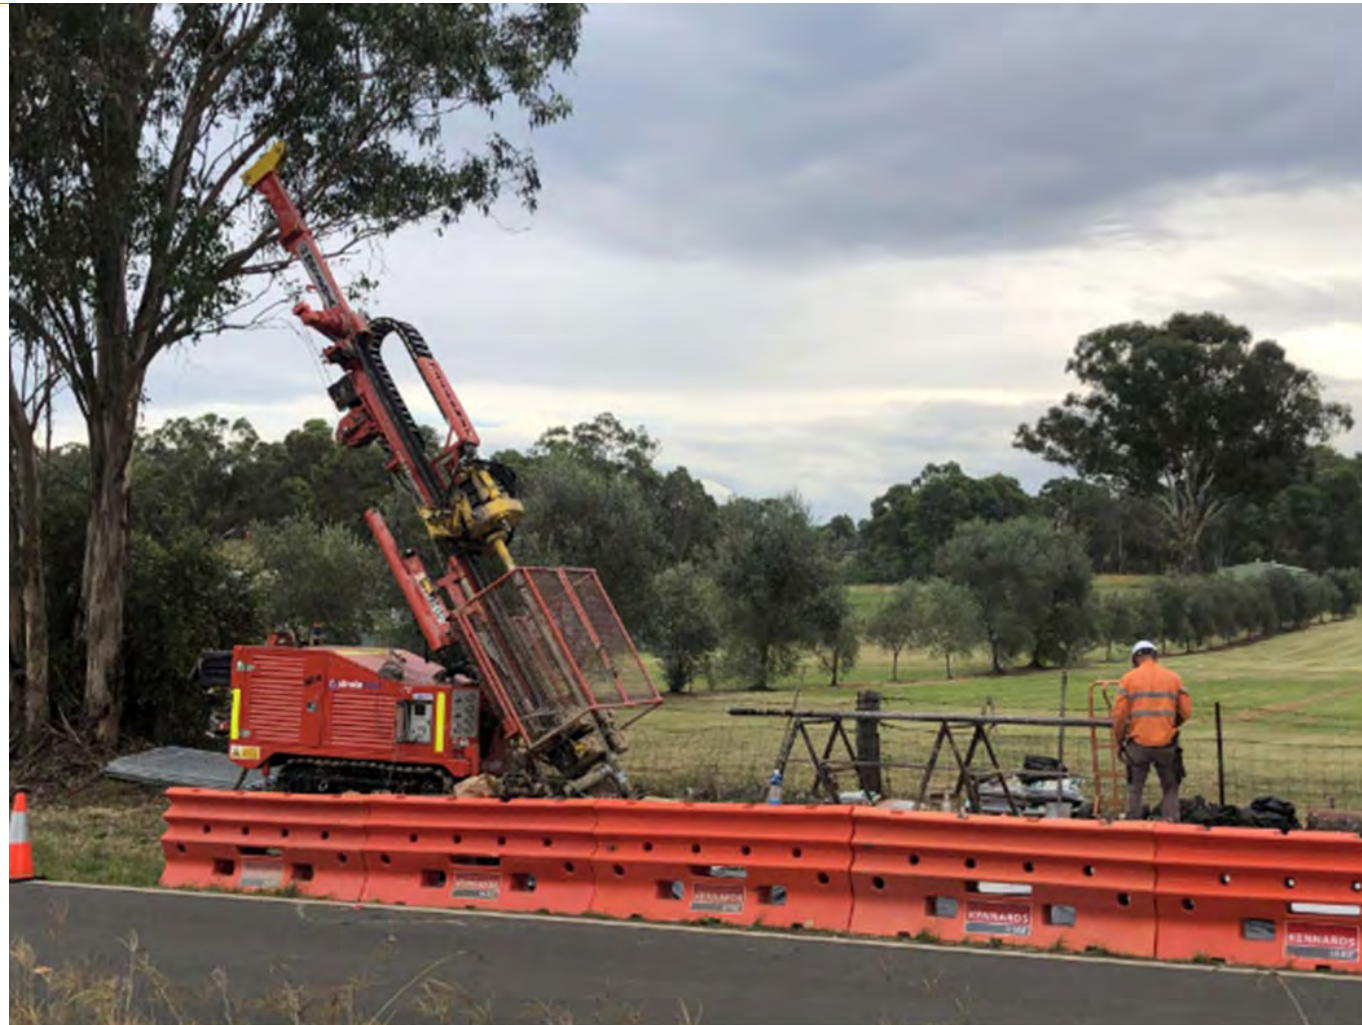
Figure 3: Example of a borehole/monitoring well set-up required for the proposed geotechnical services

Figure 3 and Figure 4 showing an example borehole/monitoring well site set-up, as well example monitoring well installation and sampling, are provided below:

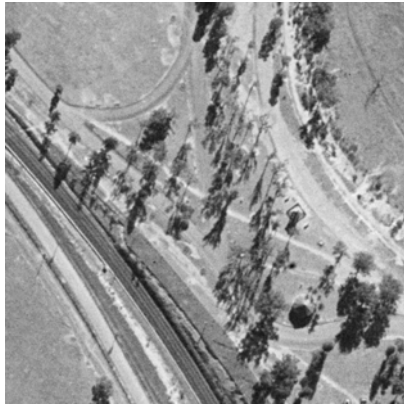
Scope ID	Discussion	Aerial Image
GALC-MW35	Several structures are depicted in the area, including the Boer War Memorial and Bath House interpretation pavilion. Since the photograph was taken, the Billy Hart Memorial and a memorial stone for the original cottage have also been installed. All four (4) structures are still extant. The formal plantings are still largely extant, although the area has been allowed to self-seed. The layout of access routes is largely unchanged.

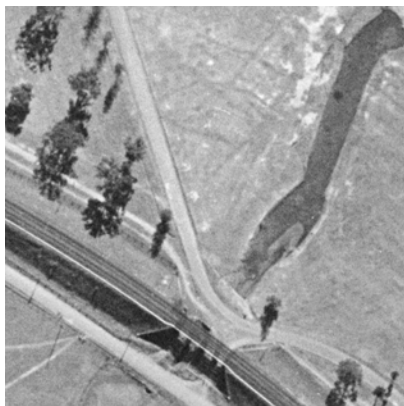
GALC-MW54	No structures are depicted in the area. The layout of the access routes has been altered, with the junction between West Domain Avenue and Railway Parade shifted north. The formal plantings are still extant and additional plantings have been established around Domain Creek.

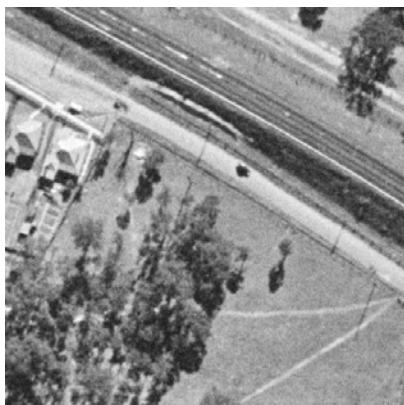
GALC-BH91	A white area adjacent to plantings may be a small structure or erosion scour, but further detail is unable to be determined. It was removed by 1951. Park Parade has since been shifted south to account for the widened railway corridor. Many of the plantings are still extant.

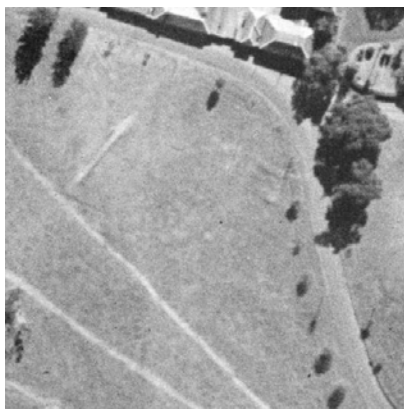
Scope ID	Discussion	Aerial Image
WTP-BH05	<p>No structures are present on the surface, however, several possible cropmarks (which may be indicative of subsurface features) are visible. This includes:</p> <ul style="list-style-type: none"> <li>• a north-east to south-west linear feature perpendicular to the northernmost pathway,</li> <li>• several east to west linear striations extending west from Federal Avenue.</li> </ul>

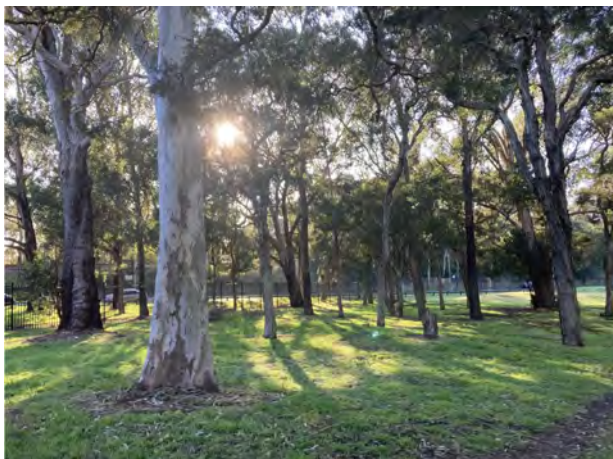
**Photo 5.1**      **Approximate Location of BH92 and MW36**

- The proposed MW36 and BH92 locations appeared heavily disturbed by previous modifications to the pathways, fences and underground services installed for adjacent residential properties.

Photo taken looking north across Parramatta Park, towards Park Parade.

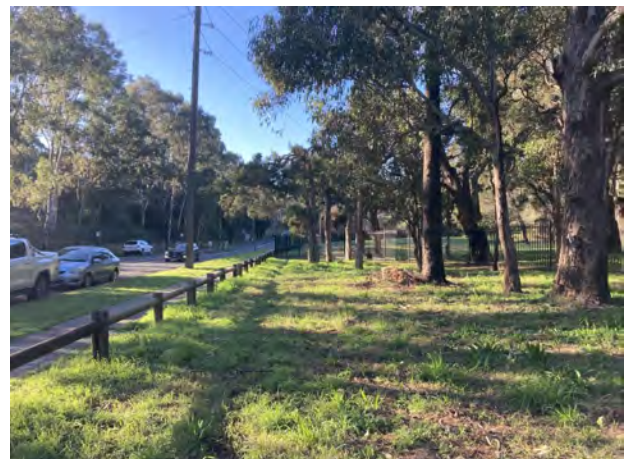
**Photo 5.2**      **Approximate Location of BH92 and MW36**

Photo taken outside the park fence along Park Parade, looking east.

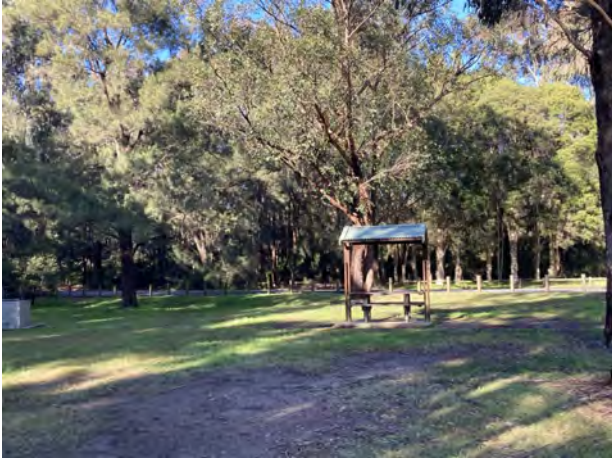
**Photo 5.3 Approximate Location of MW34**  
Looking east towards Domain Creek and Railway Parade from the southern corner of The Paddocks.

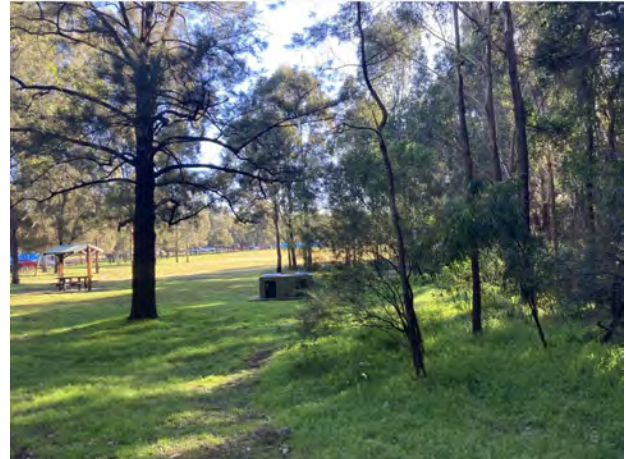
**Photo 5.4 Approximate Location of MW34**  
Looking northwest from Domain Creek and Railway Parade.

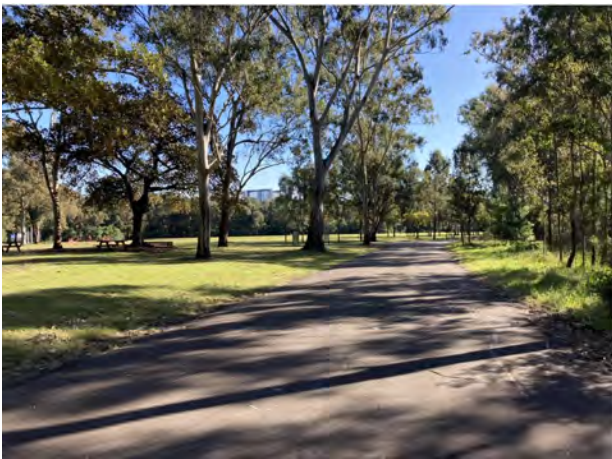
**Photo 5.5 Pedestrian Path in Vicinity of BH05**  
Photo looking west from between the Billy Hart Memorial and Boer War Memorial.

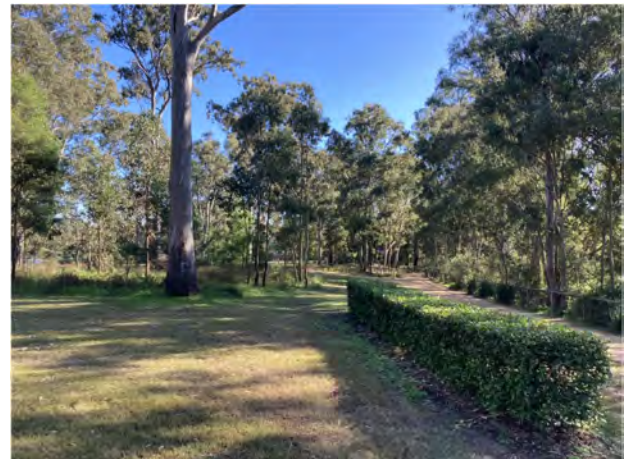
**Photo 5.6 Approximate Location of BH05,**  
Photo looking northwest towards the Paddocks.

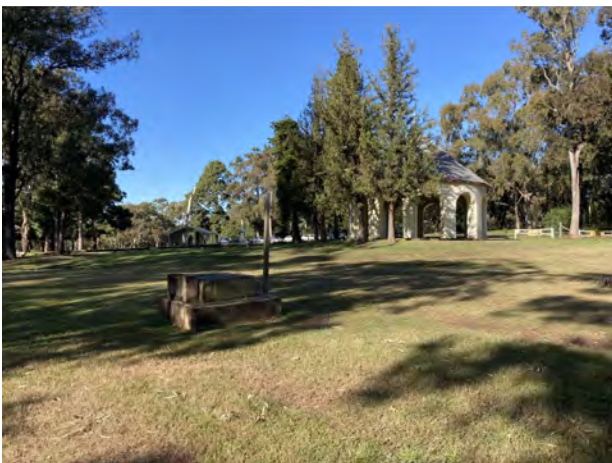
**Photo 5.7 Approximate Location of BH05**  
Photo looking east towards former Governors Bathhouse.

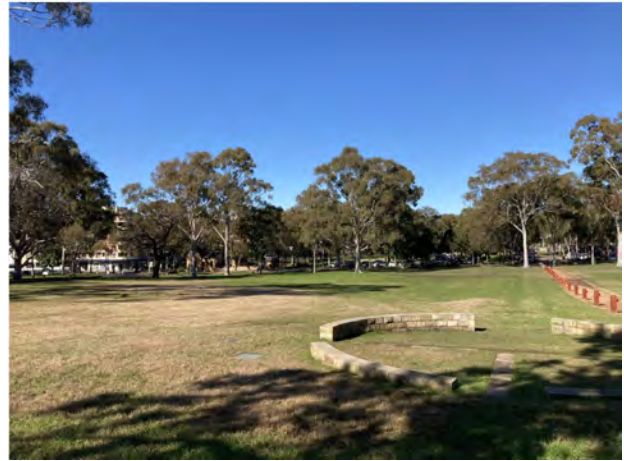
**Photo 5.10 Approximate Location of MW35**

Photo taken looking south over former Domain.

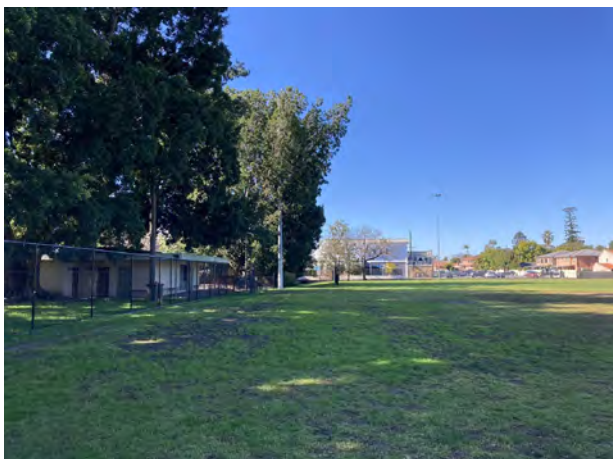
- The location of GALC-MW22, within Robin Thomas Reserve has been subject to lower levels of previous impacts, generally associated with the formation of the playing field and subsequent maintenance and use.

**Photo 6.1 Robin Thomas Reserve playing fields. Looking east towards proposed monitoring well location (GALC-MW22)**

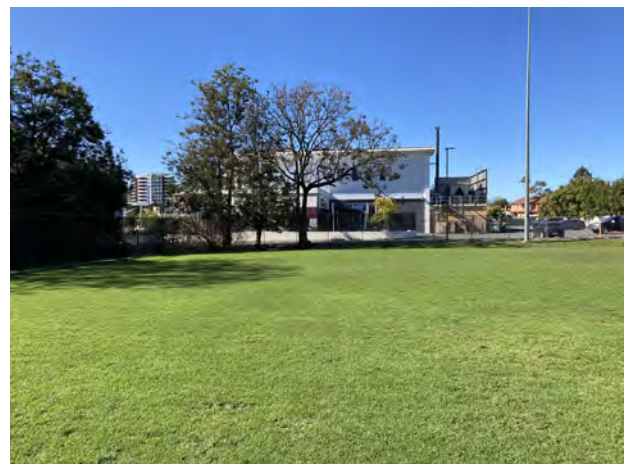
**Photo 6.2 Approximate location of GALC-MW22. Looking east from the northeast corner of the playing field. No structures visible in the area and little ground disturbance noticeable.**

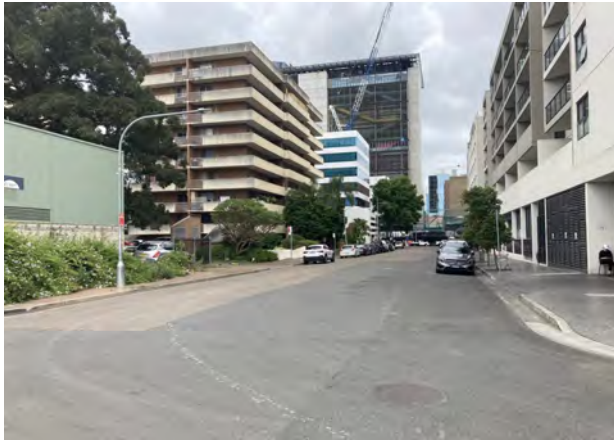
- The locations of GALC-ML23 and GALC-MW34 have been subject to some impacts, though the creation and upgrades of the road and footpaths in the area. However visual inspection cannot confirm the total removal of any historical archaeology or natural soil profiles.

**Photo 6.3** Approximate location of GALC-MW23. Looking west along Union Street from Angus Lane

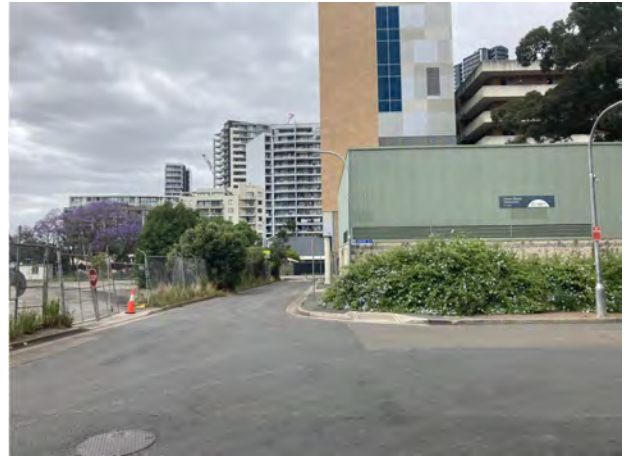
**Photo 6.4** Approximate location of GALC-MW23. Looking south from Angus Lane. The area is covered in hardstand in the public domain, no visibility of the ground surface.

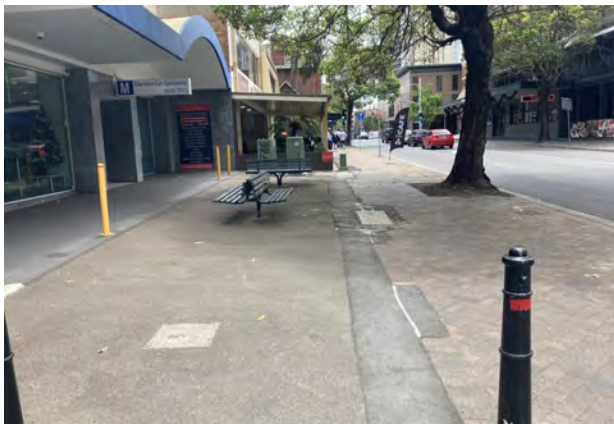
**Photo 6.5** Approximate location of GALC-MW34 looking north along Marsden Street. Area of recent trenching indicated by strip of asphalt within the brick footpath.

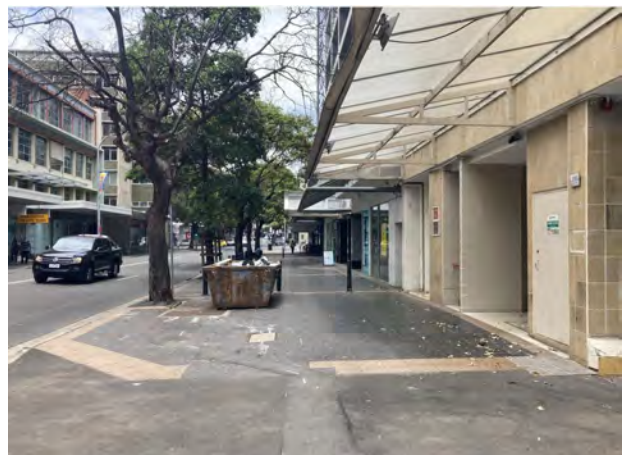
**Photo 6.6** Approximate location of GALC-MW34 looking south along Marsden Street. Area of recent trenching indicated by strip of asphalt within the brick footpath.

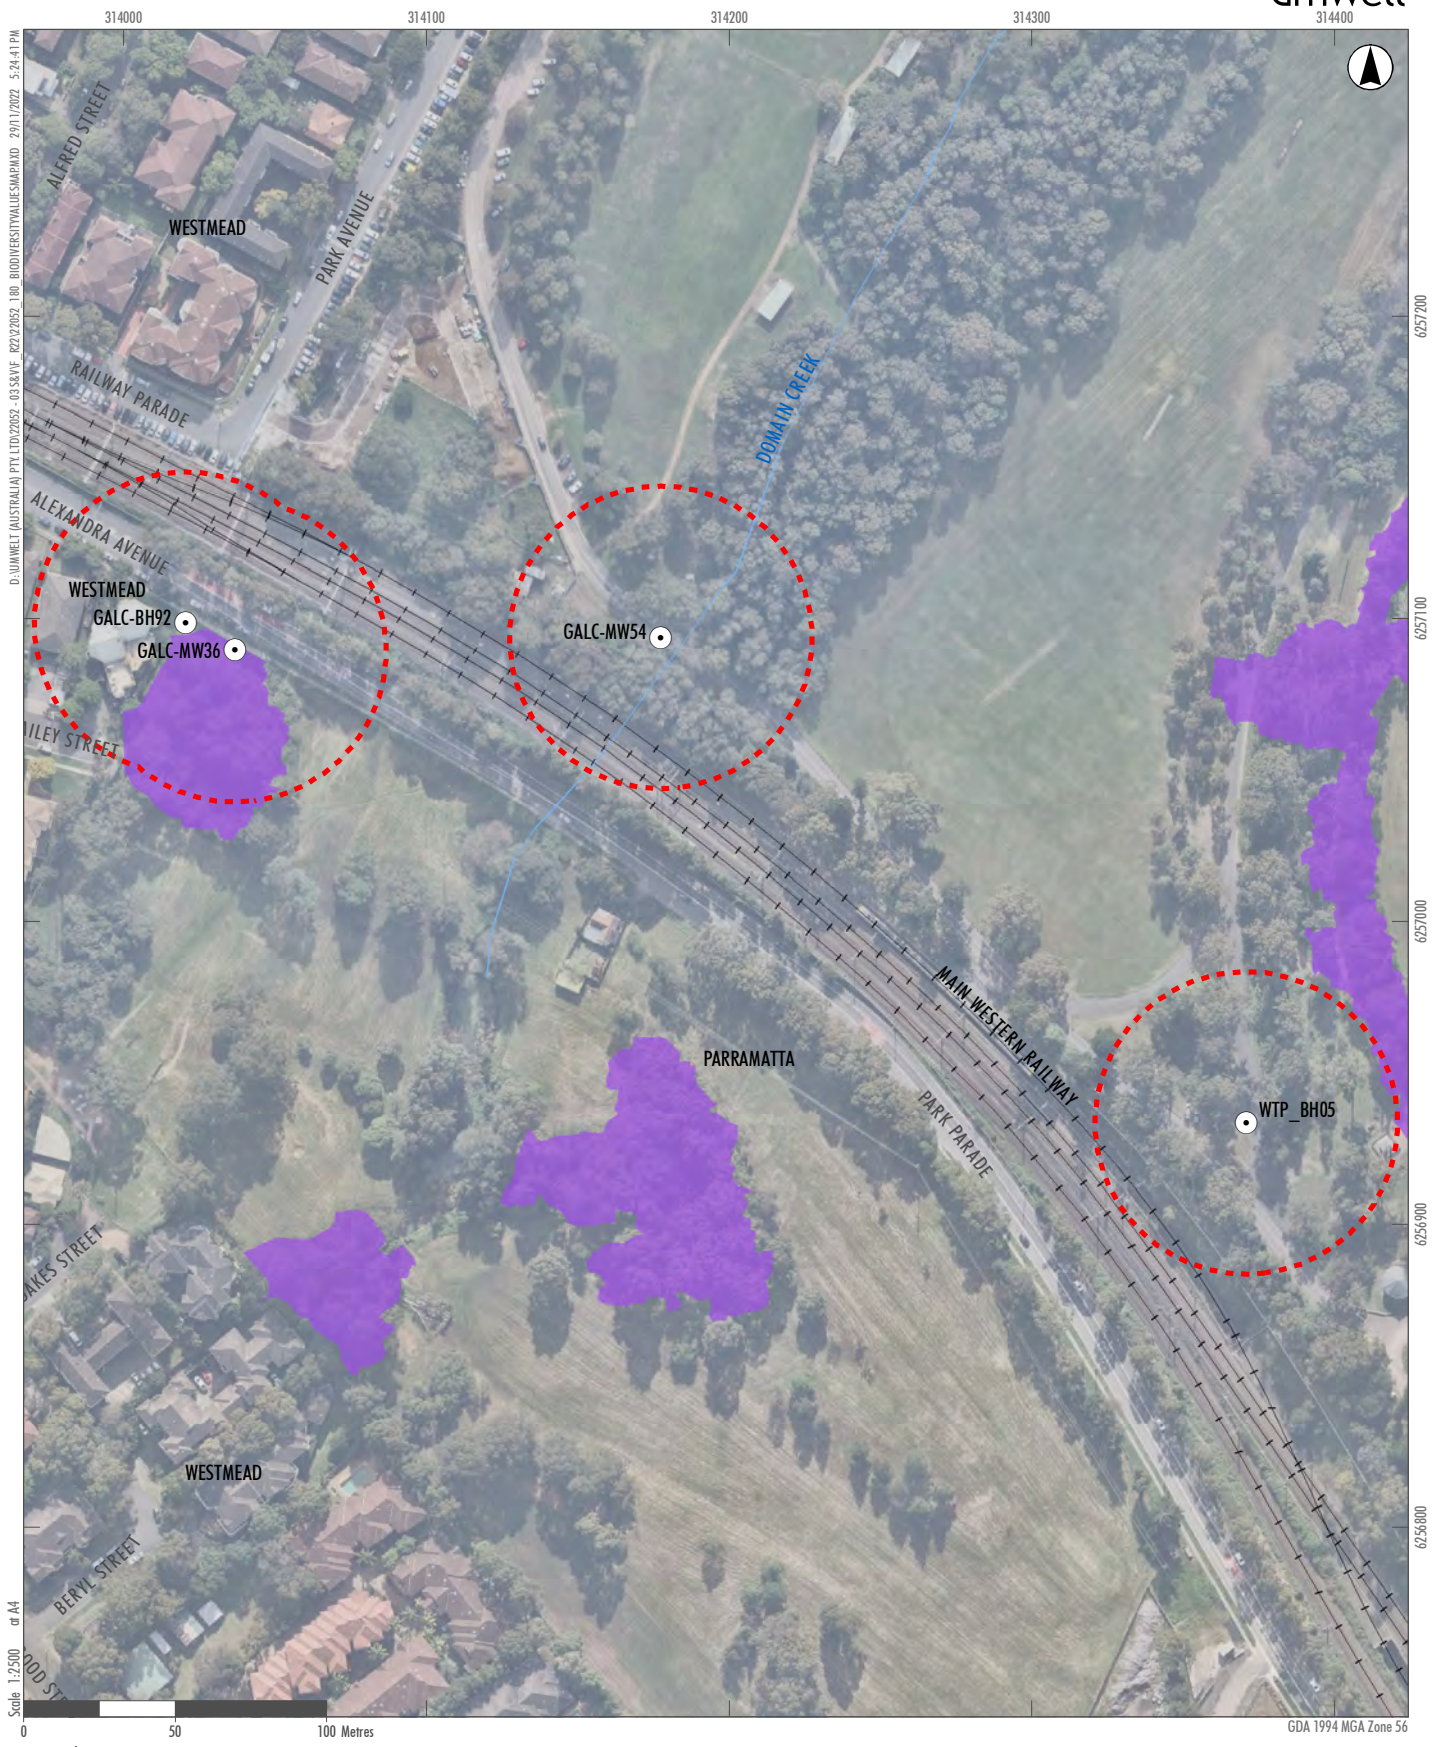
**FIGURE 3.2**

Parramatta River has been mapped as 'protected riparian land' under the Biodiversity Values Map and Threshold Tool. Additionally, patches of native vegetation identified as PCT 3320 have been mapped as 'threatened species or communities with potential for serious and irreversible impacts'. This includes the portions of PCT 3320 within the location for MW36 and in proximity to BH92 and BH05, as shown in **Figure 3.2**.
