No.	Location	SEEC Audit Report Comment	SEEC Photo (If Applicable)	SEEC Audit Report Recommendation	Open / Closed	CPBG Response / Action taken	Rectification works proposed (if not complete)	Timeframe	Justification for non response, where applicable	CPBG Update - Photo Evidence
4	St Marys	Runoff from the wheel wash trickles through the laydown yard and picks up small amounts of sediment on its way.

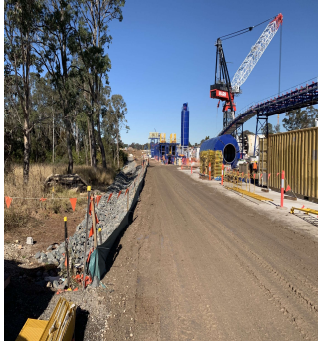
16	Orchard Hills	Eastern haul road –silt fences not dug in properly

Install the silt fence properly – trench it firmly into the ground to at least 150mm	Closed	The silt fence has been reinstated and dug into the ground as per specifications.	N/A	N/A	N/A

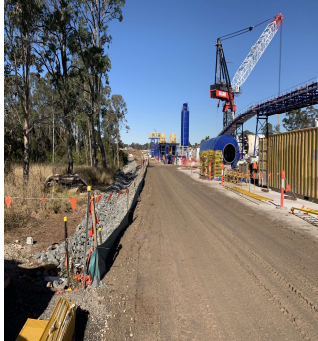
17	Orchard Hills	Eastern haul road: Coir logs require minor housekeeping. And Polymer binder is good but topdressing it on the road makes it slippery and it doesn't last very long. Use an alternative methodology to get better results.

Tidy up the controls along this edge so they provide adequate filtering of dirty water runoff from the haul road. And In future, blend the trafficable polymer into the road by: 1. Ripping the road to 100mm with a grader or a toothed excavator bucket. 2. Spraying the trafficable binder (e.g. Vital HRL), then 3. Rolling the road to blend the polymer binder and the road material together.	In progress	All coir Logs have been replaced and are now inspected daily.	A Polymer application is scheduled for this road by 21st July 2023.	Control tidy completed. Polymer application to road: 21st July 2023	N/A

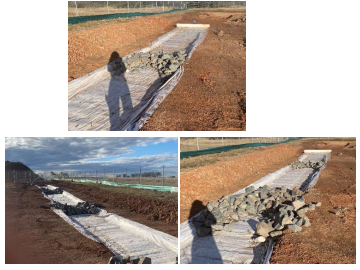
27	Aerotropolis	Spillway poorly constructed – the rock has filled up the swale.

<p>Re-dig the spillway so that the finished level of the rock creates a trapezoidal profile and the water will flow in the channel, not around the sides of it.</p>	Closed	This Channel has been excavated to design levels. Rock check dams have been reshaped to direct flows to the centre of the spillway.	N/A	Complete.	N/A

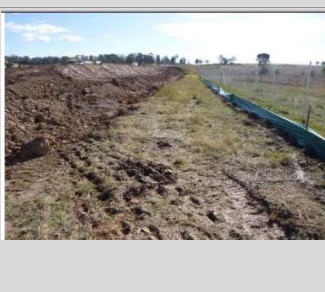
28	Aerotropolis	Stockpile adjacent to the basin blocks a large amount of site water from reaching the basin.

Remove this stockpile and form up the drain to direct all site water into the basin.	In progress	Given that this material has been sourced from the Medium Impact Area, as per Section 11.7 of the RAP, these materials cannot be reused in low impact areas or areas identified for future open space land uses. As such, the intention for this material is to use it to establish diversion bunds around the future clean water swale in the southern portion of the site. The access constraints detailed in Item No. 23 of this report apply to this area. The stockpile will be removed as soon as access allows.	Work will be undertaken once the area is accessible.	Target completion 28th July 2023	N/A	
29	Aerotropolis	Dirty water runoff from this batter would flow to the low point, where there are only minimal controls.
