Date
27 November 2020

Audit Number
TO-024-6

SITE AUDIT REPORT

SYDNEY METRO BLUES POINT ACCESS SHAFT, BLUES POINT ROAD, MCMAHONS POINT NSW

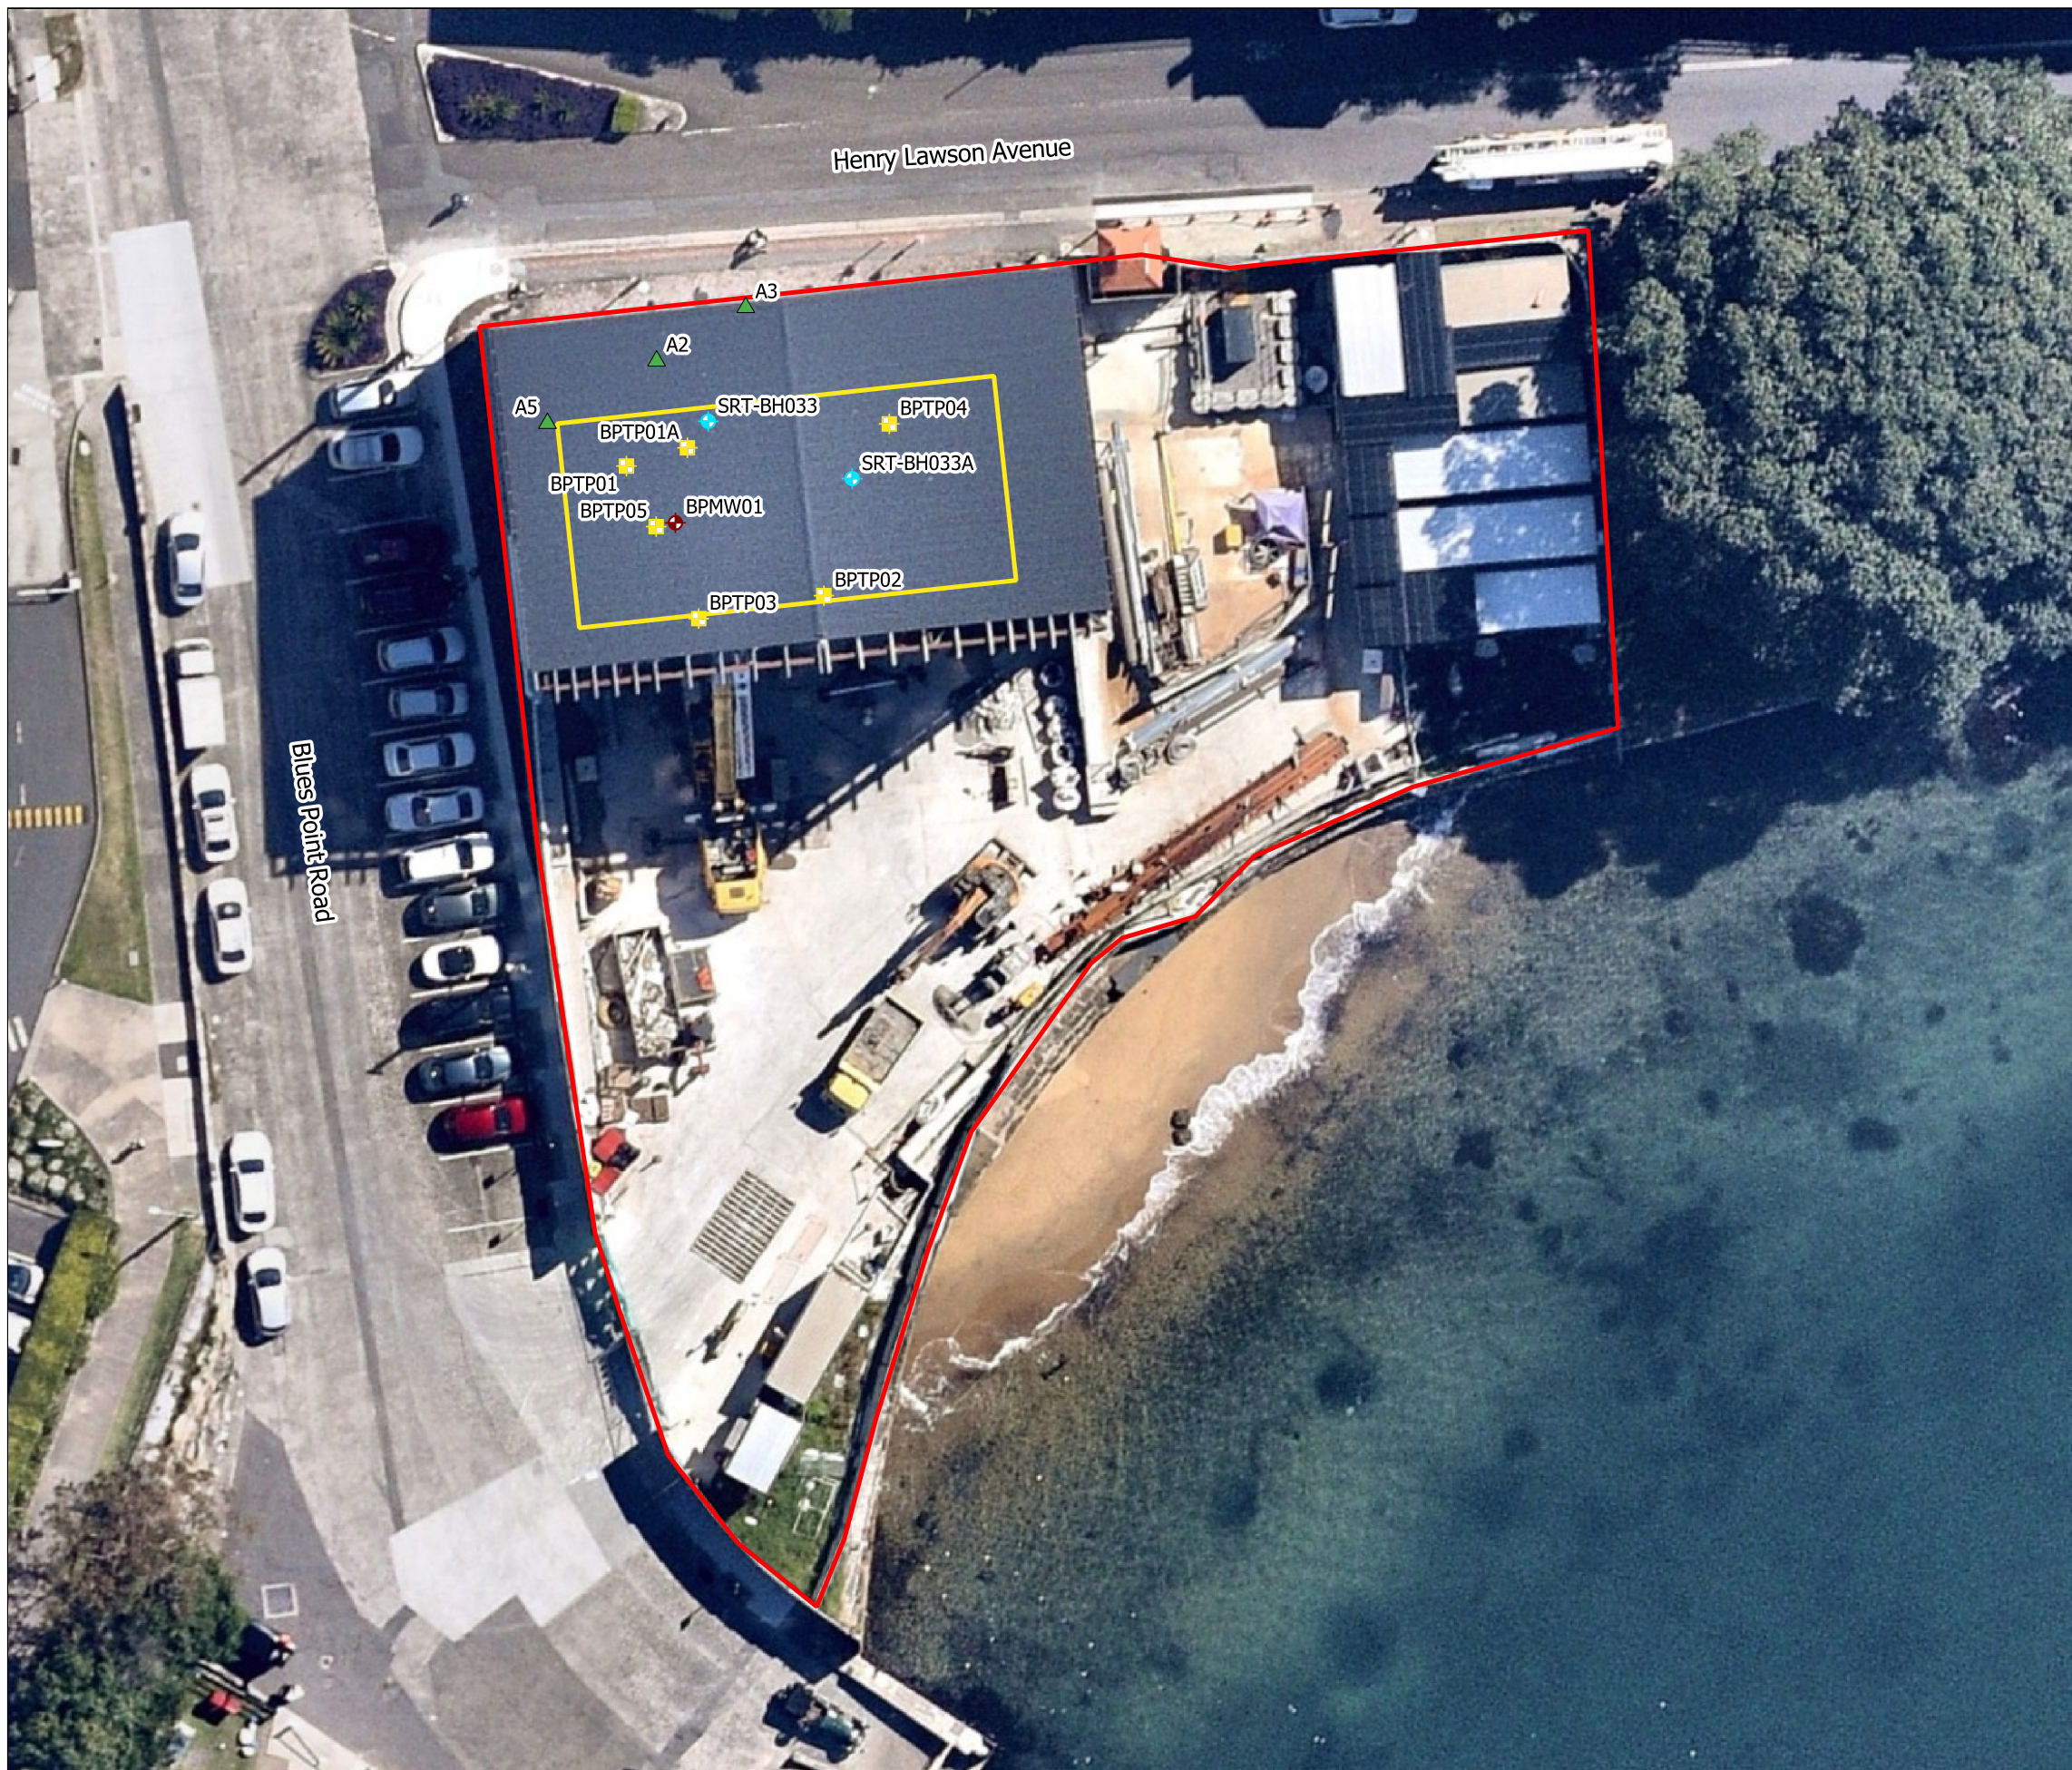
Attachment 1: Site Location and Sample Locations
Attachment 2: Site Survey

Notes:
 1. Basemap sourced from nearmap, dated 26/09/2020.
 2. Construction site boundary is approximate only.

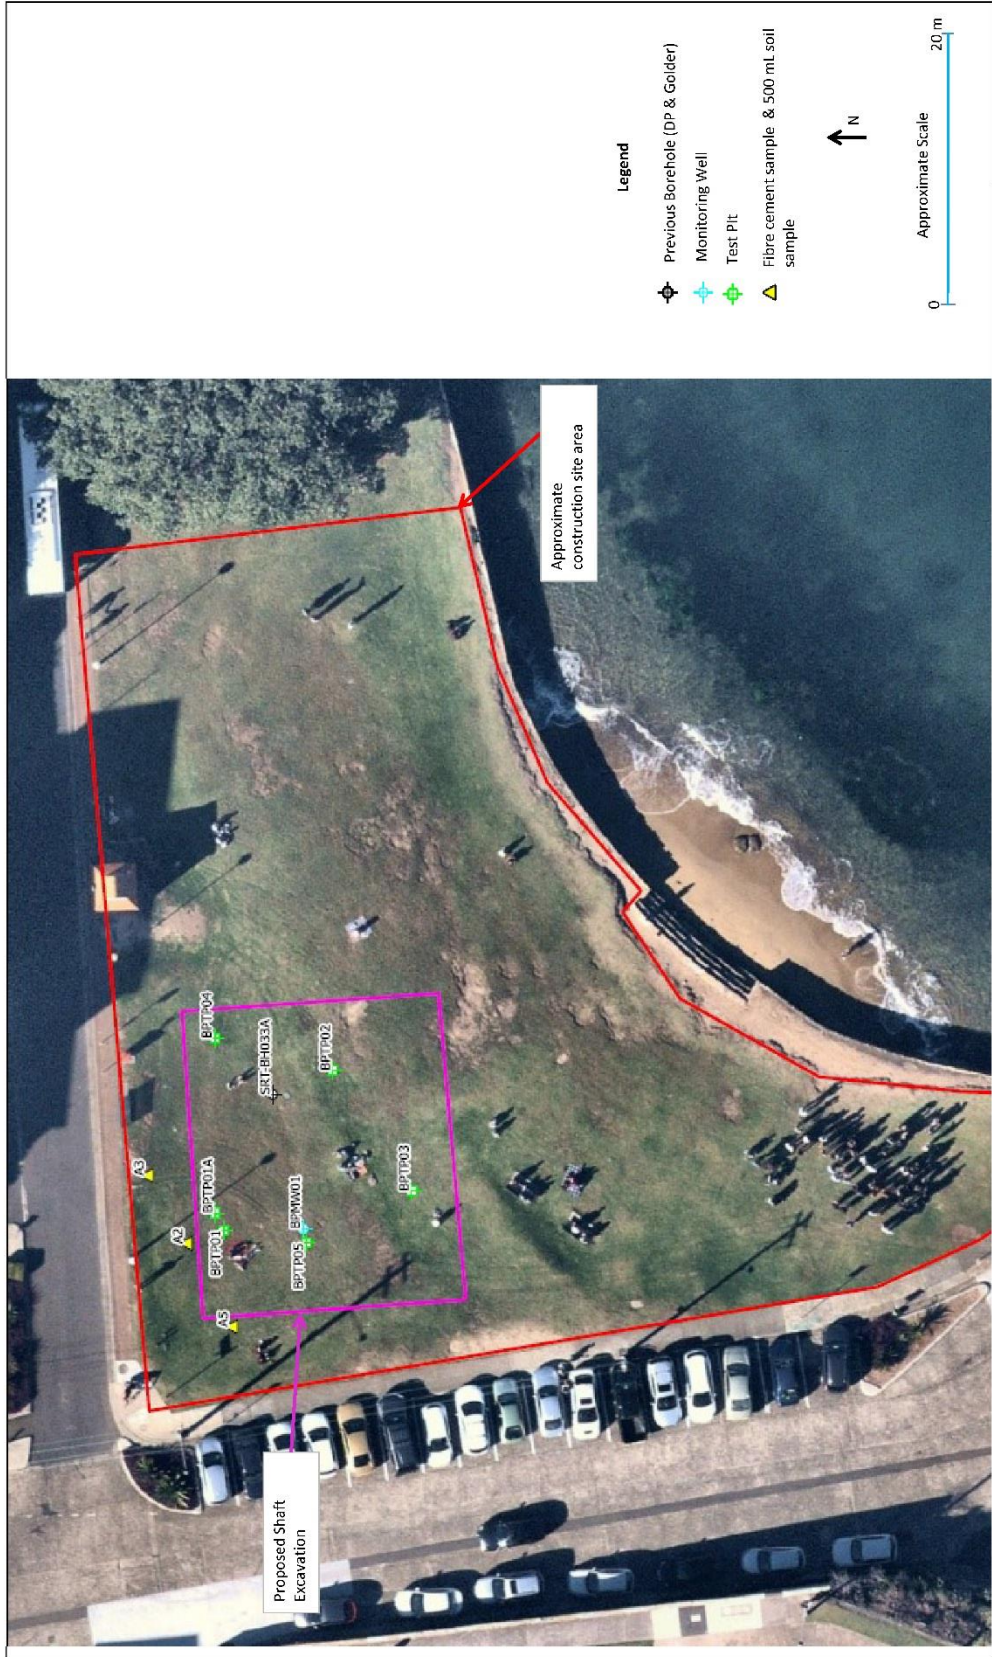
Attachments: 1. The DSI Sampling Location Plan

- Previous Borehole (DP & Golder)
- Monitoring Well
- Test Pit
- Fibre cement sample & 500 ml soil sample
