# **SITE AUDIT REPORT**

# **SYDNEY METRO BLUES**

# **POINT ACCESS SHAFT**

**SITE AUDIT REPORT - SYDNEY METRO BLUES POINT  
ACCESS SHAFT REINSTATEMENT, BLUES POINT ROAD,  
MCMAHONS POINT**

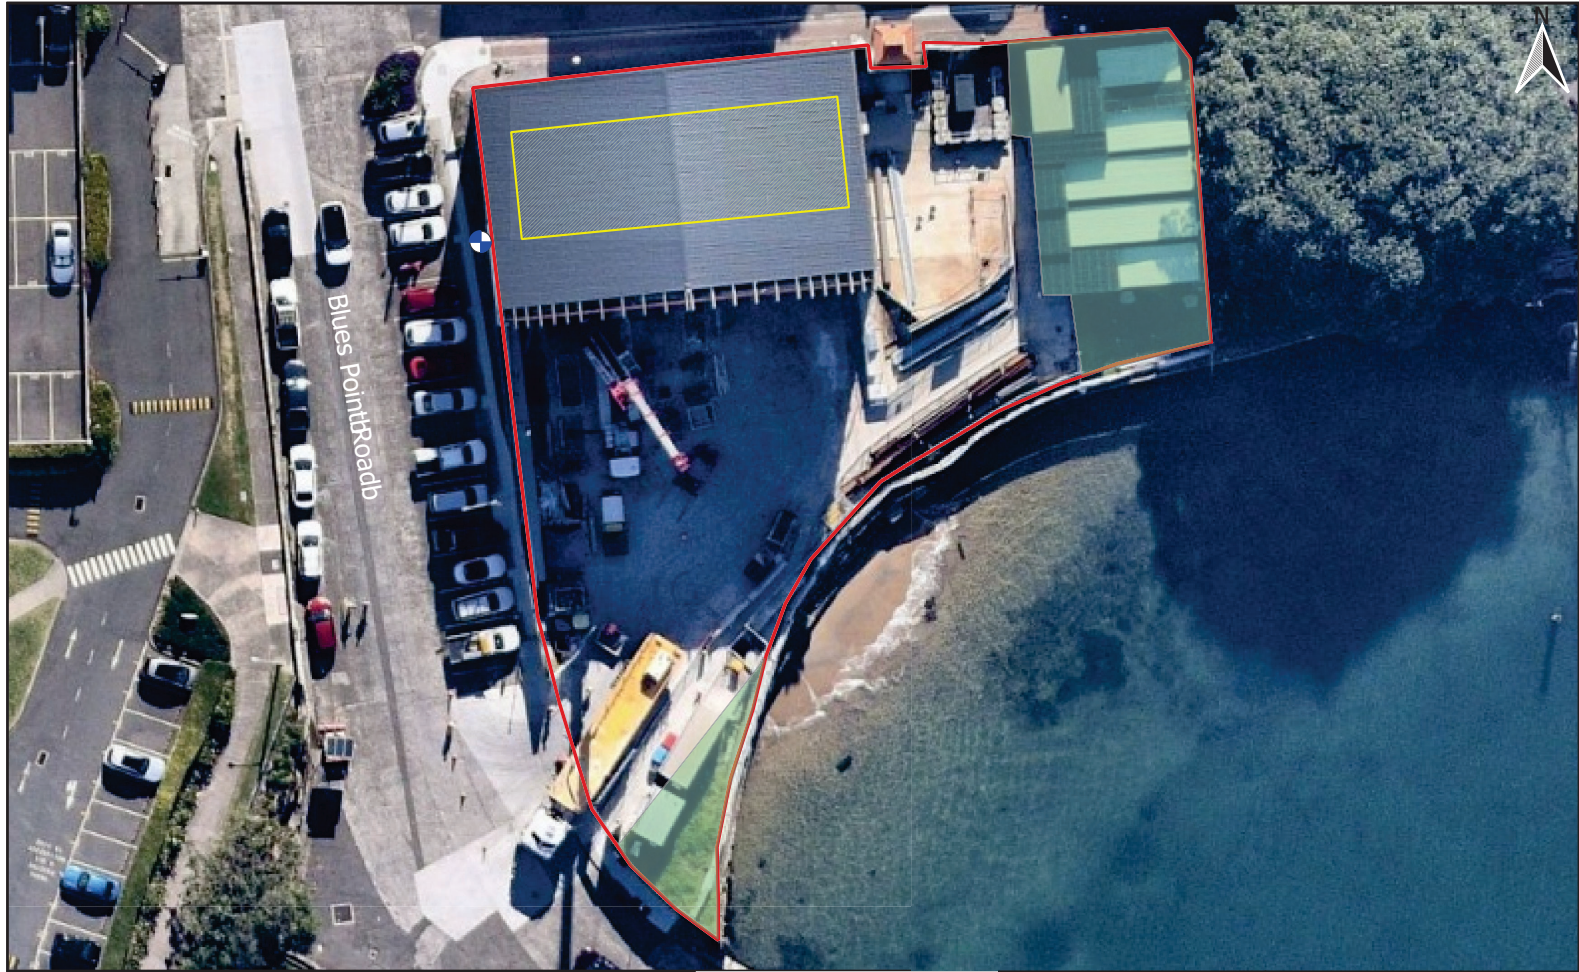
# Attachment 1: Site Boundary

The footprint of the site and the larger construction land are labelled as 'Access Shaft Site Boundary' and 'Construction Site', respectively, in **Attachment 1, Appendix A**. Only the area within the 'Access Shaft Site Boundary' constitutes the site audit area.
