Remediation Action Plan –  
Chatswood Site

Sydney Metro

Document title  
Remediation Action Plan – Chatswood Site

Version  
2.0

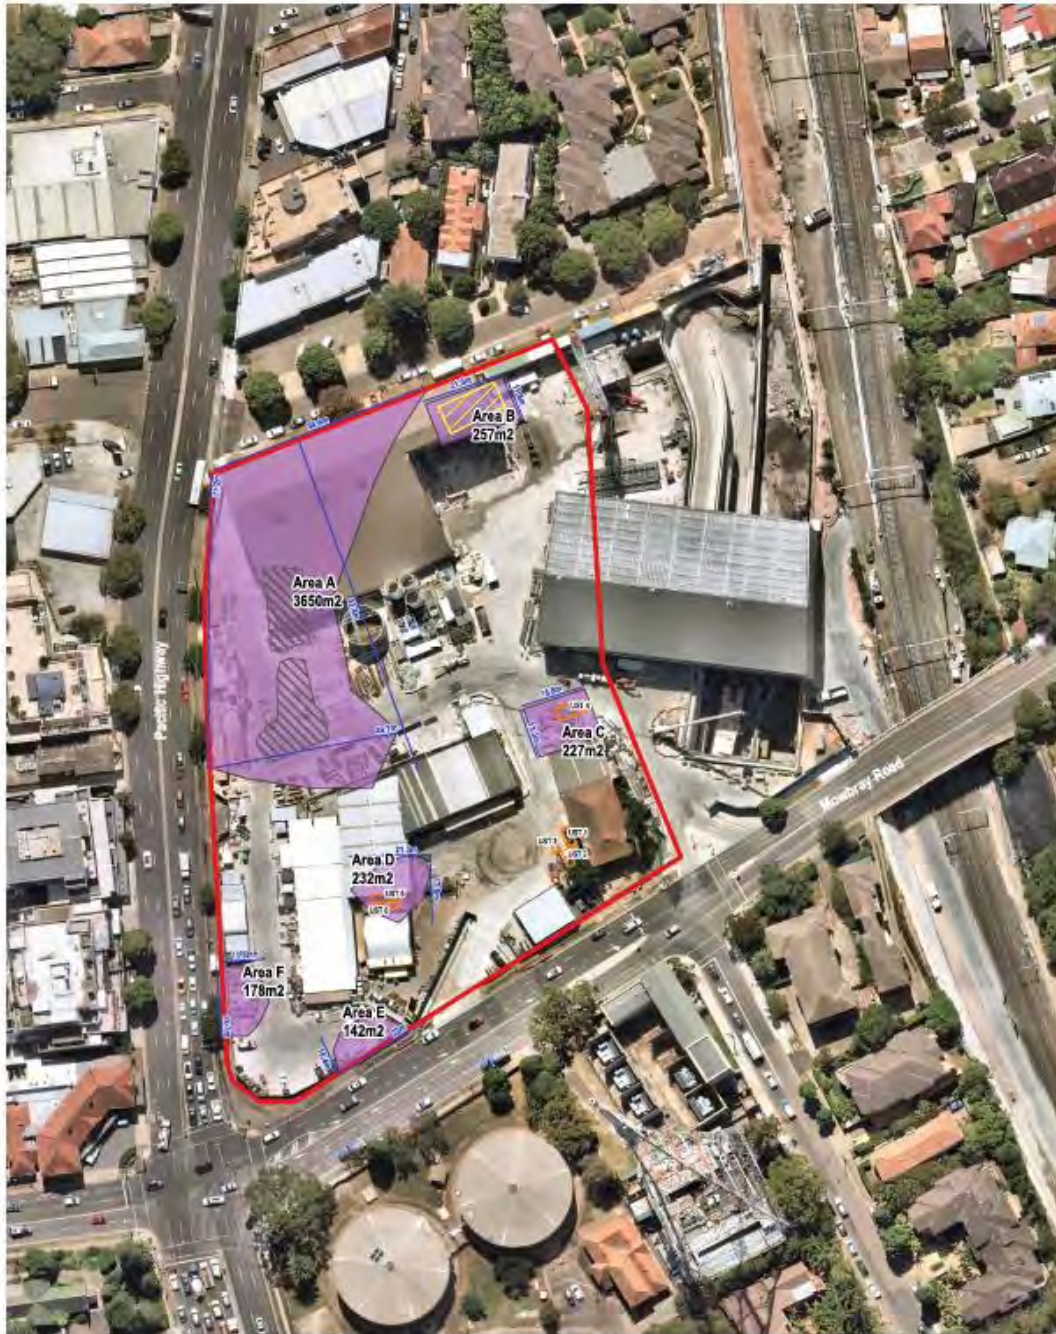
**Appendix C-1: Indicative Extent of Remediation**

| <p><b>Remediation Extent</b></p> | <p>The indicative extent of remediation, prior to refinement following the additional sampling, is defined as:</p> <ul style="list-style-type: none"> <li>» Remediation Area A – former asbestos burial pits, and chemical impacts associated with a former service station.</li> <li>» Remediation Area B – a former asbestos slab.</li> <li>» Remediation Area C – a former underground storage tank associated with a former energy depot.</li> <li>» Remediation Area D – two former USTs, also associated with the former energy depot.</li> <li>» Remediation Areas E and F – exceedances in shallow soils.</li> </ul> <p>The above indicative extents are shown on the below <b>Figure C-1</b>.</p> |

The draft RCE (Nation Partners, 2020) included conservative estimates on the extent and volume of material requiring remediation (exclusive of additional investigation for asbestos in soils), as shown in **Attachment C** and summarised in **Table 5** below. It is noted that the preferred strategy is a combination of Options A and B, outlined below, and that the actual volume will likely be between the two options.

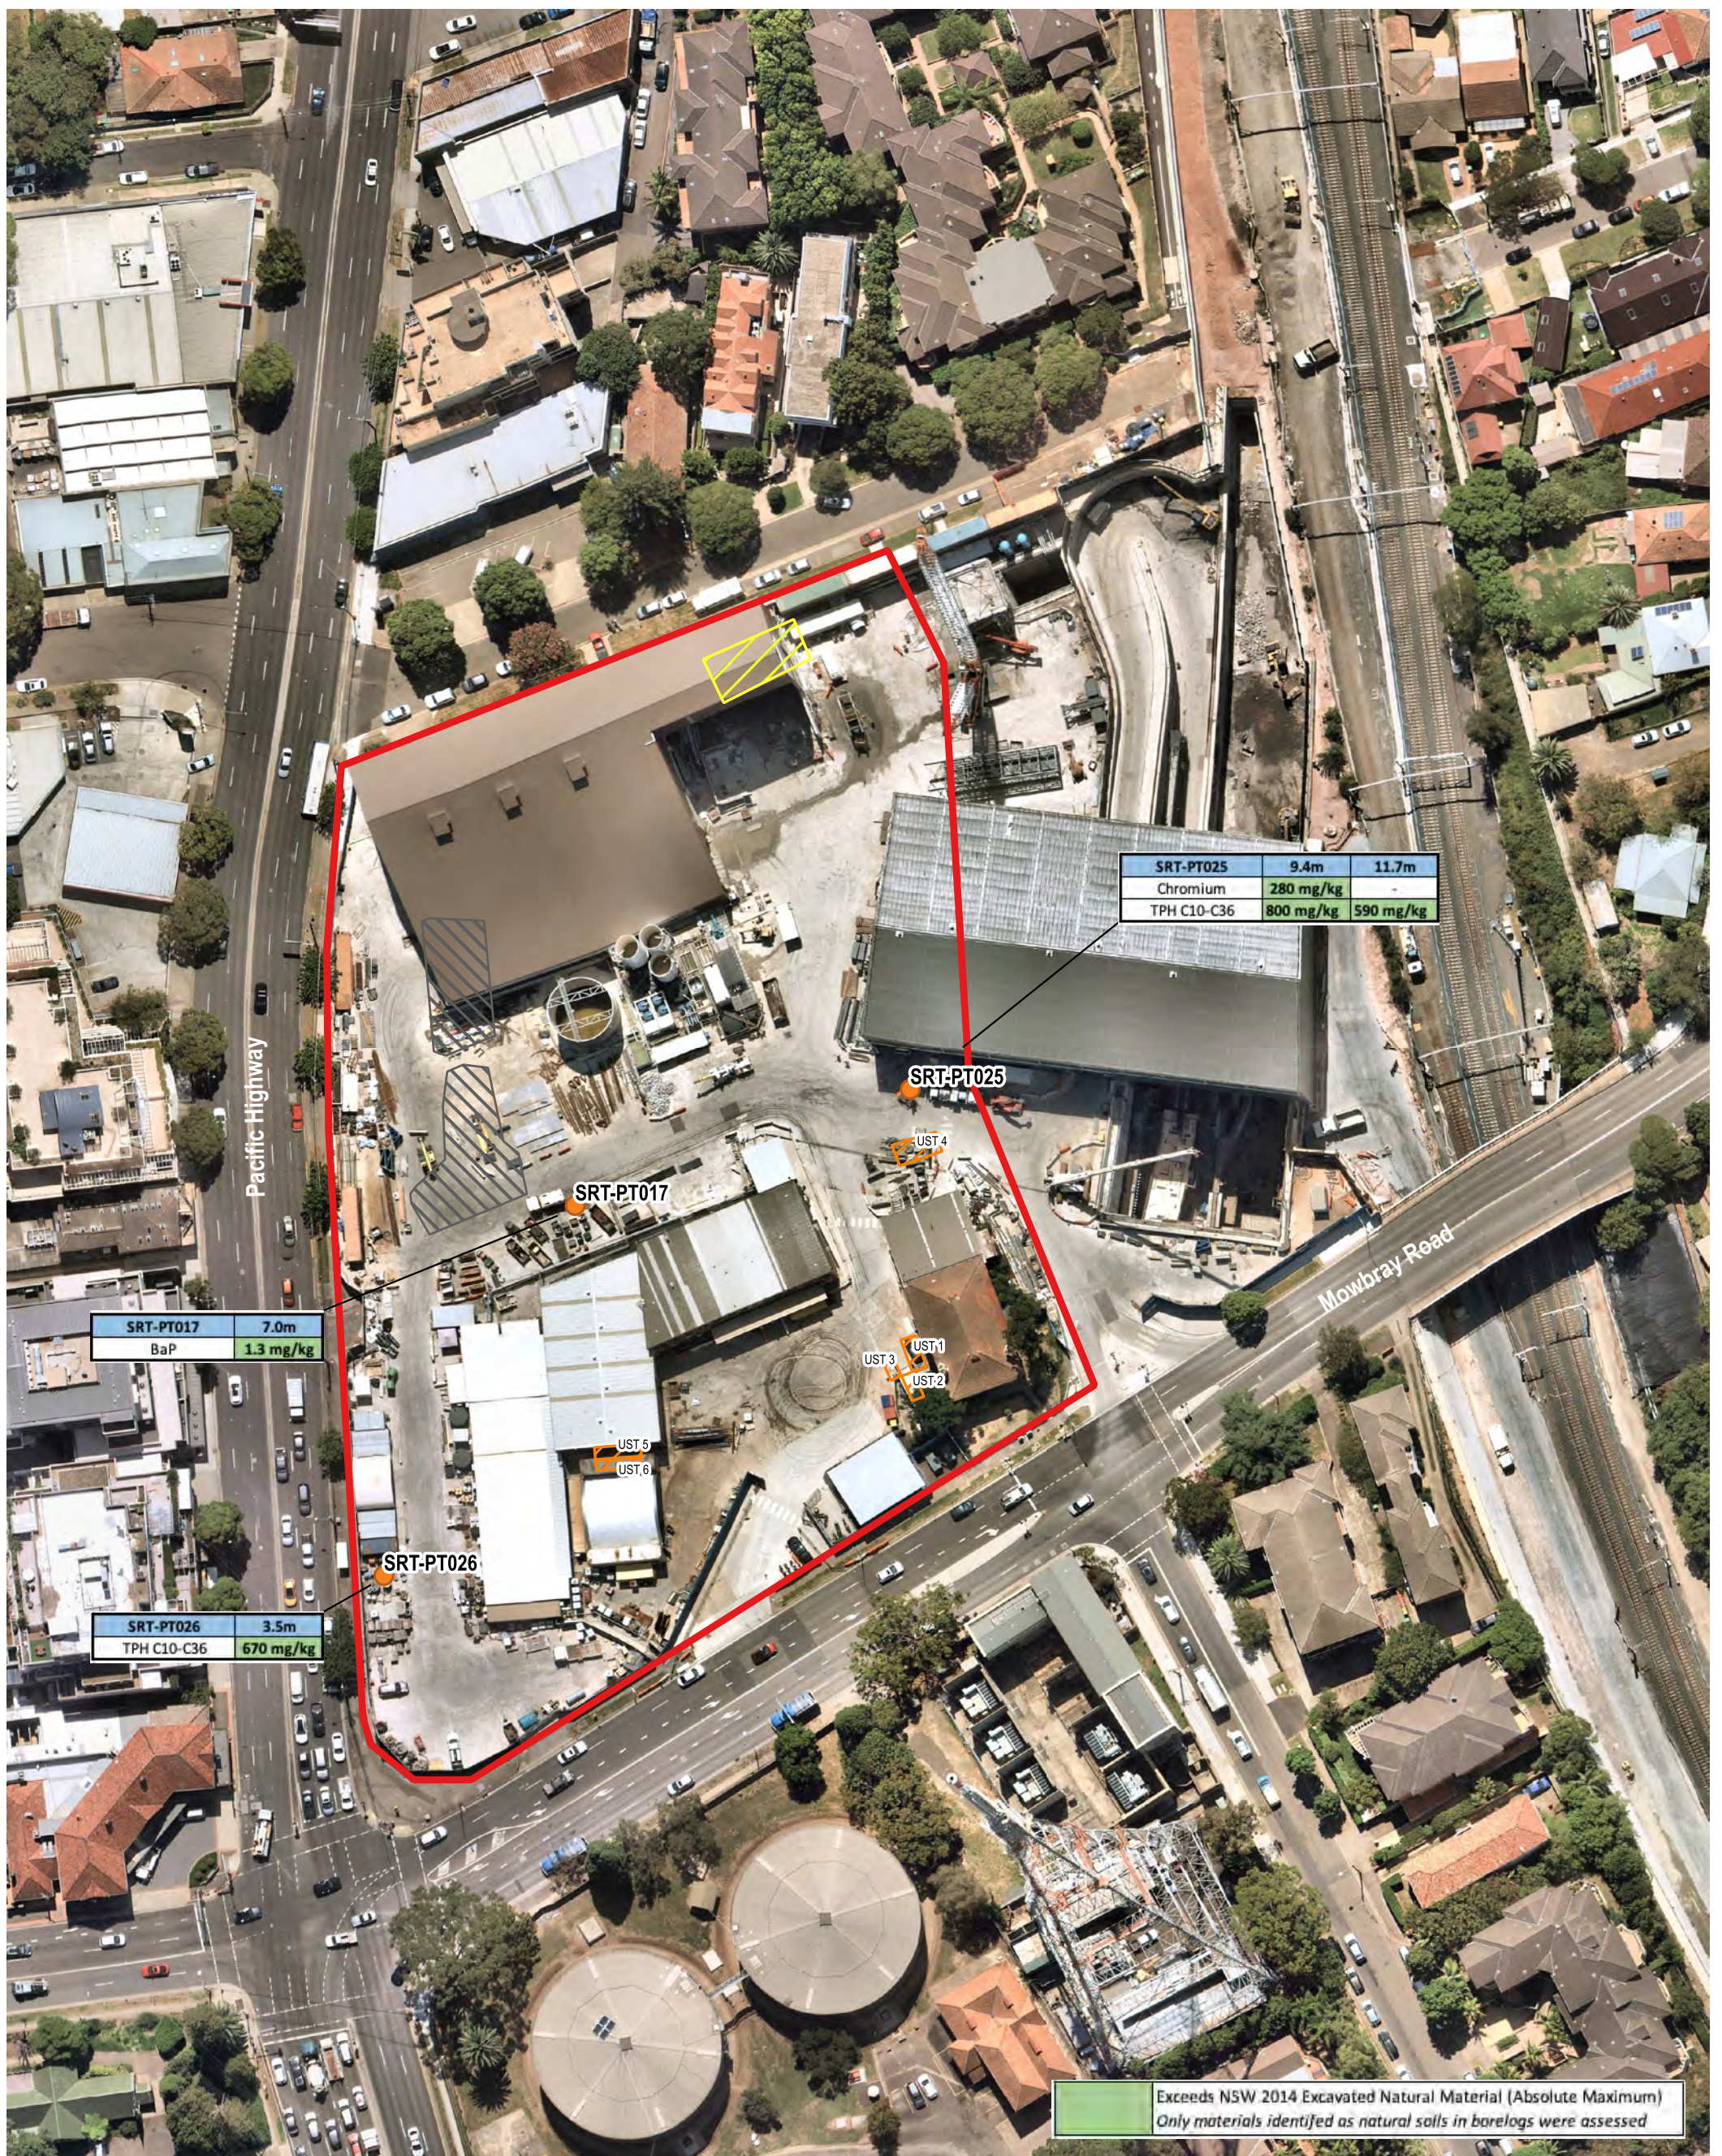
**Figure 6: ENM Classification**

- **Exceedances of the ENM Absolute Maximum:** Exceedances of TPH C<sub>10</sub>-C<sub>36</sub> and BaP above the allowable ENM Absolute Maximum was reported in five soil samples at depths of 3.4 mBGL, 7.0 mBGL, 9.4 mBGL and 11.7 mBGL across the site, shown on **Figure 6**. The average maximum of all contaminants are below the allowable maximum average. While the majority of natural soil across the site is preliminary classified as ENM, exceedances of the absolute maximum demonstrate that some natural soils at depth are classified as GSW.

| Source | Impacted Media | Pathways | Receptors | Assessment/Rationale | RAP Consideration |
|---|---|---|---|---|---|
| | | Dust and fibre inhalation | Site workers, contractors, visitors | Impacted fill and buried asbestos impacted material poses a potential risk to site workers, contractors and visitors if materials are exposed. Historic investigations indicate the presence of chrysotile asbestos ( <b>Figure 6</b> ) within the footprint of the former energy depot, though currently the site is covered by hardstand. This SPR linkage is considered to be <b>currently incomplete</b> . | The RAP is required to consider the known and potential presence of asbestos in soils. |

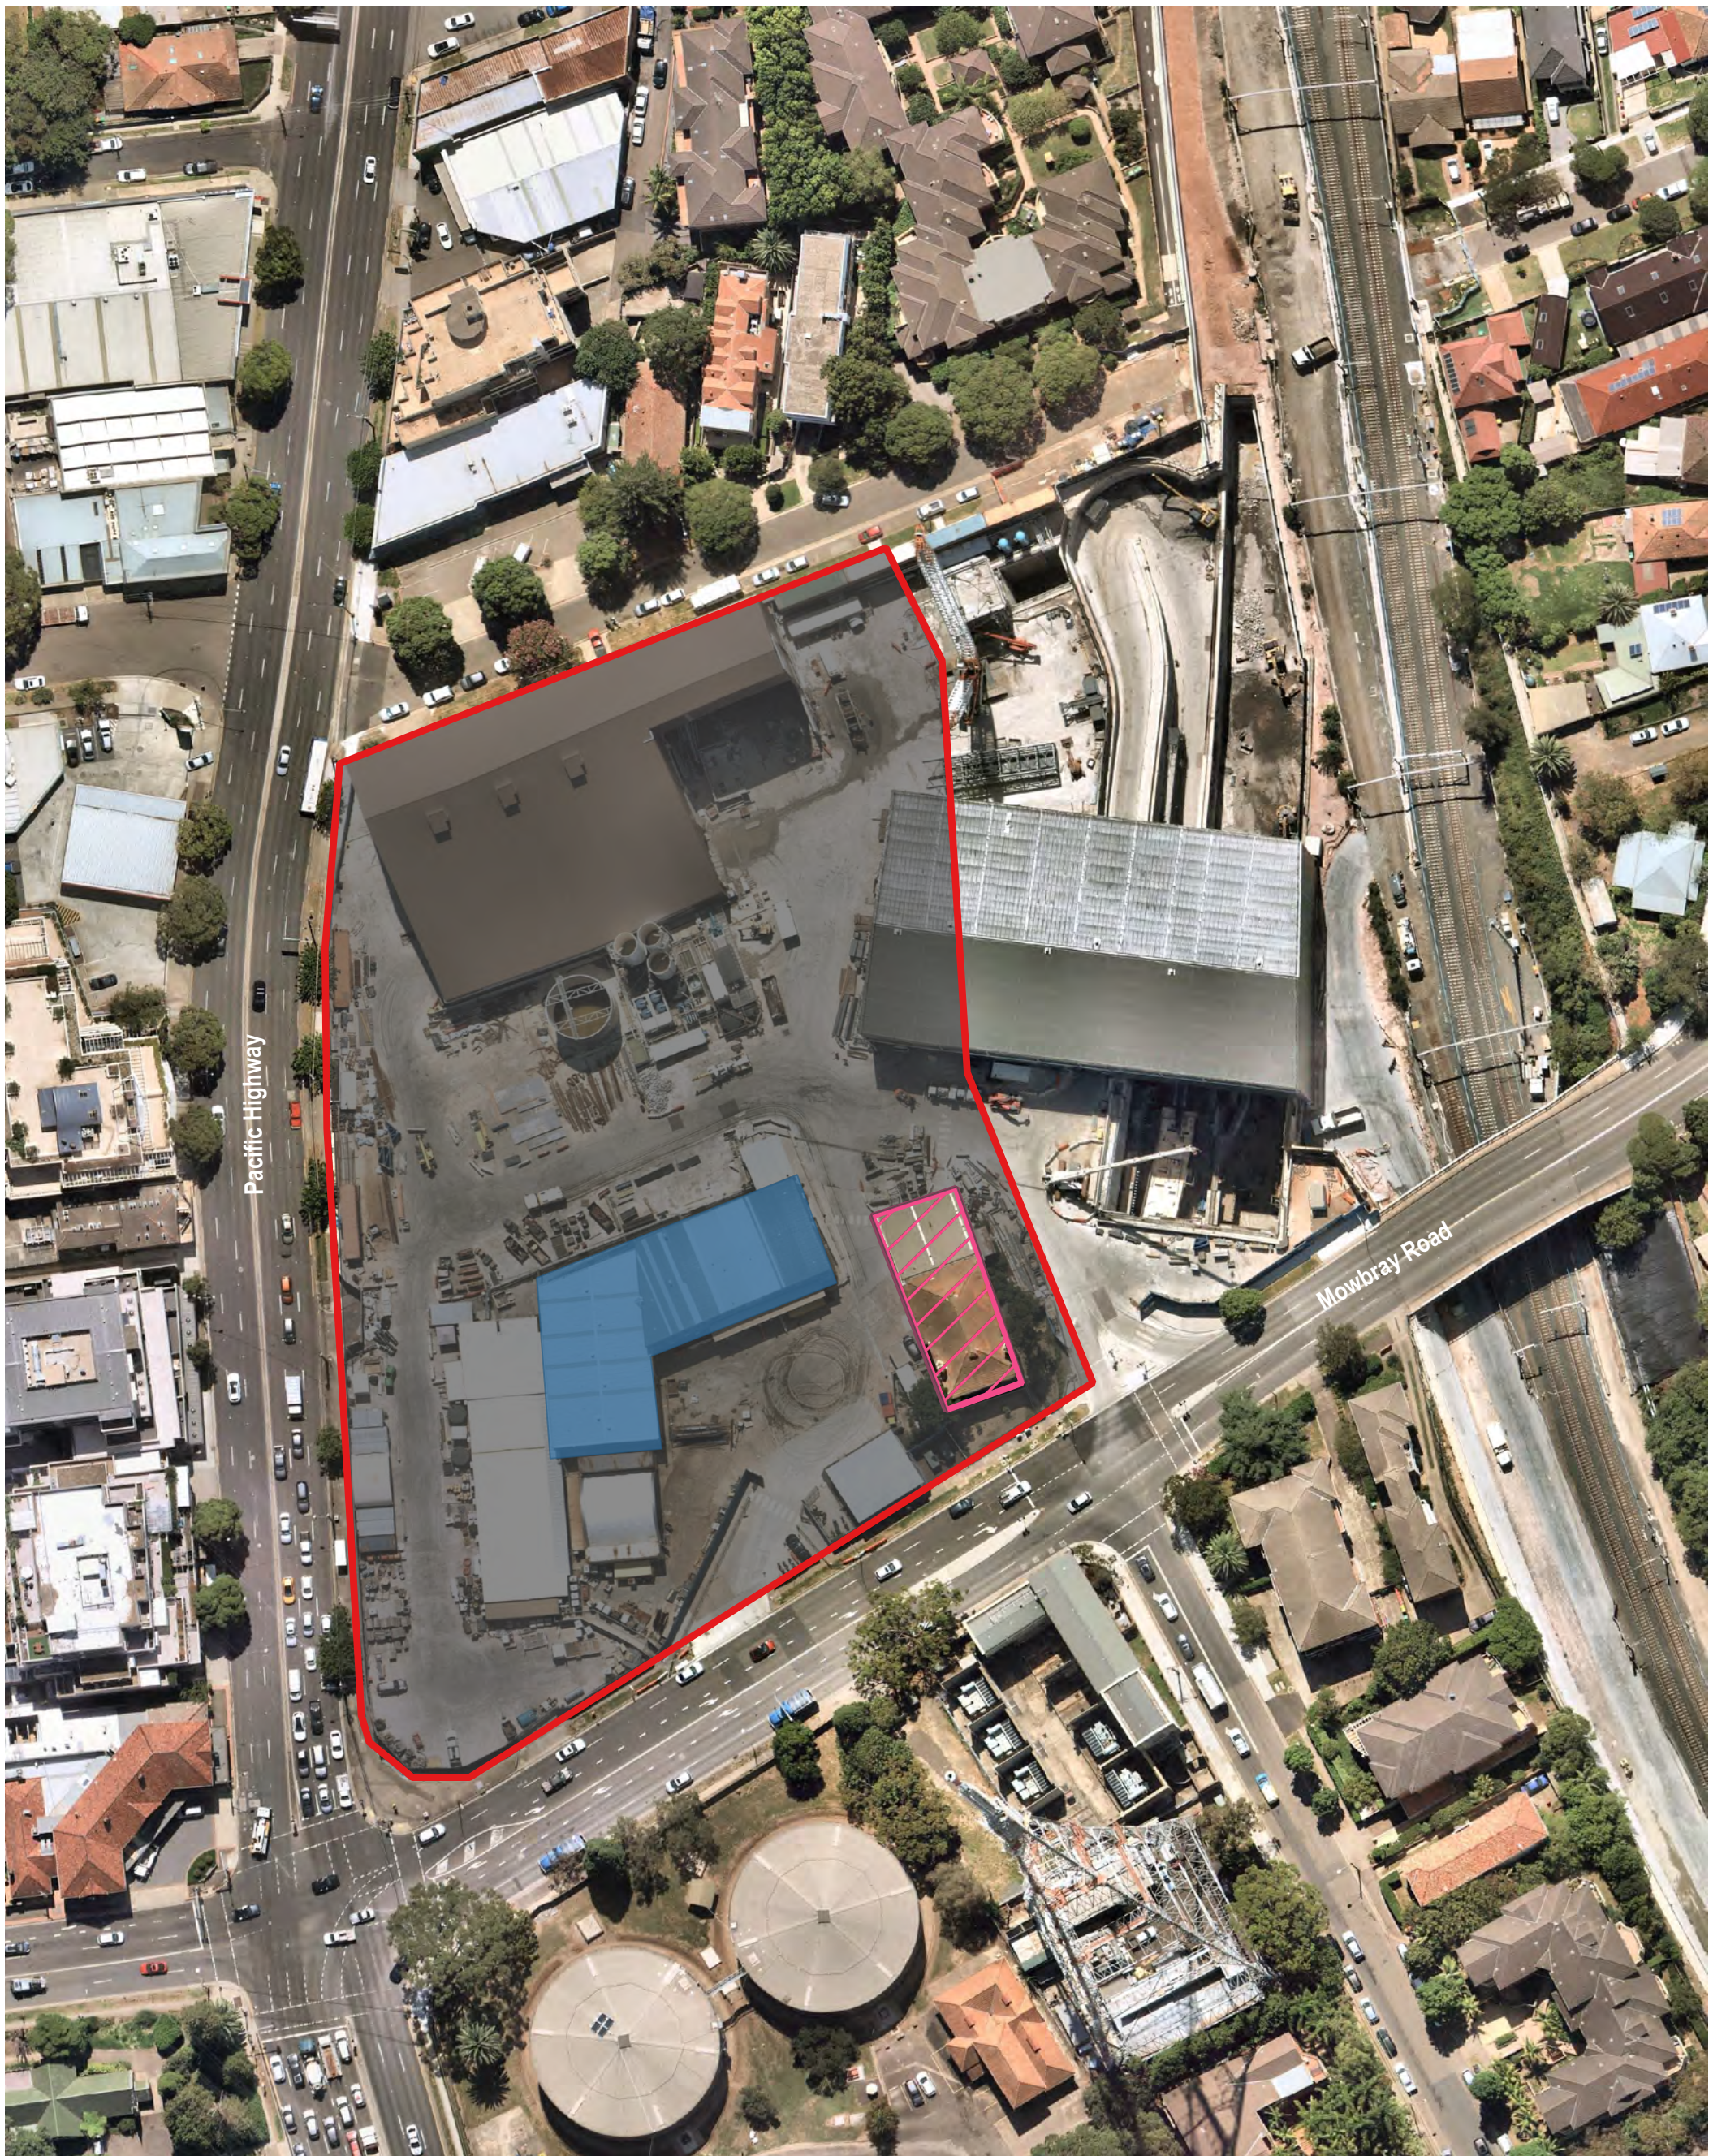
**Figure 7: Additional Sampling Areas**

To address data gaps 3, 4, and 5, following removal of site hardstand, an asbestos in soils investigation, sampling of the former energy depot building footprint, and refined preliminary waste classification sampling should be undertaken. Indicative investigation areas are shown on **Figure 7**. In particular, the following should be taken into consideration:

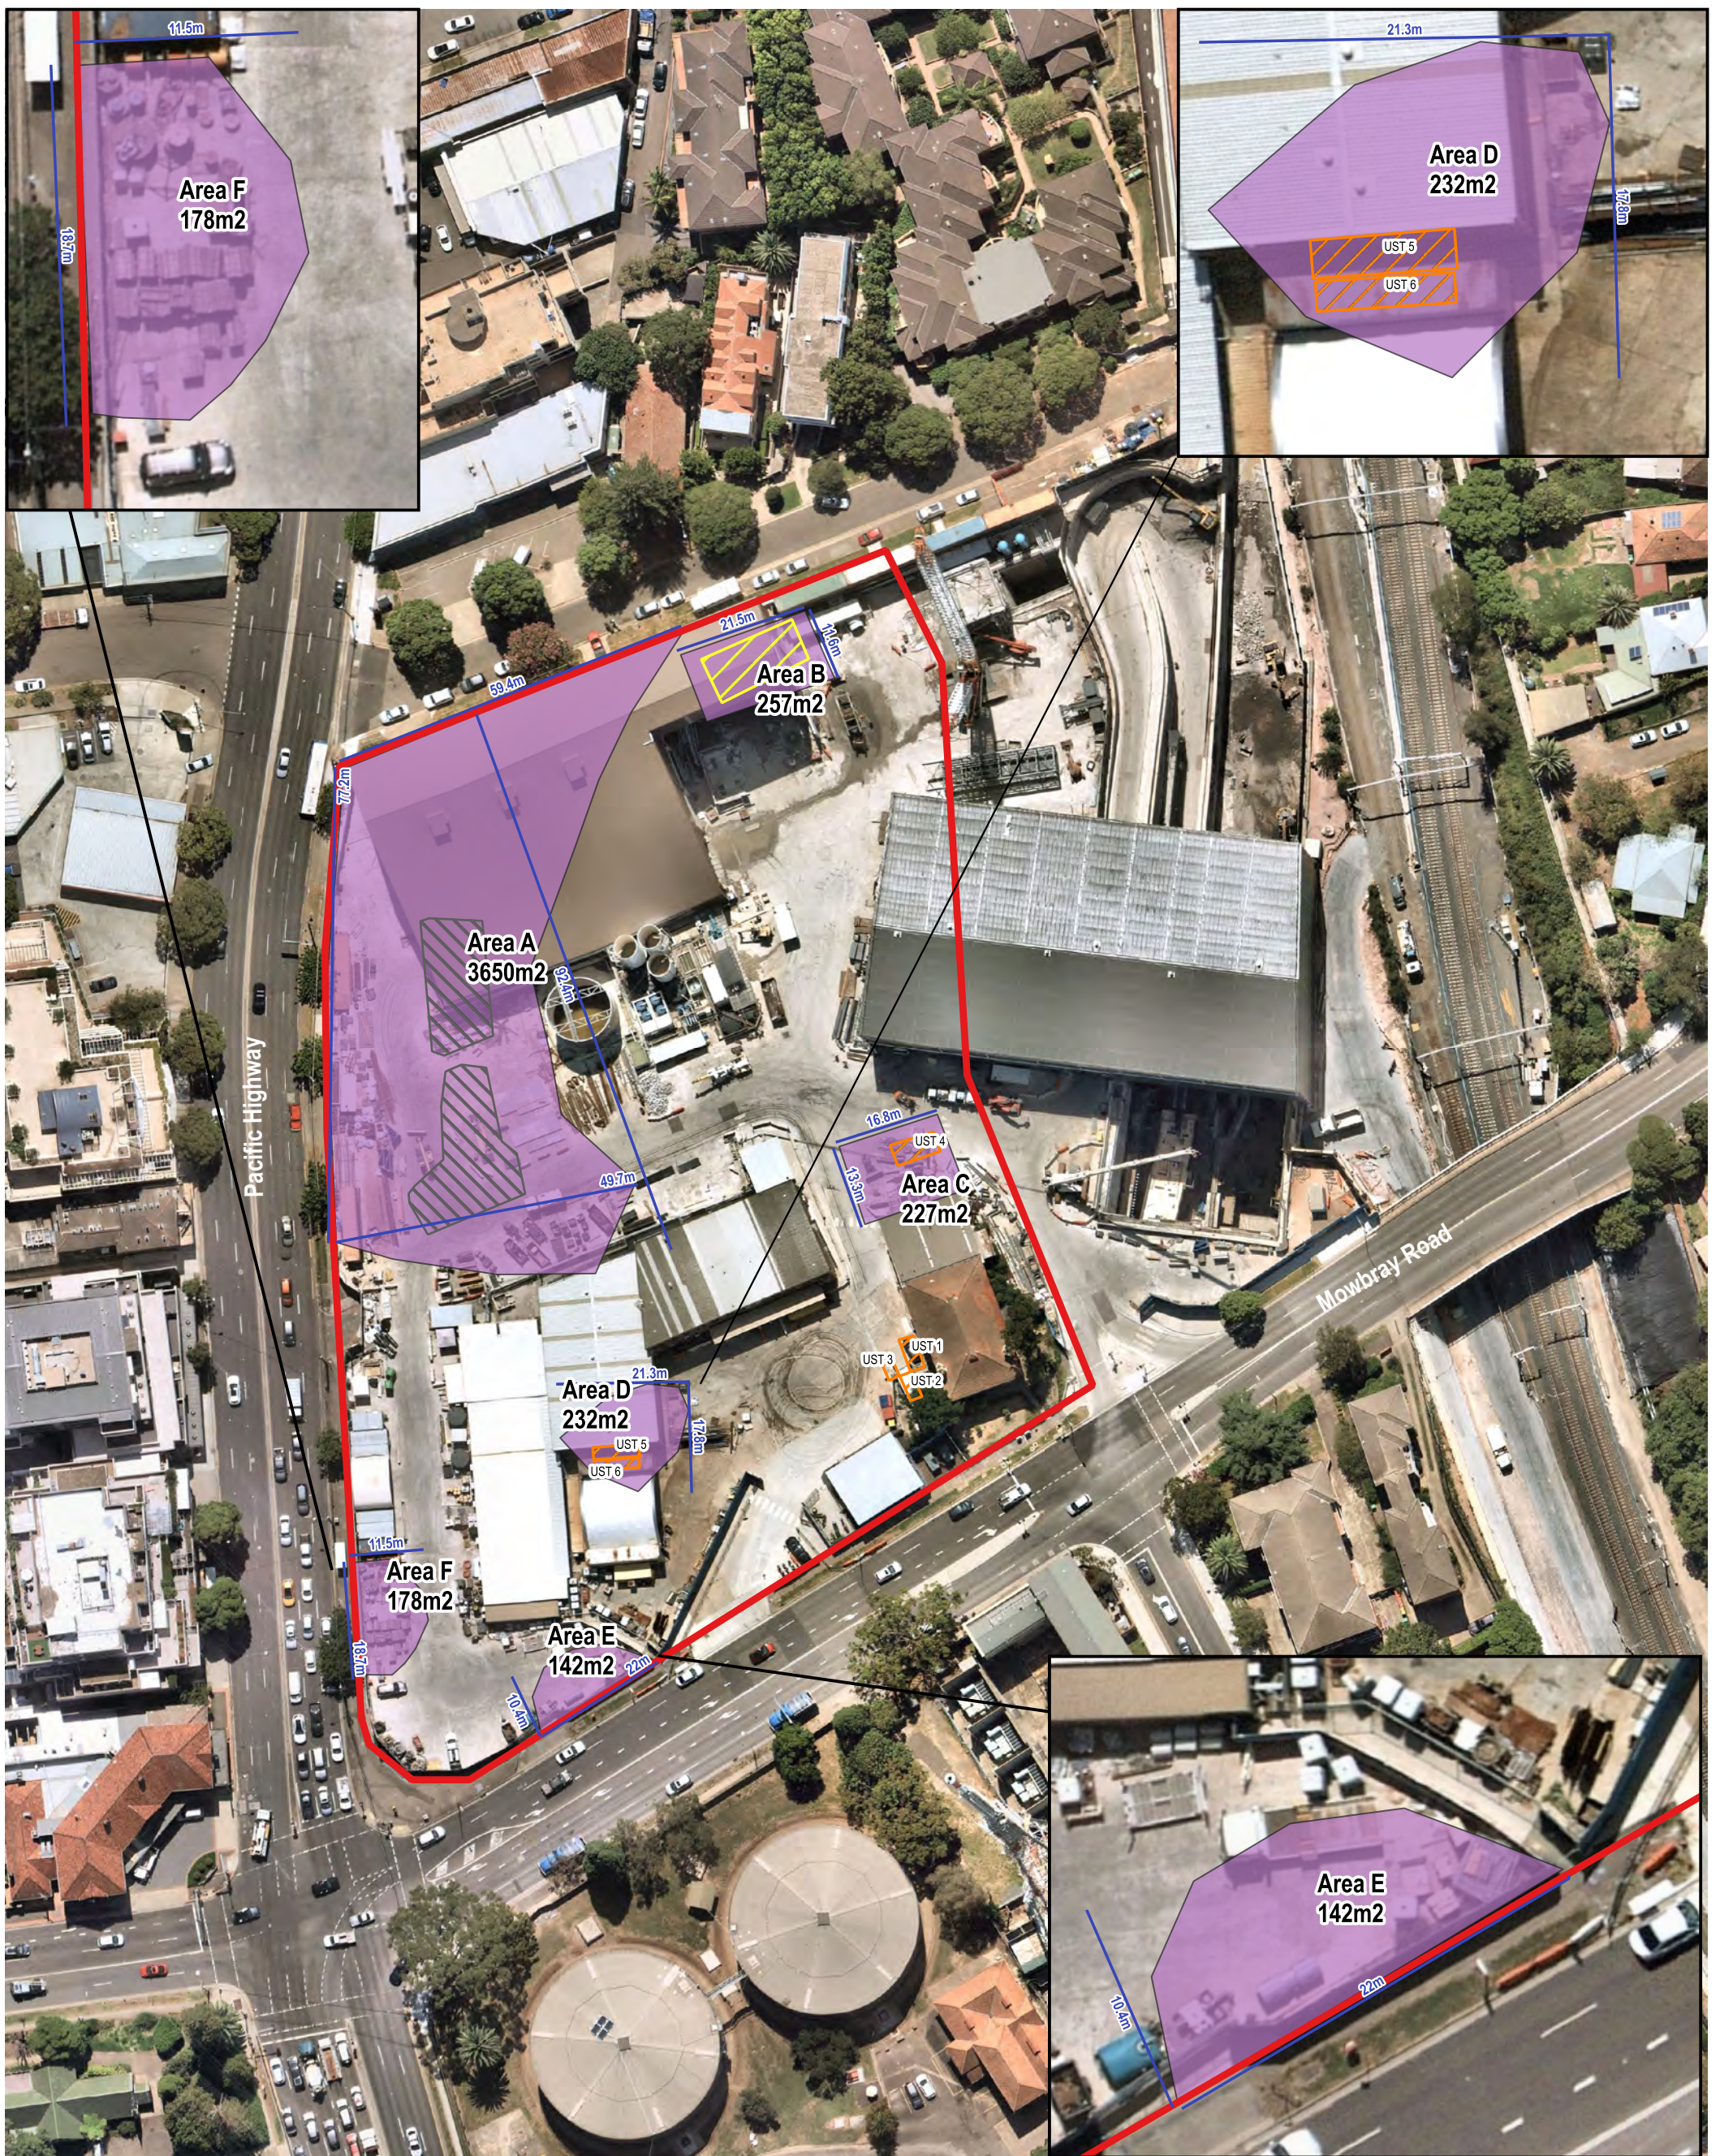
**Appendix C-3: Indicative Extent of Remediation**

| Scenario 3 - Unrestricted Redevelopment | | |
|--|---|---|
| Approximate max excavation depth | 4.5 | mbgl |
| Approximate excavation area | 8282.985 | m2 |
