# **SITE AUDIT REPORT**

## **SYDNEY METRO**

### **VICTORIA CROSS**

#### **NORTH ACCESS SHAFT,**

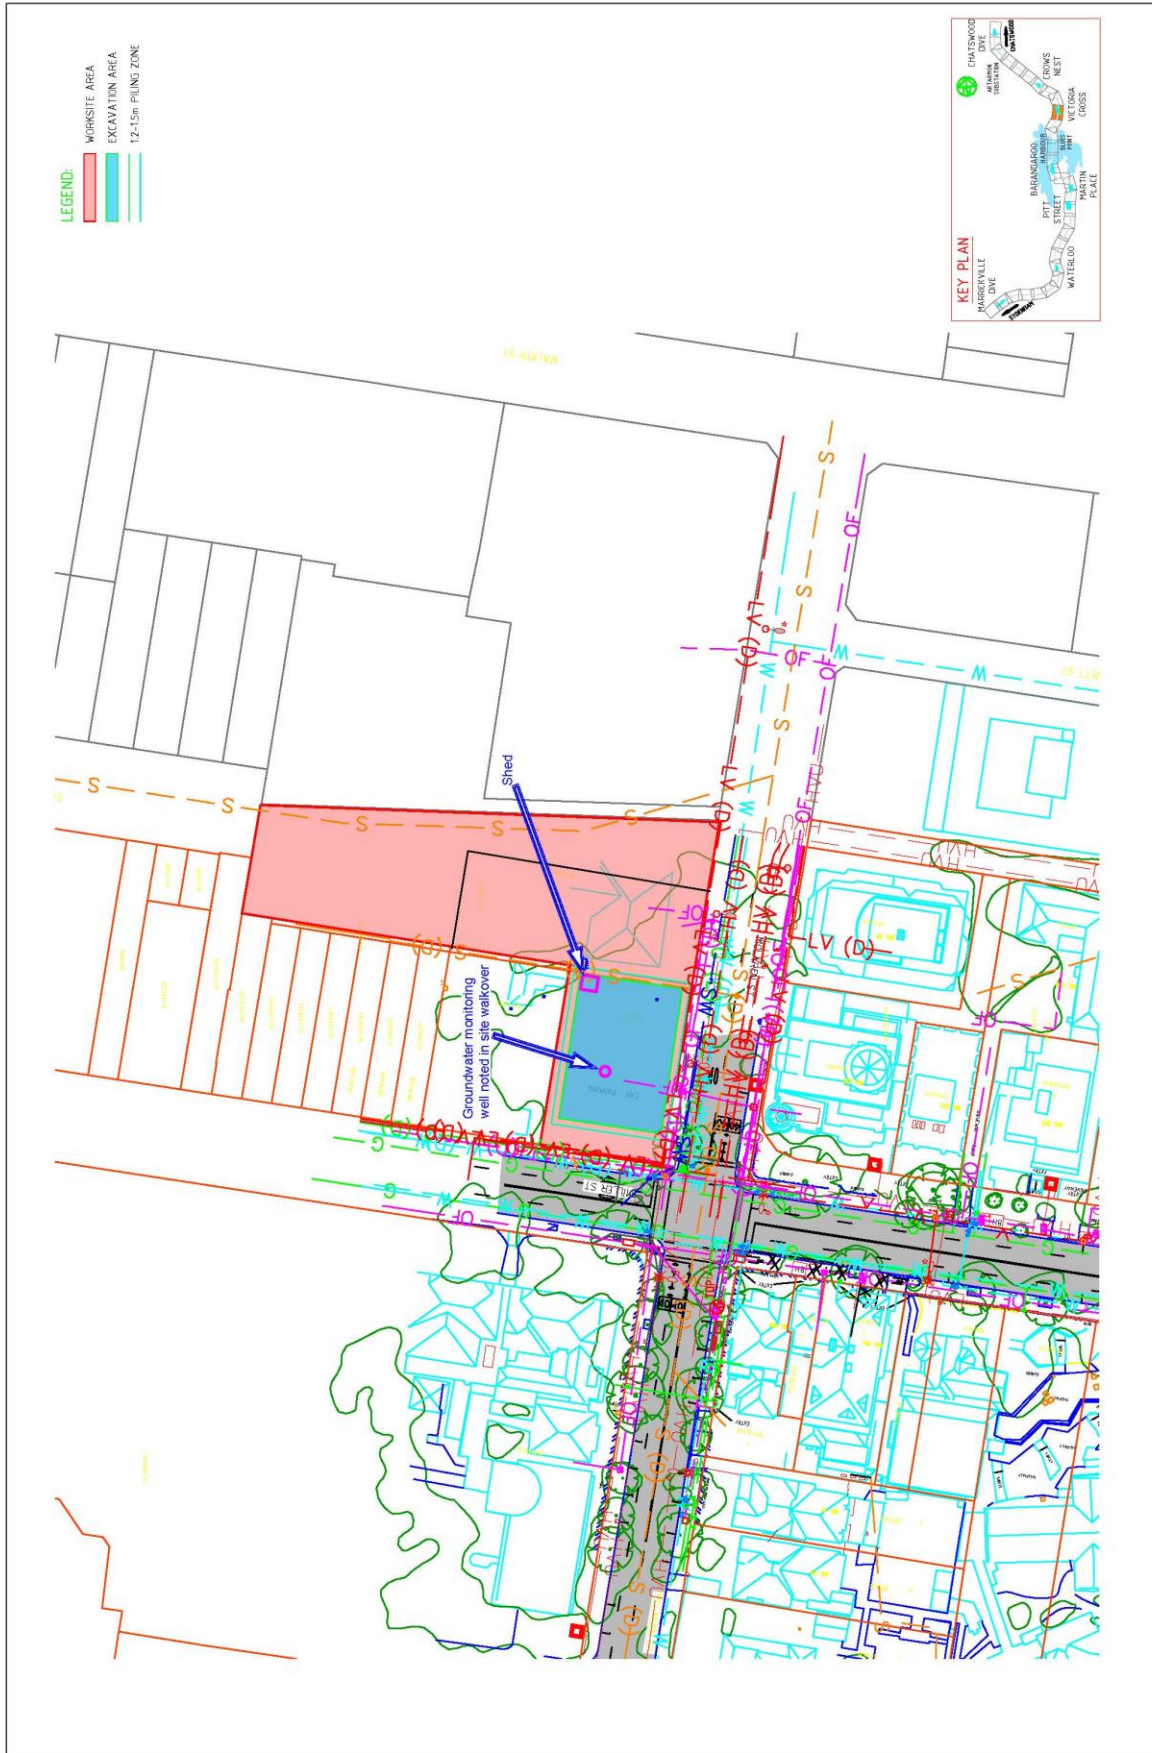
<b>Douglas Partners</b> Geotechnics   Environment   Groundwater	CLIENT: John Holland CPB Ghella JV OFFICE: Sydney SCALE: 1:1000 @ A3	TITLE: <b>Site Location &amp; Features, Sydney Metro City &amp; South West, Tunnel and Station Works Package, Proposed Victoria Cross North Access Site, McLaren Street, NORTH SYDNEY</b>	PROJECT No: 85608.05 DRAWING No: 1 REVISION: 0
	DRAWN BY: PSCH DATE: 26.10.2017

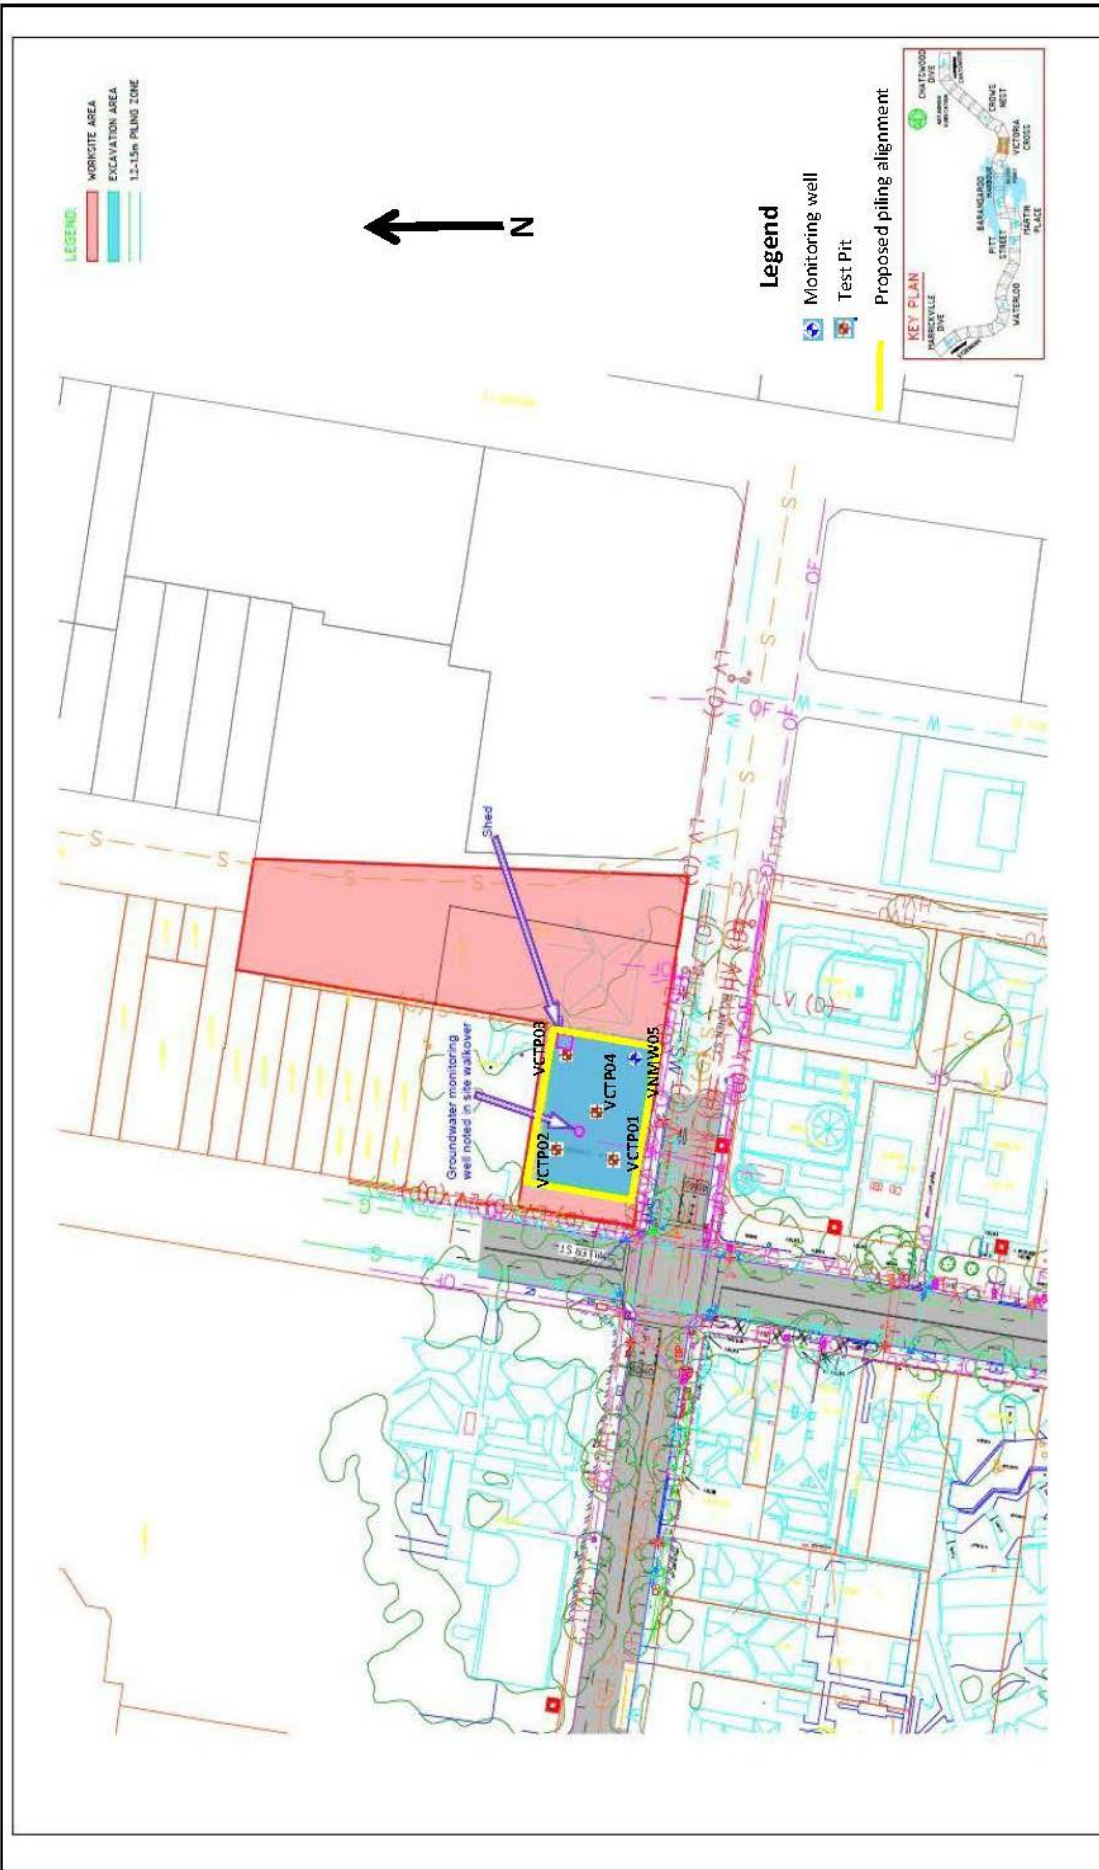
PROJECT No:	85608.05
DWG No:	2
REVISION:	1

**Proposed Piling Alignment and Test Locations**  
**Sydney Metro City & South West, Tunnel & Station Works**  
 Package  
 52 McLaren Street, North Sydney

As part of the DSI, one groundwater monitoring well was installed on the site (Attachment 2). Groundwater seepage was not noted during drilling. Groundwater observations and sampling was undertaken as part of the DSI on 24 January 2018. Depth to groundwater in the monitoring well was recorded at 8.24 mbgl. The DSI stated that groundwater is anticipated to flow to the southeast based on site topography, however an accurate flow direction was not able to be estimated based on one well.

<p><b>Sampling density</b></p> <p><i>Soil:</i> The DSI included a sampling density of 5 locations (Attachment 2) over approximately 0.05 ha, which meets the minimum recommended by EPA (1995) <i>Sampling Design Guidelines</i>. The coverage provides a 95% confidence of detecting a residual hot spot of approximately 12 m diameter.</p> <p>Samples analysed for asbestos were not collected in accordance with the density outlined in NEPM (2013).</p> <p><i>Groundwater:</i> One groundwater sample was obtained from the site.</p>	<p>In the Auditor's opinion the sampling density was adequate to give an indication of the presence/ absence of asbestos, and for general site characterisation. Further ex situ sampling may be required for waste classification purposes.</p>
<p><b>Sample depths</b></p> <p><i>Soil:</i> Samples were collected and analysed from a range of depths targeting the fill and natural clay.</p> <p>Sandstone bedrock was not sampled. Layers of ash and charcoal observed in fill material were not targeted by sampling and analysis.</p> <p>Crushed sandstone was imported subsequent to the DSI and therefore was not sampled. Sampling will be reported in the validation report.</p> <p><i>Groundwater:</i> Groundwater samples were obtained from 9 mbgl, approximately midway between the standing water level (SWL) (8.24 mbgl) and the base of the well (10 mbgl).</p>	<p>In the Auditor's opinion, this sampling strategy was adequate to characterise the primary material types present on site. Further targeted sampling of layers within fill material would be required for appropriate waste classification.</p>
