Archaeological Investigation
Temporary Works Site
Henry Lawson Reserve, Blues Point
May 2022

Sandstone foundations of mid-19th century cottages at Blues Point, Sydney (C&L 2018).

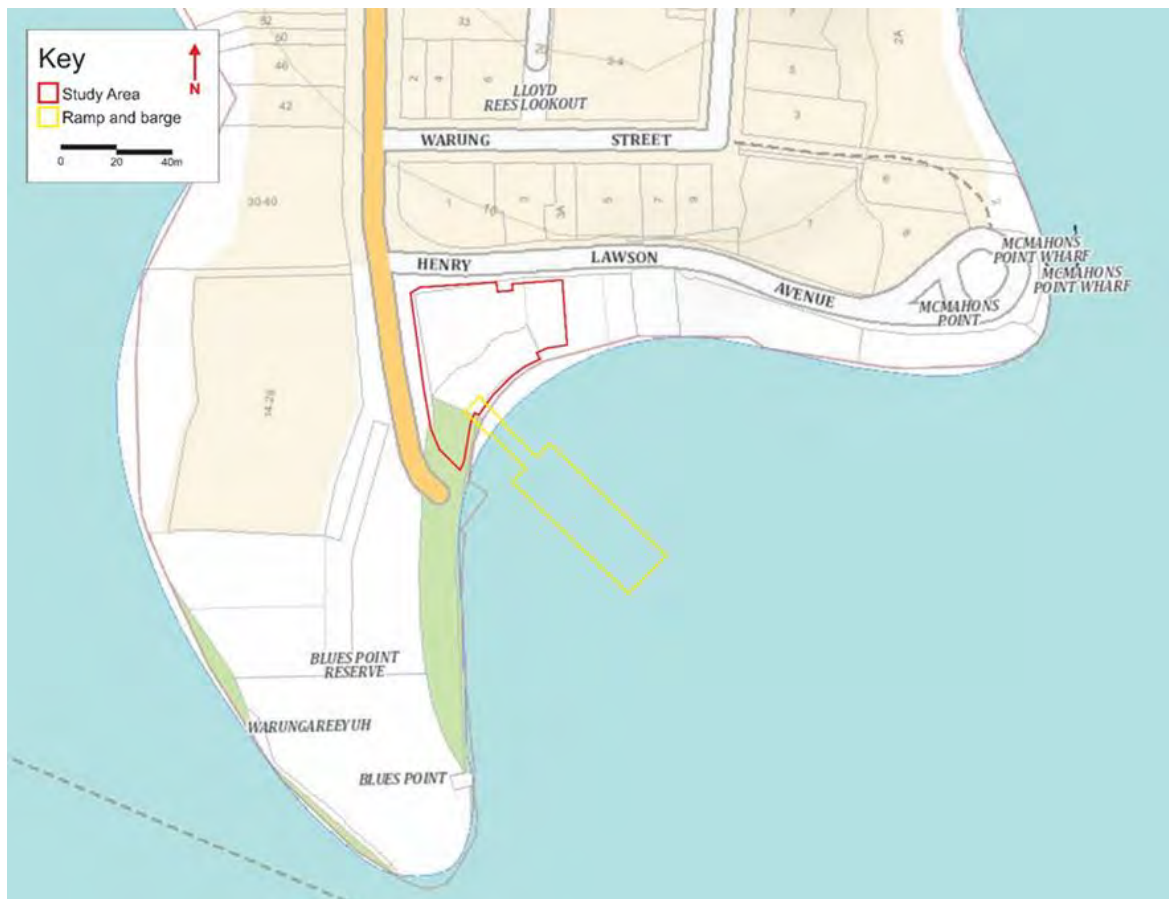
Figure 1.2: Location plan showing the Blues Point subject site outlined in red and barge and ramp in yellow. Six Maps 2017.

The Blues Point temporary works site is located at the southern end of Blues Point Road within the Blues Point Reserve and incorporates Henry Lawson Reserve. It is bounded by Henry Lawson Avenue to the north Blues Point Road to the west and Blues Bay to the south covering an area of 2100 square metres (Figure 1.2, Figure 1.3). The site was used to retrieve the Tunnel Boring Machine (TBM) cutter head and shields and involved the excavation of a shaft to the tunnels below, resulting in the removal of approximately 8,000 cubic metres of spoil.

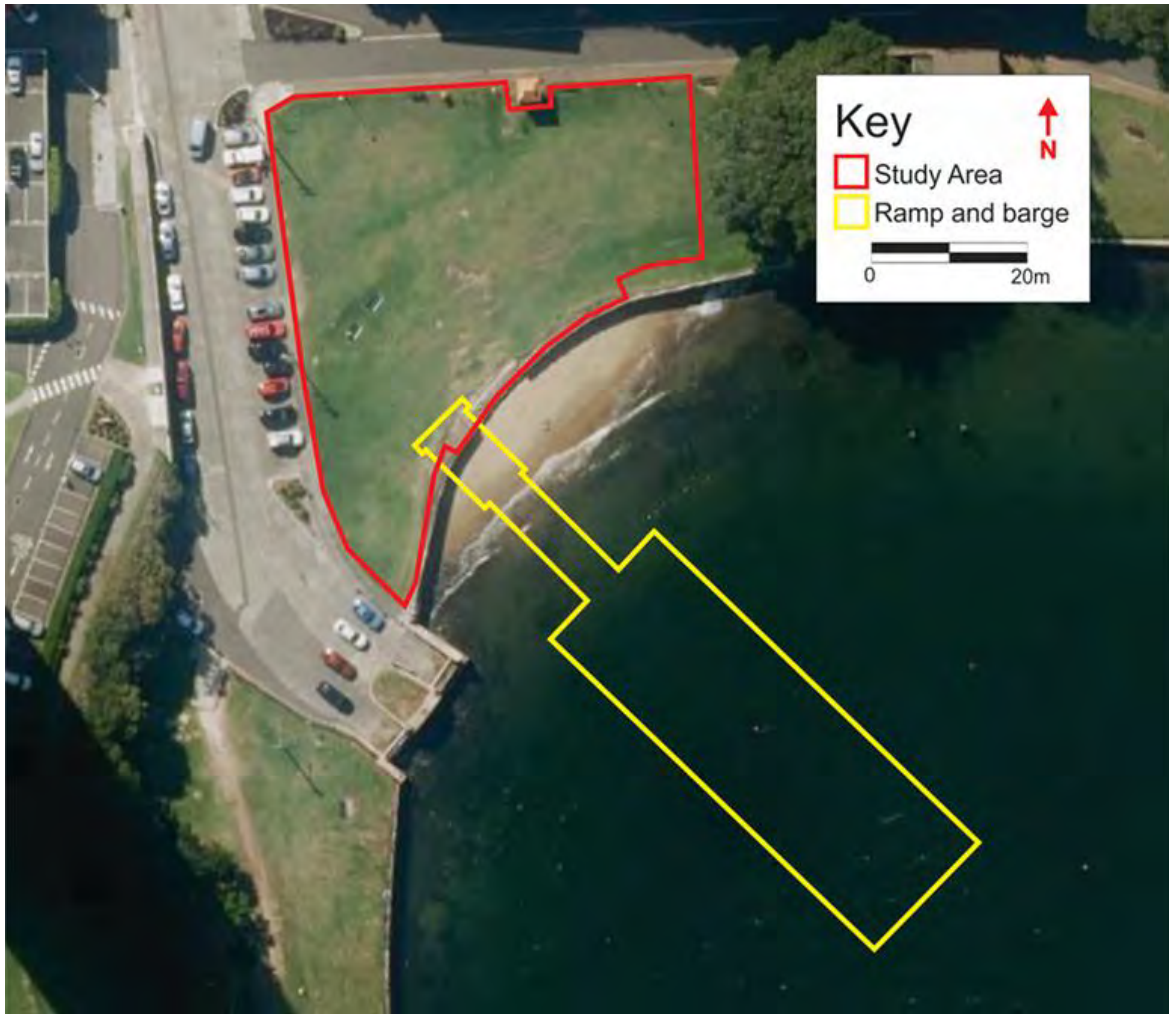
Figure 1.3: Location plan showing the study area outlined in red. The yellow outline is the proposed ramp with the location of the barge. SIX Maps, 2018.

The following history for the study area has been summarised from the comprehensive history of the site in Section 3 of the *Archaeological Method Statement* (Casey & Lowe 2018). Artefact Heritage (2016a) had previously written a historic background for the study area but it did not include any land title research to understand the early development of the site.²³ Additional research on the specific lots within the study area was undertaken by Caroline Plim, historian, with additions by Sandra Kuiters for the development of the AMS. The historic plans in this report have been updated to reflect the final amended study area as shown in Figure 1.3 with annotations by Casey & Lowe.

Prior to the archaeological works there were no extant structures within the study area (Figure 1.3) as the site was a grassed reserve that used as a public park/reserve since the 1960s. The site sloped steeply from the northwest corner at the junction of Blues Point Road and Henry Lawson Avenue towards the south to the harbour (Figure 4.2). The extant heritage seawall and foreshore steps formed the southern boundary and was not be impacted by the current site works. A number of live services ran along the northern boundary of the site over late 19th-century brick footings and cesspits associated with the houses within the study area. Below the grass turf and garden soil was a thick layer of imported fill material used to create the park/reserve in the 1960s. These late 20th-century fills were mechanically removed where necessary. Several historical construction phases were identified, buried beneath these imported fills. There were no remains of 20th-century structures, therefore minimal modern impacts.

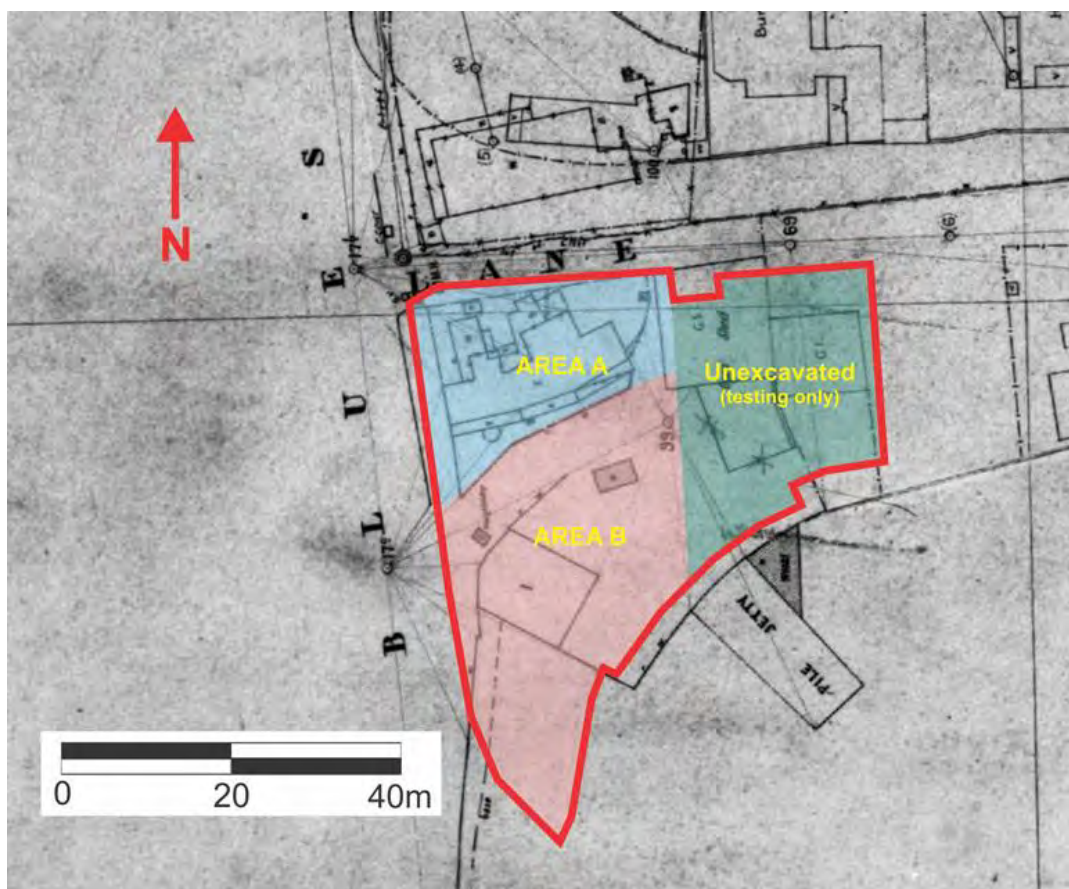
Figure 1.5: The location of the study area outlined in red overlaid onto the North Sydney sewer survey dated 1891. For the archaeological excavation the site was divided into two areas (Area A and Area B). PWDS 1544-S901 Sydney Water with Casey & Lowe annotations.

The archaeological excavation at Blues Point Reserve began on the 17 August 2018 with the final monitoring works completed on 27th November 2018. The Aboriginal archaeological excavation began after the historical excavation was completed, with some limited overlap. It was undertaken by AMBS Ecology and Heritage and began at the level of the natural sandy deposits which pre-dated the historical archaeology. The site was divided into two areas of archaeological excavation, Area A and Area B (Figure 1.5, Figure 3.1).

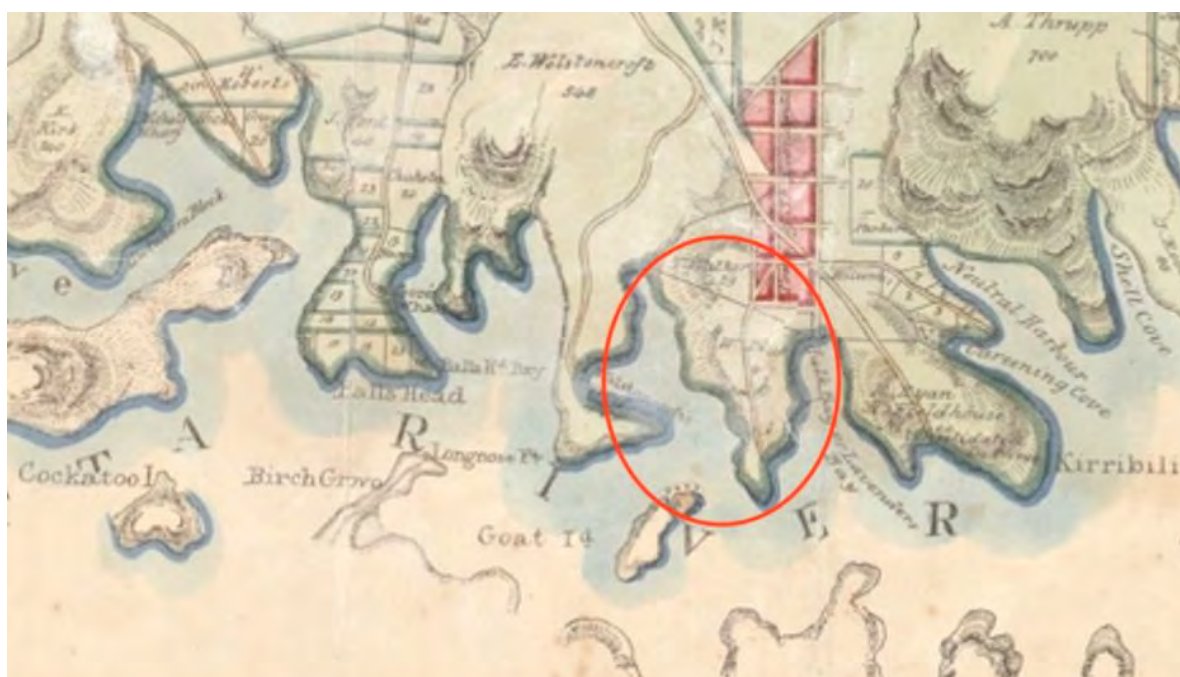
Figure 2.2: An 1831 plan in the Surveyor’s Sketch Book illustrating the location and extent of Blues 1817 grant on the northern side of Sydney Harbour opposite Dawes Point. Bk 1 Fol 22, 31 Mar 1831, State Archives.

On 24 January 1817 Governor Lachlan Macquarie granted 80 acres (32.4 ha) to William 'Billy' Blue (c.1767-1834), a convict, settler and ferryman (Figure 2.1, Figure 2.2). Named Northampton, the grant was conditional on cultivation of 18 acres (7.3 ha) with five years restriction on its sale. The location was known as Billy Blue's Point by at least 1823 and also sometimes referred to as 'Blue's Bay' and includes the study area.

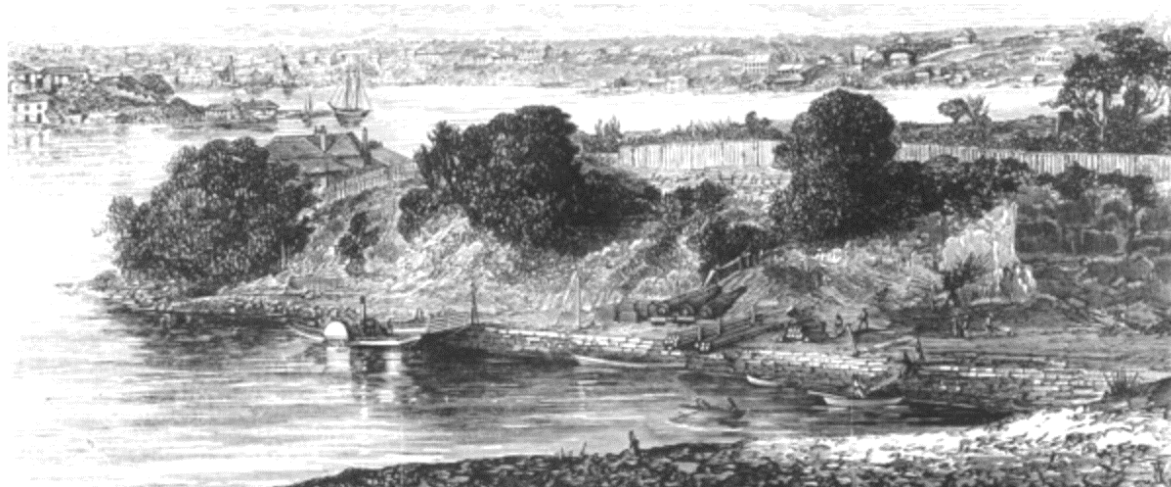
Figure 2.4: Etching of Blues Point, tentatively dated to c.1840s showing a seawall and jetty in to which a small paddle steamer is moored. 'Etching of Blues Point and view west towards Parramatta River', c.1840s, Face of North Sydney, LH REF PF393. Available at <https://stanton.imagegallery.me/site/welcome.me> (accessed 14/02/2021).

A public wharf was dedicated at Blues Point in 1839 offering a reliable link to the city. Brothers Joseph and Thomas Gerrard promptly established a steamer ferry service between the Government Jetty at Macquarie Place and ‘Billy Blue’s Point’.⁴³ Licenced waterman Charles Brown offered a similar ferry service from at least 1840.⁴⁴ An etching of Blues Point dated to c.1840s shows a stone seawall and jetty, accompanied by a number of small boats had been built in the bay by that time (Figure 2.4).

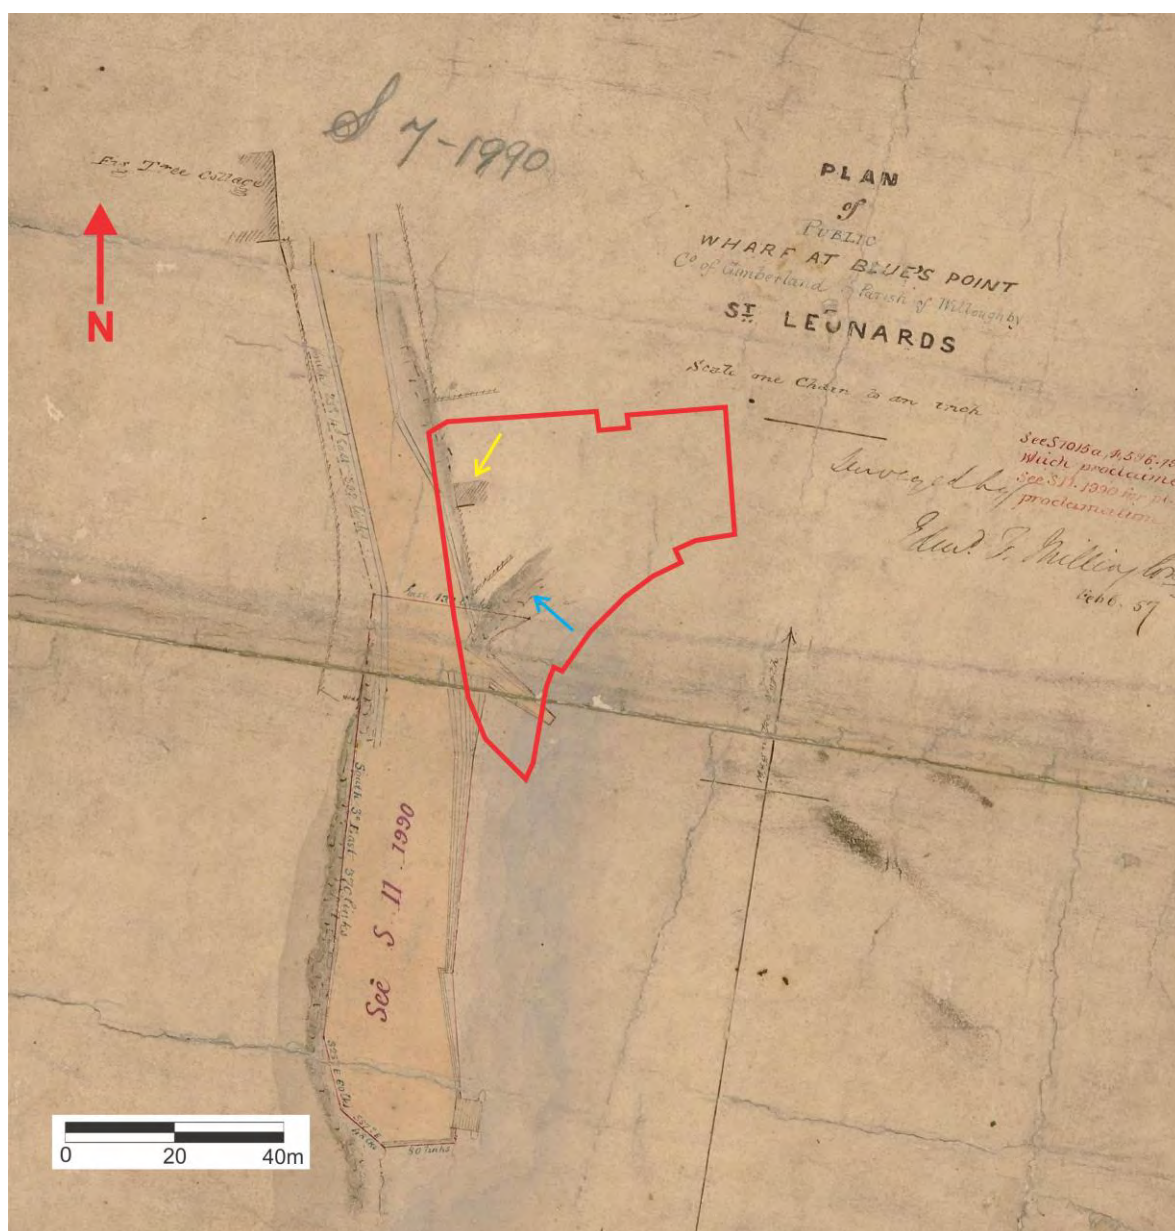
Figure 2.5: An 1857 Crown Plan illustrating the extent of development at Blues Point in the vicinity of the study area at this time. A building (yellow arrow) and a jetty or slip (blue arrow) is recorded in the study area. Crown Plan 7-1990 LPI.

Much of the land on the north shore peninsula remained in the Blue family until the 1850s, after which it was progressively subdivided and sold. An 1857 Crown Plan which includes the northeast corner of DP 902933 Lot 1 (later part of Lot 10 Section E) indicates that a building was constructed on the east side of Blues Point Road (Figure 2.5). The date this building was constructed is unclear but it is possible that it predates the 1857 plan by some time. Lot 10 Section E, including parts of the study area, remained in the ownership of the Blue family and was either occupied by the family or leased. The plan shows a 'public' wharf or pier jutting into the harbour and the waterfrontage along the point shows evidence of a terraced embankment to aid the docking of vessels (Figure 2.5). The Fig Tree Cottage Inn, an early Blues Point hotel and landmark, was named in subdivision advertisements. The public house was a short distance north of the wharf and the study area, and at this time was operated by Thomas Redgrave, although it was later linked to the family of John Stevens, the later owner of part of the study area.⁴⁵

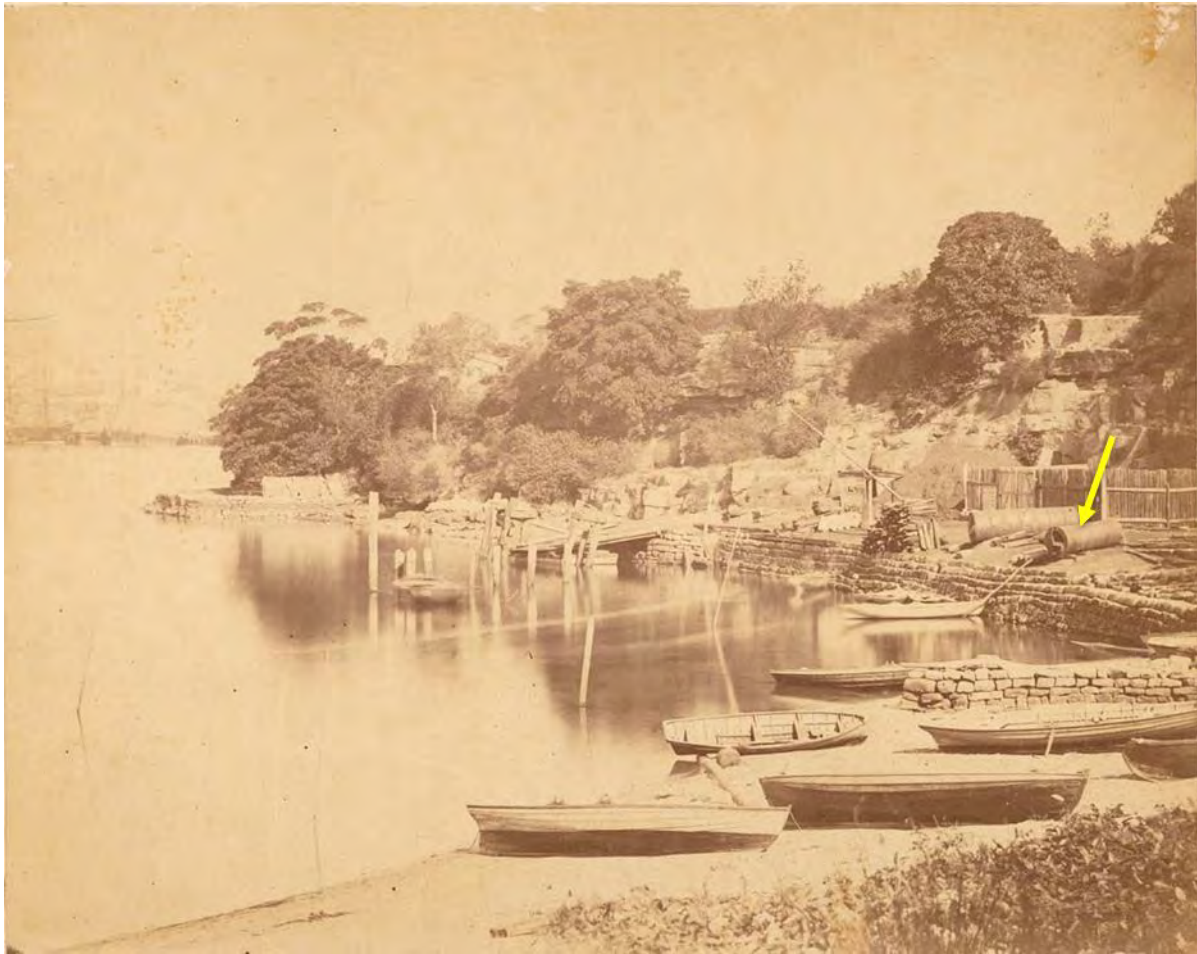
Figure 2.6: An undated (c.1858-59) photograph of Blues Point by Robert Hunt providing evidence of the sandy shoreline of the study area on the right-hand side of the image. Note the large drainage pipes (yellow arrow) ready for installation. SPF/799 ML SLNSW.

Accomplished amateur photographer Robert Hunt's c.1858-59 photograph of Blues Point provides evidence of the modifications to the shore and its use by this time. Hunt, the chief clerk at the Mint, explored the harbour in his skiff 'Terror' creating rare photographic records of the harbour landscape (Figure 2.6).⁴⁶ The photograph shows the stone seawall and jetty evident in the c.1840s etching, as well as additional structures on the waterfront, as well as the location of dinghies on the sandy beach.

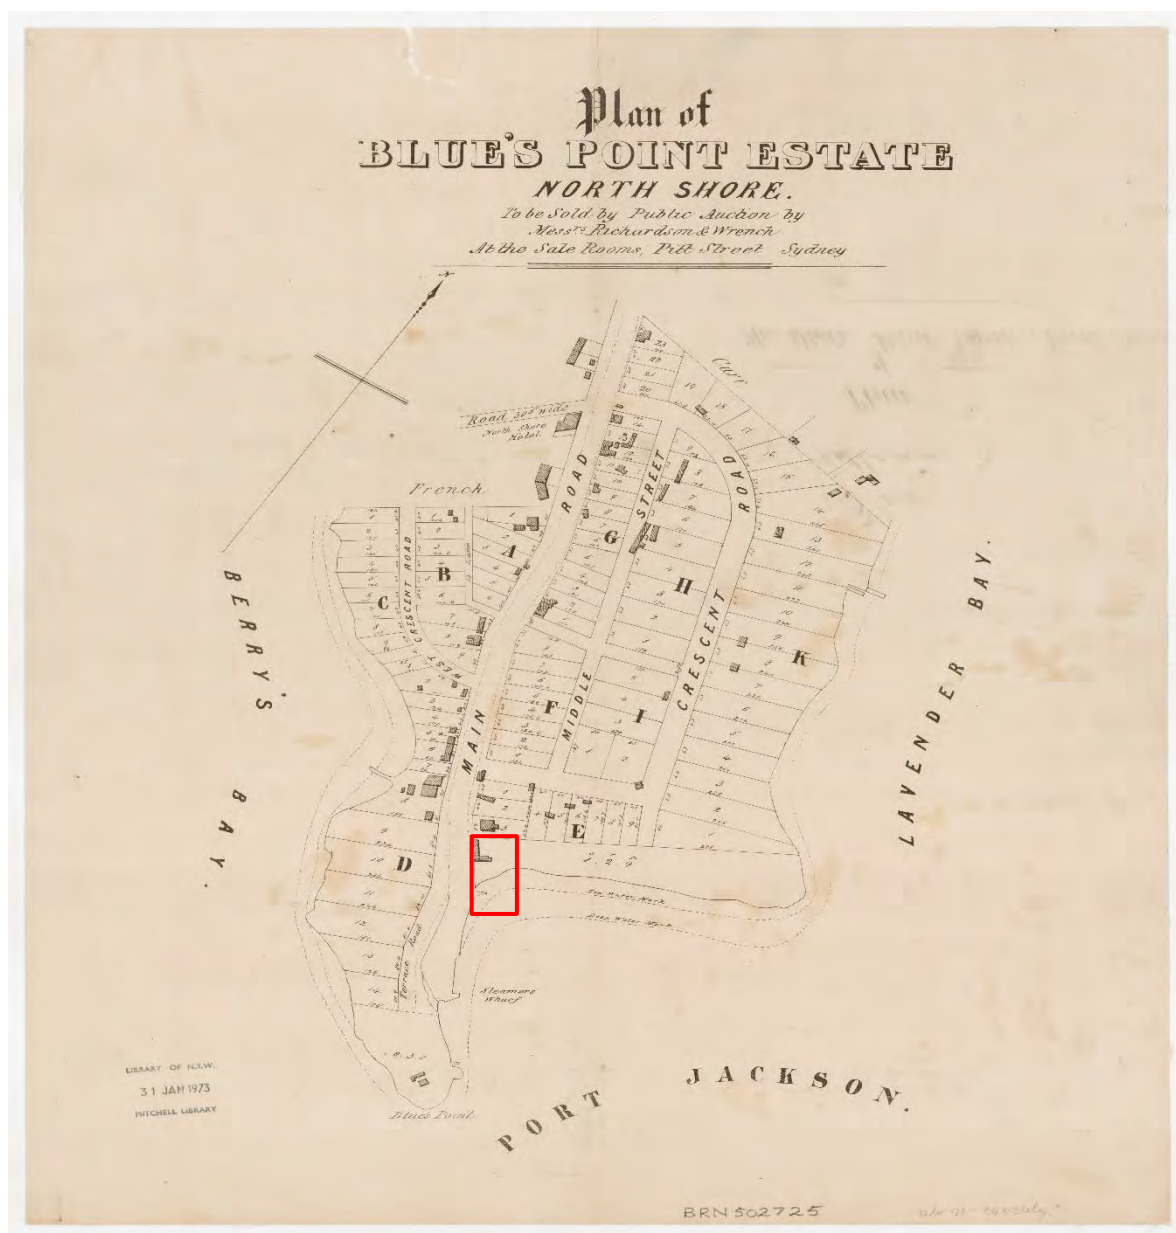
Figure 2.8: Subdivision plan of Blue's Point Estate. Shows the original buildings within the study area at the time of subdivision. House 1 was already within the study area indicating it was built by the Blue family. Plan of Blue's Point Estate North Shore: to be sold by public auction by Messrs. Richardson & Wrench at the sale rooms, Pitt Street, Sydney. Maps/0294 ML SLNSW.

continued to own the study area and surrounding land until they sold it at subdivision in 1863 (Figure 2.8).

In December 1863, 26 acres 2 roods 26 perches (10.8 ha) of what remained of Blue's grant was converted to Torrens Title in preparation for subdivision and sale (Figure 2.8). In the ownership of William Blue junior Esquire of St Leonards, representatives Richardson & Wrench sold parts of the estate from 1863.⁴⁸

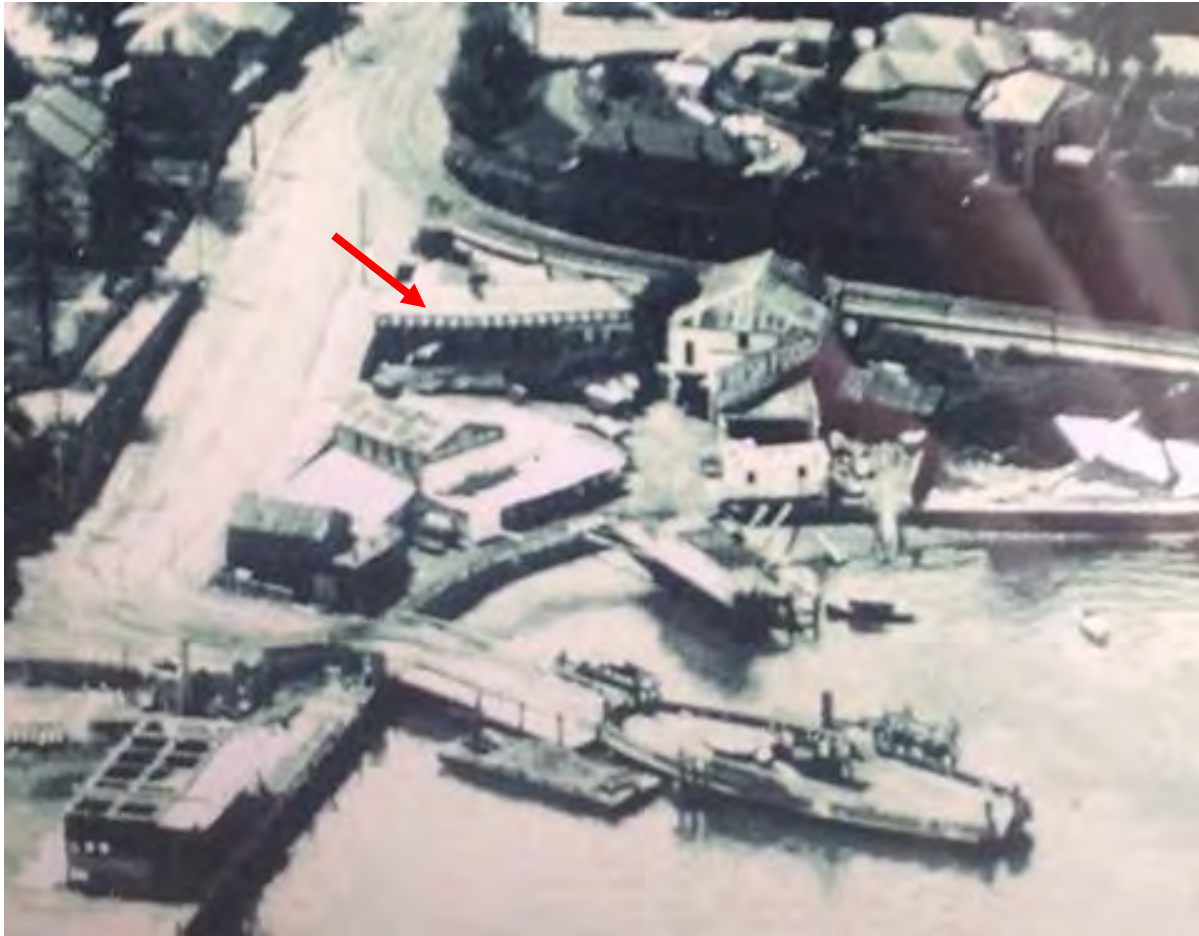
Figure 2.27: Detail of c.1921 aerial photograph of Blues Point. The cottages originally owned by Stevens are still extant (red arrow) with a number of other shed/store structures to the south and east of the cottages. The vehicular ferry is also operational. 'Sydney from the Air', Kent & Love c.1921.

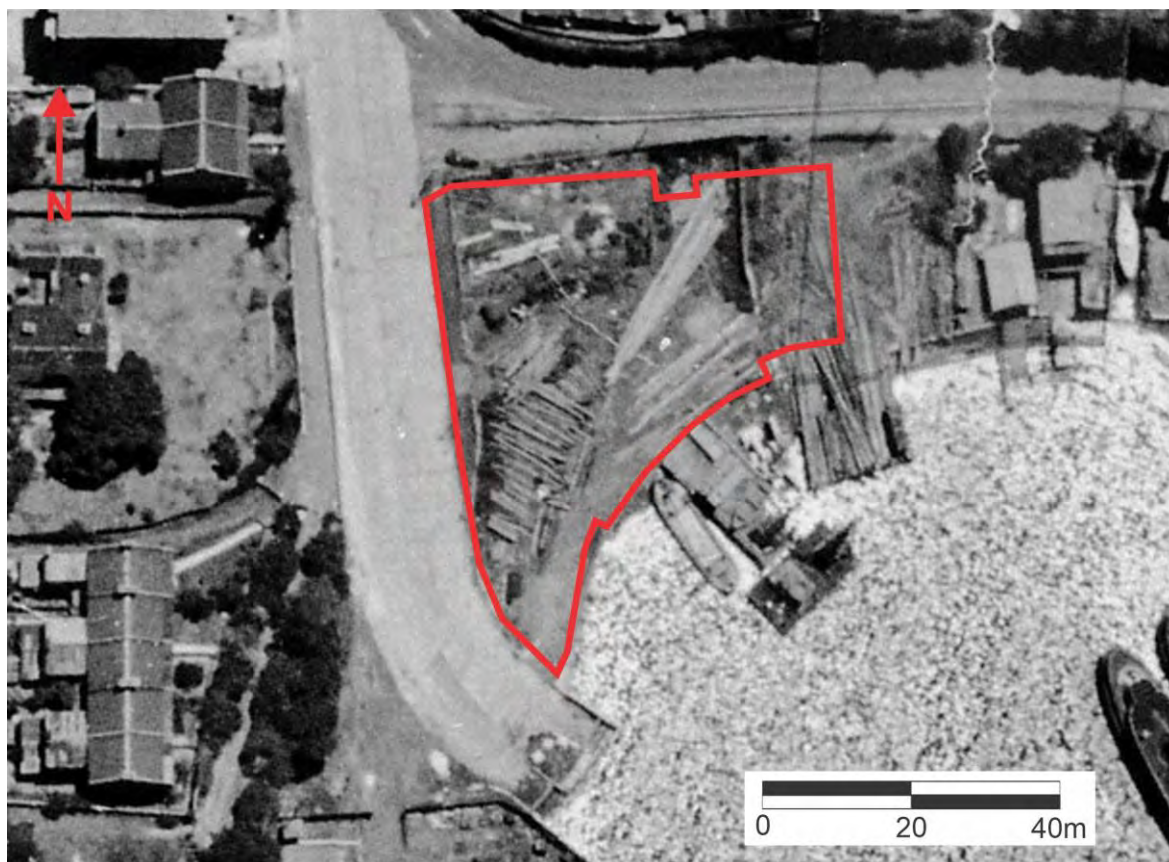
Figure 2.30: Aerial photograph showing the study area in Blues Point in 1949. The owners or lessees of the land might have used the study area as a material storage depot or salvage yard. Stevens' Wharf is still extant and a wharf or pier-type structure lies adjacent to the eastern part of Lot 10. Image No 1132-001, Historical Atlas of Sydney, CCSA.

In comparison to the photograph above, a 1949 aerial photograph of the study area provides evidence that Stevens' Wharf remained extant and that a wharf was built or land reclaimed at the shoreline of the eastern part of Lot 10. The use of the study area is not known but might be linked to building work or to a building material storage depot or salvage yard. Owners at this time include the Harbour Land and Transport Company Limited (western part of Lot 10 Sec E and reclaimed Portion Nos 1009 & 1010) and the Sydney Harbour Trust Commissioners (residue of eastern part of Lot 10 Sec E). The vehicular ferry dock was demolished by this date (Figure 2.30).

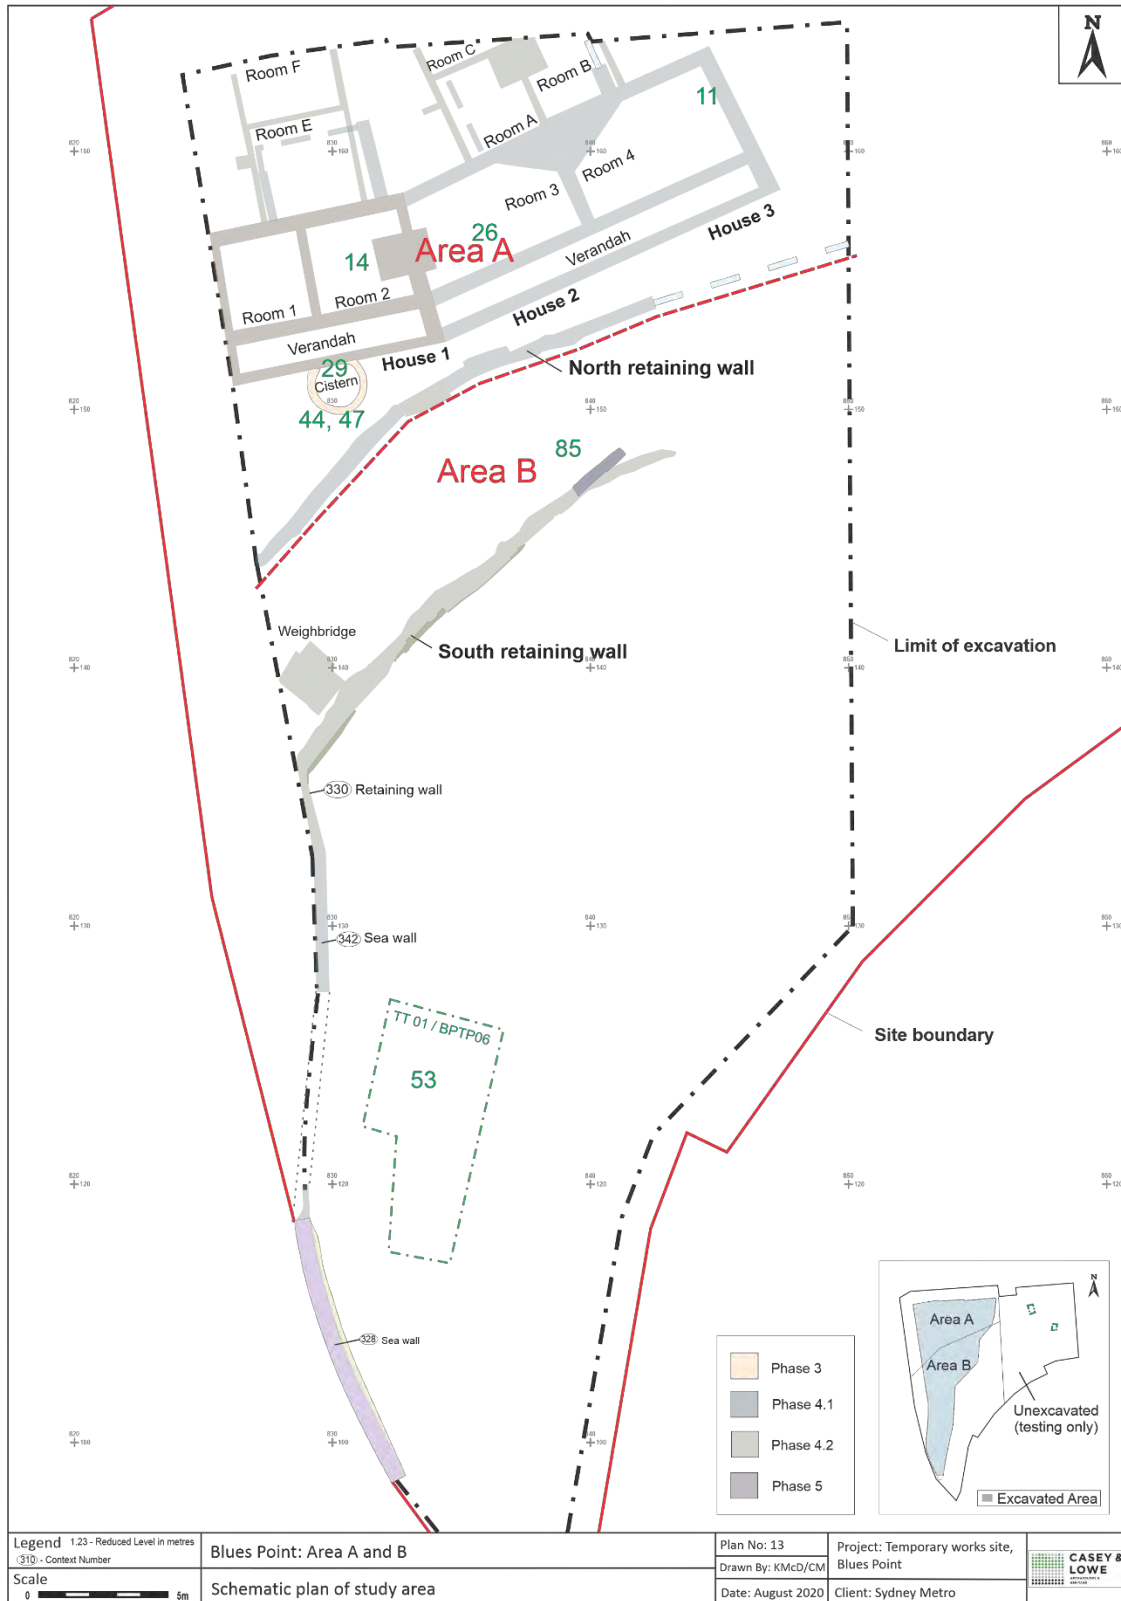
Figure 3.1: Schematic plan of the archaeological remains within the study area. The houses all located in Area A in the north. The colours reflecting the different phases of construction and occupation.

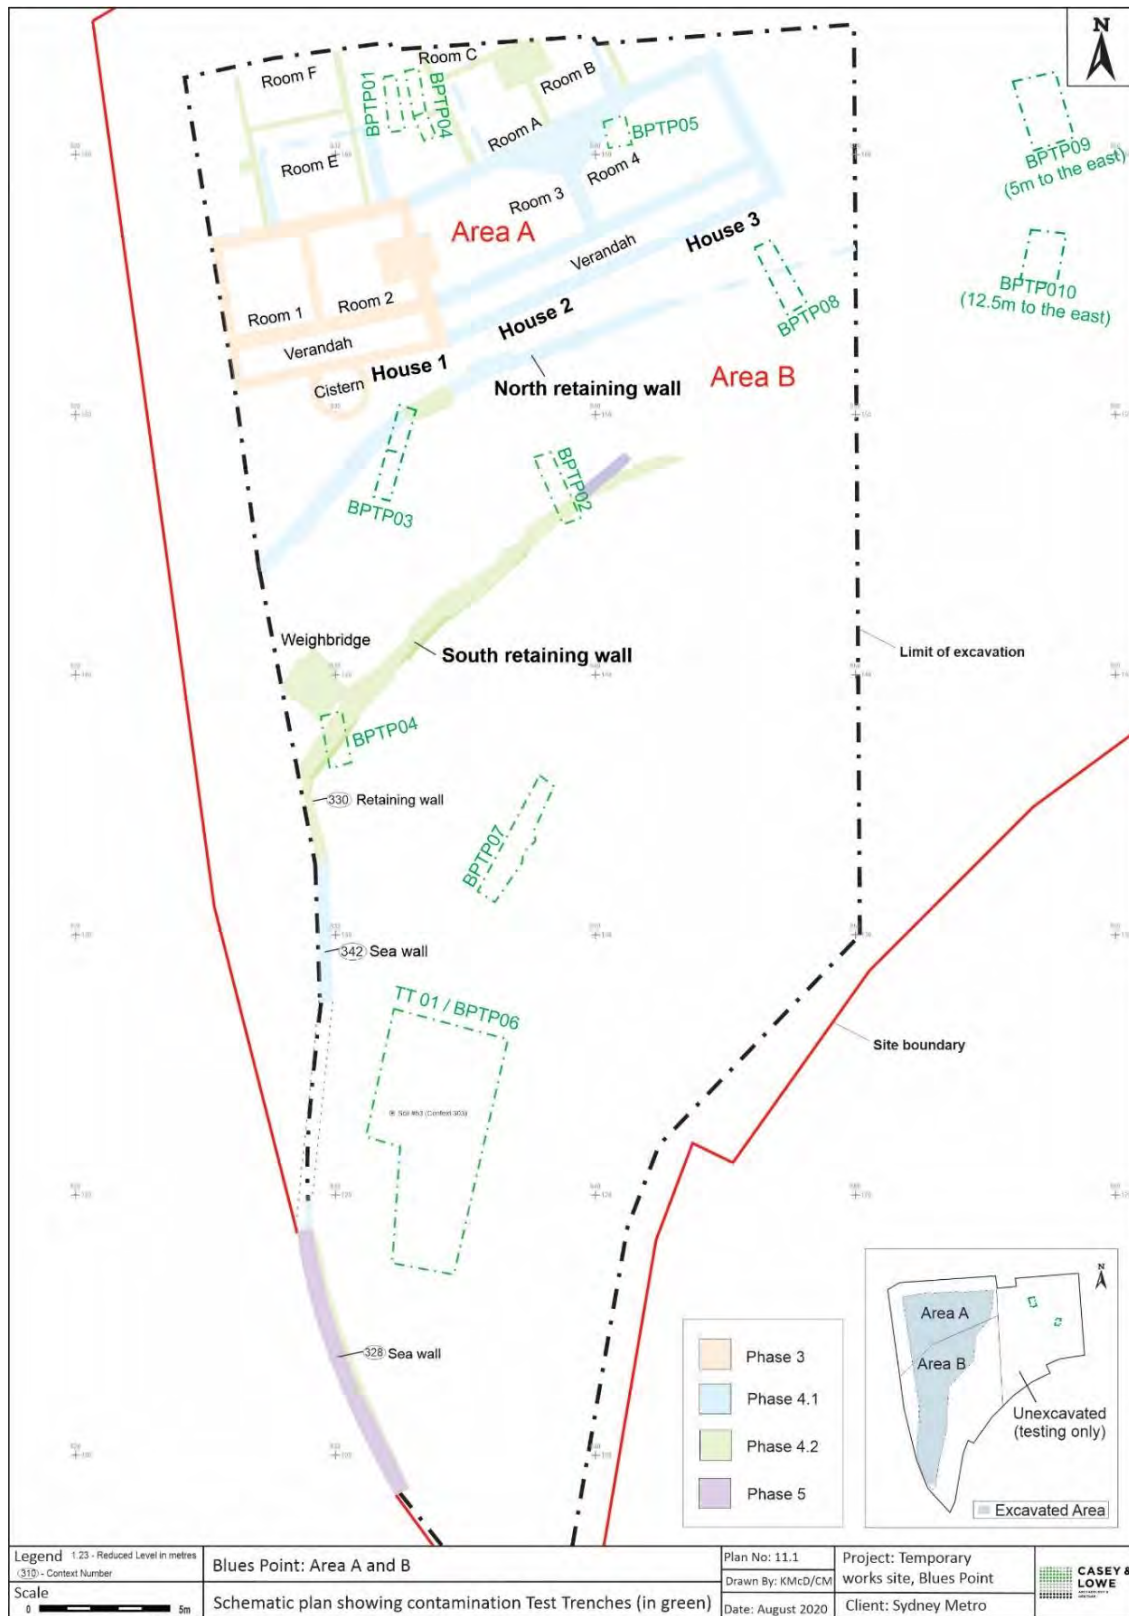
Figure 3.2: Location of machine dug test trenches across the entire site at the start of the excavation to test soils/fills for contamination.

A number of machine trenches were initially dug across all areas to test the soils for contamination (Figure 3.2). During the course of the excavation 23 test trenches were excavated throughout the project area to assist with clarifying the stratigraphy at various stages of the excavation. The test trenches were both hand and machine excavated (Figure 3.3, Figure 3.4). See Volume 4 for summaries of the location and purpose of each of these test trenches. Seven phases of activity were identified throughout the study area based on the historical research (see Section 3.3). Context numbers were allocated with reference to each archaeological area and individual features. Interpretive relationships between the features in each area were established and recorded during excavation. These associations form the basis of the archaeological analysis in Section 4. The relationships are displayed schematically in the Harris Matrix for the project (Volume 3) and accompanied with a complete set of phased site plans (Volume 3) and interspersed through the report. The archaeological evidence from this site can enhance the historical record contributing to an understanding of the history and settlement of the local region, in particular the maritime, industrial and residential development around Blues Point.

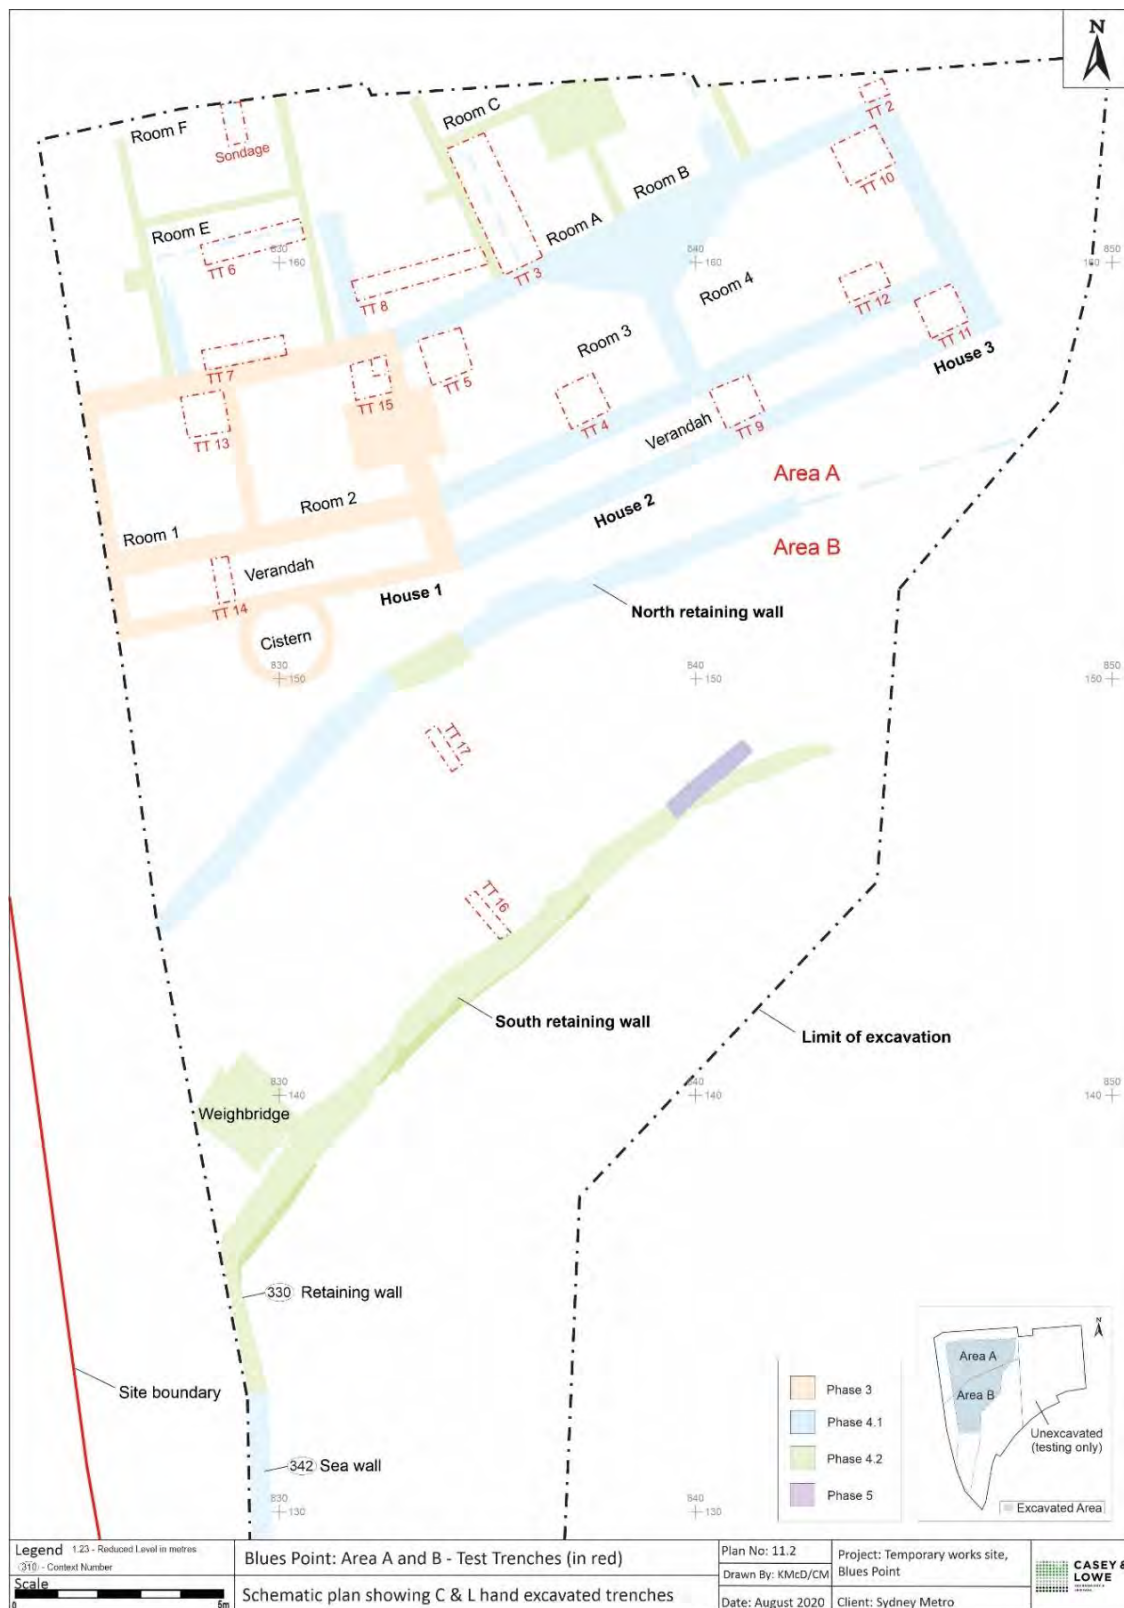
Figure 3.3: Location of hand excavated test trenches through TT 2 to TT 17 during the course of excavation.

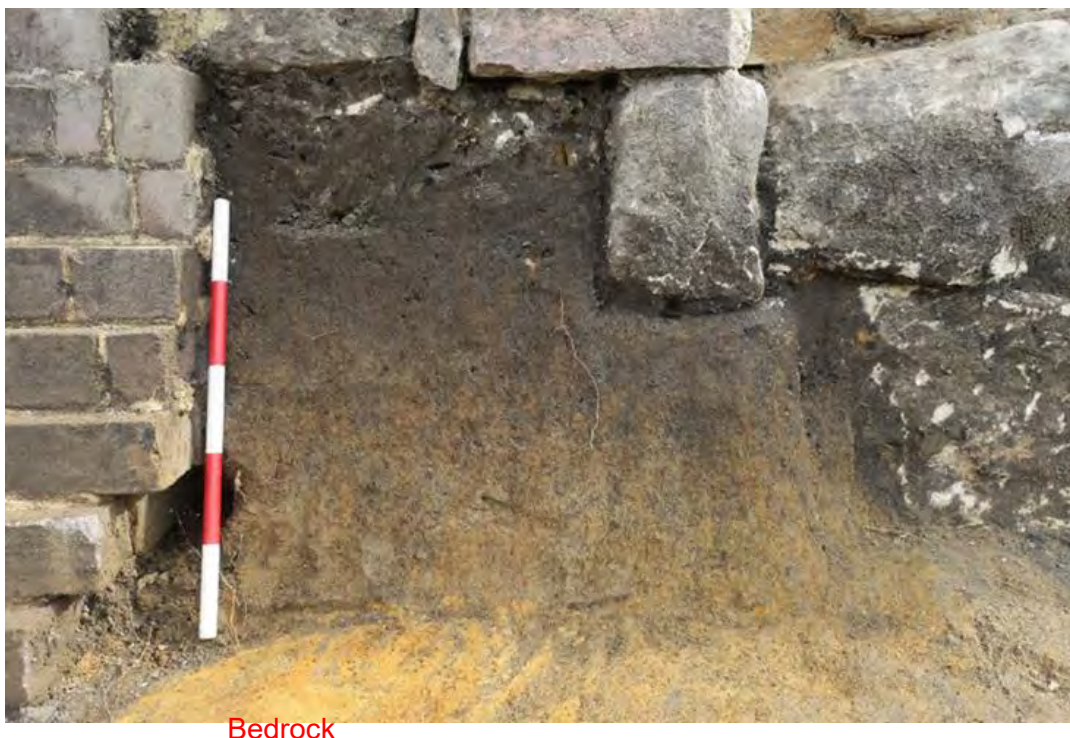
Figure 4.8: South-facing section of the natural soil profile above bedrock in Area B truncated by the retaining wall (contexts 071, 084). The profile is similar to the southern part of TT 22. View to north, scale 500mm. IMG_1363.

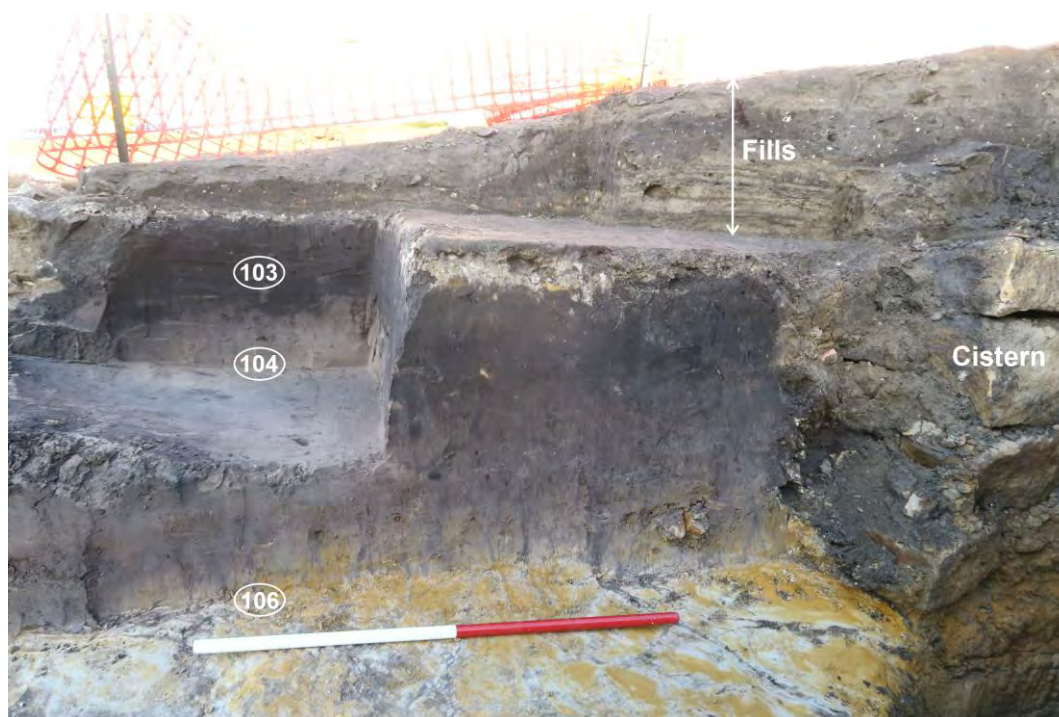
Figure 4.9: East-facing section showing the darker and lighter sands of the natural soil profile in the area between the cistern (House 1) and the north retaining wall. Above context (103) were a number of sandy fills and accumulations associated with House 1. Below context (104) was a thin clay lens (106) above the bedrock. View to west, scale 500mm. IMG_0041.

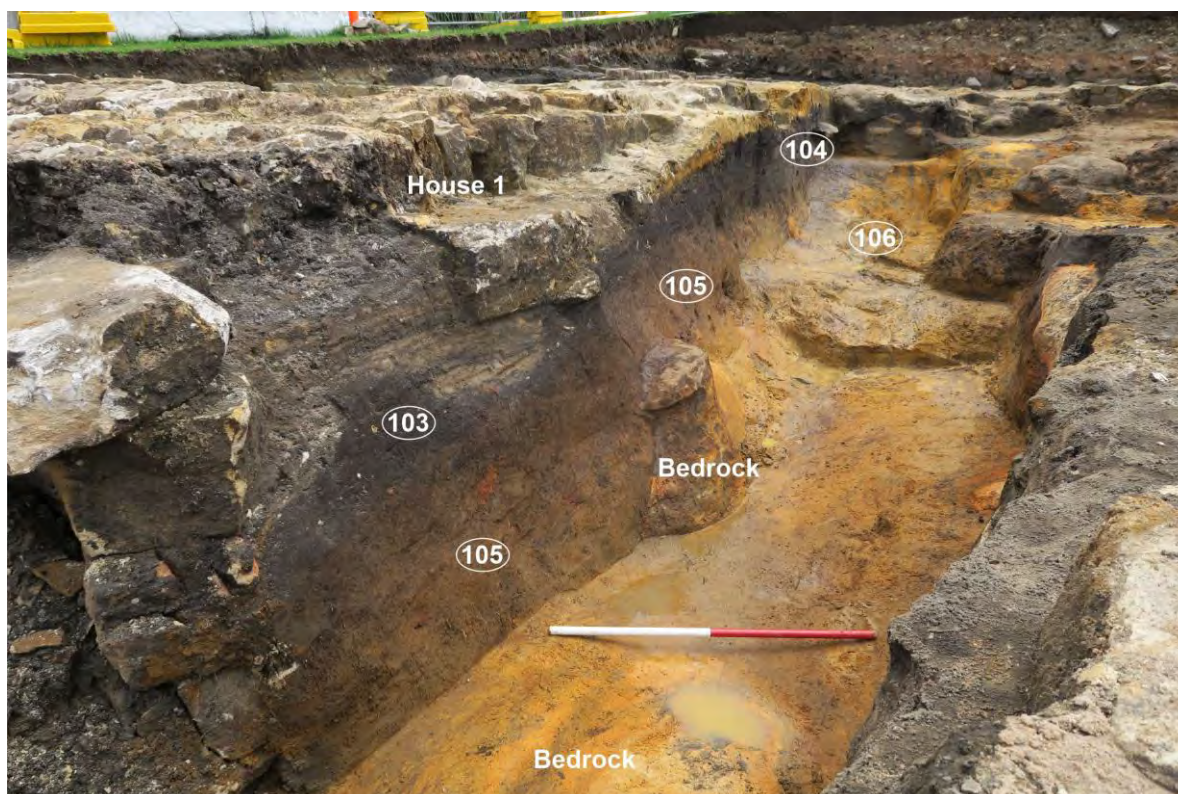
Figure 4.12: Test Trench 22 showing the natural soil profile below House 1, Room 2 and the more mottled clayey brown subsoil, context (105). View to northwest, scale 1m. IMG_0166.
