Archaeological Investigation
Temporary Works Site
Henry Lawson Reserve, Blues Point
May 2022

Sandstone foundations of mid-19th century cottages at Blues Point, Sydney (C&L 2018).

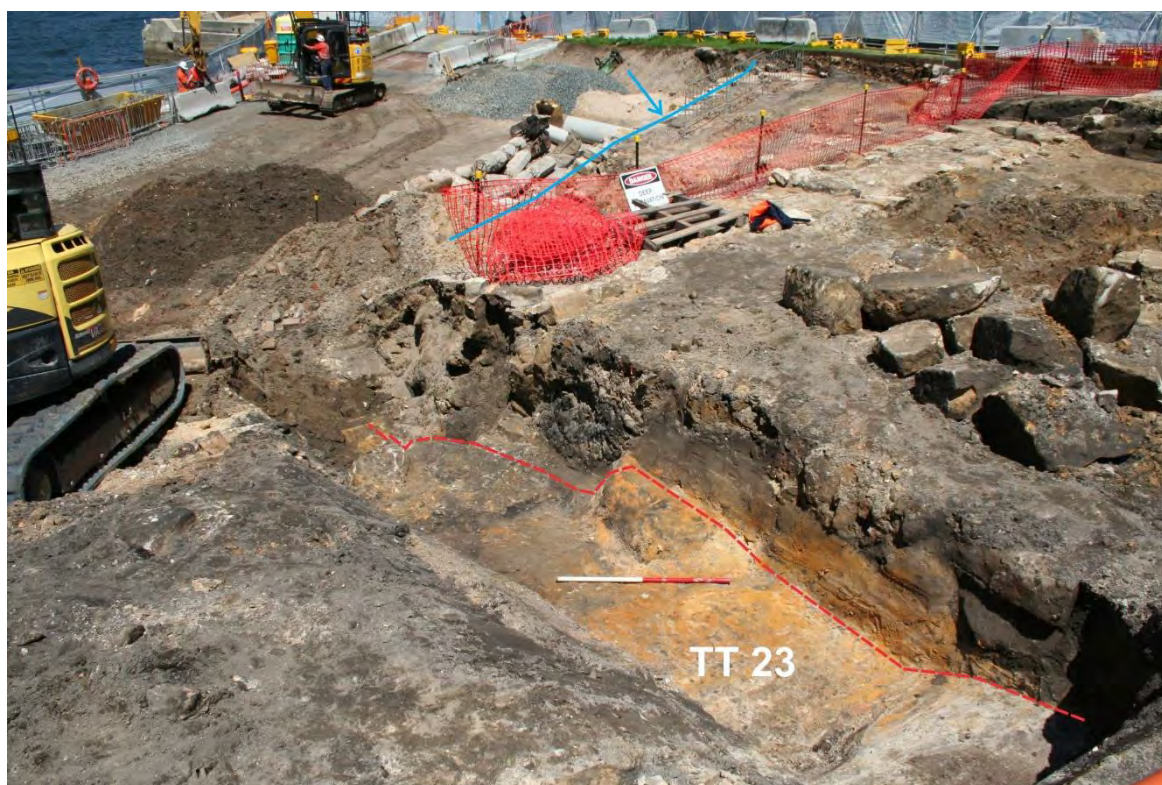
Figure 4.16: Test Trench 23 through the eastern end of House 3, the red dashed line running along the edge of the trench illustrates steps in the bedrock down towards the original foreshore. The blue east-west line is the southern retaining wall, everything to the south of this wall was reclaimed land. View to southwest, scale 1m. IMG_5539.

The natural underlying bedrock at Blues Point is Hawkesbury sandstone. Where it was exposed in large test trenches it formed a stepped effect towards the harbour (Figure 4.3, Figure 4.13, Figure 4.16). In Area A the bedrock was recorded as context (041) and in Area B as context (314). In some places the bedrock was utilised in the construction of retaining walls and seawalls. In the northwest corner of the site patches of bedrock were exposed within the footprint of Rooms E and F at the same level as the brick foundations. There was also evidence to suggest quarrying of the bedrock, with large fissures and tool marks in the rock, possibly for the construction of the local houses or the seawalls at Blues Point. A deep circular cistern, contemporary with House 1, and a small weighbridge which first appears on plan in 1891, were cut into the bedrock. Where exposed the height of the bedrock dropped from RL 7.14m in the northwest corner, where it formed a large sandstone ledge on which the houses were built, to RL 4.81m along the south retaining wall. Further evidence of cut bedrock was found at RL 3.6m along the western boundary of the site below a north-south retaining wall (Figure 4.15). The steep topography also extended to the north, outside the study area, with a perpendicular quarried rock face (c.9m high) visible along the northern edge of Henry Lawson Avenue (formerly Cliff Lane) (Figure 4.14). In the early 1880s Cliff Lane was made by excavating large quantities of sandstone, through the steep sandstone outcrop (Figure 2.17). The construction of the road involved the excavation of a large quantity of rock and took longer than expected (see Section 2.9).

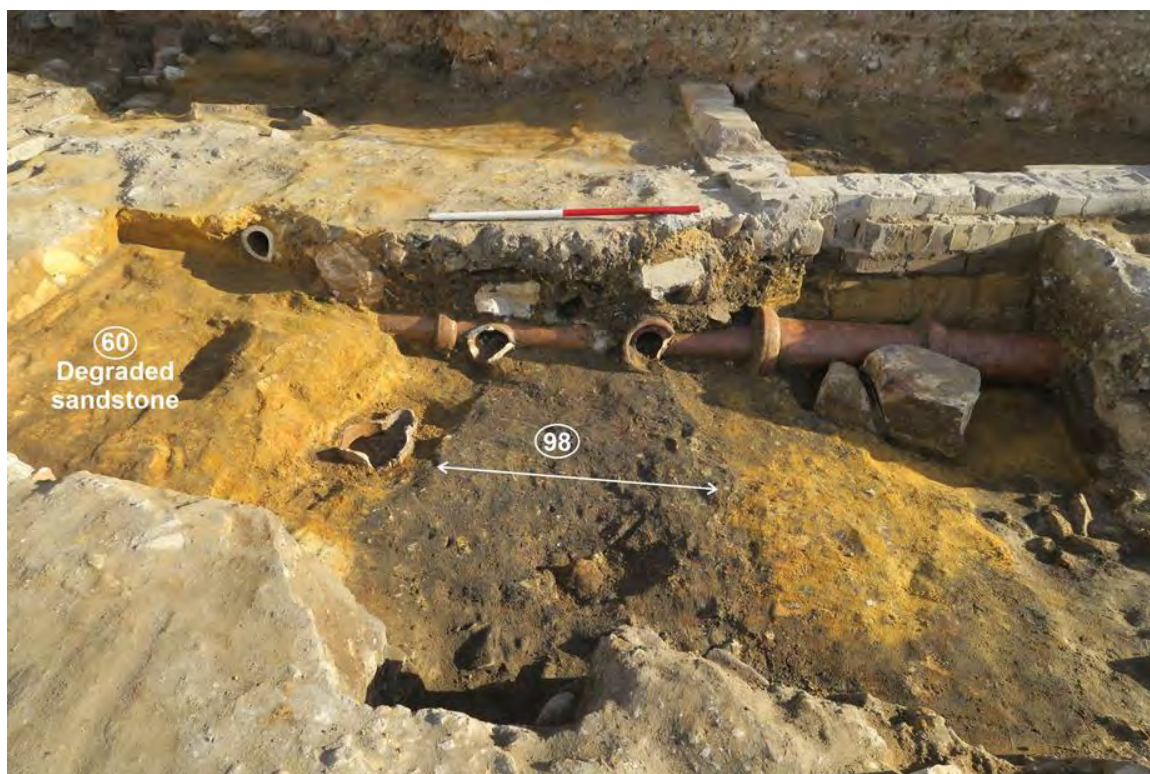
Figure 4.17: Context (098) within a shallow north-south trench/ channel through the natural yellow degraded stone (060) and impacted by later service pipes. View to north, scale 1m. IMG_9974.

At the northern end of the study area, between House 1 and House 2, a dark sandy fill (context 098) packed a shallow concave linear channel. Although directly north of the man-made channel (108), it's location along the same north-south alignment suggests it was part of the original channel (Figure 4.17). This channel (also recorded as 098) was 810mm-1.10m in width. The sandy fill (098) was rich in shell inclusions, similar to the modified topsoil deposit (063). Excavation of (098), which was only 70mm deep, showed it sat directly above the degraded yellow sandstone (060) with no subsoil present. The absence of natural sand deposits in this area and shallowness of the channel suggests the area was stripped down to accommodate later services pipes (installed c.1898) with only shallow sandy fill (098) surviving in the base of the channel below the pipes.

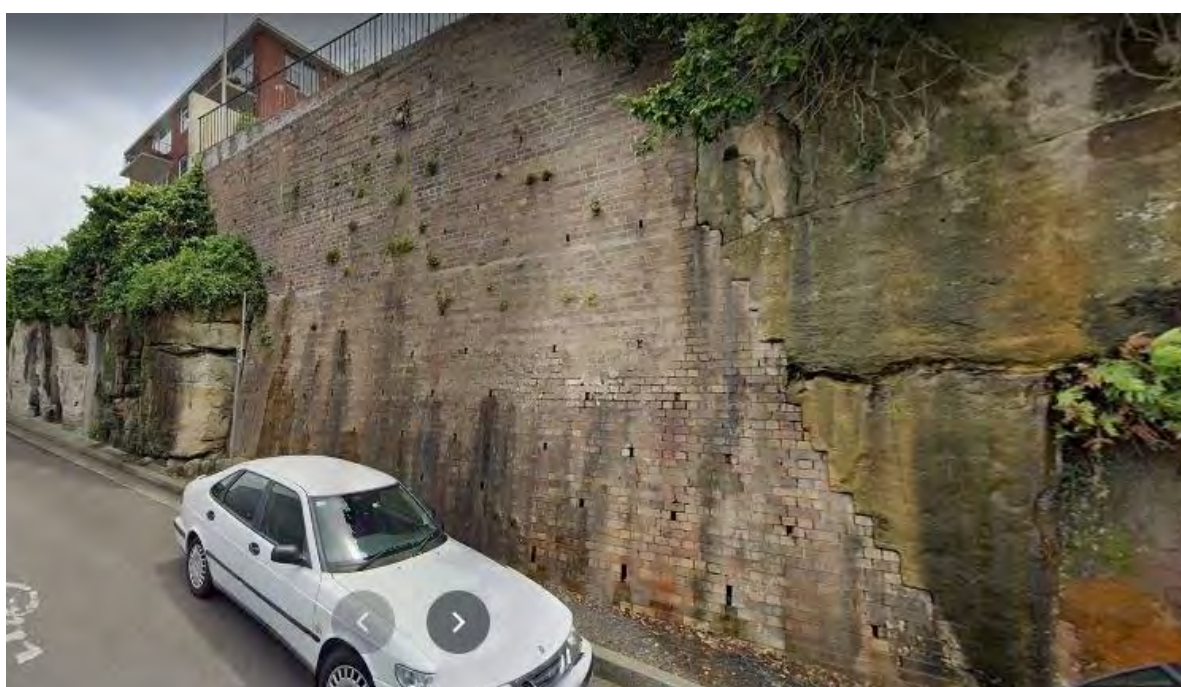
Figure 4.18: Directly north of the study area the bedrock was quarried for the construction of Henry Lawson Avenue (formally Cliff Lane) c.1883. A large brick retaining wall was keyed into the bedrock, filling a natural void or channel in the rock. The weep holes in the brick work and the water stains on both rock and bricks suggest water continually made its way through the area from higher up slope. Google Street view April 2021.

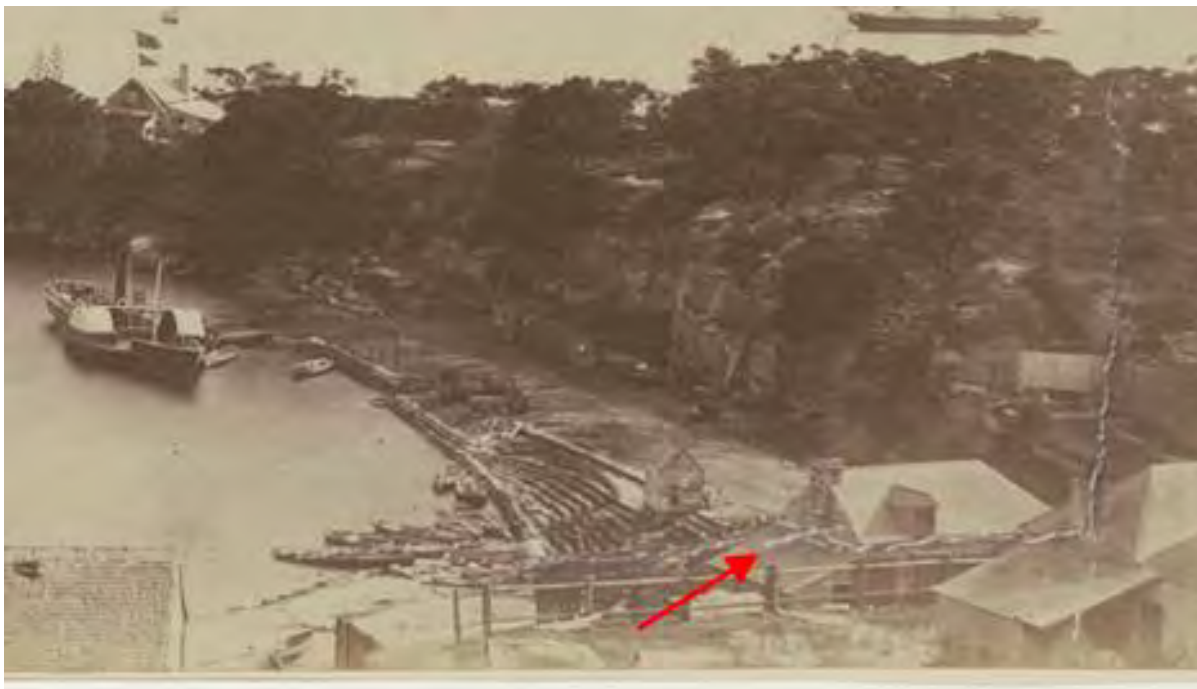
Figure 4.21: Undated c.1869 (or earlier) photograph of Blues Point showing a dormer style cottage (House 1) the gable chimney and an additional small room with a sloped roof at the eastern end of the house (red arrow). This additional room was replaced with Stevens' later cottages. View to southwest. SPF/932, ML, SLNSW.

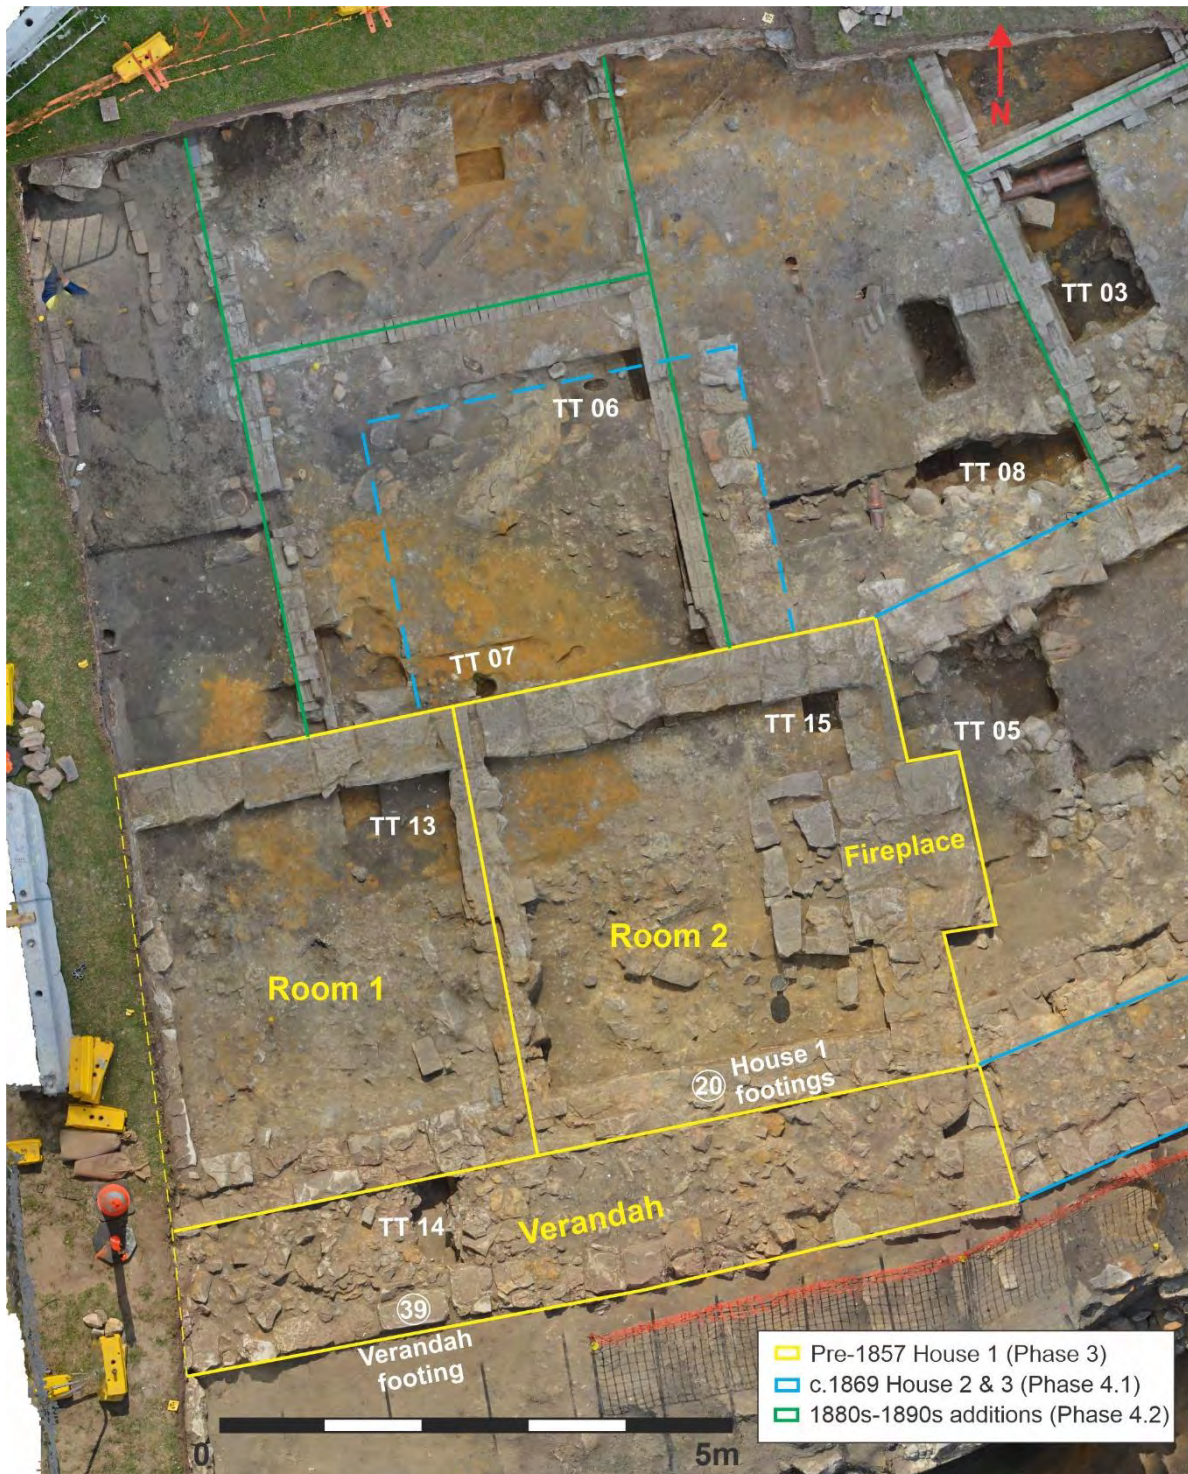
Figure 4.24: Orthophoto of House 1 (yellow), a 2-roomed cottage with a fireplace and front verandah prior to the cistern being uncovered. Later additions to House 1 are outlined in green. Arcsurv.

House 1 was built on the highest and most level part of the site, the northwest corner (Figure 4.3, Figure 4.22 to Figure 4.24). The stone footings were cut into the upper natural sand deposits. In some places a compact, clean, orange-yellow clayey sand fill (102) was deposited above the dark sandy modified A1 horizon to level uneven pockets of ground prior to the construction of House 1 (Figure 4.25). This redeposited yellow sandy fill was 100-220mm deep and was quite similar to the yellow degraded sand (060) found north of the original house. Similar pre-house levelling fills included contexts (031 and 083). Context (031) was stratigraphically the same as context (102). It was a mix of mustard yellow and black sand with occasional sandstone inclusions and extended from the western limit of excavation below Room 1 and north under the rear yard area of House 1 (Figure 4.24). The levelling fills contained occasional artefacts including bone, ceramics and glass and was only excavated within test trenches. Context (083) was exposed within a test trench (TT 15) in the northeast corner of Room 2 (Figure 4.23). When the large trench (TT 22, Figure 3.4) was excavated (at the end of the project) it confirmed contexts (083 and 102) were the same fill. Naturally occurring compacted yellow clayey sand (060) was exposed further north of House 1, the redeposited yellow sands (031, 083 and 102) may have been stripped from this higher area and spread further south to create an even surface on which to build the house.

The sandstone footings of House 1, including the verandah, measured 7.7m (east-west) by 6m (north-south). The original house had two rooms, with a fireplace in the eastern room (Figure 4.23, Figure 4.24), the rooms were almost square, Room 2 measured 3.3m x 3.3m, Room 1 was slightly smaller 3.3m x 3.1m. The foundations of the main part of the house (Rooms 1 and 2) were recorded as context (020) while the verandah footings were given a separate number (039). Archaeological remains suggest the verandah was contemporary with the original structure.

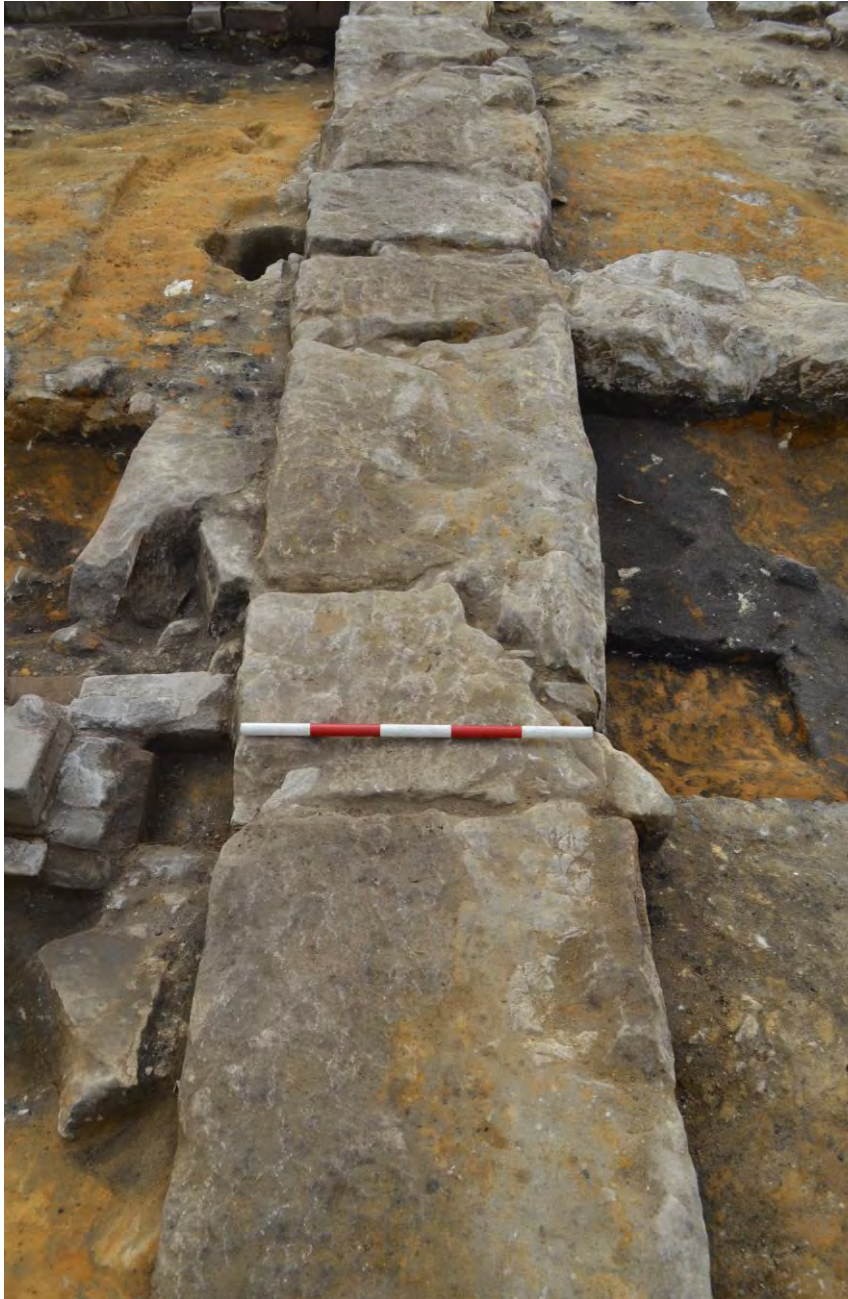
Figure 4.26: Detail of north wall of House 1 built of a single row of large rectangular blocks of stone laid end to end and cutting into the yellow sandy levelling fill (102). View to east, scale 500mm. DSC_4822.

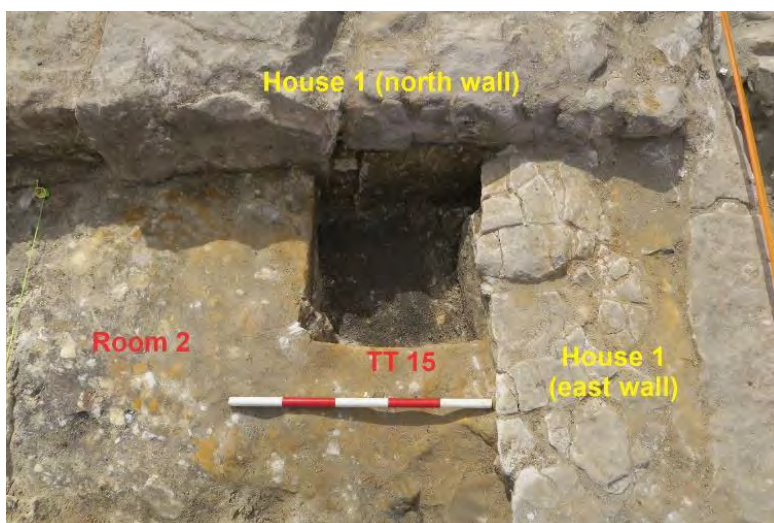
Figure 4.27: TT 15 in the northeast corner of Room 2 showing a second course of stone in the north and east walls sitting on the modified sands (104). View to north, scale 500mm. DSC_9950.

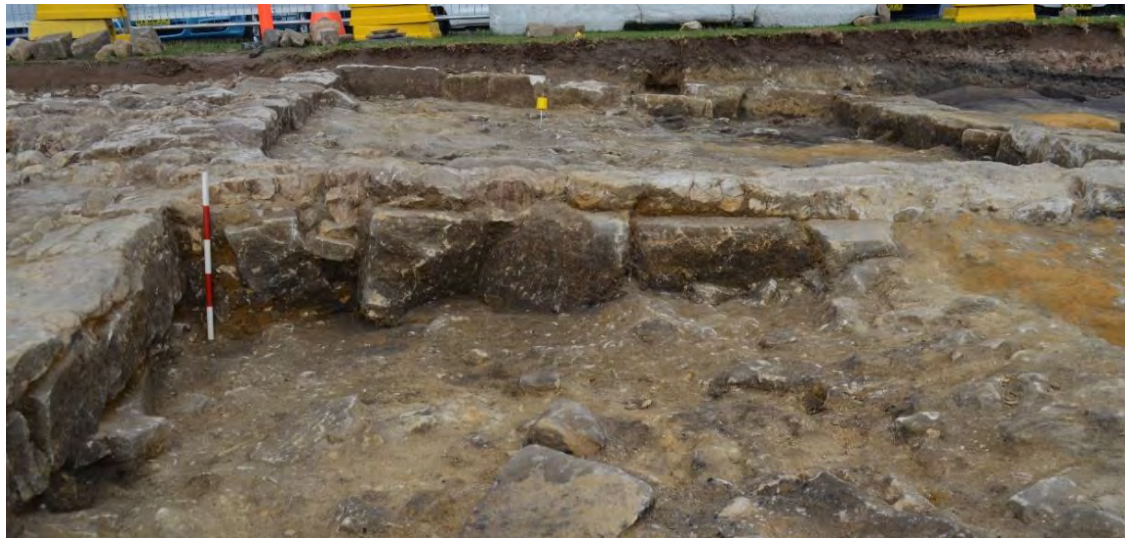
Figure 4.29: Detail of internal partition wall, House 1 with Room 2 in the foreground. This wall was not keyed into the south wall. The lower course was wider and constructed of larger blocks up to 600mm wide. View to west. Scale 500mm. DSC_4816.

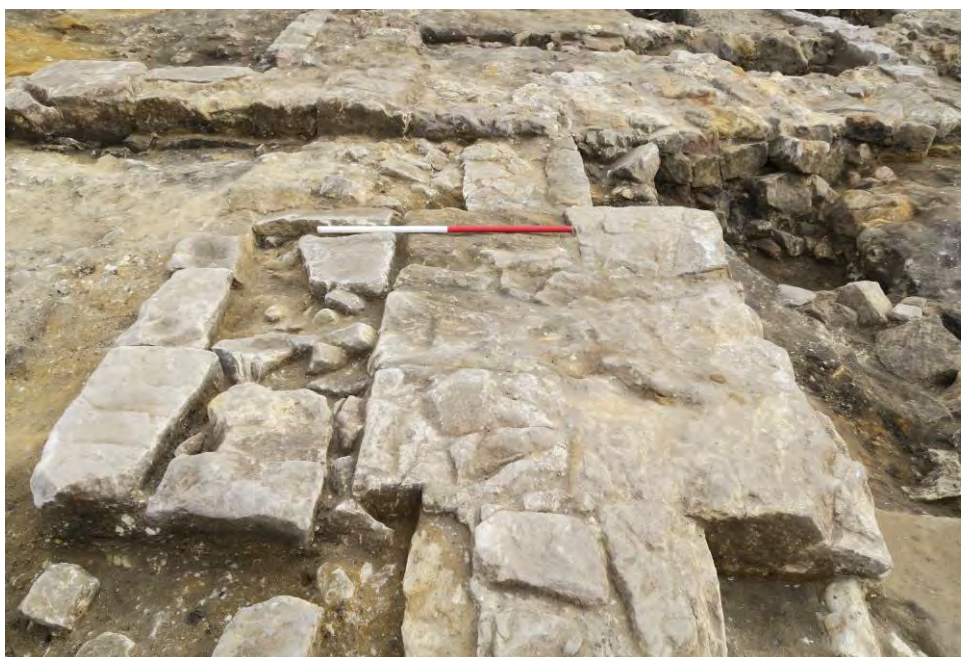
Figure 4.31: Detail of the fireplace and chimney along the east wall of House 1. View to north, scale 1m. IMG_9940.

Room 2 was a slightly larger room measuring 3.33m (north-south) by 3.34m (east-west) and contained a large fireplace keyed into the eastern wall of the room. It was 240mm wider than Room 1. The fireplace and chimney space were one course deep and measured 1.68m x 1.3m and erected from six large sandstone blocks (average size 600 x 550mm) laid in a rectangular shape. The front of the fireplace extended a further 530mm west into Room 2 terminating with a narrower single row of stones (Figure 4.31). The demolition debris (026) and the underfloor deposits (066 and 069) within this room were recorded separately and are discussed with the later phases of occupation. A number of frogged sandstock bricks, context (072) (dated 1850-1900) were reused as supports for a timber floor located within Room 2, suggesting the floorboards were replaced during the lifespan of the house. Below the underfloor deposit was remains of a construction debris (075). The construction debris was light buff-brown coloured sand mixed with sandstone rubble (Figure 4.30). It was excavated within TT 15 in the northeast corner of the room and was 10mm deep (Figure 4.23) and got thicker as it followed the natural slope to the south. In the southern half of Room 2 there were a lot of larger and more frequent pieces of stone rubble (up to 330mm deep) possibly intentionally deposited as a raising event to level the ground within the room prior to the construction of the floors. The rubble stones could have assisted with drainage as further excavation of TT 22 showed Room 2 was constructed above a natural water channel, the flow of which was diverted further east away from the house (see Section 0). No artefacts were found within this debris.

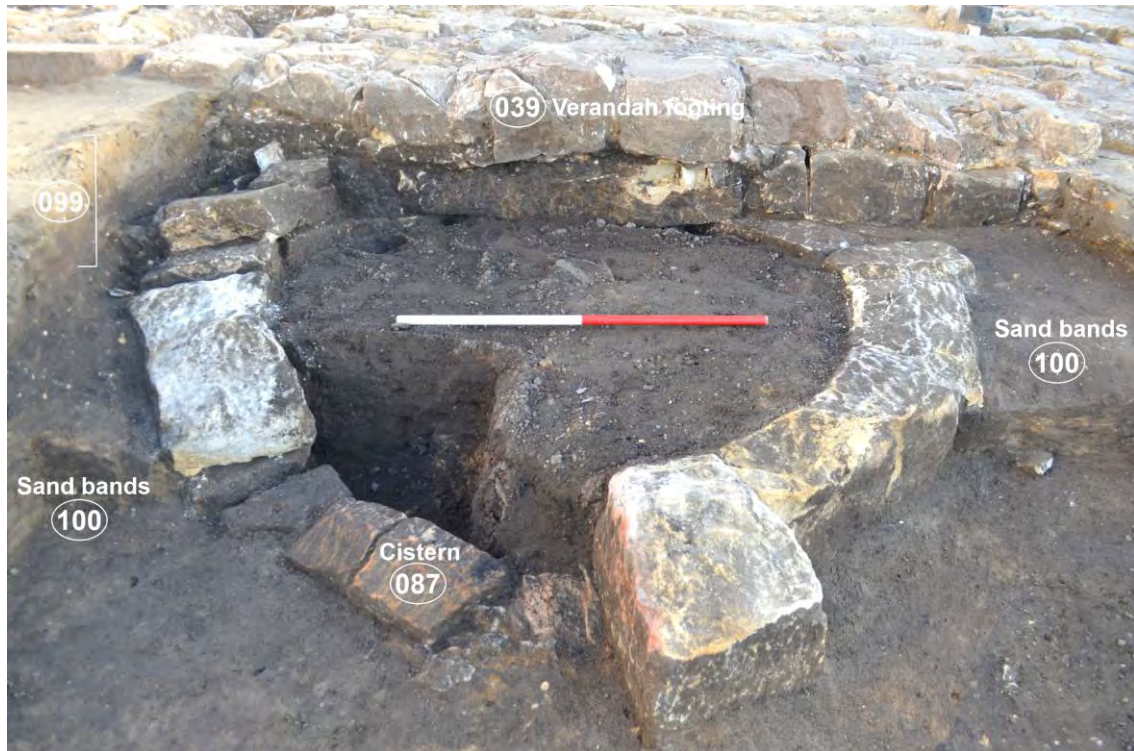
Figure 4.37: Sandstone cistern below front wall of verandah, House 1. The cistern was backfilled with four different fills. View to north, scale 1m. IMG_4859.

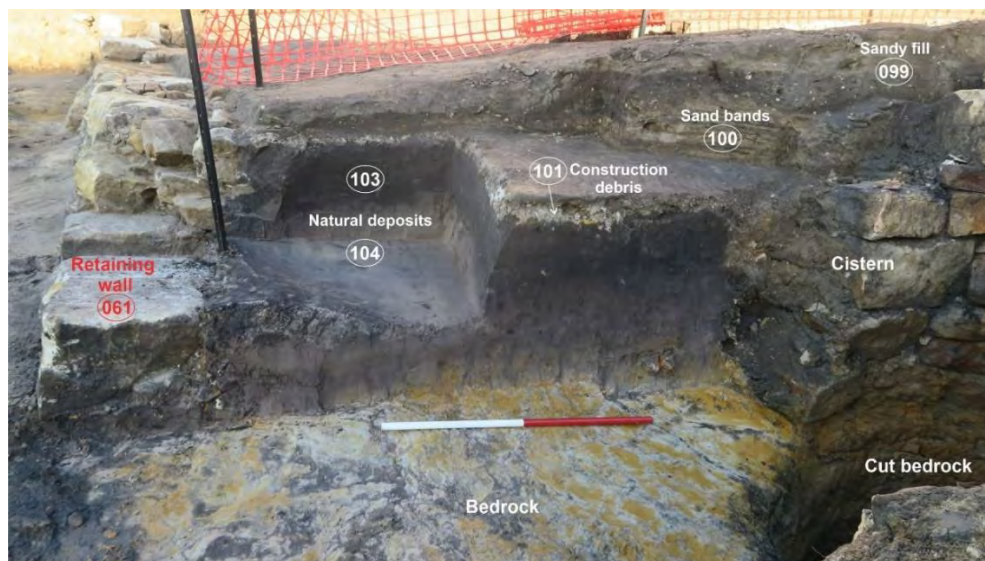
Figure 4.38: East-facing section showing the edge of the cistern cutting the natural deposits. This photo also shows construction debris/surface (101) above the natural sands likely associated with the construction of the cistern with sand bands (100) above the construction debris. View to west, scale 1m. IMG_0036.

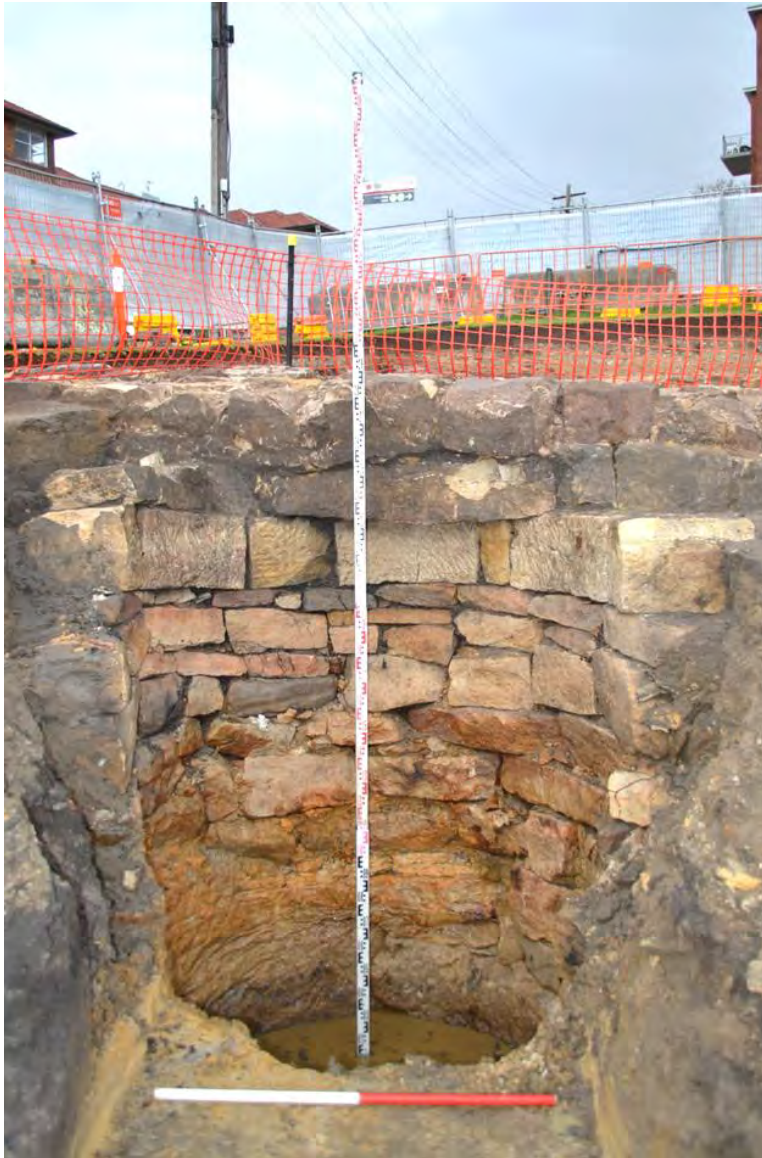
Figure 4.39: Machine excavated trench through cistern (087) cut deep into the bedrock. Note how the two courses of the verandah wall slightly overhang the cistern. View to north, scale 1m and 4m. DSC_4897.

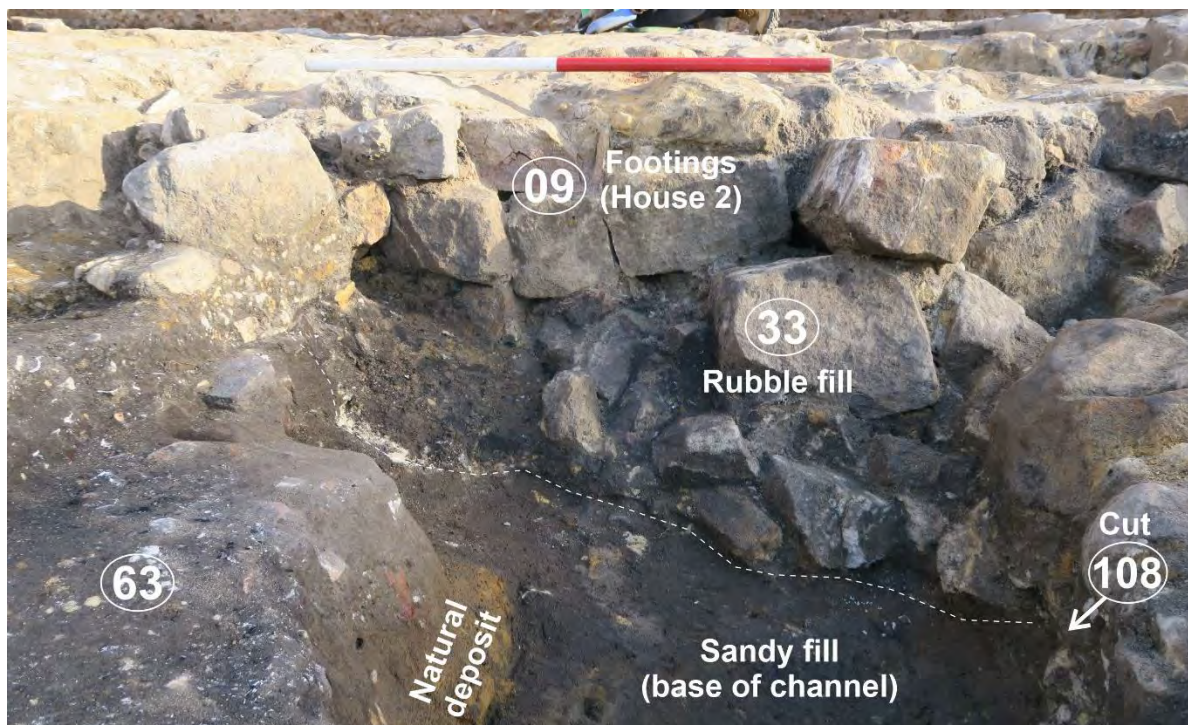
Figure 4.41: South-facing section of rubble fill (033) with north-south channel (108) below stone foundations of House 2 and cutting the shell rich deposit (063). View to north, scale 1m. IMG_9915.

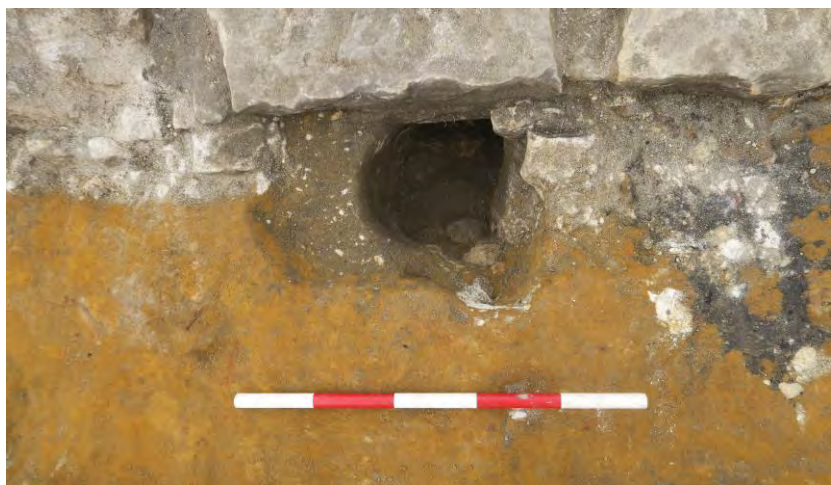
Figure 4.43: Posthole (046) abutting north wall of House 1 and cutting pre-house fill (102) and wall trench fill (045) of the house. Associated with early north-south fenceline. View to south, scale 500mm. IMG_9639.

Its location in the centre of the back yard may also have been due to water channelling downslope further to the east. The fence was on plan until 1869 but did not appear on plan after Stevens built the adjoining houses. Only one posthole (046) was found along this alignment during excavation that could be attributed to a boundary fence. Within TT 07 a sub-rectangular posthole (046) abutted the north wall of House 1 (Figure 4.23, Figure 4.43) cutting the edge of the wall trench fill (045) and the mottled yellow pre-house levelling fill (102). The posthole had a circular pipe (250mm in diameter) and vertical sides to a depth of 300mm with some corroded metal artefacts in the pipe fill (047).

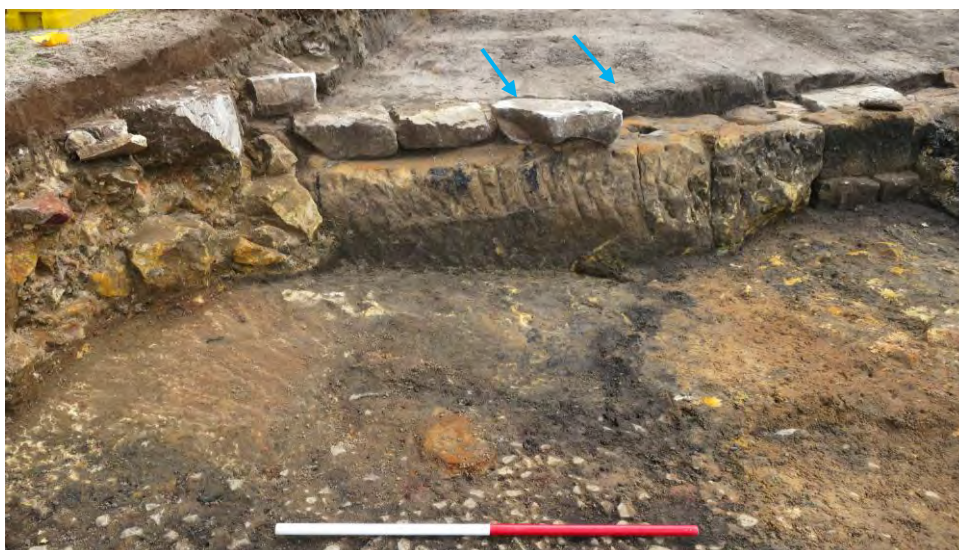
Figure 4.46: Cut and shaped bedrock at the western end of the north retaining wall (061). The blue arrows pointing to postholes in the rock. View to north, scale 1m. IMG_1216.

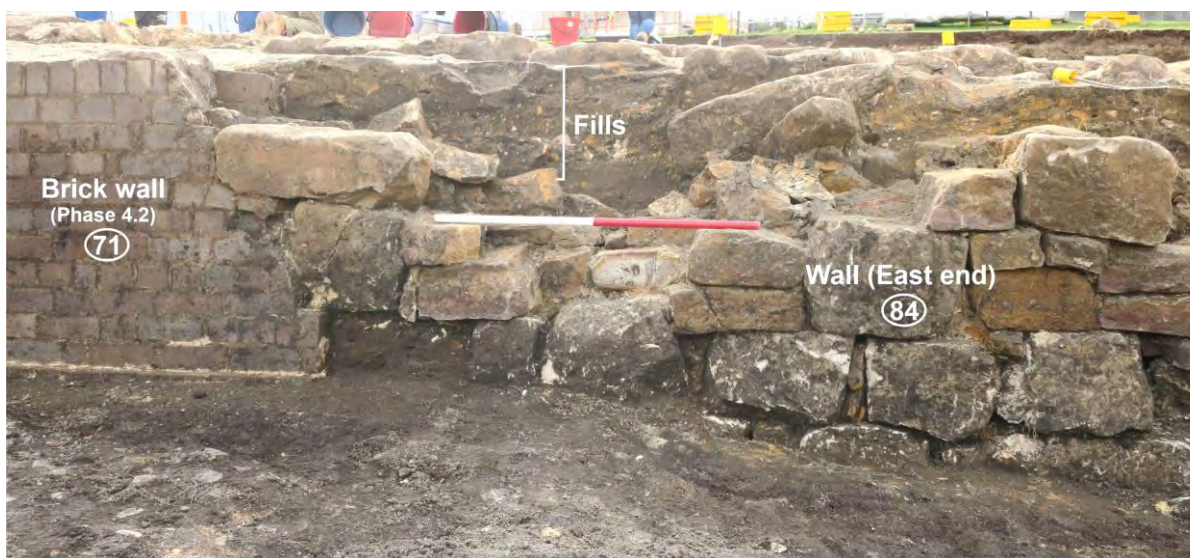
Figure 4.49: Eastern end of north retaining wall (084) with later brick wall repair (071). Behind the wall were layers of fill (collectively recorded as context 067) to raise the ground for the construction of House 2 and 3. View to north, scale 1m. IMG_1257.

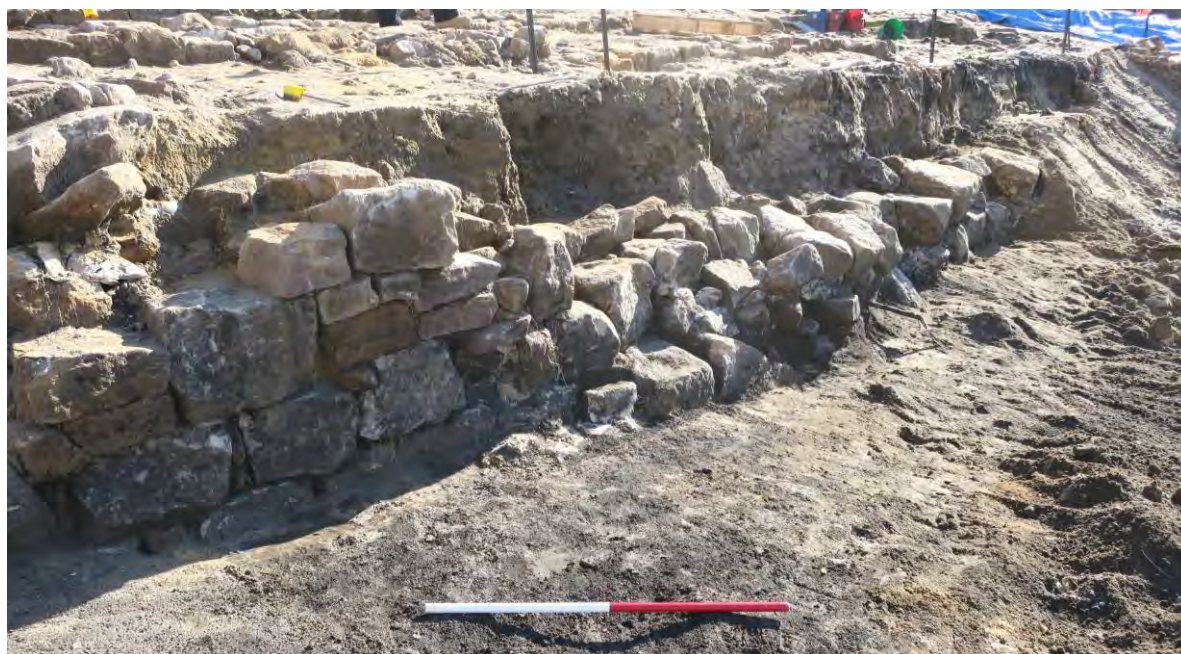
Figure 4.50: View along north retaining wall (084) below Houses 2 and 3. Some of the upper courses had collapsed. The fills that abutted the north face of the wall are visible in section. View to northeast, scale 1m. IMG_1261.

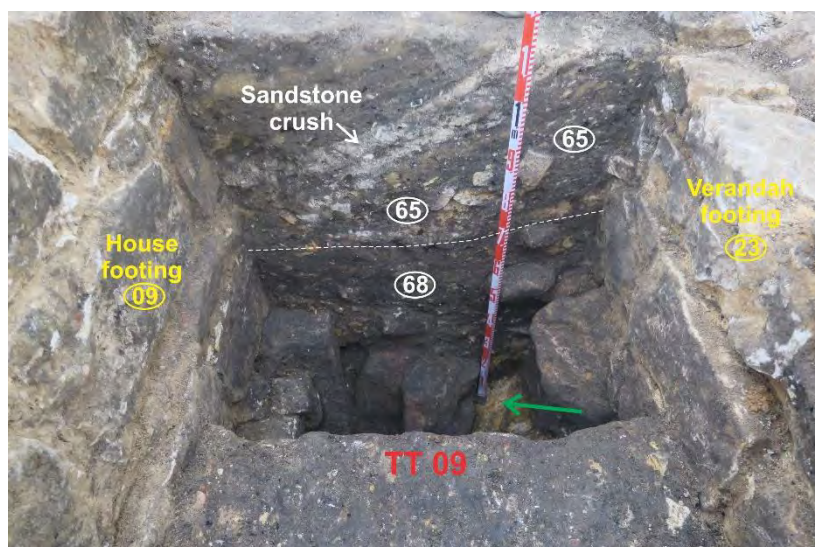
Figure 4.58: West-facing section of TT 09 within the front verandah of House 3, showing the depth of the foundations, tip lines and layers of construction debris within the bulk fill. The fills included black sandy fills (068). The green arrow is pointing to the top of the bedrock on which the footings sat. View to east, scale 1.1m. IMG_9816.

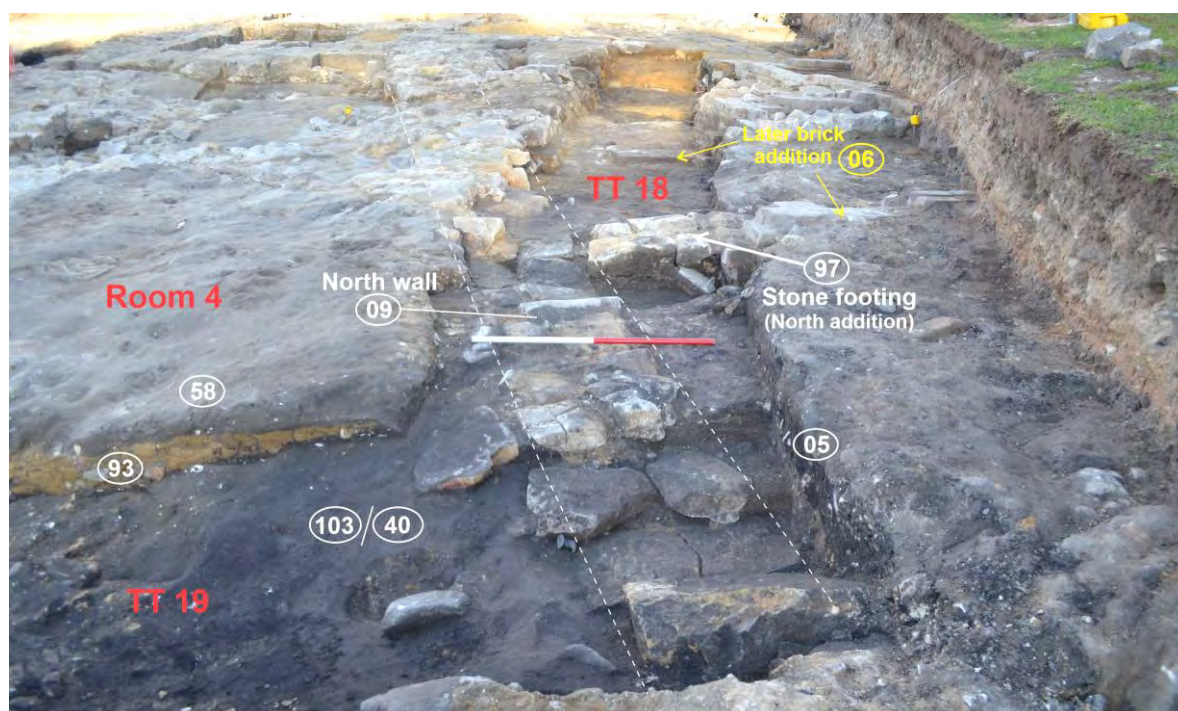
Figure 4.63: Northeast corner of House 3, Room 4 showing the alignment of the north wall of the houses also the remnant stone addition (097) to the north and the fills above the black sand deposits. View to west, scale 1m. DSC_4862.

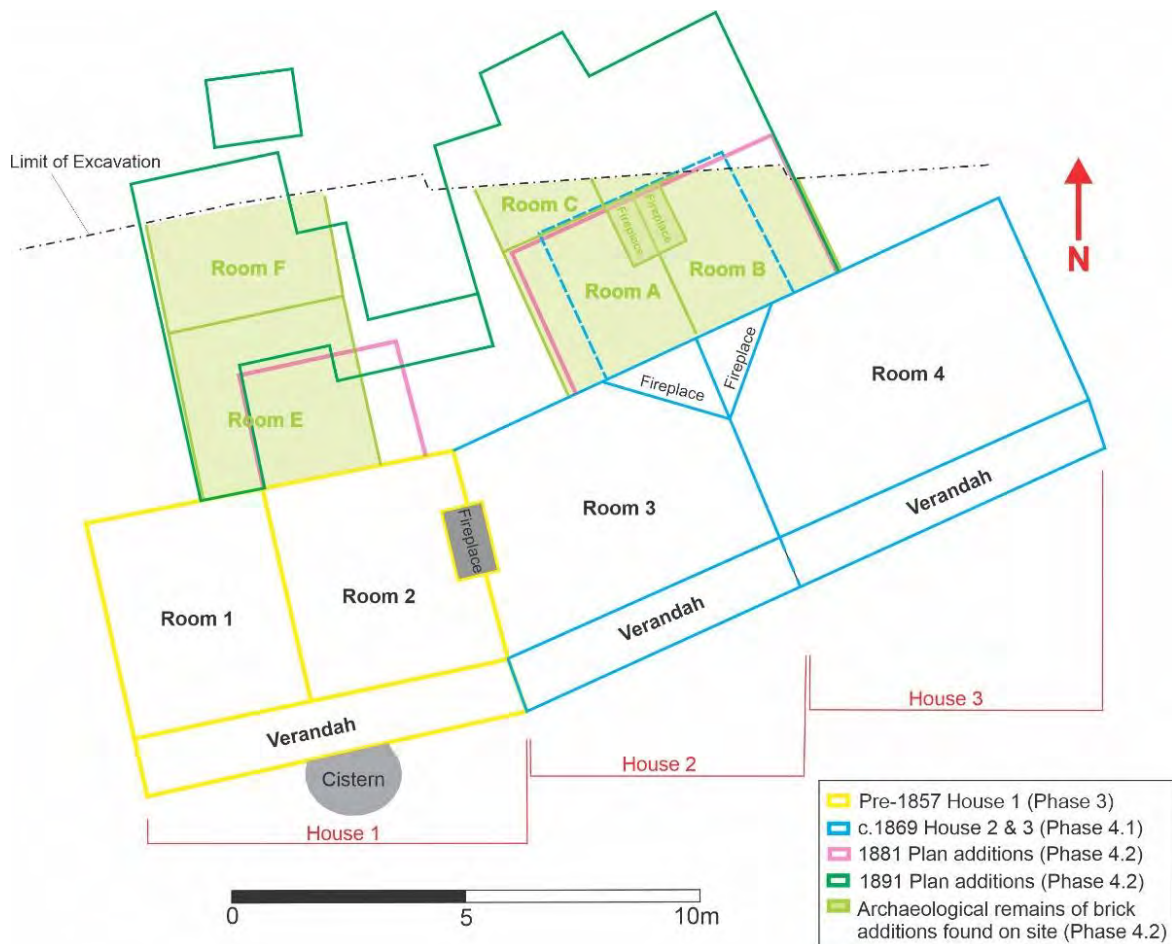
Figure 4.66: Interpretative plan of the layout of the later additions to the houses based on the archaeological evidence and the historic plans. The dark green outlines the extent of additions on the 1891 plan while the lime green shows the layout of the brick rooms found during excavation. The brick rooms were labelled Rooms A to F with some extending beyond the limit of excavation.

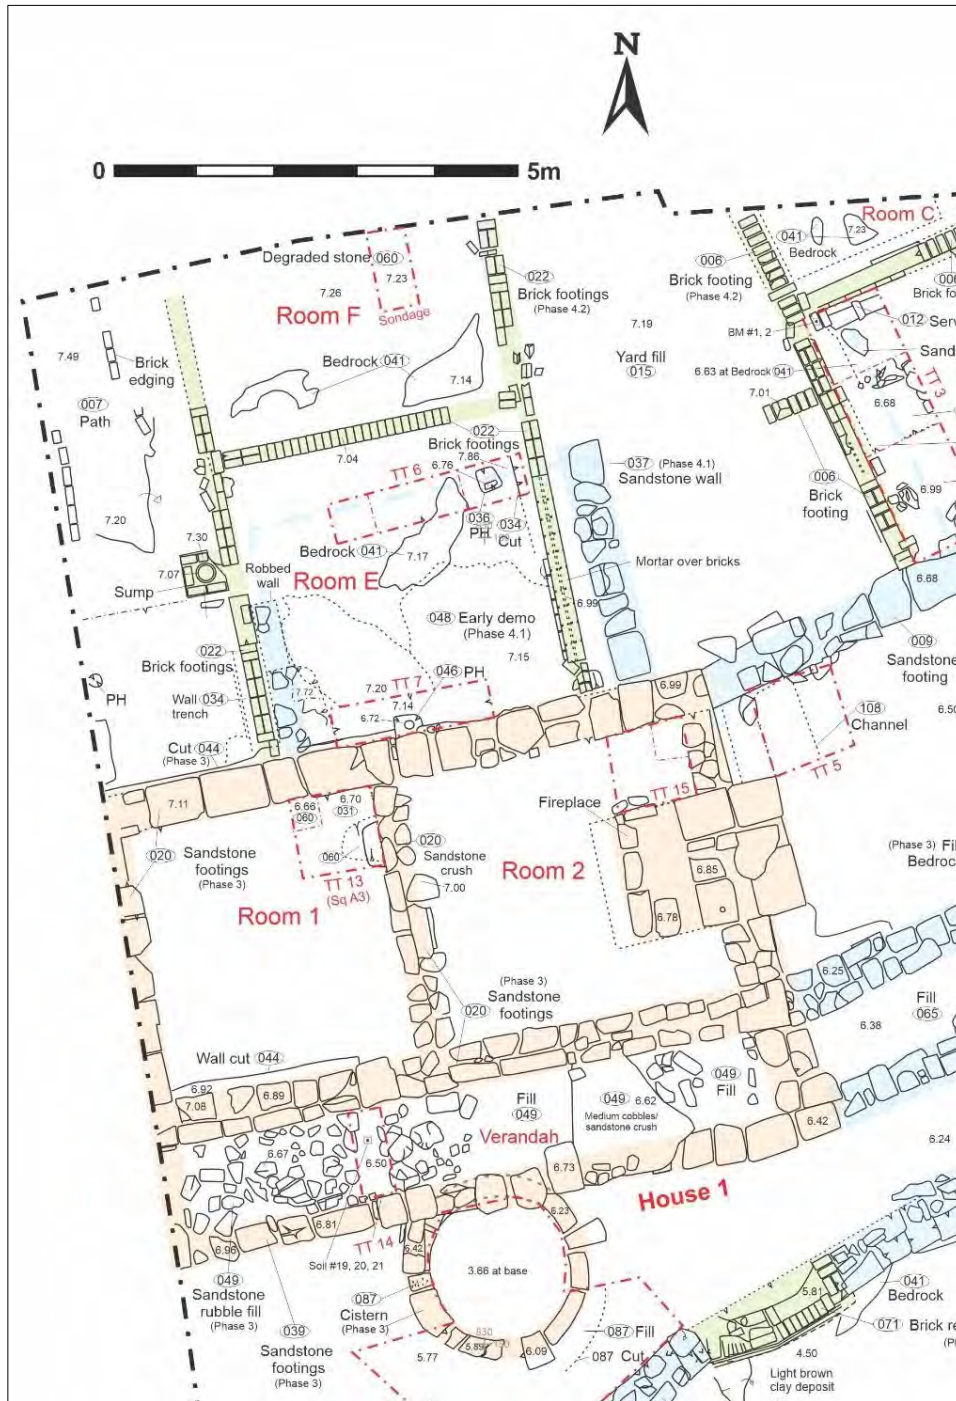
Figure 4.67: Detail of brick additions (022), Rooms E and F to the north of House 1 and bitumen path (007). Extract from Plan 2.1, Volume 3.

Room F had some slate damp proof coursing and cut through the natural yellow coloured degraded stone (060). There were some shallow sandy fills, no occupation deposits and pieces of bedrock jutting through. Service trenches and later pits (Phase 6) cut through this area.

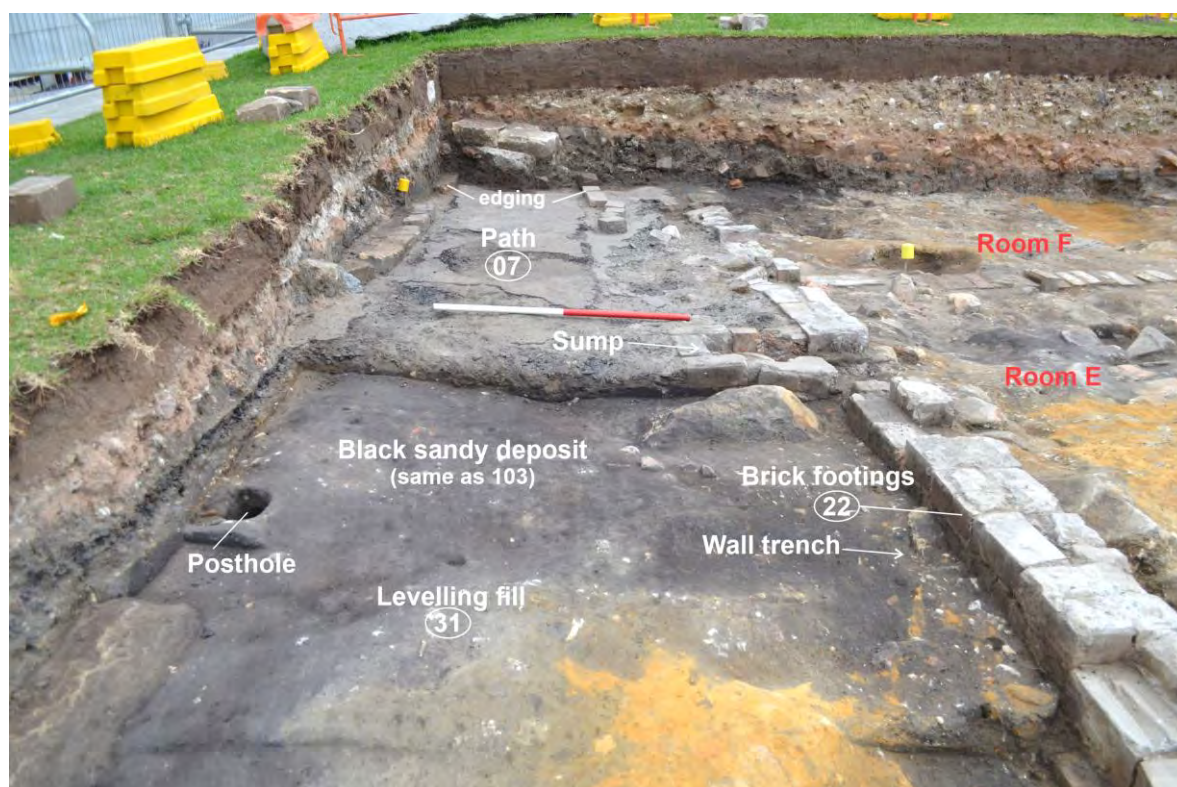
Figure 4.69: Bitumen path (007) to the west of House 1 abutting the brick additions (022). View to the north, scale 1m. DSC_4788.

A 4.2m long north-south bitumen path (007) ran along the western side of the brick additions (Figure 4.68, Figure 4.69). Two different layers of bitumen were visible. The upper bitumen layer was 30-40mm deep in an area 830mm wide with sandstock brick edging brick edging along the eastern side. The bricks were a reused mix of sandstock frogged bricks and machine-made bricks laid end to end with no mortar. The brick edging sat on an earlier bitumen surface that was wider (1.35m) abutting the walls of Rooms E and F. The lower bitumen was quite loose and crumbly and sat above the pre-house levelling fill (031) a mix of black sands and yellow clays sands, which were above the black historic A horizon (103). This bitumen path appears to have remained in use throughout the early 20th century.

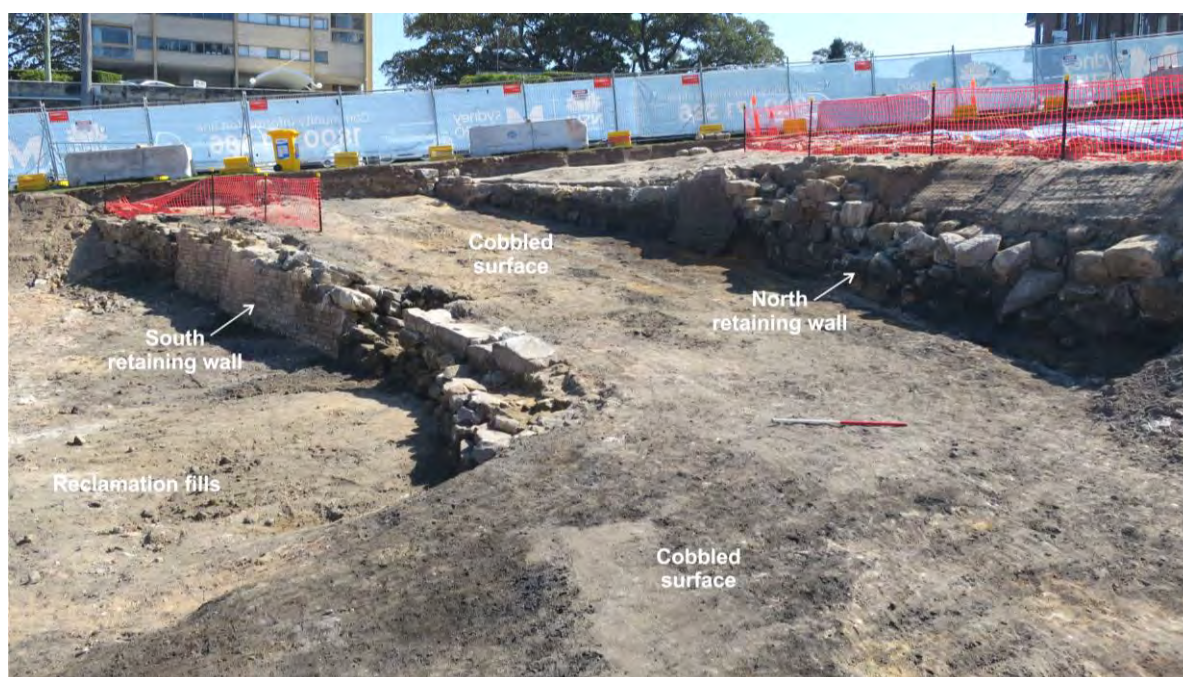
Figure 4.73: Reclamation of the beach between the high and low water marks. A second retaining wall was built to the south. An access road between the two retaining walls curved down slope towards the newly reclaimed foreshore and Stevens' jetty. Below the south retaining wall excavation ceased at the top of the reclamation fills at RL of 2.8m. View to northwest, scale 1m. IMG_1302.
