Archaeological Investigation
Temporary Works Site
Henry Lawson Reserve, Blues Point
May 2022

Sandstone foundations of mid-19th century cottages at Blues Point, Sydney (C&L 2018).

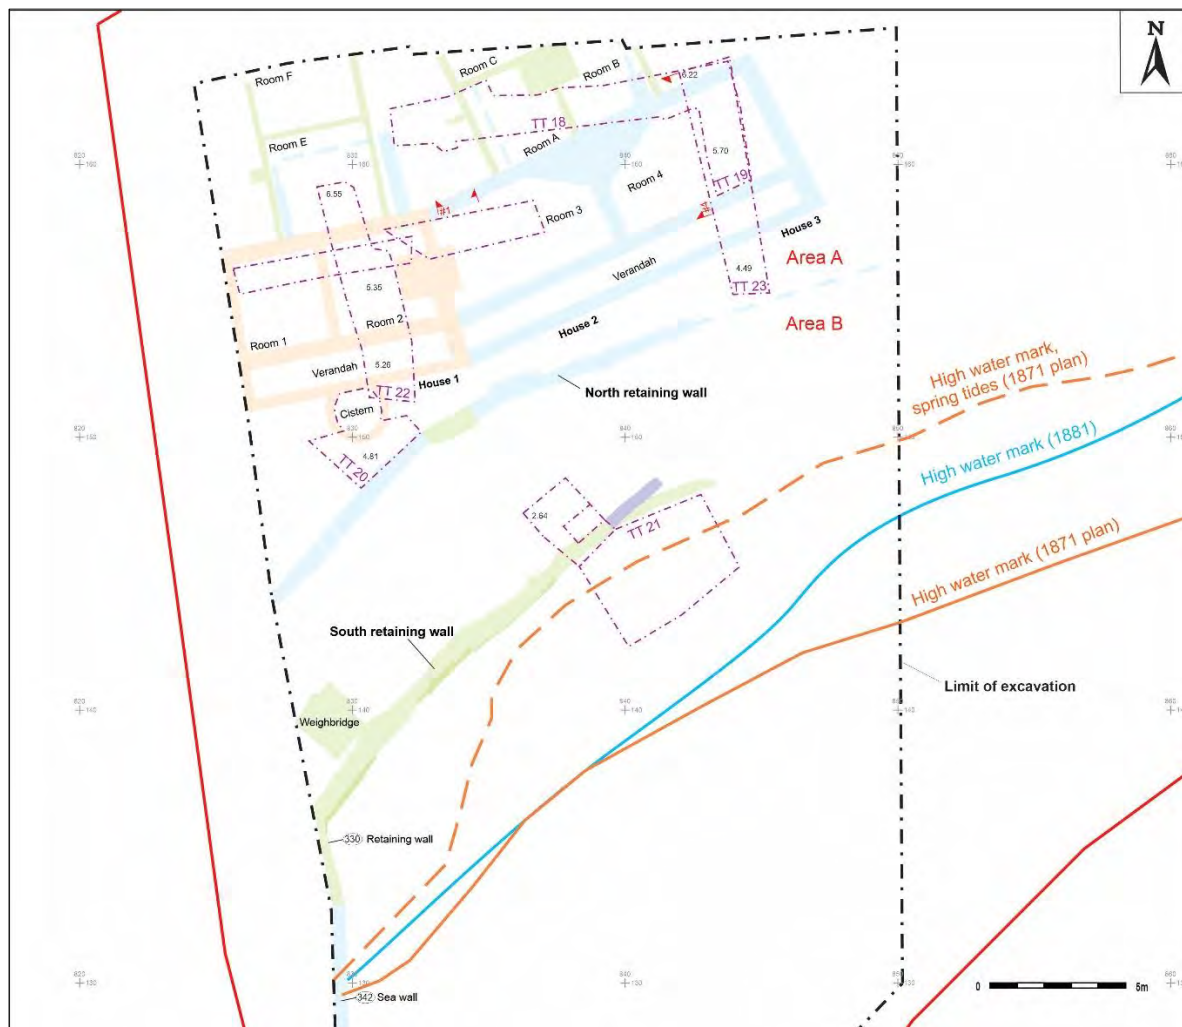
Figure 4.74: Schematic plan showing the location of the high-water marks from the 1881 plan (light blue) and the 1871 plan (purple) with Area B, south of the retaining walls. The dashed purple line represents the high-water mark of the spring tides also from the 1871 plan. Extract from Plan 11, Volume 3.

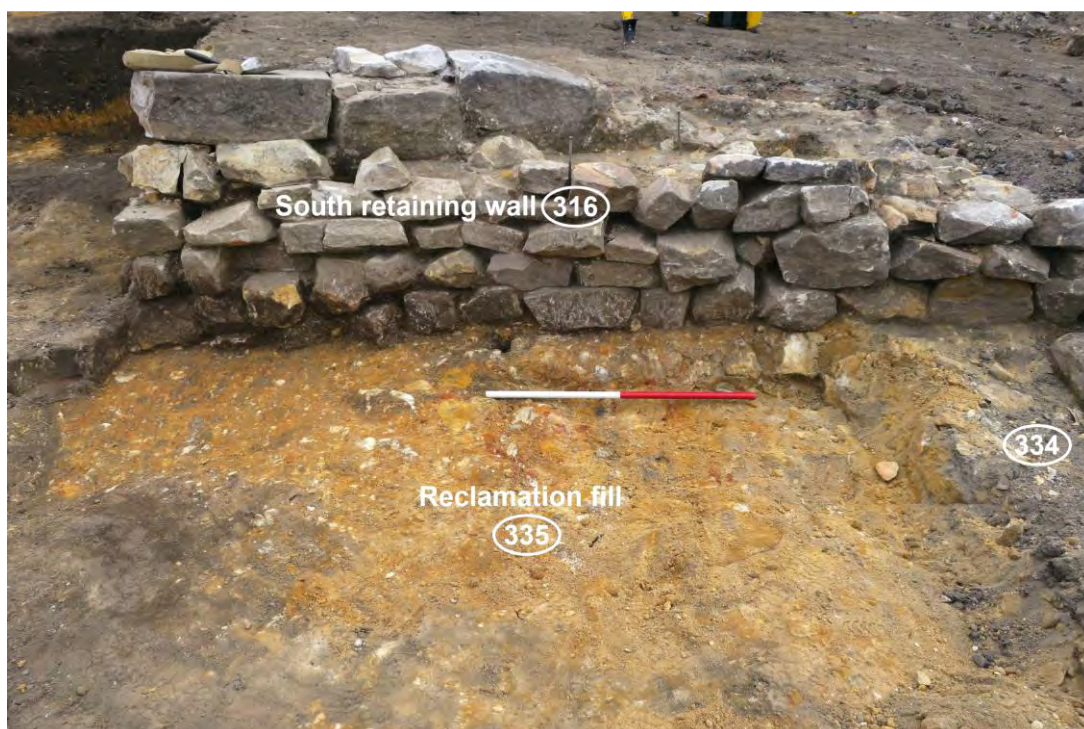
Figure 4.75: Yellow-brown sandy reclamation fill (335) with sandstone rubble. The eastern end of the south retaining wall (316) was built directly on top of the compacted bulk fill. Some remnant black industrial fill (334) to the right. View to north, scale 1m. IMG_1442.

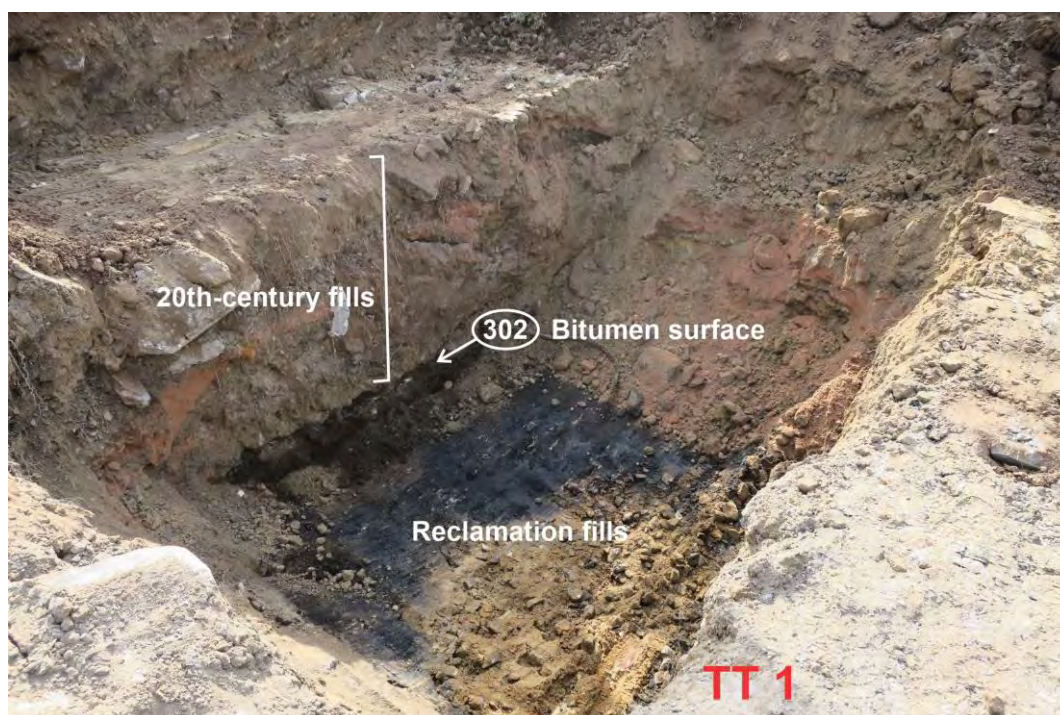
Figure 4.76: Machine excavated TT 01, below the modern (post-1960) fills was a bitumen surface (302) sitting above two reclamation fills, a black industrial waste fill and below it yellow-brown sandy rubble. View to northwest. IMG_1153.

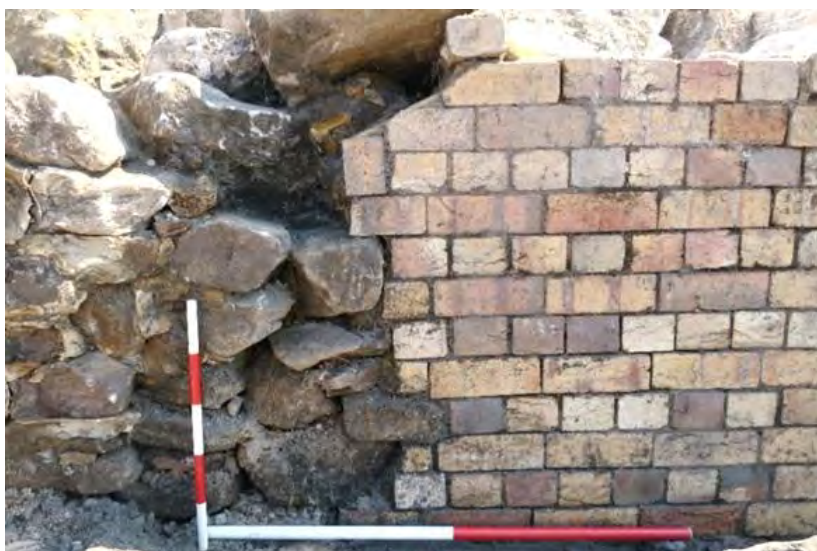
Figure 4.80: The bricks (321) were bevelled to key into the earlier sandstone wall (316) with smaller stones packed in to fill the voids. View to north, 50cm and 1m scales. IMG_1282.

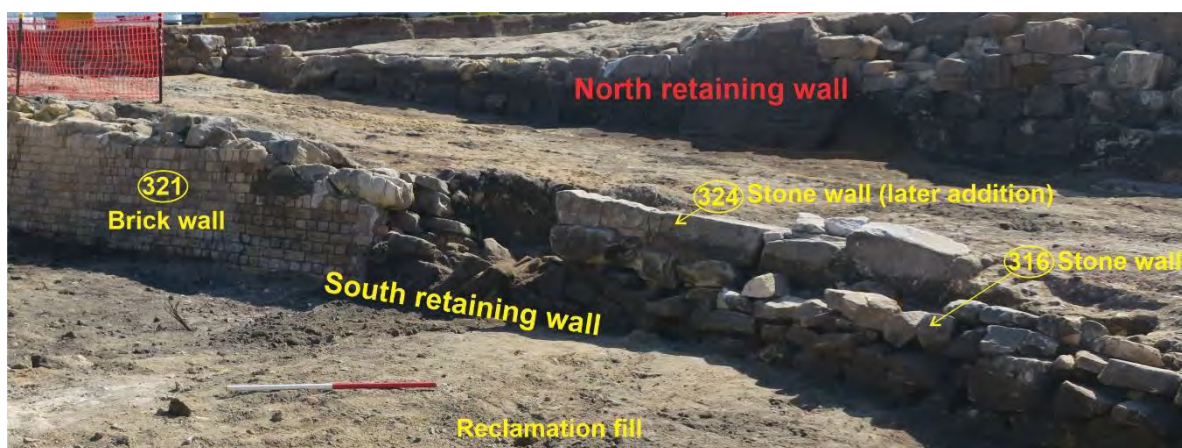
Figure 4.81: Detail of the eastern end of the south retaining wall (316) including the later modifications (321 and 324). View to northwest, scale 1m. IMG_1306.

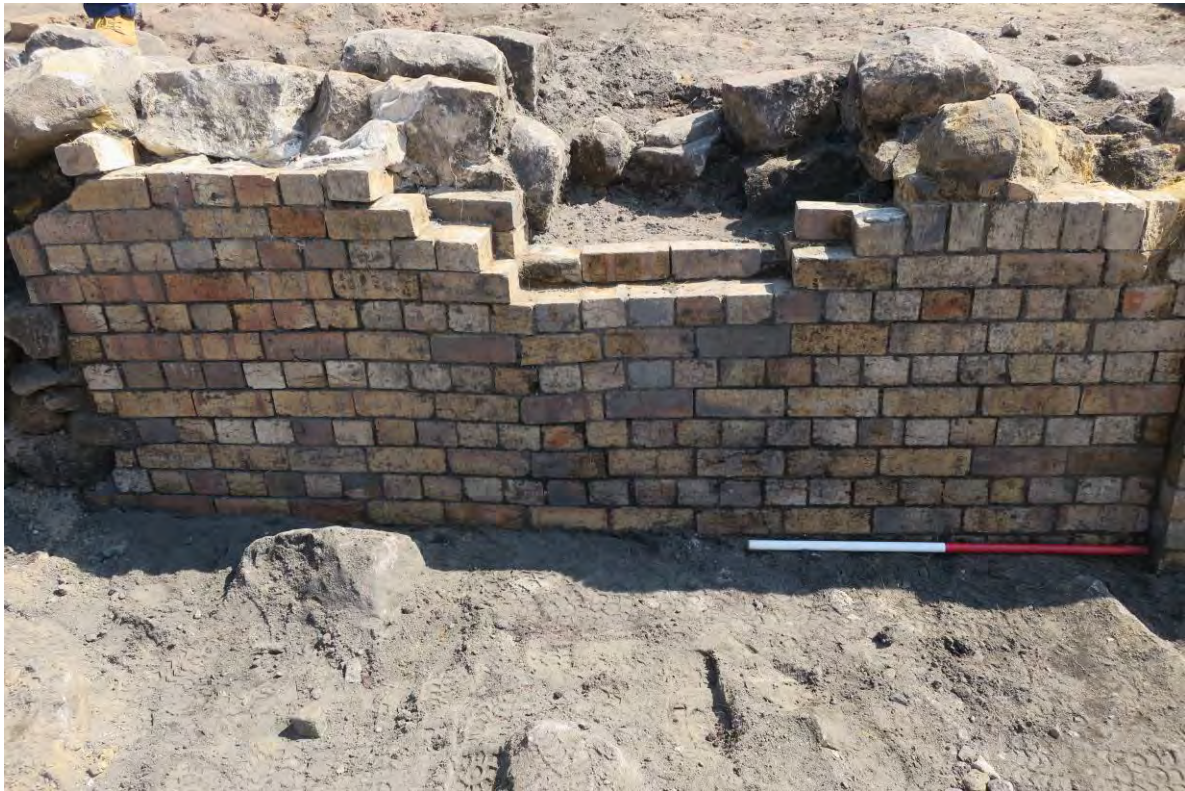
Figure 4.82: Portion of south retaining wall replaced with a later brick wall (321). View to north, scale 1m. IMG_1281.

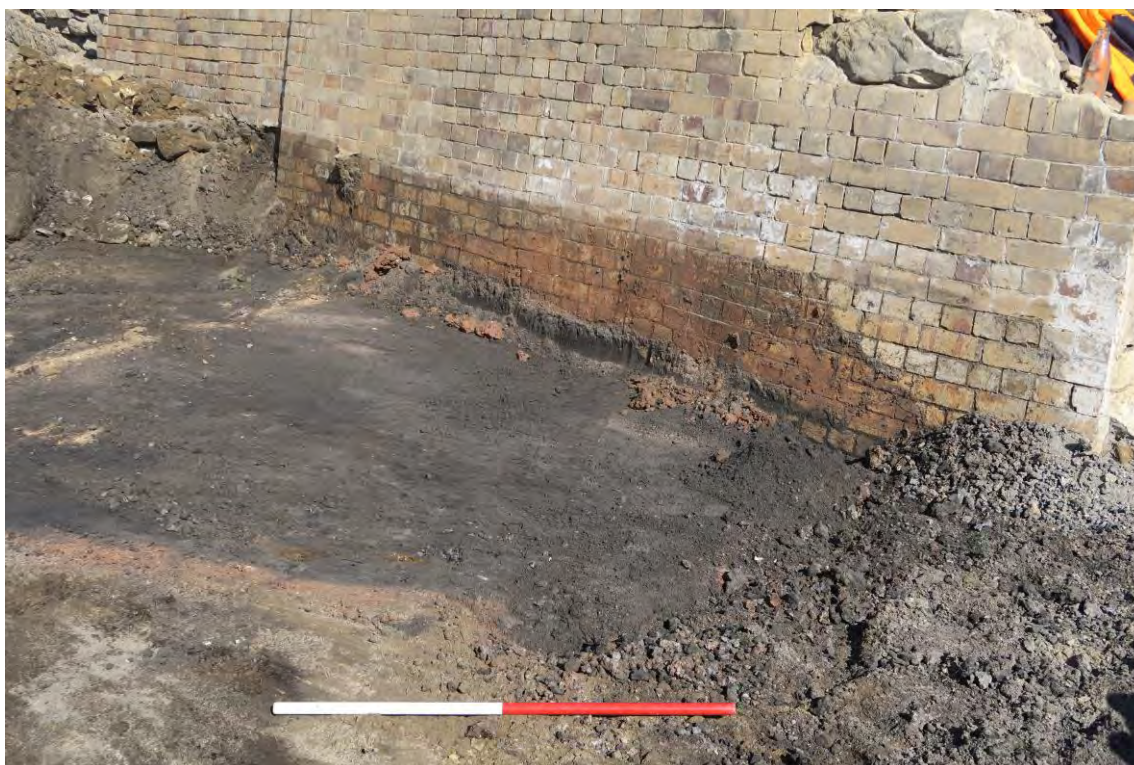
Figure 4.83: Machine excavation exposed more fills abutting the brick portion (321) of the south retaining wall. View to northwest, scale 1m. IMG_0057.

Monitored machine excavation to the south of the retaining wall took place on 10th October 2018 to ensure the RL of 2.8m was reached in this area. During machining more courses of the brick wall (321) were exposed, along with mixed clay fills and a grey-black industrial waste fill with slag and cinder inclusions (Figure 4.83). These were probably a levelling fill or potential surface above the reclamation fills, similar to what was found in TT 01.

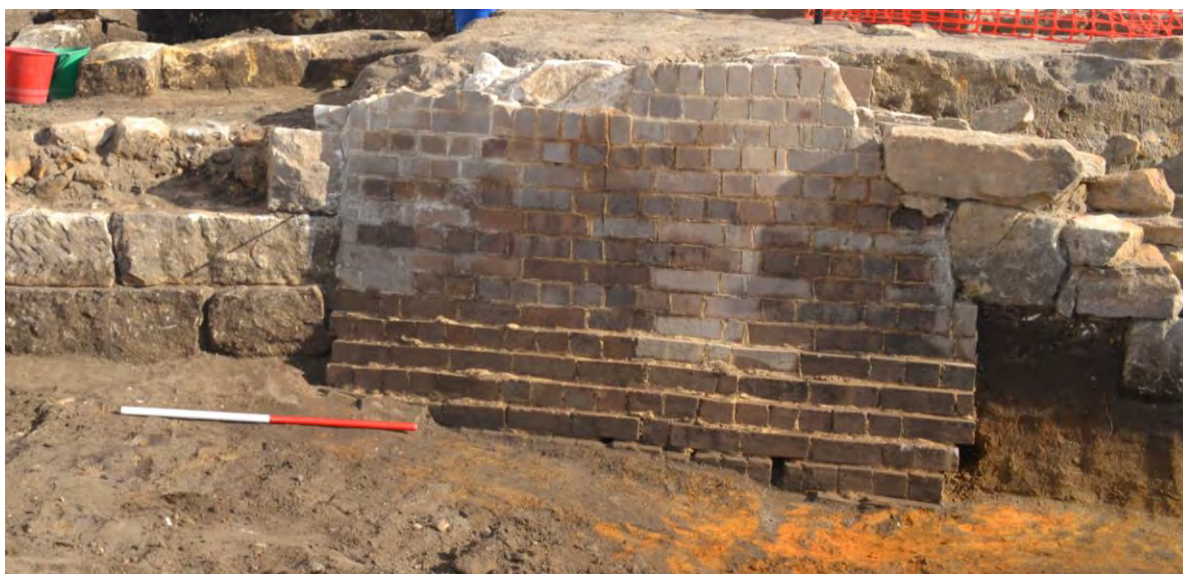
Figure 4.84: Detail of the brick segment (071) of the north retaining wall. View to northwest, scale 1m. DSC_4883.

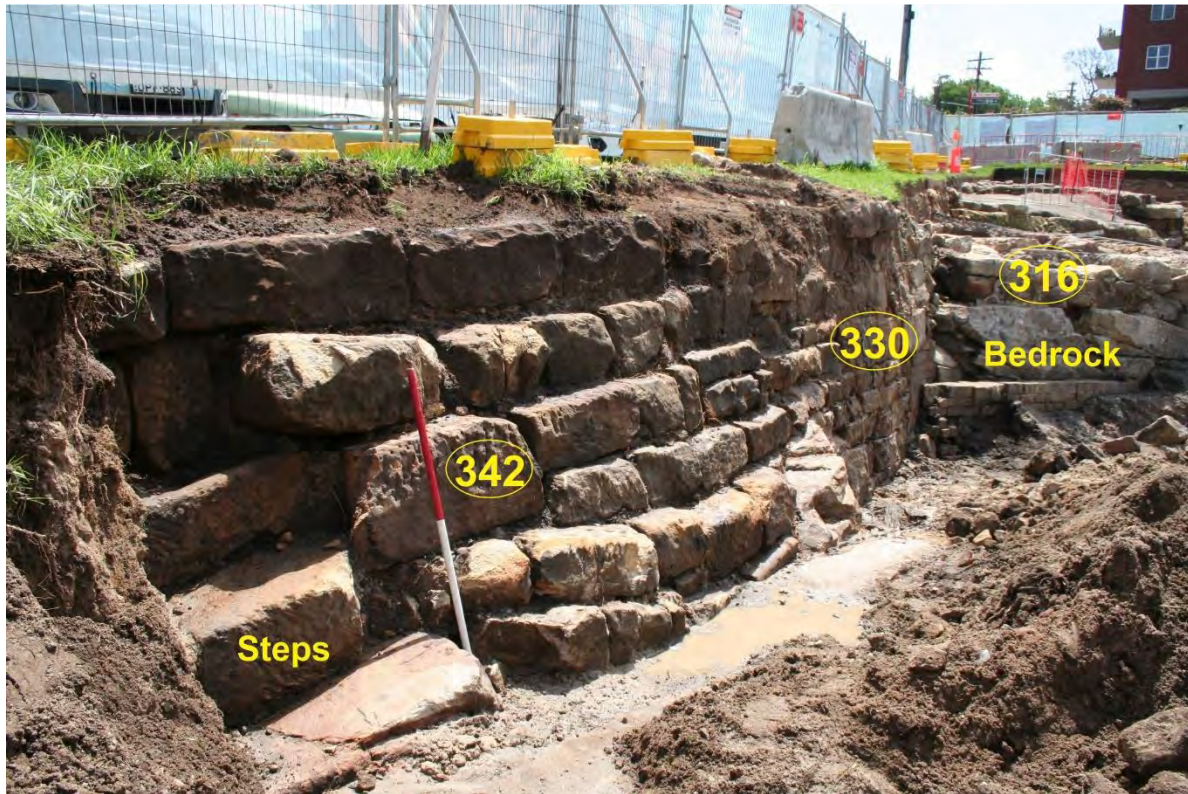
Figure 4.88: Different phases of north-south seawall and retaining wall (342 and 330) along the western edge of the site with steps in the foreground. View northwest, scale 1m. IMG_5603.

The earliest seawall found during excavation was given two separate context numbers (333 and 342) as was initially exposed in two separate stages but was later found to align and form part of the same wall. It's location and alignment corresponded with the western side of the seawall on the 1869, 1881 and 1891 plans (Figure 4.85). To the north it was bound by a later addition (330) in the 1880s which was constructed of both brick and stone. Section (330) then joined the south retained wall (316) which ran east-west (within the study area) (Figure 4.88). To the south wall (342) was renumbered wall (333) (Figure 4.87, Figure 4.88). Within the study area the length of the wall (342) exposed was c.5m. Wall (342) was constructed of large rectangular sandstone blocks (average size 560 x 360 x 300mm) laid end to end with each course slightly stepped in (80-100mm) from the course below, very different to the vertical coursing on wall (330). There was no mortar visible in the construction. Six courses of stone were exposed, the lower course was concave in shape. At the southern end of the exposed section of wall were three dressed sandstone blocks with tool marks forming steps to the water's edge (Figure 4.88).

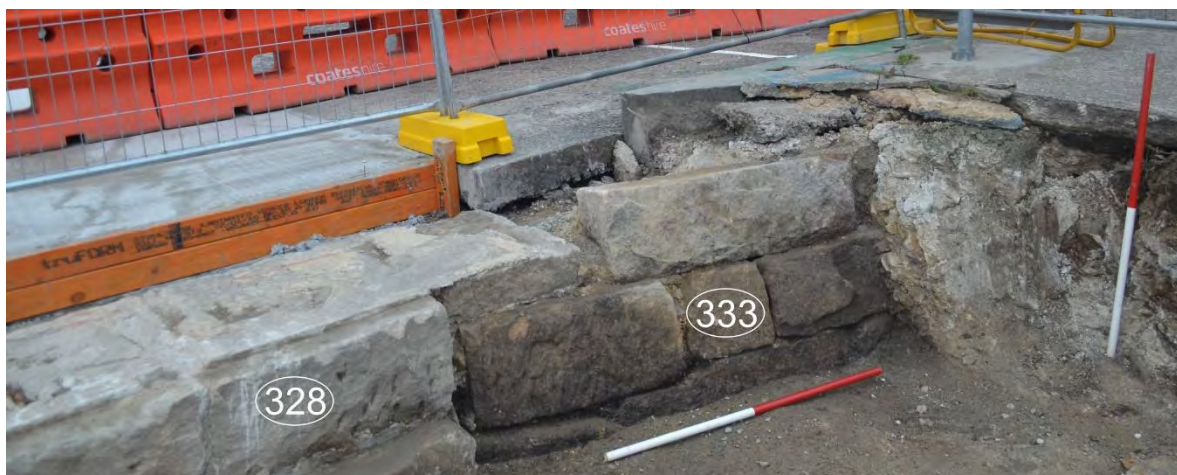
Figure 4.89: A small portion of seawall (333) below the footpath of Blues Pont Road but joined wall (342) above. A later wall (328) ran south on a different alignment. View to northwest, scale 1m. DSC_4911.

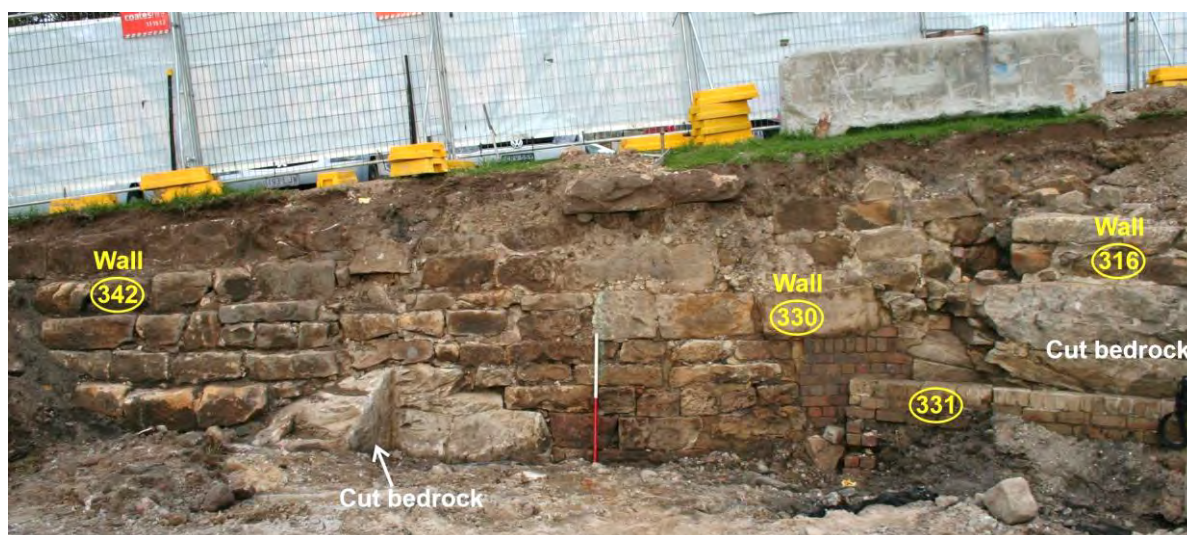
Figure 4.90: Different phases of wall construction, the earlier stepped seawall (342) and retaining wall (316) were joined with a short wall (330) constructed of bricks and stone. View to west, scale 1m. IMG_5620.

The 1891 plan (Figure 4.85) shows the north-south seawall and the south retaining were joined together. This would have corresponded with Stevens' land reclamation events in this area. A small segment of wall c.4m in length was distinctly different to the earlier stone wall (342) and was recorded as context (330) (Figure 4.90, Figure 4.91). The wall was constructed of both sandstone and machine-made bricks and reached up to 2.3m in height. At the northern end, where it joined the east-west end of the south retaining wall (316), it was irregularly built with machine-made bricks and rubble sandstone bonded to the south retaining wall (316) with a hard, dense grey lime sand (cement) mortar (BM samples #18, 20). Moving south the wall was more regularly constructed predominantly of sandstone blocks with occasional half sized dry-pressed bricks between the courses and bonded with a pale beige cement. Nine courses were visible. A large piece of cut bedrock separated wall (342) from wall (330) (Figure 4.90).

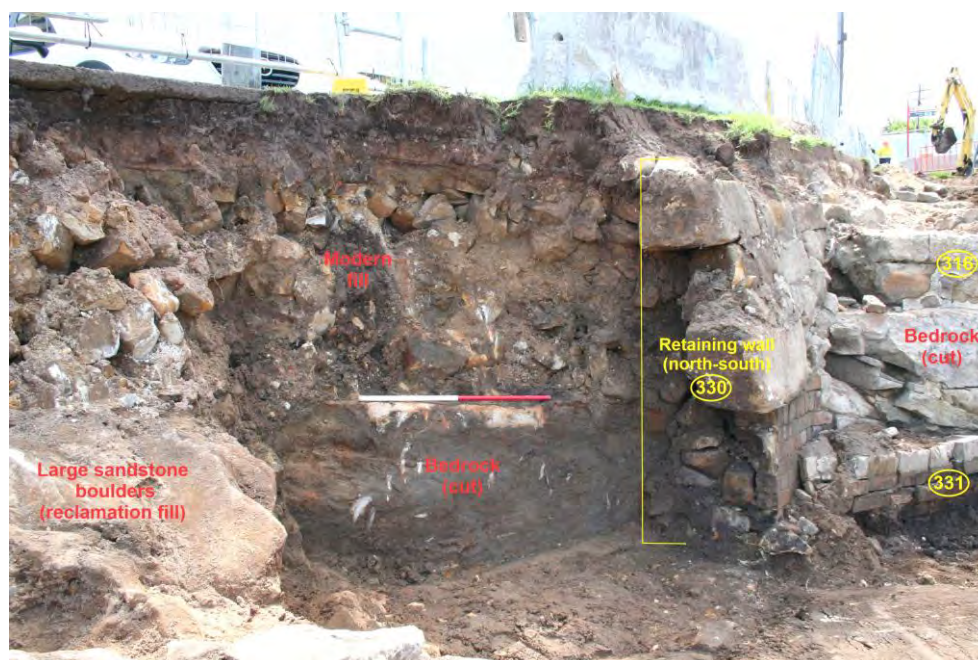
Figure 4.92: Cut bedrock, associated with the south retaining wall, continued to the southwest behind the wall (330) confirming this portion of the wall was a later addition. View to northwest, scale 1m IMG_5685.

On the 25th October 2018 the stone walls (330 and 342) along the western limit of the site were removed by machine and was monitored by an archaeologist to look for potential remains of the predicted earlier seawall. In the area behind wall (330) was a bulk yellow-brown sandy fill with sandstone rubble. At the base of the sandy fill were large sandstone boulders (c 900mm-1.2m in length) acting to retain lower fills. Gaps between the bedrock were filled with beach sands and occasional artefacts, all part of the reclamation event of the 1880s. Also, behind wall (330) was more cut bedrock. The cutting of bedrock to shape it was an earlier event while the wall in front of it was a later construction stage (Figure 4.92).

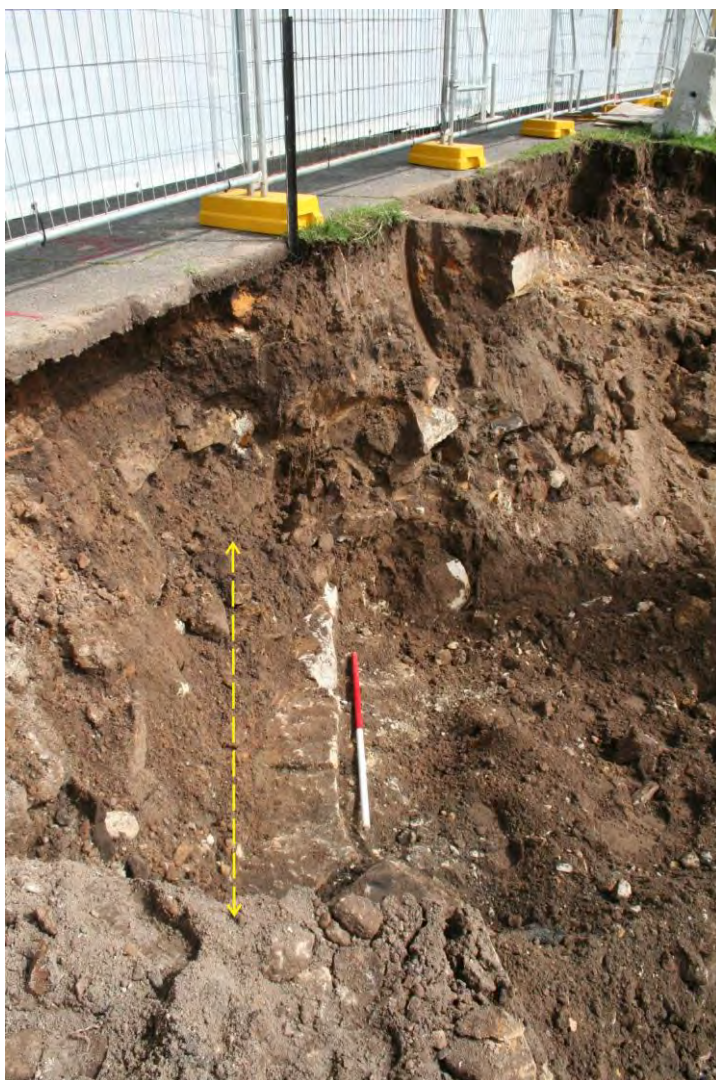
Figure 4.93: Small section of stone wall running northwest-southeast behind seawall (342). Only a small portion of wall survived but it continued to extend northwards below the Blues Point footpath. View to northwest, scale 1m. IMG_5651.

A small segment of an earlier seawall running northwest-southeast was exposed during machining behind wall (342) at a depth of 1.3m below the footpath along Blues Point Road (Figure 4.93). This earlier portion of wall pre-dated wall (342) and was only visible for a length of c.2m. It was on a completely different alignment to the other walls and could be associated

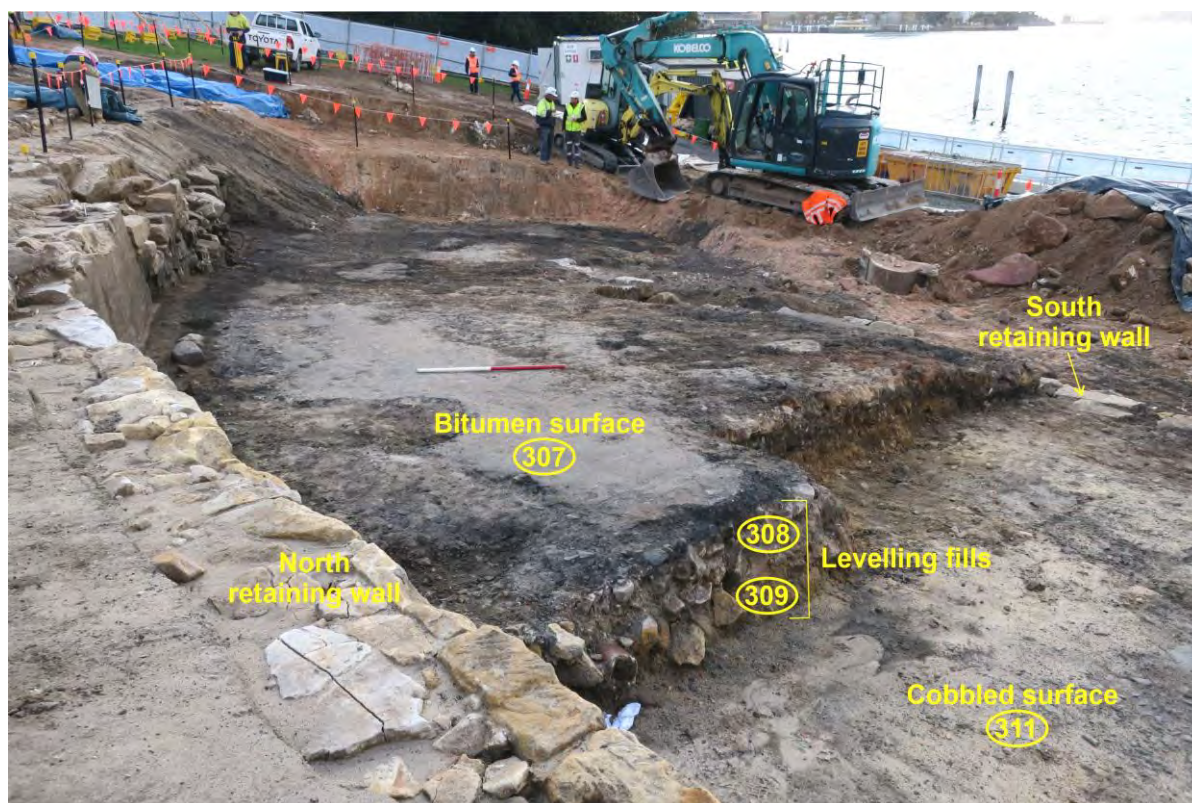
Figure 4.96: Different phases of road surfaces (311, 307) separated with levelling fills between the two retaining walls. The upper surface and fills were removed by machine. The roadway was still evident on the 1943 aerial (Figure 2.29) indicating it remained in use for at least 60 years. View southeast, scale 1m. IMG_1272.

Different phases and types of road surface were present between the retaining walls and followed the slope down to the east and then turning to the south (Figure 4.96). This access road was in use from the 1880s until the 1940s. The 1943 aerial shows both the retaining walls and roadway still extant as was Stevens' jetty, the western boundary wall and some structures on the reclaimed land close to the jetty (Figure 2.27). The three houses further north were demolished by this date and the vacant land was overgrown. The earliest cobbled surface (311) was a grey-black coarse sand compacted with angular stones (basalt) up to 70mm in length with small patches of bitumen in places (Figure 4.94). It abutted the light brown sand rubble fill (336) towards the south. Fill (336) was only found alongside the replacement brick wall (321) and may have post-dated or removed the cobbled surface in that area, further east where the roadway curved to the south, the cobbled surface (311) continued. Above the cobbled surface was 300mm of levelling fills (308, 309) laid in preparation for the later bitumen surface (307) (Figure 4.96) (see Phase 5). Context 323 was given to any unstratified fill and artefacts collected above the cobbles (311) but below the later levelling events for the next surface.

road surface and ground raising events were exposed along this roadway (Figure 4.96). The earliest cobbled surface (311) is discussed in Phase 4.2. Above the cobbled surface and between the retaining walls were two fills used to raise and level the ground for a later bitumen surface. The lower fill (309) was coarse grained sand with frequent rubble sandstone inclusions (c.150 x 150mm in size). The fill was 180-200mm deep. Directly above (309) and below the bitumen was a finer black-brown silty sand (308) with iron staining and small sandstone inclusions (<20mm), 100-130mm deep (Figure 4.96). Both of these fills were cut by the pipe trench (327) (Figure 4.113). Sealing the fills was a road surface (307). The top 10-20mm was compact asphalt sitting on 40-50mm of coarse blue aggregate road base. Directly above the asphalt surface were imported bulk levelling fills (315, 317) suggesting this surface remained exposed during the 1940s and 1950s until the site was changed into a public park.

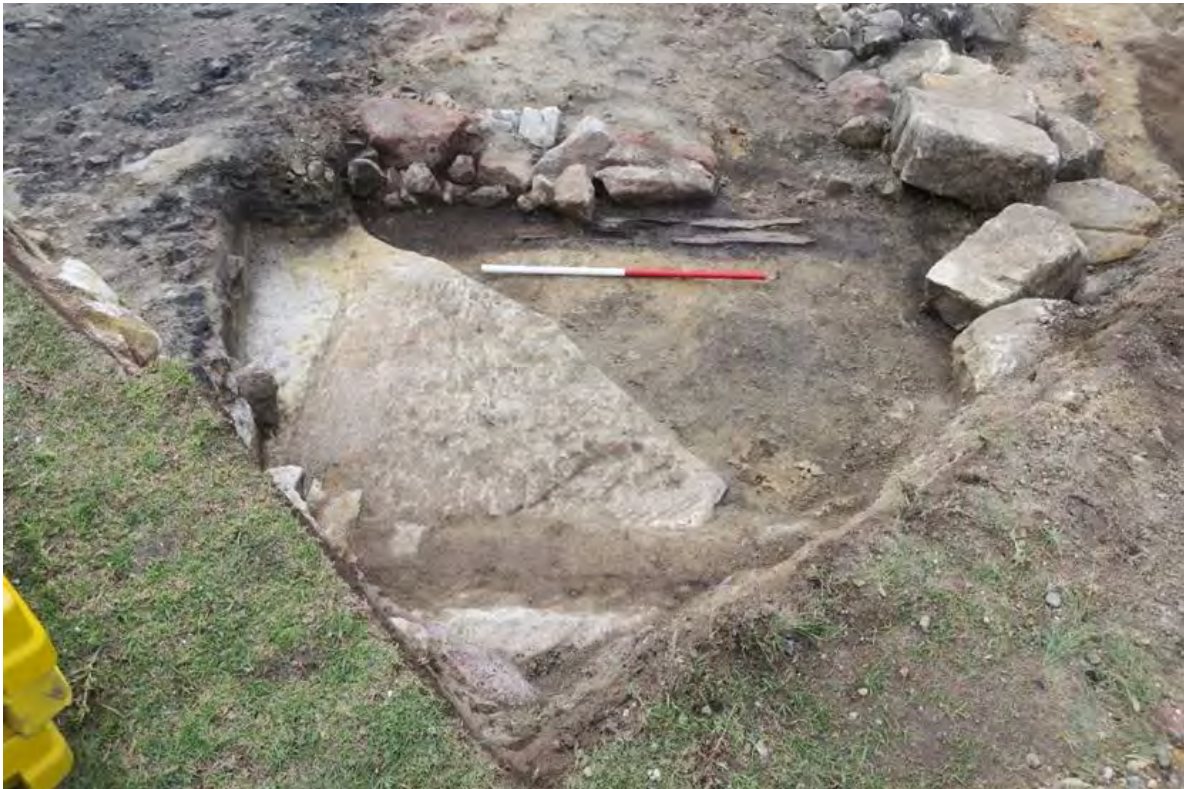
Figure 4.97: Remains of a weighbridge (322) close to Blues Point Road. This was labelled on the 1891 plan. View to east, scale 1m. IMG_1250.

bedrock (Figure 4.97, Figure 4.98). The perimeter walls of the structure were a combination of sandstone, concrete, timber and lead sheeting. The eastern edge was formed with rubble sandstone. The eastern half of the structure was backfilled with two different fills (325, 326) sitting above the bedrock (Figure 4.97), at RL 5.06m. The uppermost fill (325) was a fine yellow sand with no inclusions or artefacts (30-240mm deep). The lower fill (326) was loose dark grey sand, gravelly inclusions and occasional artefacts up to 250mm in depth.

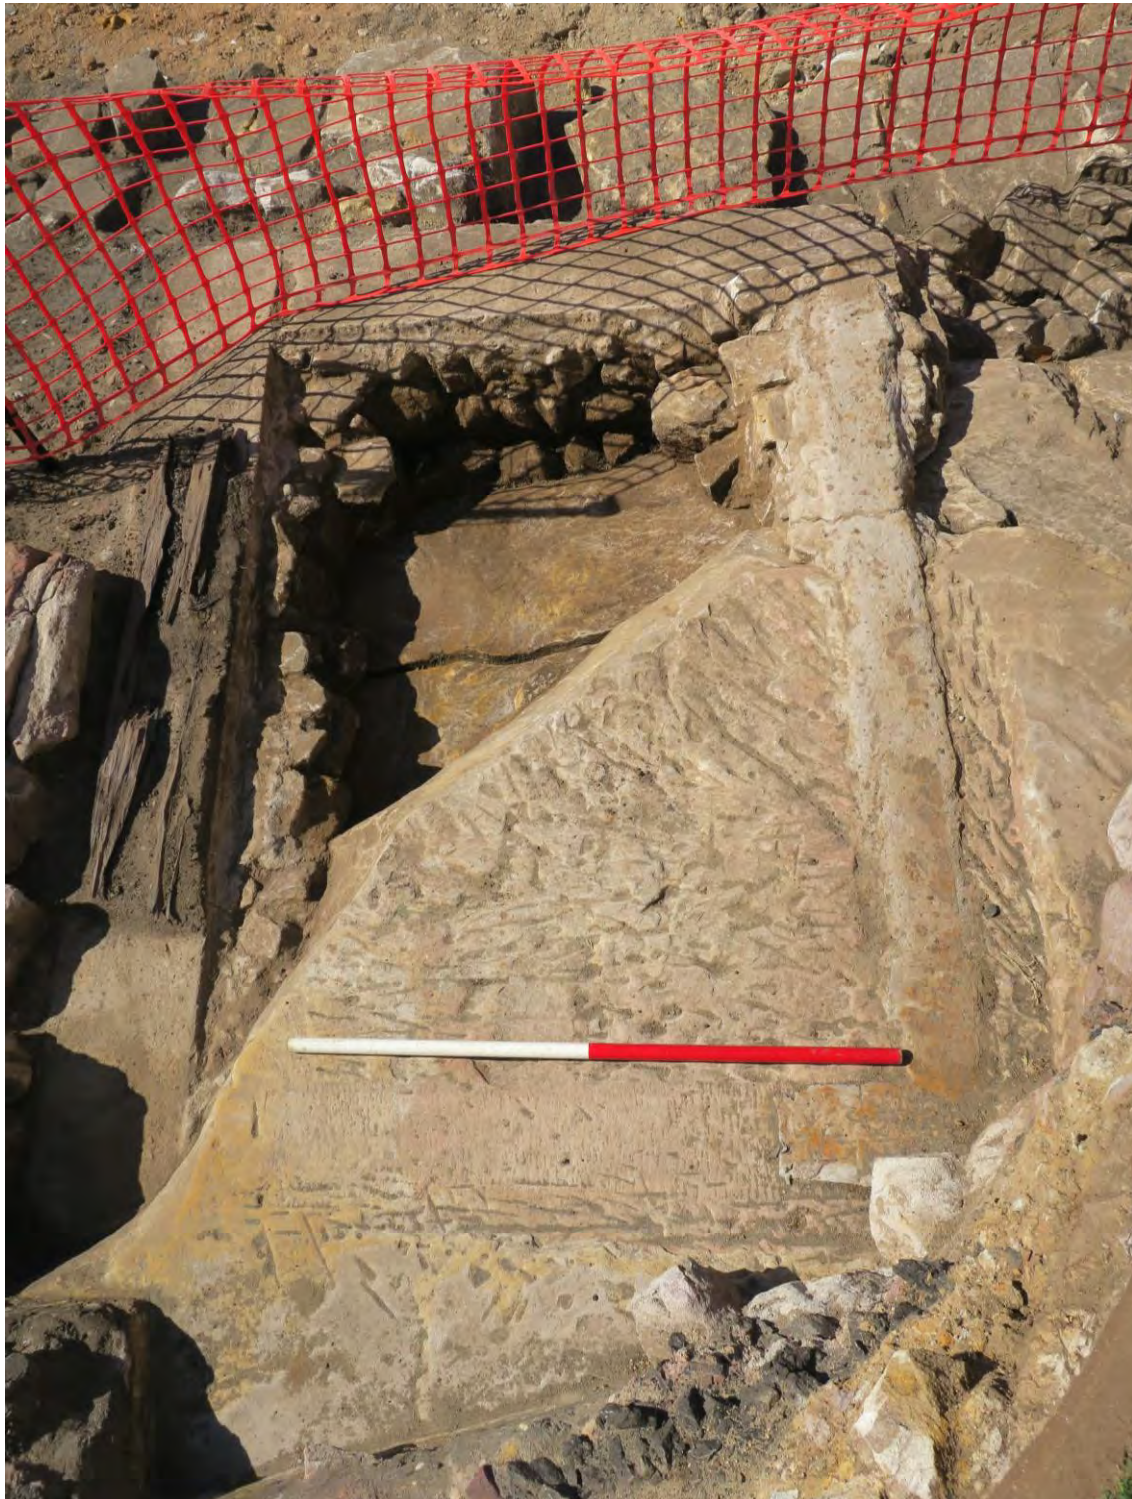
Figure 4.98: Base of weighbridge (322) cut into the bedrock with a concrete and timber frame. South retaining wall in the background (behind the safety fence). View to east, scale 1m. IMG_1310.

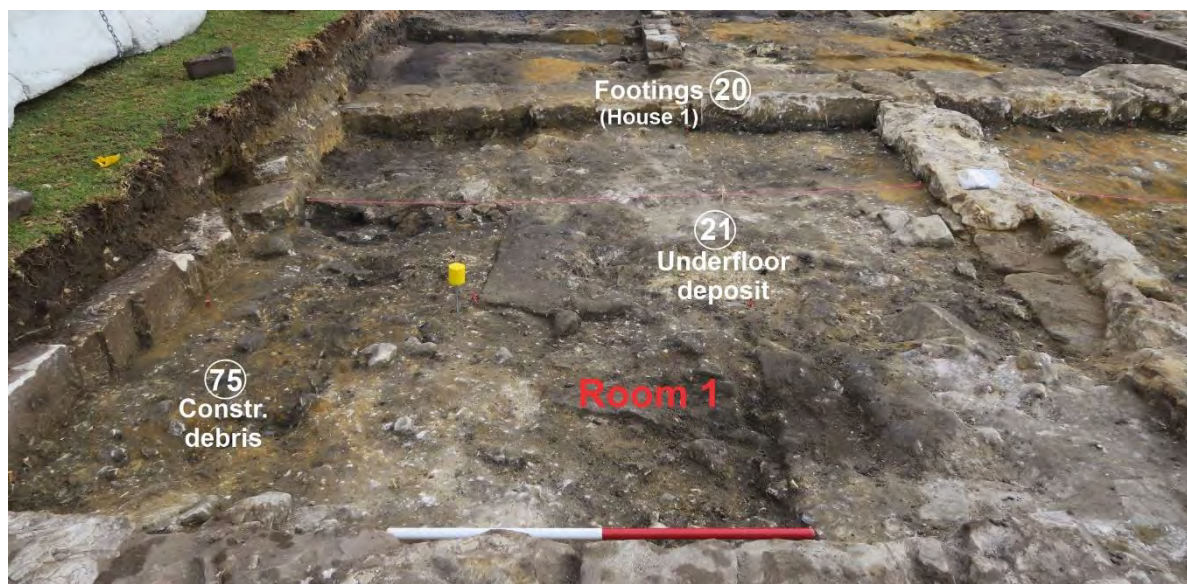
Figure 4.108: Room 1, House 1 in the foreground. This photo is a mid-excitation working shot showing the removal of the dark brown silty underfloor deposit (021) in 50mm spits within a 1m x 1m grid. View to north, scale 1m. IMG_9832.

The underfloor deposit within Room 1, House 1 was a dark brown sandy silt (021), it was patchy in places, varying in thickness from 3mm up to 100mm (Figure 4.108). In the northern half of the room the deposit sat above pre-house levelling fills (031, 083) which were either a black gravelly sand or mottled yellow-brown sand. Room 1, at the front of the house did not contain the same concentration of artefacts as found in Room 2 (rear). Along the southern edge of the room was a small concentration of finds, notably coloured beads probably from the same piece of broken jewellery. A large amount of rubble material including brick fragments and sandstone blocks were found in the southeast corner of the room, the stones were probably collapse from the internal partition wall. In both rooms below the underfloor deposits was patches of remnant construction debris (075).

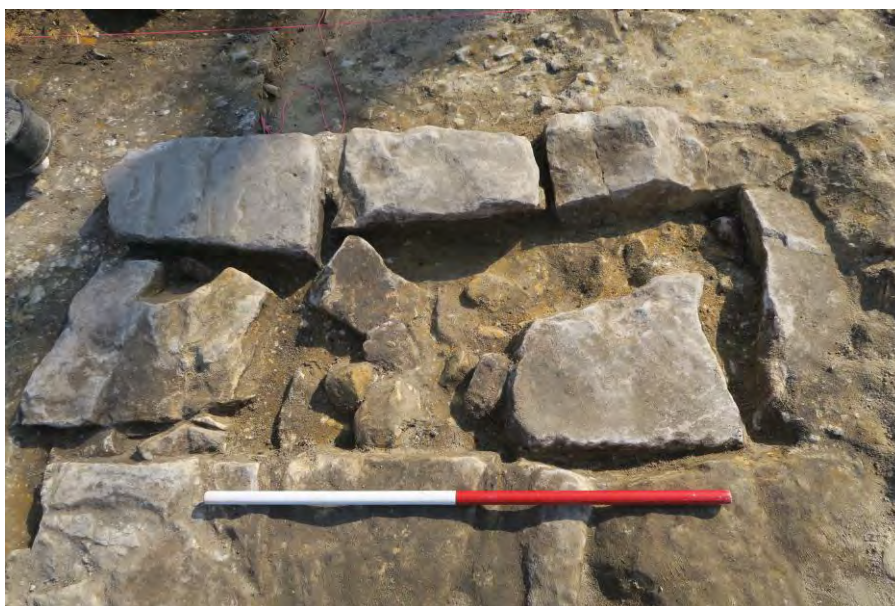
Figure 4.110: Detail of the fireplace in Room 2, House 1 after the fireplace fill (069) was removed in spits. View to west, scale 1m. IMG_9871.

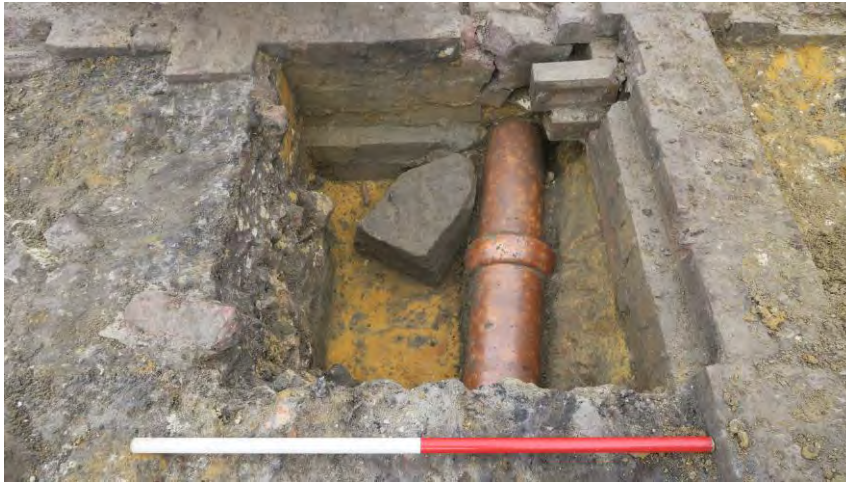
Figure 4.111: East-west service pipe (012) cutting through the brick footings of Room A, House 2 and into the bedrock, within TT 03. View to west, scale 1m. IMG_9504.

With the installation of the sewer line to the North Sydney area from the 1890s there was clear evidence of houses within the study area being plumbed into the mains. A large salt glazed clay pipe (012) ran in an east-west direction cutting through the brick foundations (006) of the north additions to the houses (**Error! Reference source not found.**, Figure 4.111). The pipe was 180mm in diameter with cement used to seal the collars. The trench for the pipe was 500mm deep below the top of the brick footings (006) cutting through the lower courses of brick and was 300mm wide. It also cut into the bedrock, presumably to achieve an adequate fall (Figure 4.111). The same pipe was evident further west cutting the brick foundations (022) associated with Room F to the north of House 1. The extent of this pipe further to the east was not exposed.

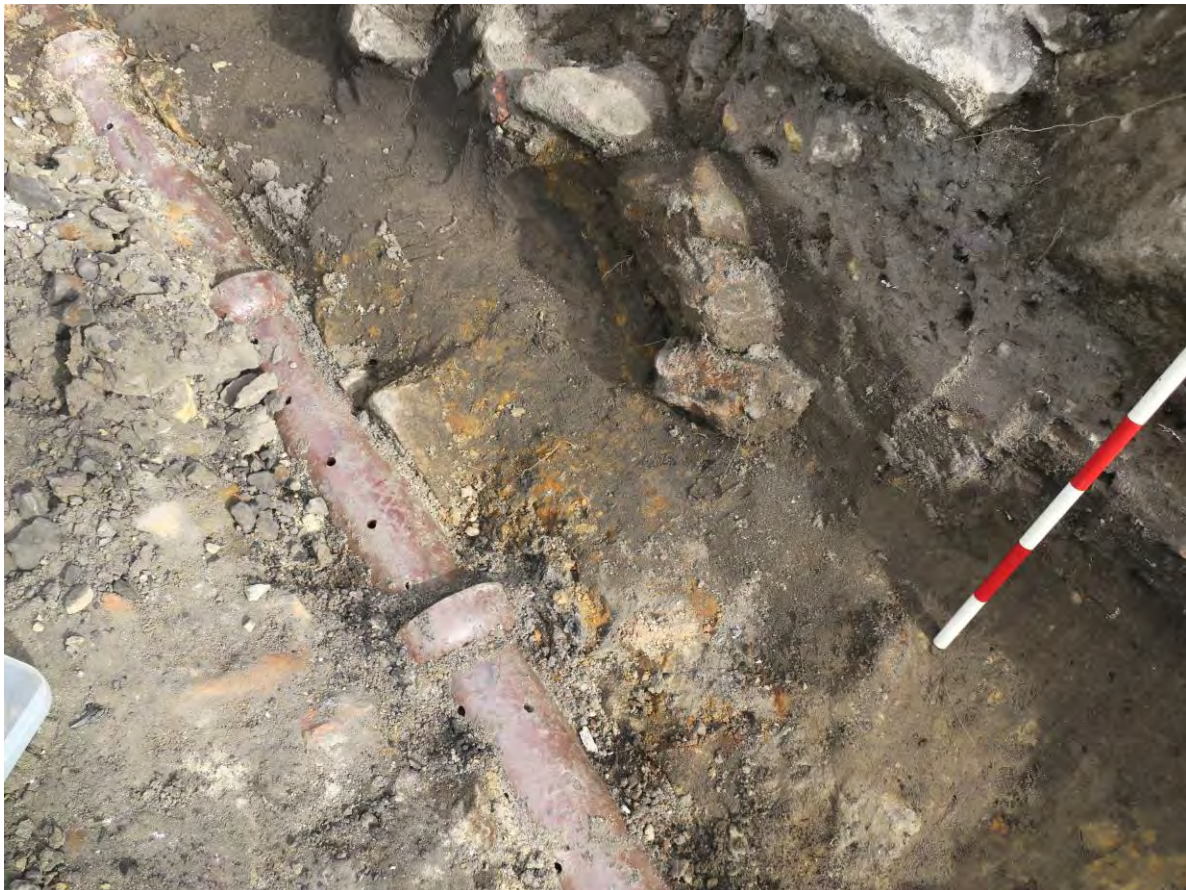
Figure 4.113: Segment of pipe with holes (327) running along the access road below the north retaining wall. Scale 500mm. IMG_1366.

and continued to the east with c.5m of it exposed in length. The ceramic pipe (185mm diameter) was drilled with two rows of small circular holes running the length of the top of the pipe (Figure 4.113). These holes were 95-120mm apart. The glaze on the pipe was visible within the holes indicating they were intentional and part of its manufacture and not a later addition. Each segment was joined with a firm yellow-orange sand packed in around the collar. These holes apparently were made to assist with surface drainage or runoff from higher up the slope to catch excess water and help prevent erosion of the roadway. Above the pipe and in the backfill of the pipe trench was a loose, gravelly purple-red industrial waste fill (320) with frequent slag inclusions (<30mm). This would have aided drainage and free flowing water.

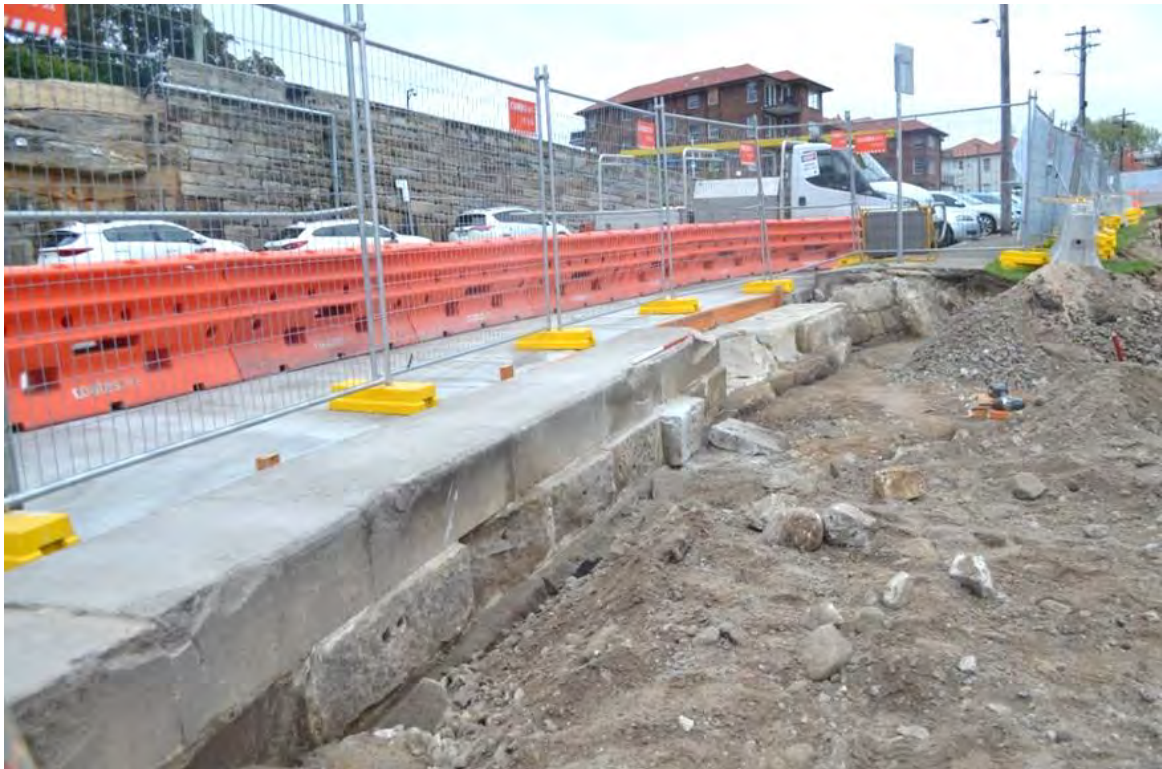
Figure 4.115: Different phases of sandstone seawall along the edge of Blues Point Road. The upper row of dressed blocks formed the edging of the present-day footpath and was bonded with concrete to the lower courses. The grey sandy rubble fill abutting the wall to the east is context (329). View to northwest, 1m scale. DSC_4921.

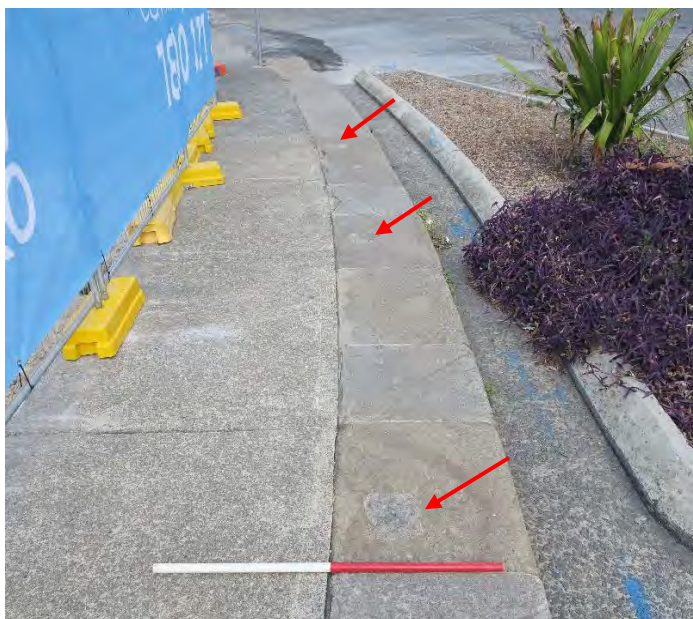
Figure 4.116: Wall (328) formed the edge of the kerb along the Blues Point Road footpath. Small square postholes (arrows), from an earlier fenceline were evident along the sandstone blocks, now filled with concrete. View to south, scale 1m. IMG_1323.

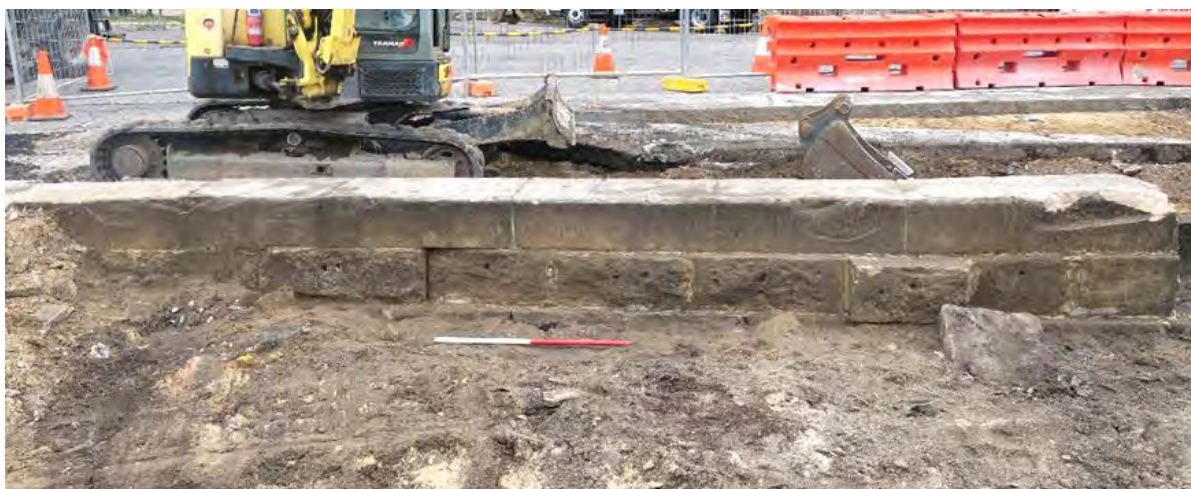
Figure 4.117: Upper courses of the seawall (328). The top row of dressed blocks was built into the footpath. View to east, 1m scale. IMG_1393.

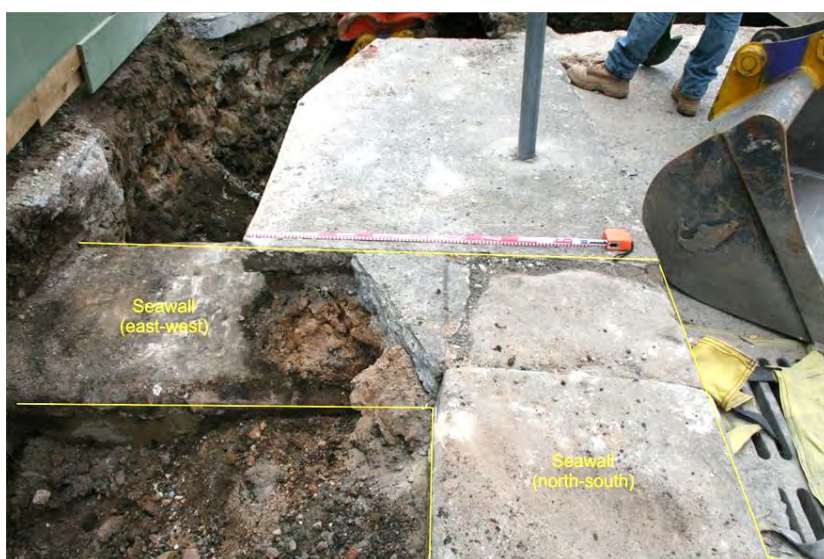
Figure 4.118: Eastern return to wall (328) within a modern service trench. The walls formed a right angle. Both walls contained large dressed sandstone blocks. View to south, scale 1m. IMG_5720.

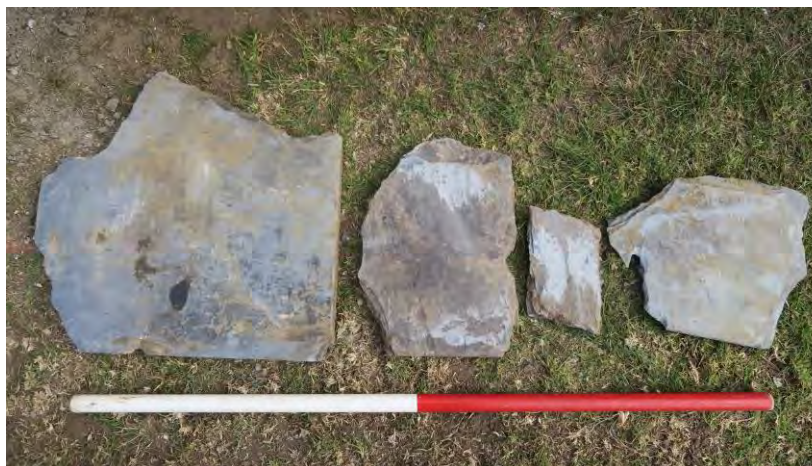
Figure 4.121: Detail of the dressed slate fragments recovered from the demolition debris (019) in Room 1. The thickness and finish to the slate suggests it may be from a mantelpiece. Scale 1m. IMG_9534.
