Archaeological Investigation
Temporary Works Site
Henry Lawson Reserve, Blues Point
May 2022

Sandstone foundations of mid-19th century cottages at Blues Point, Sydney (C&L 2018).

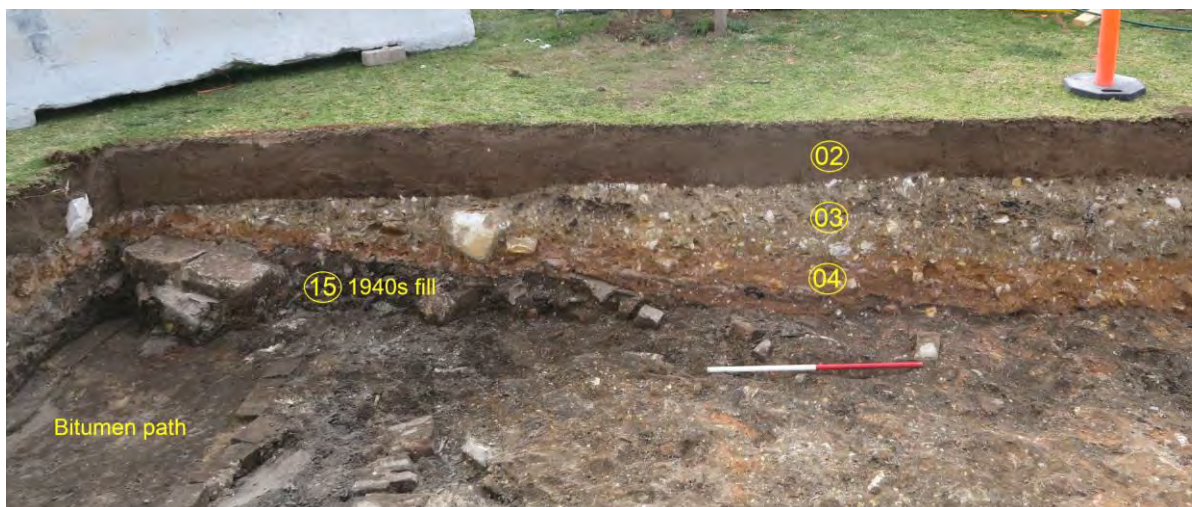
Figure 4.124: Northwest corner of the study area showing the garden soil and fills in the south-facing section above House 1 post-1860s. These fills got a lot deeper towards the south and east, as the ground level sloped away from this corner. View to north, scale 1m. IMG_9450.

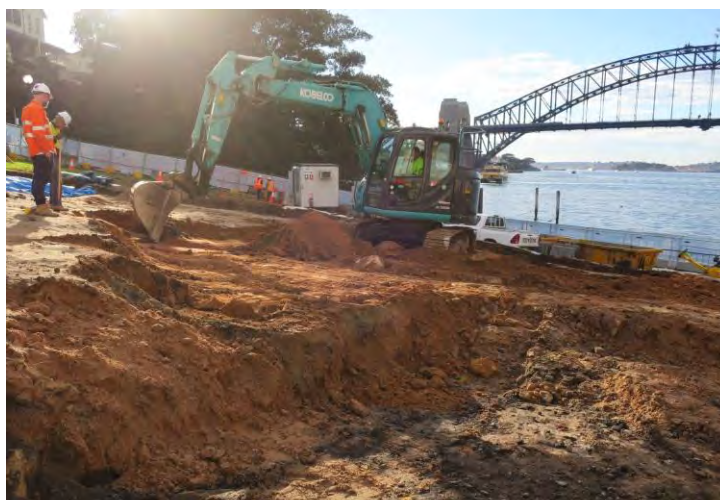
Figure 4.125: Excavation of the 20th-century bulk fills within the study area.

Top: Removal of fills (315 and 318) from the centre of the site above the retaining walls. View east. IMG_1242.

Bottom: Light grey bulk fill (328) above seawall (333) and extended eastwards. The garden soil was recorded as context (319). View north, scale 1m. IMG_1398.

commencing works (Figure 1.3). Above the bulk fills was 200-300mm of mid-dark brown loamy garden soil (002, 319) covered with grass (Figure 4.124, Figure 4.125). Different context numbers were given to bulk fills in both Area A and Area B but the stratigraphy was similar across both areas (see Table 4.4). The modern fills were removed by machine excavation and 139 artefacts were collected during the machine excavation and clean-up process (context 301).

The largest levelling fill across the site was a mixed orange and pinkish-red sandy fill that sat directly above the archaeological remains (Figure 4.125). The fill contained sandstone rubble of varying sizes with some boulders as large as 1.5m x 1m. It was only 250mm deep in the northwest corner of the site (004) but extended in depth as it continued towards the south (315, 318), (Figure 4.124). Within TT 01 the same two fills were found above a bitumen surface, a mix of loosely light grey sandy fill and a red-pink sandy fill both containing large rubble stones and were recorded together as context (306) (Figure 4.76). To the south of the north retaining wall was an isolated 20th-century fill (317). This localised fill or dump (317) varied in depth from 100-600mm and pressed up against the retaining wall in places and was above the c.1940s road surface (307). It was black silty sand with small sandstone rubble inclusions and contained whole brown beer bottles with 1955 dates, fragments of timber and rusted tin cans and may have been dumped while the site was used for storage or the beginning of backfilling to make a park. A similar localised sandy fill (310) was found in the northwest corner of Area B above the roadway to the jetty. The sand was fine and relatively clean and may just be a runoff accumulation from the slope above prior to the bulk levelling fill events.

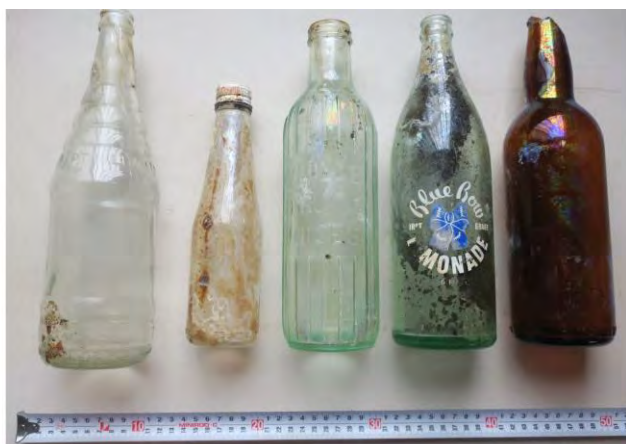
Figure 4.126: 1960s bottles from the bulk ground raising fills, discarded on site. IMG_1378, 1385.

Below the imported garden soil were two main ground raising fills. They were given different context numbers in each area. The uppermost fill (003, 329) was mixed whitish-grey sand and yellow sand with rubble stone, some broken pipes, broken concrete and timber pieces. In the southwest corner of the site this bulk fill (329) extended under the current footpath and covered an earlier seawall (333). During machining a large number of amber coloured beer and wine bottles were found in this fill (329) and marked “the property of the NSW Bottle Co Pty Ltd” with a 1968 date confirming the deposition date of this fill to the late 1960s or early 1970s. Other types of 20th-century refreshment bottles were also found and photographed but not retained (Figure 4.126).
