# **SITE AUDIT REPORT**

# **WATERLOO STATION,**

# **150 AND PART 140**

# **COPE STREET,**

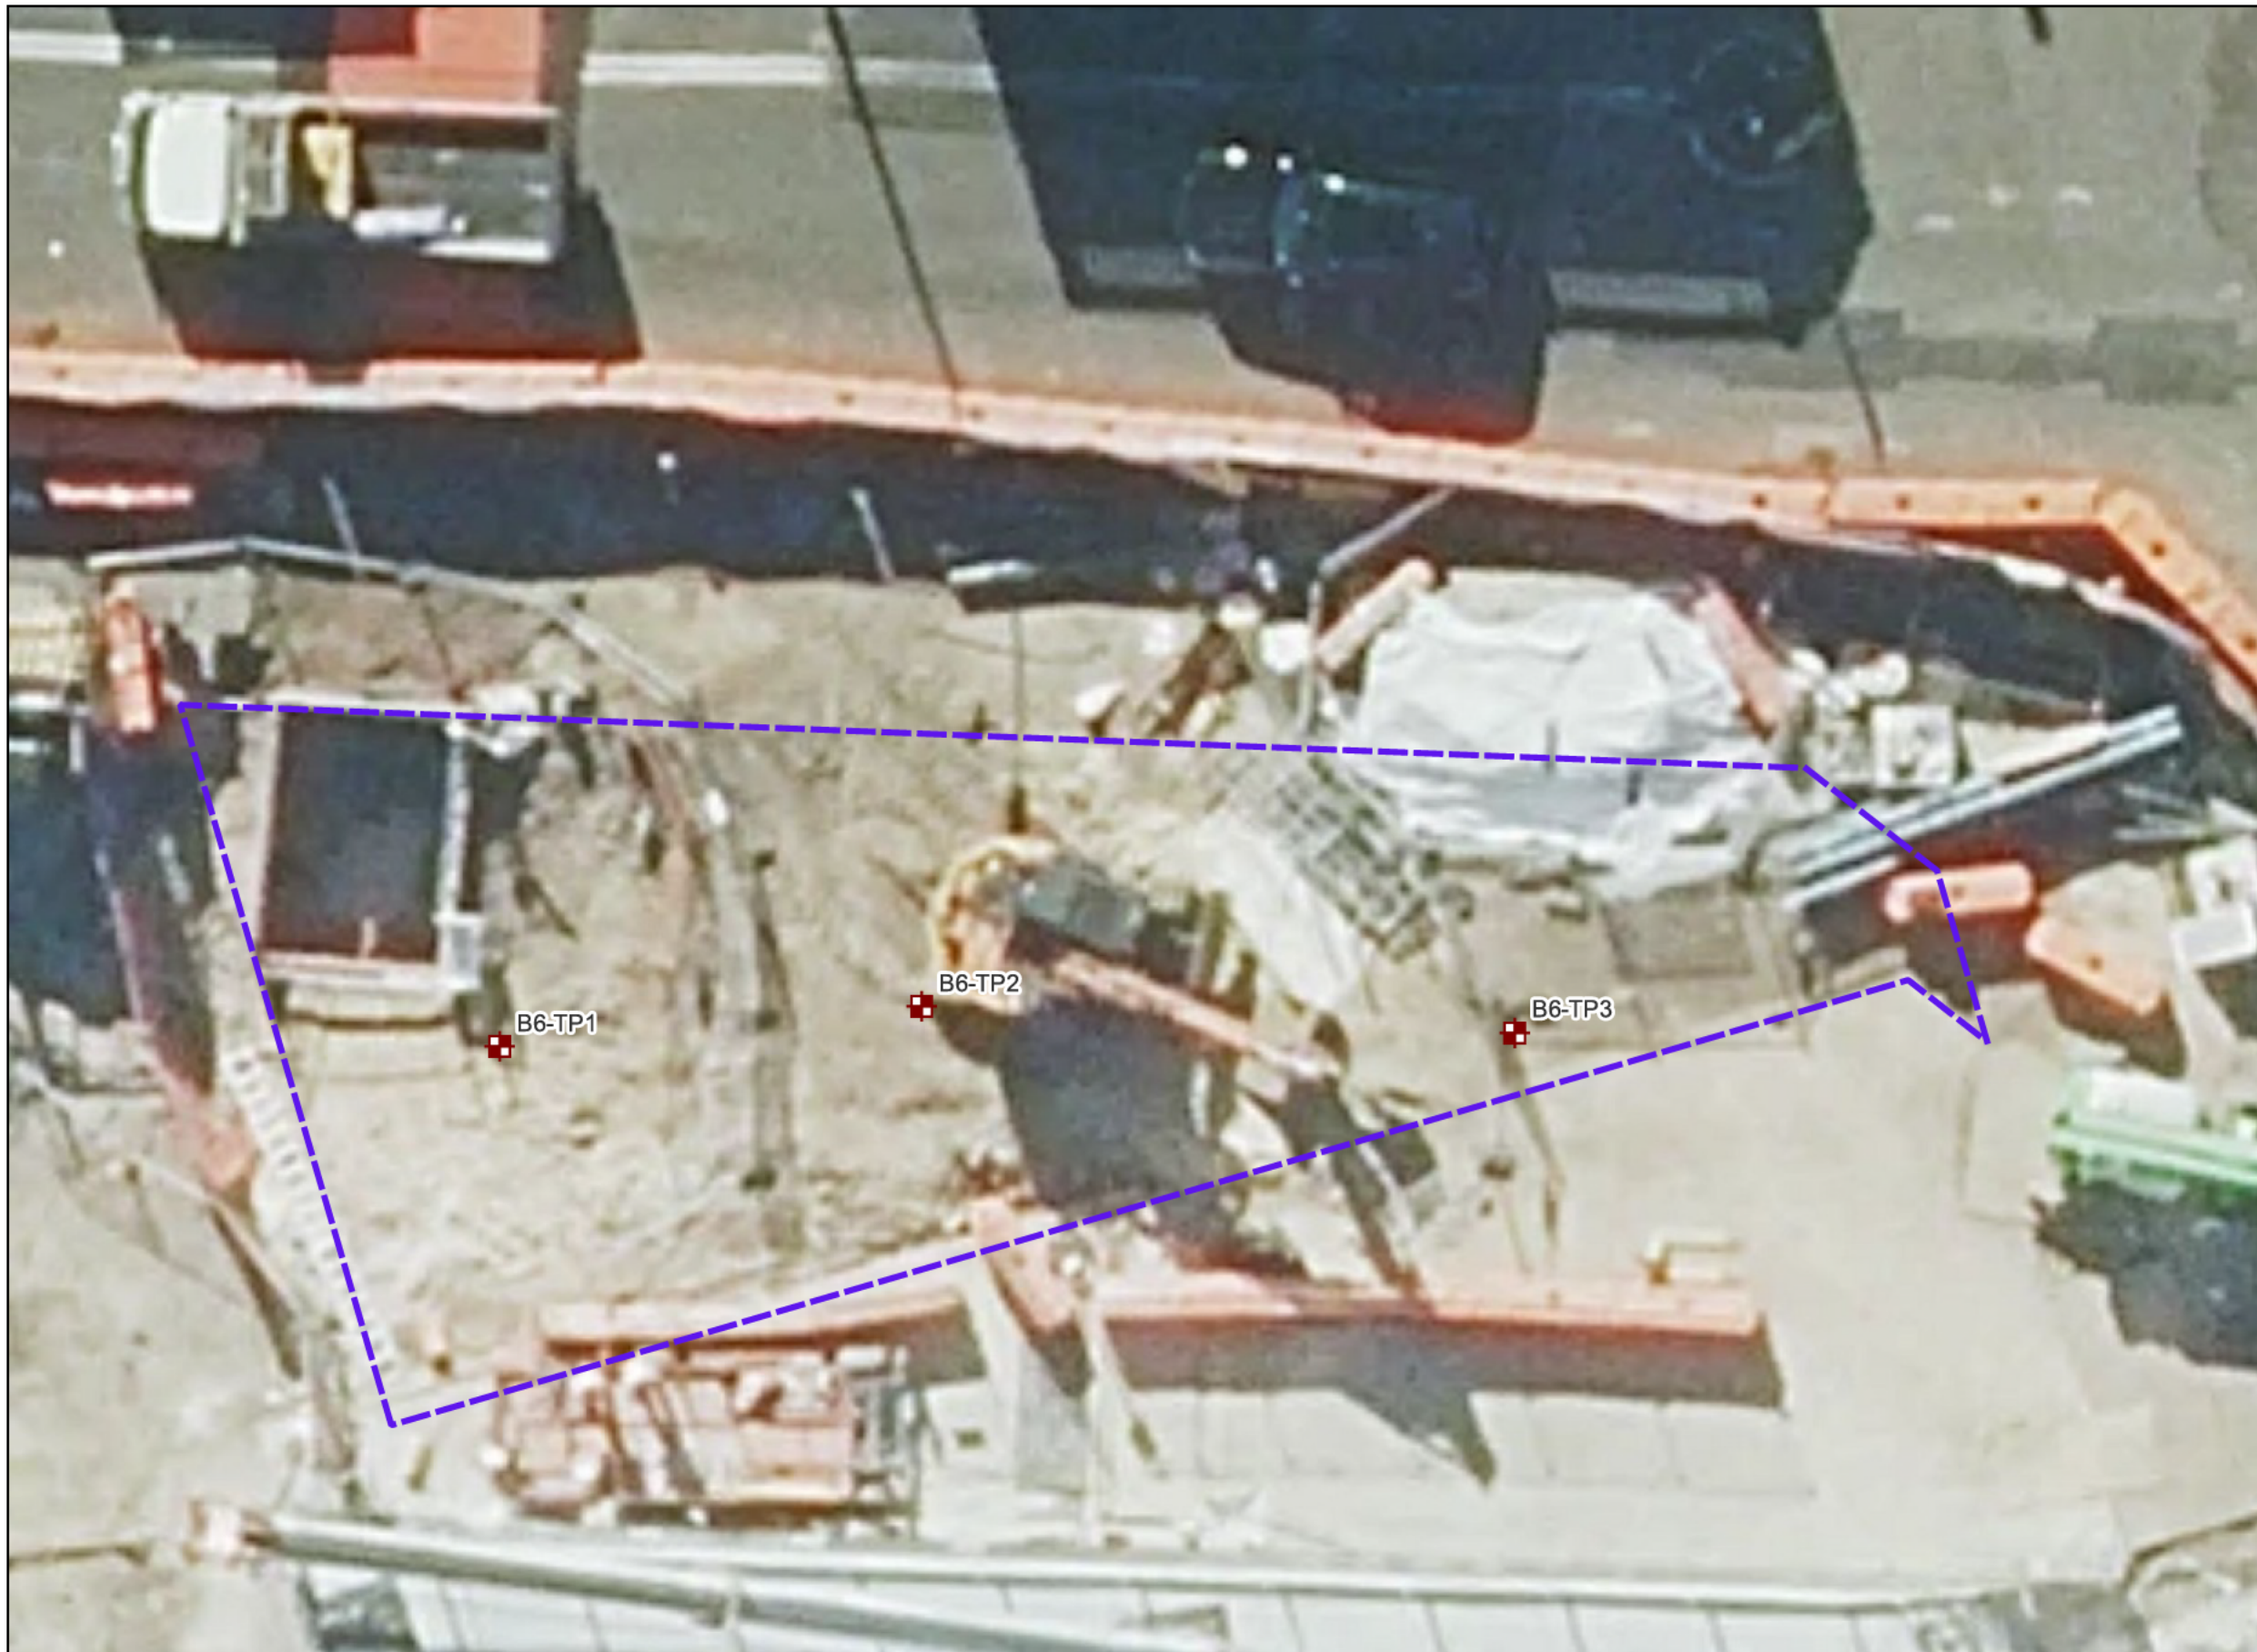
# Attachment 4: Area B6 Investigation Sample Locations

- Suspected ACM was identified during gravimetric assessment of one 10 litre bulk sample (TP1 (0-0.5 m)) within Area B6. Laboratory analysis confirmed the presence of asbestos. The concentration of asbestos was calculated to be 0.06% (w/w) which exceeded the HSL for commercial/industrial land use. Asbestos was not observed or identified during remaining sampling or gravimetric assessment. AF/FA was not detected in the samples analysed by the laboratory.

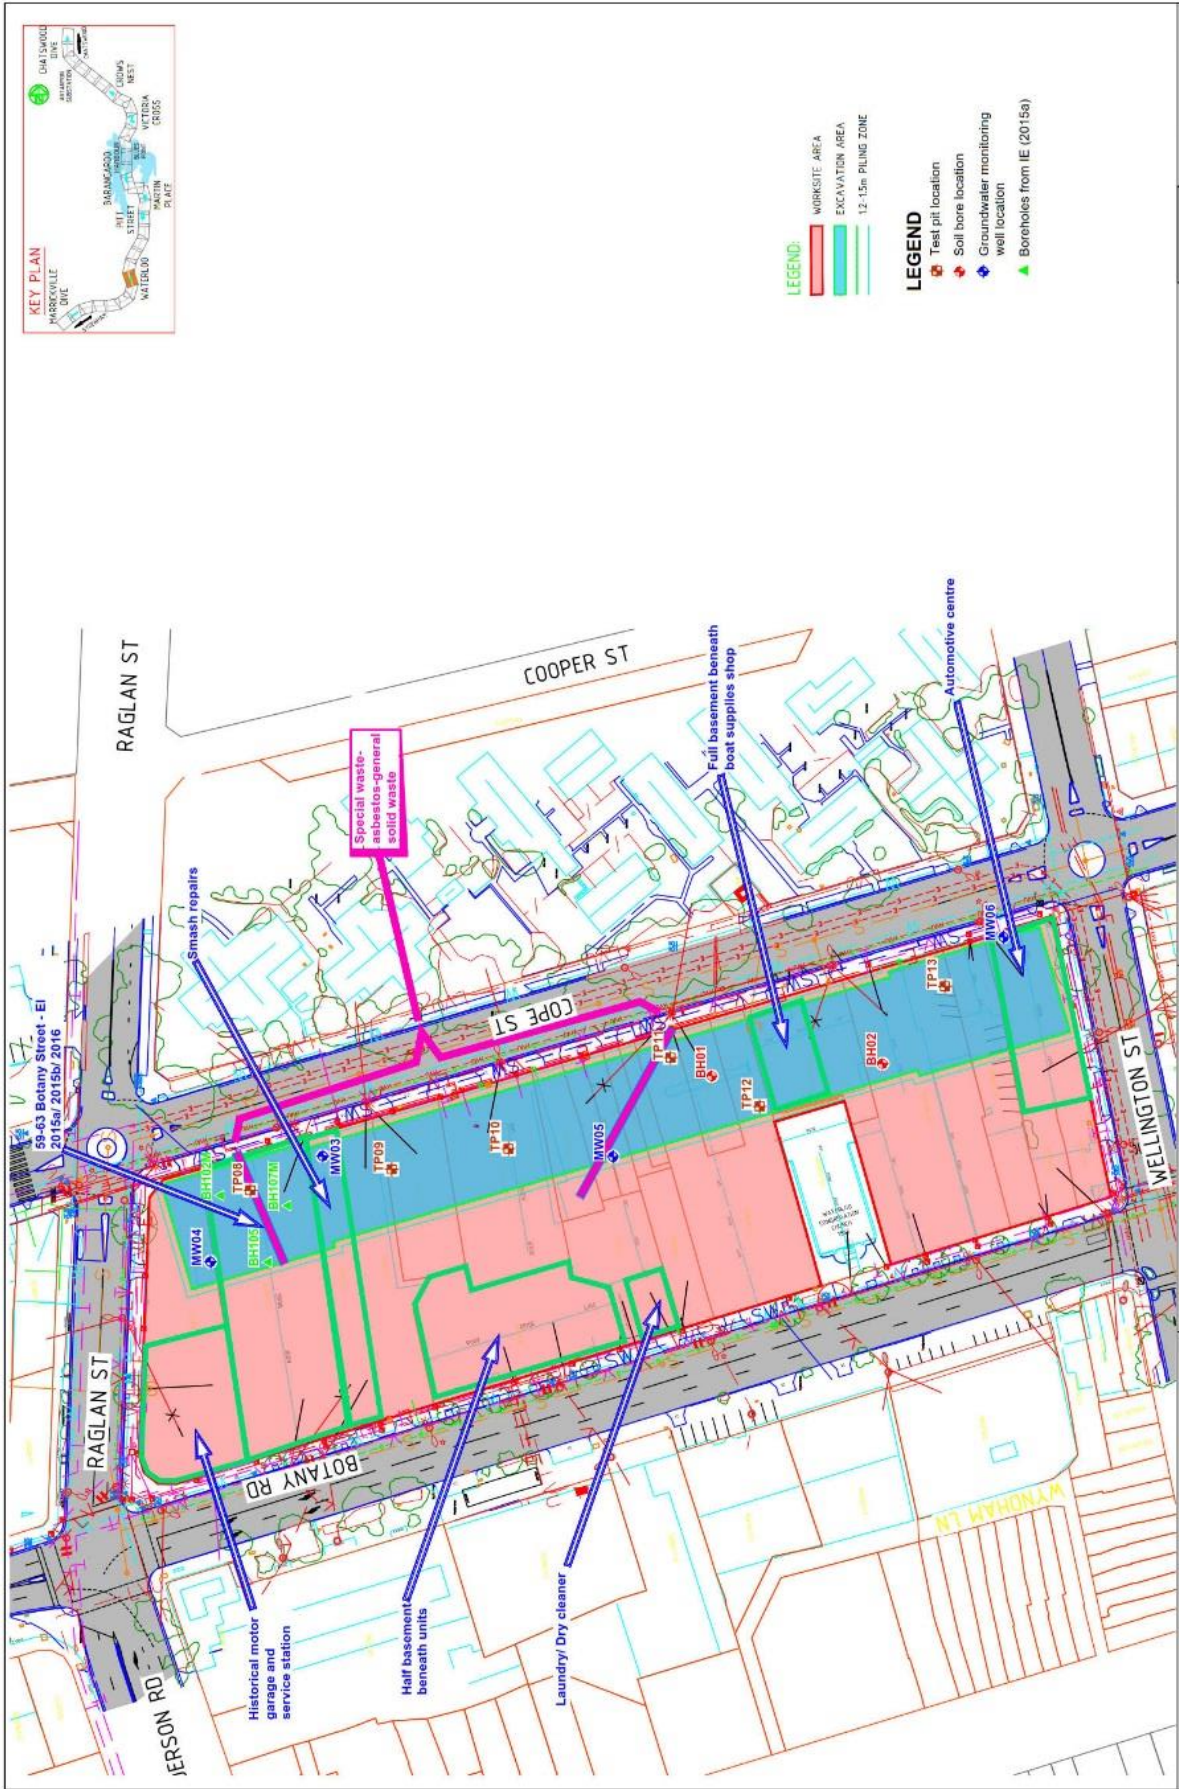
PROJECT No:	85608.14
DRAWING No:	2
REVISION:	0

<p><b>Sampling density</b></p> <p><i>Soil:</i> The DSI included a sampling density of 12 locations (Attachment 2) over approximately 0.5 ha, which does not meet the minimum density of 13 recommended by EPA (1995) <i>Sampling Design Guidelines</i>. The coverage provides a 95% confidence of detecting a residual hot spot of approximately 24 m diameter.</p> <p>Samples analysed for asbestos were not collected in accordance with the density outlined in NEPM (2013).</p> <p><i>Groundwater:</i> Three groundwater samples were obtained from the monitoring wells at the site.</p>	<p>In the Auditor’s opinion the sampling density was appropriate to inform the remediation planning process. Considering that the fill from the entire site would be excavated and disposed off-site as part of the development, the sampling adopted by DP is acceptable to give a general indication of the presence/absence of asbestos in soil.</p> <p>The density of groundwater monitoring wells is not adequate to assess the extent and magnitude of groundwater contamination associated with the former dry cleaner. Further investigation is proposed by DP prior to remediation of the site.</p>
