Excavation Directors Report
*Sydney Metro, City & Southwest
Pitt Street South Station*
15/12/2023

Final Excavation Report on the Pitt Street South Station

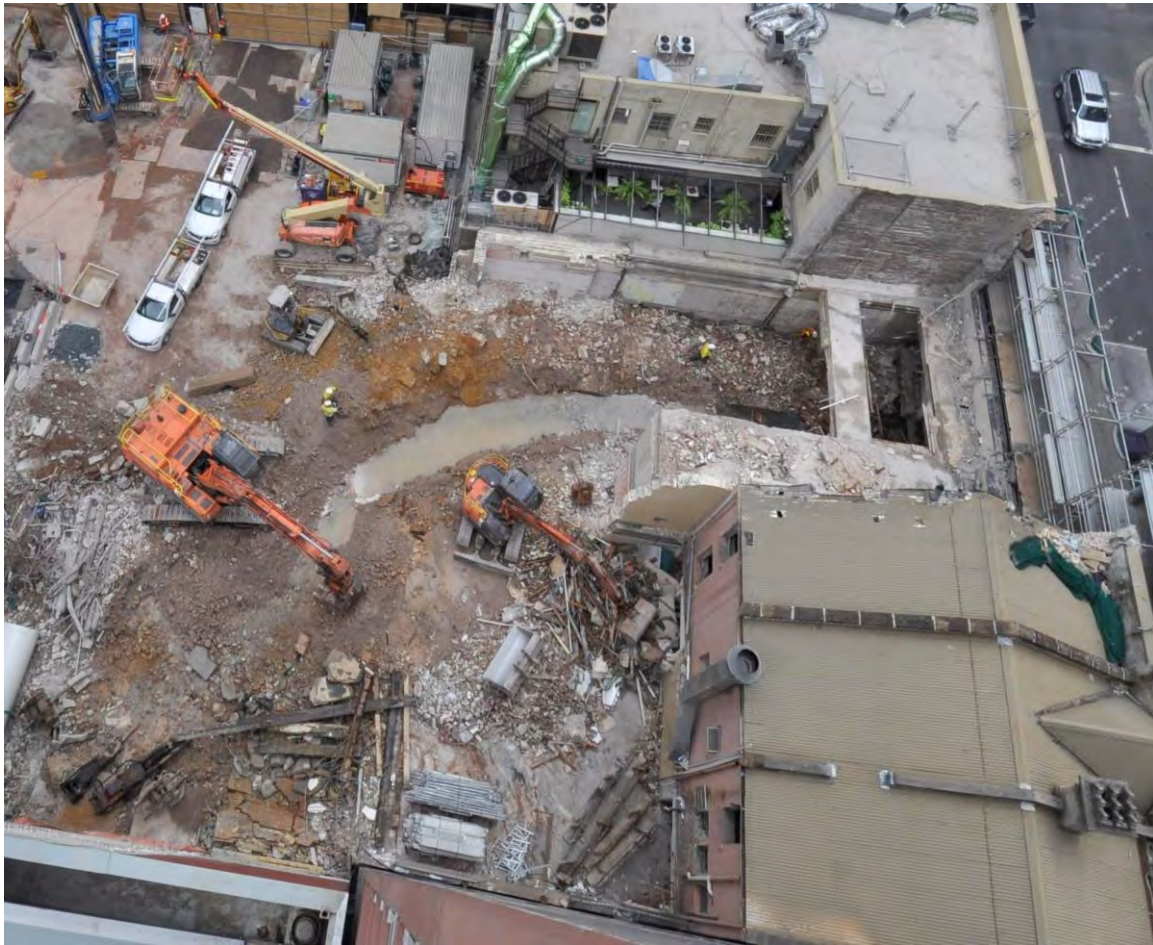
Figure 4.3 Aerial view of PS3 and PS4 on Bathurst Street and the trench excavated by Delta to drain the site (JHCPBG JV).

Prior to archaeological monitoring in PS3, during demolition of the buildings within PS3 and the rear of PS4, Delta inadvertently broke through a water main causing extensive flooding. The trench excavated to drain the water caused extensive damage to PS3 and damaged an area of PS4 (Figure 4.3).

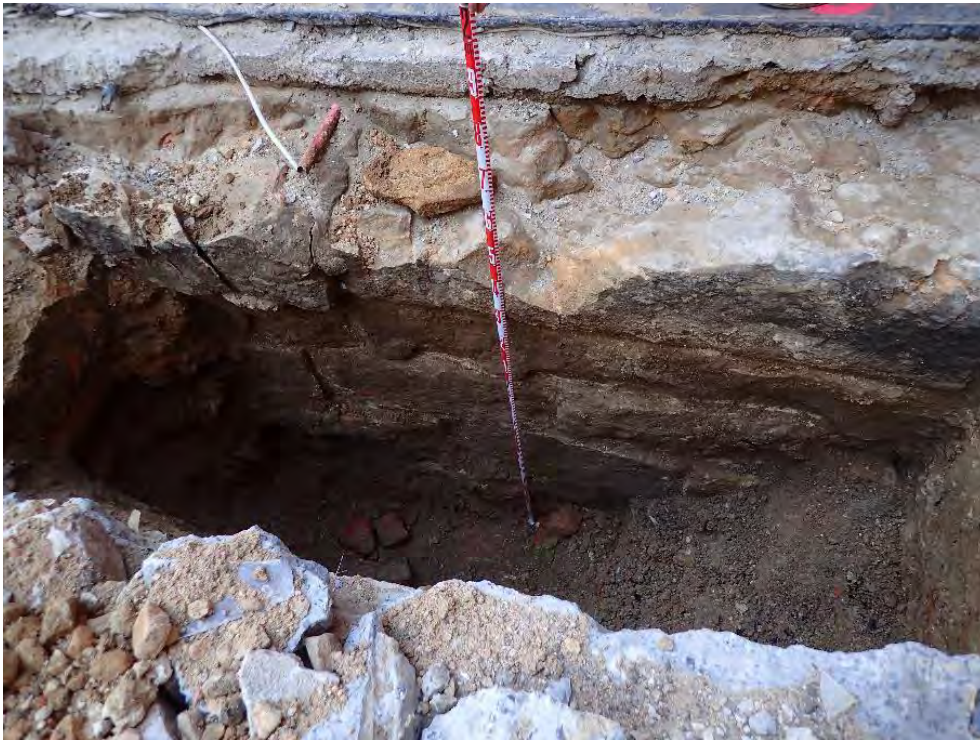
Figure 4.7 Cellar wall identified during monitoring, post excavation.

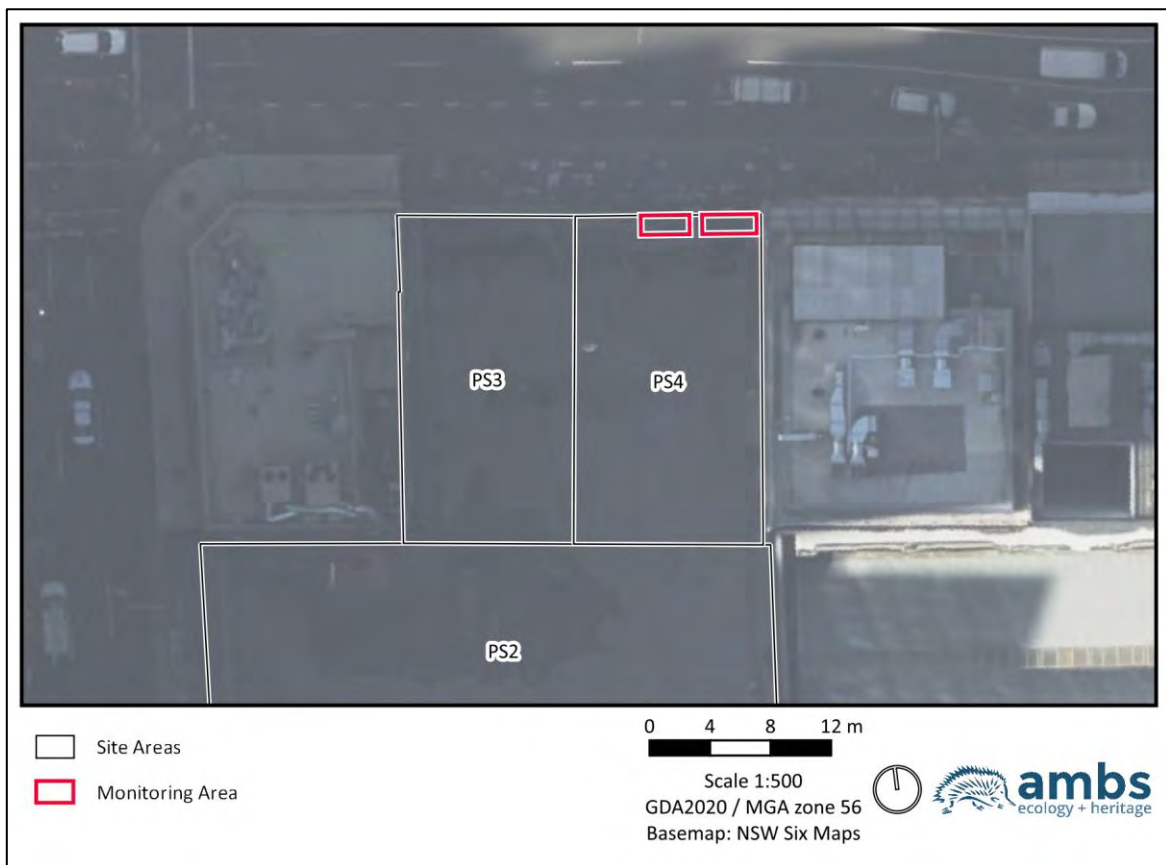
Figure 4.8 Location of areas monitored for piling trench.

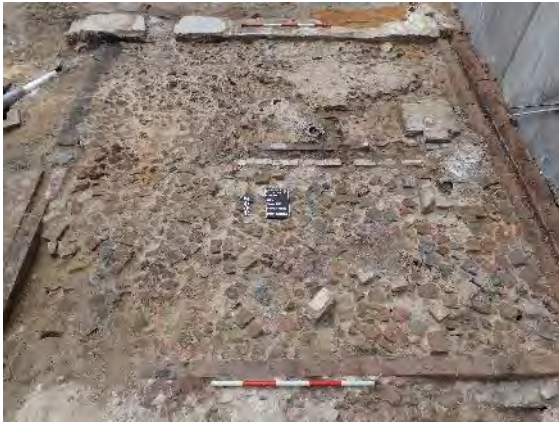
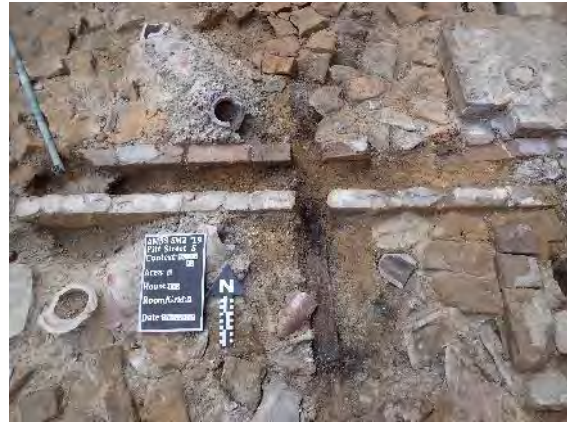
Figure 5.6 Brick rubble surface [1043], view north. **Figure 5.7** Detail of brick drain [1051] within House 135 room 2.

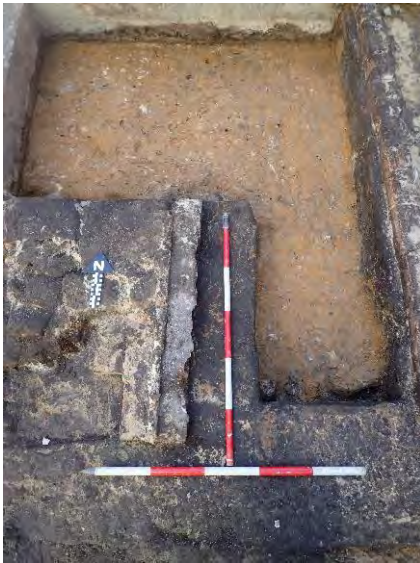
Figure 5.16 House 133, room 5, showing location of hearth [1097], after the excavation of the underfloor.

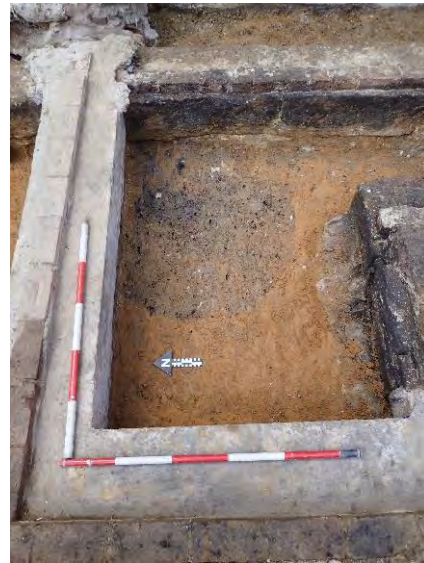
Figure 5.17 House 133, room 5, showing location of the burn pit [1162], pre-excavation.

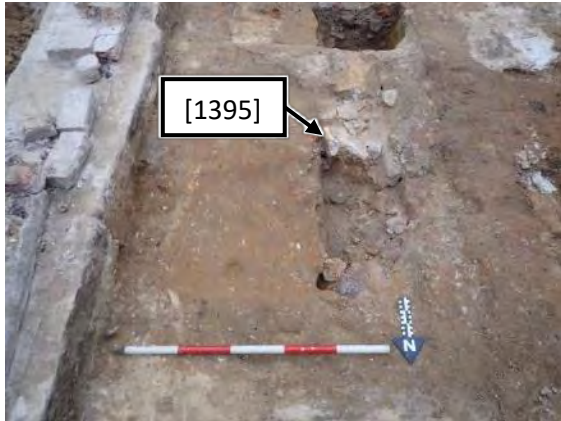
Figure 5.20. House 131, room 1, foundation trench for the early building indicated by arrow, view south.

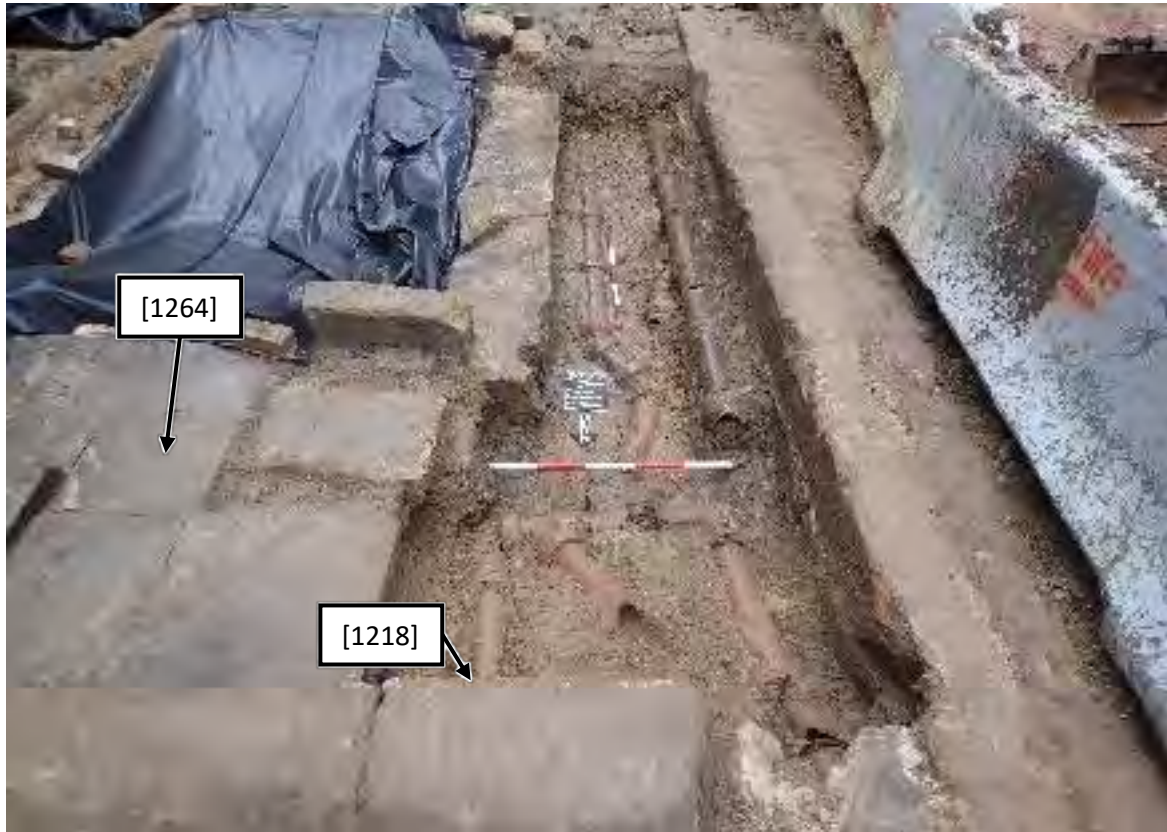
Figure 5.22 House 131 room 3 and back passage, showing sandstone flagging and services, view south.

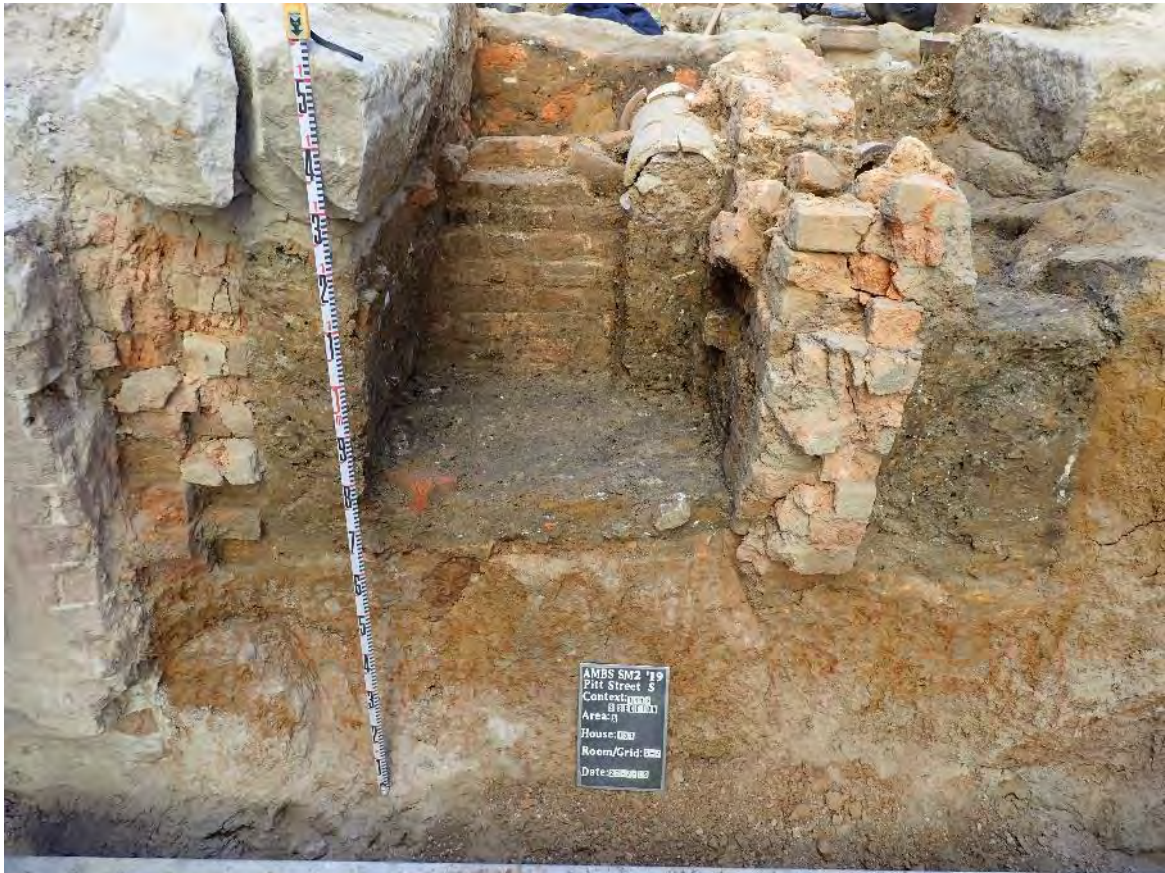
Figure 5.30 Detail of the WC, view north post excavation.

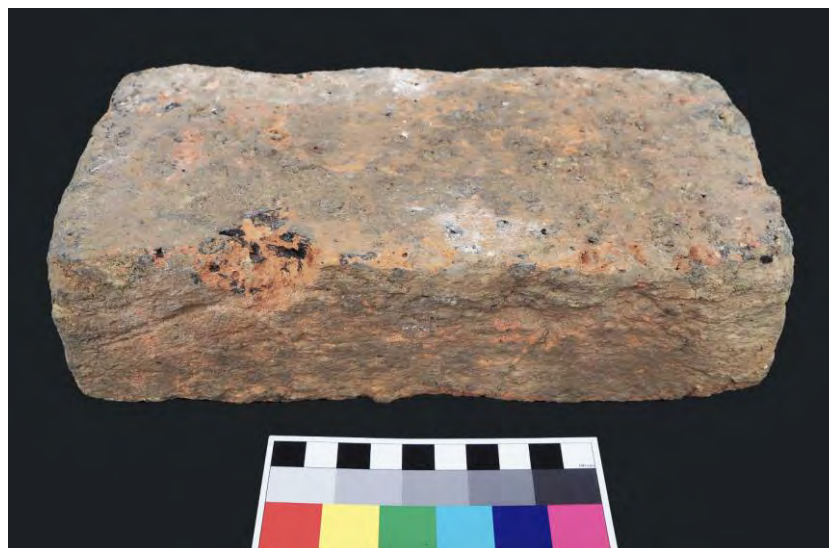
Figure 6.1 Sandstock brick from Louisa Terrace ([1474]/#1977). Note the large inclusions and uneven edges. 100mm scale.
