# Planning Approval Environmental Review Form

<b>Assessment Name:</b>	TfNSW85 – Additional impact to heritage items along the SWM alignment.
<b>Prepared by:</b>	Sydney Metro
<b>Prepared for:</b>	Sydney Metro, All C&SW contracts
<b>Assessment number</b>	TfNSW 85
<b>Type of assessment:</b>	Assessment under EP&A Act 1979, Division 5.2
<b>Version:</b>	Final (1.0)
<b>Planning approval No. (where relevant):</b>	SSI 8256
<b>Date required:</b>	December 2024
<b>iCentral number</b>	SM-24-00312295

Report to Martinus and Sydney Metro

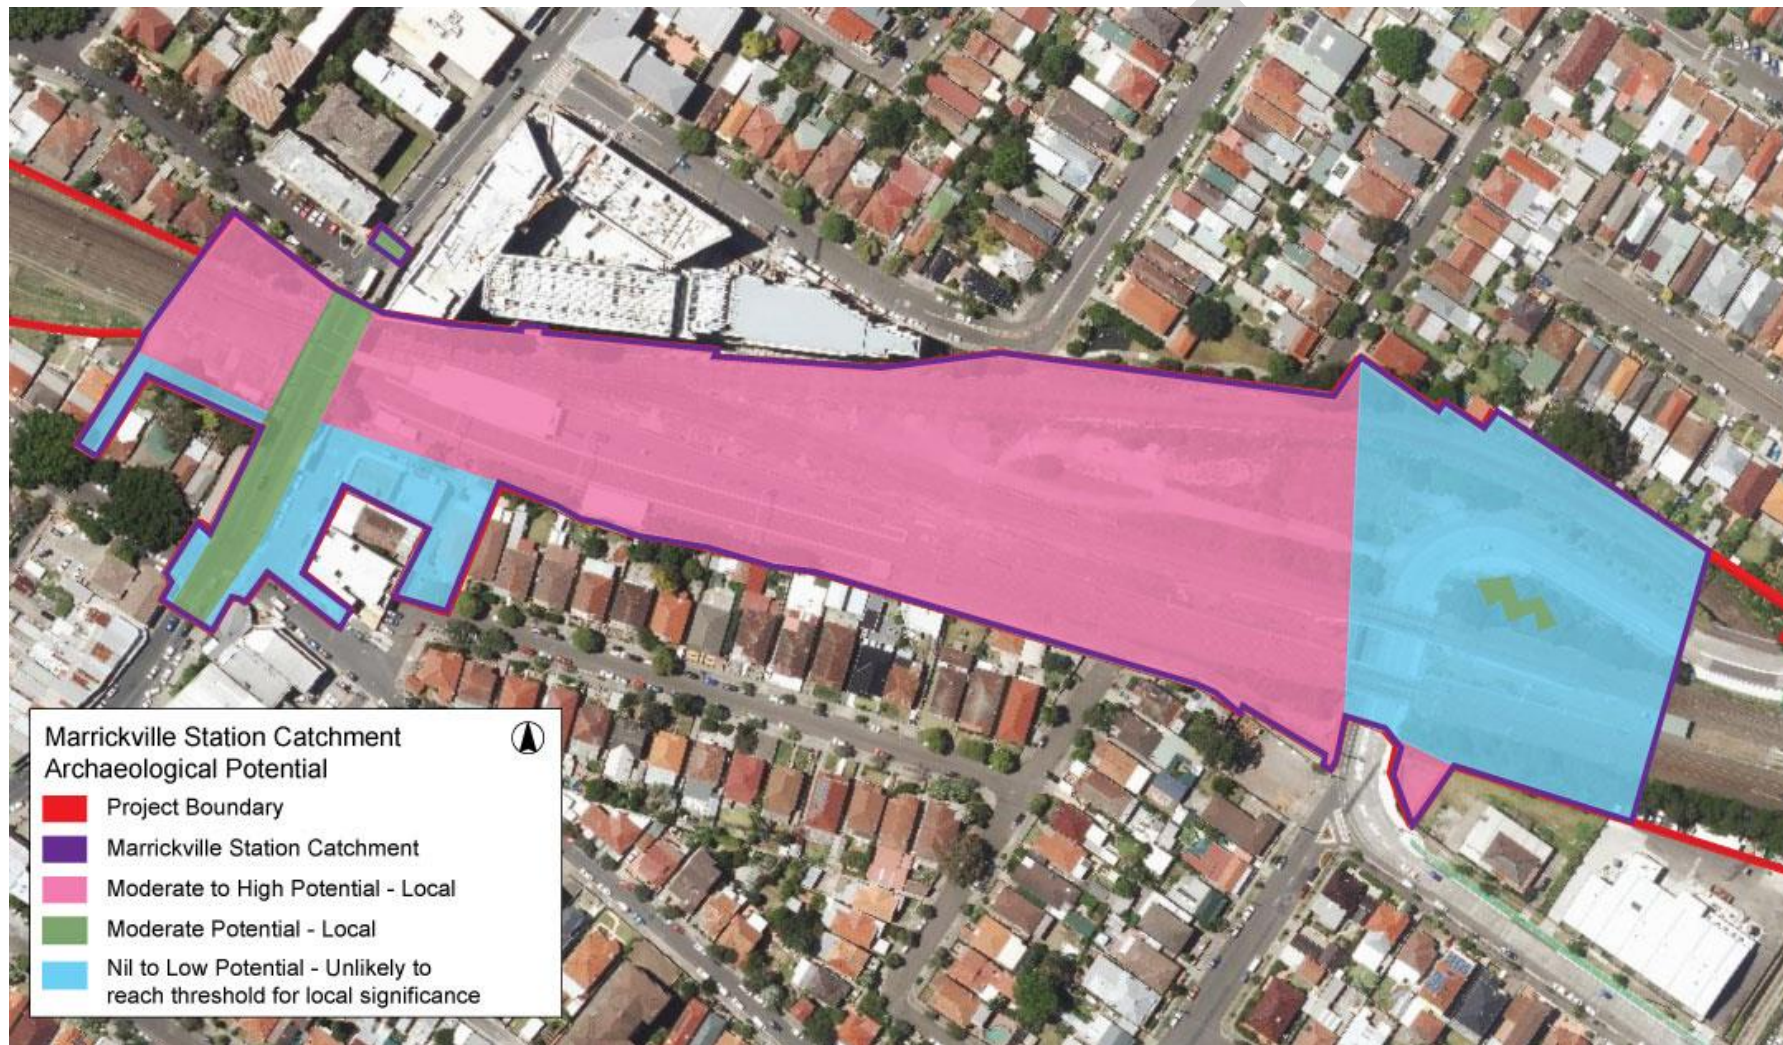
Figure 21: Archaeological potential for Marrickville Station Catchment<sup>11</sup>

The AARD predicted archaeological remains of local significance to be present at Marrickville Station. A summary of the archaeological potential and significance of predicted remains is provided in Table 2 and the location of these archaeological resources is provided in Figure 21.

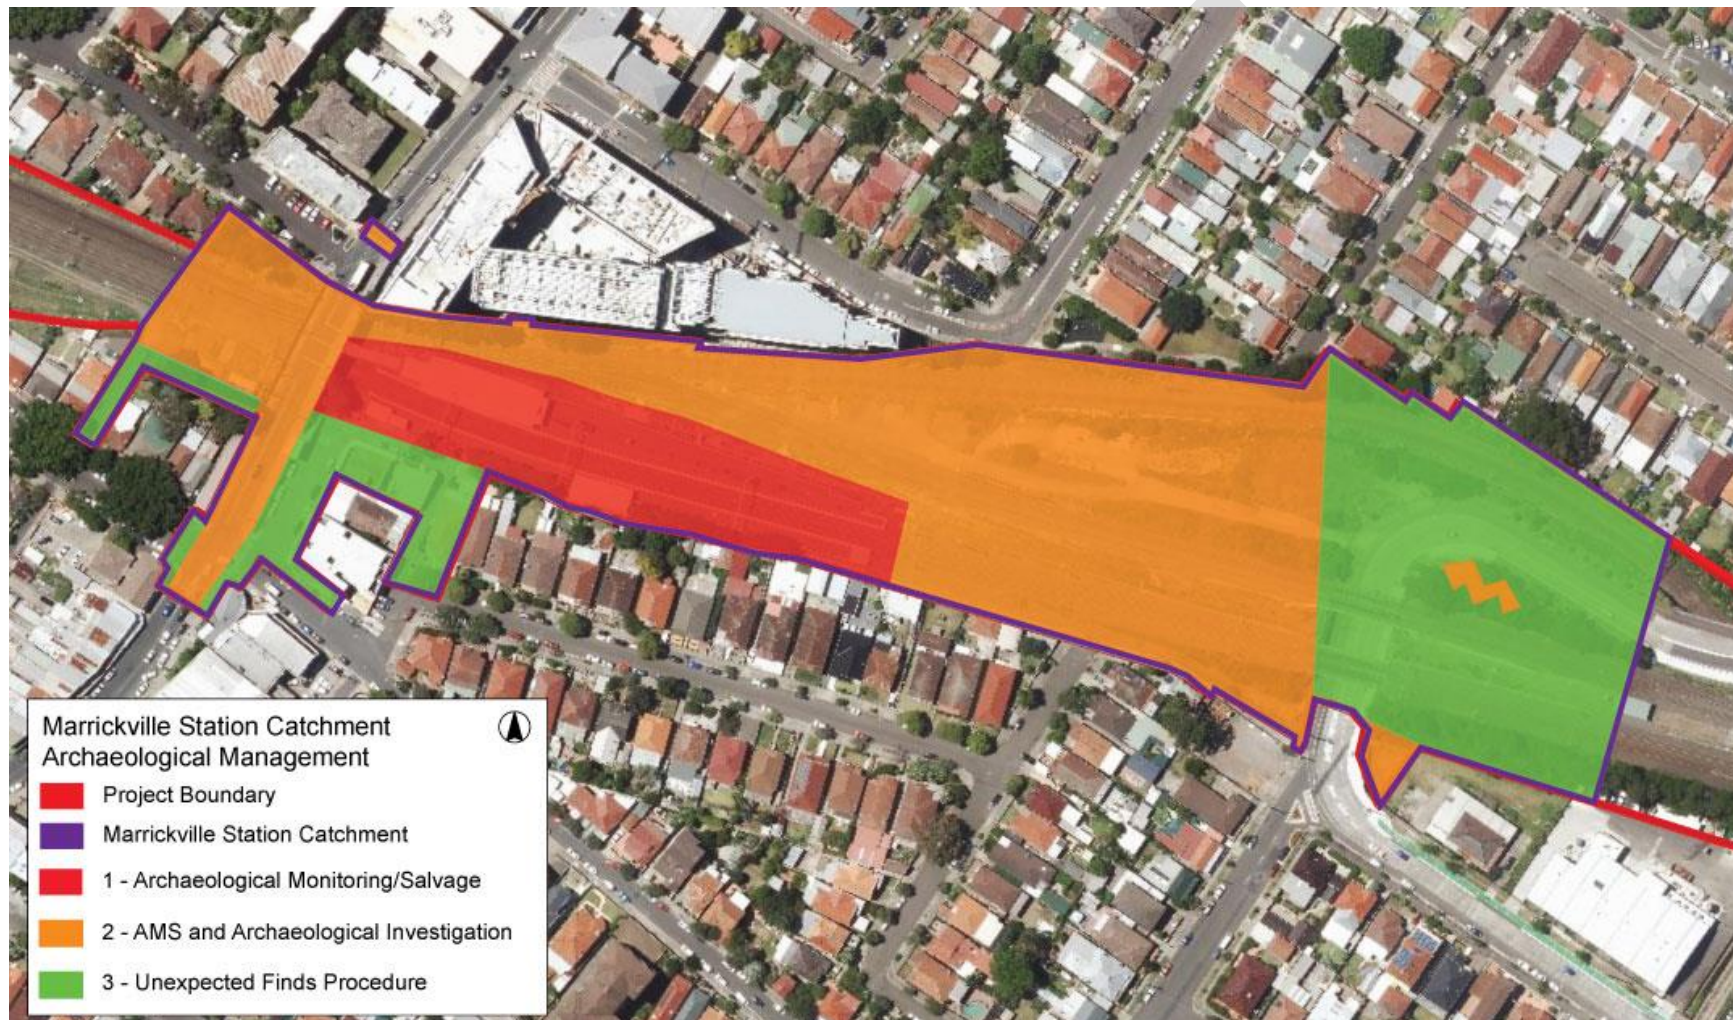
Figure 22: Marrickville Station Catchment archaeological management zones<sup>12</sup>

The AARD assessed potential impacts to archaeological resources at Marrickville Station from the works required as part of the project. The archaeological management policies are outlined in Table 3 and the location of the archaeological management zones are illustrated in Figure 22.

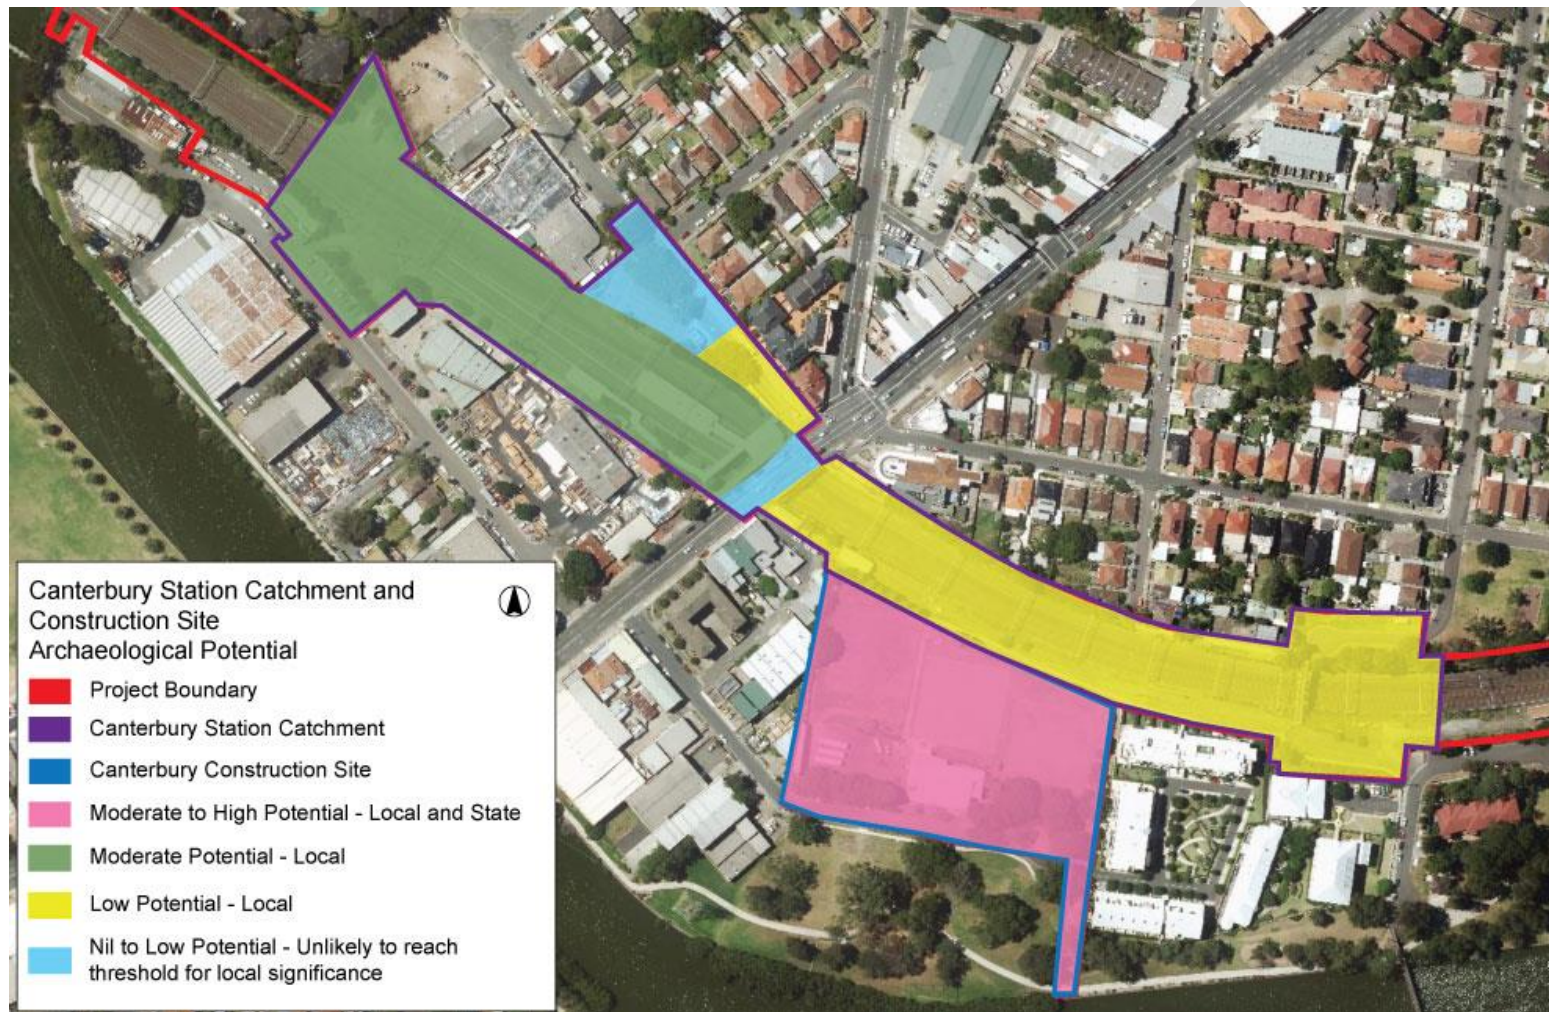
Figure 24: Archaeological potential for Canterbury Station Catchment<sup>16</sup>

The AARD predicted archaeological remains of State and local significance to be present at Canterbury Station (including the Canterbury Construction Site). A summary of the archaeological potential and significance of predicted remains is provided in Table 4, and the location of these archaeological resources is provided in Figure 23 and Figure 24.

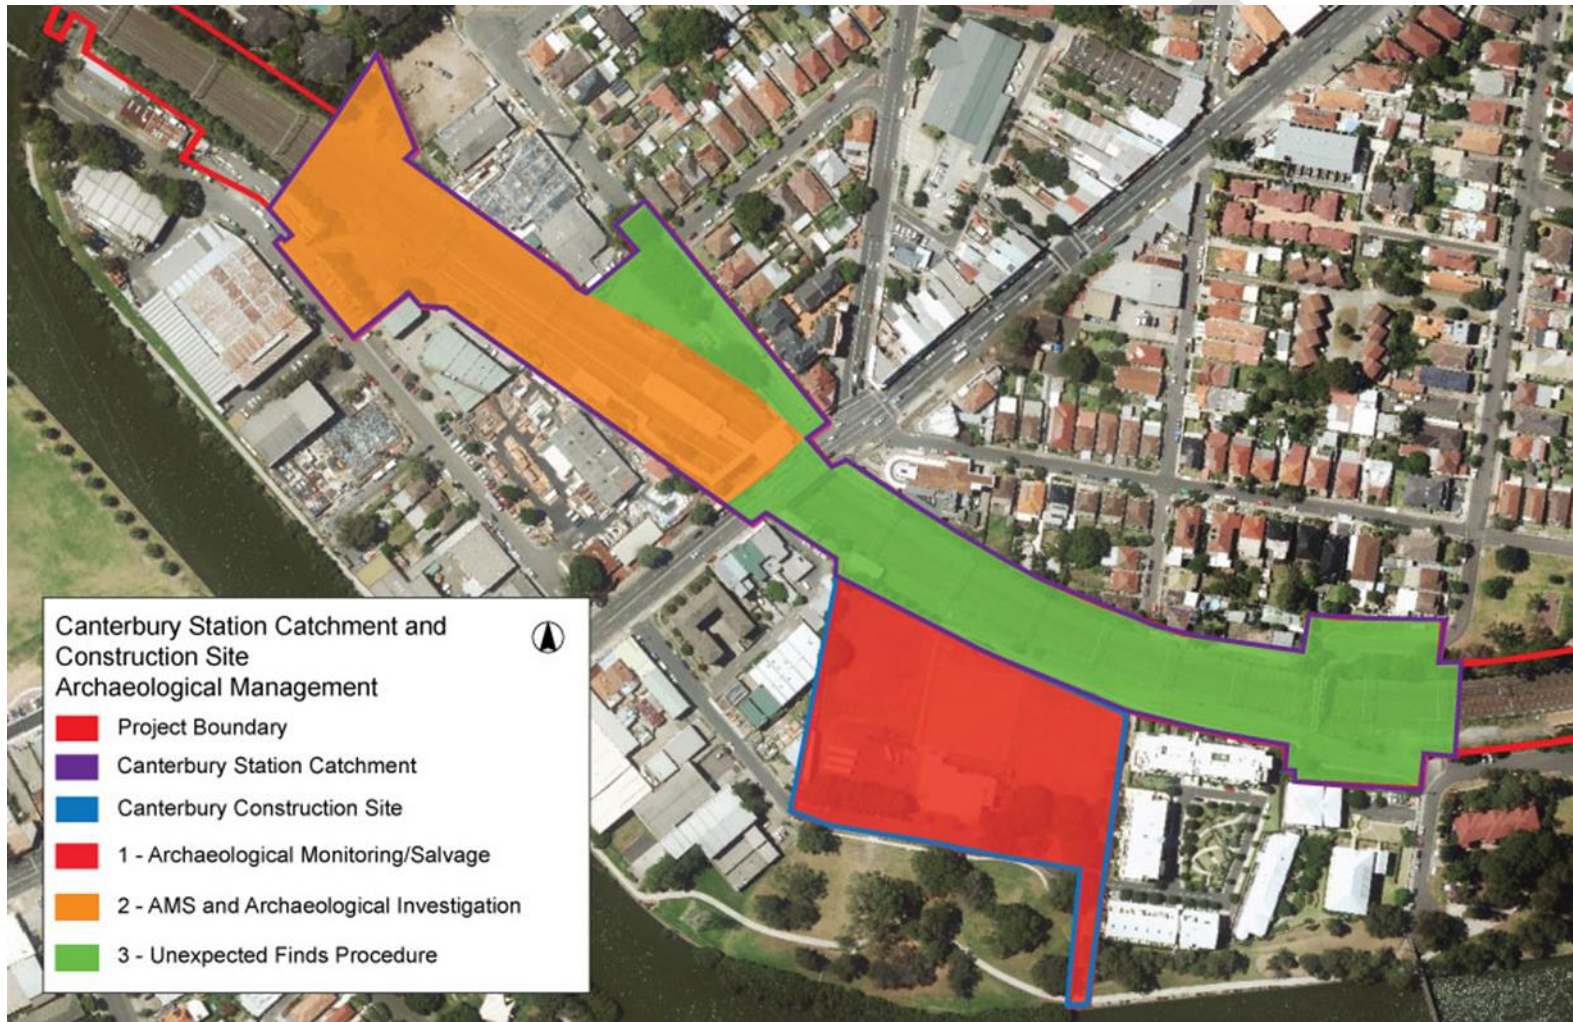
Figure 25: Canterbury Station Catchment archaeological management zones<sup>17</sup>

The AARD assessed potential impacts to archaeological resources at Canterbury Station from the works required as part of the project. The archaeological management policies are outlined in Table 5 and the location of the archaeological management zones are illustrated in Figure 25.

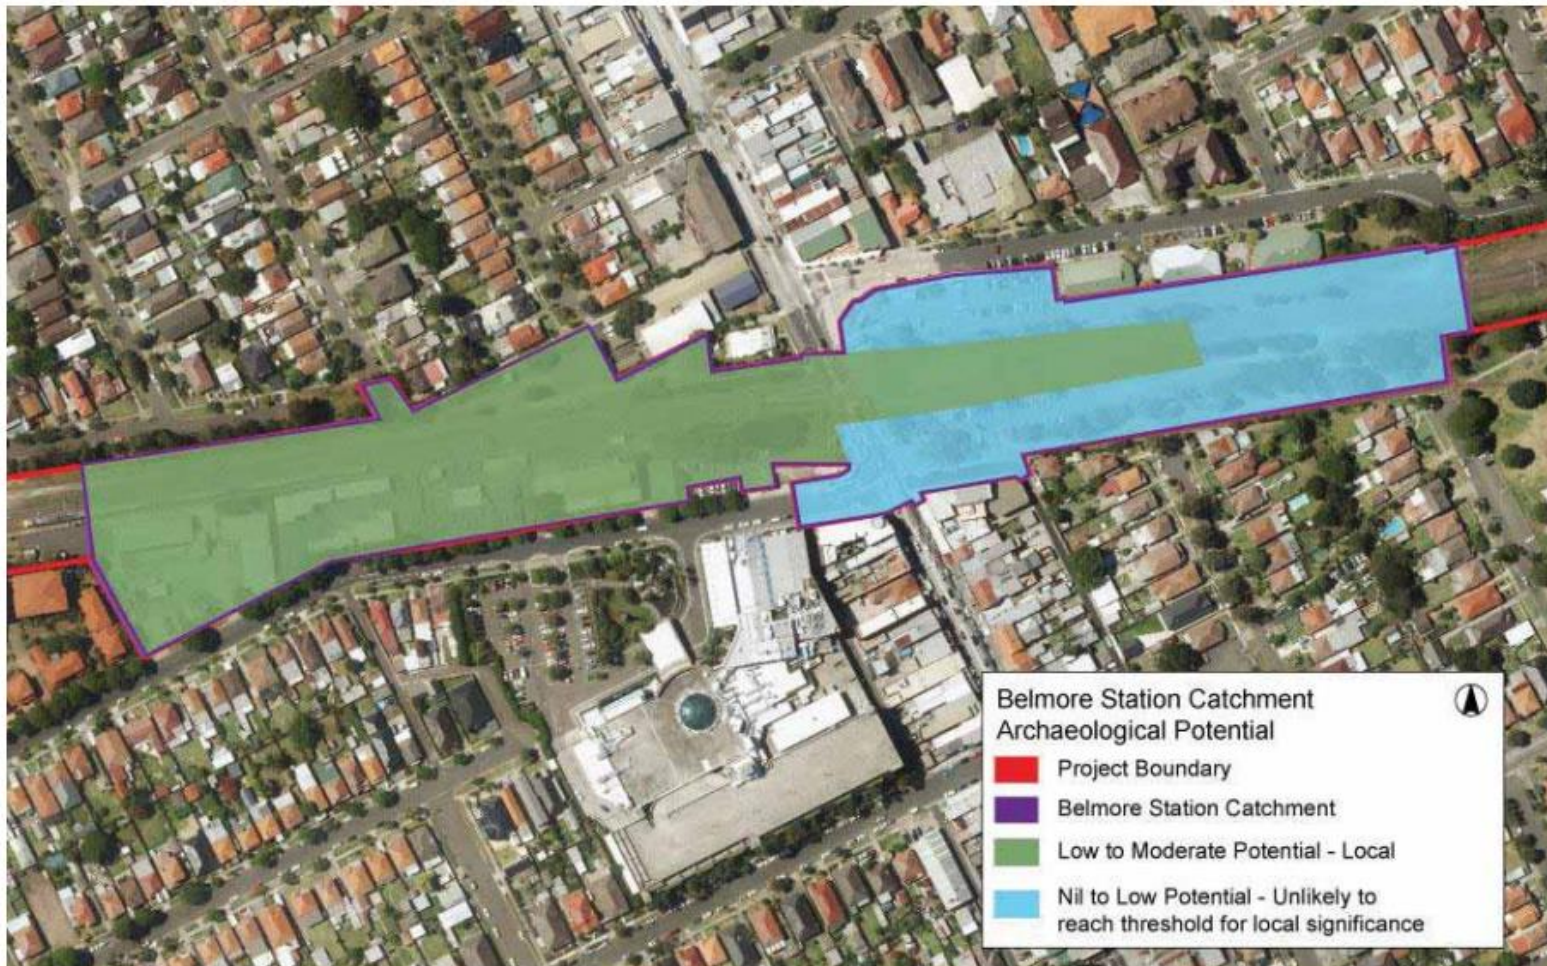
Figure 26: Archaeological potential for Belmore Station Catchment<sup>20</sup>

The AARD predicted archaeological remains of local significance to be present at Belmore Station. A summary of the archaeological potential and significance of predicted remains is provided in Table 6 and the location of these archaeological resources is provided in Figure 26.

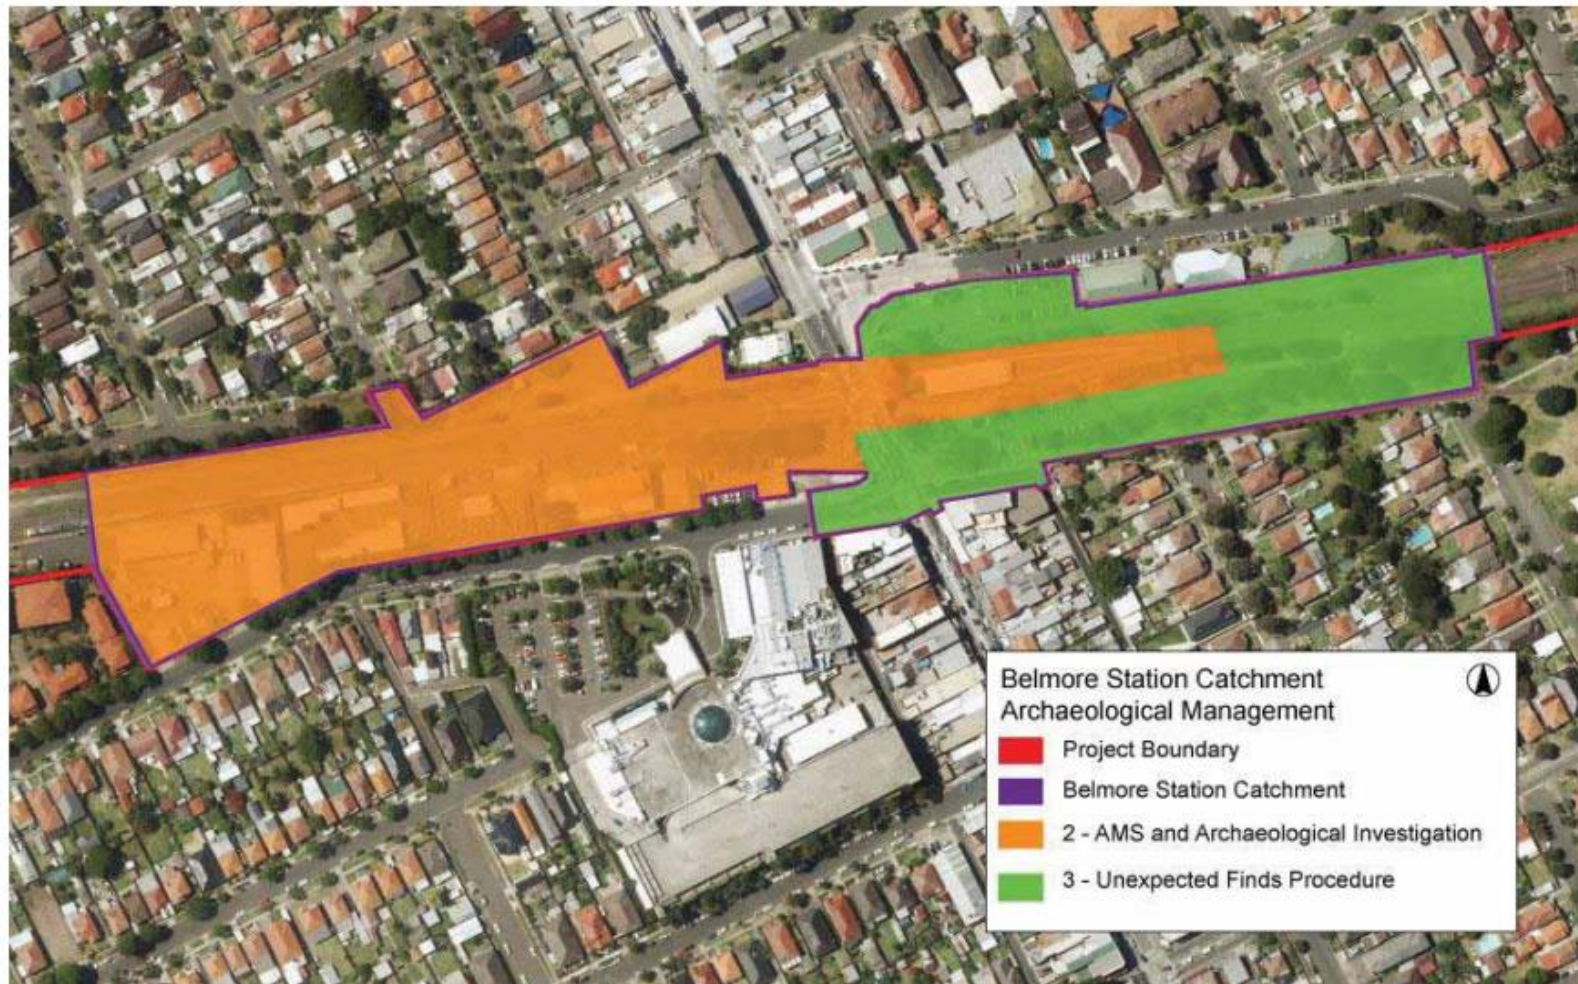
Figure 27: Belmore Station Catchment archaeological management zones<sup>21</sup>

The AARD assessed potential impacts to archaeological resources at Belmore Station from the works required as part of the project. The archaeological management policies are outlined in Table 7 and the location of the archaeological management zones are illustrated in Figure 27.

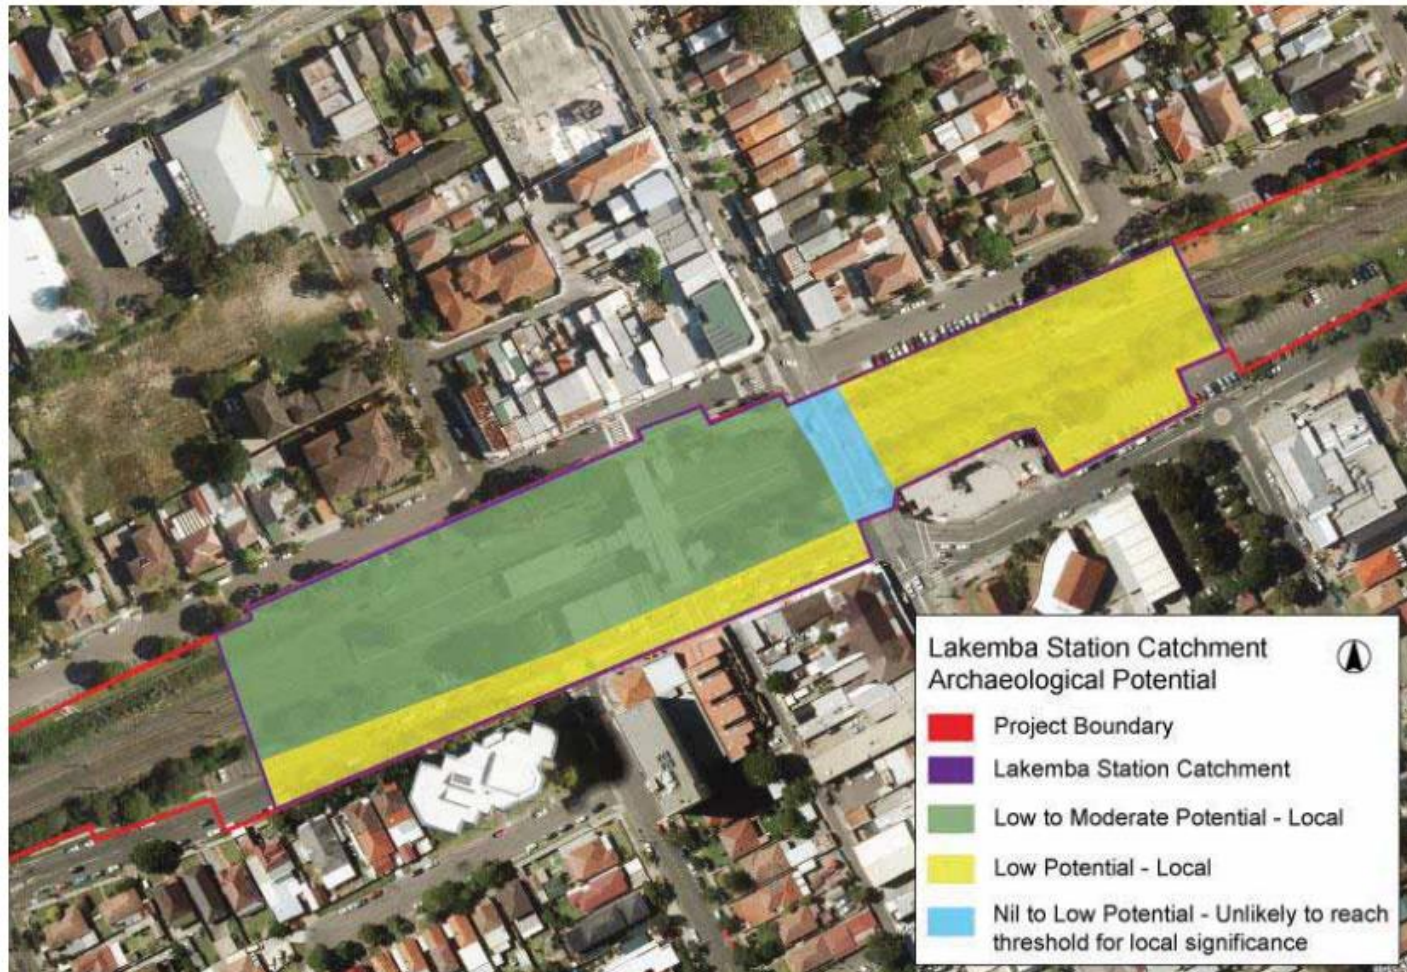
Figure 28: Archaeological potential for Lakemba Station Catchment<sup>24</sup>

The AARD predicted archaeological remains of local significance to be present at Lakemba Station. A summary of the archaeological potential and significance of predicted remains is provided in Table 8 and the location of these archaeological resources is provided in Figure 28.

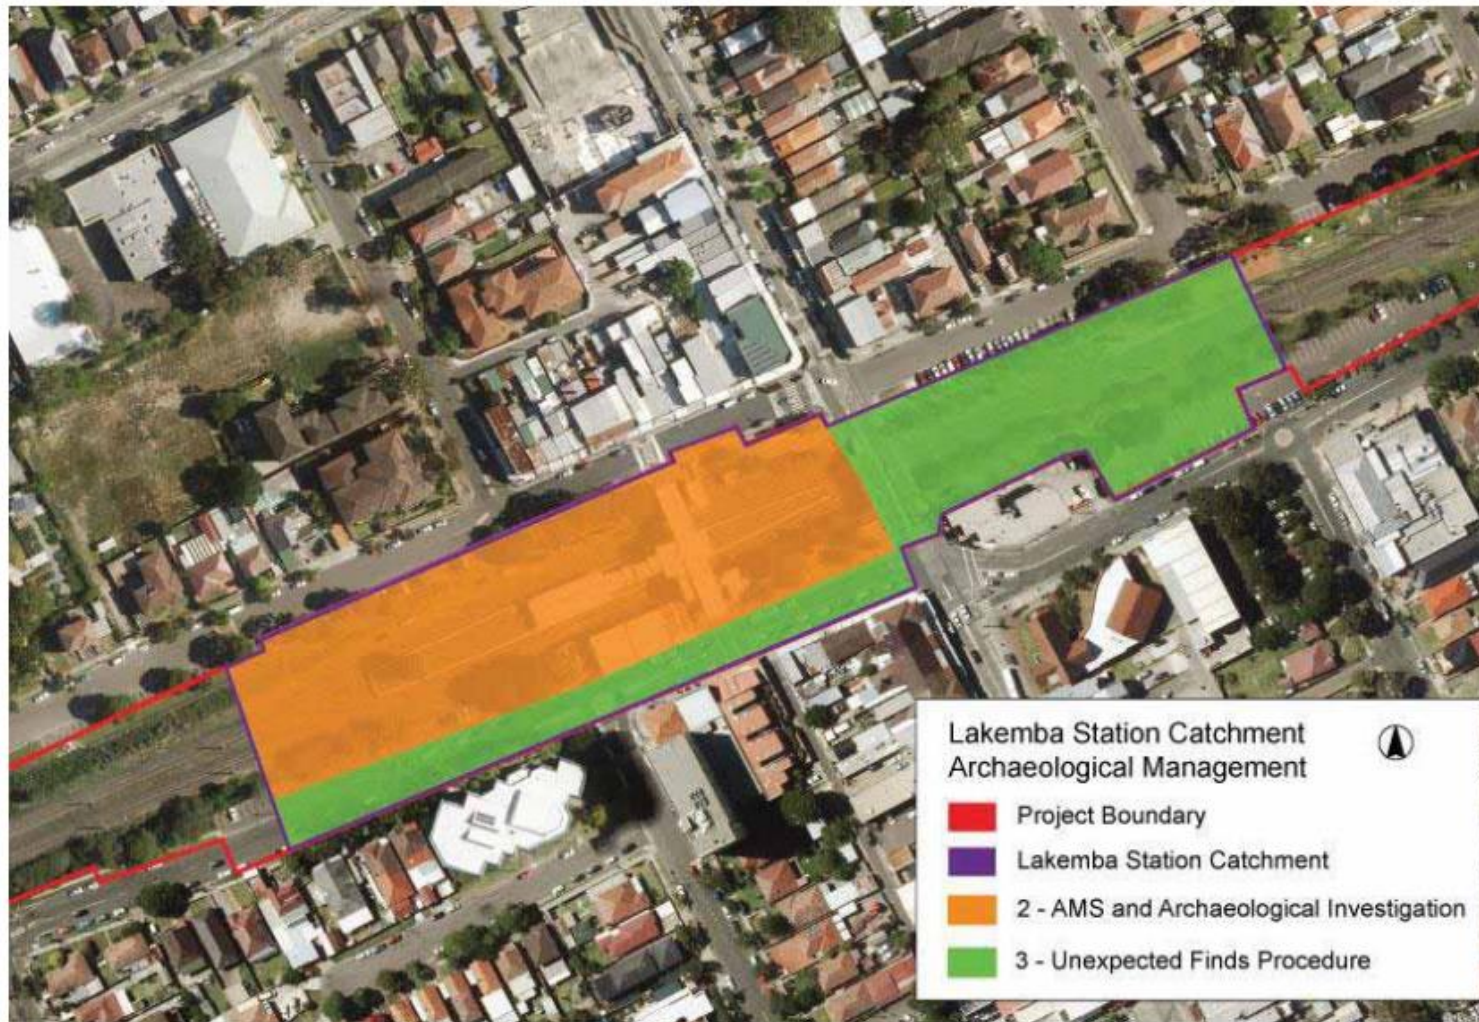
Figure 29: Lakemba Station Catchment archaeological management zones<sup>25</sup>

The AARD assessed potential impacts to archaeological resources at Lakemba Station from the works required as part of the project. The archaeological management policies are outlined in Table 9 and the location of the archaeological management zones are illustrated in Figure 29.

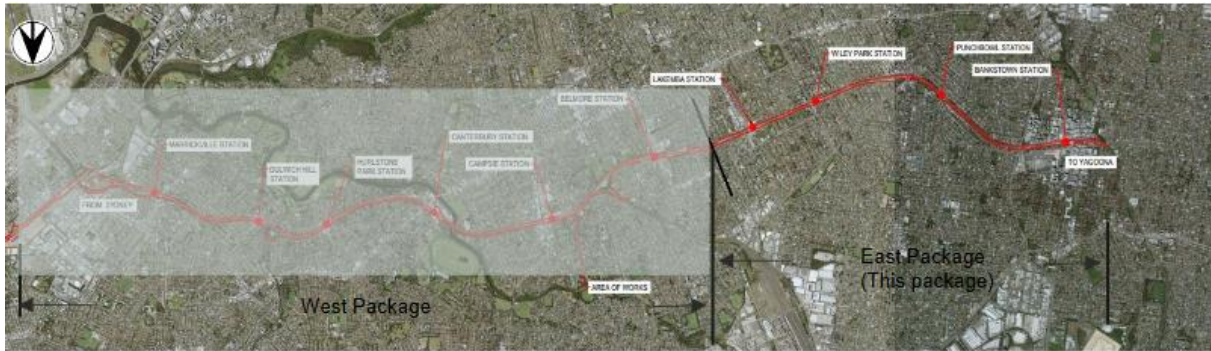
**Figure 31: East and west package areas for non-bridge locations (Source: Aurecon, DP941 Non-bridge areas – East Design Report, p. 11)**

The treatment is to design different types of barriers to mitigate risks associated with road vehicles intruding into the rail corridor and causing derailment of Sydney Metro and ARTC trains. The road barriers typically include TL3 post and beam barriers, TL4 steel post and beam barriers, TL3 concrete barriers, TL4 concrete barriers, and TL5 concrete barriers. The installation of these barriers would require ground penetrations where they are installed. The installation of new barriers would involve the removal of existing fences in these locations where present.

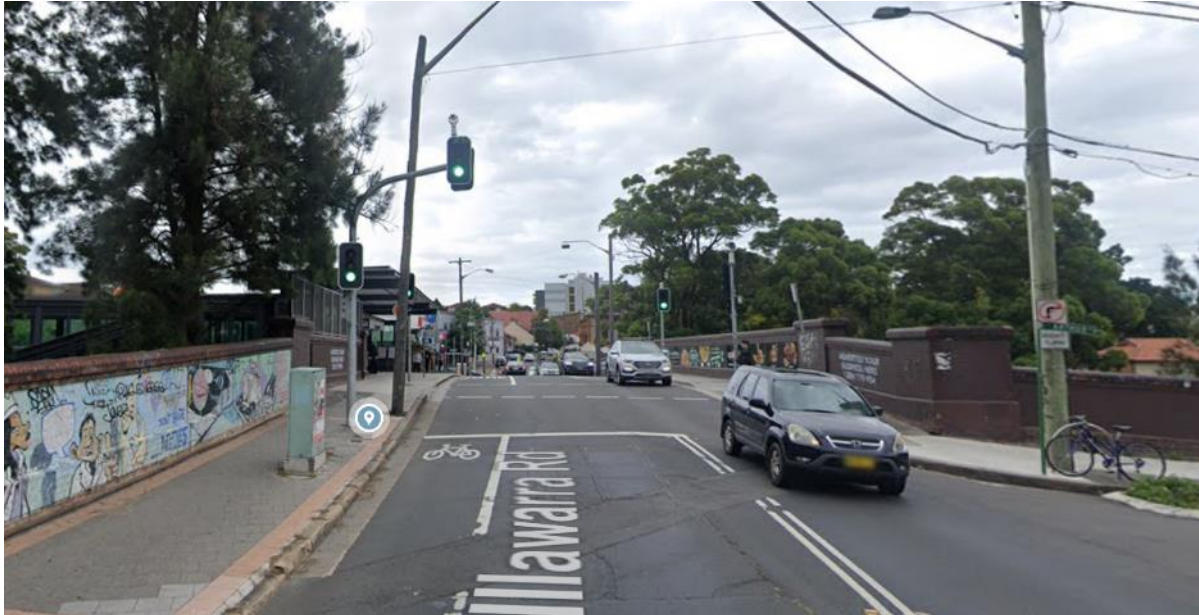
Figure 32: Illawarra Road Bridge (Source: Google maps)

The Illawarra Road Bridge, which runs northeast- southwest above Marrickville Station consists of steel girders and a concrete slab supported on central brick piers and side brick abutments.<sup>28</sup> The existing barriers between the road and the rail corridor consist of painted brick parapet walls with steel mesh throw screens fixed to the top of the parapet walls on the eastern side of the road. The kerbing along the bridge consists of modern concrete sections and earlier sections of trachyte and sandstone.

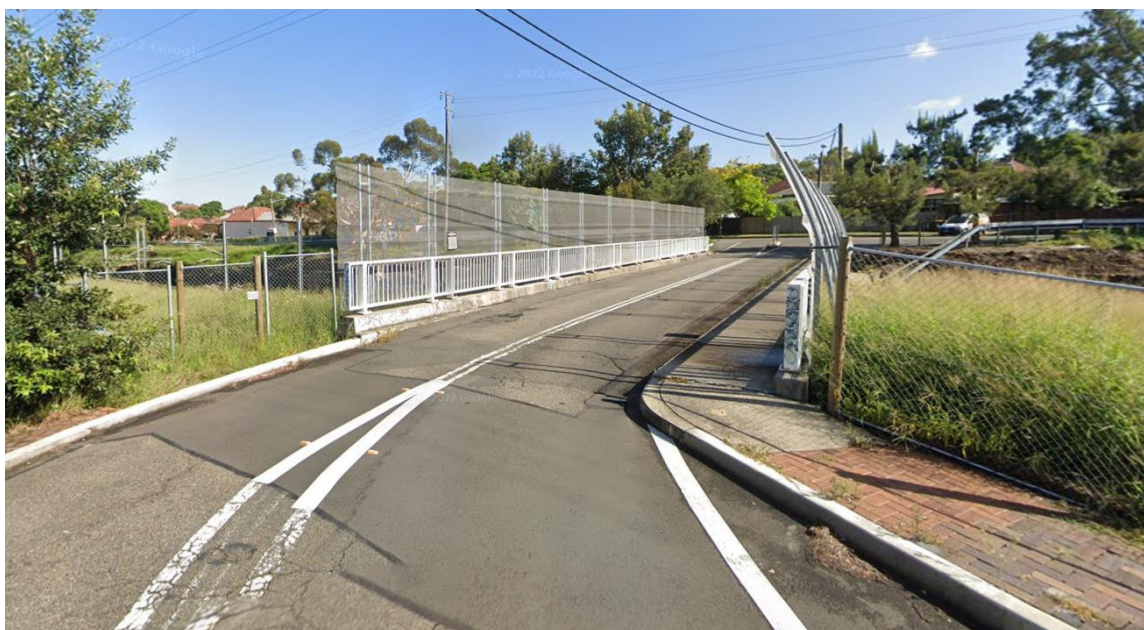
Figure 34: Albermarle Street Overbridge, with Depression era brick paving visible on the right (east) side (Source: Google Maps)

Albermarle Street Overbridge consists of a concrete road deck atop girders which span between the embankments on either side of the rail corridor. The girders are supported by metal piers. A metal balustrade and safety fence line each side of the road deck. The brick footpath on the eastern side of Albermarle Street is part of the extensive brick paving that was laid in the Great Depression as part of the Employment Relief Schemes in the 1930s.

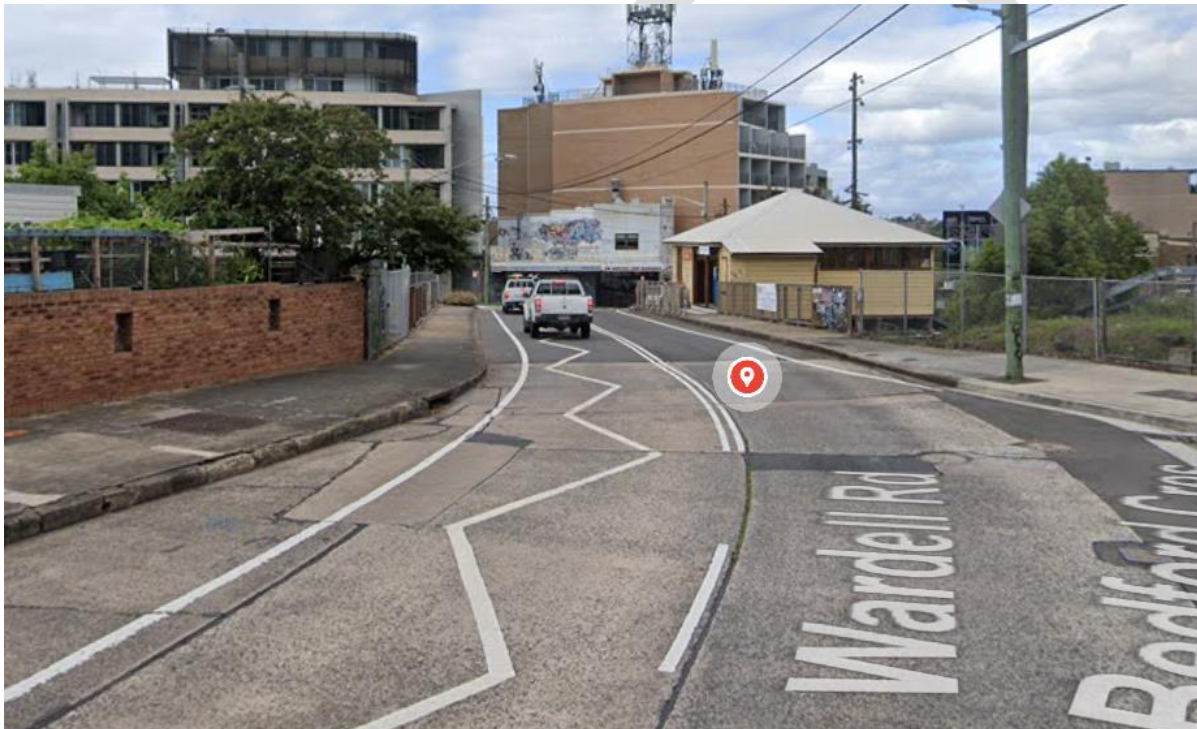
Figure 36: Wardell Road Overbridge (Source: Google maps)

The Wardell Road Overbridge consists of a modern, pre-stressed concrete road deck spanning between lateral concrete beams. These beams bear on the original face brick platform and the embankment piers on each side.<sup>33</sup>

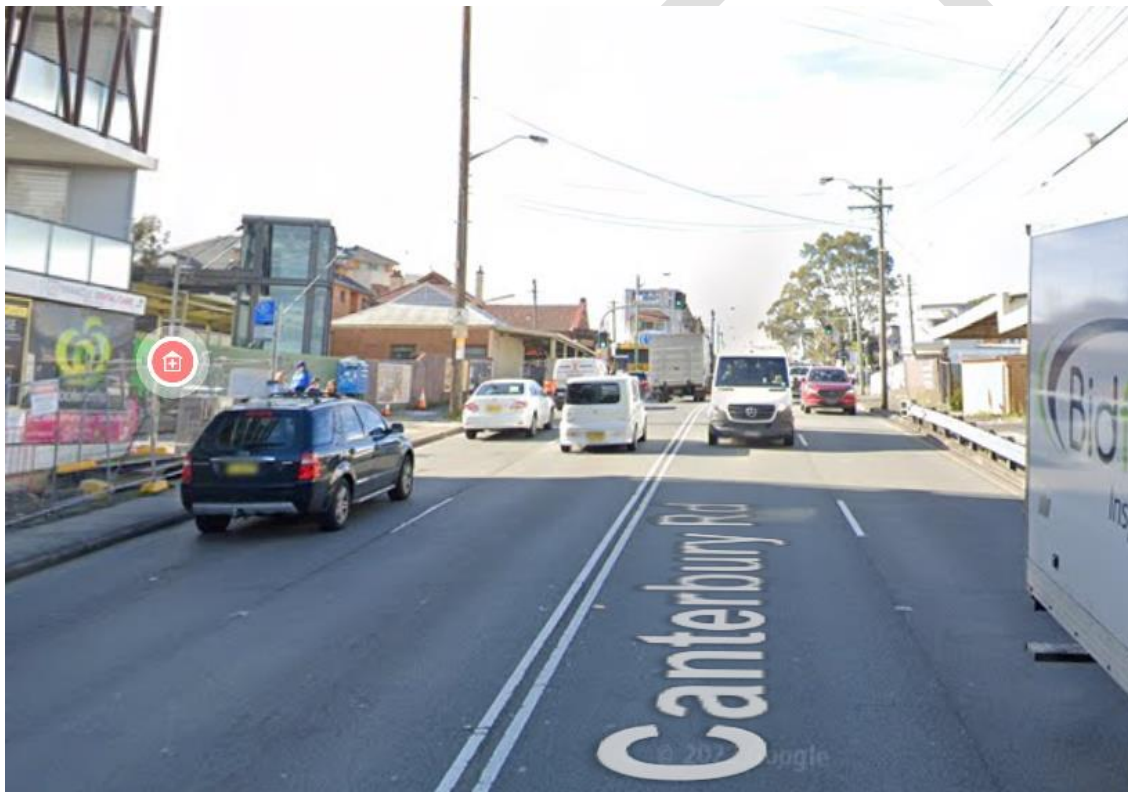
Figure 40: Canterbury Road Bridge (Source: Google maps)

The Canterbury Road Bridge consists of a jack arched brick and concrete deck support by steel girders. The girders are supported by concrete and brick abutments and span the Up and Down Line. The parapet walls lining the road deck are brick.

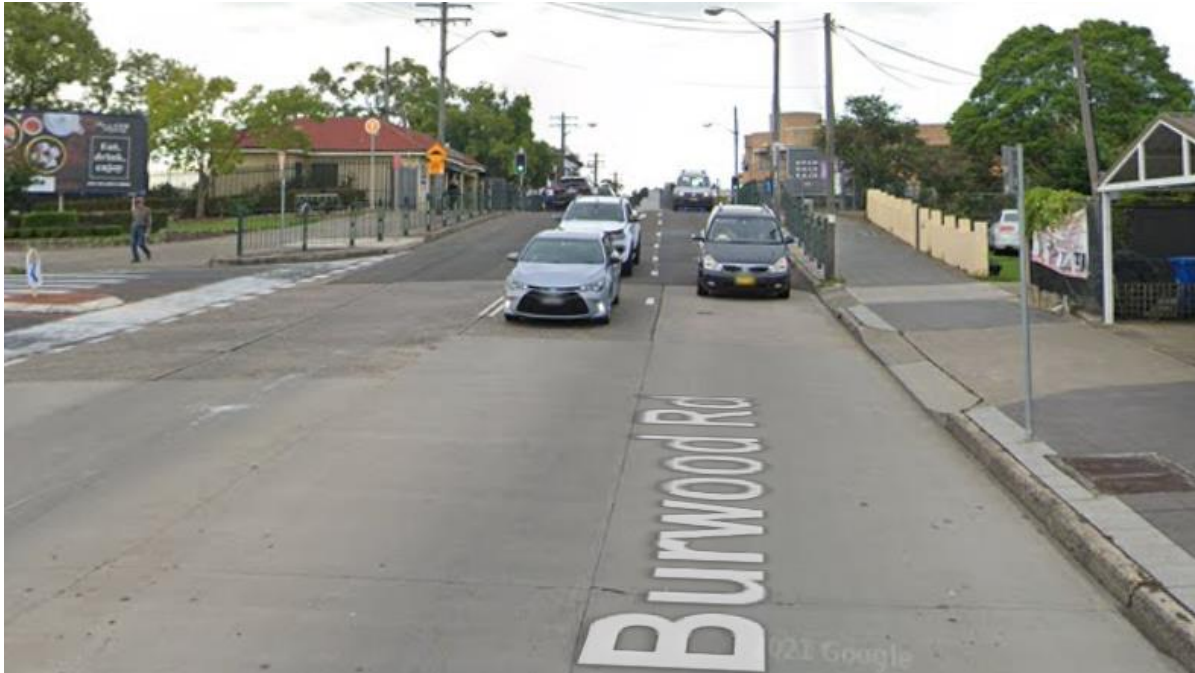
Figure 42: Burwood Road Bridge (Source: Google maps)

The Burwood Road Bridge consists of a prestressed concrete road deck, support by concrete abutments on either side and a central brick pier which was part of the original overbridge.<sup>42</sup> The existing barriers between the road and the rail corridor are steel mesh screens fixed to the concrete pavement.

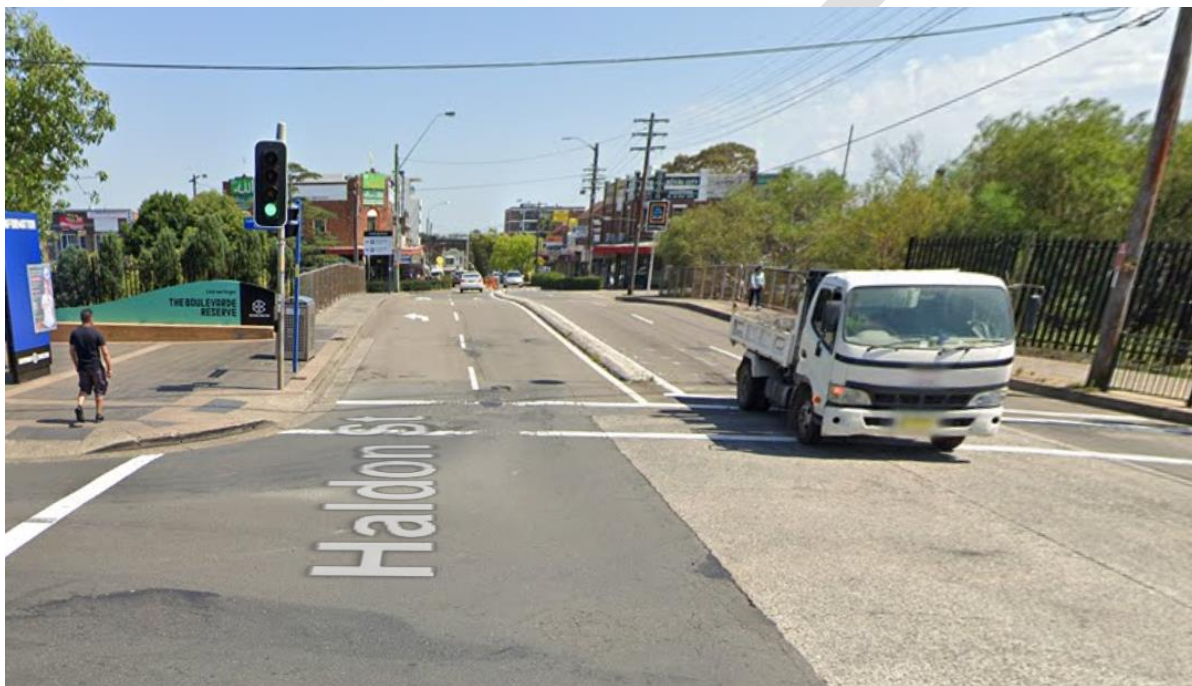
Figure 44: Haldon Street Bridge (Source: Google maps)

Haldon Street overbridge is a two span concrete girder structure, stretching approximately 27m.

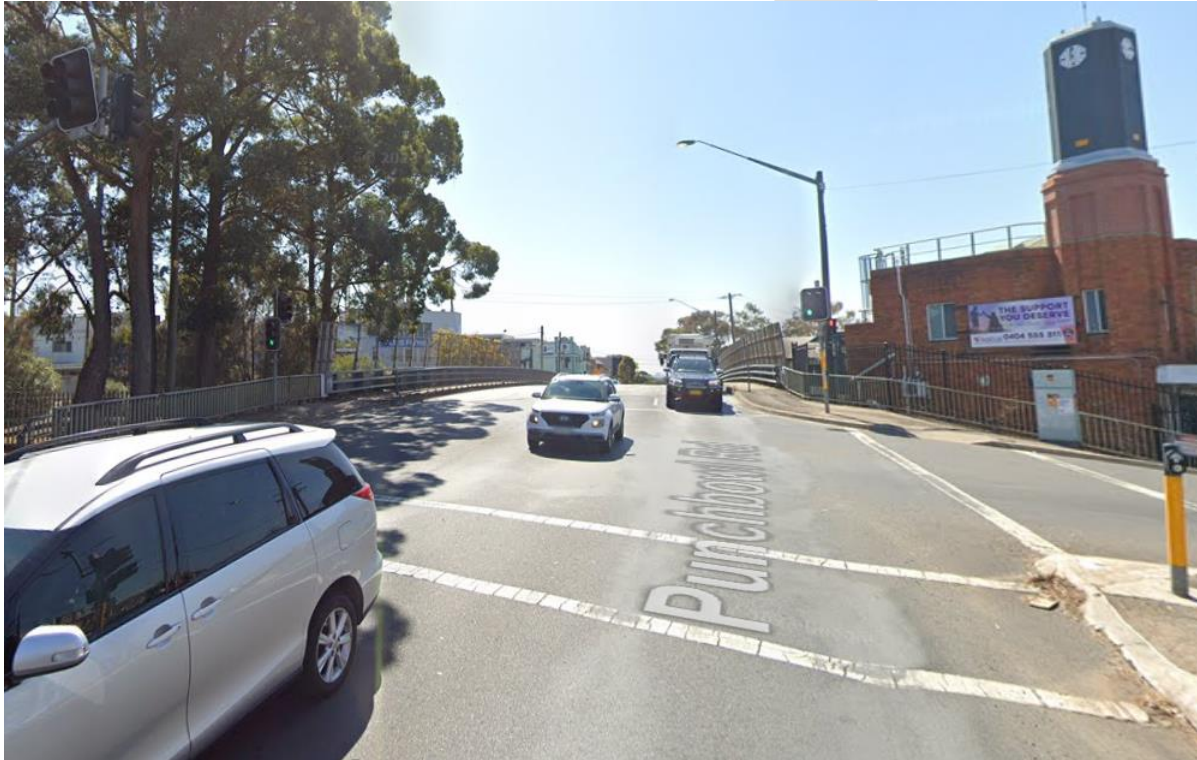
Figure 46: Punchbowl Road Bridge (Source: Google Maps)

Punchbowl Road overbridge, constructed in 1979, is a two span concrete girder bridge spanning approximately 48 metres.<sup>47</sup>

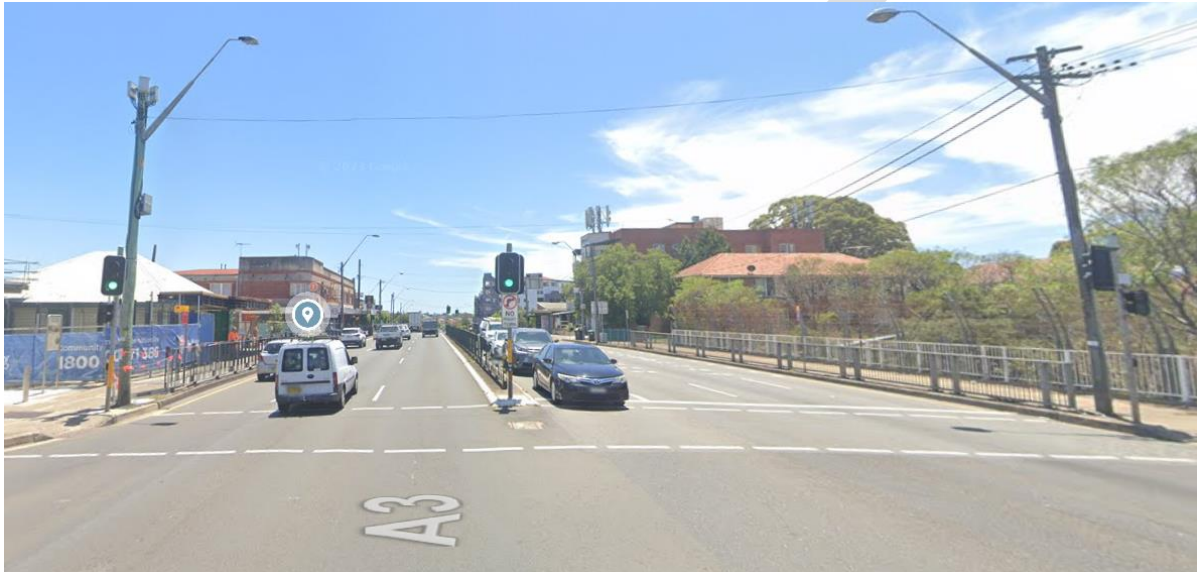
Figure 48: King Georges Road Bridge (Source: Google Maps)

The King Georges overbridge is a three span concrete girder structure spanning approximately 31 metres.<sup>51</sup>
