RE: Sydney Metro City and South West – ER Monthly Reports for March 2025

The attached summaries detail the key activities undertaken by Environmental Representatives for Sydney Metro – City and South West Sydenham to Bankstown for the month of **March 2025**.

1. Sydenham to Bankstown – TSOM

2. [Southwest Metro Corridor Package 3 \(SWM3\) JHLOR](#)

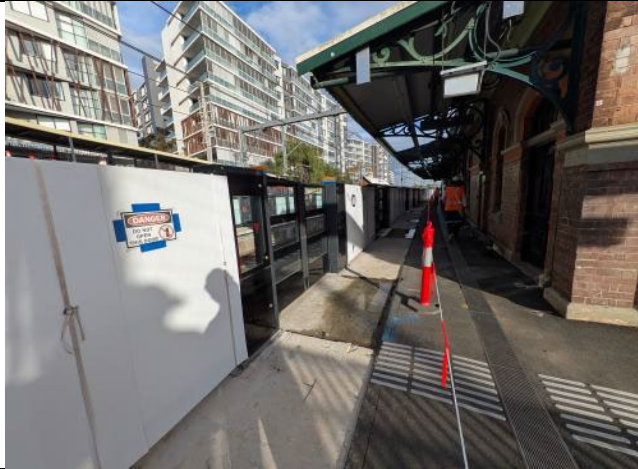
Figure 1 – Canterbury Station - Platform works, and station cleanup ongoing. Energisation complete in the preparation of testing and commissioning commencement.

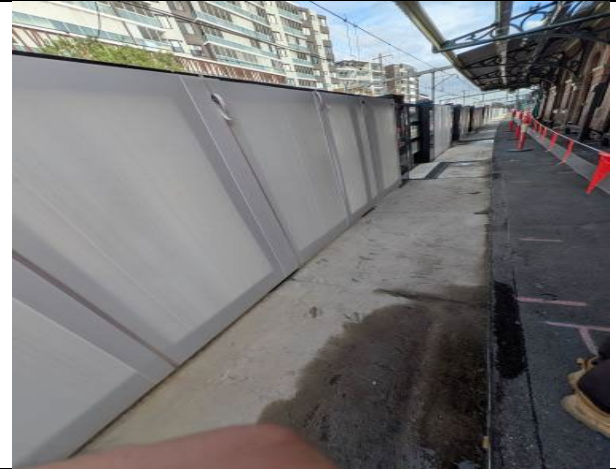
Figure 2 – Canterbury Station – Platform screen doors and mechanical gap fillers installation complete.

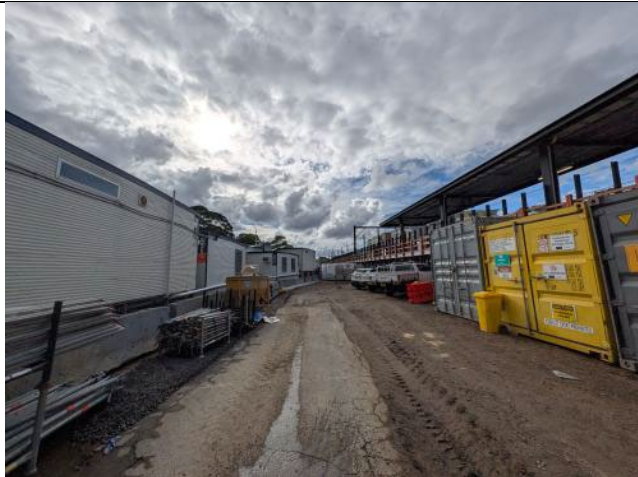
Figure 3 – Bankstown Station – Laydown area in use.

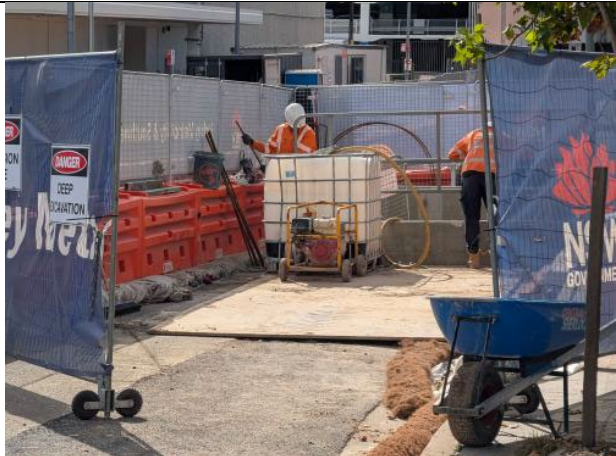
Figure 4 – Bankstown – Sewer works nearing completion at North Terrace.

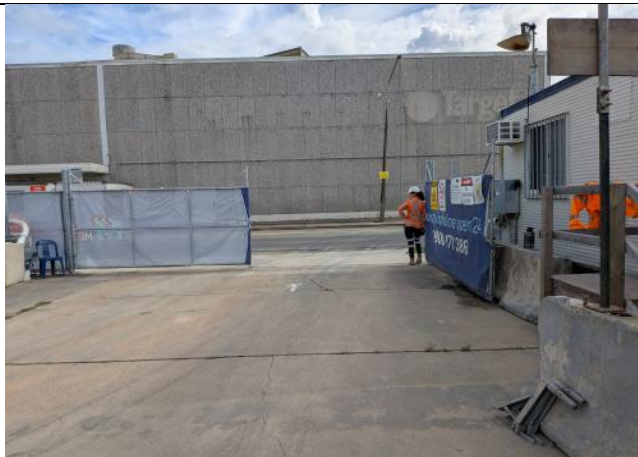
Figure 5 – Bankstown Station - Some dirt/mud tracking on hardstand area between site exit and laydown area. Street sweeper was in attendance at the time of inspection cleaning public road adjacent to the site.

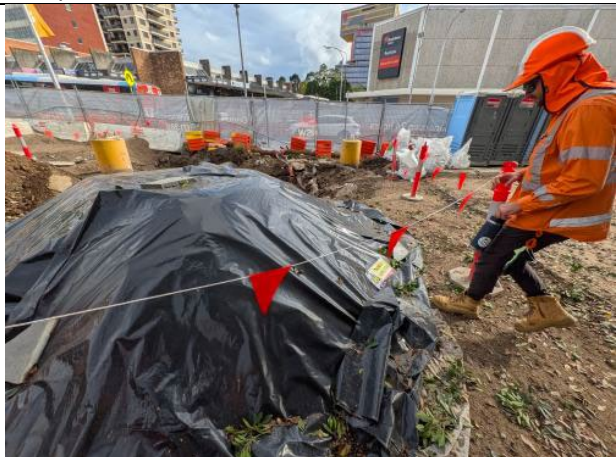
Figure 6 – Bankstown Station - Asbestos containing material stockpile, awaiting material classification report prior to offsite disposal to a licenced facility.

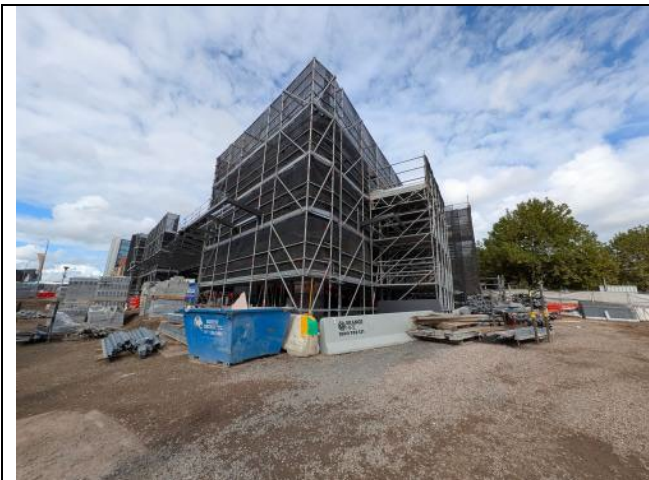
Figure 7 – Bankstown Station - Brick works and block works, roofing, utilities works ongoing on Sydney Trains side plaza areas.

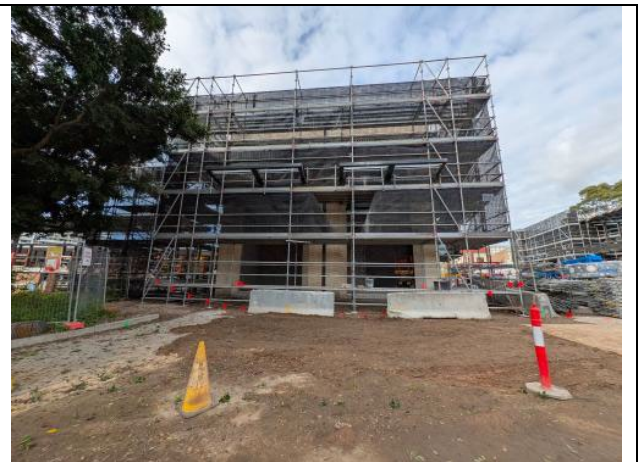
Figure 8 – Bankstown Station - Brick works and block works, roofing, utilities works ongoing on Sydney Metro side plaza areas.

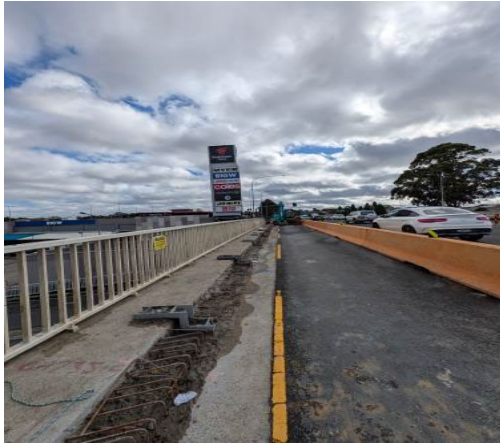
Figure 1 – Stacey St, Bankstown – Stage 2 of the hydro-demo works have been successfully completed. Site clean-up and footpath widening works in progress. Some tree branches pruning is required, arborist assessments underway.

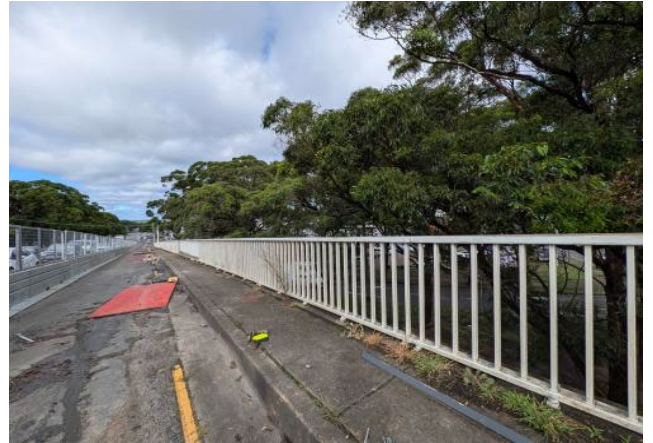
Figure 2 – Stacey St, Bankstown – Tree trimming required to support footpath widening activities, ecologist/arborist survey to be undertaken.

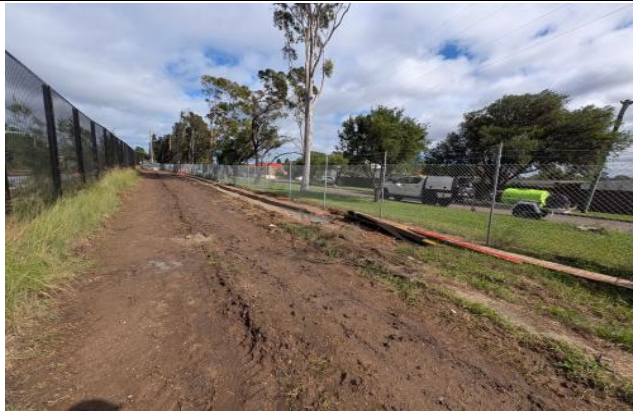
Figure 3 – Brande St/Urunga Parade (non-bridge) – concrete barrier works in progress.

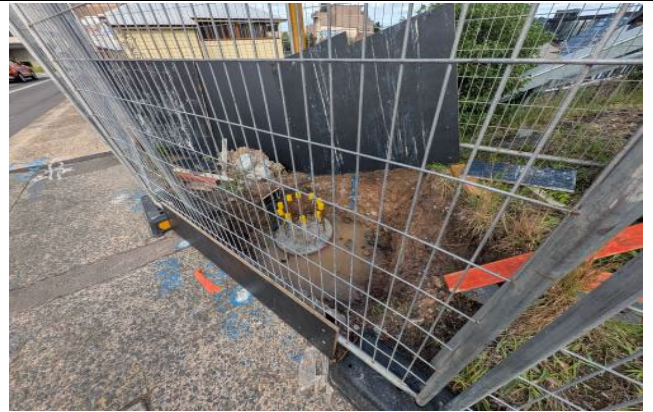
Figure 4 – Wardell Road – Piling completed, preparation works for girder delivery and installation in an upcoming possession.

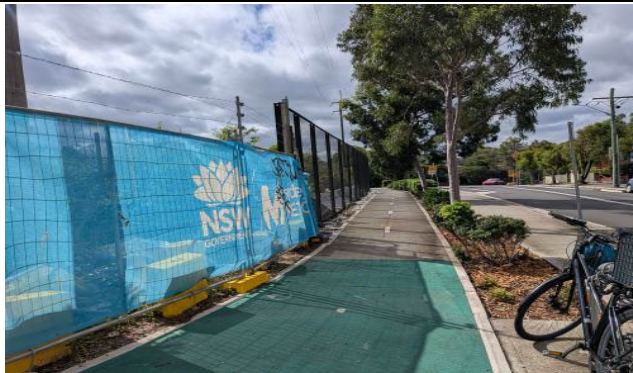
Figure 5 – Dulwich Hill - Steel barrier works planning ongoing, Martinus to avoid all impacts to TEC/PCT in this area as per recent discussions with SM and ER. Contractor Environment Manager to discuss the potential issues with the design and construction teams.
