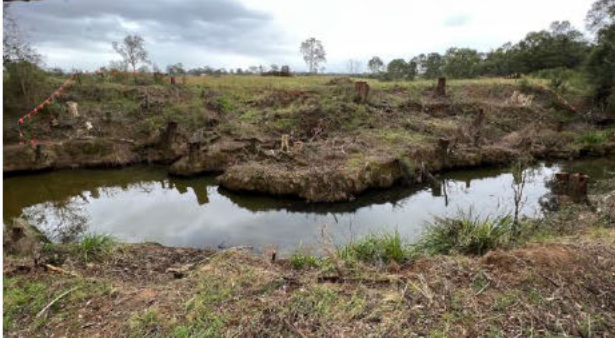
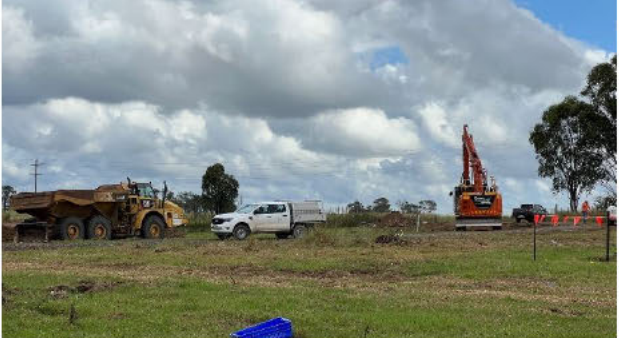
<p>SMF – One of the proposed crossing points at Blaxland Creek</p>	<p>Luddenham South - Works continue at the Luddenham South site</p>
<p>Endorsed Document/s</p>	
<p>The following documents were endorsed by the ER:</p> <ul style="list-style-type: none"> ▪ None <p>The following documents were provided for information or reviewed:</p> <ul style="list-style-type: none"> ▪ Surface and Civil Alignment Works – Flora and Fauna Management Sub Plan (rev 2) 	
<p>Complaints / Incidents / Non-compliance</p>	
<p>Three (3) complaints were reported to the ER during the period.</p> <ul style="list-style-type: none"> ○ 21/04/23 – Stakeholder reported grass and weed maintenance west of property, weeds south of the property inside SMF and noise from the SMF during standard construction hours. Continuous noise data was checked and grass and weeds were reviewed. Noise monitoring data was complaint and was offered to the stakeholder. Grass and weeds are to be maintained by the SCAW and Sydney Metro property teams. ○ 28/04/23 - Stakeholder was provided information on concerns raised in SM Complaints ID: 4644. However, they contacted CPBUI stating that they were not satisfied by the interaction they had with the Community Place Manager. The CPBUI stakeholder and communication manager contacted the stakeholder regarding the interaction with the community place manager and updated the stakeholder that they had since spoken with the community place manager and drone operator. The stakeholder also requested an apology from the community place manager,
