our reference: 21000264-ESCR-04-06-20230628

28 June 2023

**Soil Conservationist Inspection of Erosion and Sediment Controls;
Various Sites, Airport Metro SBT; 29 May and 9 June 2023**

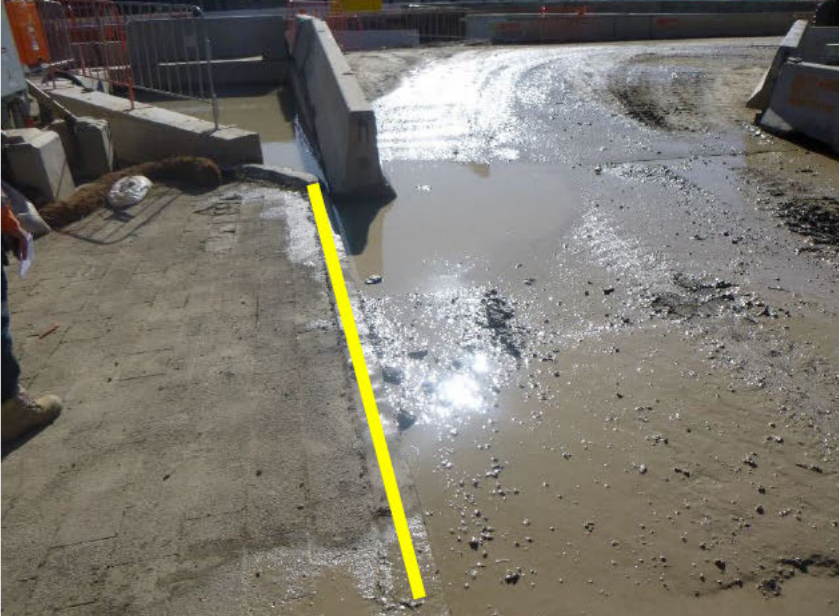
<p>Continue to sweep this clean prior to forecast rainfall to minimise the amount of sediment that runs to the sump.</p> <p>No other action is required here – the controls in place are appropriate.</p>	Ongoing medium priority
6.	St Marys	<p>Sump at entrance to moxy haul road.</p> <p>Risk of dirty water splashing over the kerb and missing the sump.</p>

<p>Extend the concrete lip on top of the kerb along the alignment shown (and as discussed onsite). Raise it by about 100mm.</p>	Medium

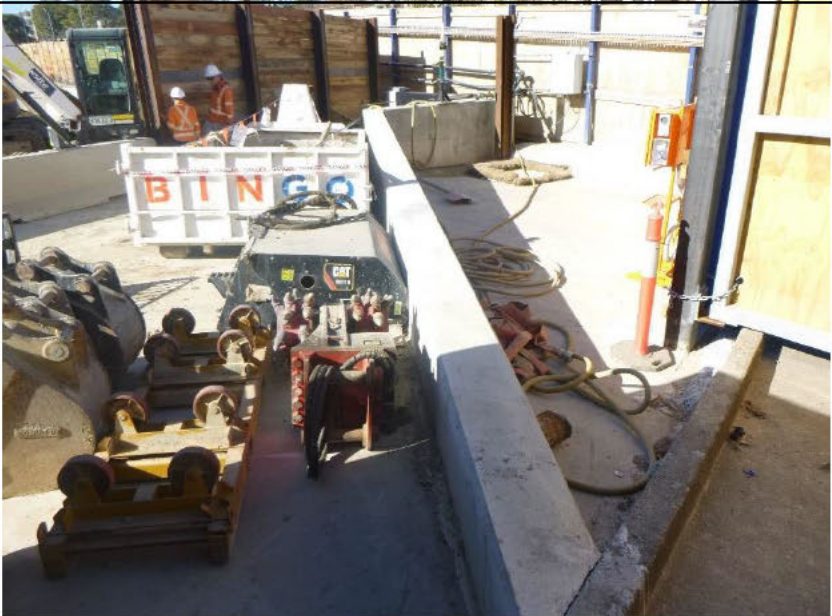
Positive feedback	N/A
8.	St Marys	<p>Nib wall is working well to trap dirty water runoff from the stockpiling area.</p> <p>However, no materials should be stored here – they reduce the capacity of the sump created by the nib wall.</p>

Remove materials and bin from the nib wall sump area.	Medium

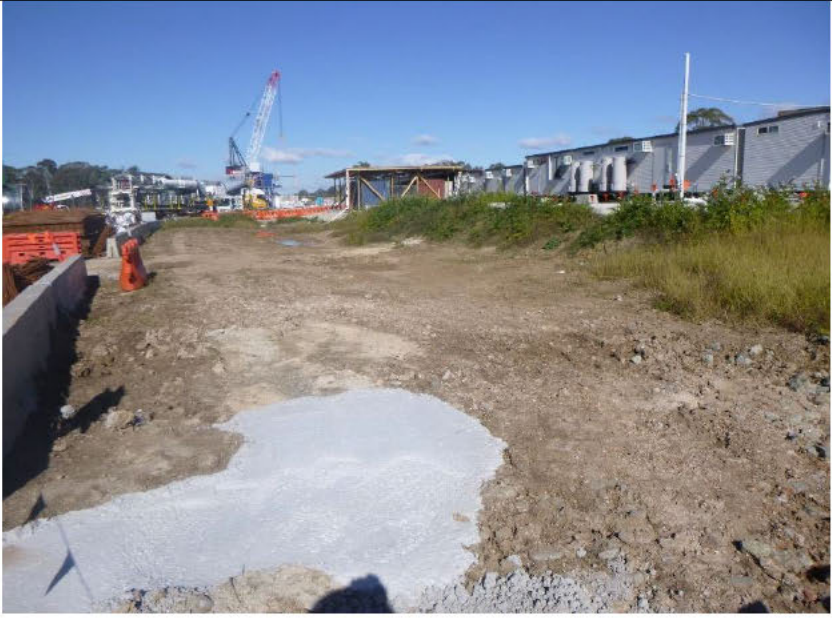
Adjust the sprinkler heads to a fine mist.	Low
10.	Orchard Hills	Clean water drain ripped up by recent works.

<p>Spray this area with polymer binder and seed.</p> <p>(Note that photo evidence was provided by CPBG JV staff that this has been closed out already)</p>	Closed out

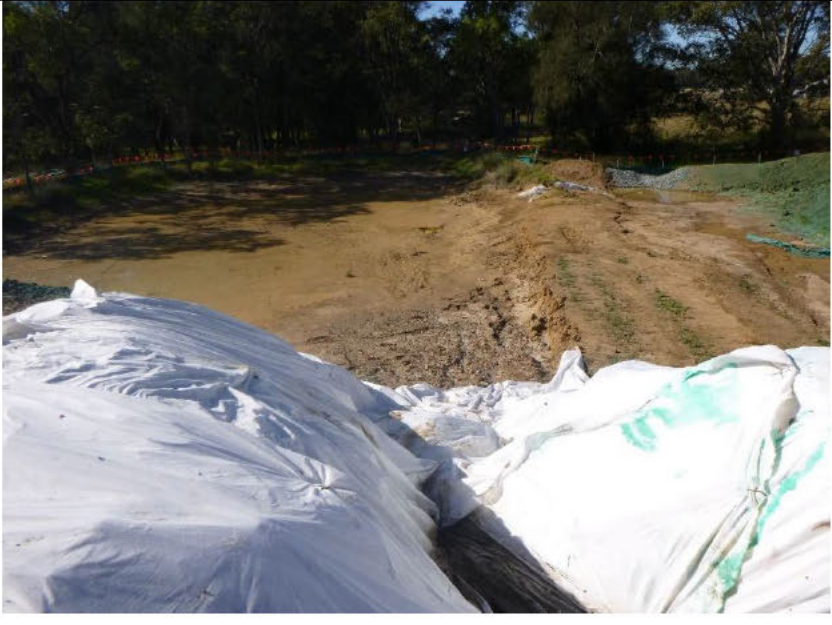
<p>Lap the fabric correctly so that water won't go under the fabric.</p> <p>Upslope fabric must go over the downslope fabric.</p> <p>Note that the chutes are fine otherwise – there's no need for rock as well.</p>	Medium
12.	Orchard Hills	<p>Basin capacity needs to be checked to ensure it meets the ESCP minimum.</p>

<p>Basin has accumulated plenty of sediment, and needs to be de-silted if the capacity falls below the minimum required under the ESCP.</p> <p>Check capacity against the ESCP.</p>	Medium

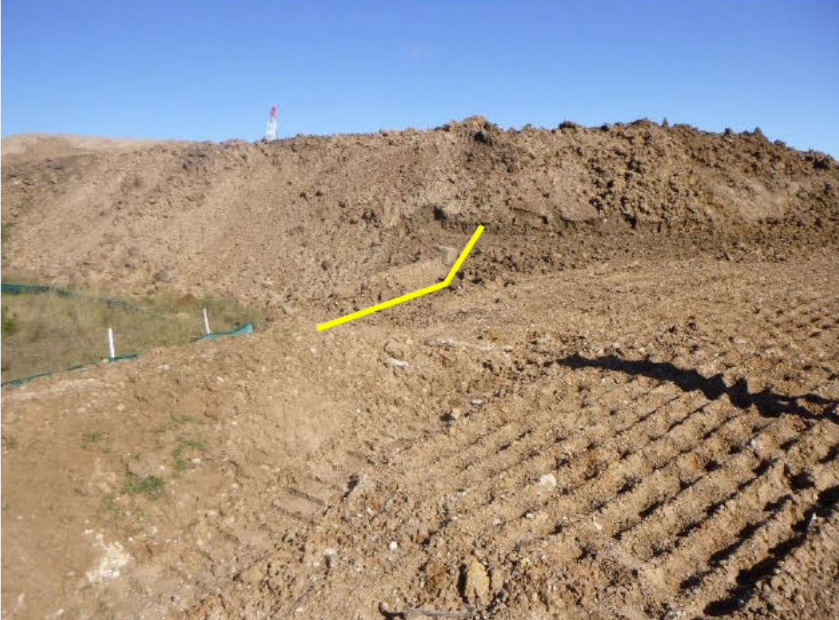
<p>Install the silt fence properly – trench it firmly into the ground to at least 150mm.</p> <p>And</p> <p>Spray the backside (east face) of the stockpile with polymer binder.</p>	<p>High</p> <p>High</p>
14.	Orchard Hills	<p>Runoff from part of the stockpile would miss the basin.</p>

<p>Extend the bund as shown to ensure that as much as possible of the stockpile will direct runoff to the basin.</p> <p>(Note: photo provided by CPBG JV staff to demonstrate this has already been closed out)</p>	<p>Closed out</p>

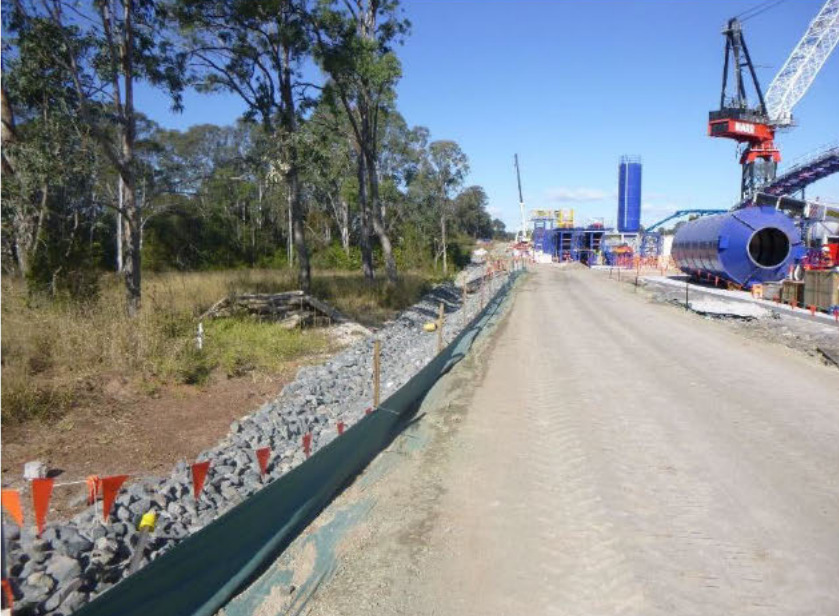
<p>Re-jig the silt fence along the sides of the rock-lined spillway as shown in red.</p> <p>Remove the silt fence from across the rock spillway.</p>	Low
16.	Orchard Hills	Eastern haul road – silt fences not dug in properly.

Install the silt fence properly – trench it firmly into the ground to at least 150mm	Medium

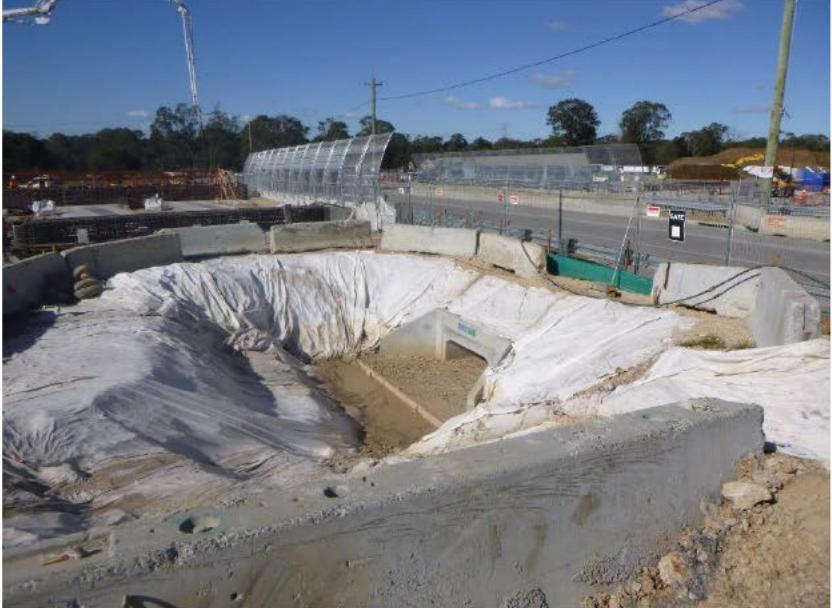
<p>Ensure silt fences are properly installed:</p> <p>Trench them in at least 150mm deep. Returns at 20m intervals</p> <p>Posts at 2.5m centres (metal posts) or 1.5m centres (wooden posts)</p>	High
20.	Orchard Hills, just north of Lansdowne Rd	<p>Positive feedback:</p> <p>Good use of a temporary sump to detain dirty site water</p>

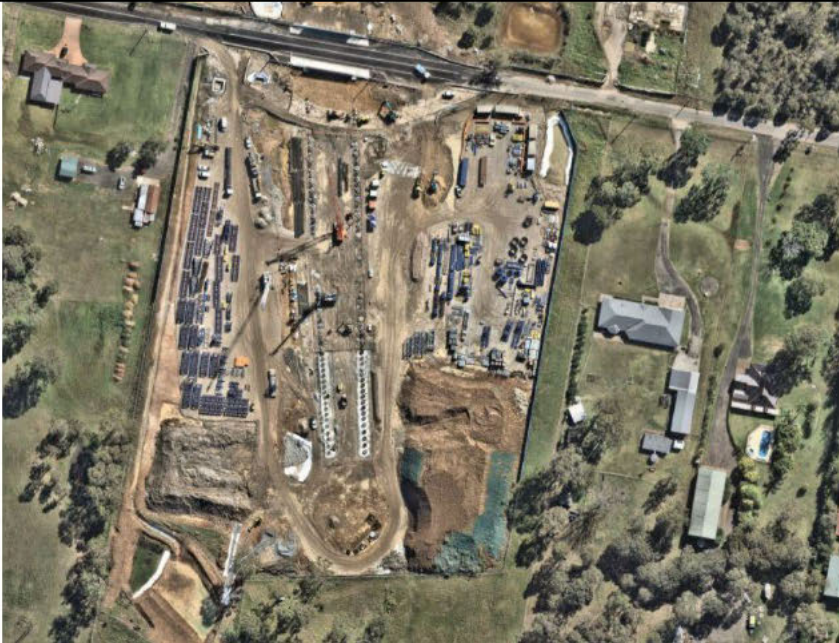
If possible, reuse the mulched vegetation to create a mulch bund at least 500mm high along the eastern edge of the cleared area.	Low
22.	Orchard Hills	Swale drain along western edge, south of Lansdowne Road is suitable as is, and does not need to be stabilised further.

No action required.	N/A

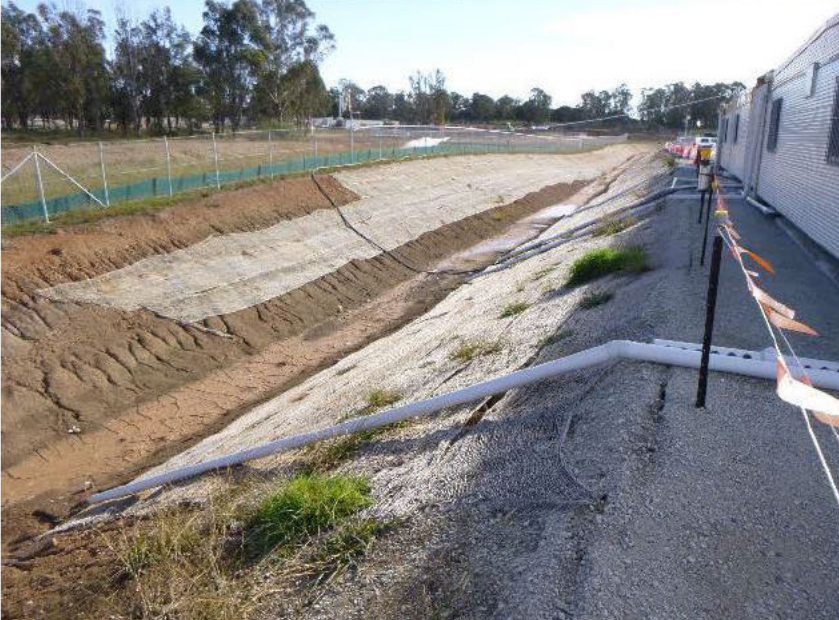
24.	Aerotropolis	<p>Clean water drain not lined. As a result, any water in this drain must be managed as dirty water.</p>

<p>If this drain needs to be vegetated, it will need to be veneered with topsoil prior to seeding.</p> <p>Alternatively, a compost blanket could be sprayed onto the drain (note that the cost of compost blanket is generally quite high and the lead time could be long because of the quantities of compost that are required).</p> <p>A biodegradable mat or mesh (e.g. jute mesh) should be placed over the topsoil or compost blanket in the invert of the channel.</p> <p>If the channel doesn't require vegetation, consider just using thick jutemat (700gsm), shotcrete or concrete canvas (or a similar GCCM)</p>	High

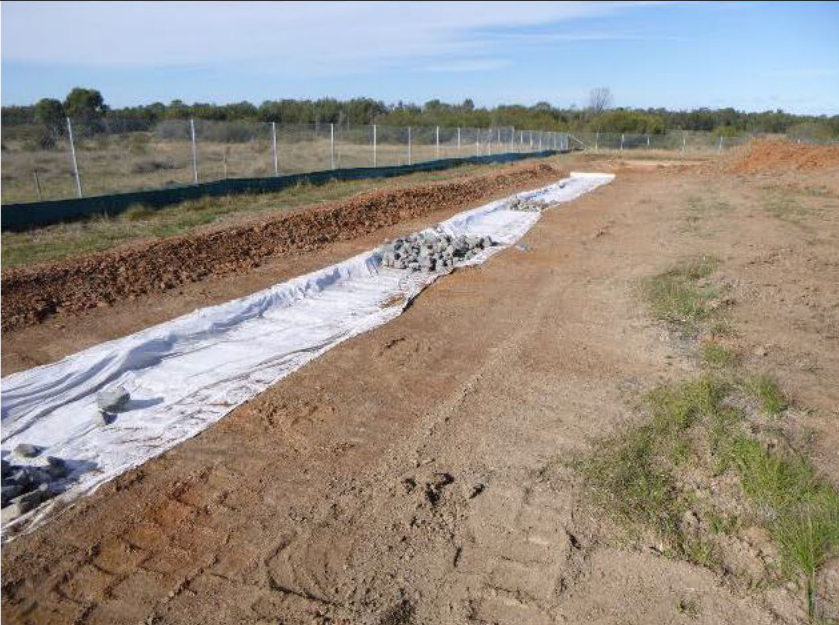
<p>Spray the stockpiles with soil binder (or an alternative ground cover)</p>	<p>Low</p>
26.	Aerotropolis	<p>Sediment basin spillway is not complete and doesn't extend to the boundary.</p>

<p>Extend the spillway all the way to the boundary discharge point, and fully line the spillway.</p>	<p>Low</p>

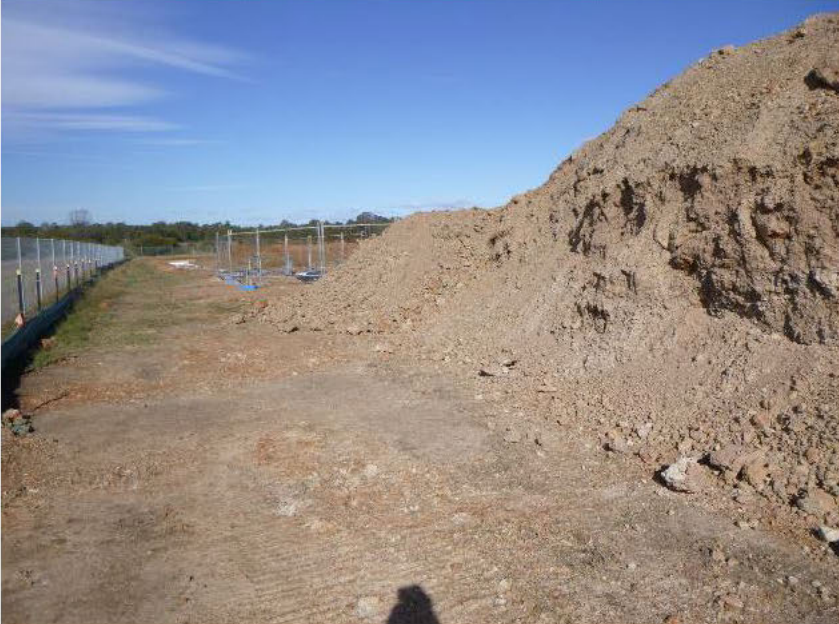
Re-dig the spillway so that the finished level of the rock creates a trapezoidal profile and the water will flow in the channel, not around the sides of it.	Low
28.	Aerotropolis	Stockpile adjacent to the basin blocks a large amount of site water from reaching the basin.

Remove this stockpile and form up the drain to direct all site water into the basin.	Medium

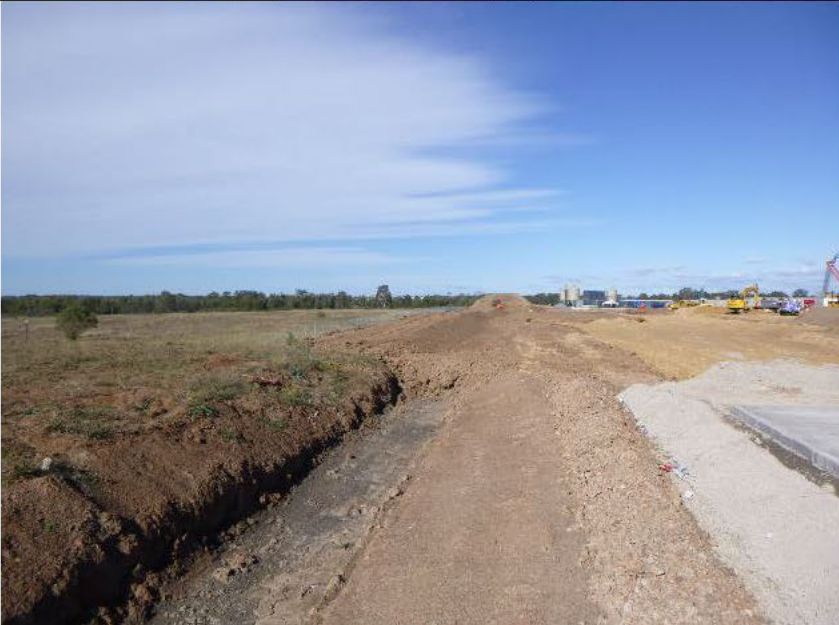
Finish off the batter, veneer it with topsoil and vegetate it.	Medium
30.	Aerotropolis	Stockpile adjacent to the basin blocks a large amount of site water from reaching the basin.

Remove the stockpile and form up the drain to direct all site water into the basin.	Medium
