Blues Point Archaeological Monitoring Report

Prepared by AMBS Ecology & Heritage
for Systems Connect

March 2023

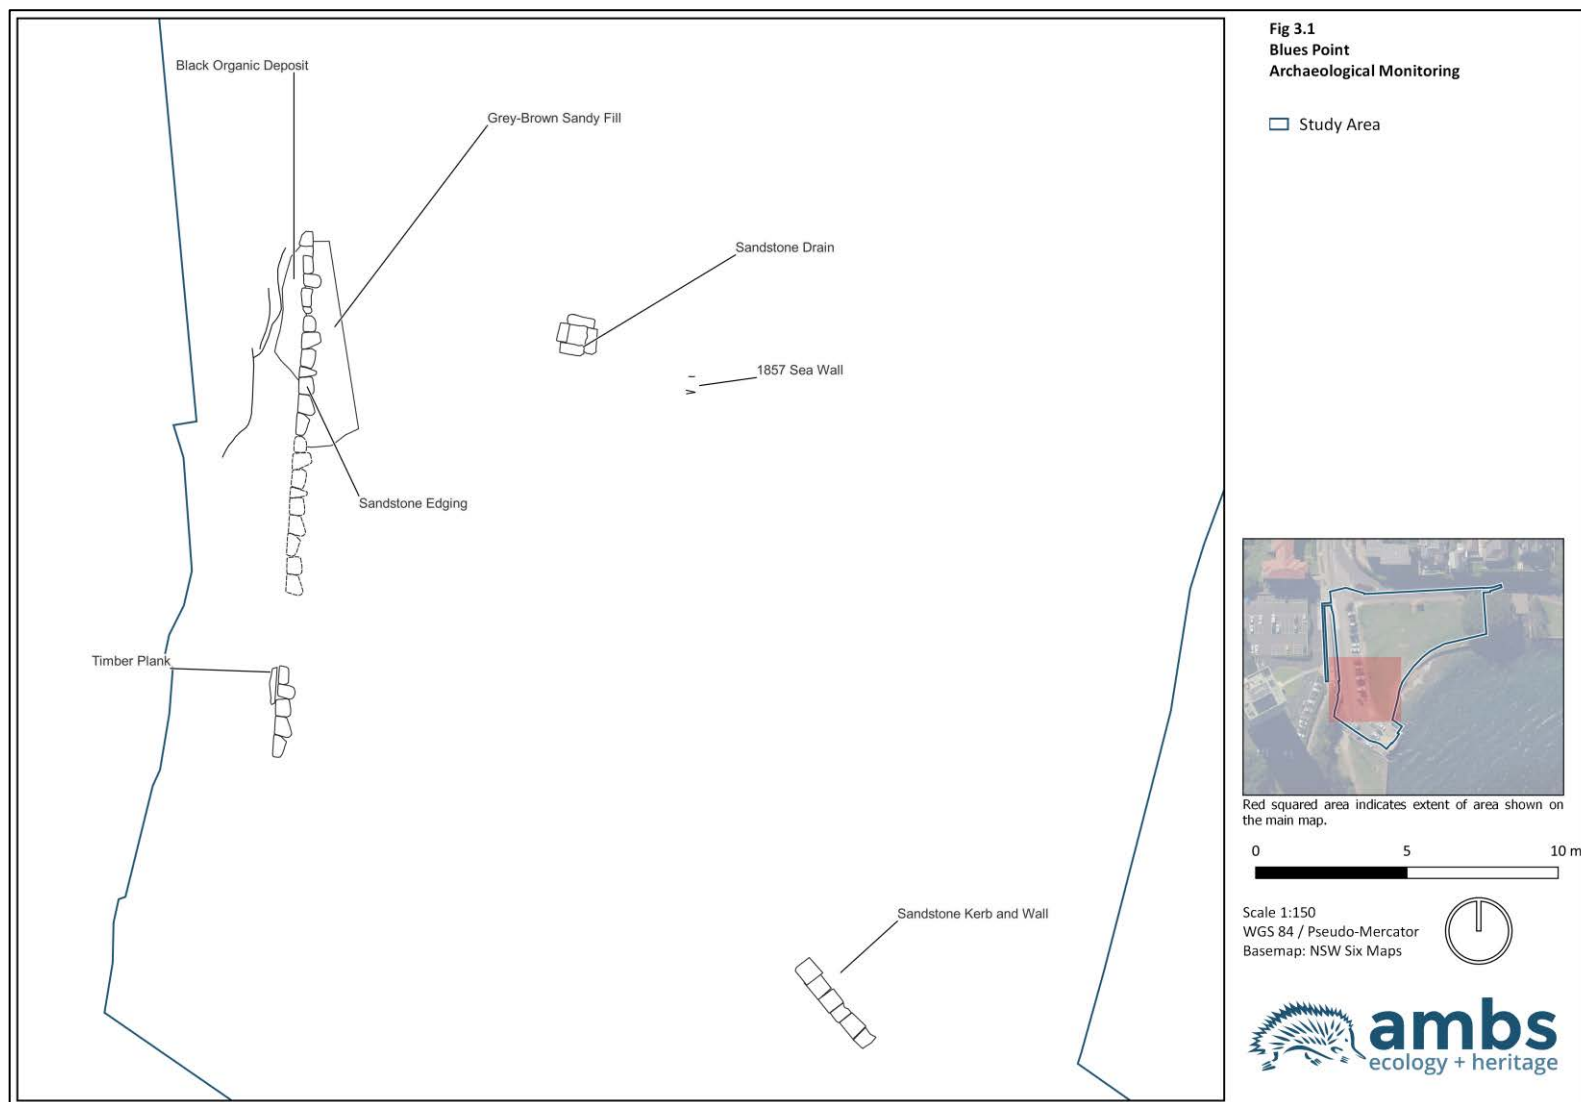
Figure 3.1: Plan of features uncovered during Blues Point Monitoring. The red square indicates the extent of the study area shown on the main map.

A series of features, including edging, drains and walls were found in Work Zones 1A, 1B, 1C, 1D, 3A, and 3D which were likely locally sourced and utilised for the everyday use of the area (Figure 3.1).

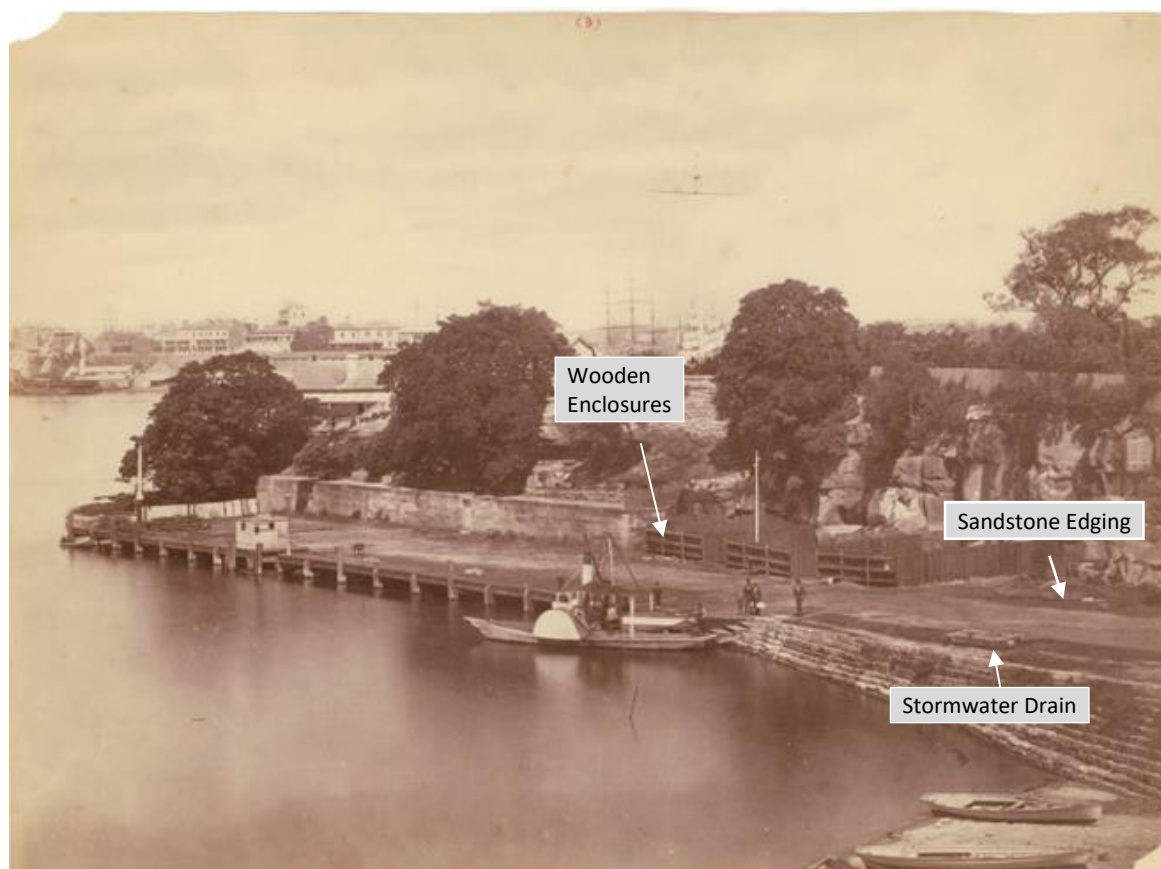
The c.1874 image following shows sandstone edging just north of three wooden structures probably associated with the coal yard (Figure 3.8). The wooden plank identified in WZ1A is likely associated with these wooden structures. This image also shows a sandstone stormwater drain at the top of the seawall; both these features are discussed below.

Figure 3.8: Image of the coal yard at the bottom of Blues Point Road dating from c.1874. The sandstone edging can be seen on the western side of the road. Note the wooden enclosures with horizontal planks across the front. Also visible on this image is the sandstone stormwater drain and the sea wall. SPF/800 ML SLNSW.

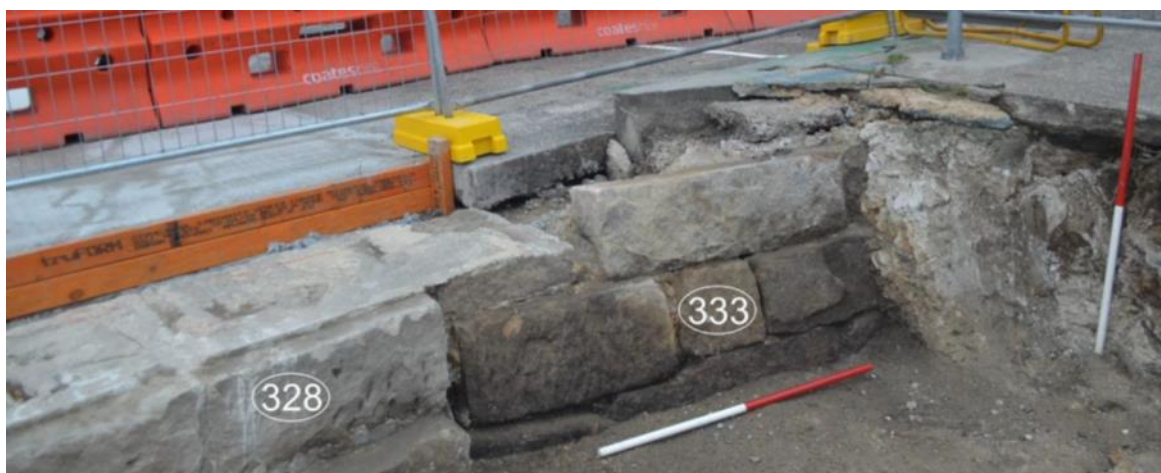
inclusion of the bluestone seat, three courses of a sandstone wall [019] were exposed. In 2018 Casey & Lowe excavated a northern section of a north-south sea wall [328] that was incorporated into the footpath and that joined the earlier c.1850s sea wall [333] (Figure 3.17). However, the alignment of the wall in WZ3A is different to all variations of the seawalls or retaining walls suggesting its later construction and use.

Figure 3.17: c.1800's seawall incorporated into a footpath along east side of Blues Point Rd and connecting to the earlier 1850's sea wall. View to north-west. Source: Casey & Lowe 2021. Figure 4.89.P.173.

The section of the c.1850s sea wall [333] excavated by Casey & Lowe in 2018 was also uncovered during excavation in WZ3D (Figure 3.17 and Figure 3.1)

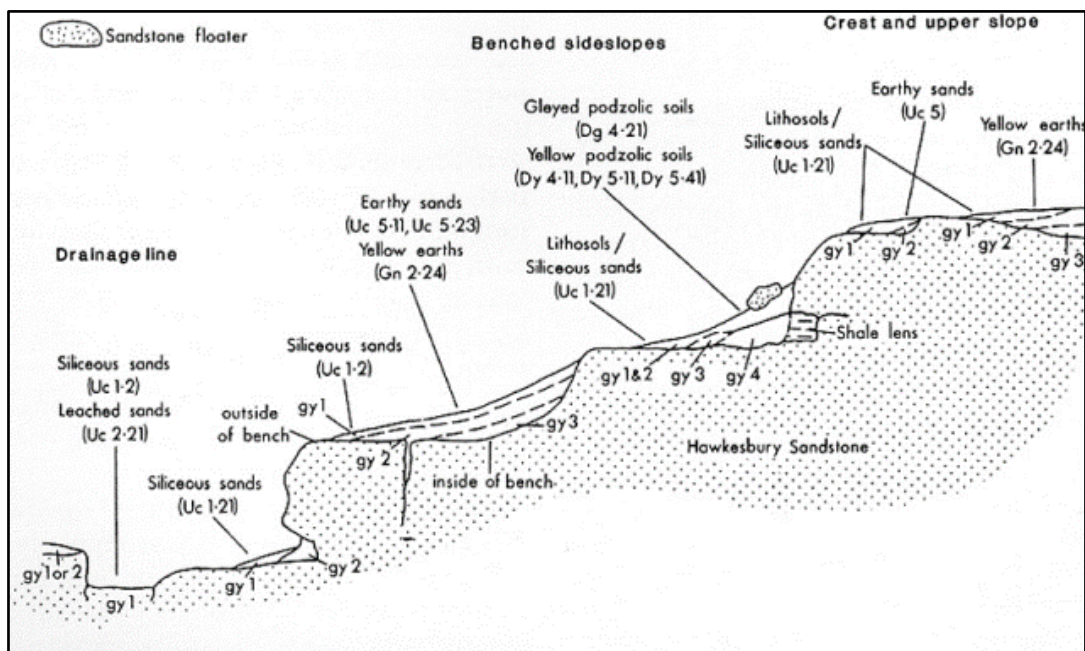
The excavation for the five garden beds and associated drainage in WZs 3D and 3E required a depth of 1020mm to lay drainage from garden bed to bed. The depth of the trenches revealed the undulating nature of the Hawkesbury Sandstone and its natural benching (Figure 3.22).

Figure 3.22: Schematic cross section of Gynea soil landscape illustrating the natural benching of Hawkesbury sandstone and the occurrence and the relationship of the dominant soil materials. (<https://www.environment.nsw.gov.au/Salis5app/resources/spade/reports/9130gy.pdf>).
