SITE AUDIT REPORT

ROAD INFRASTRUCTURE

AT 1C SYDNEY STEEL

ROAD, MARRICKVILLE

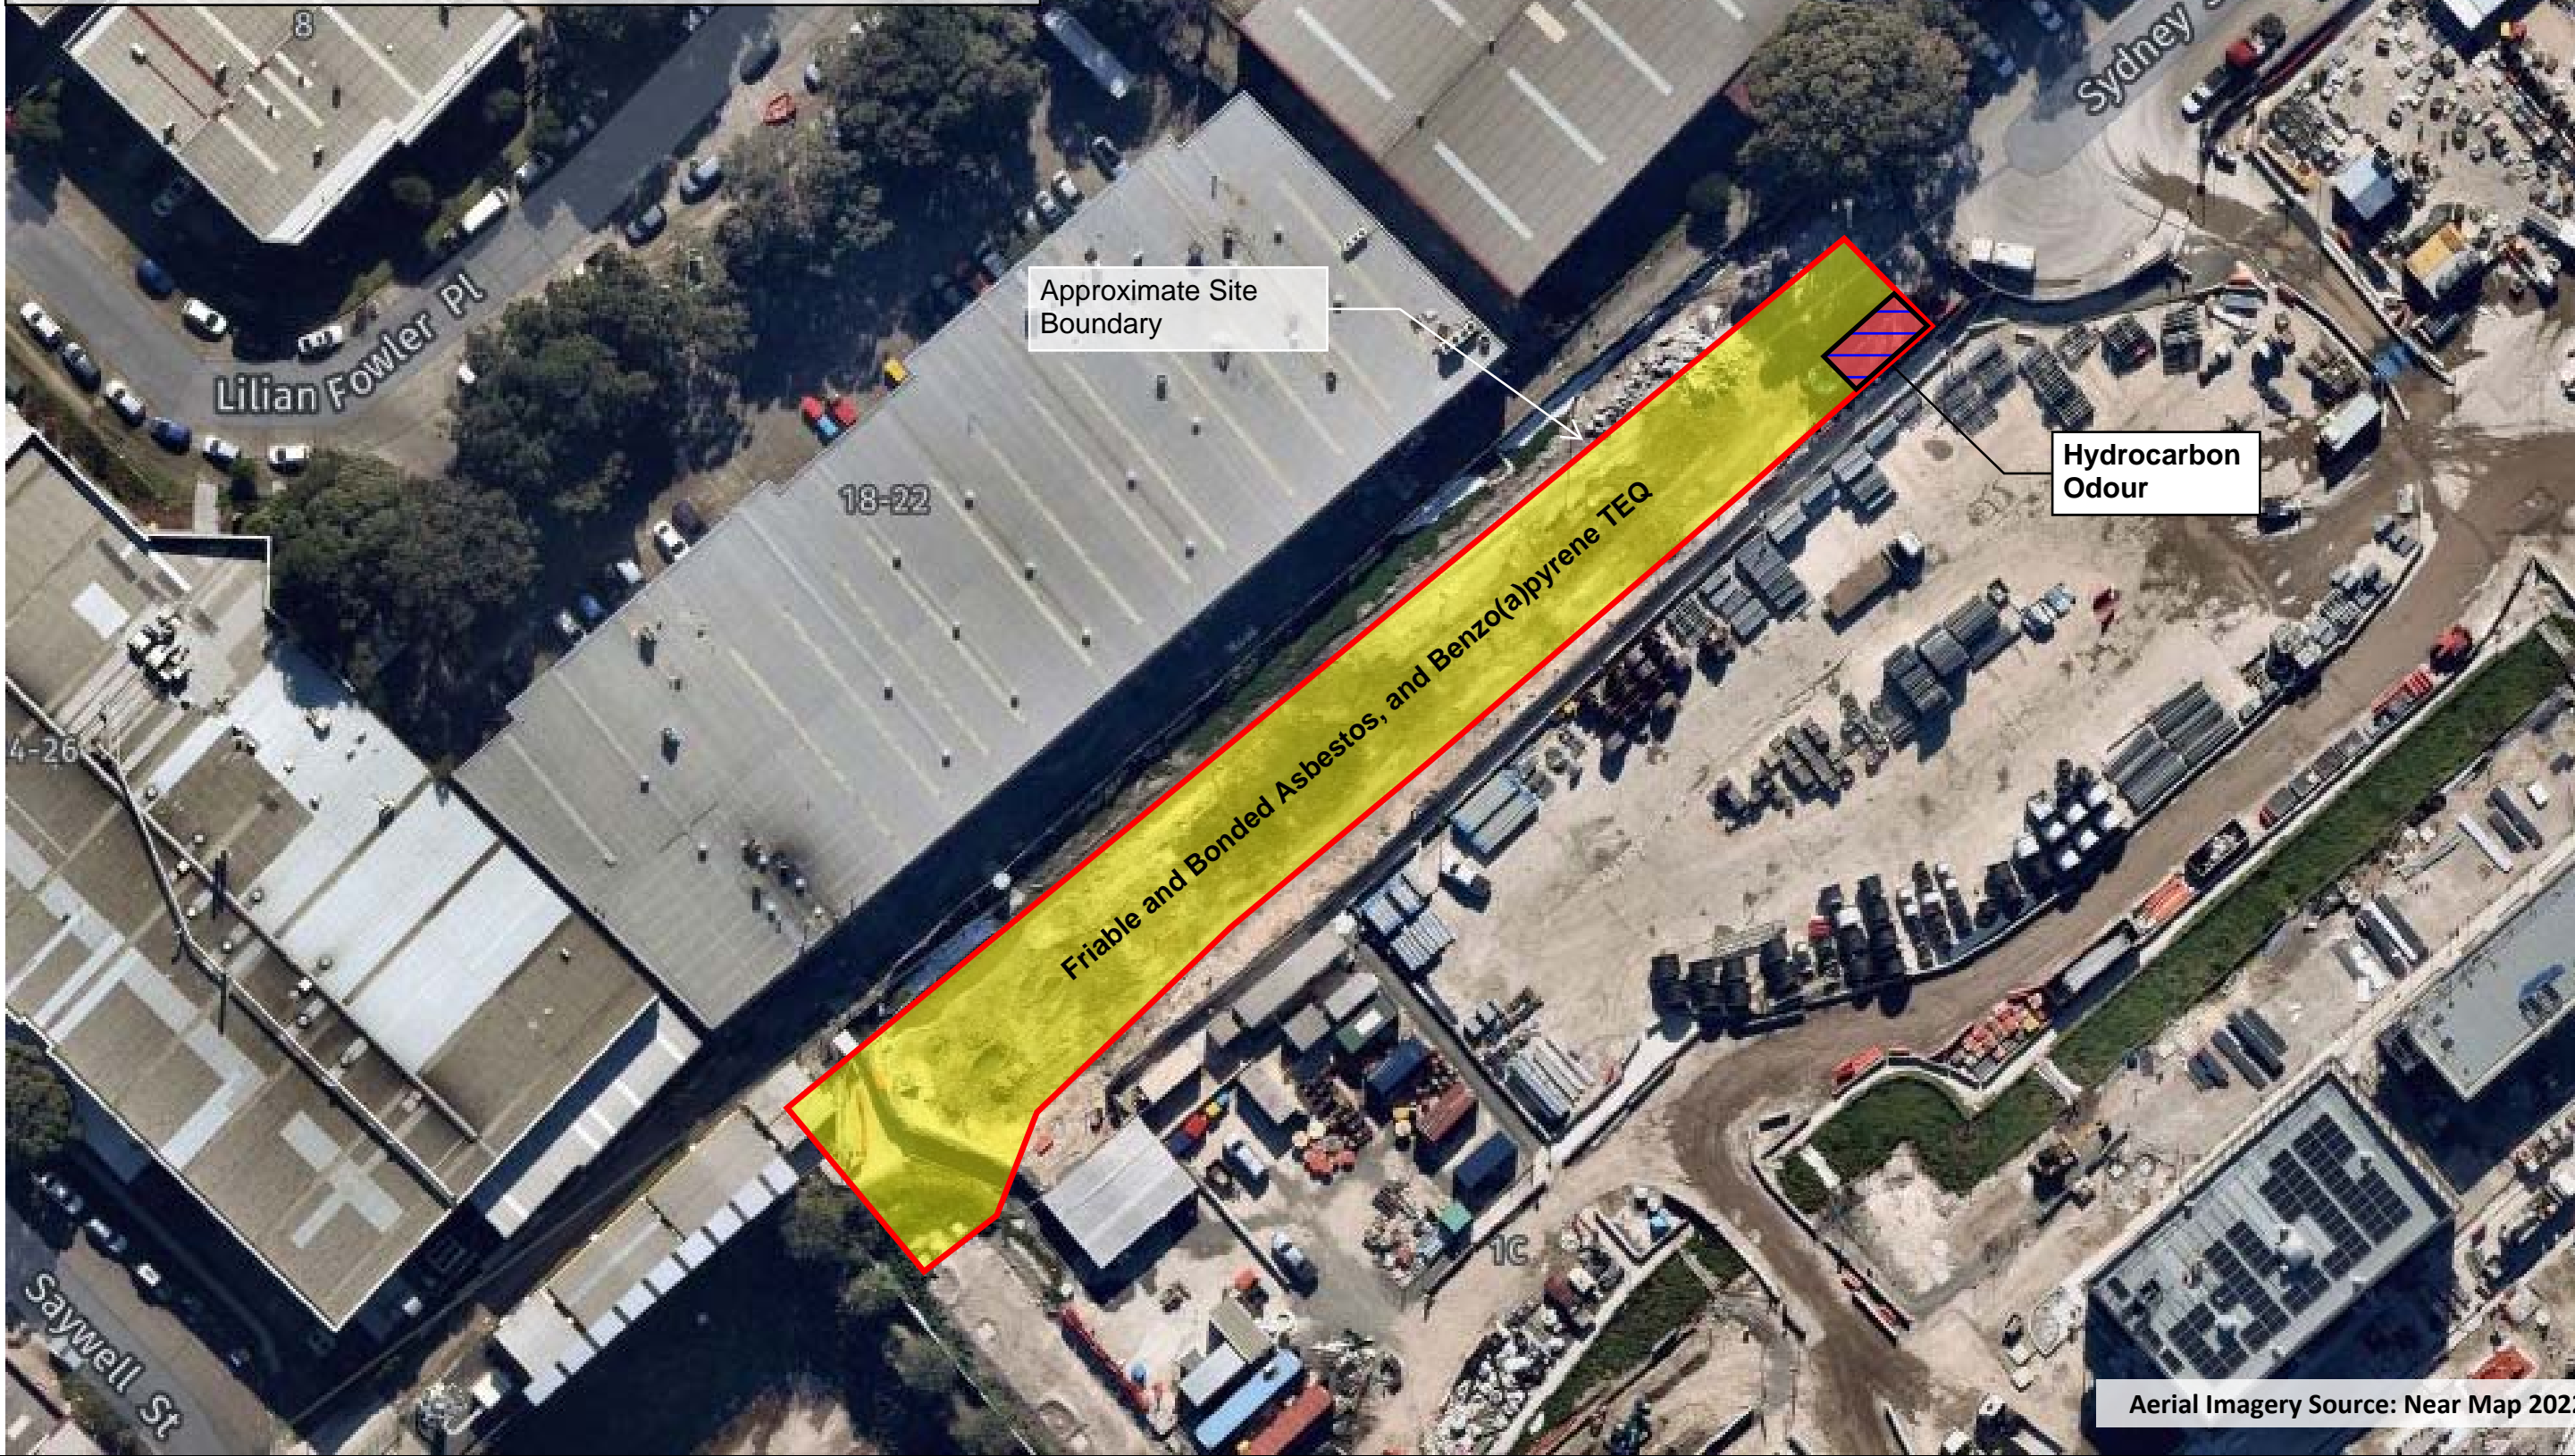
Area of Environmental Concern Plan

- Approx. Site Boundary
- Approx. Location of Friable and Bonded Asbestos, and Benzo(a)pyrene TEQ
- Approx. Location of Hydrocarbon Odour

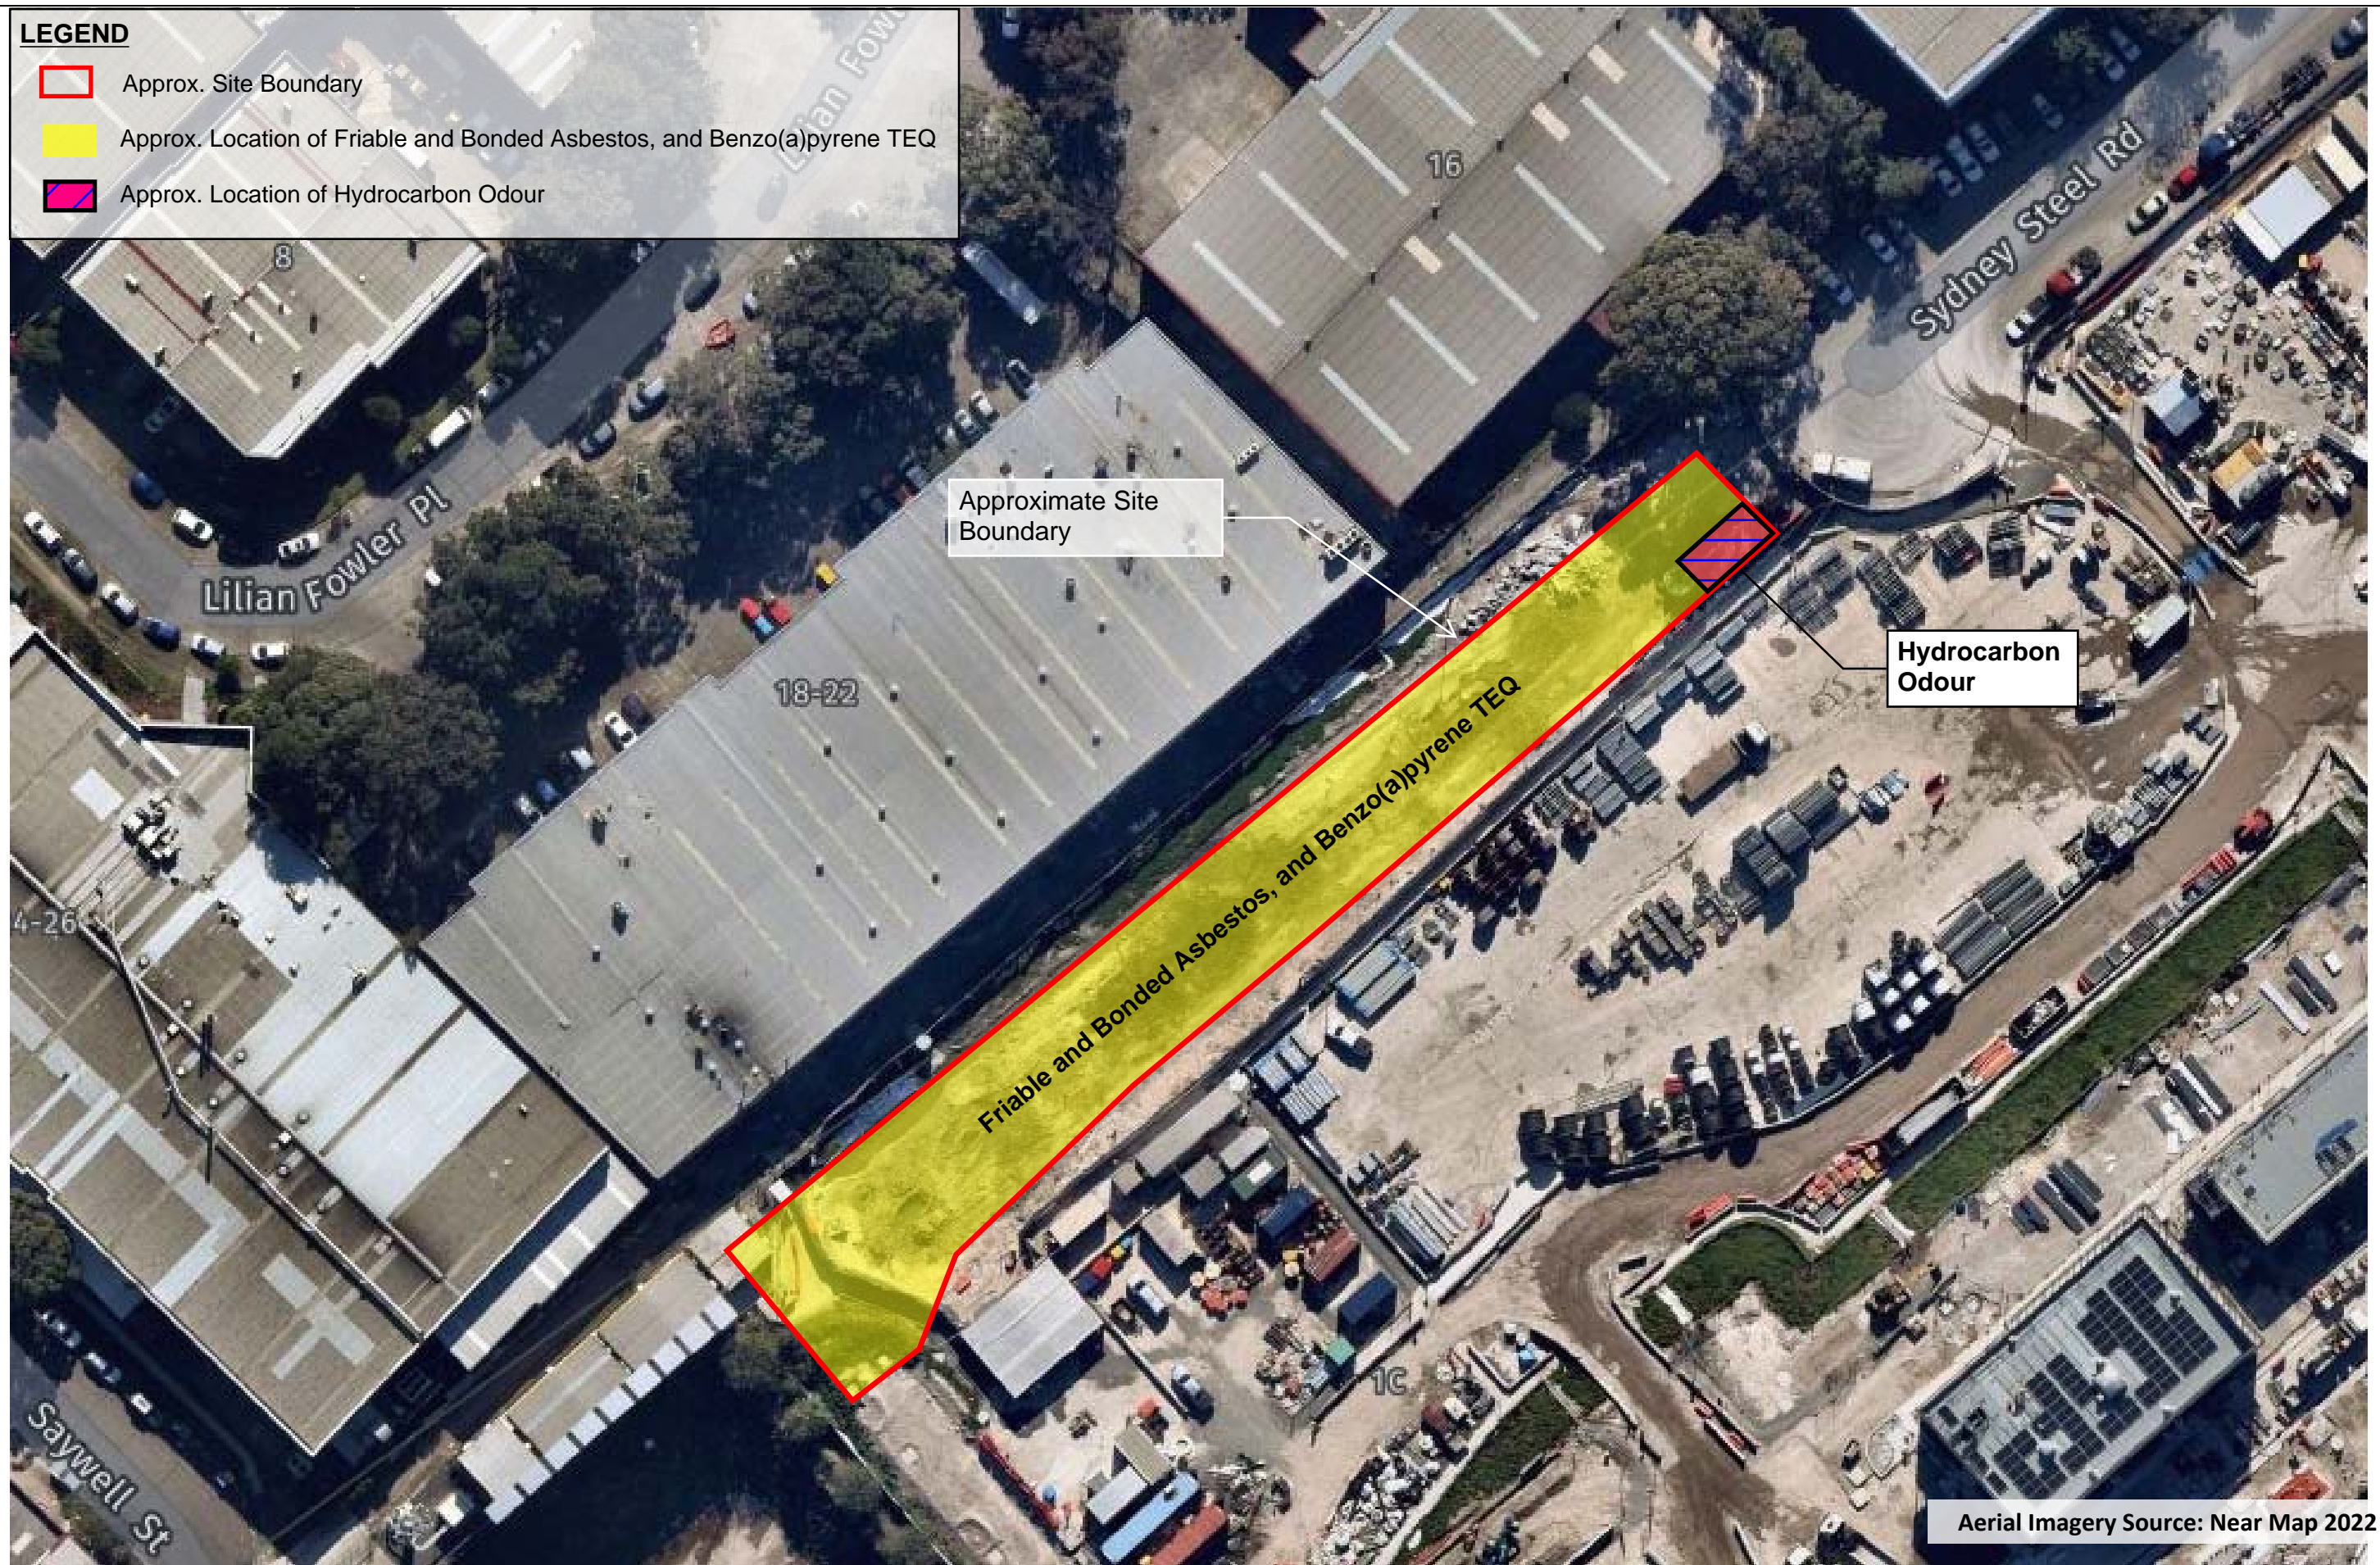
Area of Environmental Concern Plan

- Approx. Site Boundary
- Approx. Location of Friable and Bonded Asbestos, and Benzo(a)pyrene TEQ
- Approx. Location of Hydrocarbon Odour

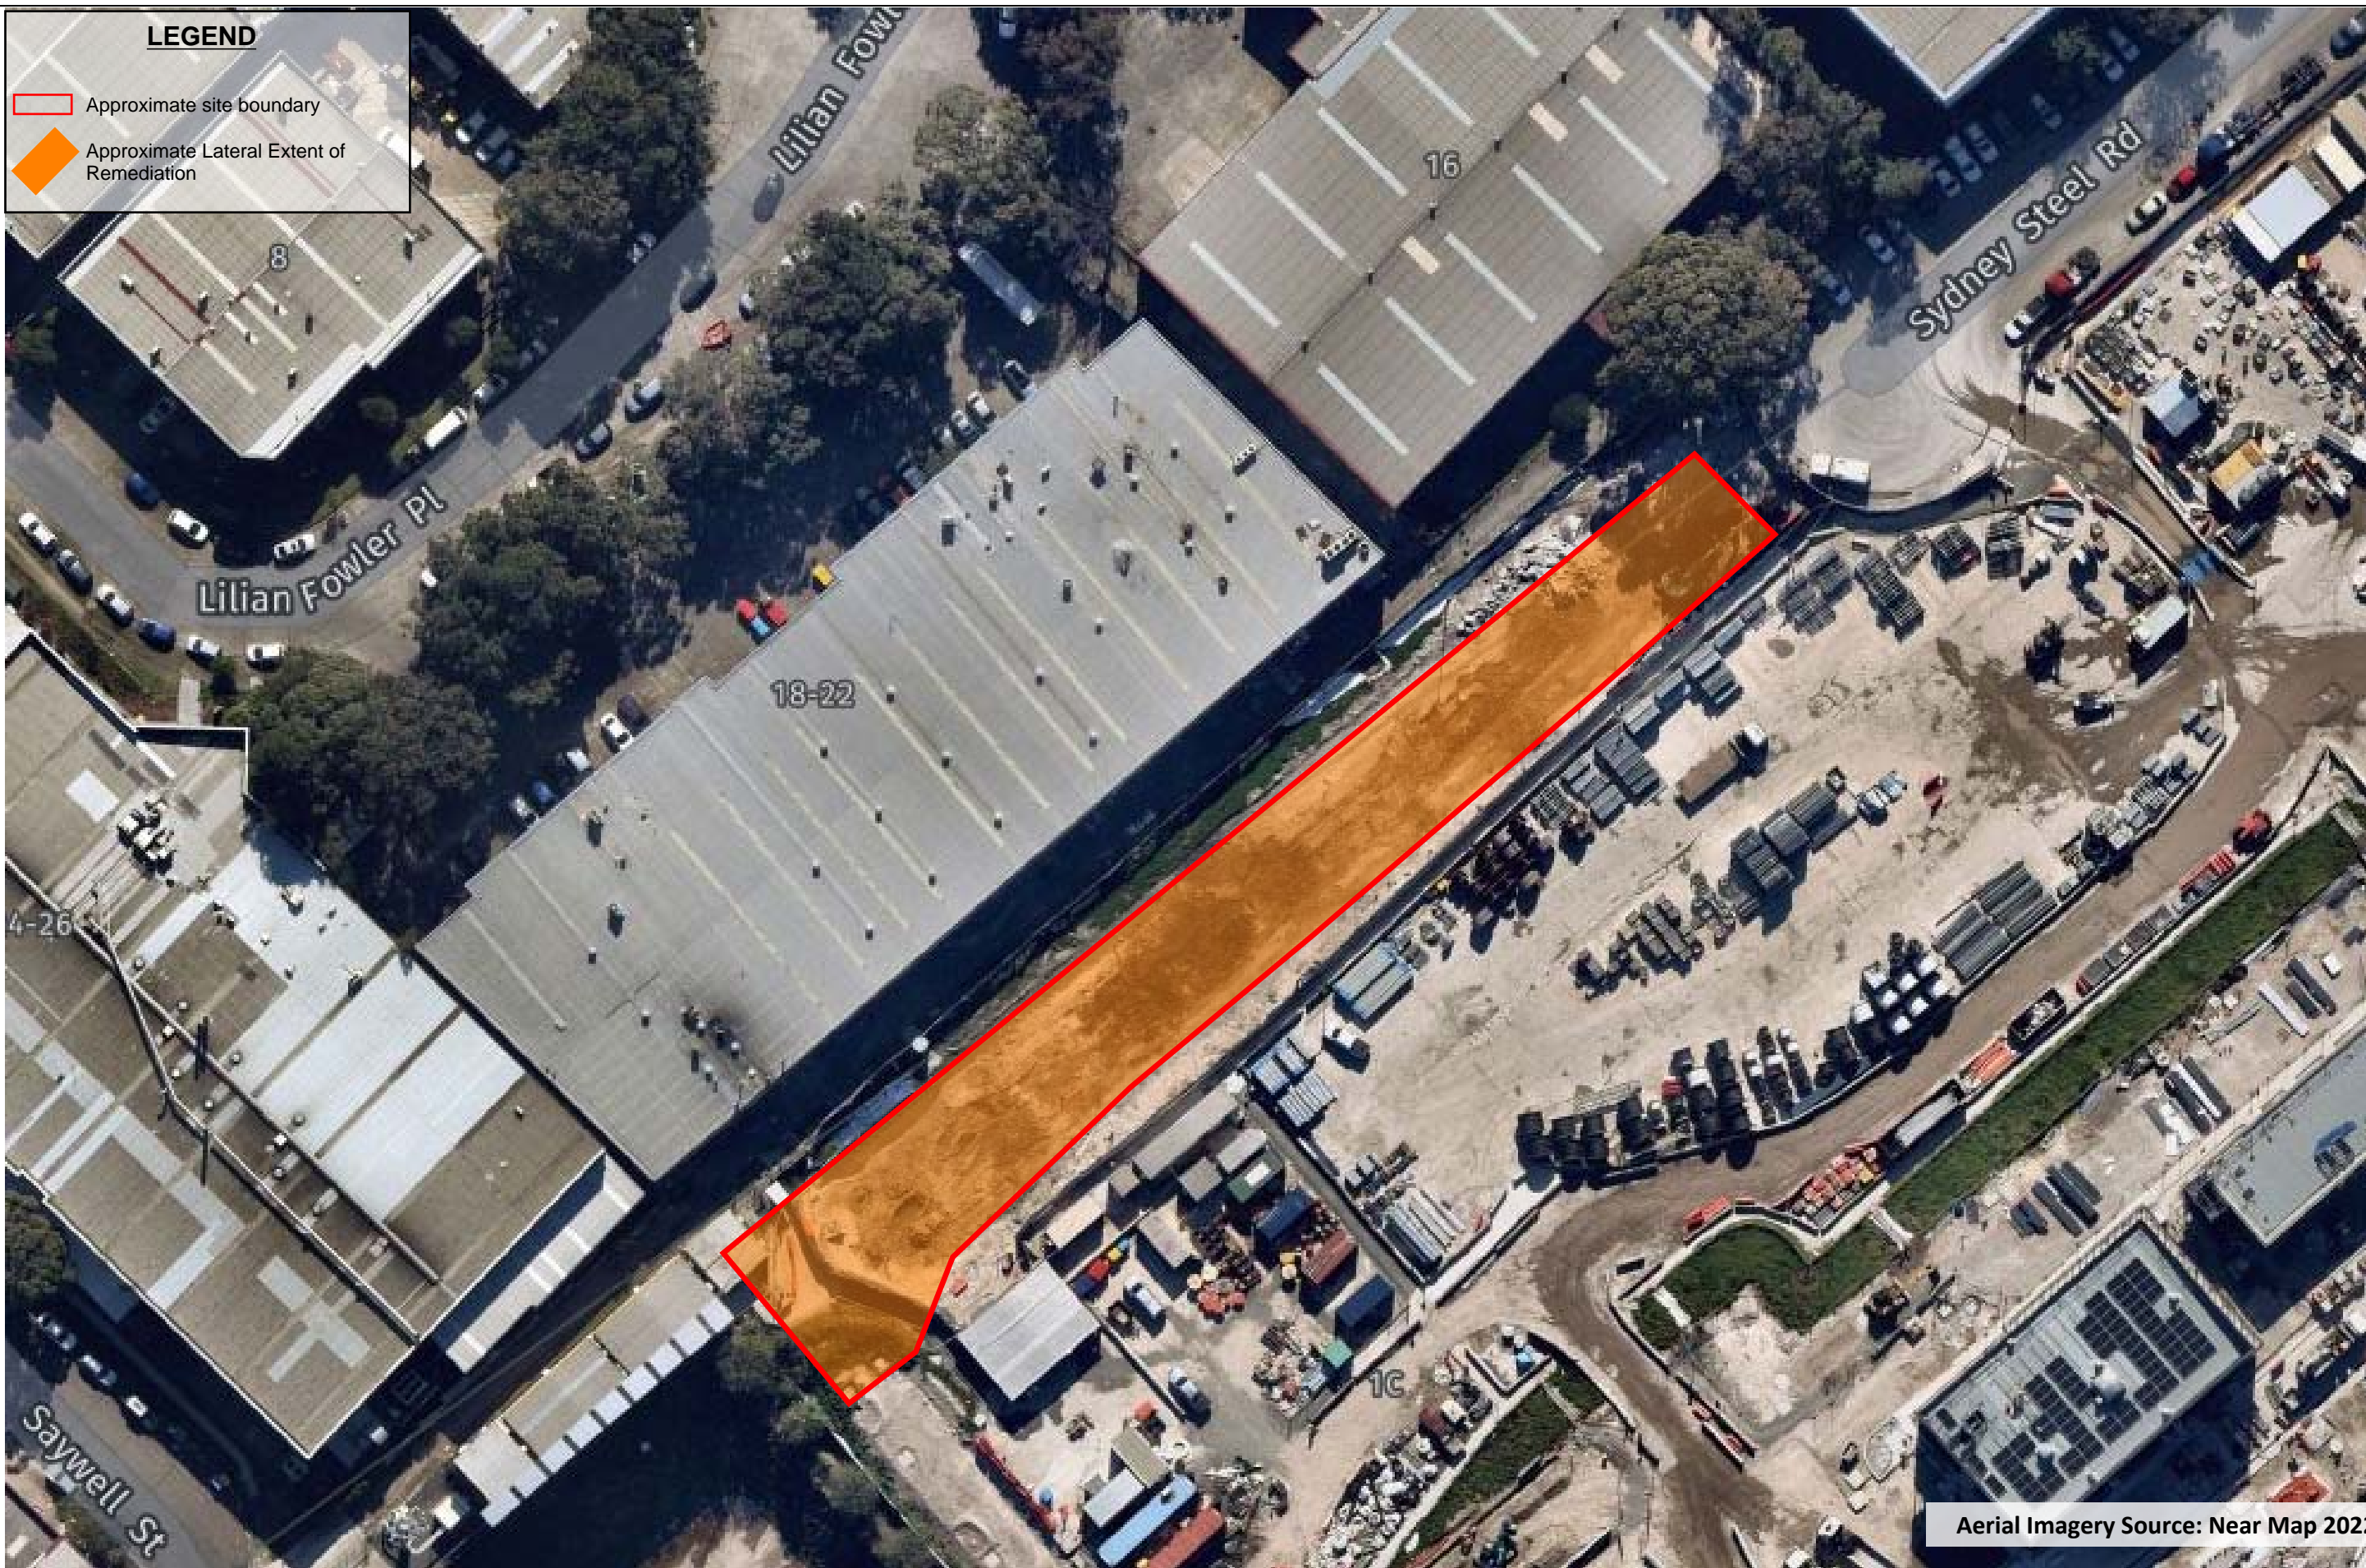
Lateral - Inferred Extent of Remediation

- Approximate site boundary
- Approximate Lateral Extent of Remediation
