Sydney Metro Project Barangaroo Station UDHB1 'Barangaroo Boat'

Excavation Report VOLUME 2

Sydney Metro Project: Barangaroo Station

Excavation Report

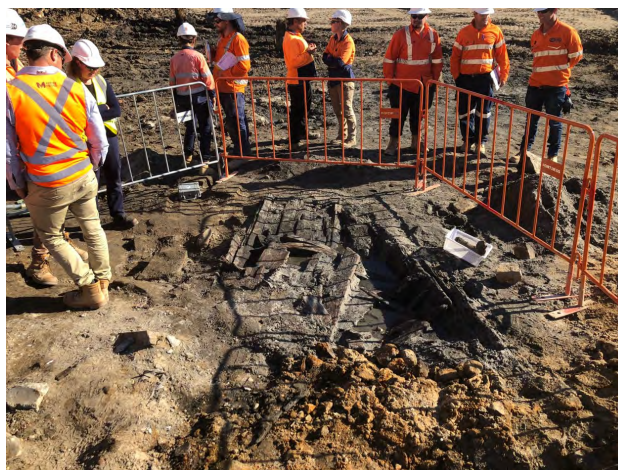
Figure 4: Timber planking that would eventually be identified as UDHB1. Source: Cosmos Archaeology.

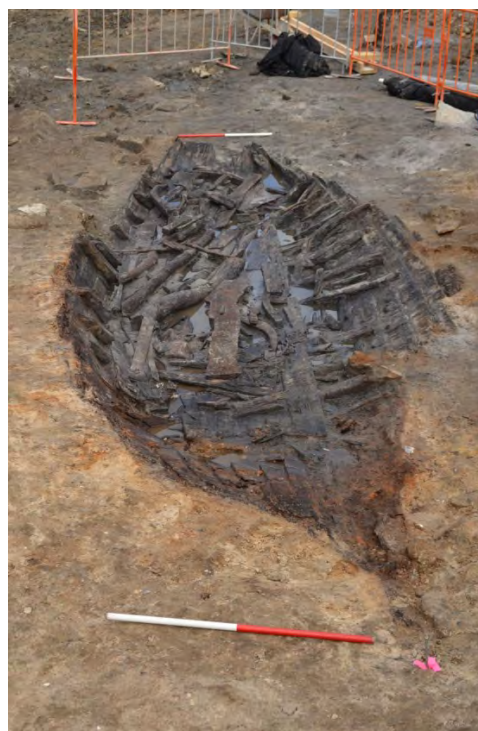
Figure 7: Loose timbers can be seen deposited in the hull. Scale in 500 mm increments. Source: Cosmos Archaeology.

There were timbers, fibre rope and leather objects within the hull, some of which appeared to be associated with the vessel while others may have been deposited into the boat after it had been dragged into its position. The wreck appeared to have been used in part as a skip bin by the adjacent boatyard.

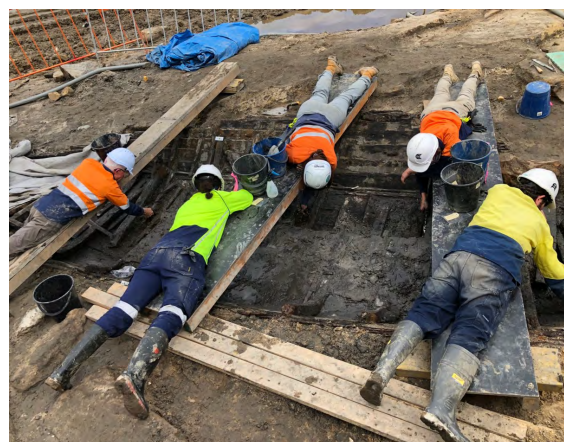
Figure 9: Timber walkways used to assist with the recording process.

The unique site presented a number of challenges for accessing the wreck during the recording and excavation process. Once the baulks were removed, timber walkways were erected spanning the wreck so that the archaeologists could lie horizontally to work.

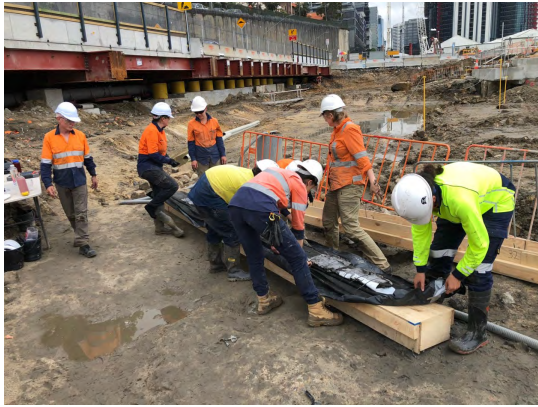
Figure 10: Ceiling planking being wrapped and placed into a custom-made crate.
Source: Cosmos Archaeology.

Once photographed, the loose timbers were recorded then wrapped in geotextile material which had been cut to size. The bundle was then soaked in fresh water before being wrapped in plastic. The bundle was cable-tied in a manner so as to retain the water for as long as possible. This was because it was imperative to keep the timbers as wet as possible until they were placed under conservation. The timbers were then placed in custom-made timber crates and stored on site in refrigerated containers.

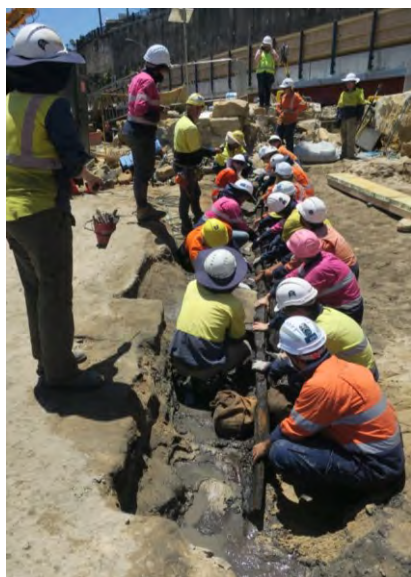
Figure 12: Removal of the keel.
Source: Cosmos Archaeology.

Removal of the keel and components of the bow and stern was undertaken using similar techniques. However, much preparation was needed, including the design and construction of custom crates, design of specific packing methods and preparation of the materials, as well as organising a crane lift, and the disassembly and removal of the keel. The keel lifted cleanly off the rider keel, and the ease of separation was due to the unexpected corrosion of the iron fastenings. Due to the length and weight of the keel elements, a team of 17 people was needed for the lift. The keel was lifted from the rider keel and carried to a pre-prepared board placed alongside the wreck for packaging. The two rider keel elements were then lifted in the same manner as the keel. A crane was used to transport the elements to the refrigerated shipping containers.

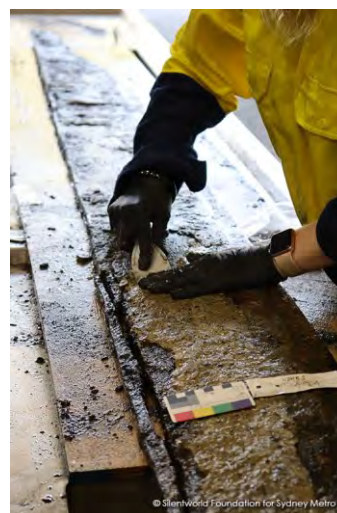
Figure 15: White material, possibly for anti-fouling, being removed during the conservation process. Source: Silentworld Foundation.

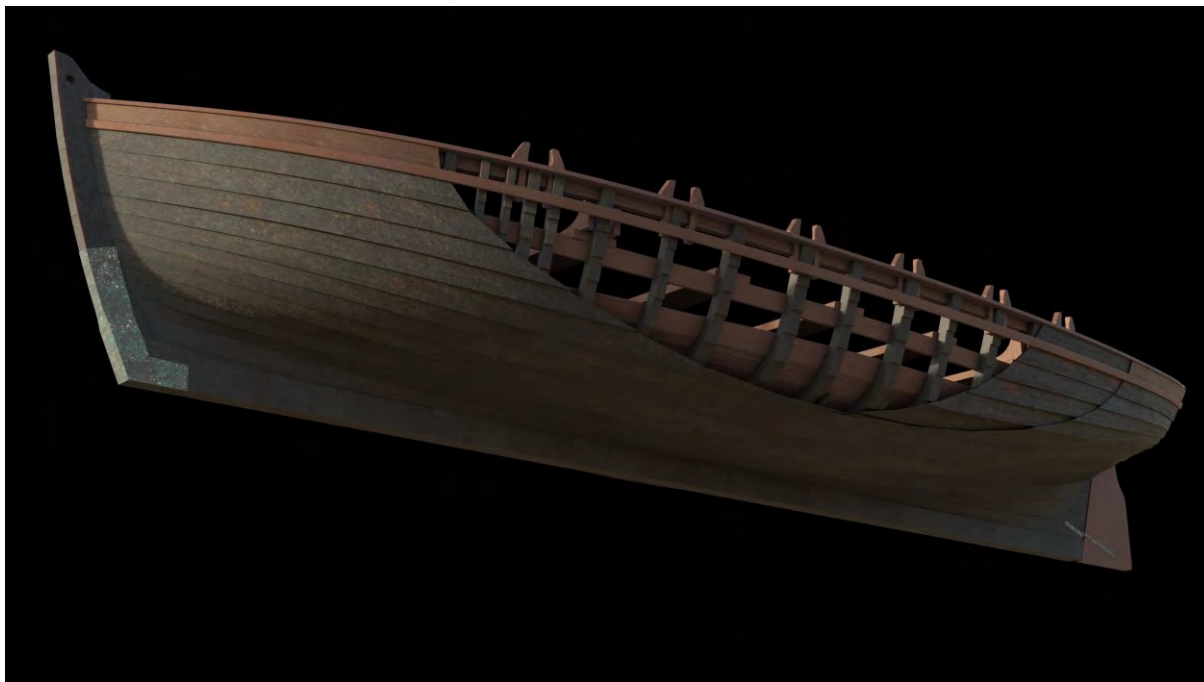
Figure 18: Port cutaway view of reconstructed vessel showing framing and double planking. Reconstruction and 3D rendering by B. Wharton and K. Edwards.

The vessel was also originally built with one layer of clinker planking. It underwent major repairs during its lifetime before having a rider keel added (thereby lengthening the boat by 0.5 m) which allowed a second layer of planking to be added.

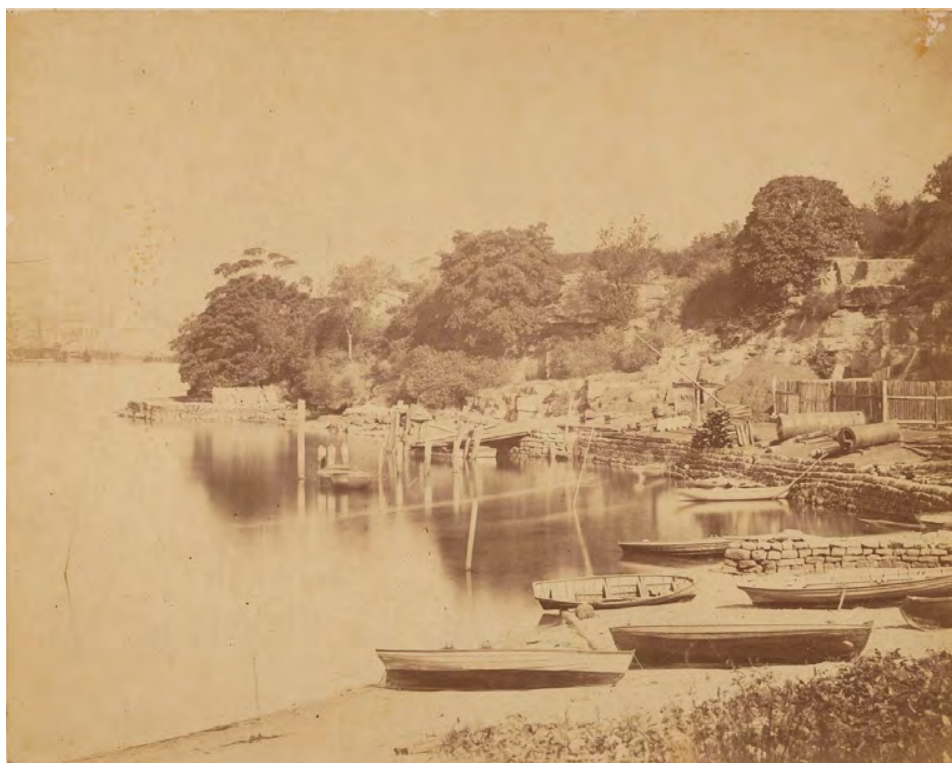
Figure 19: Clinker boats with hard chine drawn up onto beach at Blues Point in 1850s. Source: Robert Hunt, Mitchell Library. Image SPF/799.

Establishing the identity of UDHB1 has been problematic, and may never be achieved with a high degree of certainty. This is because official records from the time the vessel was built and operated are lacking, and the vessel's relatively small size means that it may never have been registered. However, based on the available information, it is thought that the vessel was originally built 10 to 20 years before it was abandoned. Therefore, UDHB1's construction could be dated to approximately the 1820s. It is likely to have been used as a general-purpose vessel for conveying goods and people, or possibly as a nearshore fishing boat. The hardness of the chine (turn of the bilge on the hull) indicates it was designed to be dragged ashore.

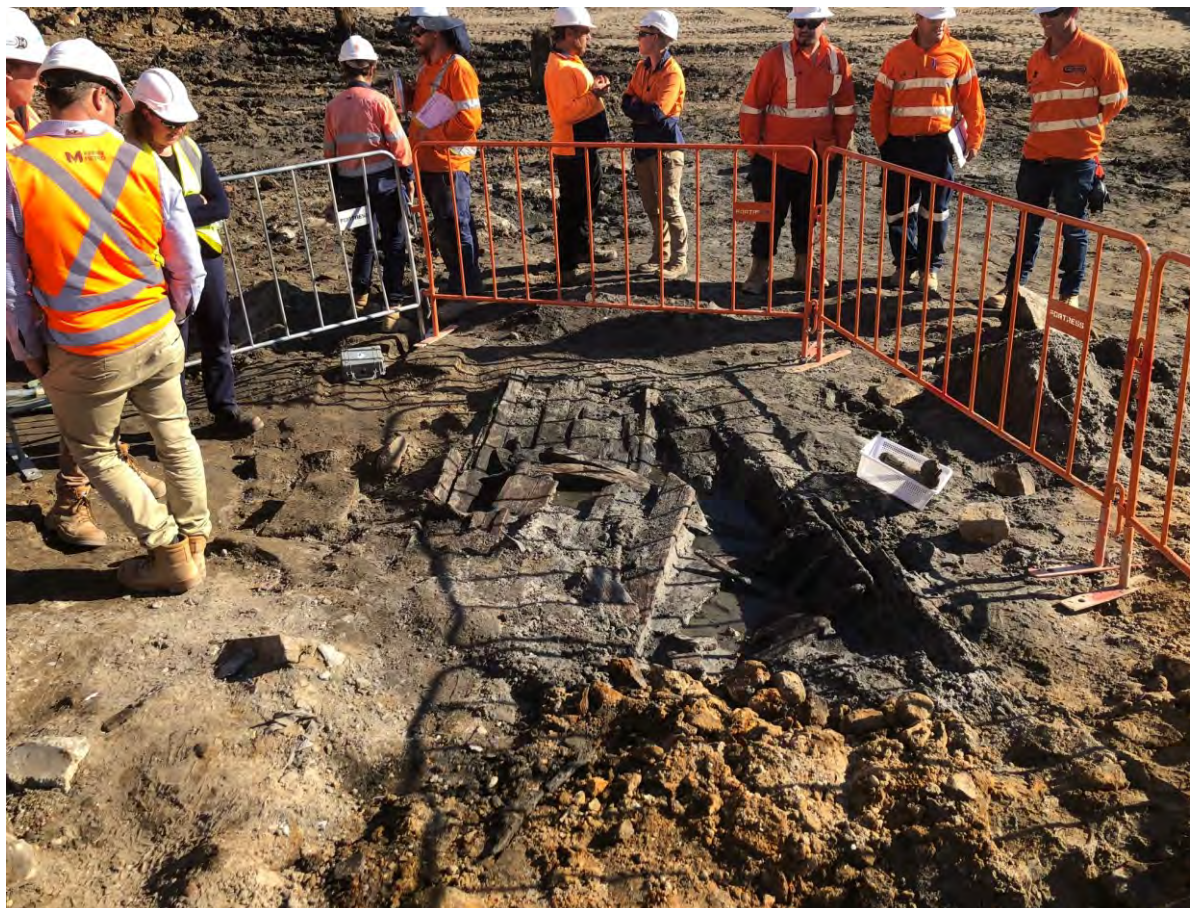
Figure 1.4: The exposed stern of the wreck on 21st September 2018.

The wreck of UDHB1 was uncovered by the Casey & Lowe excavation team under the direction of Mike Hincks, Secondary Excavation Director, on Friday 21st September 2018. The archaeologists noted the initial exposure of a curved timber structure that was unlikely to be the remains of a timber deck associated with a jetty/wharf or corduroy surface on boggy ground. After revealing more of the feature, it became apparent that it was the remains of a timber vessel. On the afternoon of 21st September 2018, the project's maritime heritage advisor, Cosmos Coroneos, visited the site with fellow maritime archaeologist, Jane Mitchell, and confirmed that the structure was the stern of a clinker-built timber boat (Figure 1.4).

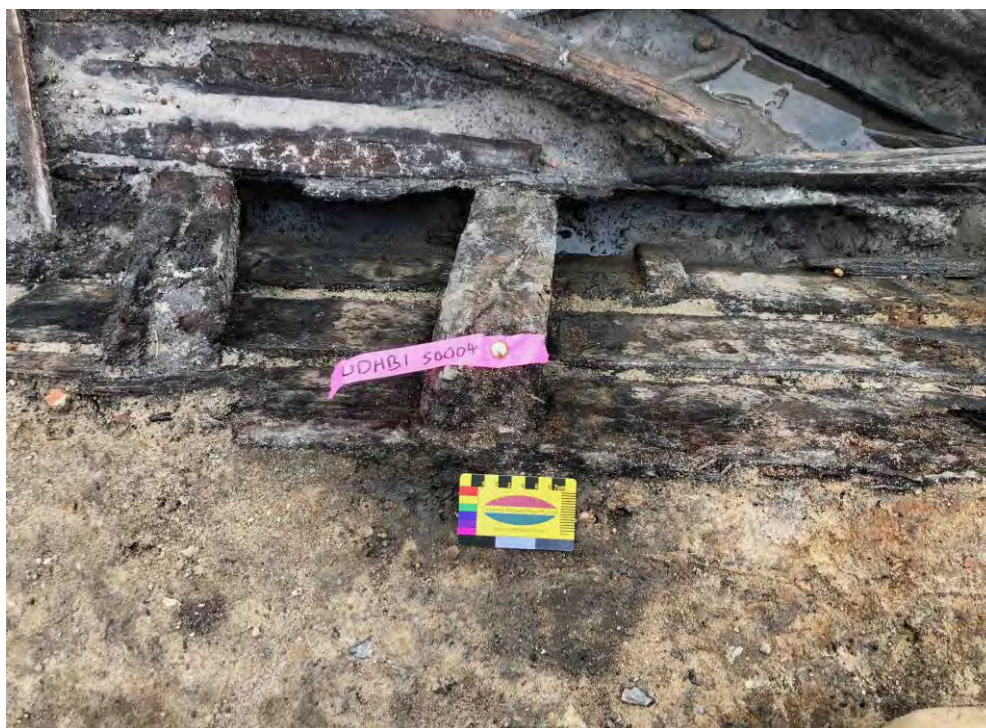
Figure 1.5: Timber sample S0004 taken from a frame on the port side of the wreck on 3rd October. Looking eastwards.

The removal of the overlaying sediments revealed that the interior of the remnant hull was filled with loose timbers, the majority of which were not associated with the structure of the vessel. Sufficient hull remains were accessible which allowed for the procurement of timber samples. Four samples were taken – two from planks and two from frames – on October 3rd 2018 (Figure 1.5). These samples were identified as being Sydney Blue Gum (n=2), Stringybark and Spotted Gum, which provided sufficient confidence to state that the vessel was most likely locally built.¹⁵

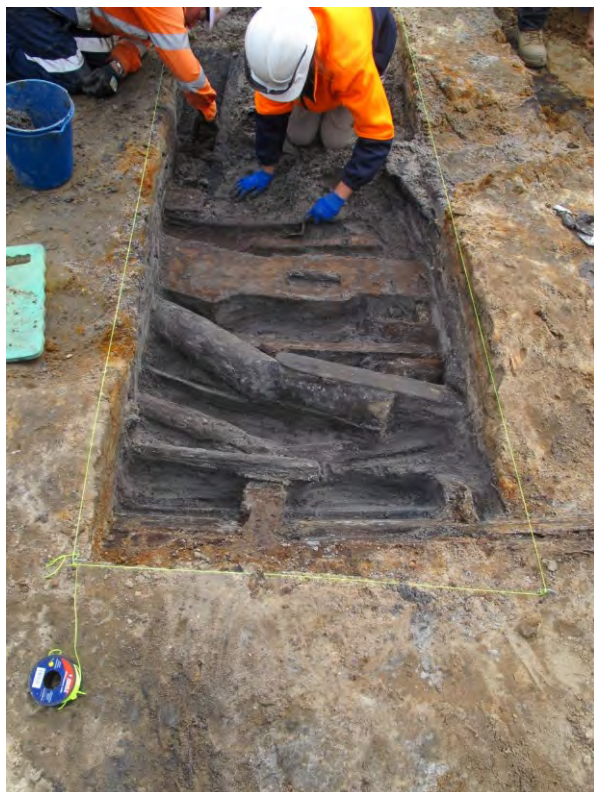
Figure 2.1: Sondage (test trench) perpendicular to the axis of the keel. Bow left of image.

The sediments overlaying the wreck and contents – contexts 132, 133, 141, 142 and 144 – were excavated as with any other deposit on a land site (for discussion on the contexts see Section 3 in Volume 1 and Section 4.7.3). This excavation commenced with a series of sondages across the wreck, the purpose of this was to get an initial understanding of the extent of the wreck remains and its condition (Figure 2.1). Once the baulks were removed, timber walkways were built that could span the wreck (Figure 2.2).

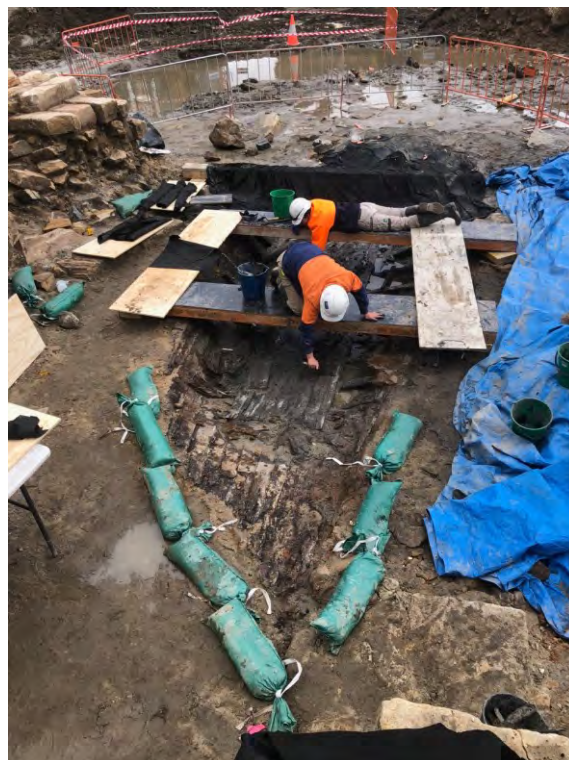
Figure 2.2: Cleaning timbers using the walkways. Note the sandbags placed at bow to prevent sediments washing into hull during heavy rain.

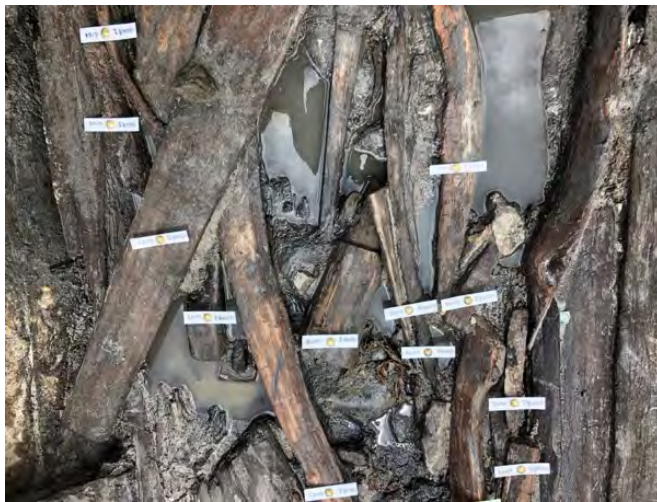
Figure 2.3: Identification tags on loose timbers. Bow top of image.

The loose timbers (context 148) within the wreck were labelled before being planned and removed. The labels were cut from polypropylene A4 tab dividers and marked with permanent black marker. The labelling included the following information: UDHB1 [id number]. The numbering started with 0001 at the stern. UDHB1 0001 therefore was the southernmost or most sternwards of the exposed timbers. The timbers were numbered in order of appearance, irrespective of whether they were a loose or intact structure, moving towards the bow (Figure 2.3). The labels were orientated with the text perpendicular with the axis of the keel and the text reading left to right (from starboard to port).

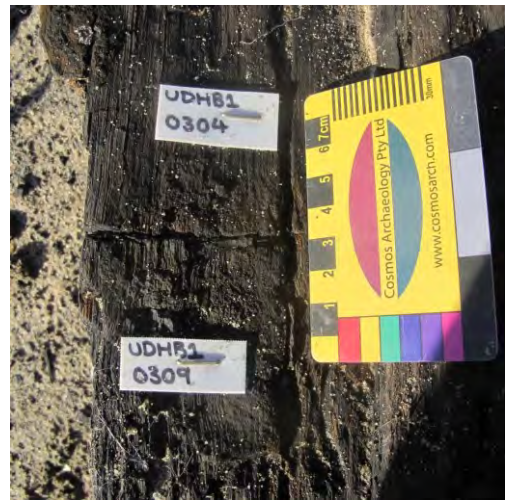
Figure 2.4: Tags attached to planking with stainless steel staples, which were not always effective.

Some consideration was given to the method of attaching the labels as there was a desire to impact the timbers as little as possible. Stainless steel staples were initially attempted but the timbers were either too hard to be penetrated without using what was feared to be excessive force, or the arms of the staples were too short to grip effectively (Figure 2.4). The labels were attached to the timbers with brass upholstery tacks (see Figure 2.3). Brass was used as it would not corrode and stain the timbers. They were attached by hand, rather than using a hammer. Usually, the tacks were able to grip, however there were some exceptions where the timber was too hard. The use of mylar tags attached with brass tacks was suitable in the short term for immediate recording purposes. They were not suitable long term as they were easily dislodged by the geotextile, which was placed over the wreck to keep it wet.

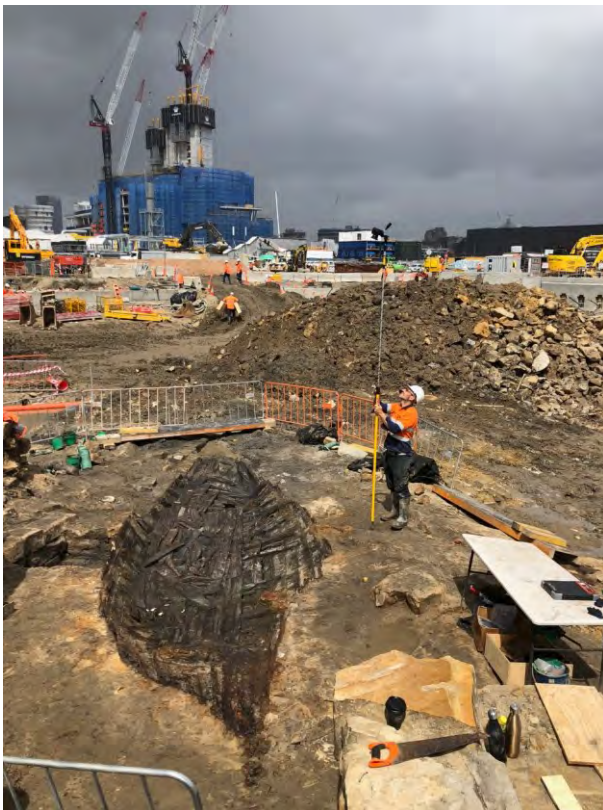
Figure 2.5: Photography with camera mounted on pole.

Once labelled, the loose timbers (context 148) were photographed to create a photogrammetric model (Figure 2.5 and Figure 2.6 as well as see Section 2.3.4). The wreck and loose timbers were then planned before the loose timbers were removed (Figure 2.7). Only labelled loose timbers were recovered. New loose timbers exposed during the process were left *in situ* until all the labelled loose timbers were recovered. These newly exposed timbers were given new identification numbers and new labels were attached. This exposed layer of timbers was planned and the timbers removed. This process was repeated a third time before all the timbers were removed.

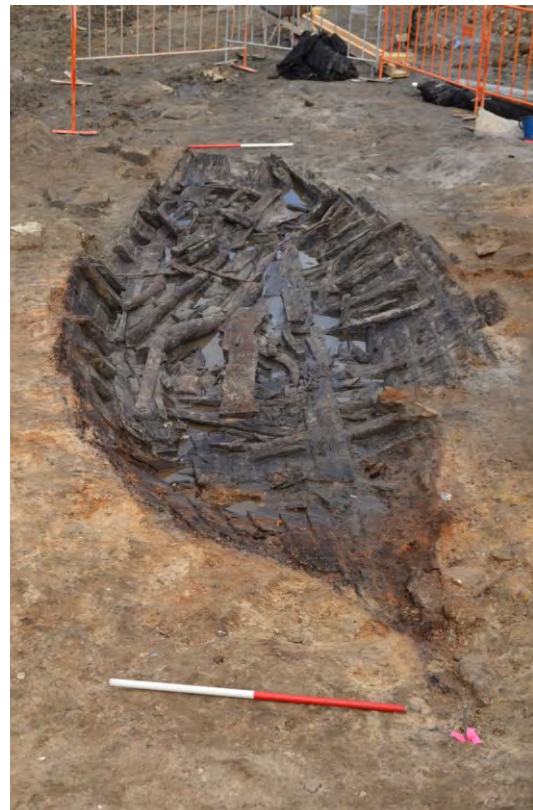
Figure 2.6: Oblique shots of wreck. Scales in 500 mm increments. Bow in foreground (Source: Casey & Lowe).

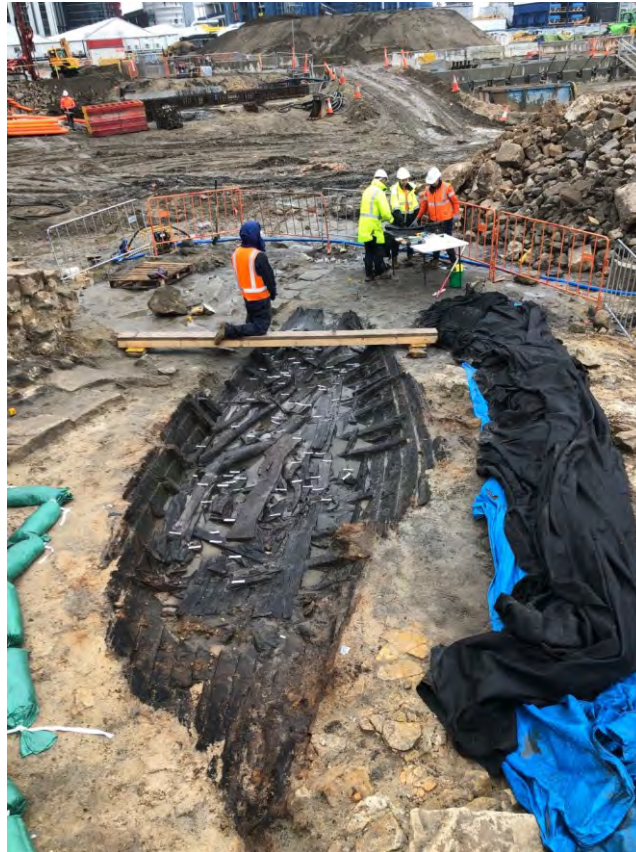
Figure 2.8: Recording table for loose timbers set up adjacent to wreck.

The loose timbers were taken to a table set up near the wreck for further recording (Figure 2.8). Details such as a brief description of the object with length, breadth and depth measurements were recorded. The purpose of the recording at this stage was to provide enough information so that, in the event that the label became separated from the object, it could be identified. The object was given a registration photograph and was then photographed from all angles so that a 3D model could be generated if required (Figure 2.9 and Figure 2.10). See Volume 8.1 for the photographs of the loose timbers as they were recovered from the wreck. There was a cursory cleaning of the sediments from the timbers before they were photographed.

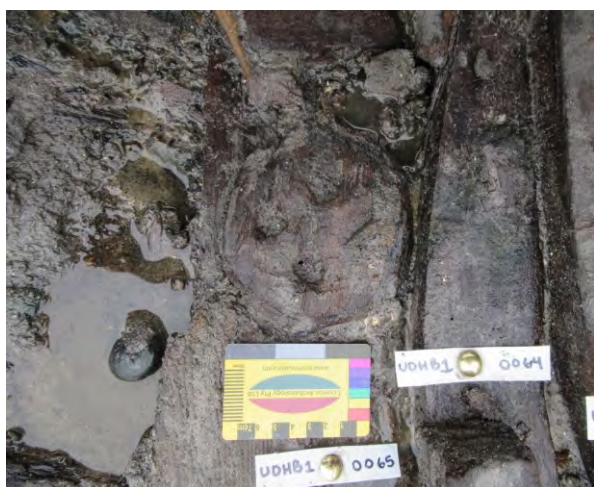
Figure 2.9: Small deadeye.

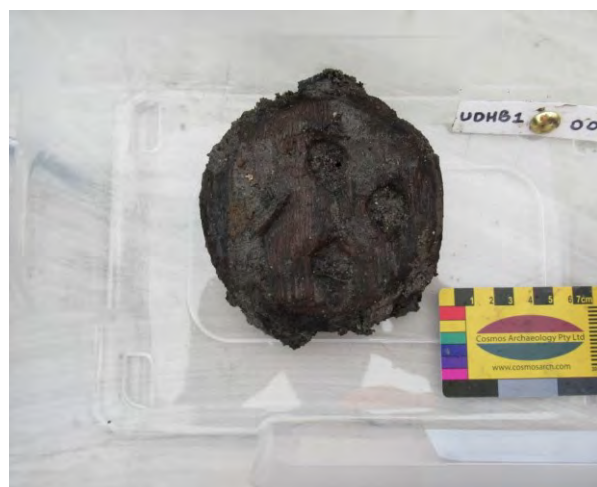
Figure 2.10: Registration photograph of the deadeye.

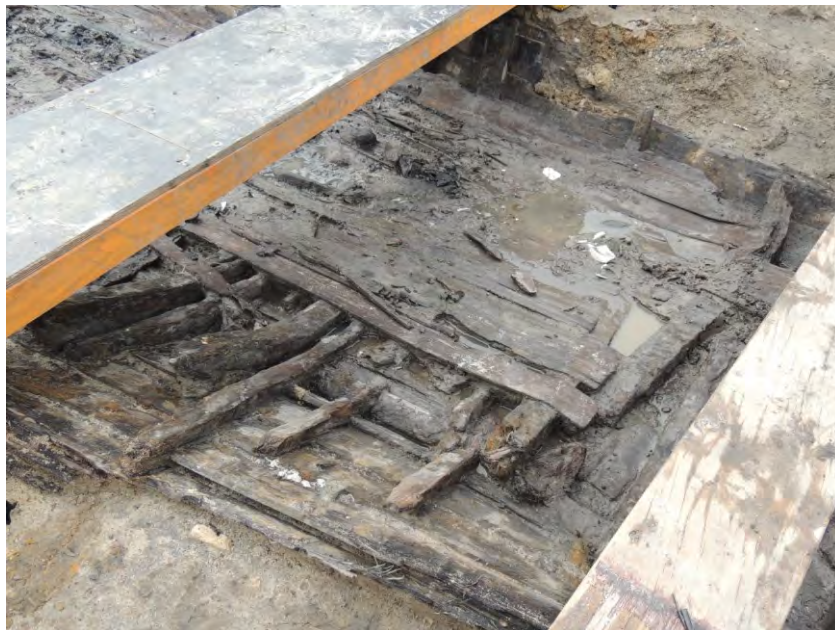
Figure 2.11: Sediments, including artefacts such as ceramics, overlaying ceiling planking after removal of loose timbers. Note the sagging ends of the ceiling planking.

The removal of the loose timbers exposed a layer of sediment which overlaid the remains of ceiling planking (Figure 2.11 and Figure 2.12). The sediment was removed as contexts 152, 153 and 156 (see Section 3) and the ceiling planks labelled and tagged. Another series of photographs were taken for photogrammetry purposes (see Section 2.3.4) before the wreck was re-planned with the ceiling planking (Figure 2.13).

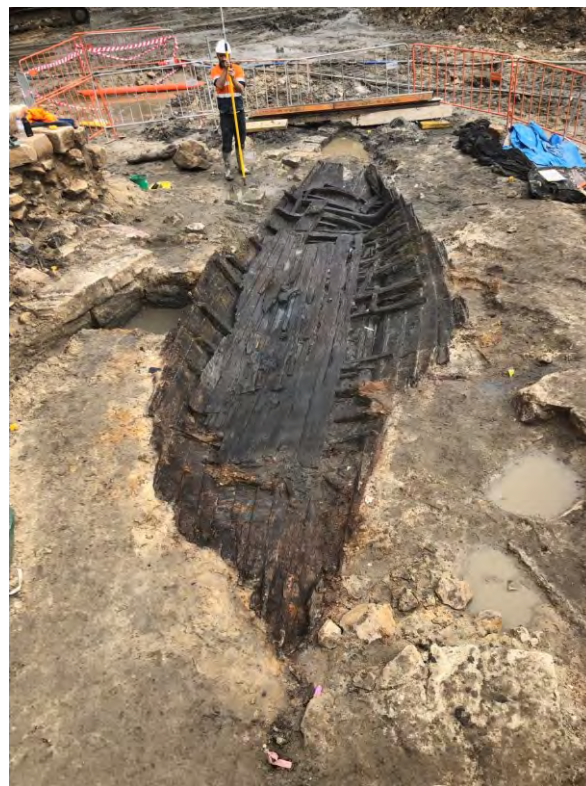
Figure 2.12: Wreck with remnant ceiling planking exposed after removal of loose timbers and sediments.

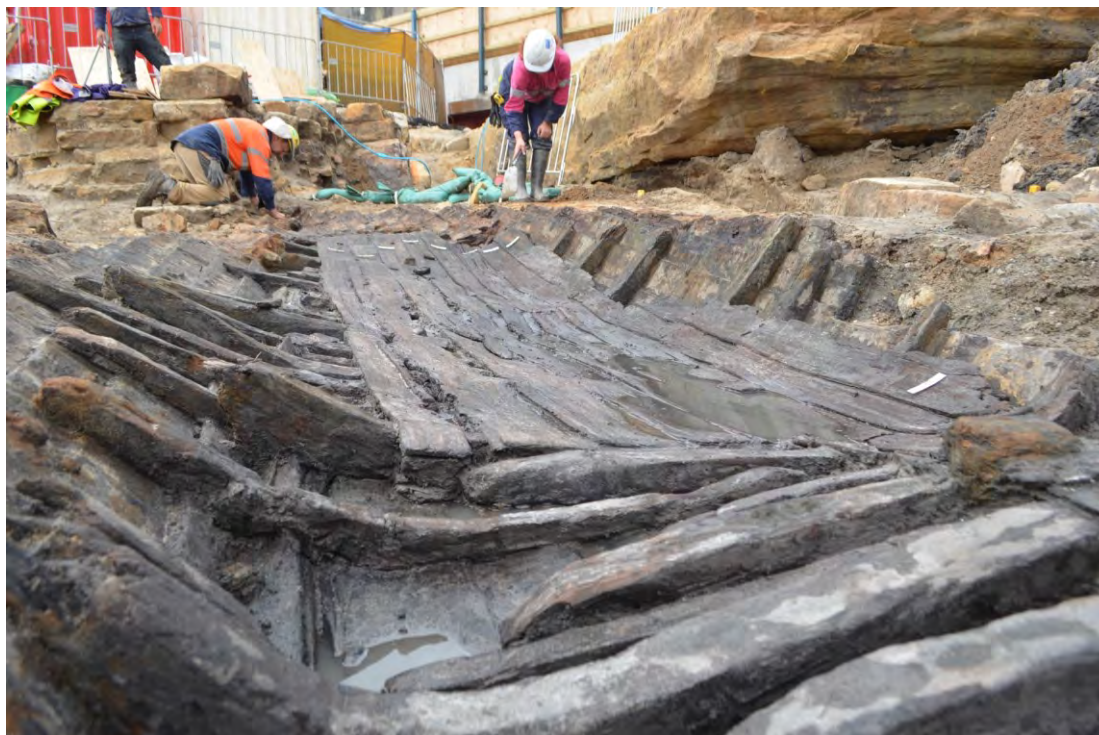
Figure 2.14: Oblique view of wreck showing the undulating ceiling planks caused by sagging between the frames.

The removal of the ceiling planking provided a challenge, as most of the planks, where they were in contact with the frames, had been crushed. The loss of structural integrity of the planks along their length resulted in the intact portions of plank sagging between the frames (Figure 2.14). These fragile ceiling planks therefore required direct support prior to lifting to prevent collapse. The ceiling planks requiring additional support typically displayed deterioration such as splintering, longitudinal cracking, fracturing or soft wood.

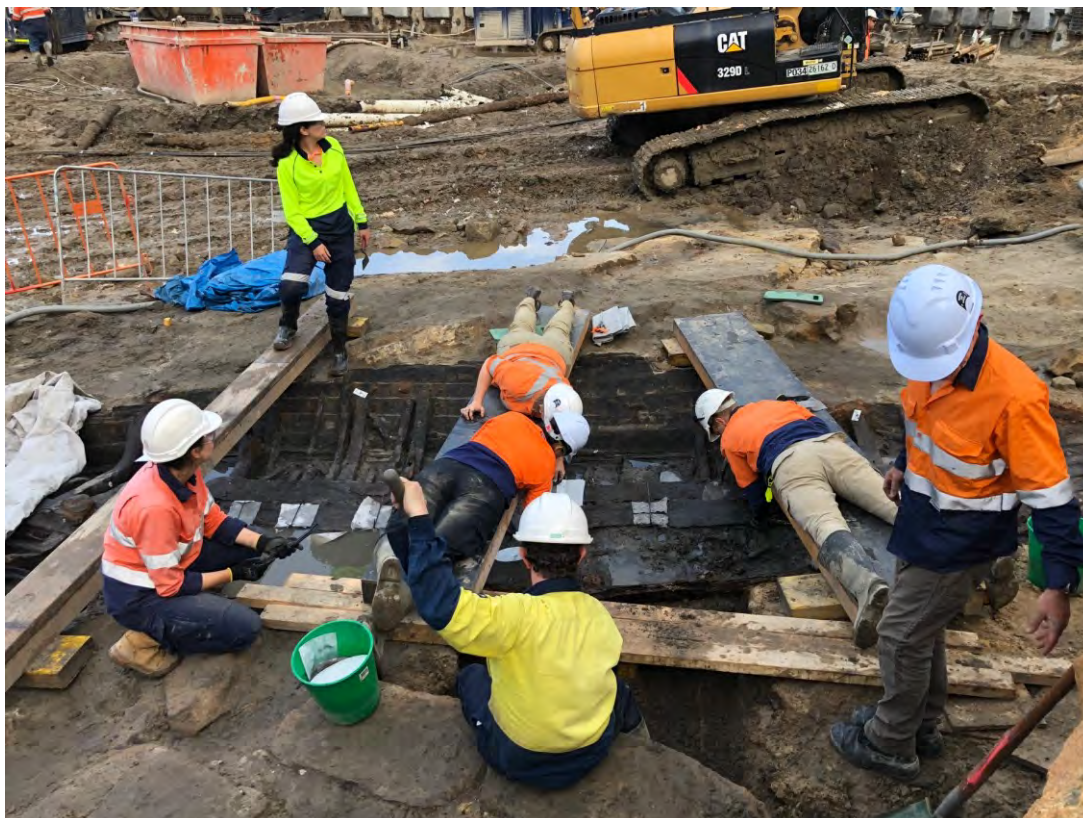
Figure 2.15: Preparation to lift a ceiling plank. Note the supporting of weak areas (which correspond to the frames) with Mylar sheets and cable ties.

For the ceiling planks, Mylar sheets were also used to wrap around the element (Figure 2.15). The Mylar was inserted by folding an edge and pushing through with a trowel or other blade. Temporary splints were also installed for additional support, and materials used included wooden icy-pole (aka craft) sticks and bamboo skewers. The direct supports were secured with double-jointed cable ties, with the head located at the sides to reduce the risk of imprints/damage.

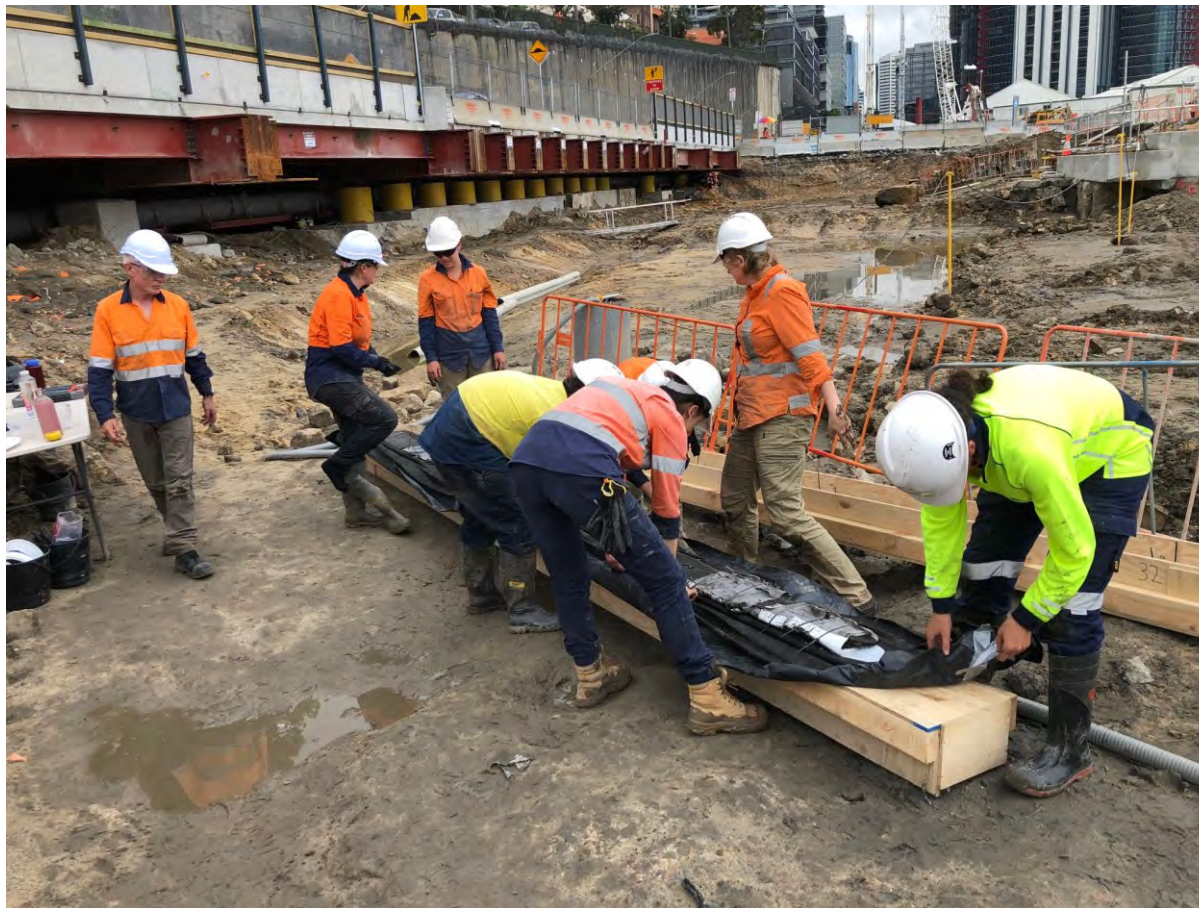
Figure 2.16: Ceiling planking being wrapped before being placed into a custom-made crate (in background) with upside down and unused crate being used as a work table. Note that a layer of geotextile and black plastic had already been placed onto the board before the plank was slid on. This allowed for the element to be wrapped without it being moved for a second time.

The secured planks were slid onto a plywood board cut to size. Overlaying the board was a layer of black plastic followed by the geotextile used for wrapping (see Section 2.3.3). This was done so that the planks would not have to be moved again for wrapping. Removing the ceiling planks posed a challenge. The length of the planks, and therefore the boards, meant that unless they were fully supported during removal there would be flex in the timbers resulting in the element breaking apart. Furthermore, their location within the wreck meant that team members would still need to be positioned on the timber walkways to safely handle the board/plank recovery. To negotiate the limited space for each lift, the board with the plank attached was slid towards the stern where team members were in place to grab and support the board. The ceiling planks, still fastened to their boards and wrapped, were placed immediately into plywood crates that were custom made for each plank (Figure 2.16). They were not photographed or recorded in the same manner as the loose timbers.

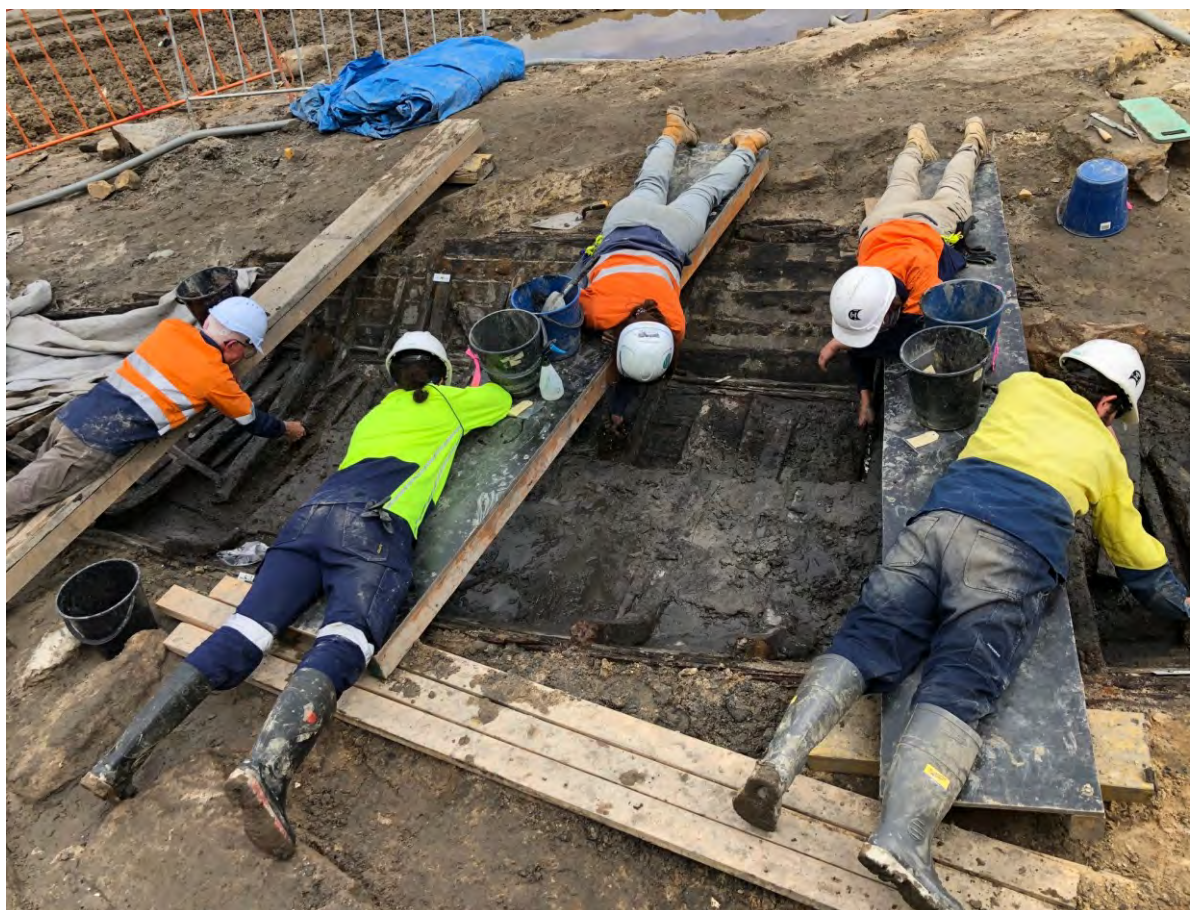
Figure 2.17: Excavation of the bilge deposits after the ceiling planking was removed.

The bilge deposits (contexts 151, 154, 155, 157, 158, and 159) exposed by the removal of the ceiling planking were excavated (Figure 2.17). The sediments were sieved and soil samples kept for pollen analysis (see Section 3 for the findings and Volume 3, Section 10).

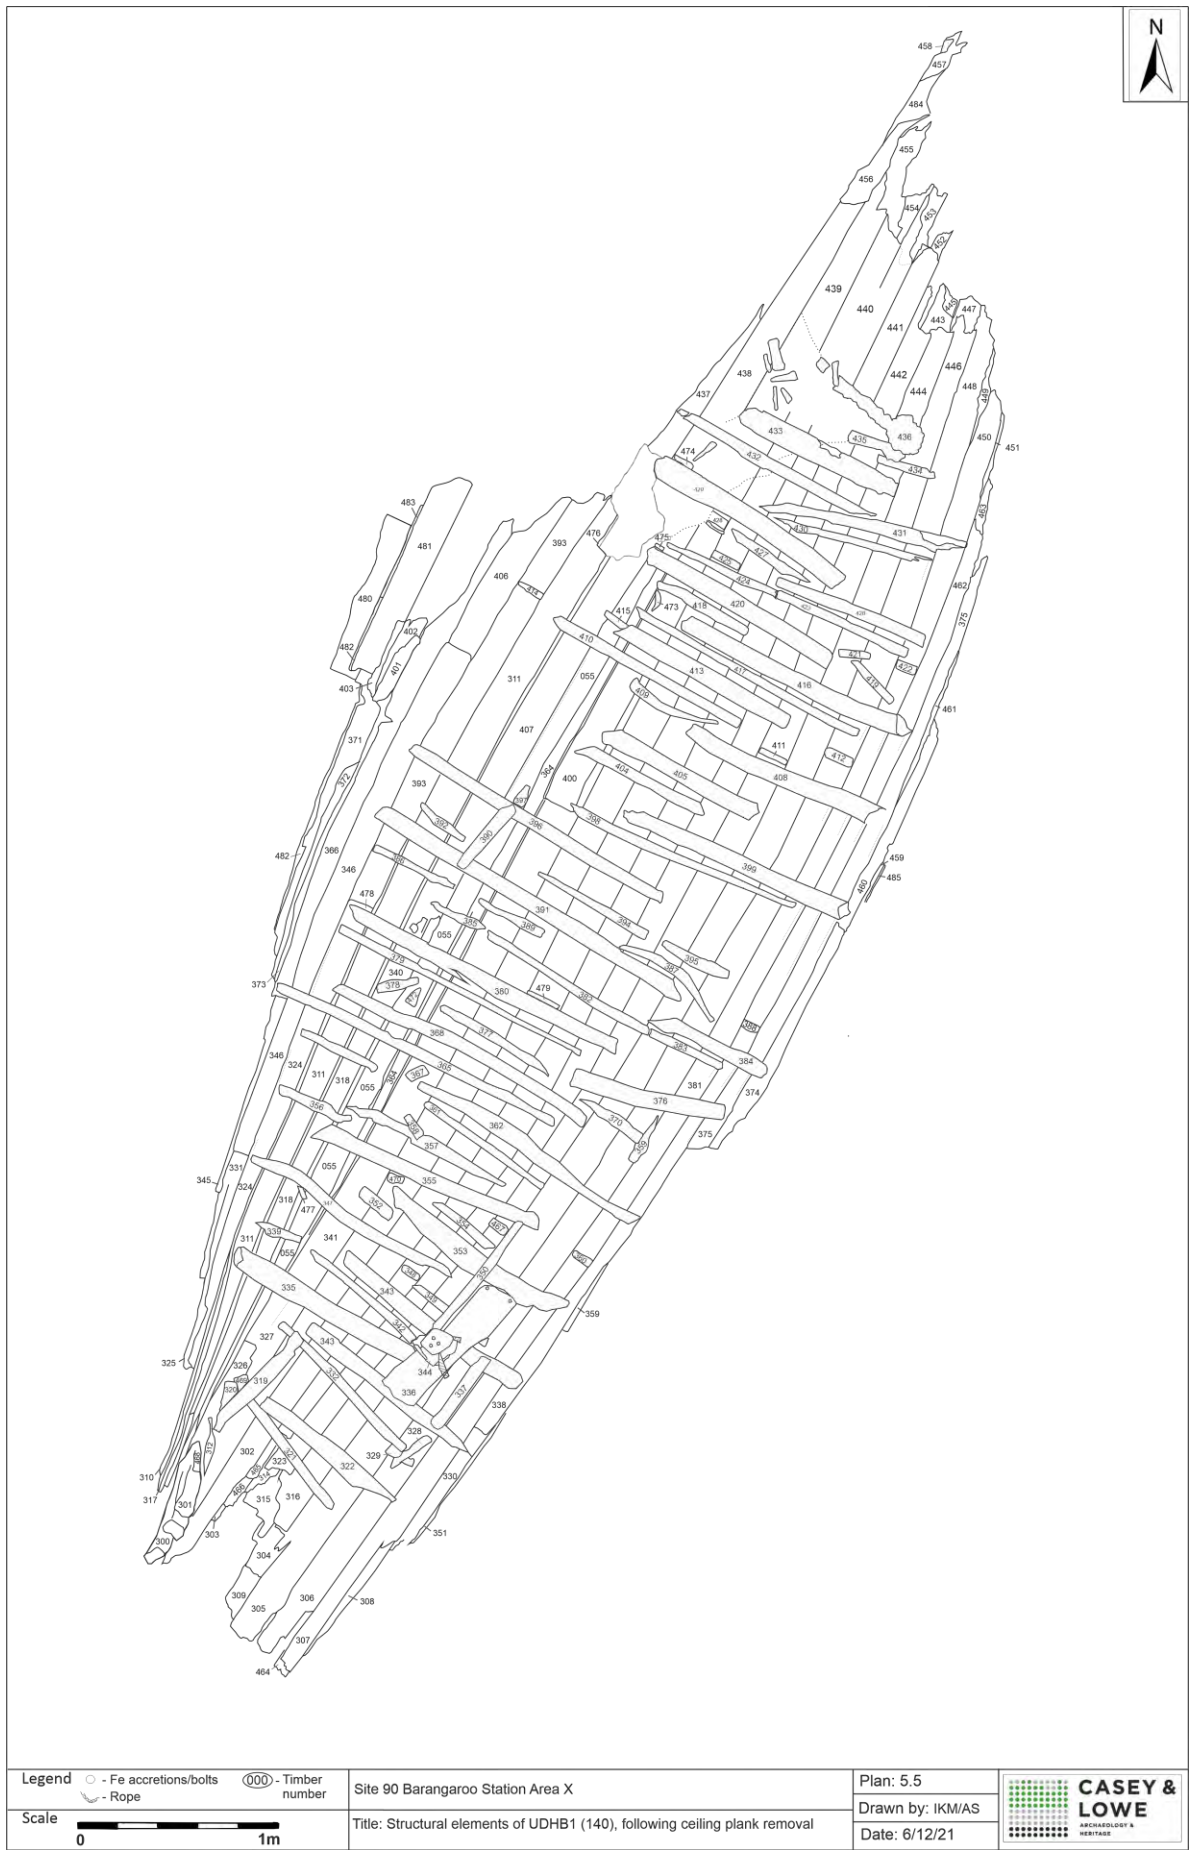
Figure 2.18: Hull plan after ceiling planking was removed, with visible elements numbered.

At the completion of the excavation of the bilge, the wreck was prepared for a final round of planning and photography for photogrammetry, before the wreck was to be removed (Figure 2.18 and see Section 2.3.4 as well as Volume 4.1 for finished models). This was considered to be the most critical of the photo surveys as the removal of the ceiling planking exposed the frames and interior of the hull. This was the best opportunity to obtain an accurate measurement of the curve of the hull, which in turn would allow for a more informed interpretation of the shape of the vessel.

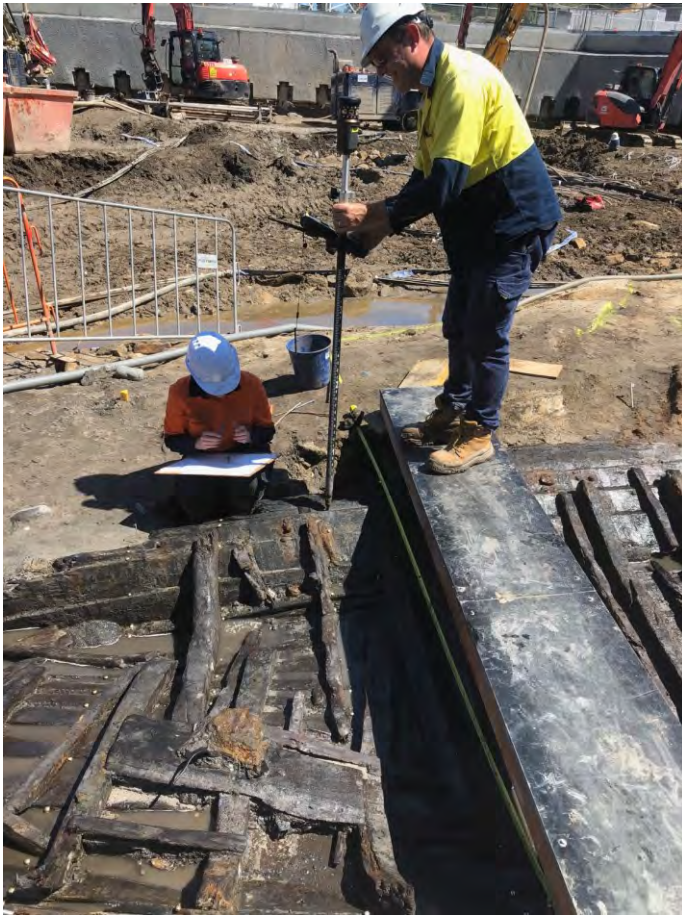
Figure 2.19: Taking the 'lines' of the hull – from the inside – using a Total Station. Note the brass tacks placed in the hull from where spot heights are to be taken.

As well as the photogrammetry survey, lines were also taken of the interior of the hull. In a more traditional method of recording the form of the hull, 25 stations, or transects, were run from stern to bow perpendicular to the keel (Figure 2.19). Spot heights were taken along each station where inner planking was exposed using a Total Station (Figure 2.20 and Volume 8).

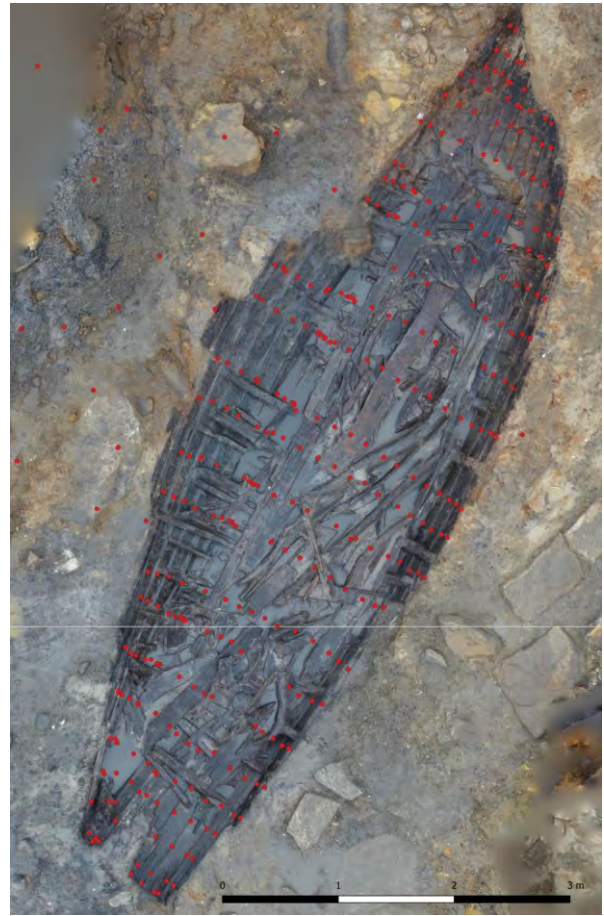
Figure 2.20: Spot heights taken inside hull for the purpose of recording its shape. Note the base image shows the loose timbers. Spot heights were taken after the ceiling planking was removed and bilge deposits excavated. (Prepared by Brian Shanahan).

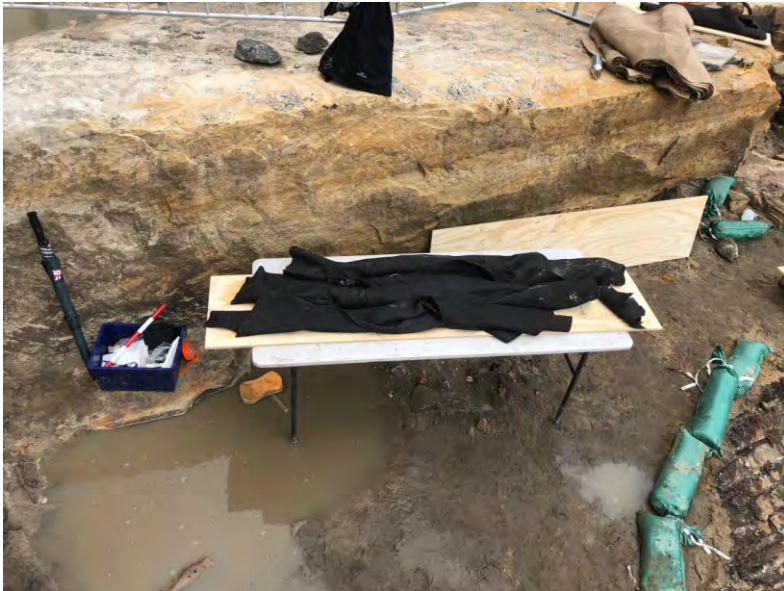
Figure 2.22: Timbers being wrapped in unwoven ‘felt-like’ geotextile. Although the material shed fibres, it was found to retain water better than hessian. The retention of water was seen as a priority as it was unknown how long the timbers would stay in cold storage. Potential for mould growth was also a concern and hessian is more susceptible to such a process than geotextile.

Once photographed, the loose timbers were recorded then wrapped in a black, coarse, unwoven (felt) geotextile cut to size. The bundle was then soaked in fresh water before being wrapped in thick black plastic. The bundle was cable tied in a manner so as to retain the water for as long as possible (Figure 2.22 and Figure 2.23). The unwoven geotextile at the time was the preferred medium for wrapping, as it was considered to be the best material for retaining moisture. Although the geotextile shed fibres and caught on the timbers, this was seen as an acceptable negative, as it was imperative to keep the timbers as wet as possible until they were placed under conservation. Hessian was used for wrapping when available, but was not preferred as it dried out relatively quickly compared to the geotextile.

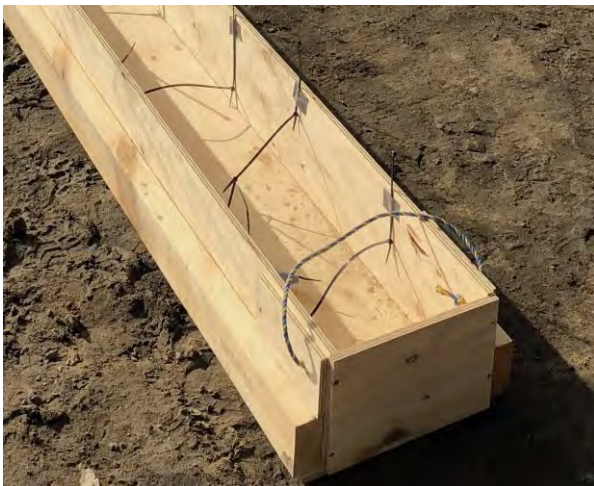
Figure 2.24: Crate made on site for the ceiling planking. Note the cable ties stuck to the inside of the crate to better secure the contents.

The JV carpenters constructed a number of plywood crates to store the timbers. These crates ranged in size from 0.5 m to 2.2 m in length, 0.5 m in width and 0.2 m in height. Special reinforced crates were made for the ceiling planking (Figure 2.24 and Figure 2.25).

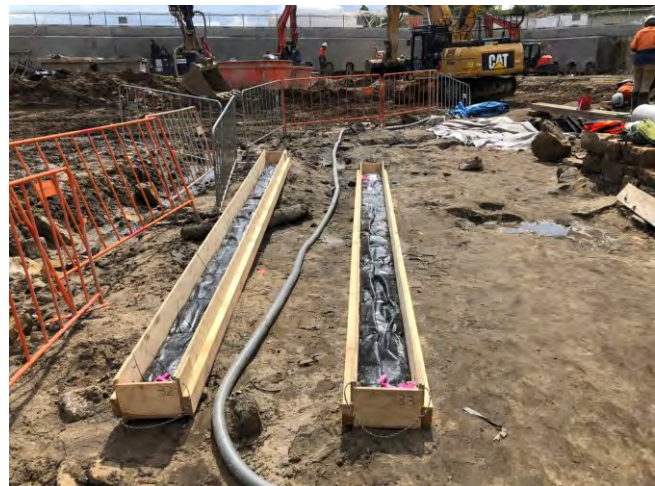
Figure 2.25: Ceiling planks inside their crates. Note the nylon rope lifting handles.
