Sydney Metro Project Barangaroo Station UDHB1 'Barangaroo Boat'

Excavation Report VOLUME 2

Sydney Metro Project: Barangaroo Station

Excavation Report

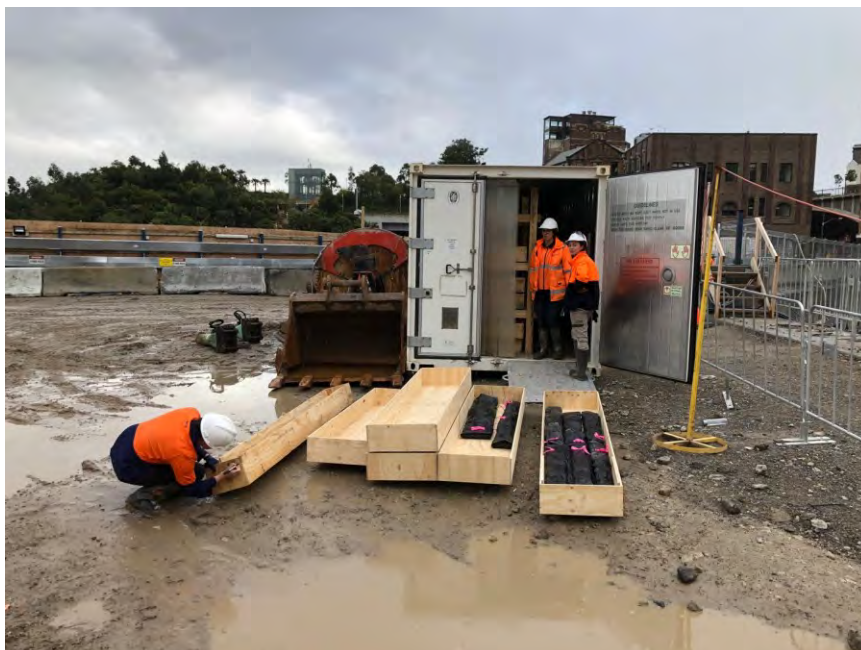
Figure 2.26: Crates for loose timbers prepared for being shelved inside the refrigerated container.

The crates containing the timbers were placed into refrigerated containers. The JV carpenter also built shelving within the containers to allow easy access to the crates as needed. The crates were labelled, and their contents documented and tracked (Figure 2.26). The refrigerated containers were set at around 3°C.

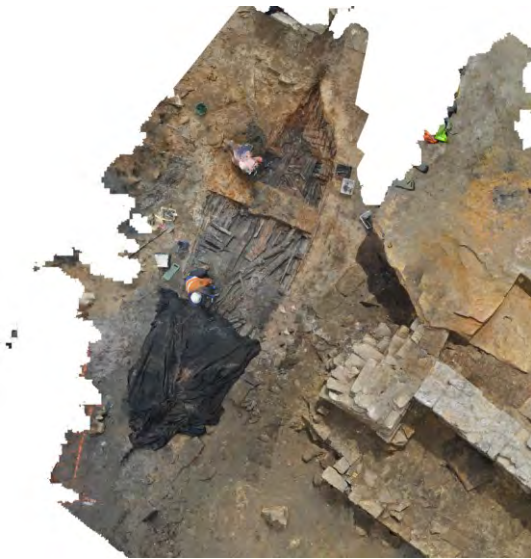
Figure 2.27: Exposed hull, 25th September 2018
(Rendered by Brian Shanahan).

1. The wreck in the process of being exposed (Figure 2.27);
2. The wreck with loose timbers in situ – 29th September and 4th October 2018 (Figure 2.28);
3. The wreck with some loose timbers removed – 11th October 2018 am (Figure 2.29);
4. The wreck with some loose timbers removed – 11th October 2018 pm;
5. The wreck with most loose timbers removed – 12th October 2018 pm (Figure 2.30);

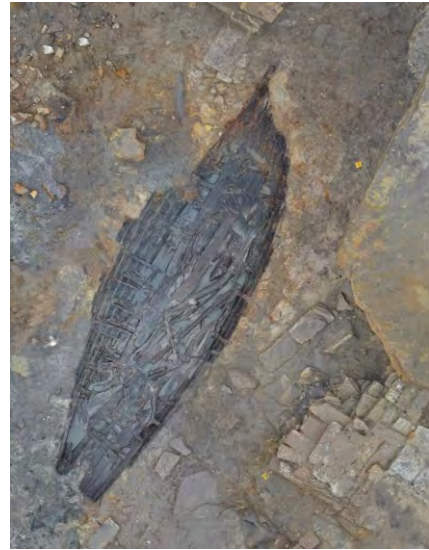
Figure 2.28: Exposed hull, 26th September 2018
(Rendered by Brian Shanahan).

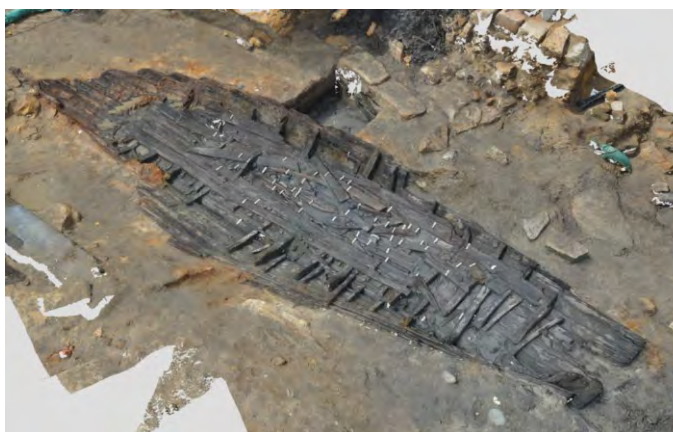
Figure 2.29: The wreck with some loose timbers removed, 11th October 2018 (am). (Rendered by Guy Hazell).

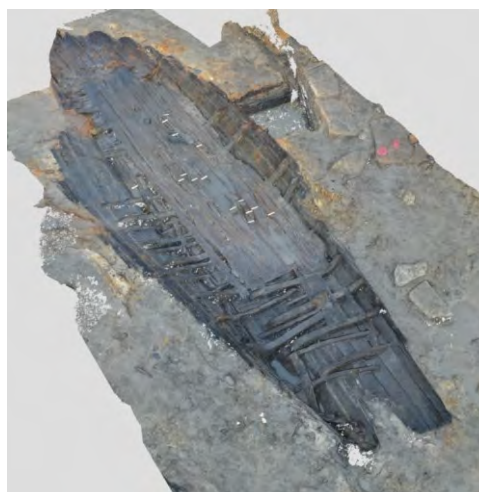
Figure 2.30: The wreck with most loose timbers removed, 12th October 2018. (Rendered by Guy Hazell).

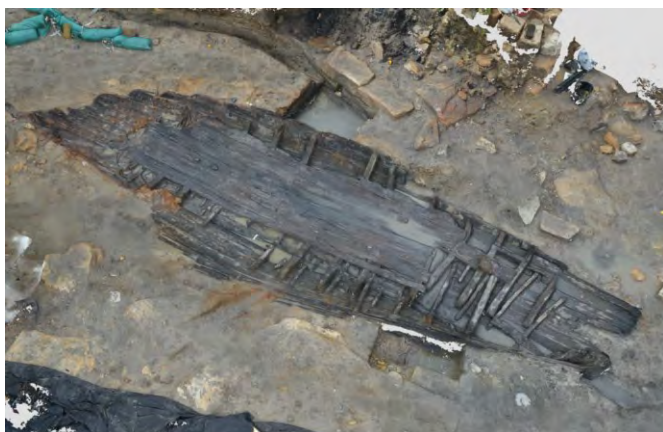
Figure 2.31: The wreck with loose timbers removed and ceiling planking exposed, 15th October 2018. (Rendered by Guy Hazell).

6. The wreck with loose timbers removed and ceiling planking exposed – 15th October 2018 pm (Figure 2.31); and
7. The wreck with ceiling planking removed with frames exposed – 19th October 2018 (Figure 2.32).

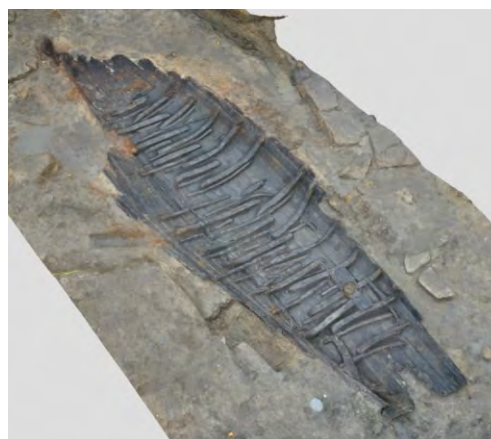
Figure 2.32: The wreck with ceiling planking removed with frames exposed, 19th October 2018. (Rendered by Guy Hazell).

With regards to the final survey undertaken on the 19th October 2018, a model was generated in a short period of time which allowed for an assessment to be made as to whether there were any gaps in the survey. In this instance, a point cloud was derived from photogrammetry using a sample of 242 photographs out of 786 photographs (Figure 2.33). Camera alignment was set to medium and dense point cloud reconstruction was set to medium. The scene was clipped, and the remaining 3.7 million points related to the surface of the boat.

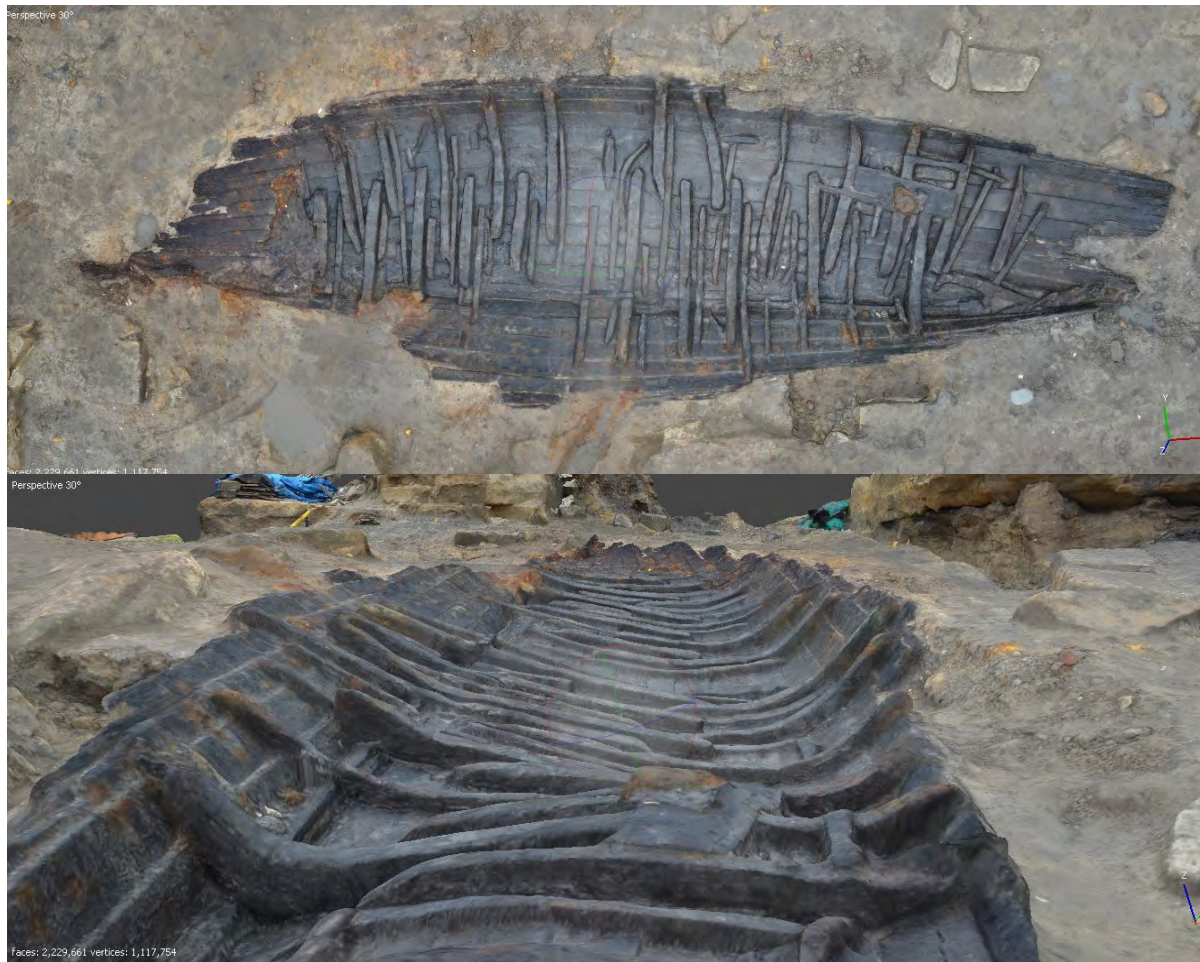
Figure 2.33: Top view and oblique view of rendered mesh model with the ceiling planking removed using 31% of photographs taken for the survey. (Rendered by Brian Shanahan).

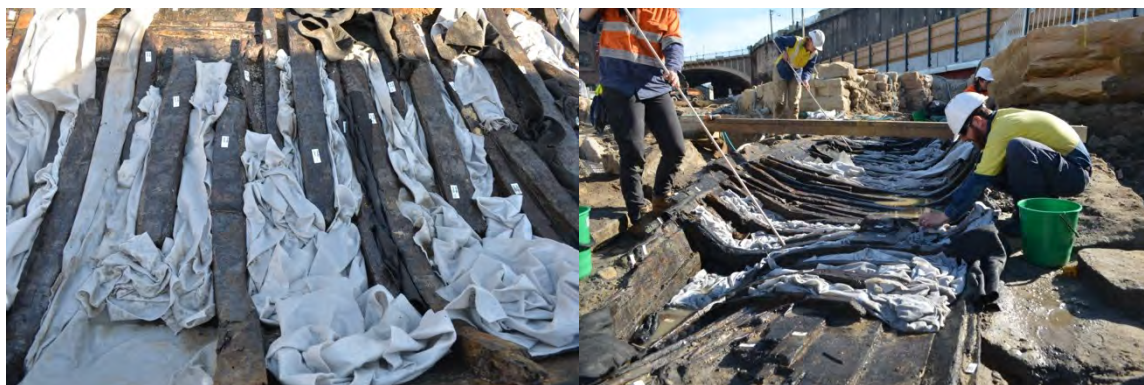
Figure 2.36: Padding between the frames. (Source: ICS).

In situ protection was put in place, starting with the padding of spaces between the frames with wet wads of geotextile (Figure 2.36). The padding was installed until the interior surface of the remains of the boat was even. Multiple layers of wet geotextile were then placed over the wreck surface (Figure 2.37 and Figure 2.38). The geotextile was completely saturated by spray hose. Thick sheets (80-100 mm) of polyurethane foam were then placed over the geotextile (Figure 2.39 and Figure 2.40). Polyurethane foam has good compressive and supportive qualities and allows water movement, so would not isolate the wreck from any rainfall. The foam was also wet by hose and then covered with sand by machine, which was supervised by the archaeology site supervisor (Figure 2.41 to Figure 2.44). Tarpaulins were placed over the sand to reduce the rate of any evaporation and wind erosion.

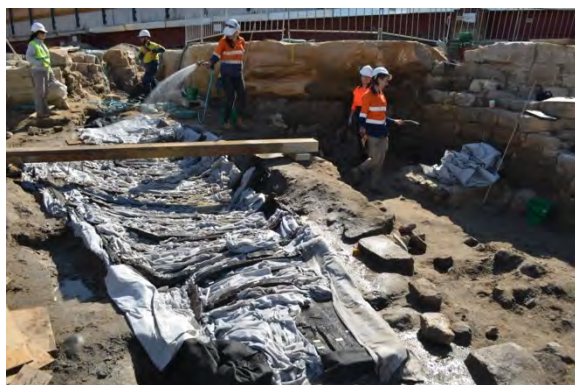
Figure 2.37: Keeping wreck wet with hose. (Source: ICS).

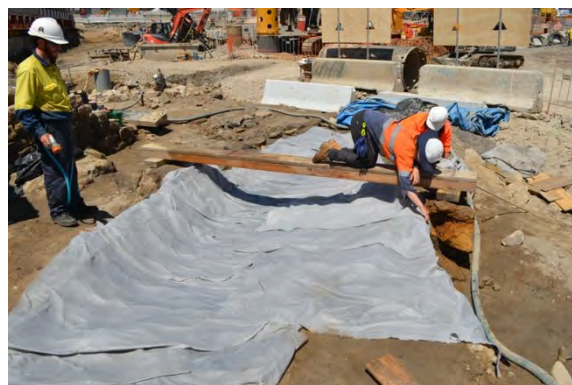
Figure 2.38: Final layers of geotextile. (Source: ICS).

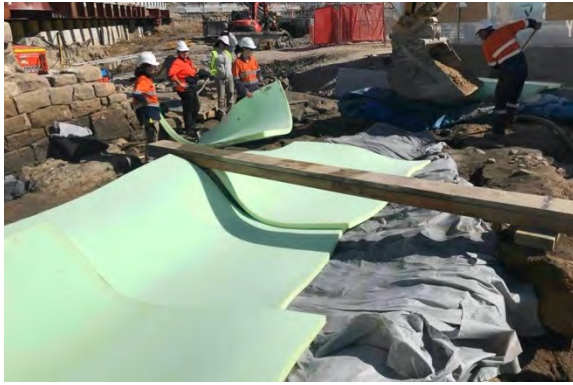
Figure 2.39: Installing polyurethane foam. (Source: ICS).

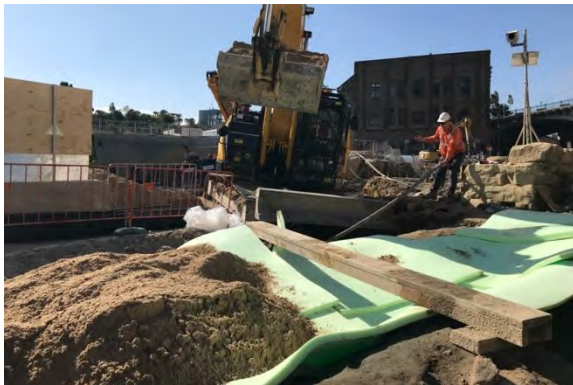
Figure 2.41: Covering with sand. (Source: ICS).

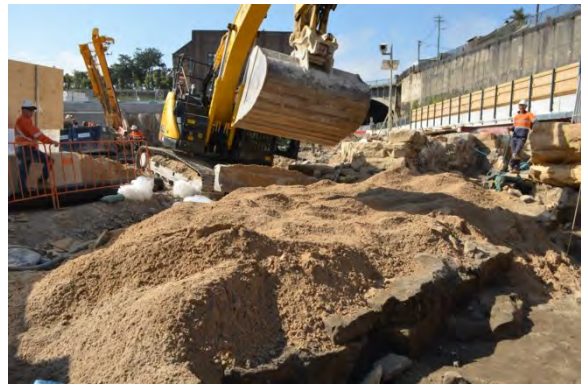
Figure 2.42: Covered with sand. (Source: ICS).

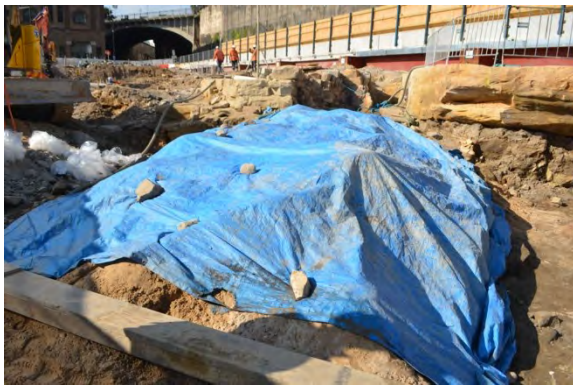
Figure 2.43: Wreck protected in situ. (Source: ICS).

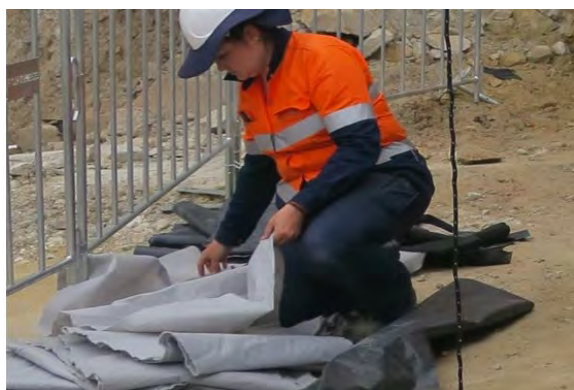
Figure 2.55: Pre-cut geotextile for packing.

- Labels were pre-cut and pre-numbered;
- Labels were installed in advance (where possible) with an agreed convention on label location to indicate orientation;
- Prefilled spray bottles and buckets of water were prepared and placed at each workstation, and refreshed during downtimes;
- Geotextile and plastic sheeting was cut into standard sizes in preparation for lifting and packing (Figure 2.55 and Figure 2.57);
- Custom padding cushions (polystyrene balls sewn into Tyvek) were prepared off site;
- Polyurethane foam padding was pre-cut into strips and blocks of various thicknesses (the foam used in the temporary protection of the boat was reused);
- Ethafoam was cut into standard sizes for further customisation and use in packing;

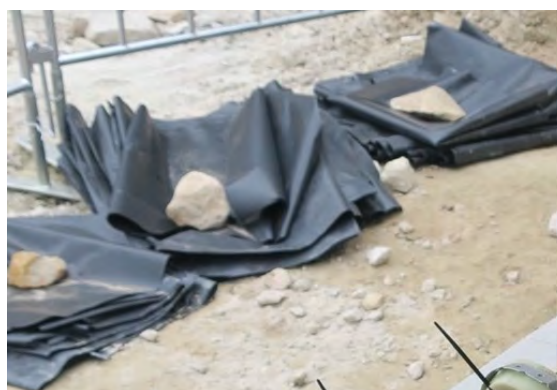
Figure 2.56: Pre-cut polyethylene sheet.

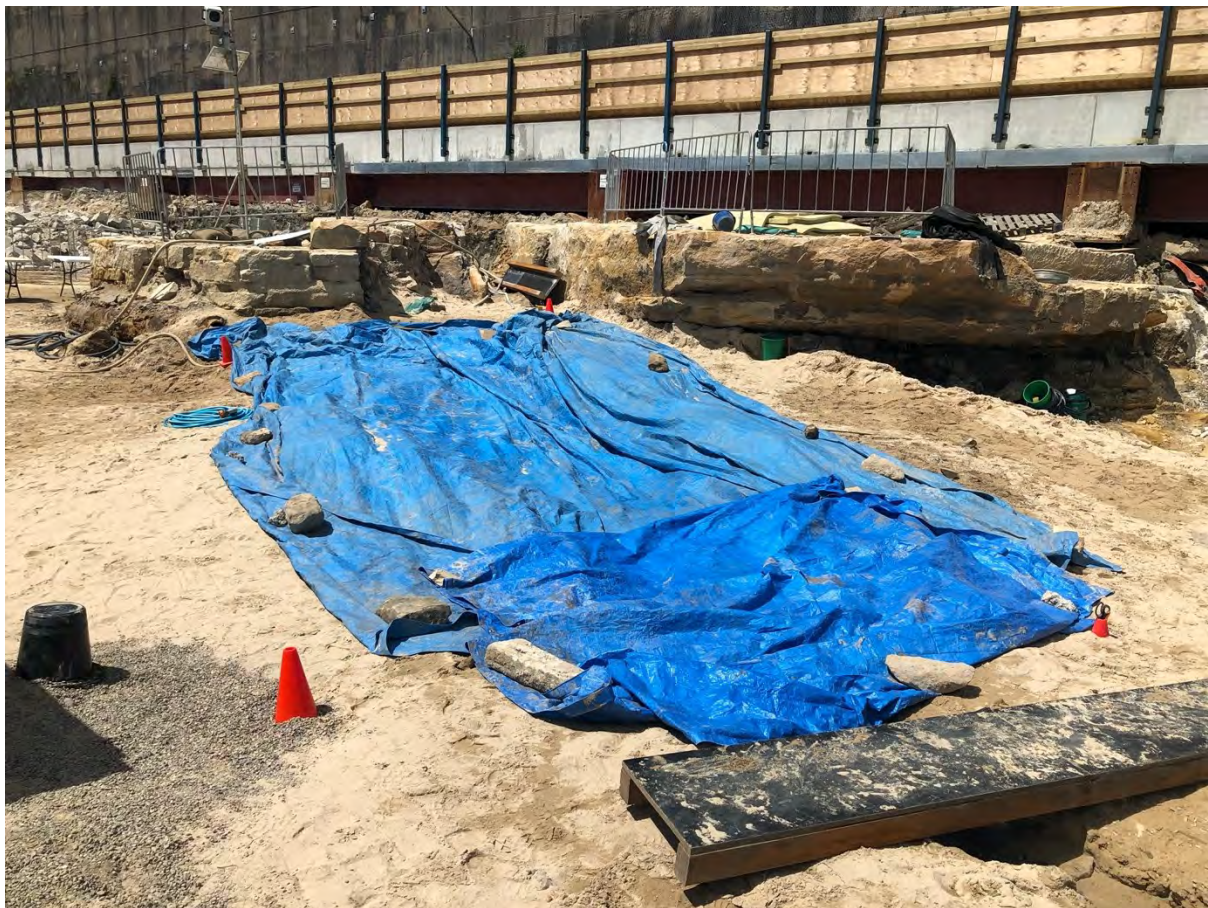
Figure 2.57: In situ maintenance included covering the wreck at the end of the workday.

The boat was completely covered overnight and localised areas were uncovered for works and then re-covered during breaks and at the end of the day (Figure 2.57). The boat was covered with layers of water-saturated fabric and waterproof plastic (spun-bonded geotextile and plastic tarpaulins). Overnight and on weekends, a 'soaker' hose with fine holes along the length of the hose was placed on the boat, over the geotextile and below the tarpaulin, to prevent drying out.

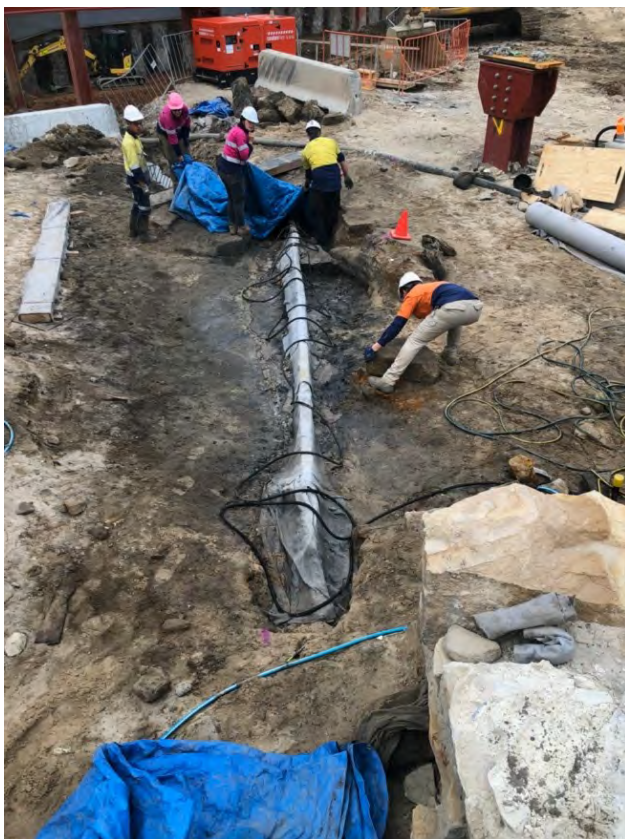
Figure 2.59: Installing soaker hose and covering wreck, in last stages of recovery.

The boat was kept wet during works by uncovering the smallest area possible to provide access for the immediate task (Figure 2.58). Where possible, during works a hose would be used to keep a flow of water on the boat (Figure 2.59). Otherwise, it was kept wet by hand spraying water. A multi-pattern trigger spray gun on a garden hose was used on mist and shower functions (Figure 2.60 and Figure 2.61).

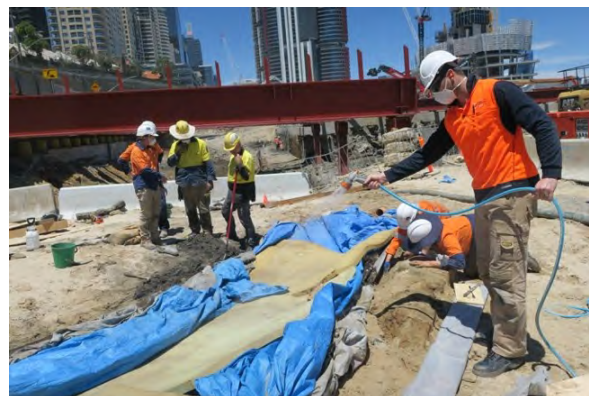
Figure 2.60: Keeping wreck wet with hose.

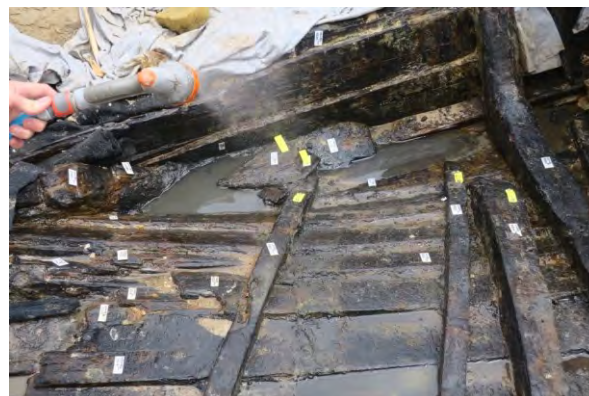
Figure 2.61: Often water accumulated in hull which had a minor effect on data gathering, especially with photogrammetry. Keeping the timbers wet was a priority.

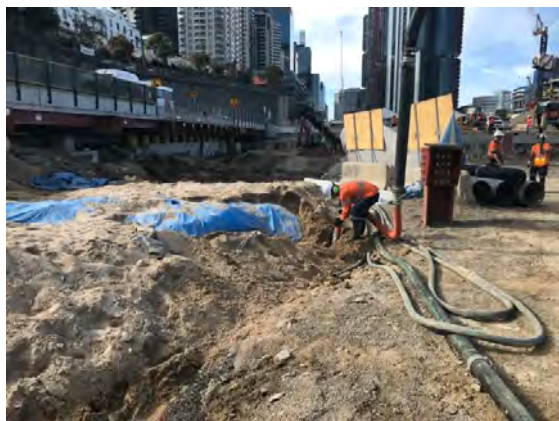
Figure 2.62: Removal of sand by vacuum truck.

The temporary *in situ* protection put in place in October 2018 was removed between 13th November 2018 and 16th November 2018. Sand covering the boat was removed by machine and vacuum truck to a safe depth, and then by hand shovel to expose the polyurethane foam (Figure 2.62 to Figure 2.65). During the manual removal of foam and geotextile, water was regularly applied via a hose to prevent the wreck from drying out during works (Figure 2.66).

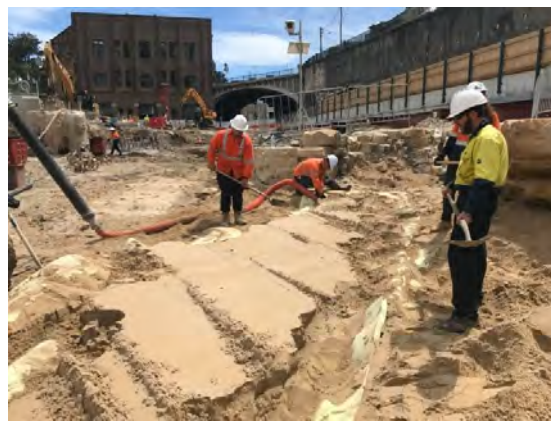
Figure 2.63: Removal of sand by vacuum truck.

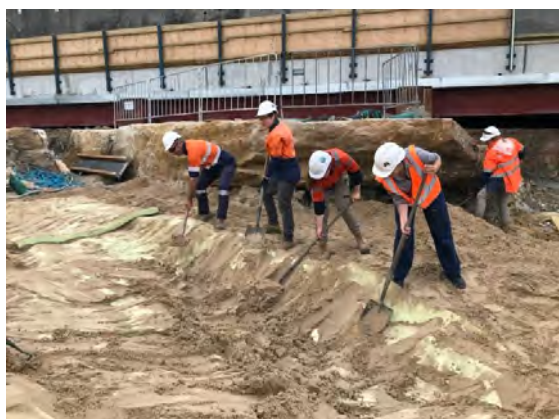
Figure 2.64: Removal of sand by shovel.

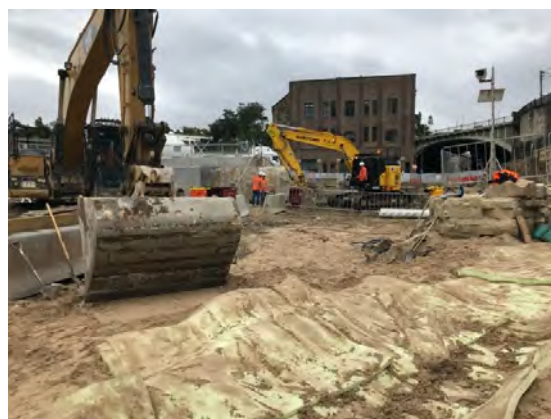
Figure 2.65: Removal of associated spoil by machine.

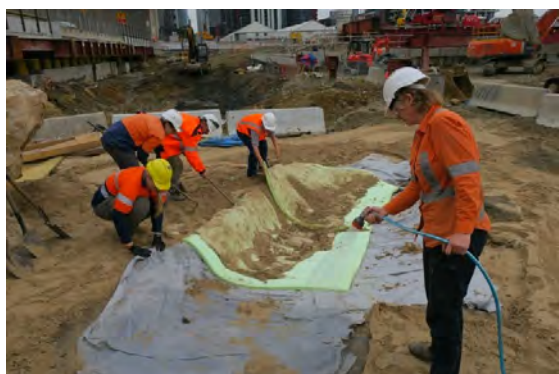
Figure 2.66: Removal of polyurethane foam and wetting geotextile.

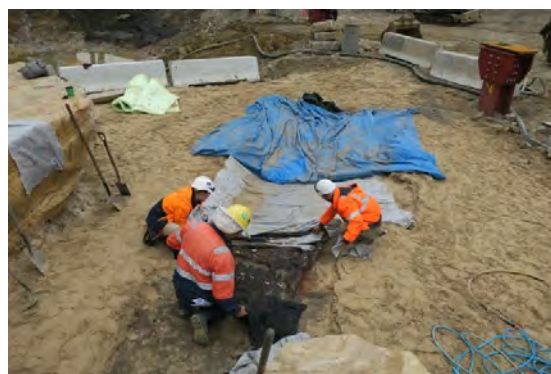
Figure 2.67: Condition of boat assessed.

The boat was inspected to confirm that no new damage had occurred during the temporary protection (Figure 2.67). The form and structure appeared unchanged. The wood was not dry and there was no evidence of crushing or distortion. No changes were observed and the temporary protection was considered successful. The geotextile was reinstalled and the boat was wet with water again, and covered with tarpaulins.

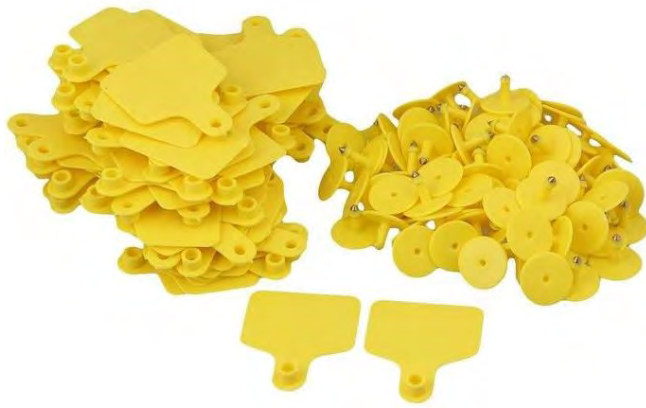
Figure 2.68: Cattle tags come in a variety of sizes and colours, with yellow or green being the preferred colour for use in maritime archaeological applications.

Any timbers that had been previously labelled with the white polypropylene tags were replaced by rectangular strips of yellow thick plastic cut up from cattle tags (Figure 2.68 and Figure 2.69).³⁵ Such tags had been used by Cosmos Archaeology for over 10 years on *in situ* underwater remains and had performed well, retaining their integrity and markings.

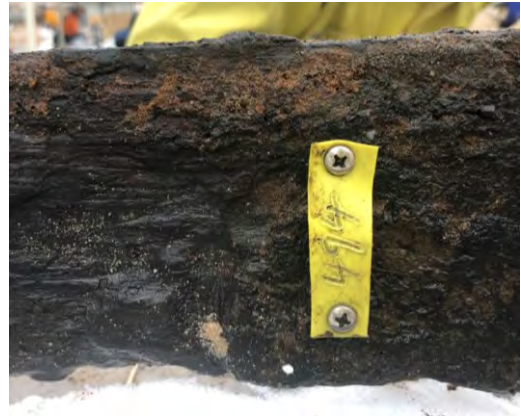
Figure 2.69: It was decided not to use the complete tag as it would require more than two attachments to secure. Instead, the tag was cut into strips. Also, tags can be purchased pre-numbered but etching the number into the plastic was a more durable solution.

The ID number was etched into the plastic using a soldering iron. This ensured that the number would not be erased during the removal, packing and conservation process. These tags were secured to the timber by two stainless steel screws, one at each end of the strip, using a hand-operated power drill.

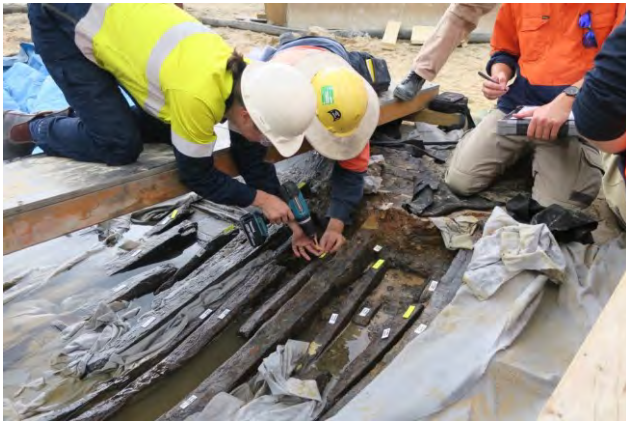
Figure 2.70: Yellow tags being fixed to a frame – on the upper face and on port end (bow at right of image).

The tags were orientated on each element to read port to starboard when facing the bow. For the frames, the tags were attached on structurally sound timber as close to the port side-sided face as possible (Figure 2.70). The planks were tagged on the interior, that is, the upper face, at the fore end (Figure 2.71). All other timbers were tagged at the fore end, port end and upper face. Any variations were noted on the registration form (see below).

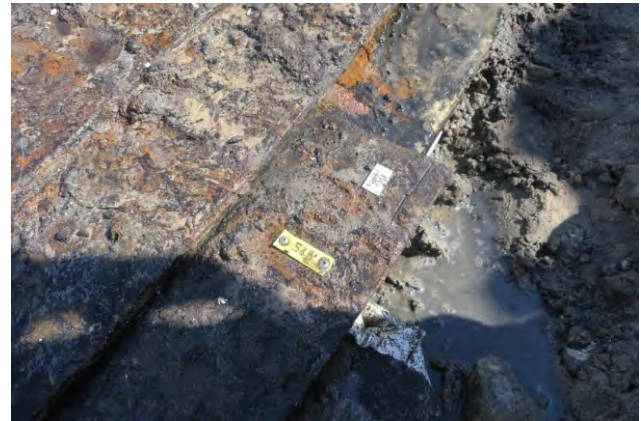
Figure 2.71: Yellow tag fixed to fore end of inner plank, reading port to starboard. Note the white polypropylene tags were often left on the timber after the yellow tag was attached.

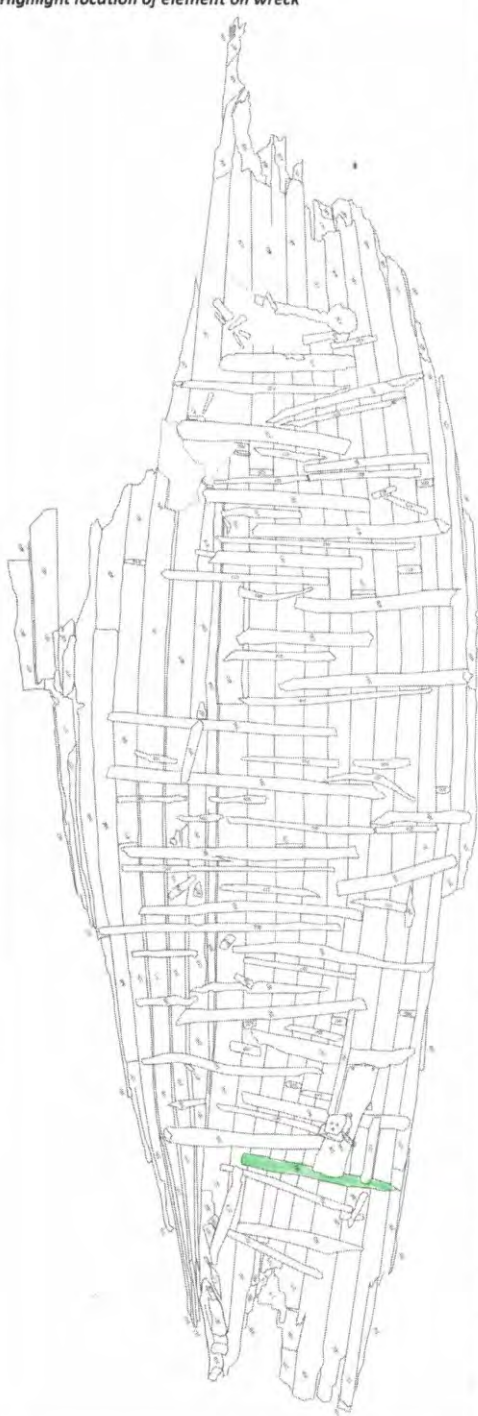
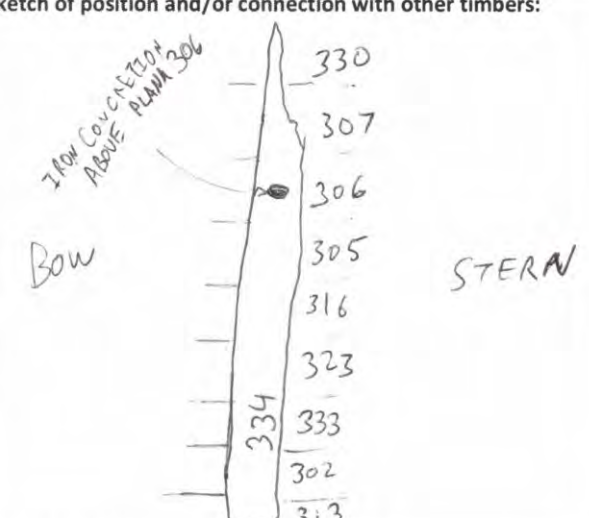
C&L Site: 90 SM2: Barangaroo Stn UDHB1 2018		Element ID: 334 Element Type: CANT FRAME (Plank) Layer No.		
Wreck Map Highlight location of element on wreck

Description of position and function CANT FRAME AT VESSEL STERN 334 IS ABOVE PLANKS 313, 302, 333, 323, 316, 305, 306, + 307 IT IS ABOVE, BUT NOT TOUCHING, 330 DUE TO DETERORATION OF 334 IRON CONCRETION ON THE TOP OF 334 ABOVE PLANK 306 *334 IS NUMBERED AS 343 ON SITE PLAN - ERROR			
	Displaced? Yes <input checked="" type="checkbox"/> No <input type="checkbox"/> Warped? Yes <input type="checkbox"/> No <input checked="" type="checkbox"/>			
	Sketch of position and/or connection with other timbers:

Photo Nos. 107-2736, 37, 38, 39, 40, * Camera No. 1			
	Relationship		Element No.	
	Overlaps			
	Overlapped by			
	Abuts		Fore	Aft
	Underneath			
	Above		313, 302, 333, 323, 316, 305,	
Other (specify)		306, 307, 330

Figure 2.72: Example of front page of element registration form.

Once the element tag was replaced, details about the elements were entered onto a specially designed registration form (Figure 2.72). Each element had its own registration form. At this stage of the process, with the element still *in situ*, the front page of the registration form was filled out.

A site plan of the wreck after the ceiling planks had been removed dominated the left side of the form. The recorder was to colour in the element that was removed. As the vessel had been double planked, the planks shown on the map in Figure 2.72 correspond to the inner layer of hull planking. The outer layer of hull planks, which were exposed, could be coloured in by eye as they were adjacent to, although under, the inner layer of hull planks shown on the plan. This was the same for the rider keel elements and the garboard shelves for the outer planking.

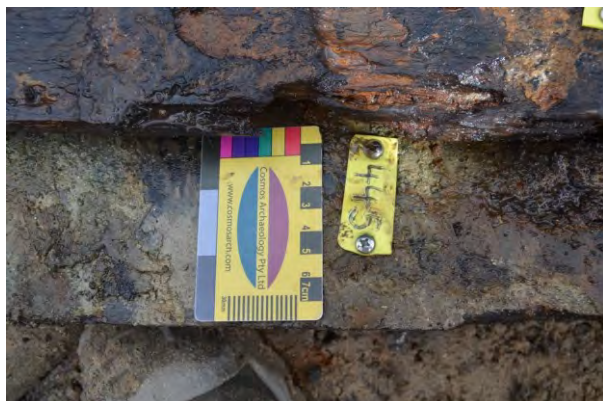
Figure 2.73: ID tag clearly visible. (Source: Casey & Lowe).

- An image of the ID tag with the information clearly readable (Figure 2.73);
- An image of the element showing the orientation of the tag as the element sat in the wreck (Figure 2.74);
- An image showing the relationship between the element and the surrounding elements (Figure 2.75), and;
- Any noteworthy features.

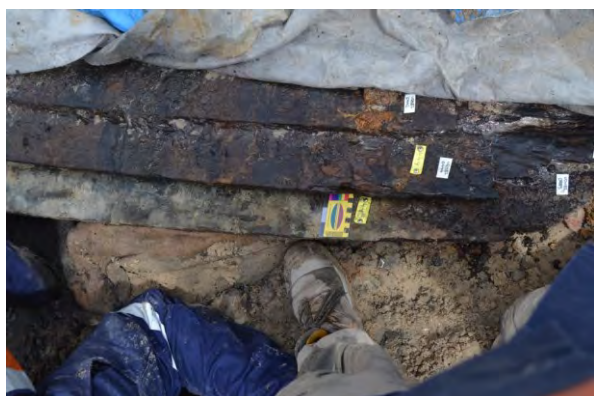
Figure 2.75: Photograph showing the relationship of the element with the surrounding elements. (Source: Casey & Lowe).

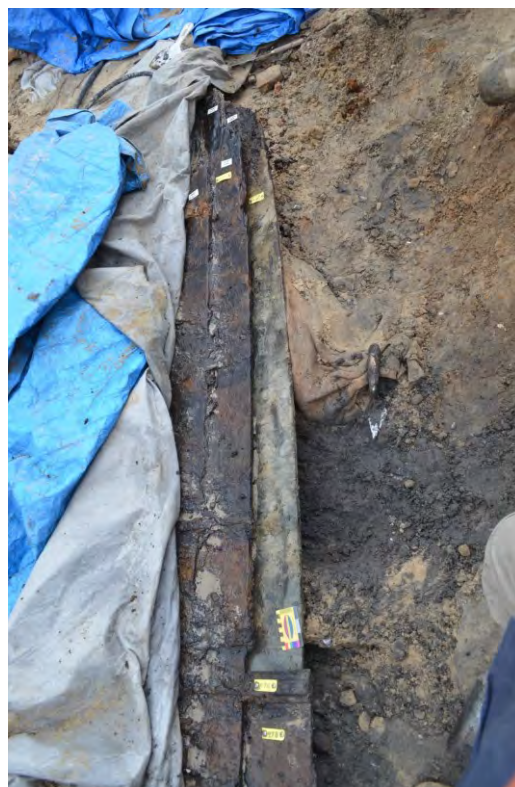
Figure 2.74: Photograph of element showing the orientation of tag and element in relation to the rest of the wreck. Facing bow. (Source: Casey & Lowe).

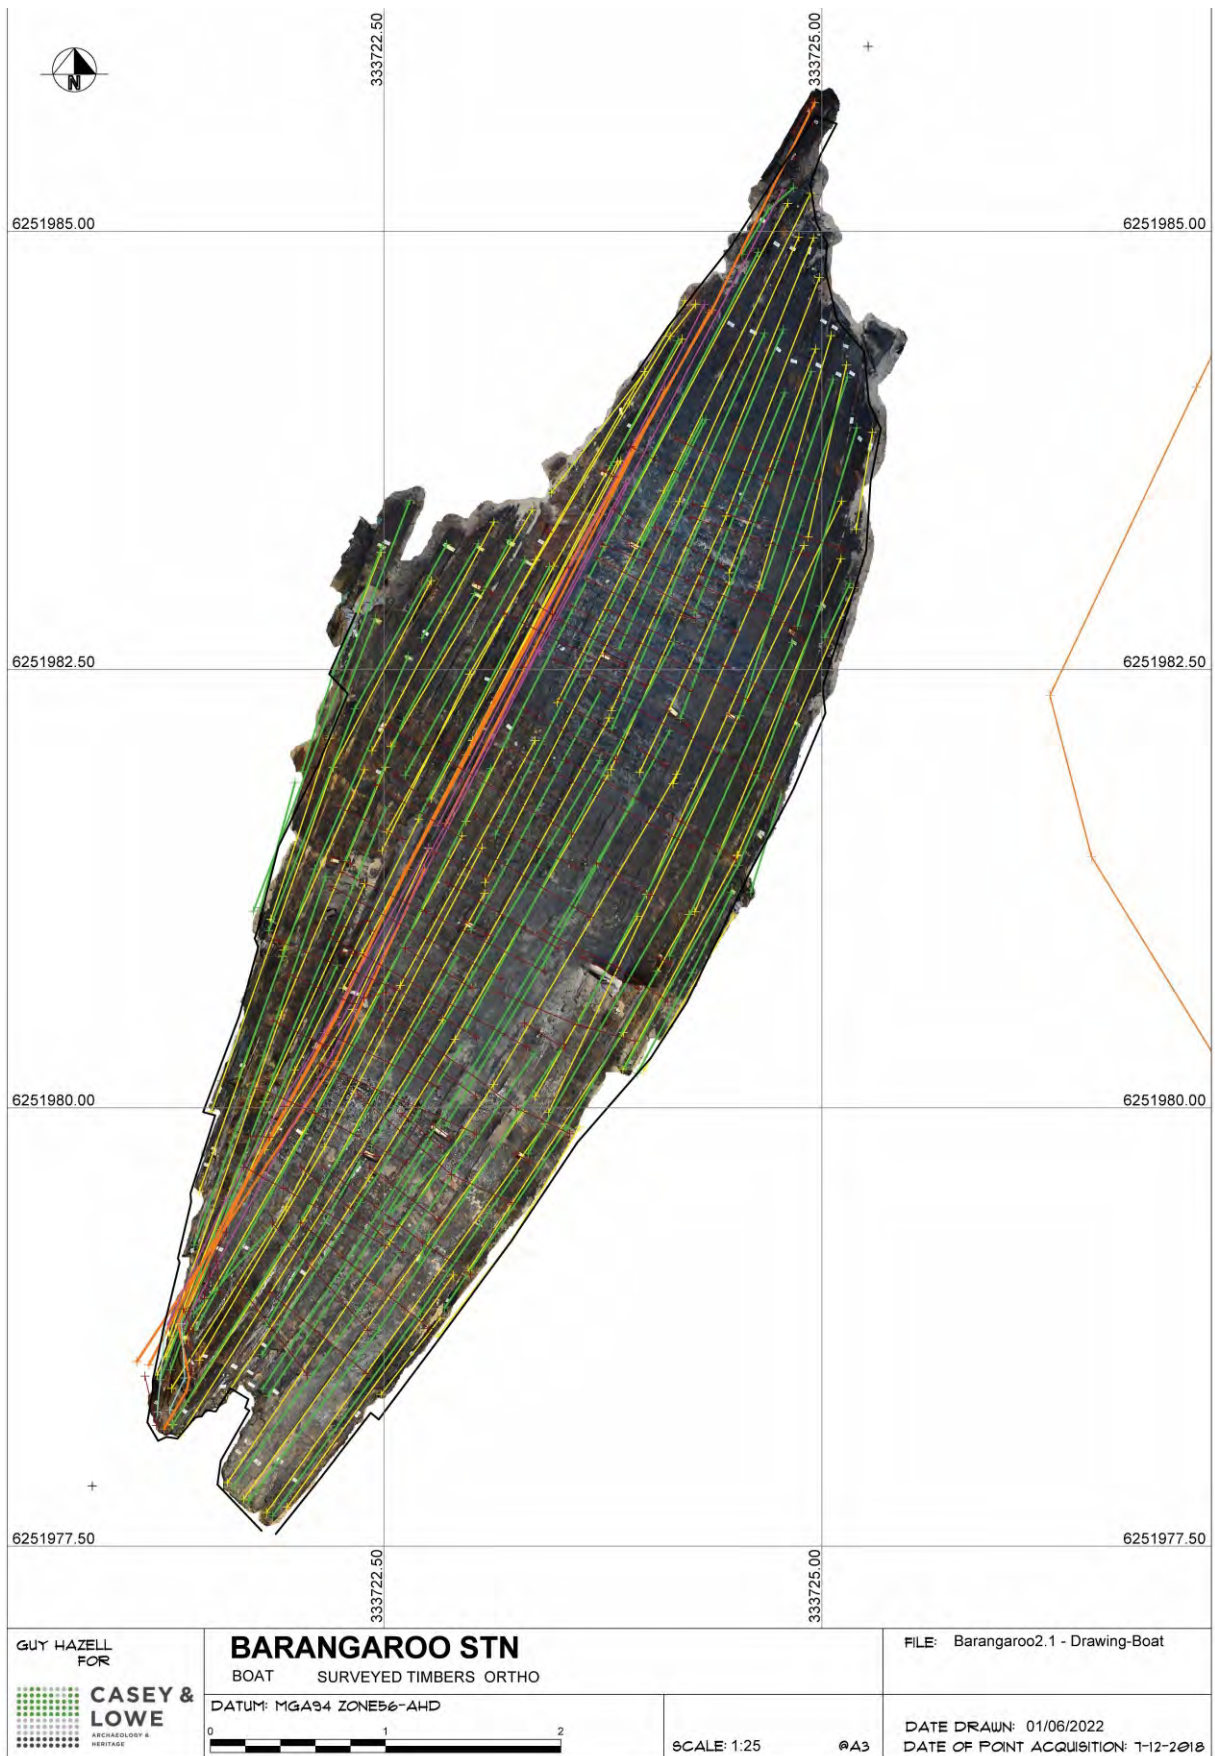
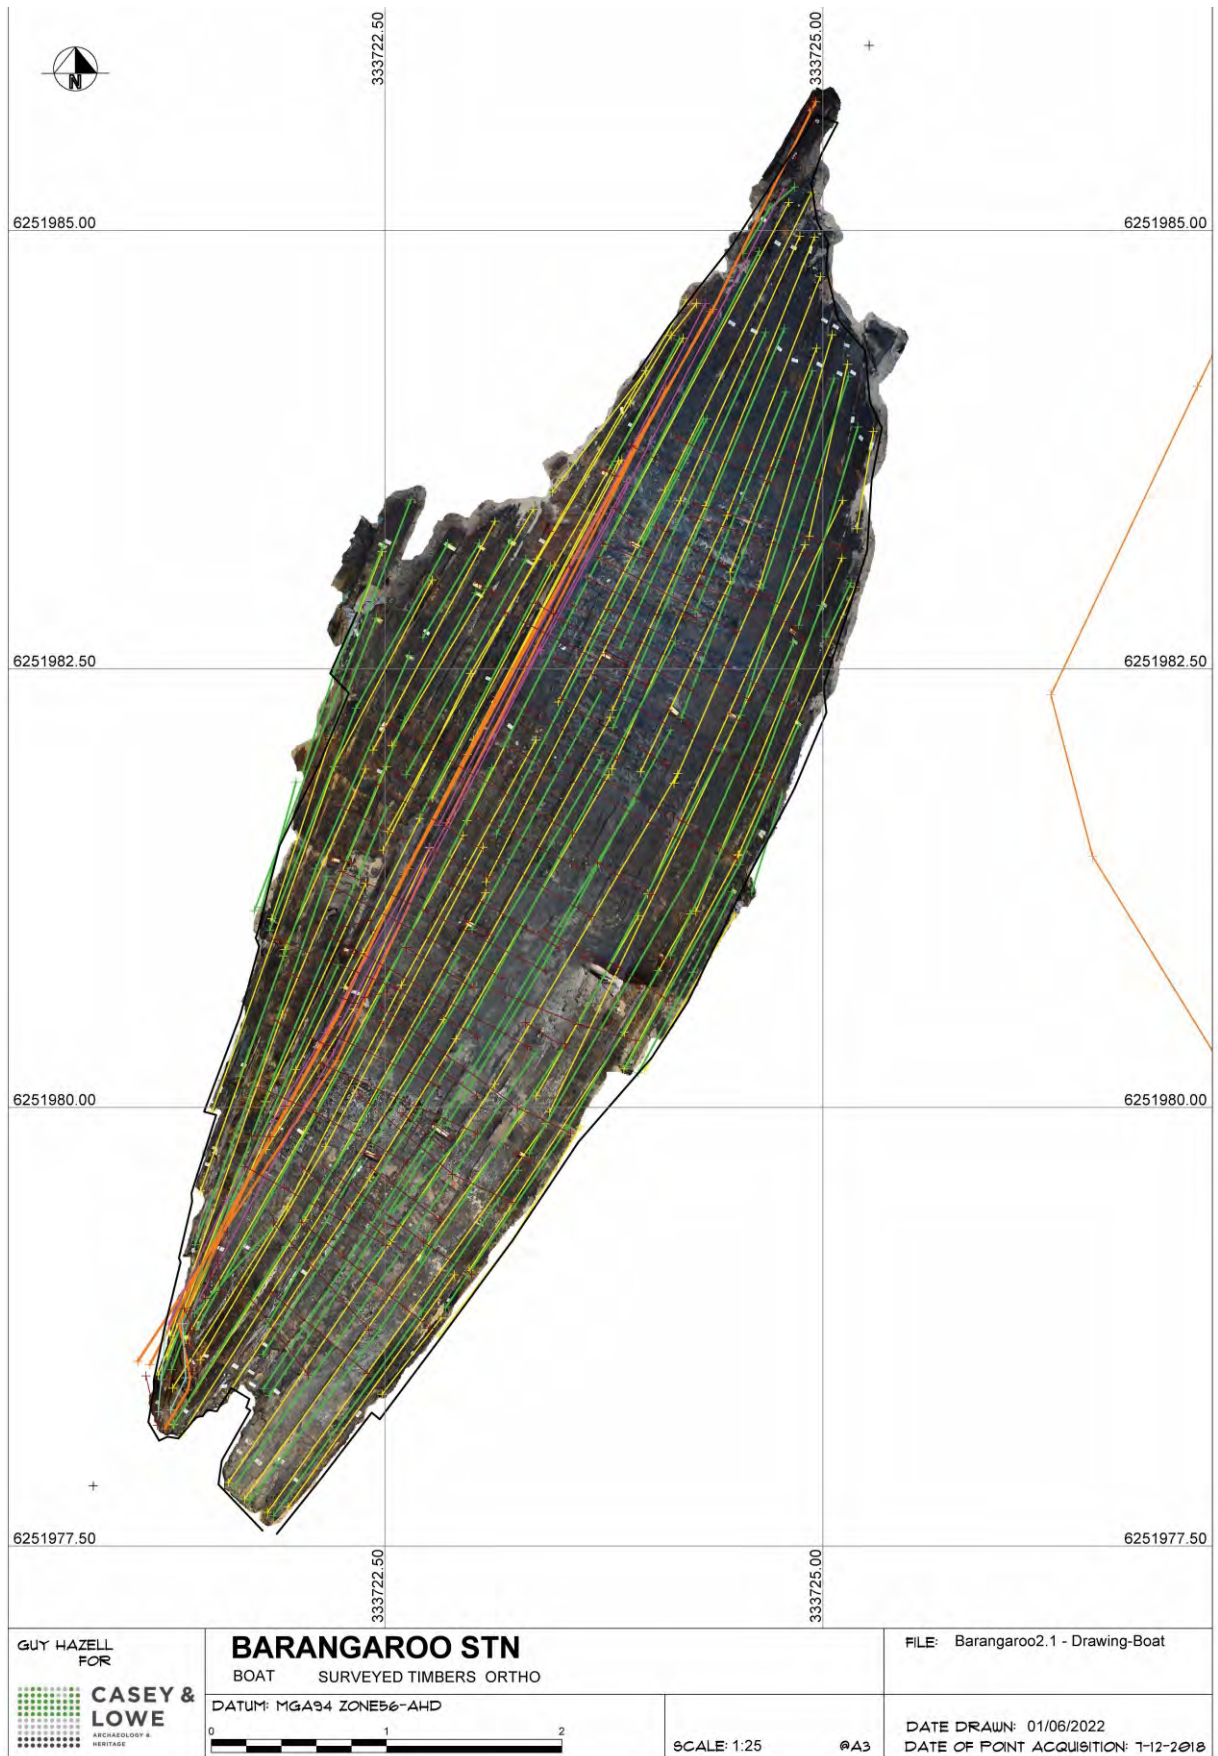
Figure 2.76: Surveyed positions of wreck elements. Green lines represent the outer planking, yellow lines the inner planking, thin red lines the frames, and thick orange lines are the keel, rider keel and stern assembly. Purple lines are the shelf panels.

The team surveyor had the task of obtaining the position of each element using a Total Station. This task was initially viewed as an 'if required' method of recording but it quickly became part of the standard operating procedure on account that it did not take long to do. A position was taken of one of the screws that attached the tag to the element and another position taken at the opposite end of the element. This method provided an absolute position for each element fixed in space (

Figure 2.76). This information is not seen as the primary data source that will guide re-assembly but is there as back up if there are gaps in the other forms of recording undertaken.

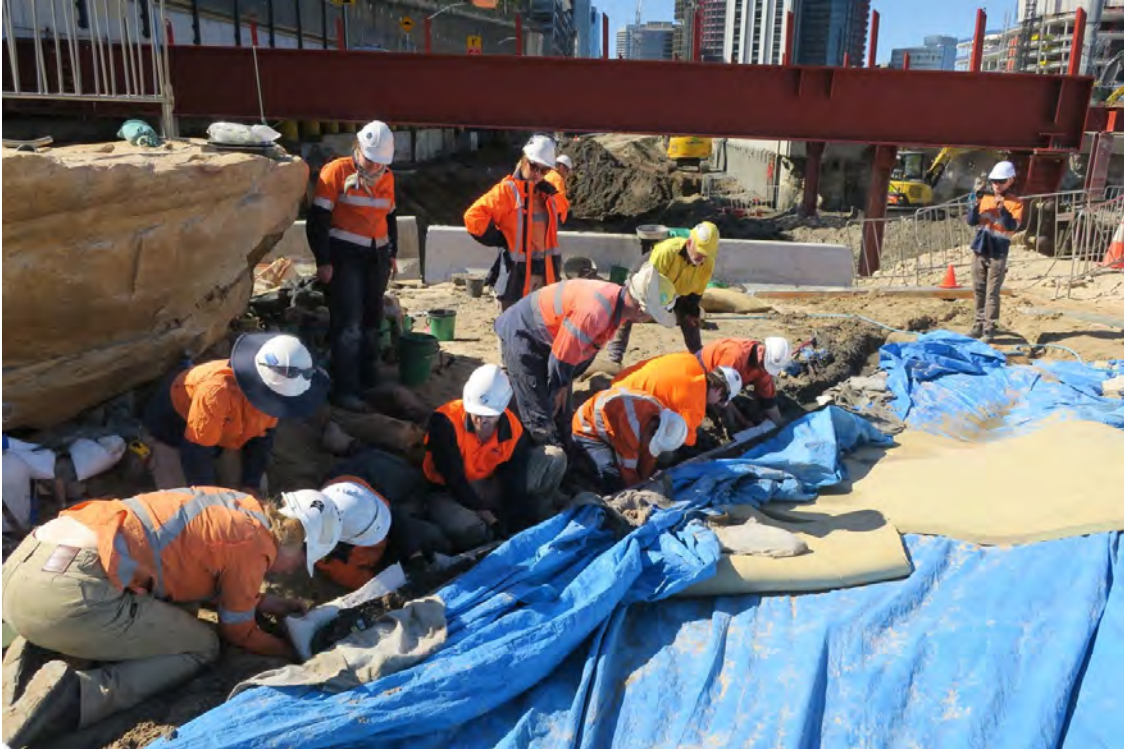
Figure 2.77: Video recording, recorder standing to right of image.

A video recording was made of each element as it was being removed from the wreck. Understanding how the element fitted in with the surrounding elements will be of great assistance in the re-assembly of the hull. The video recording, saved in MP4 format, commenced with the element as it was loosened for removal, and continued until it was clear of the wreck (Figure 2.77). A log sheet was kept separately which noted the video file number and which element was videoed.

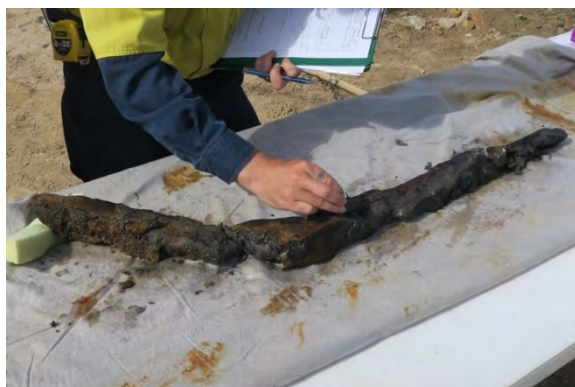
Figure 2.79: Assessing wood softness with pin.

1. Assessment to determine if warping was present (Yes/No);
2. Subjective assessment of condition on a 6-point scale (A to F) of good to poor;
3. Recording of softness as measured by pin depth in mm on a 4-point scale (0-2, 2-5, 5-10 & >10mm) as an indication of the degree of wood deterioration (Figure 2.79); and
4. Location of iron as detected by an earth magnet as an indicator of possible fasteners, contamination and consideration for future conservation (Figure 2.80).

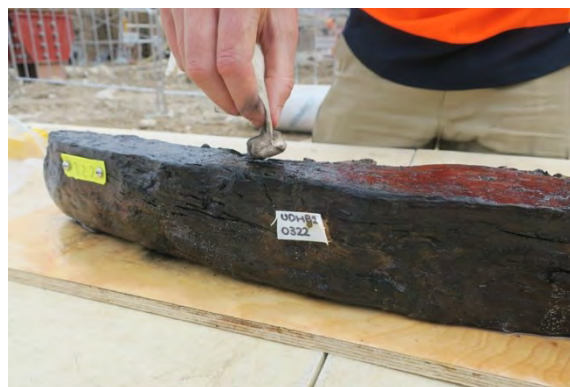
Figure 2.80: Detecting iron with earth magnet.

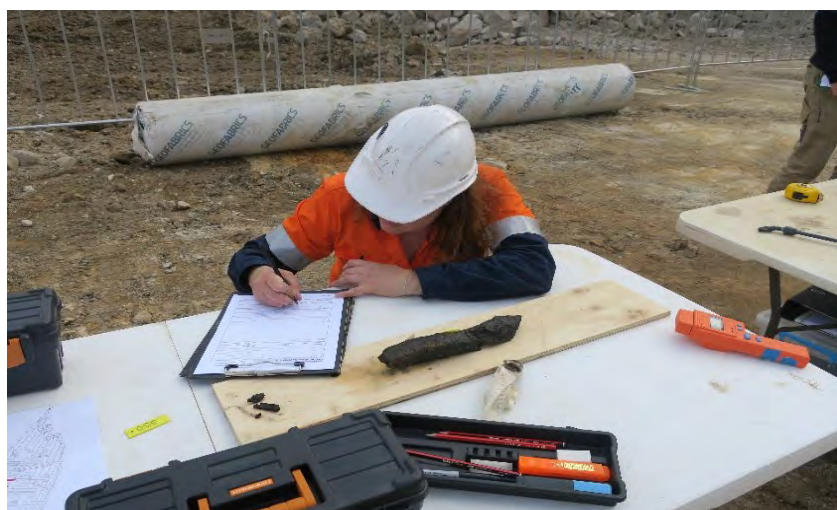
Figure 2.81: Surface moisture measurement station.

Additional condition recording included a measurement of surface moisture (%) as displayed by a FX-2000 Delmhurst moisture meter (Figure 2.81). Measurements were taken on a sample selection of elements in the first week of removal to confirm to what extent the wood of the wreck was wet.

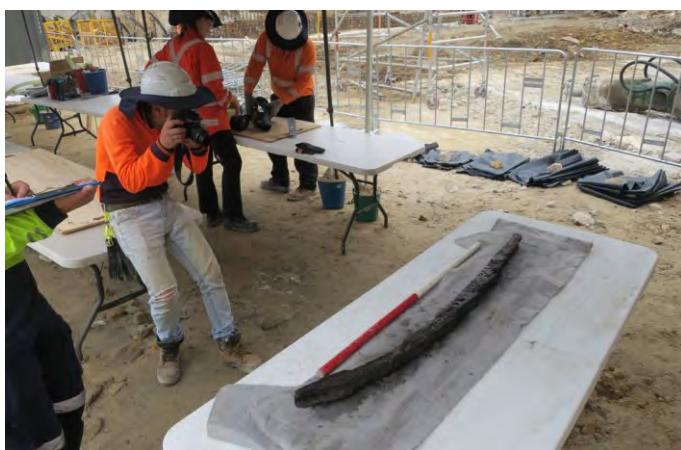
Figure 2.82 : Detailed photography of an element from an oblique angle.

The element's ID tag was photographed, followed by shots of all faces (so if needed, some 3D modelling could be attempted) as well as any noteworthy features (Figure 2.82). The photo numbers were then added onto the registration form.

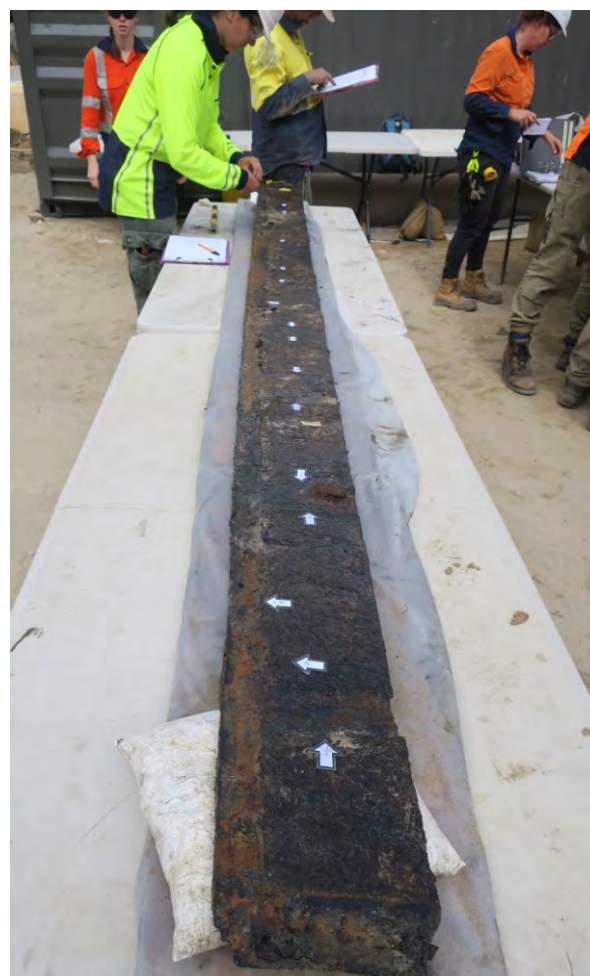
Figure 2.83 : Arrows placed on plank fastening holes.

Initially, features such as fastening holes were highlighted by placing plastic arrows on the elements. However, windy conditions sometimes made it difficult to keep the arrows in place without resorting to intrusive fastening measures (Figure 2.83 and Figure 2.84).
