Sydney Metro Project Barangaroo Station UDHB1 'Barangaroo Boat'

Excavation Report VOLUME 2

Sydney Metro Project: Barangaroo Station

Excavation Report

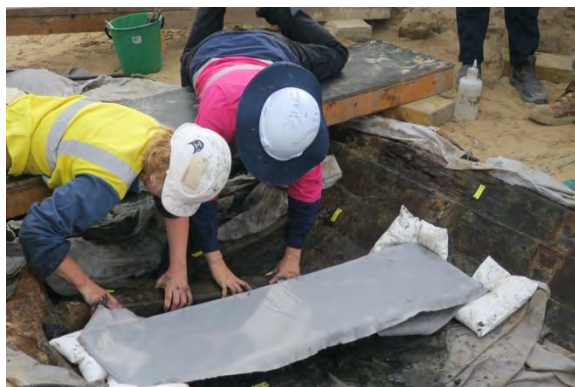
Figure 2.85: Padded alignment of support board.

Preparations for lifting were made when the component was free. A solid board (6-12 mm plywood) of appropriate size was placed adjacent to the component. A piece of geotextile was wrapped around the board, which would be used in packaging to minimise handling risks in subsequent recording and packing. Where necessary, padding or support under the board was used to protect the wreck from sharp edges or pressure, or to match the alignment of the piece to be removed (Figure 2.85).

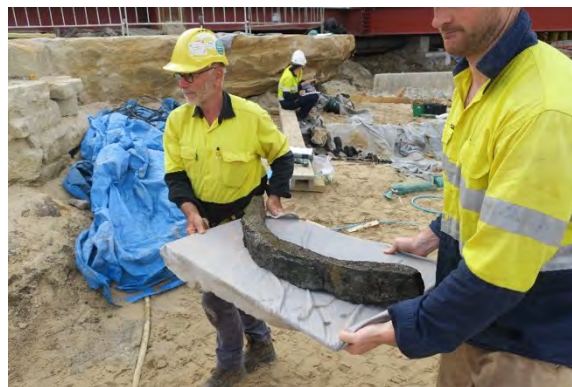
Figure 2.86: Carrying frame to Registration.

When preparations were complete, the element was lifted. Frames were removed and lifted by 1 to 3-person teams depending on the size of the element. The frame was generally rotated 90 degrees when lifted to lay flat on the board (Figure 2.87). Once secure, the board would be passed out of the wreck and carried to the registration area for recording and packing (Figure 2.86).

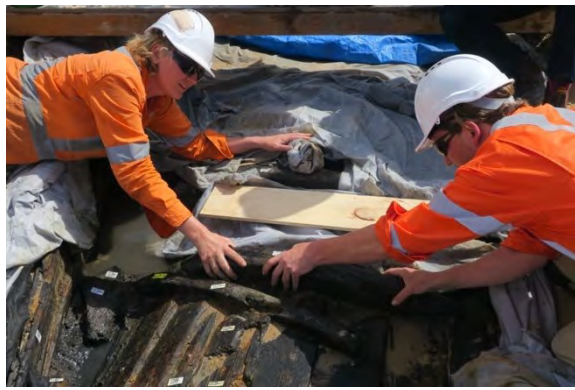
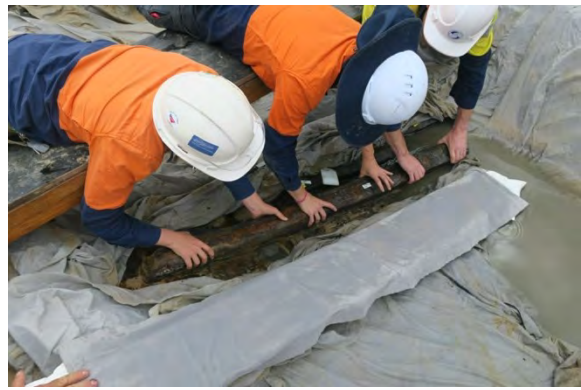
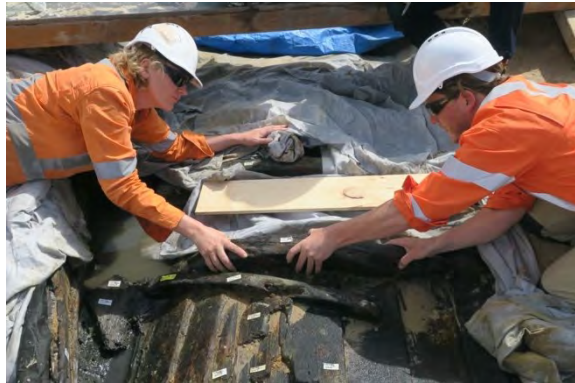
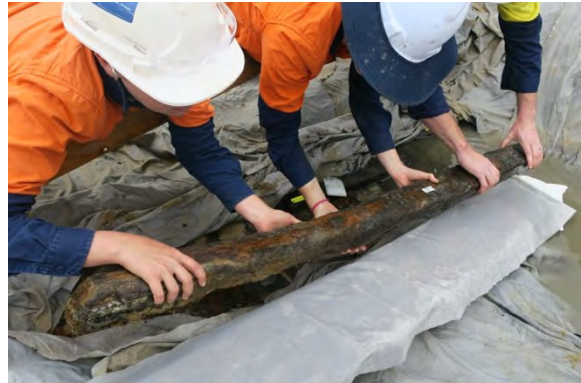
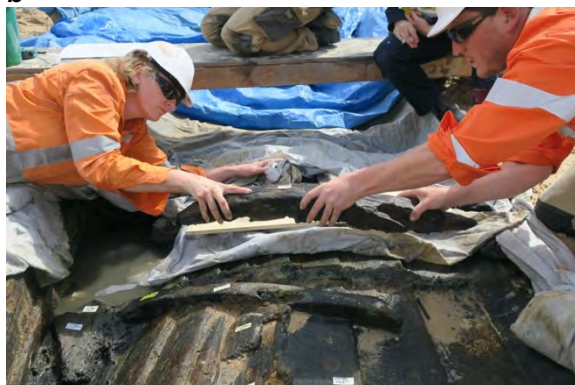
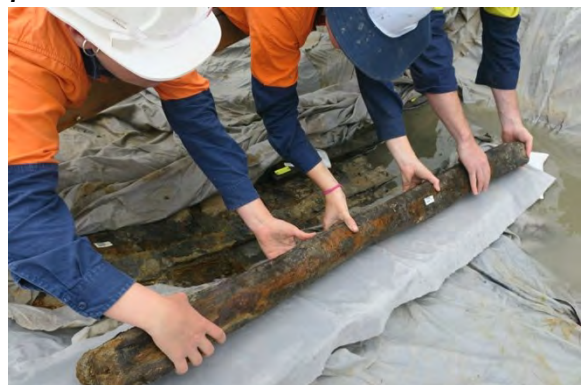
Figure 2.87 (a-h): Removal of frame element.
(Source: Casey & Lowe).

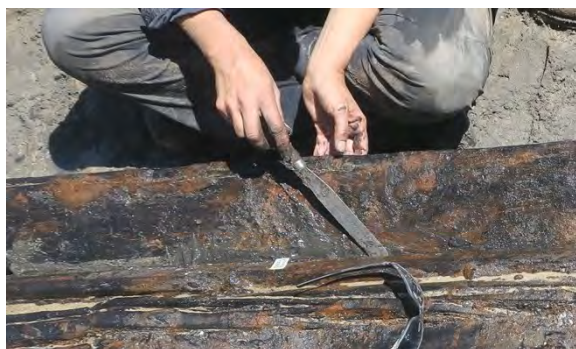
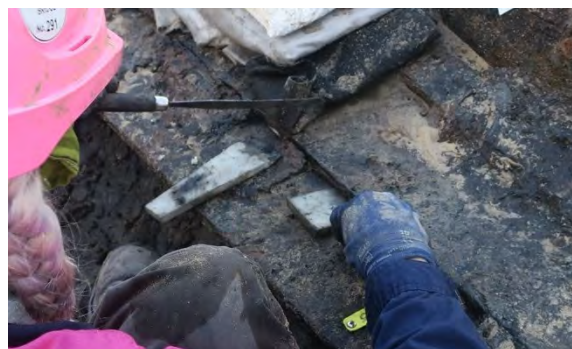
Figure 2.88 (a-b): Separating the planks.

Planks were separated from one another (and the sediment) by breaking the tension using thin, flexible and long-bladed palette knives (artist's style) or similar tools to cut through the mud (Figure 2.88a). Folded strips of Mylar were sometimes pushed into the join with the knife when the knife alone failed to break the tension. As with the frames thin, custom-made Teflon wedges were then used along the length of the components to lever the component free - evenly and gently (Figure 2.88b). Thin, plastic spatulas (the blade edge of which had been smoothed) were also used.

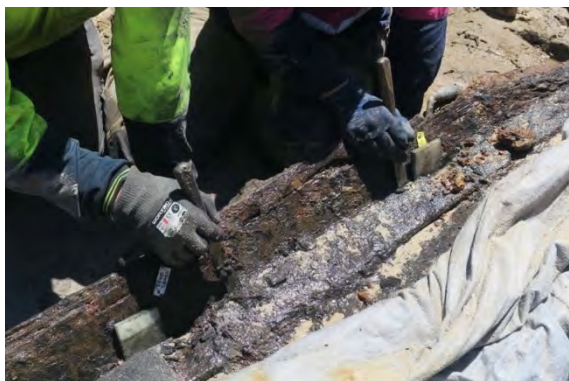
Figure 2.89: Separating the hull planks.

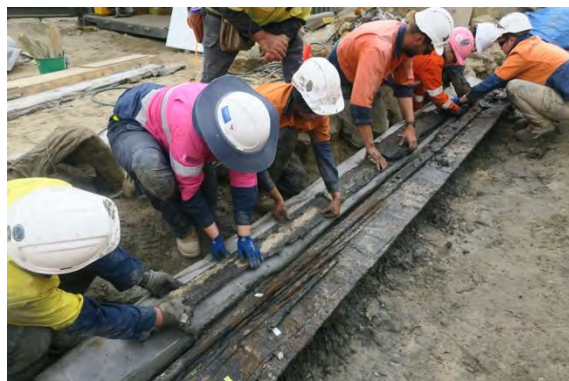
Figure 2.90: Removal of a plank.

situ (Figure 2.90 to Figure 2.93). When this was not possible, it was placed as close as possible to the plank to be removed.

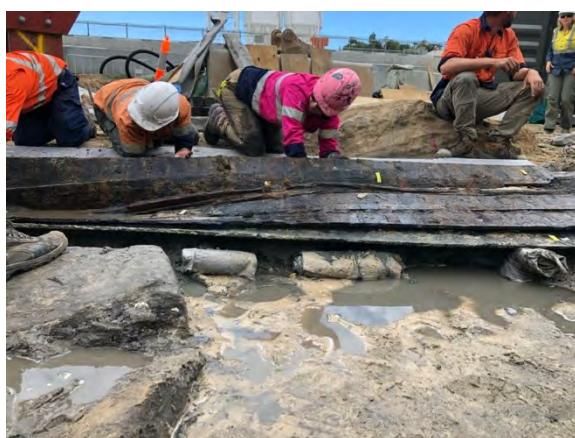
Figure 2.91: Preparation for lifting.

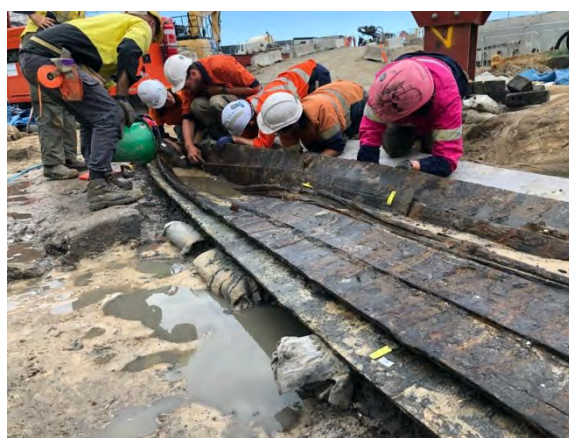
Figure 2.92: Preparation for team lift.

Planks were removed and lifted by teams (Figure 2.93). For the removal of planks, a team of six people was usually required to support the element, however this varied based on the element being removed, and for each lift, the team size could range from 2 to 10 people. When preparations were complete, the plank was removed by slowly separating it from adjacent planks until clear of any fasteners or other elements. Separation occurred through synchronised movements by the lift team including gentle pulling, lifting, lowering and/or rotation along the length. The lead lifter would call the movements. For larger or more complex lifts a spotter would observe from the opposite side of the boat and relay observations to the lead lifter.

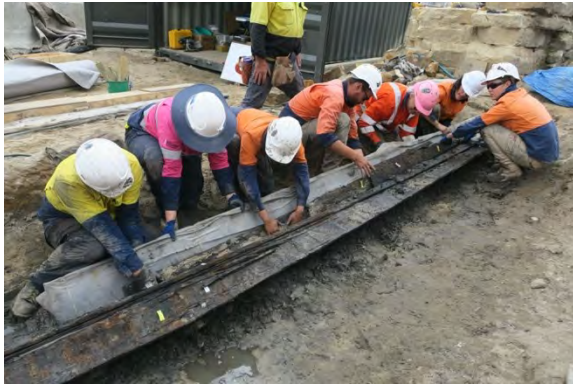
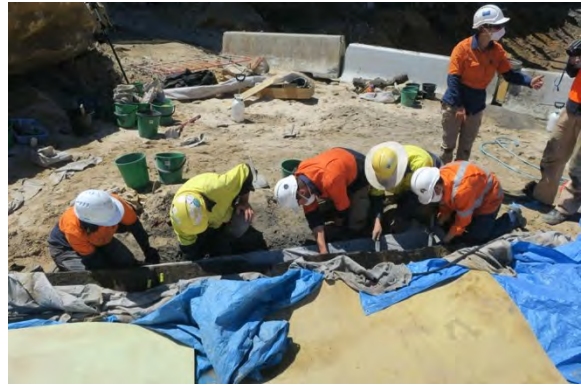
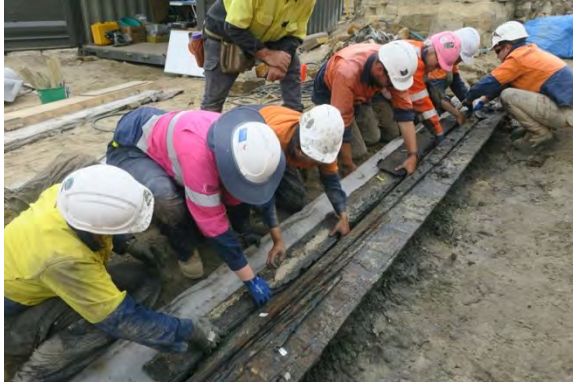
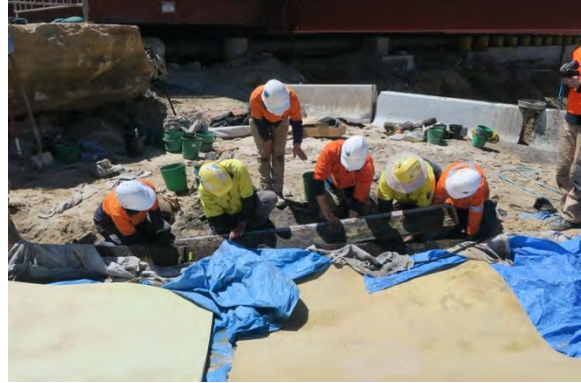
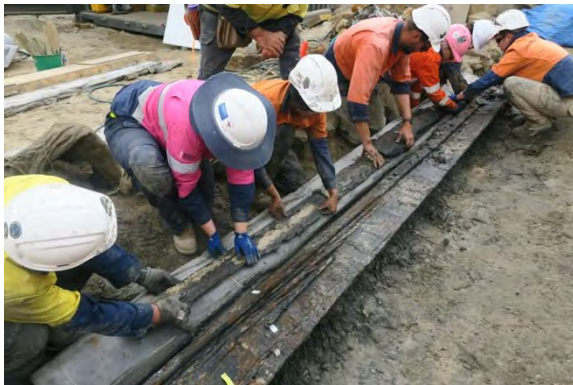
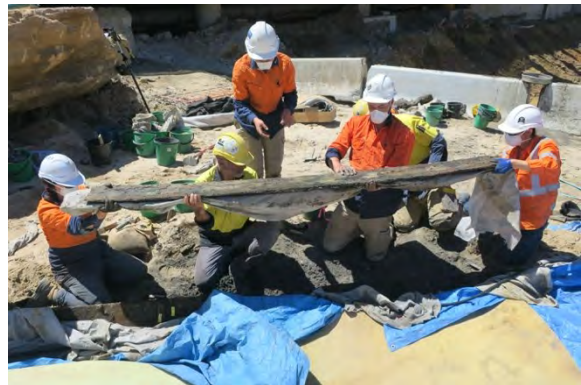
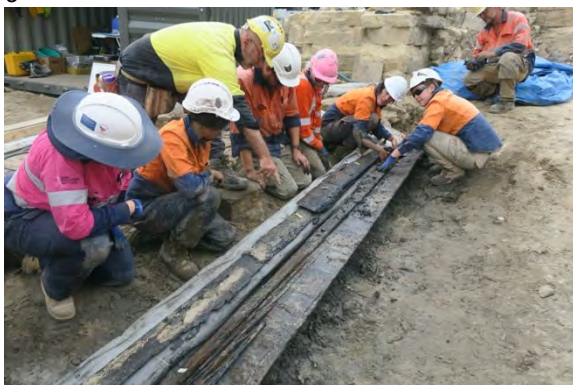
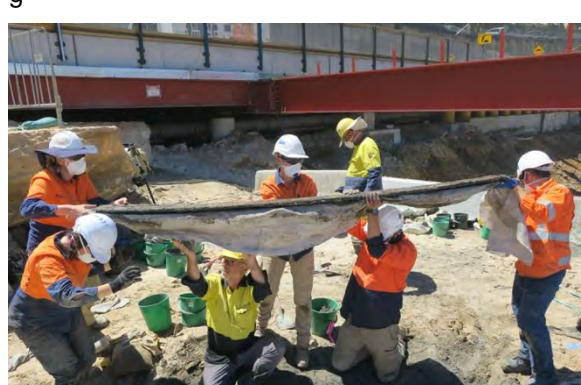
Figure 2.93 (a-h): Removal of plank element.
(Source: Casey & Lowe).

The selected plank was loosened along the face where it overlapped the adjacent plank, and along the bottom edge abutting/overlapping the next plank, and at any scarf joints. The location of the scarf joint was not necessarily immediately apparent due to surface materials, mud and accreted sediments. Scarf plates generally indicated the location of a scarf joint on the interior surface. Separation at the scarf joint required precise and gentle movements to prevent marking the edges, and following the angle of the joint correctly.

The plank was slid, lowered or lifted directly onto the waiting support board. The plank was padded on the support board as appropriate to account for any warping or curvature. Padding materials included rolled geotextile, Oasis foam, and polystyrene Tyvek cushions. At the same time, the newly exposed *in situ* timbers of the boat were also supported using the same materials and sandbags as appropriate.

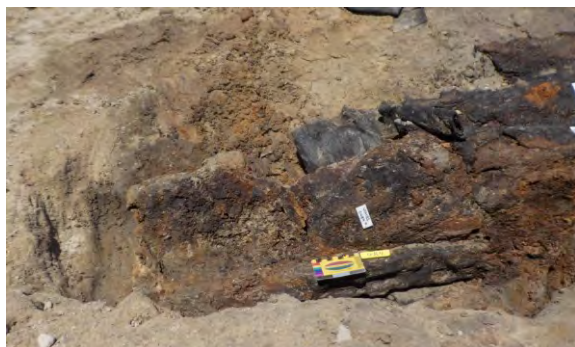
Figure 2.94: Remains of the stem and apron in situ. (Source: Casey & Lowe).

The bow of the boat was in worse condition overall, with significant loss of material and severe deterioration of remaining material. Excavation of the remnant stem at the port side exposed the deteriorated remains of this component of the wreck *in situ* (Figure 2.94). The timber of what appeared to be the stem and apron were in extremely poor condition, with almost no structural integrity remaining. Detailed recording was carried out *in situ* and the 'mud-like' consistency of the remnant timber was recovered to allow for the possibility of further recording and assessment. Other elements of the bow and construction details at the stem were visible after removal (Figure 2.95).

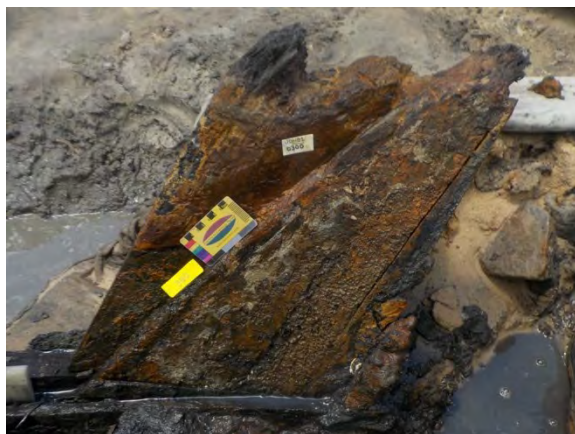
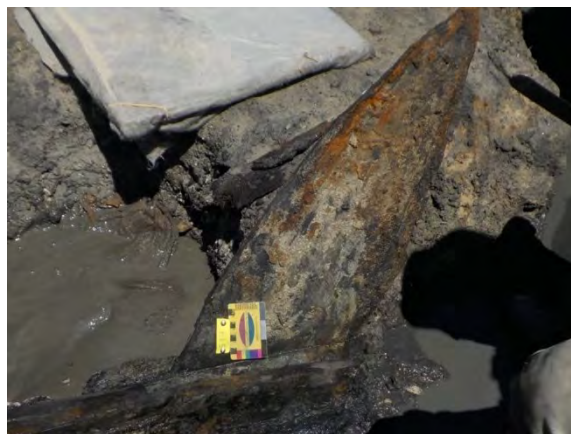
Figure 2.96: Remains of the sternpost in situ. Figure 2.97: During removal of sternpost.

Removal of the stern continued in conjunction with recording and archaeological investigation (Figure 2.96 and Figure 2.97). The stern was heavily concreted compared to other parts of the wreck and thick iron-based concretions were removed from the keel and stern. The components detached easily, with no fasteners preventing removal, and were recorded and retained for further assessment and analysis, including radiography. These components could be what remains of (or provide evidence of) fittings such as the gudgeons and pintles, which form part of the rudder assembly.

Once the concretions in this area were removed, further disassembly of the stern area continued with removal of the sternpost and the shelf piece which supported the garboard strake of the outer hull. The removal of the outer garboard strakes of the keel followed. By 6th December 2018, only the keel and rider keel remained *in situ*.

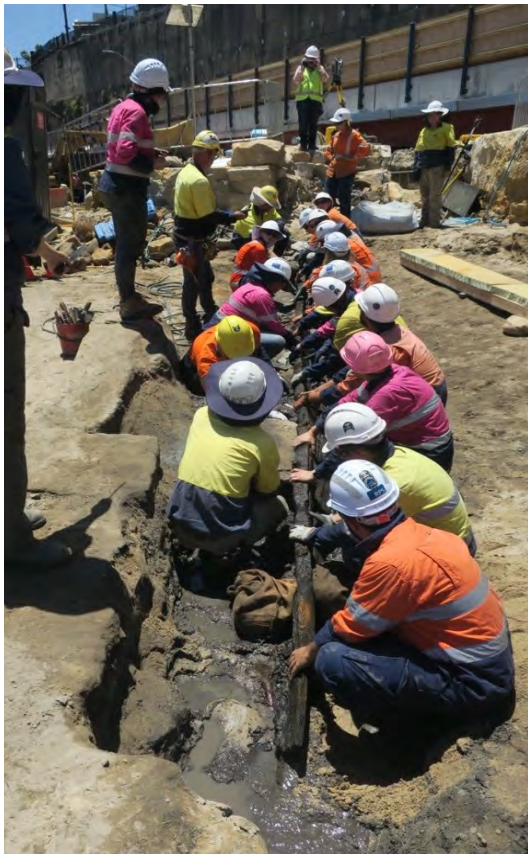
Figure 2.98: Removal of the keel.

The keel consisted of three main elements, i.e., keel and two sections of the rider keel, that were lifted separately. The keel lifted cleanly off the rider keel, and the ease of separation was due to the (unexpected) total corrosion of the iron fastenings. Due to the length and weight of the keel elements, the removal was undertaken by a larger team of people. Due to the size of the elements, practice lifts were carried out on-site to ensure that the project team was clear on their roles and tasks during the lift, and that the lifting team worked in co-ordination. The keel lift was undertaken by 17 people. Twelve people were placed evenly along the starboard side and took the majority of the load of the lift while five people along the port side assisted in the lift and guided the movement. The Lead Lifter called the entire removal process from a central viewing point with two additional spotters as support. In addition, 2 to 3 people recorded the process and 2 to 4 people were at hand to provide materials and supplies as required.

The keel was lifted from the rider keel and carried to a pre-prepared board placed alongside the wreck for packaging (see Section 2.6.5). The two rider keel elements were then lifted in the same manner as the keel (Figure 2.98 to Figure 2.100).

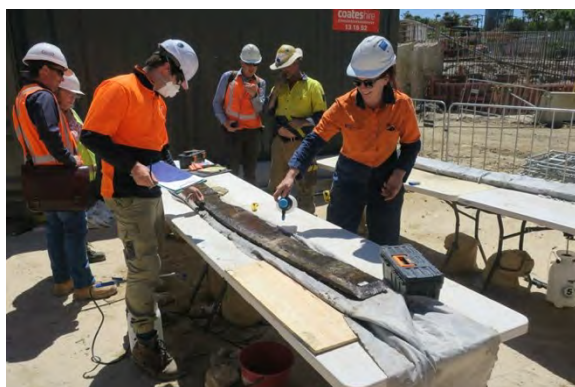
Figure 2.101: Keeping elements wet. (Source: Casey & Lowe).

Elements were sprayed with water prior to packing (Figure 2.101). As noted previously, elements were not cleaned prior to packing on the basis that conservation would commence in the short-term and that valuable information could be lost. Furthermore, the wet surface dirt and mud would reduce the rate of the wood drying in cold-storage.

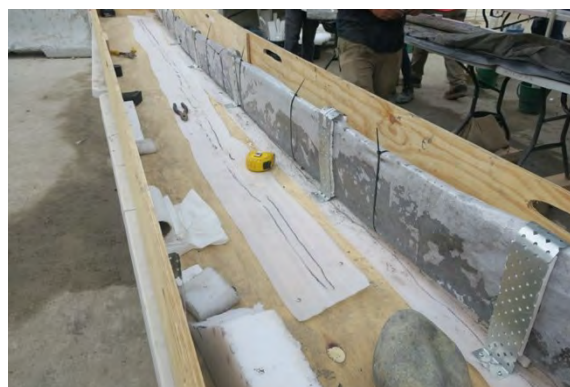
Figure 2.102: Example tracing of element. (Source: Casey & Lowe).

An outline tracing was taken of elements considered at risk of distortion during conservation. Tracings were made on Mylar with permanent marker. Later, tracings were made on Cell-Aire foam when Mylar became unavailable. The tracings were packed with the elements (Figure 2.102).

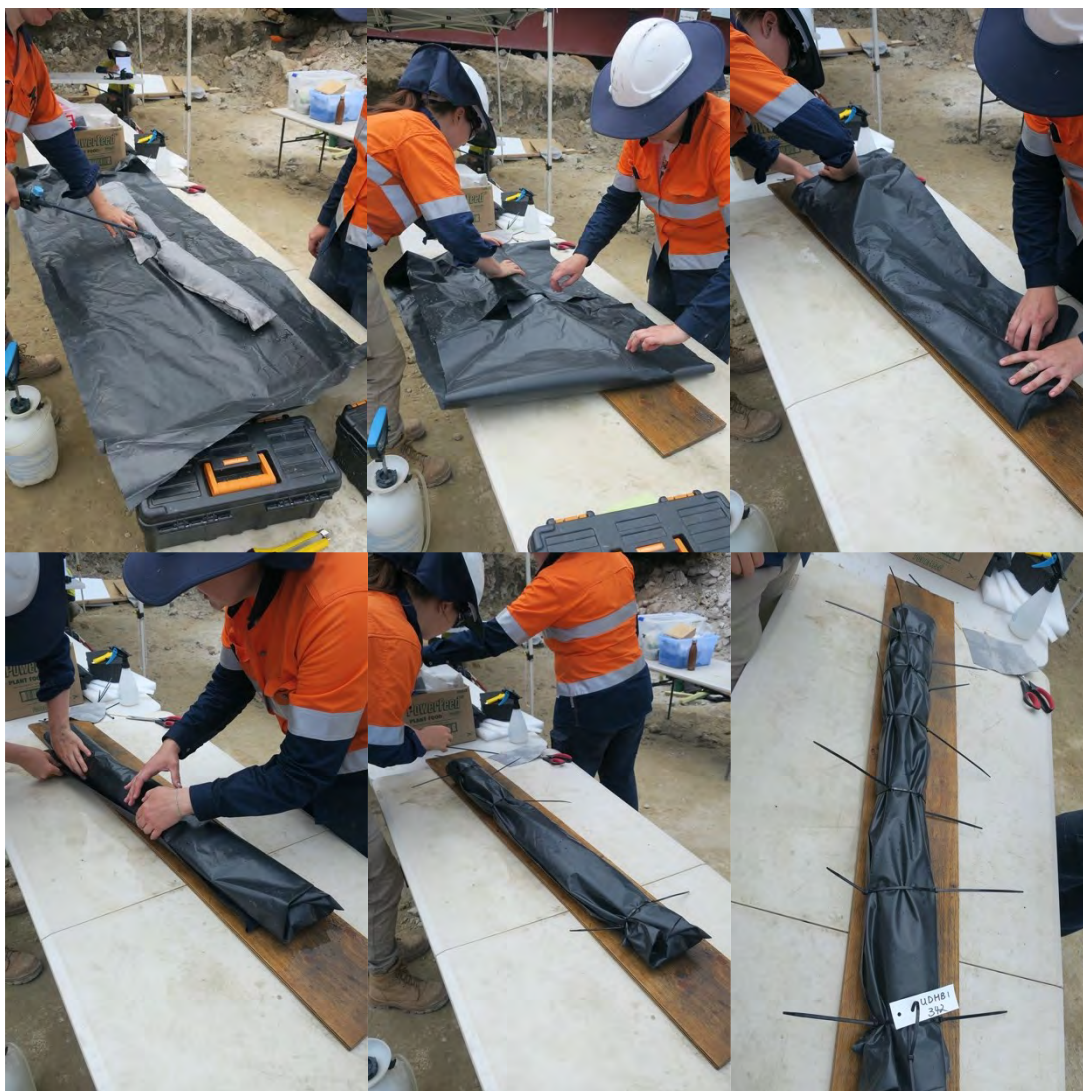
Figure 2.103: Wrapping element in wet geotextile and polyethylene sheet. (Source: Casey & Lowe).

Each element was wrapped in wet Bidim K (a non-woven polyester geotextile) and polyethylene sheet (Figure 2.103). Plastic-spun bonded geotextile was selected due to its ability to hold water and because it would not biodegrade in storage or imprint the wood. It was noted that water would pool due to gravity and that the upper surfaces would be most likely to dry in the event of any storage issues, or delay in the next phase of conservation. Thick polyethylene sheet was used to limit/reduce water loss in cold storage. The edges were folded over to reduce the rate of water loss in storage through the plastic.

The wrapping was secured with nylon cable ties. Cable ties were extended by double or triple connections where required, and the head/s were carefully located to avoid imprinting on the element. An identification label (usually Tyvek and permanent marker) was secured on the outside via one of the cable ties.

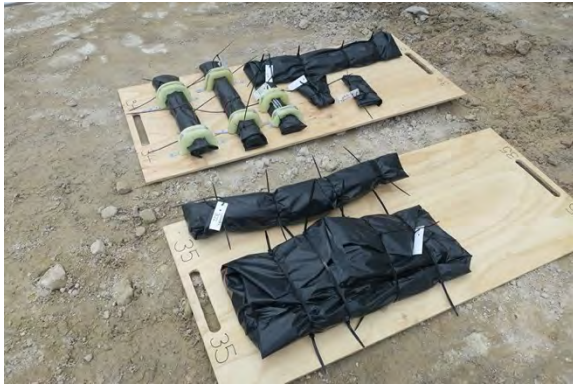
Figure 2.104: Partially packed boards. (Source: Casey & Lowe).

Possible warping and other distortions of the disassembled elements were of concern. To minimise the risk of damage due to any movement, disassembled elements were secured to plywood crates (either a box or board). This reduced the risk of distortion in storage, minimised handling of elements, made future transport easier and used storage space more efficiently (Figure 2.104). Each element was secured to the board or in the box with a series of brackets. 'Carinya Make-A-Bracket'³⁷ was used to prepare custom-made 'saddle' brackets that conformed to the shape of the element and secured it in place (Figure 2.105 to Figure 2.107). Once full, the board/box was placed in cold storage.

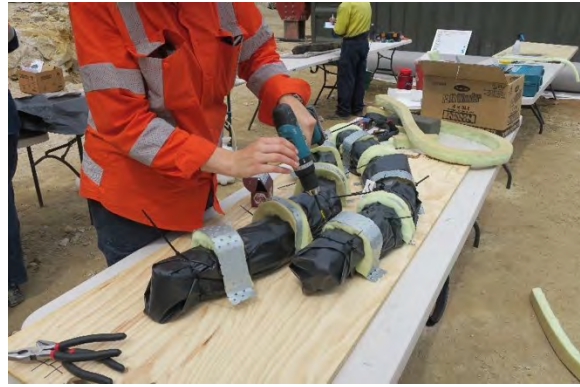
Figure 2.105: Securing elements with 'saddle' brackets. (Source: Casey & Lowe).

Each bracket was padded with strips of polyurethane foam or polystyrene foam to protect the element from the edges of the bracket and distribute the force. For the more solid and stable frame elements that were less prone to distortion, the brackets were padded with polyurethane foam. For the more fragile planks at greater risk of distortion, the brackets were padded with polystyrene foam. Polystyrene was selected as it allowed the bracket to strongly clamp the plank in place, while protecting the surface of the wood.

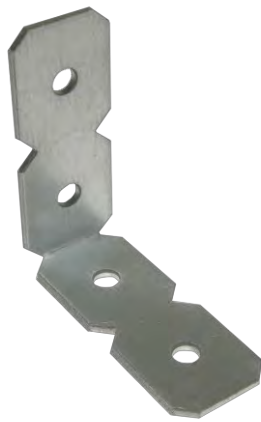
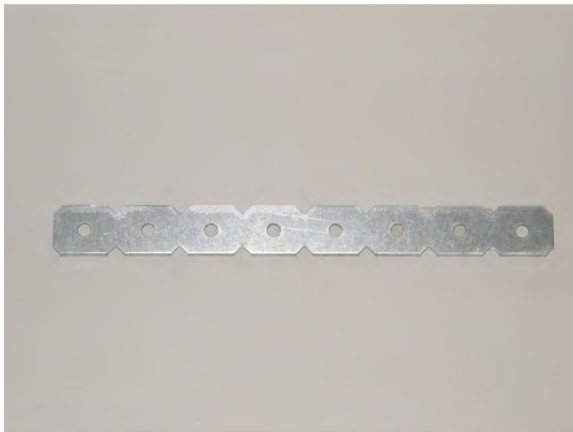
Figure 2.106: Locally available brackets.³⁸

³⁷ Galvanised steel pre-formed strips in various thicknesses, perforated to allow easier folding and shaping, while retaining strength and rigidity.

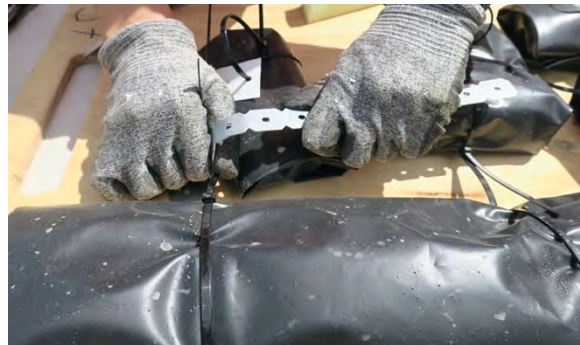
Figure 2.107: Shaping a bracket. (Source: Casey & Lowe).

The brackets were shaped to fit the profile of each element at a specific point - selected prior to packing - with sufficient space for padding. The locations selected for the brackets were

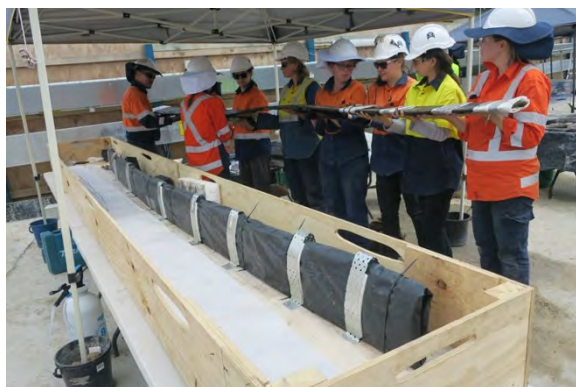
Figure 2.108: Packaged plank. (Source: Casey & Lowe).

The alignment of the elements in storage was also considered, and a determination was made based on risk of distortion and condition. Planks were packed and secured in place upright instead of flat to maintain the existing curvature (Figure 2.110). Unstable or fragile planks were packed and secured flat when upright storage was considered too risky (Figure 2.111). Ethafoam wedges and additional brackets were provided for planks with a significant curvature or lean, where the standard brackets may not have been sufficient.

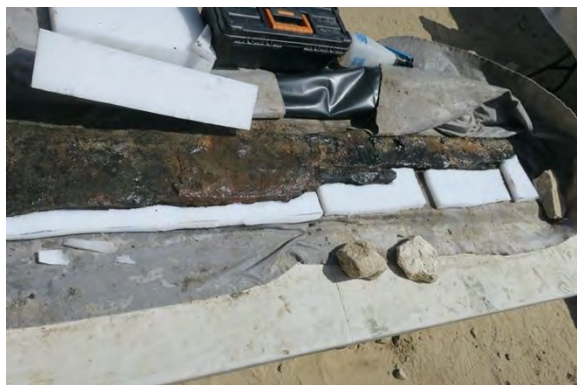
Figure 2.112: Shaped Ethafoam cut-outs to mimic edge. (Source: Casey & Lowe).

Custom padding and supports were placed inside the packing material where required for particularly fragile or damaged elements. This included the use of Ethafoam³⁹ wedges or cut-outs, geotextile rolls or wads, Cell-Aire foam wrapping, cable ties, bamboo skewers and wooden splints (Figure 2.112 and Figure 2.113).

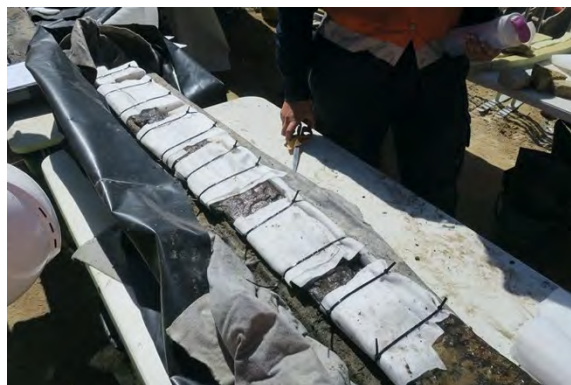
Figure 2.113: Bandaging split element. (Source: Casey & Lowe).

Consideration was also given to the surface texture of the packing material and the risk of imprinting caused by dense or woven materials. Large and numerous splints were wrapped (bandaged) to maintain the correct shape with geotextile or Cell-Aire foam and secured with

cable ties. The heads of the ties were carefully located. Wooden or bamboo splints were incorporated above the bandage if additional structure was required. Geotextile wads or rolls were used when a softer filler of padding was required.

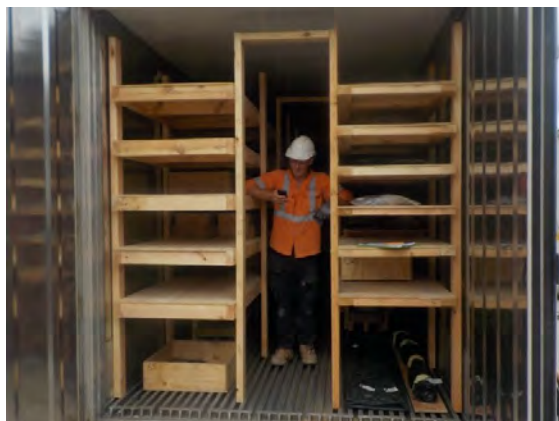
Figure 2.114: Custom-made shelving.
(Source: Casey & Lowe).

Timber and plywood shelving was custom built in the refrigerated containers by the JV carpenters (Figure 2.114). Shelving was designed with different configurations at standard distances for either boards or boxes.

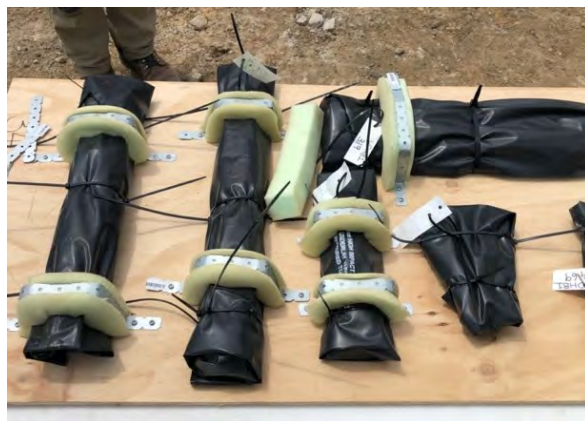
Figure 2.115: Crating on plywood board.
(Source: Casey & Lowe).

During Phase 5, smaller disassembled elements such as frames or other components were secured to plywood boards (Figure 2.115). Boards were used for easier handling and access and reduced manual handling risks. Handles were cut into the short end of each board. Larger or longer elements were packed in custom-built plywood boxes (Figure 2.116). Planks were packed upright in plywood boxes, nesting one another where there was a distinct curvature.

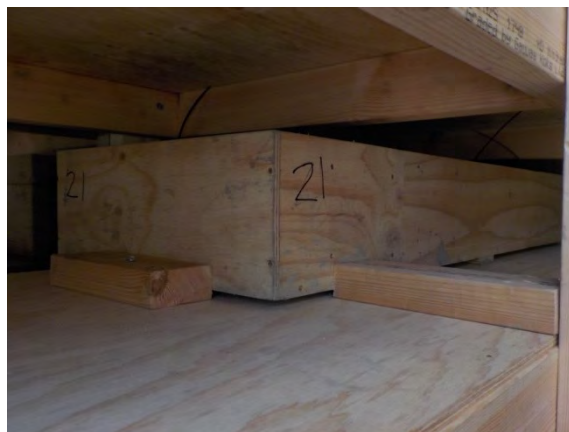
Figure 2.117: Crate secured for transport.
(Source: Casey & Lowe).

The crates and boards were secured to the plywood shelves with bolts, or wedged in place with bolted blocks in preparation for the containers to be transported to the conservation facility (Figure 2.117).

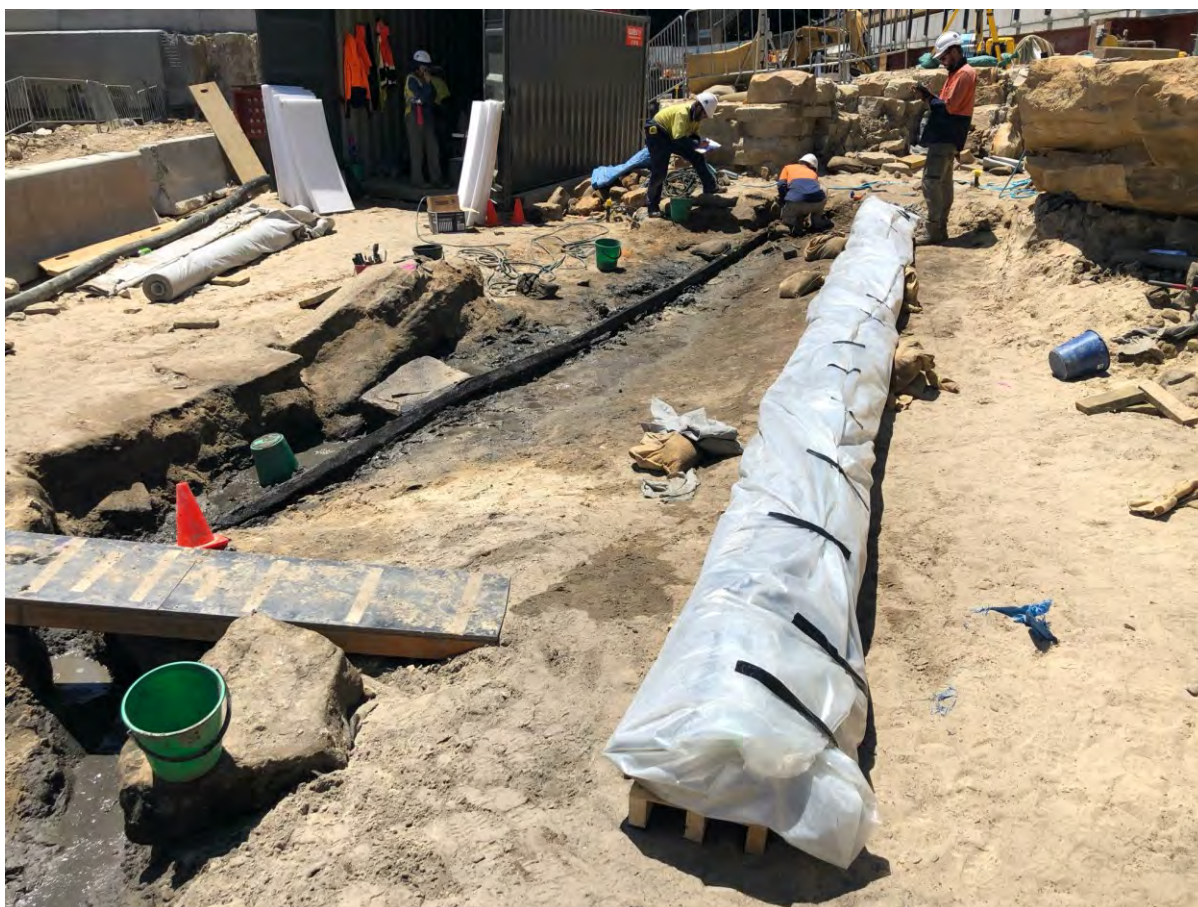
Figure 2.118: Temporary wrapping of the keel (right) with the rider keel in situ (left). (Source: Cosmos Archaeology).

Packing stations were prepared so packing could commence as soon as each element of the keel was removed. The keel was lifted and moved to the packing station. Prior to the lowering of the keel onto the base of the box, the keel was held in place by the lift team, and the wrapping material was unrolled on the base of the box. The keel was immediately placed down. Where there was a gap between the keel and the wrapping material (due to distortion) the area was padded with polyurethane foam offcuts. The geotextile and foam padding was saturated with water and the keel was wrapped in the same manner as the other elements (see above). The keel was wrapped temporarily to allow for the removal of all the keel

elements to be completed (Figure 2.118). The removal and placing of the two rider keel elements followed the same process.

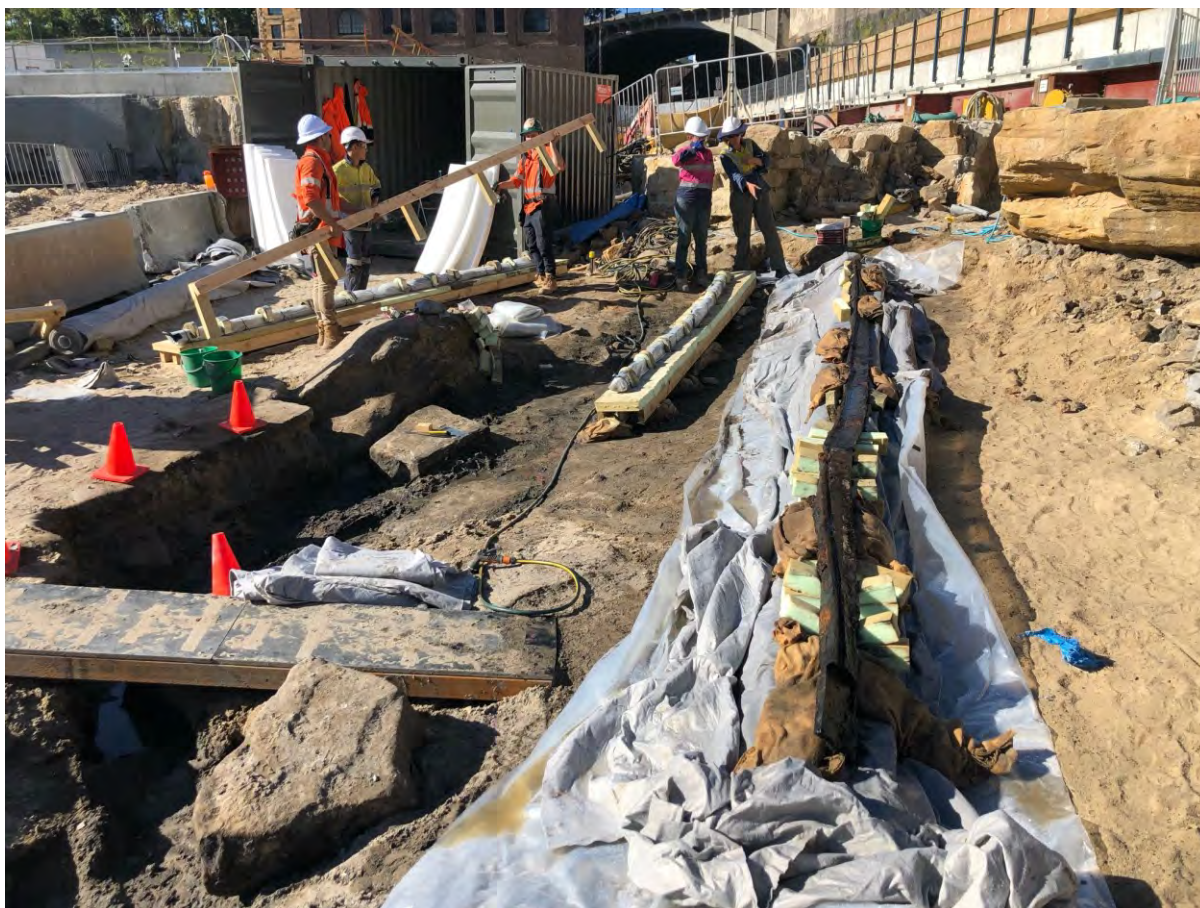
Figure 2.119: Carpenters installing the sides to the crates (left), keel unwrapped for recording prior to packing for storage (right). (Source: Cosmos Archaeology).

Once all elements had been removed from the wreck site, packing of the keel elements could occur at this location. Each element was wrapped securely with an initial layer of wet geotextile and a waterproof polyethylene outer layer (Figure 2.119). The edges of the plastic film were placed on the upper surface and folded over double to reduce water loss. Custom brackets were shaped using wider 'Carinya Make-A-Bracket' to provide additional strength. The brackets were secured through the polyurethane base into the plywood base with large hex-head screws (Figure 2.120).

Once the element was safely padded, packed, and secured, the crate could be constructed. An open crate (or stillage) was designed and sides were installed into the base and secured by cross bracing at the top (Figure 2.119).

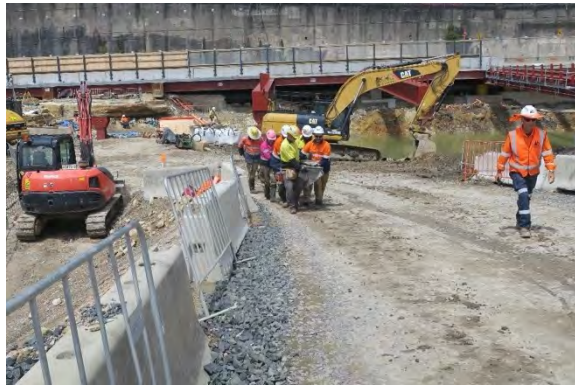
Figure 2.122: Carrying element from boat to processing area. (Source: Casey & Lowe).

The packed boards and boxes were heavy and required large teams to handle them, impacting the project (Figure 2.122 to Figure 2.125). Recommended improvements included

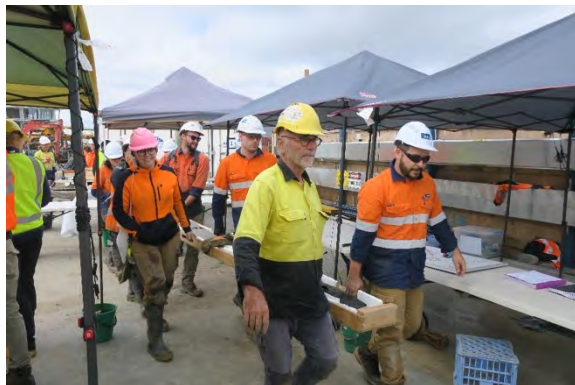
Figure 2.124: Delivery to processing area. (Source: Casey & Lowe).

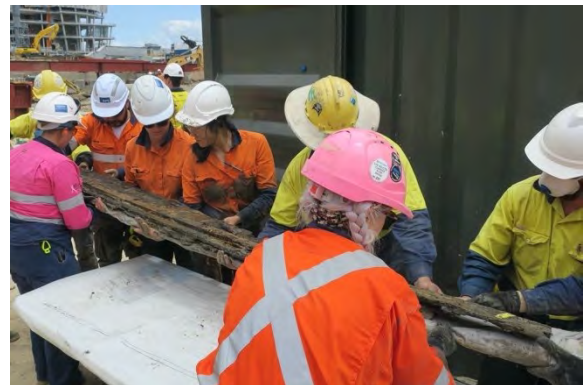
Figure 2.125: Delivery to processing area. (Source: Casey & Lowe).

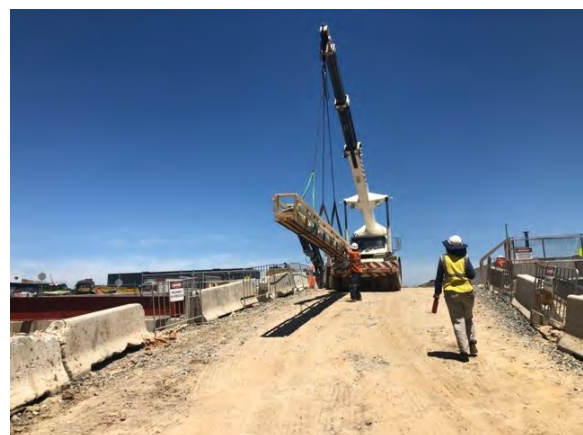
Figure 2.127: Crane lift of keel. (Source: Cosmos Archaeology).

The crated keel components were oversized and handling was minimised by crane lifts to relocate the components to the storage area and place them into the storage container (Figure 2.126 and Figure 2.127).

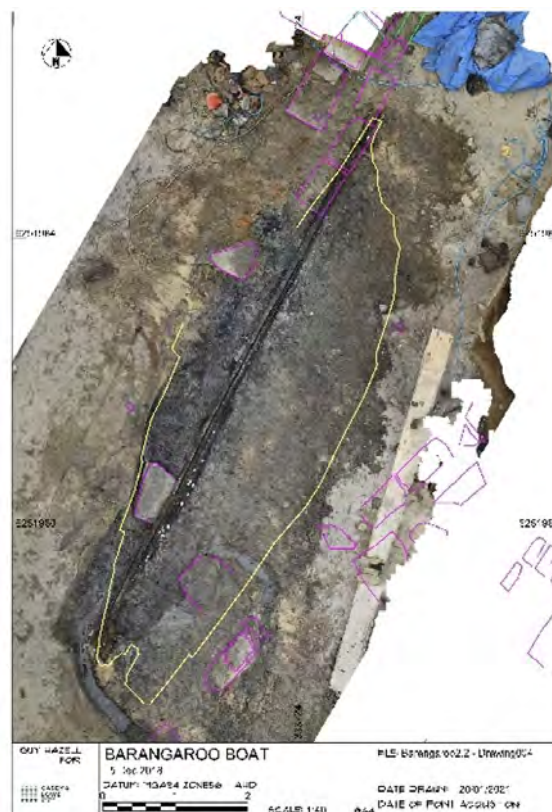
Figure 2.129: Wreck with only keel remaining, 5th December 2018. (Rendered by Guy Hazell).

Photogrammetry during this disassembly phase took place after the frames were removed (Figure 2.128) and when only the keel remained (Figure 2.129). A total of 4,873 photographs, for photogrammetry and general recording, were taken over the duration of the

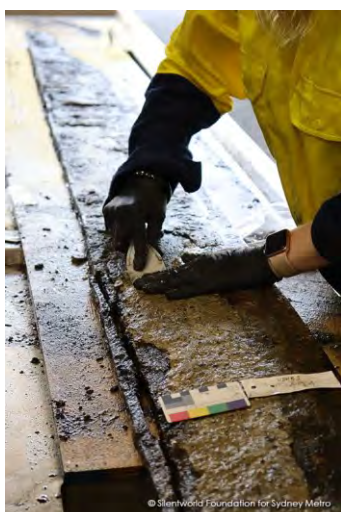
Figure 2.130: White material, which may have been for anti-fouling, being removed from a plank during the cleaning process. (Source: Silentworld Foundation for Sydney Metro).

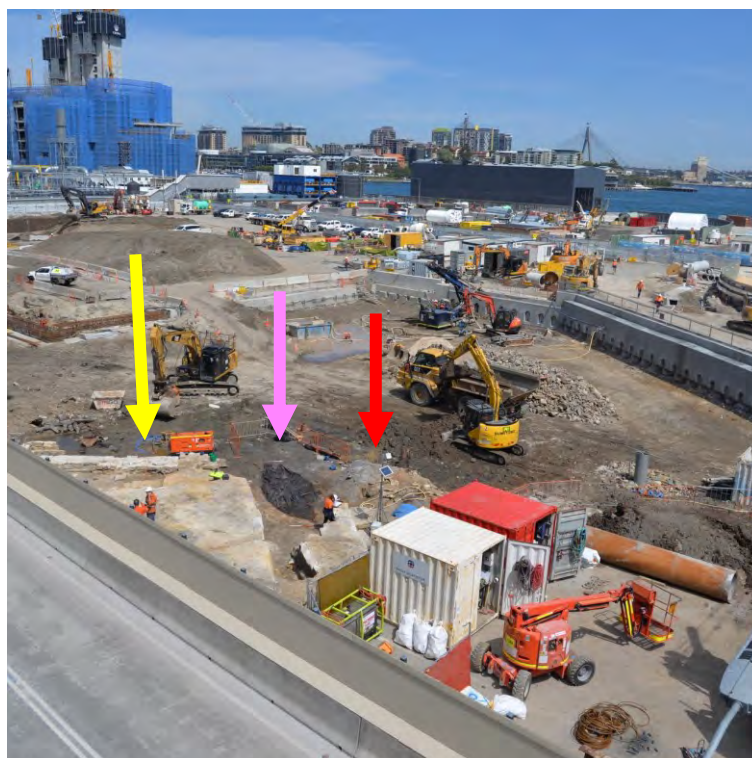
Figure 3.2: View of UDHB1 (pink arrow) looking to the south west. Hickson Road in foreground. Remains of Langford's house (yellow arrow) and location of Cuthbert's sawshed (red arrow). (Source: Casey & Lowe).

The wreck of UDHB1 (context 140) was found at the foot of the historical location of Clyde Street (see Section 4.3.5.3 in Volume 1 Main Report). It was located in a former intertidal zone, between Langford's boatyard to its immediate east and the open water to the west (Figure 3.1 and Figure 3.2). William Langford's boatyard operated from around 1833 up until possibly the late 1870s/early 1880s, while John Cuthbert, who appears to have started his business further west along the shore of Darling Harbour as early as 1849, did not acquire the land adjacent to the wreck until the late 1850s.

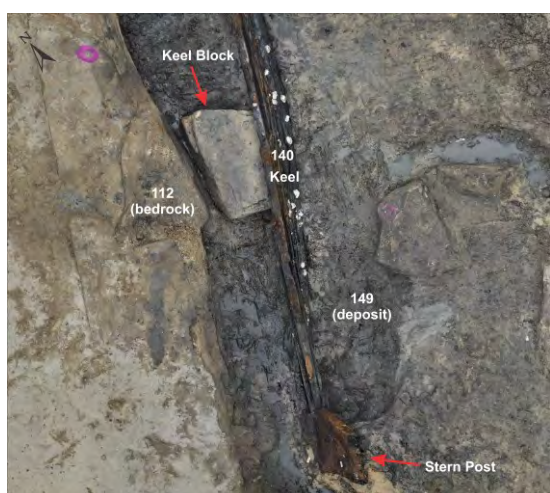
Figure 3.3: Detail of photogrammetry of the stern with the keel remaining. The keel block which kept the vessel in place is *in situ*. Note the oyster shell on the keel indicating how this part of the wreck was almost always immersed. (Photogrammetry by Guy Hazell).

The vessel was resting on its starboard side with a cut sandstone block (no context assigned) underneath its portside keel (Figure 3.3 and Figure 3.4).⁴⁷ This block, with oyster shells on its underside, had been deliberately moved into position under the vessel to keep it in place. This indicates that the vessel did not sink at its moorings adjacent to Langford's western wharf wall (145) or drift into the small cove and beach itself. It is likely to have been

The hull had been distorted over time on the starboard side where it had been chocked with a sandstone block/ashlar (see Figure 3.3 and Figure 3.4). To correct this distortion, first, a photogrammetry model of the shell of the hull after the framing had been removed was processed into station, buttock, and waterlines to be able to adjust the lines where necessary (Figure 5.10 and Figure 5.11). Distortion is seen between Stations 2 and 3 and are most apparent in the breadth-plan in Figure 5.12. The lines were faired at this point.

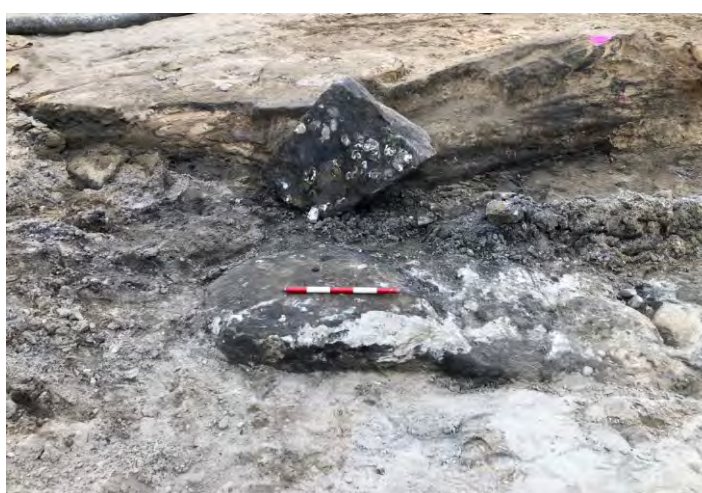
Figure 3.4: View to the west of keel block after keel has been removed. The keel block has been moved to reveal the underside of the block. The oysters present indicate the block was moved into this position and in its new location oysters did not grow on the exposed surface. Perhaps the top of the block was often out of the water. Scale in 100 mm increments.

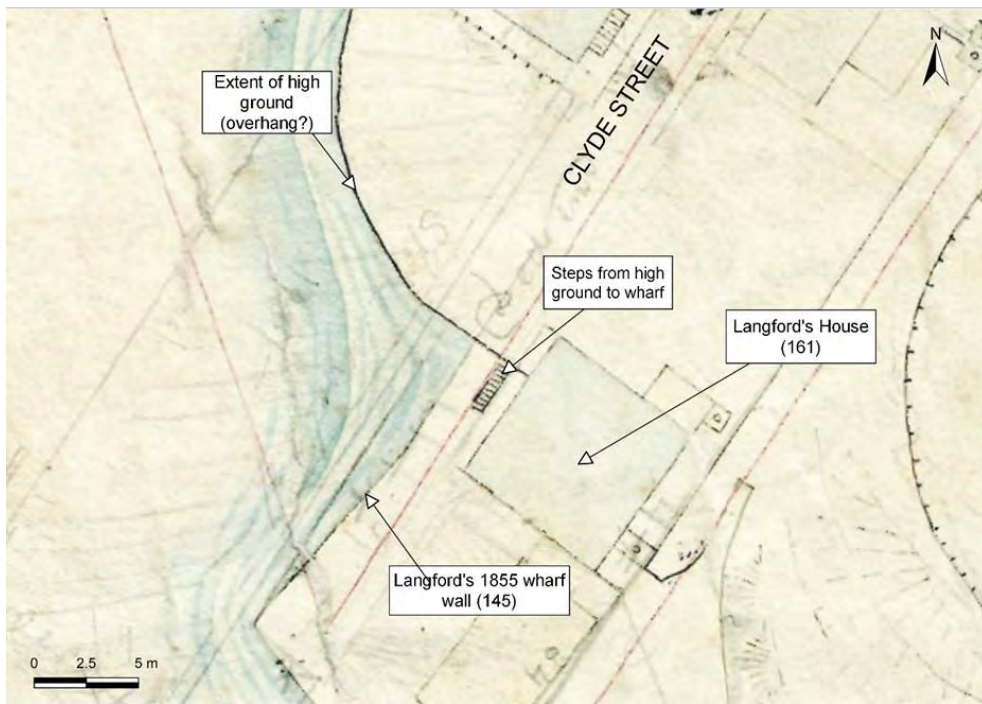
Figure 3.5: 1855 plan showing Langford's wharf and small beach to the north. ⁵⁰

The earliest definite depiction of the western wall (context 145) of Langford's wharf dates to an 1855 plan of the area (Figure 3.5). A plan from around 1833 however, which clearly shows Langford's house (107), also shows a rectangular projection which does not appear to align squarely with Langford's western property boundary, as is the case with the western wall (145) of the wharf in the 1855 plan (Figure 3.6 and Figure 3.7). This projection may be an annotation on the base map indicating a later addition but a drawing dated to 1835 shows that this projection seems to be present (Figure 3.8).⁴⁹ It is unclear whether what is depicted is a timber structure or reclamation.

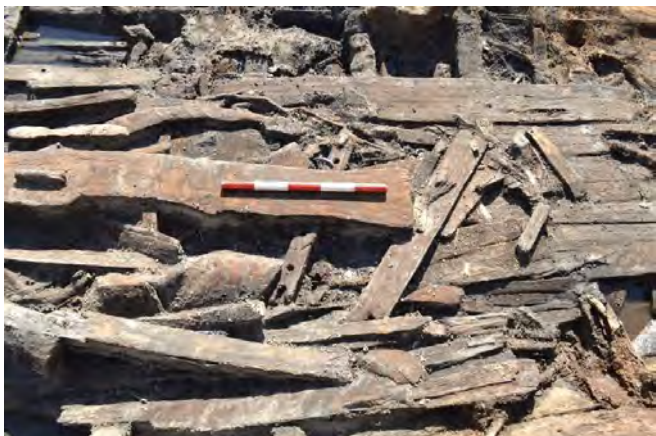
Figure 3.16: Loose timbers (148) within the wreck (140) were a mix of flotsam that came in with the tide, offcuts of frames, planks and rigging from presumably Langford’s boatyard. (Source: Casey & Lowe).

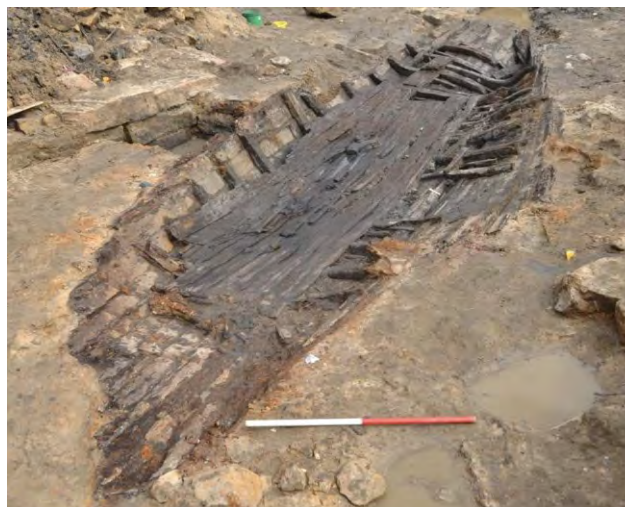
Figure 3.17: Ceiling planking sealing deposits in the bilges can provide information on the voyages of the vessel and when it was abandoned.⁶³ (Source: Casey & Lowe).
